STAFF REPORT

RE: **Key West Historic Seaport (permit application # T18-8977)**

FROM: Karen DeMaria, City of Key West Urban Forestry Manager

An application was received requesting the review of a conceptual landscape plan in association with the proposed renovations at the Key West Historic Seaport area. This review will be discussed in stages.

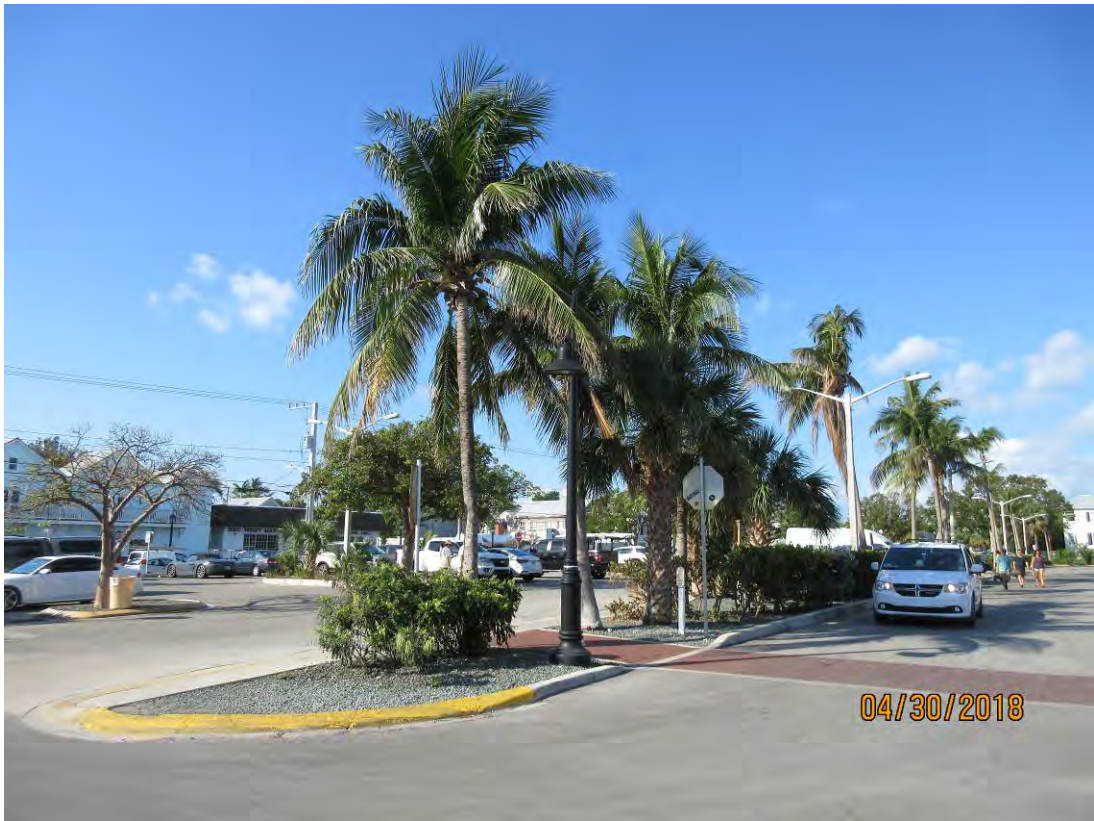
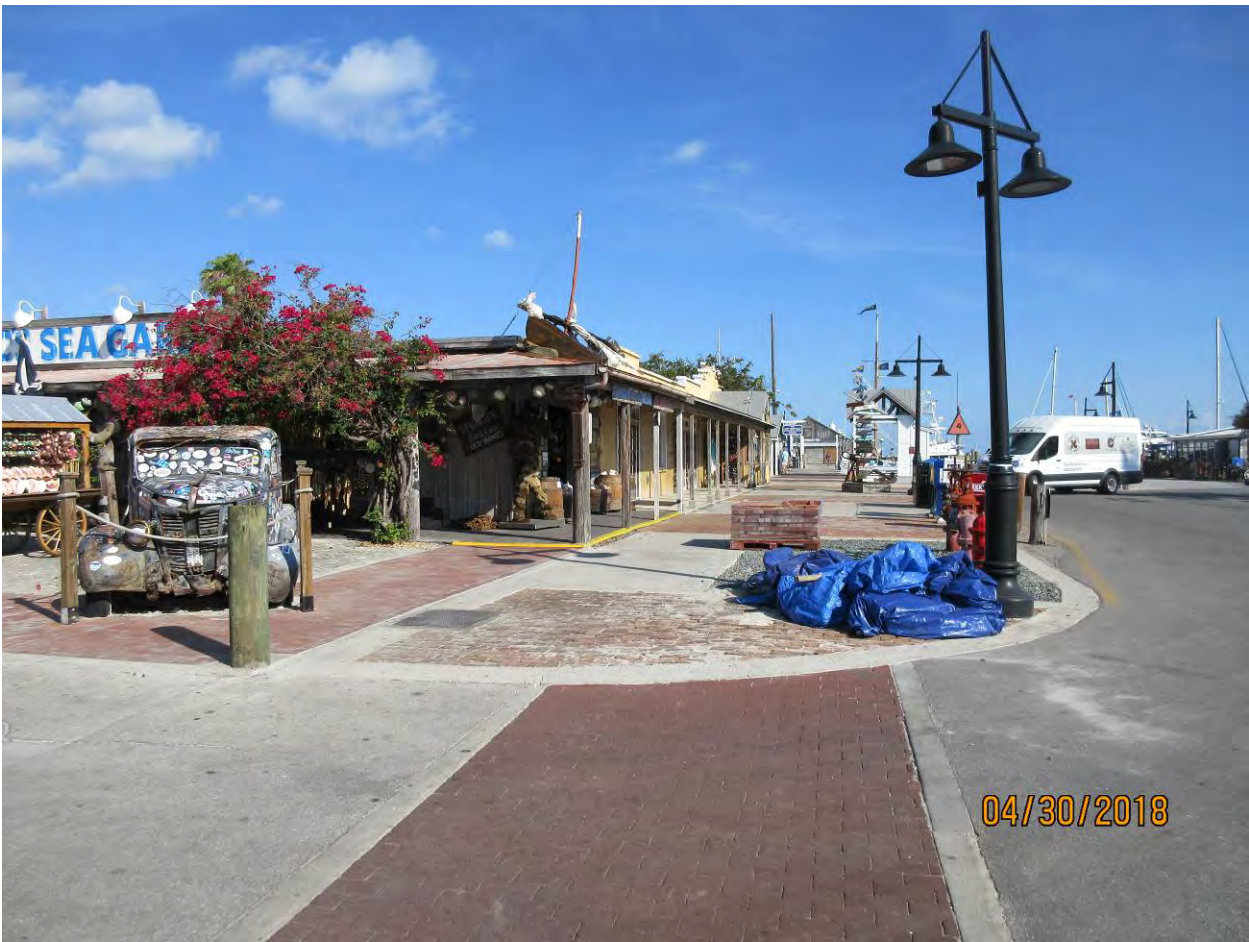
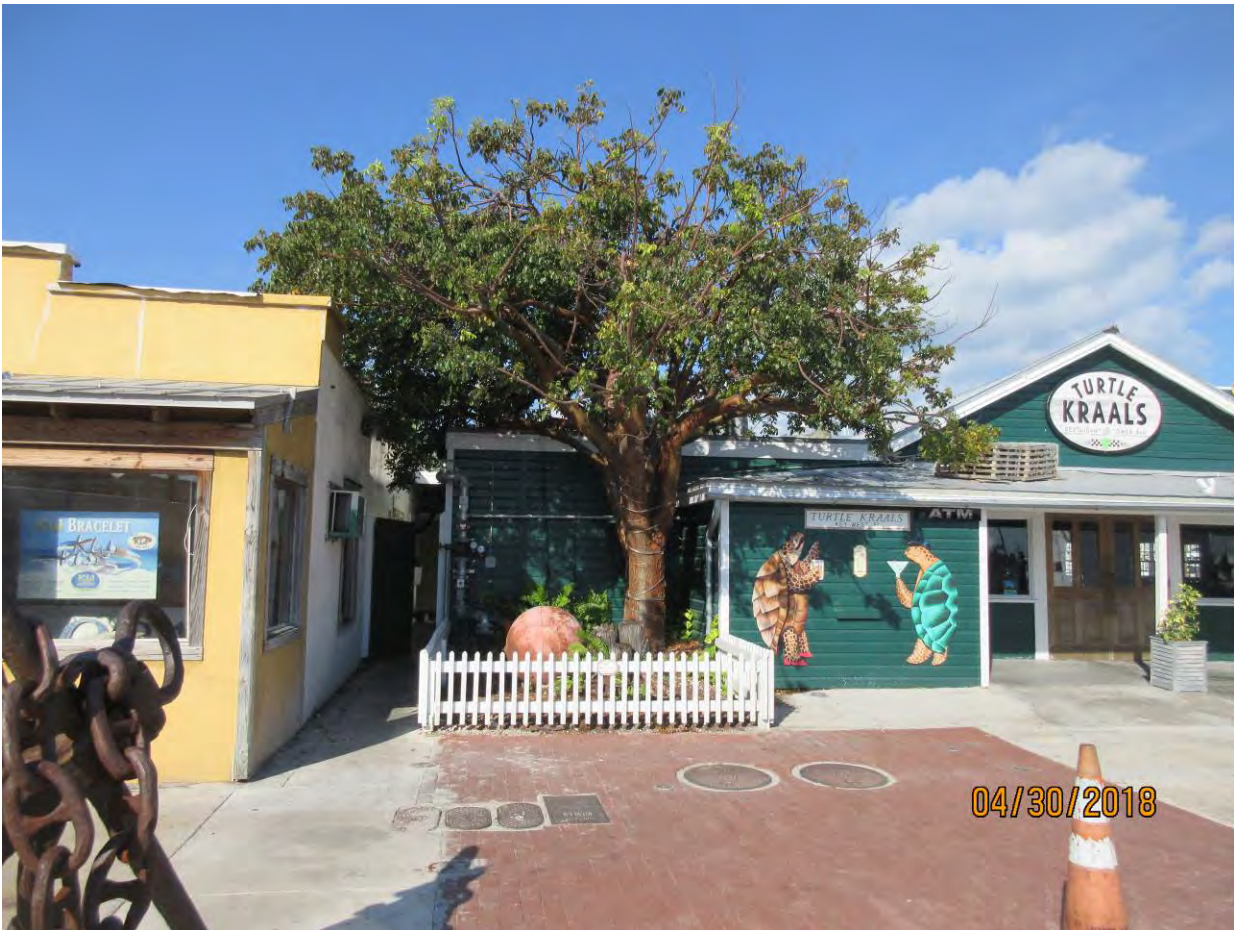
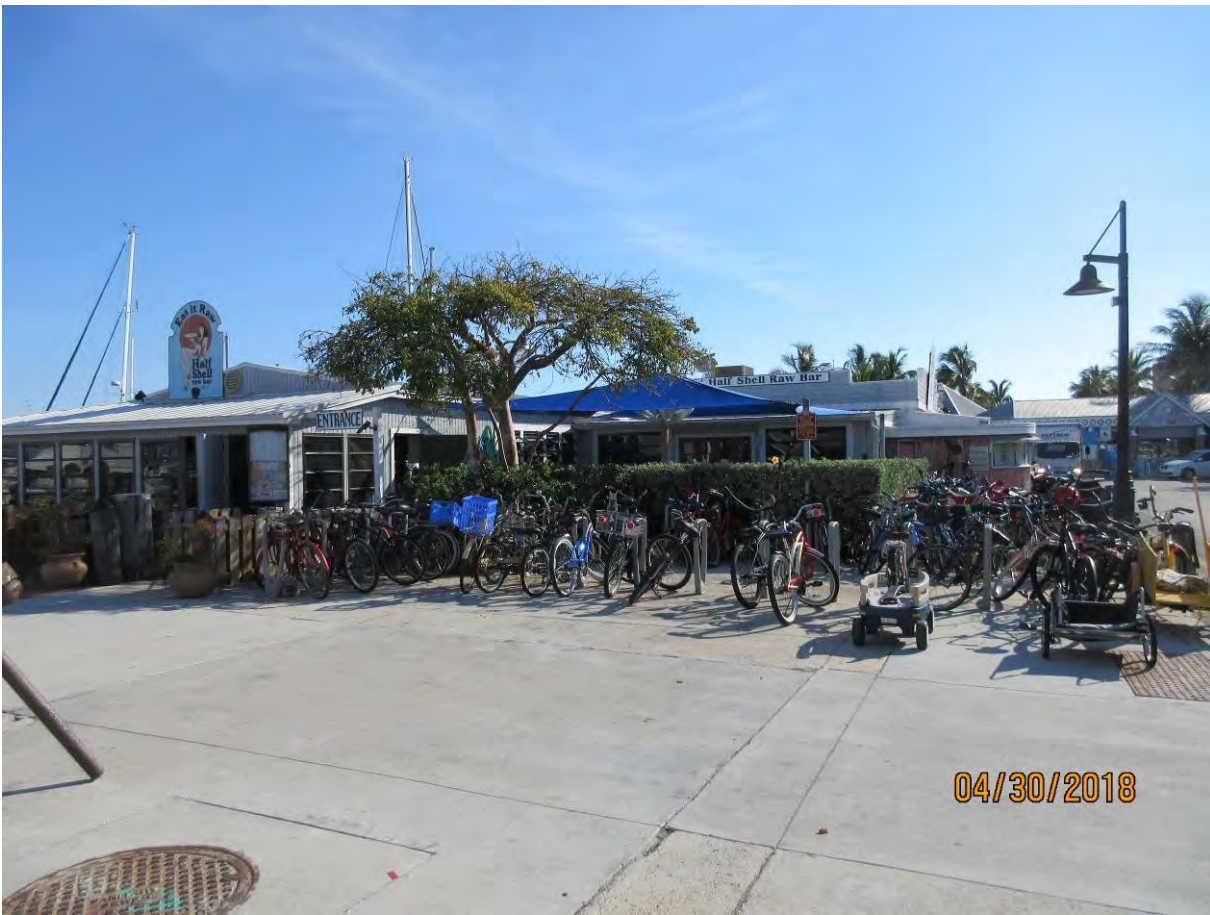
Below are recent photos of the proposed work areas. All existing palms and trees are to remain and the area enhanced with additional landscaping.

The landscape plan proposes to add tree planters with Pigeon Plum trees along the Margaret Street store front area. Would possibly like to see two or three different species of trees instead of all seven new trees being the same species or is there a certain look for the area that is being developed? The landscape plan says Thatch palms will be transplanted into this area. Where from and where on the plans?
