RFP # 001-19

## FORMER KEYS DIESEL PLANT STABILIZATION & REDEVELOPMENT

PREPARED BY:  
City of Key West  
Engineering Services

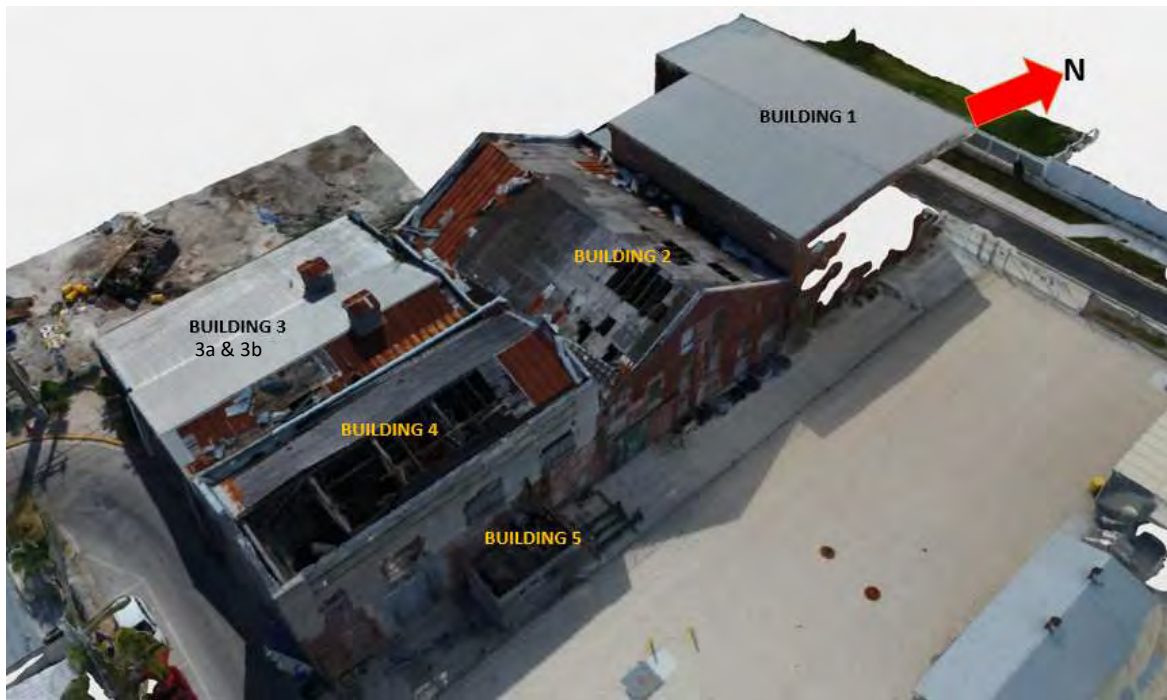
**Figure 1:** Aerial view of the KWDP from the South-East of the property.

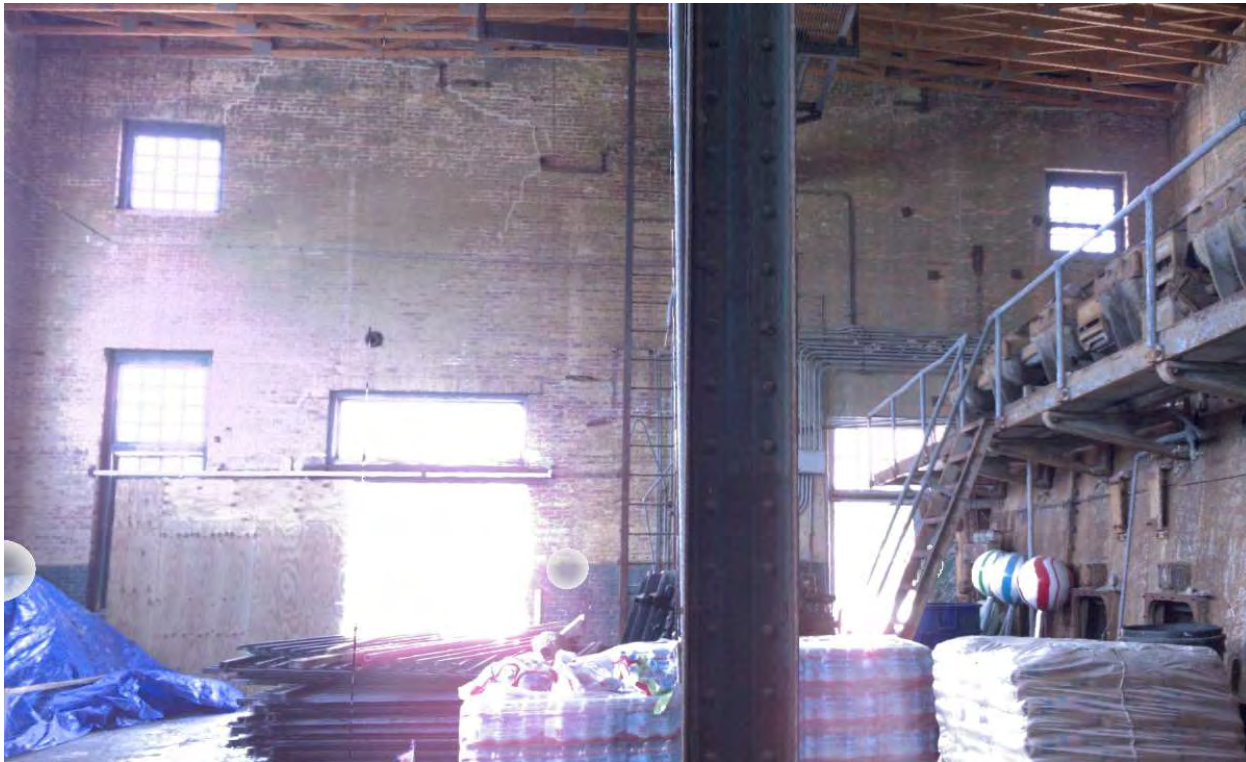
**Figure A2.1:** Building 1, Interior Wall A Elevation from 3D view.

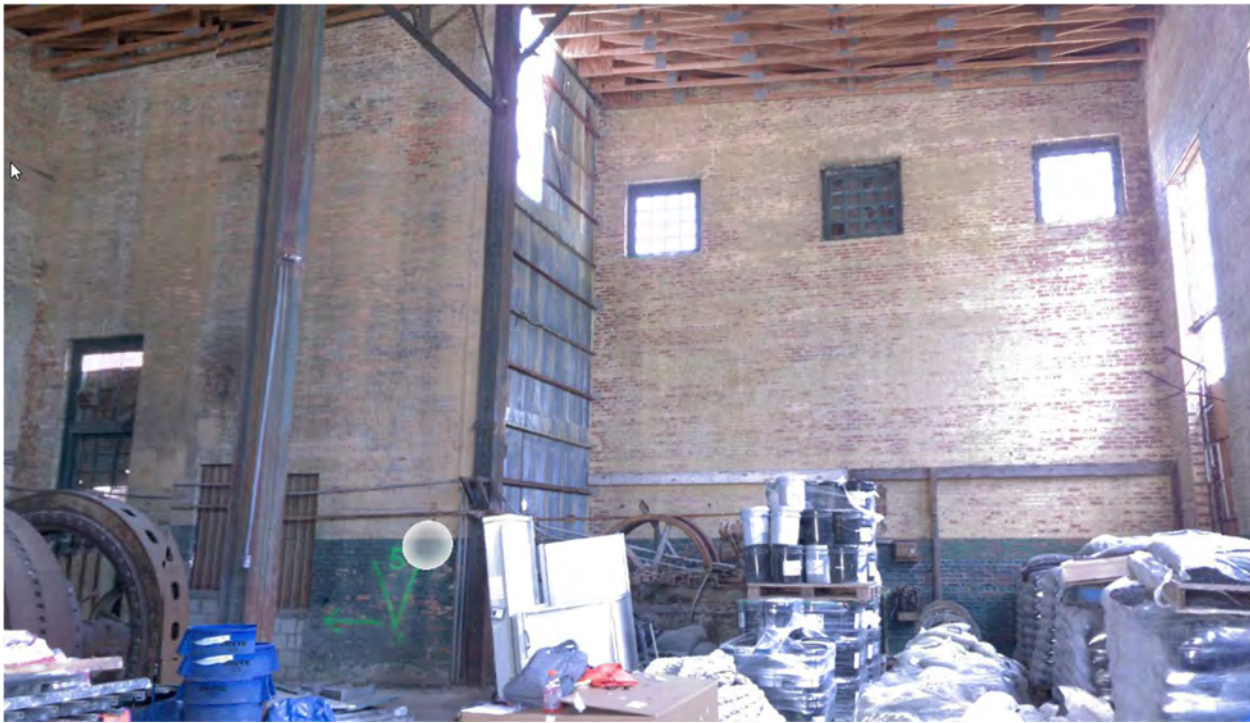
**Figure A4.1:** Building 1, Interior Wall C elevation from 3D view.

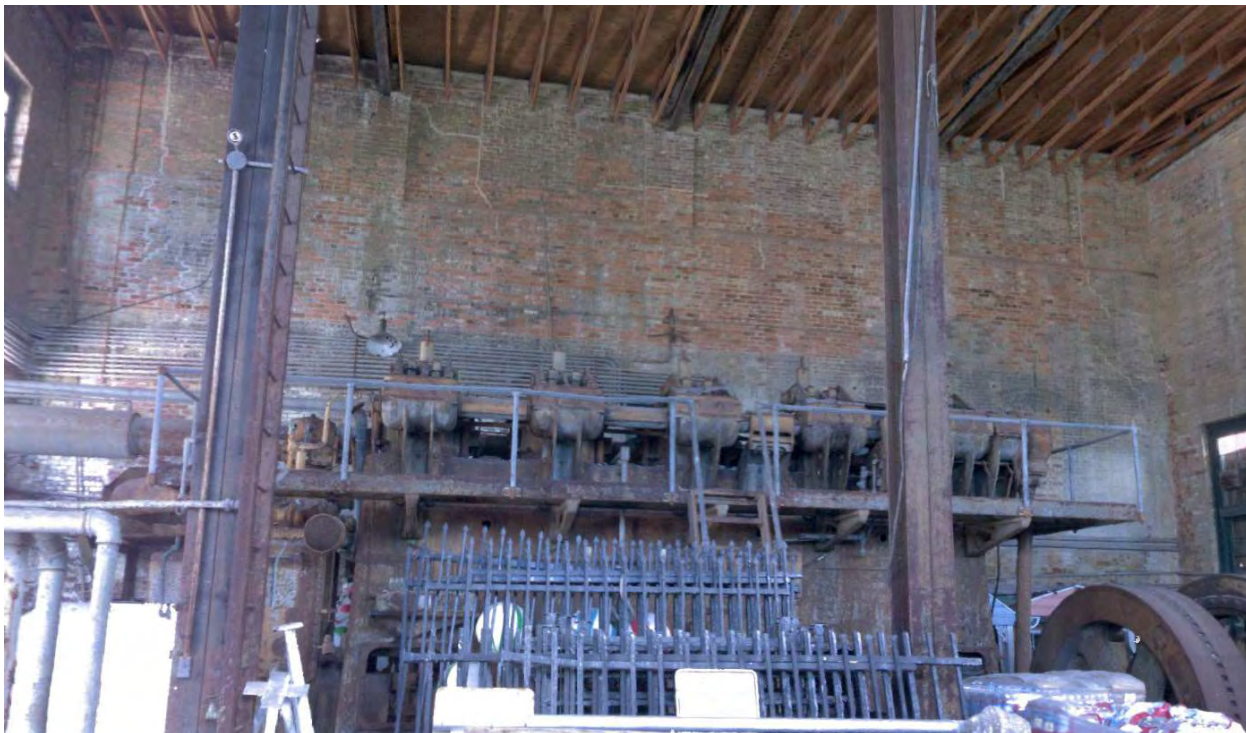
**Figure A5.1:** Building 1, Interior Wall D elevation from 3D view.

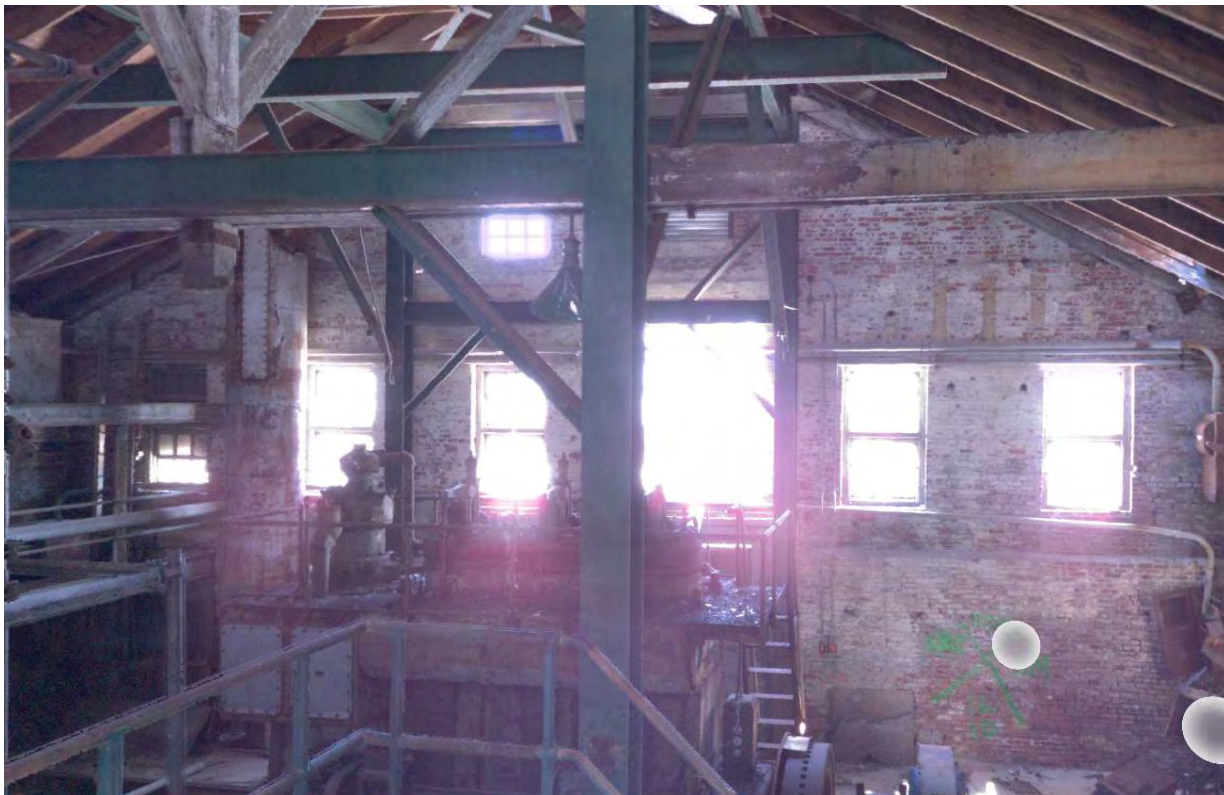
**Figure B4.1:** Building 2, Wall C, interior elevation from 3D view.

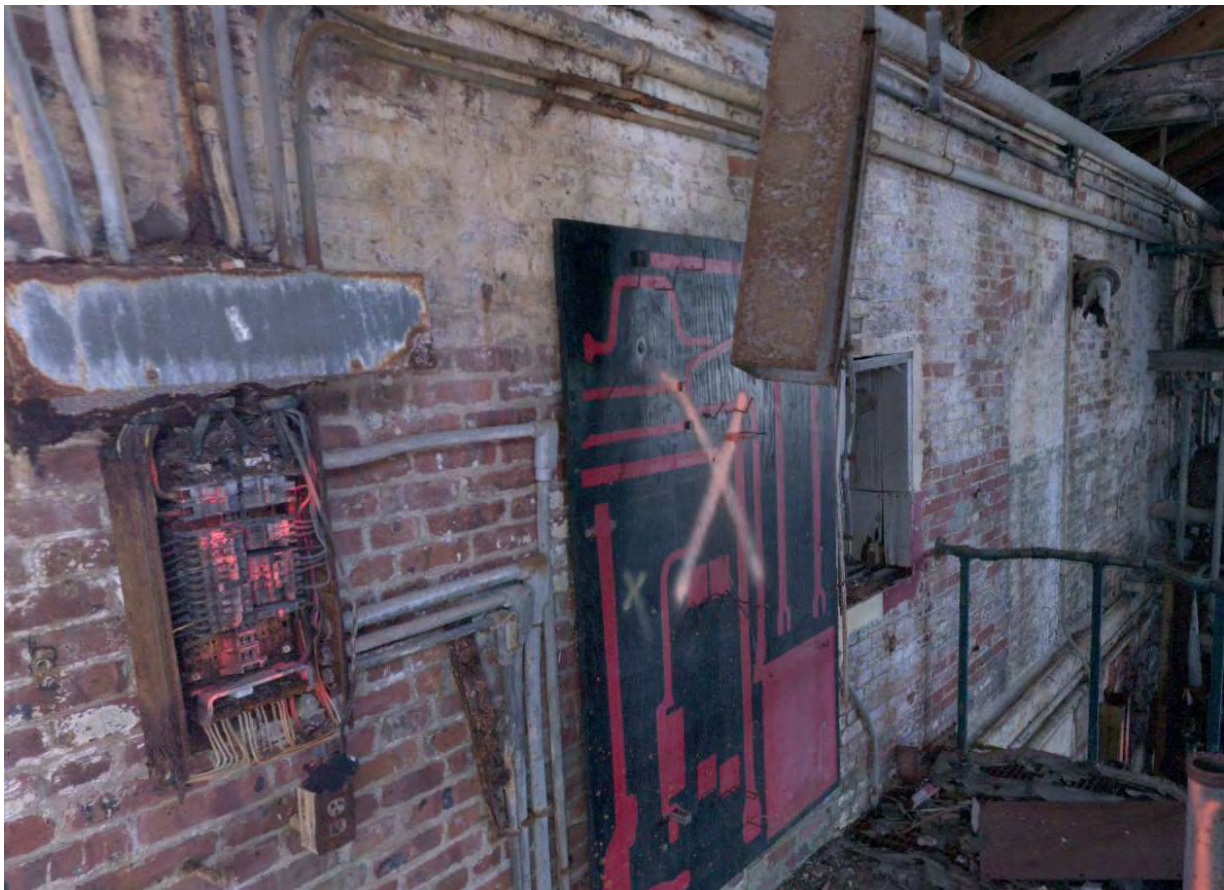
**Figure B5.1:** Building 2, Wall D interior elevation from 3D view.

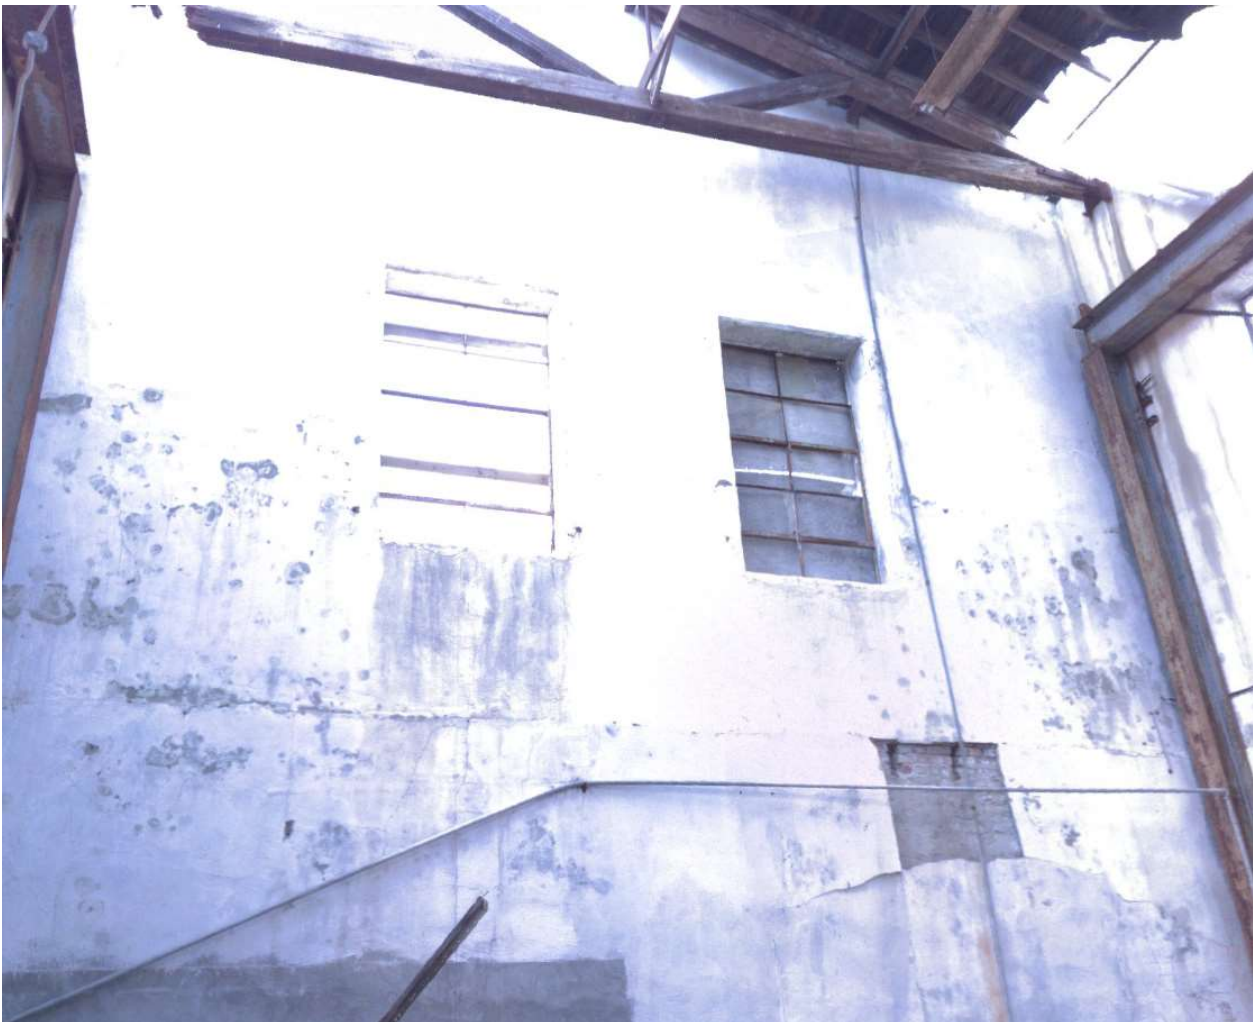
**Figure C7.1:** Building 4, Wall C interior elevation from 3D view.

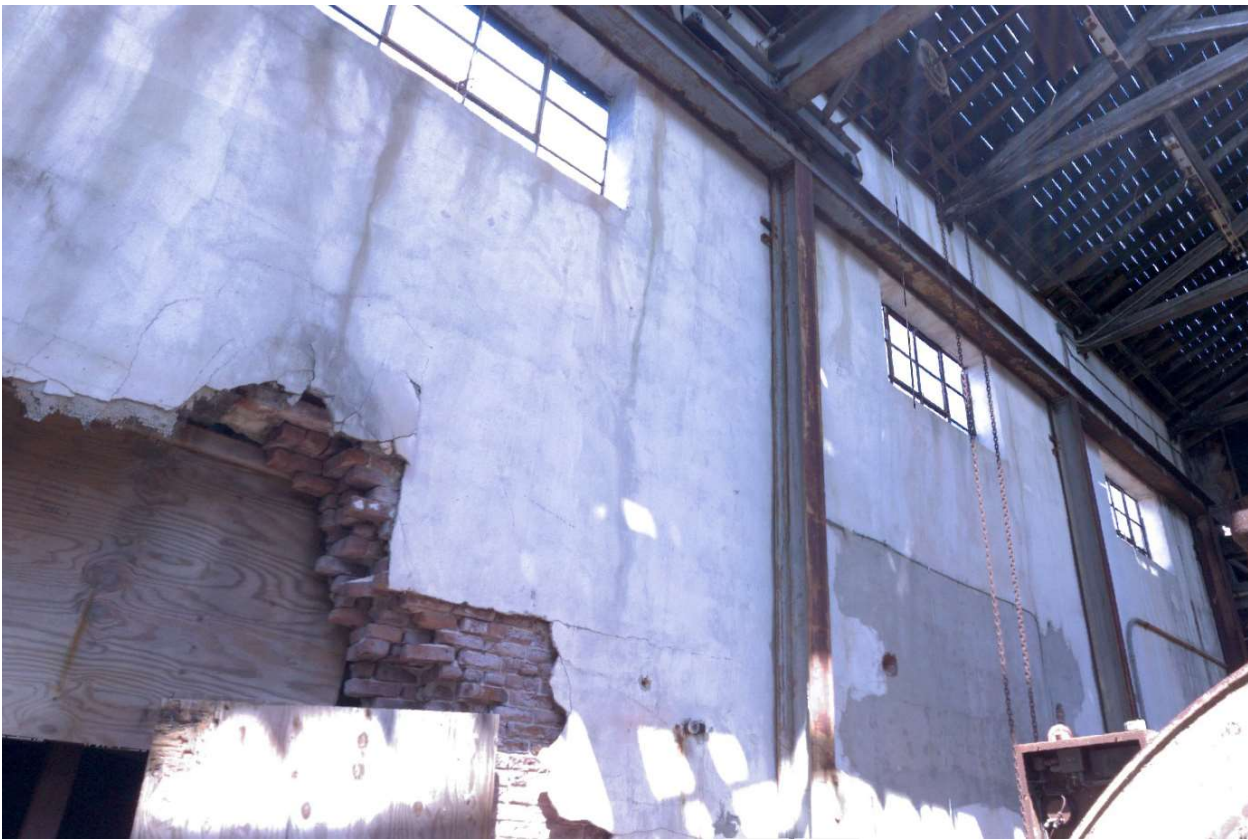
**Figure C8.1:** Building 4, Wall D interior elevation from 3D view.
