Single-Family Home Rainwater-Harvesting System Demonstration Project For Stormwater-Runoff Control and Utility-Water Saving

Hammerstrom, J. and T. Younos. 2014. Single-family home rainwater-harvesting system demonstration project for stormwater-runoff control and utility-water saving. The Cabell Brand Center Special Report No. 100-2014, 34 pp.

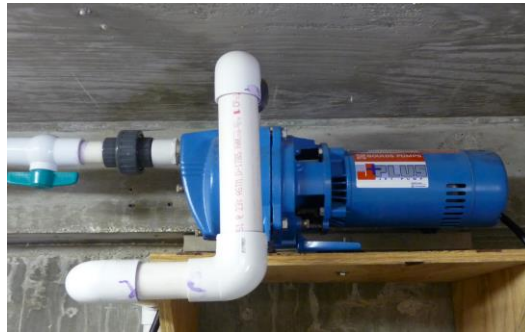
Figure 9

foot valves by a $\frac{3}{4}$ hp Jet Pump shown in Figure 9. Water pressure is maintained by an 80-gallon pressure tank (Figure 10). For treatment, rainwater flows from left to right through the three canisters of a Pura Big Boy UVBB3, filtration, and 115-volt ultraviolet system (Figure 11). The first canister houses a dual-density polypropylene sediment filter, (nominal 25-micron pre-filtration and 1-micron post filtration), the second houses a 5-micron nominal carbon block and the final canister is the UV chamber for disinfection (Figure 11). After final treatment, the treated rainwater flows through the selection valves (Fig. 7) to the household fixtures.

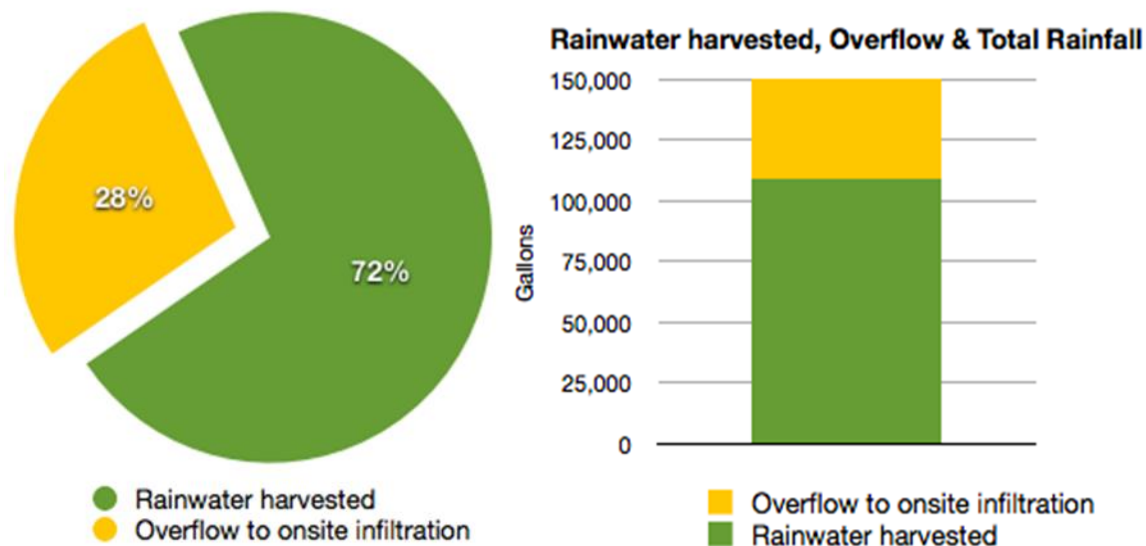
Seventy-two percent (72%) of the total 150,500 gallons of rain that fell on the rooftop—or 108,850 gallons—was captured for household and landscape uses (Figure 13). The remaining 41,650 gallons (28%) was overflowed to an onsite spreader swale (Figure 6). Thus, the residential water system allowed for total onsite use of rooftop rainwater with near zero stormwater runoff.

Figure 13 Harvested rainwater and use
