RE: 1319 William Street and 1316 Royal Street Final Approval

FROM: Karen DeMaria, Urban Forestry Manager, City of Key West

DRAWING NUMBER
	L.401
	DRAWING NAME

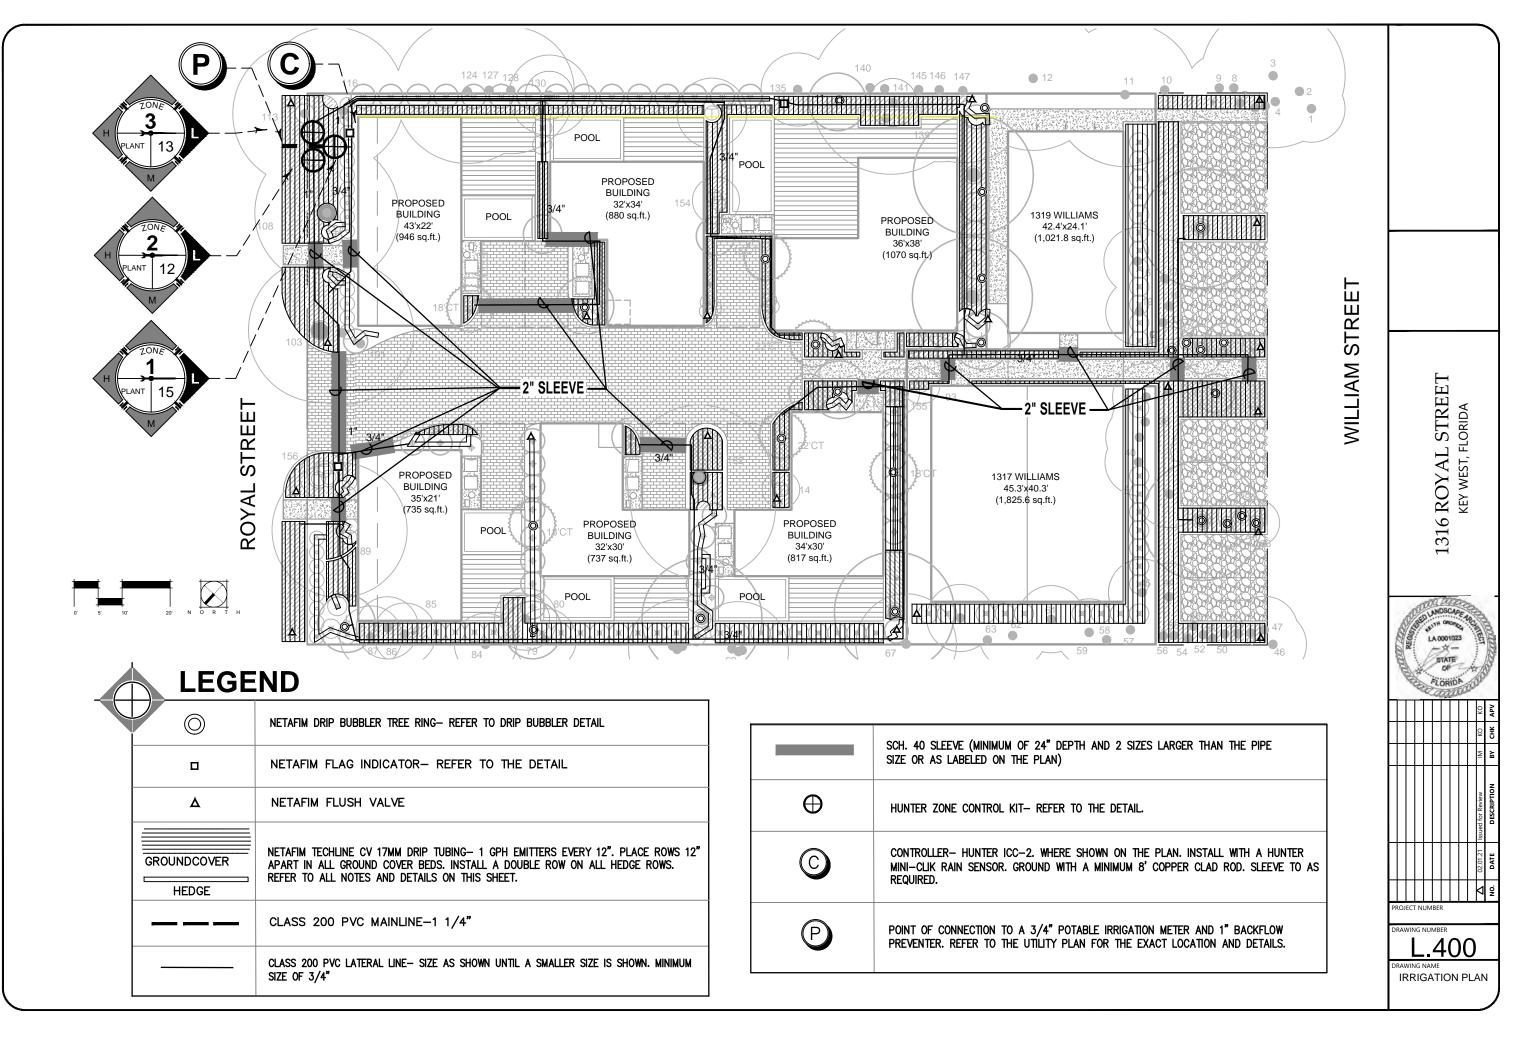
ZONE CHART

ZONE	PLANT (TYPE)		(DEMAND)	PRECIP. (RATE) (I	APPLIC. N. PER WEEK REC	GPM	MINUTES (PER CYCLE)	TOTAL (GALLONS)
1 2 3	PLANT PLANT PLANT	DRIP DRIP DRIP	LOW LOW LOW	1.5 1.5 1.5	0.5 0.5 0.5	15 12 13	10 10 10	150 120 130
						40	30	400
								800

THE RUN TIMES SHOWN FOR THE ZONE IS FOR ONE RUN CYCLE AND WILL PROVIDE HALF THE REQUIRED AMOUNT OF WATER NEEDED PER WEEK. TWO RUN CYCLES PER WEEK ARE REQUIRED TO PROVIDE THE TOTAL WEEKLY REQUIREMENT. ALL RUN TIMES SHALL BE SET TO FOLLOW THE CURRENT WATER MANAGEMENT DISTRICT REGULATIONS AND REDUCED TO ONLY ONE RUN TIME PER WEEK WHEN RESTRICTED BY DAYLIGHT SAVINGS TIME OR WATER RESTRICTIONS. THE ZONE CHART IS PROVIDED AS A GENERAL OUTLINE ONLY. THE CONTRACTOR SHALL BE RESPONSIBLE TO SET THE RUN TIMES BASED ON THE SPECIFIC SITE CONDITIONS AND PLANT REQUIREMENTS. THIS SHALL INCLUDE, BUT NOT LIMITED TO, SOIL TYPE, DRAINAGE, SLOPES, SUN EXPOSURE AND THE ESTABLISHMENT PERIOD. THE TOTAL GPM REQUIRED PER YEAR WILL BE LESS THAN THE PEAK DEMAND PER WEEK TIMES 52 WEEKS, BASED ON THE RUN TIMES BEING REDUCED BY SENSORS AND A REDUCED WATER DEMAND IN THE WINTER MONTHS.
