#### **Historic Architectural Review Commission**

#### Staff Report Item 8

#803 Emma Street

Structural stabilization and repairs

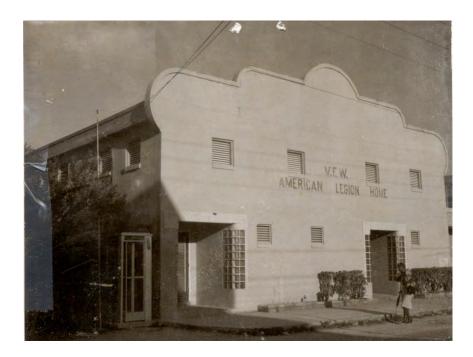
Historic 1965 photo of front façade. Note that corners at doorways had glass block, with what appears to be a steel column behind it at each corner. It is likely that the glass block still exists, and was just stuccoed over. As part of ALTERNATE #1, Contractor shall carefully remove stucco at glass block locations. If glass block still remains, restore block. For bidding purposes, Contractor to assume that glass block is gone, and will be rebuilt.

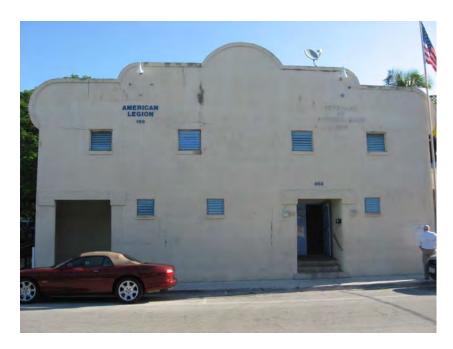
2012 Photo of front of building. Repair all spalling at tie beams and columns. See specifications and structural drawings. See info in photo above about glass block at corner of door openings.

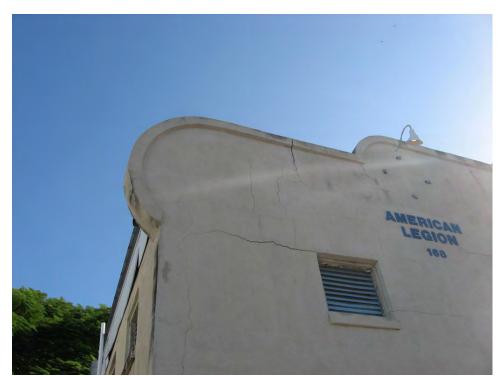
Detail photo of front façade showing spalling at tie beam. Contractor to repair spalling at tie beams and columns and patch stucco. See structural details and specifications. The parapet will be secured to the top chord of the first truss.

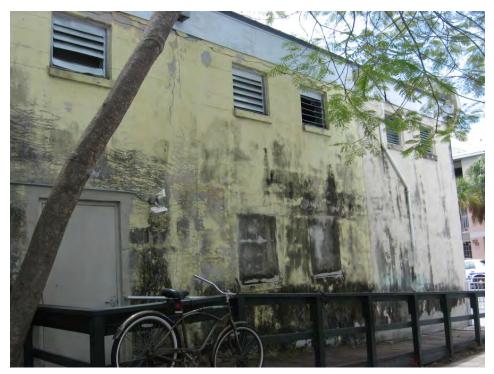
Exterior photo of north façade. Note spalling along tie beams at first and second floors, and columns. Contractor to repair spalling at tie beams and columns and patch stucco. See structural details and specifications. Remove and replace plywood fascia at top of wall as required for spalling repairs.

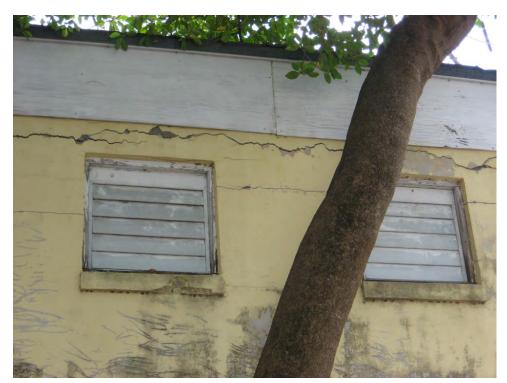
Detail photo of 2<sup>nd</sup> floor spalling tie beam at north façade. Contractor to repair spalling at tie beams and columns and patch stucco. See structural details and specifications.

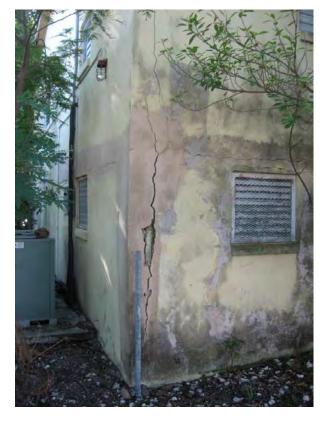
Detail photo of spalling at NE corner of building. Contractor to repair spalling at tie beams and columns and patch stucco. See structural details and specifications.

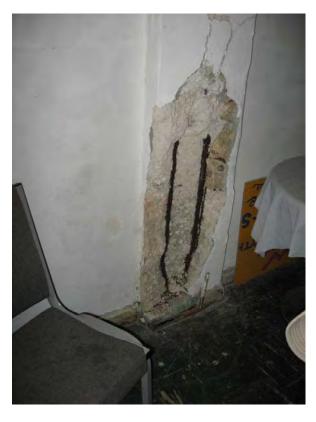
Photo of existing spalled concrete column at inside of building, along exterior wall. Contractor to repair spalling at all tie beams and columns and patch stucco. These columns are marked RC2 on Structural Plan S1.1. See repair detail, sheet S2.1. See structural details and specifications.

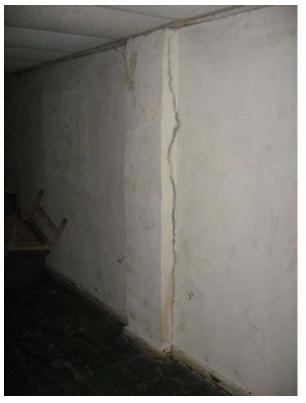
Photo of existing spalled concrete column at inside of building, along exterior wall. Note crack at wall-column joint. Contractor to repair spalling at all tie beams and columns and patch stucco. These columns are located under each wood truss, and are marked RC2 on Structural Plan S1.1. See repair detail, sheet S2.1. See structural details and specifications.

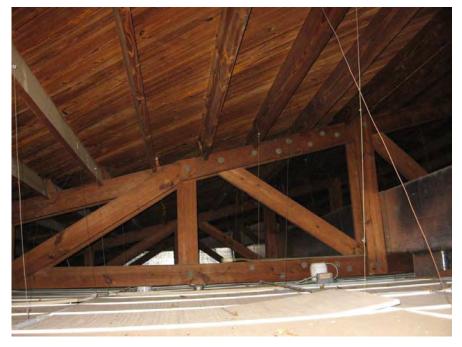
Photo of existing roof truss. All roof trusses are to remain, and shall be shored during spalling repair per Plan drawing S1.1, and shoring details on S2.1. Carefully remove suspended ceiling tiles as required for Work. Suspended ceiling grid to remain. Replace existing ceiling tiles after work is complete. (No new ceiling tiles shall be purchased.) Ductwork to remain. Protect ductwork during construction.

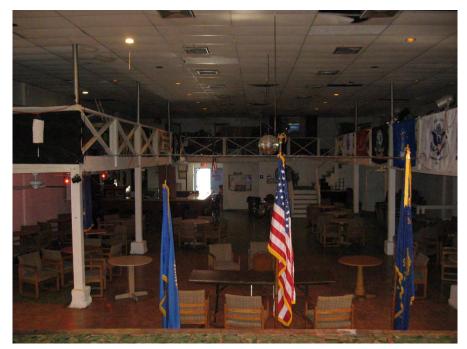
General photo of interior. Columns along mezzanine shall be replaced with steel columns per structural details, sheets S1.1 and S2.1. The floor is composed of historic Cuban floor tiles, and shall be covered and protected during construction. Carefully remove suspended ceiling tiles as required for Work. Suspended ceiling grid to remain. Replace existing ceiling tiles after work is complete. (No new ceiling tiles shall be purchased.).

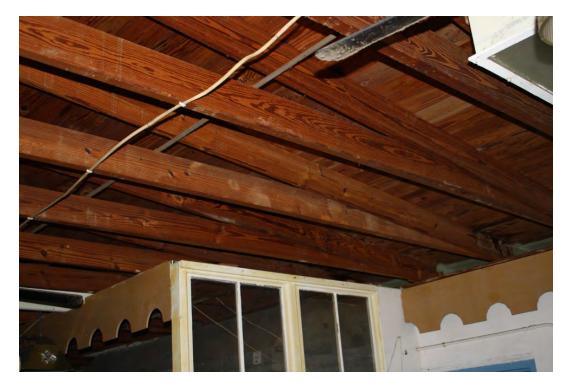
Photo of ceiling at kitchen. Sister roof rafters per Structural drawings.
