Staff Report

MEMORANDUM FOR THE FILE

RE: 2800 Flagler Avenue (permit application #6650)

FROM: Karen DeMaria, Urban Forestry Manager,
City of Key West

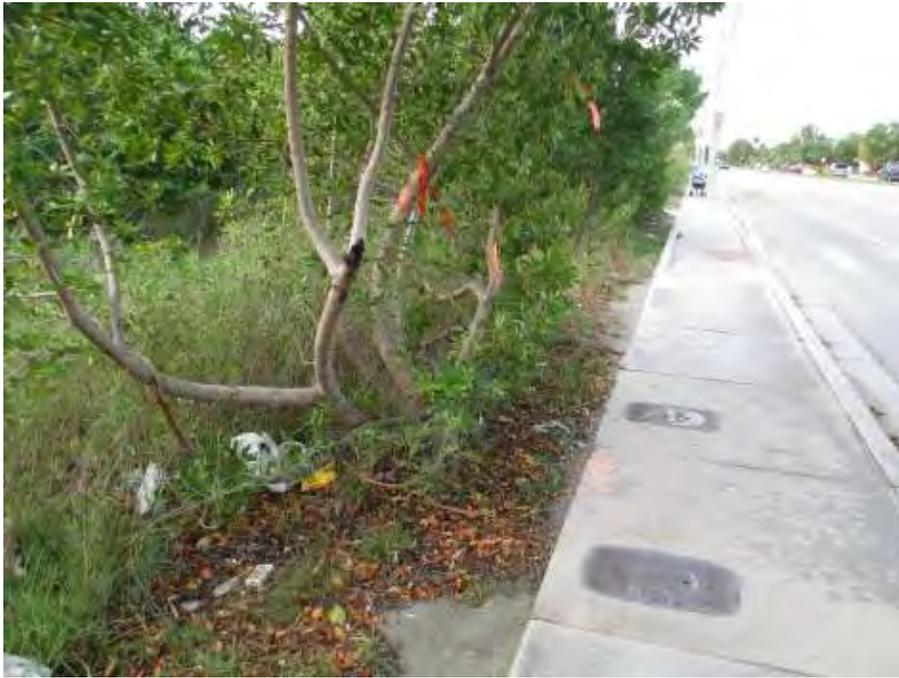
Northwestern corner of the property on Flagler Avenue.

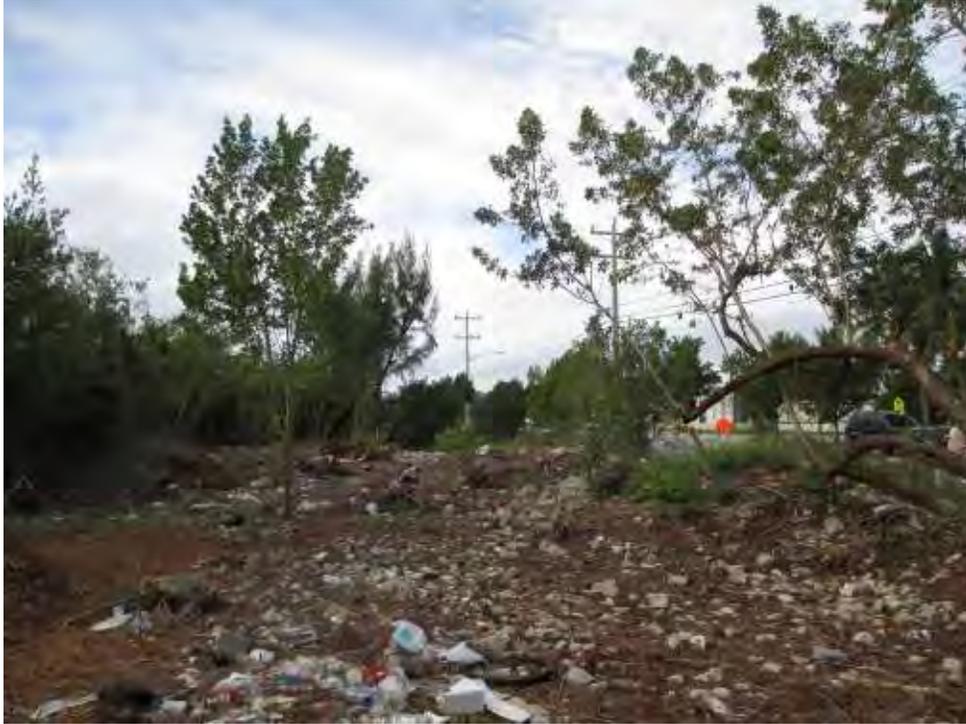
Standing in the interior of the property looking toward the west at the western property line.

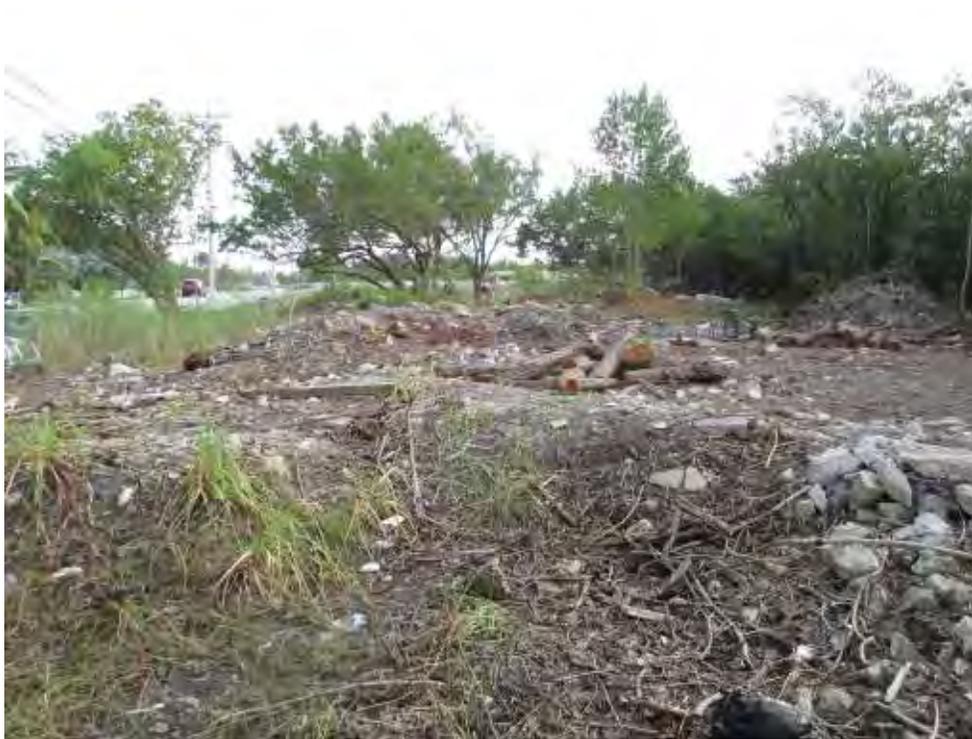
Standing near the western property line looking toward the east at the interior of the property. Property owner cleared most of the invasive and exotic vegetation from the lot. Old construction debris piles are all over lot.

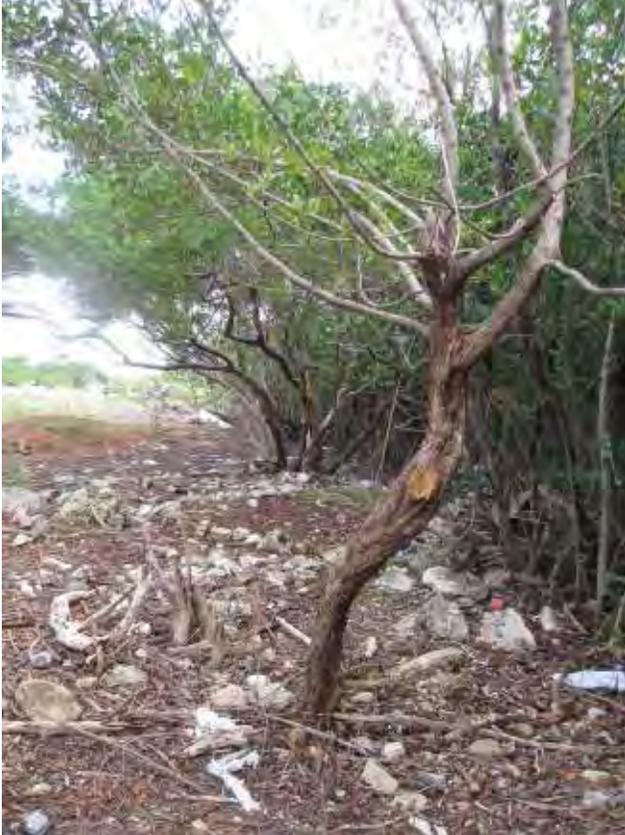
Standing on the edge of the wetland area looking toward the east (notice the debris). The property owner has verified the wetland line with the State of Florida (SFWMD).

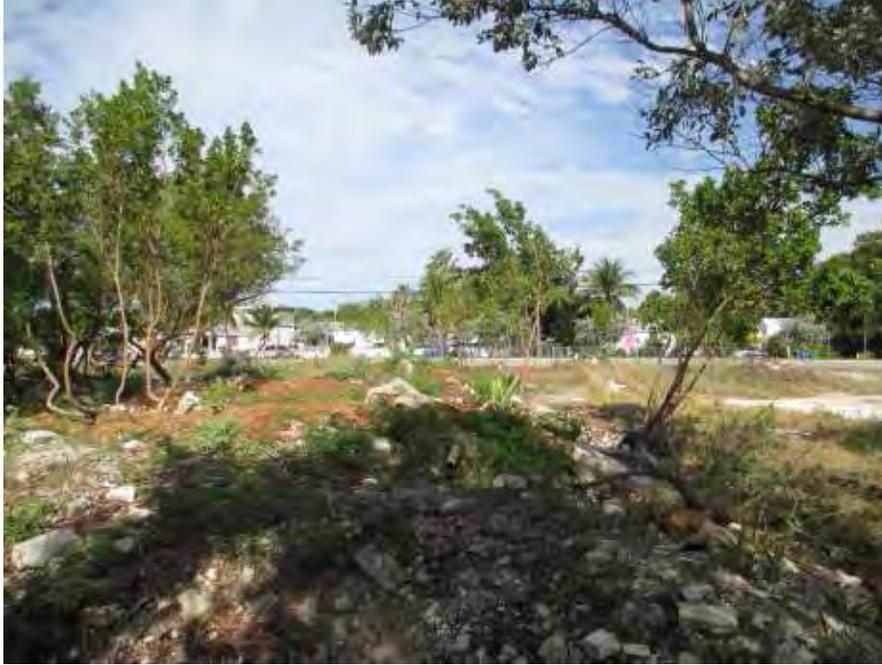
Standing near the wetland line (southern property boundary) looking toward the north toward Flagler Avenue (notice piles of old construction debris).

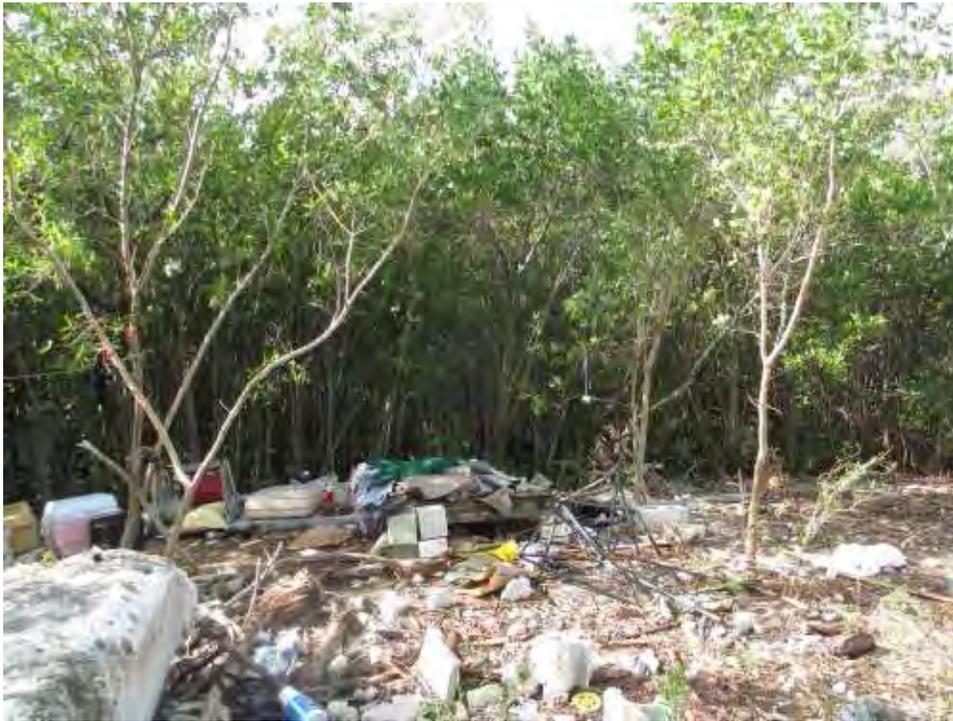
Existing homeless encampment and debris along wetland line/southern property boundary.

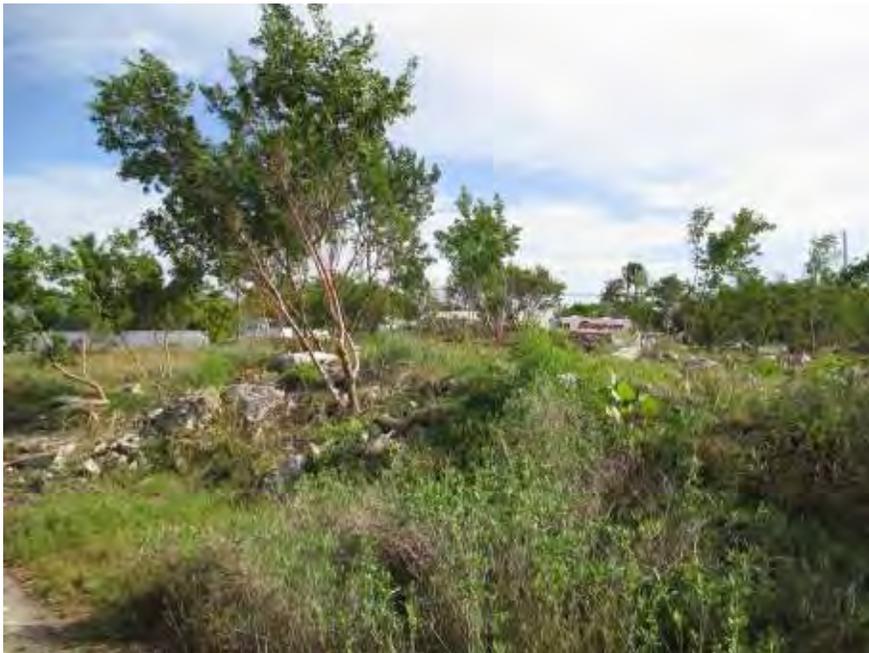
Standing in the center of the property looking toward the southeast toward the 11th Street and Riviera Drive intersection (notice the large construction debris piles).

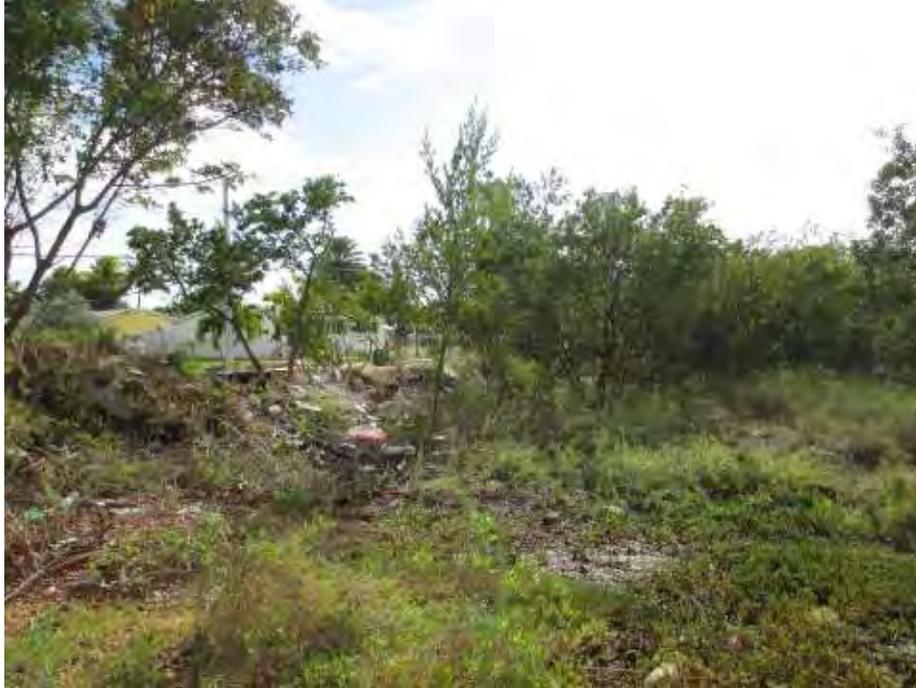
Standing near 11th Street looking south toward Riviera Canal and Drive (notice construction debris piles along the right side of photo).

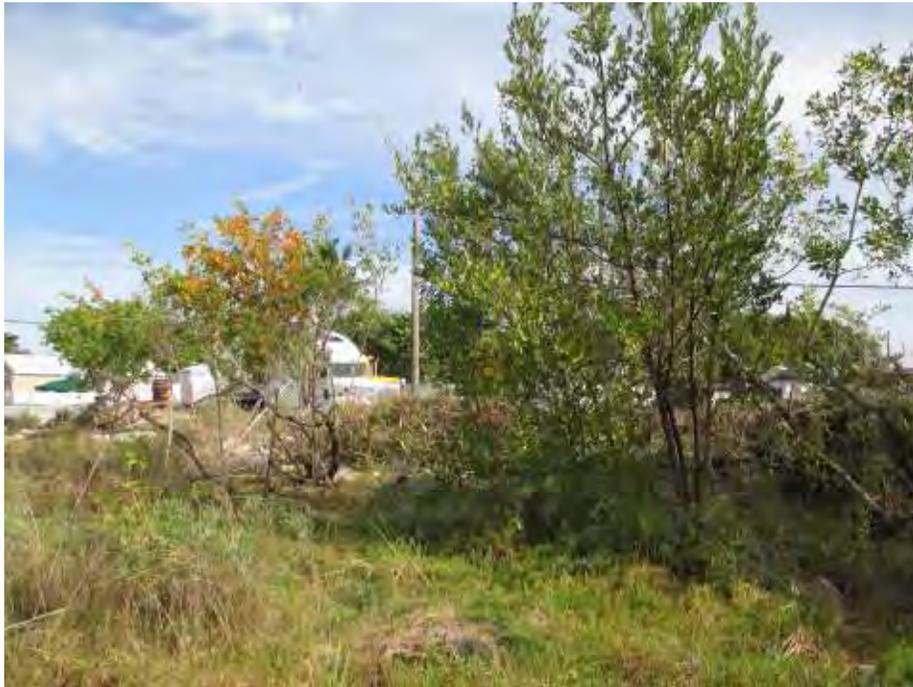
Standing near 11th Street looking toward the northeast at the intersection of Flagler and 11th Street (notice long construction debris pile along 11th St).

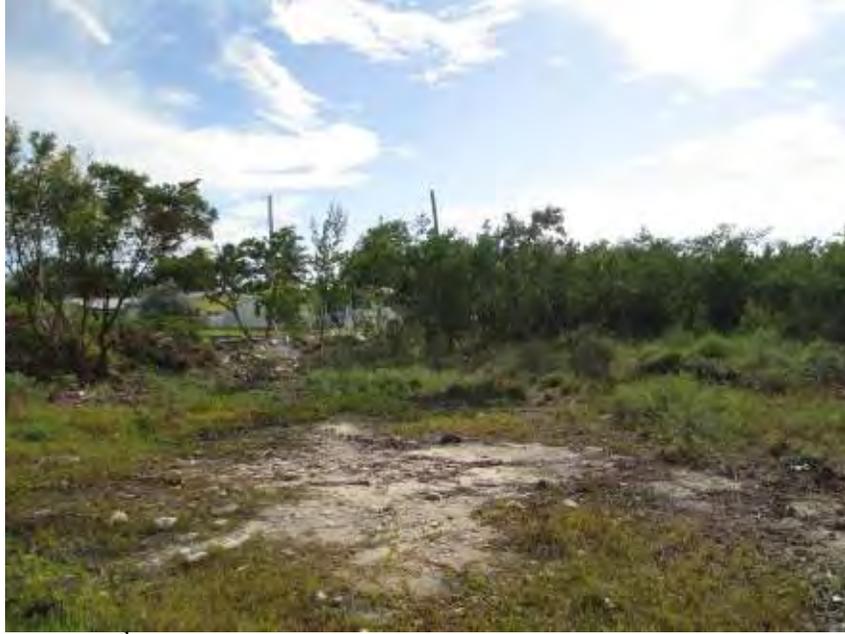
Standing near 11th Street looking south (line of trees represents the approximate wetland line).

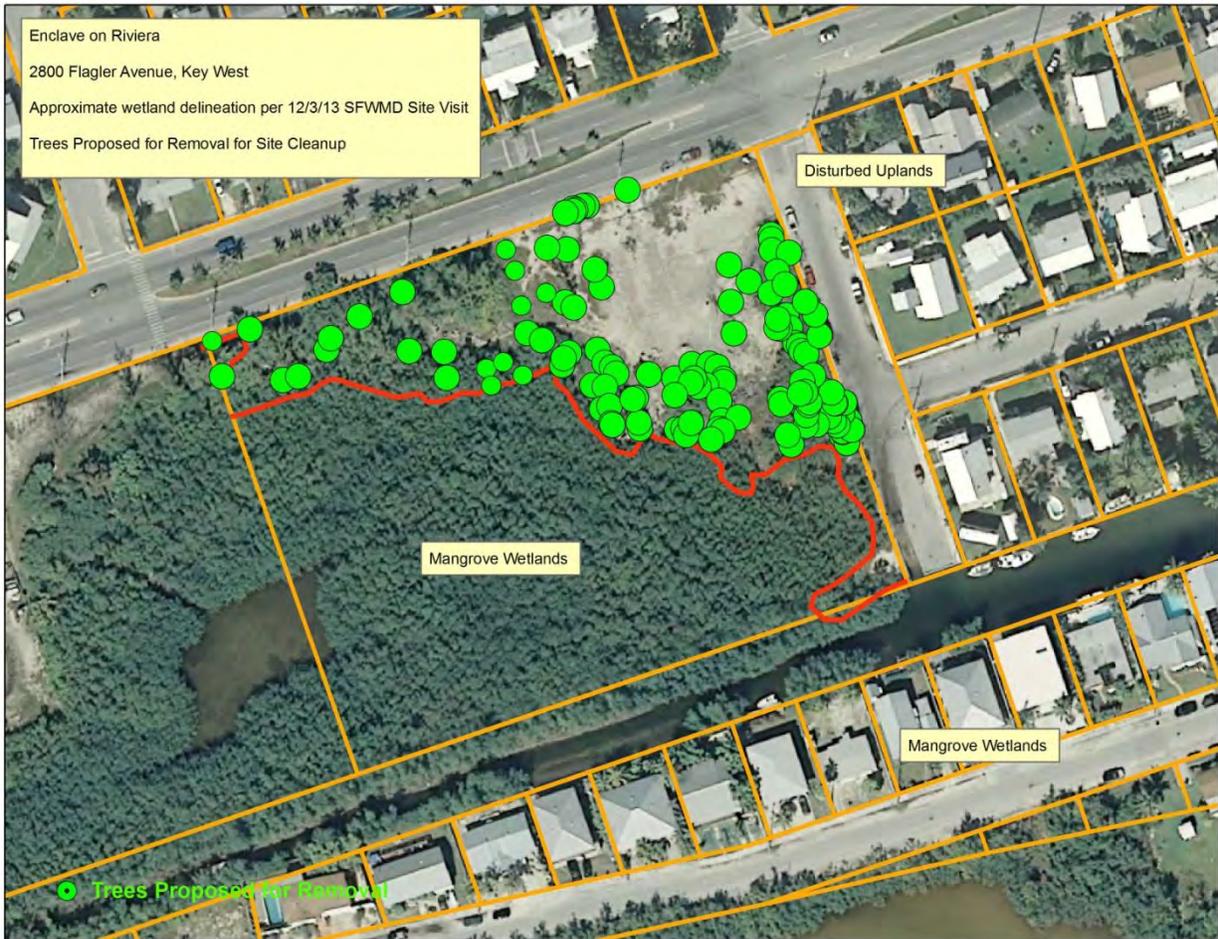
Figure 1. Location of trees impacted by the site cleanup (trees added following the 12/16/13 site review are indicated by smaller markers).

In order to effectively clean up the property, impacts to trees regulated by the City of Key West will be required. We conducted a tree impact assessment on December 12, 2013, and identified all impacted trees to species, obtained DBH using a tree caliper gauge, and located each tree using a sub-foot DGPS unit. The Table 1 and Attachment 1 in this report summarize tree impacts based on our assessment, and Figure 1 shows the location of proposed tree removals.

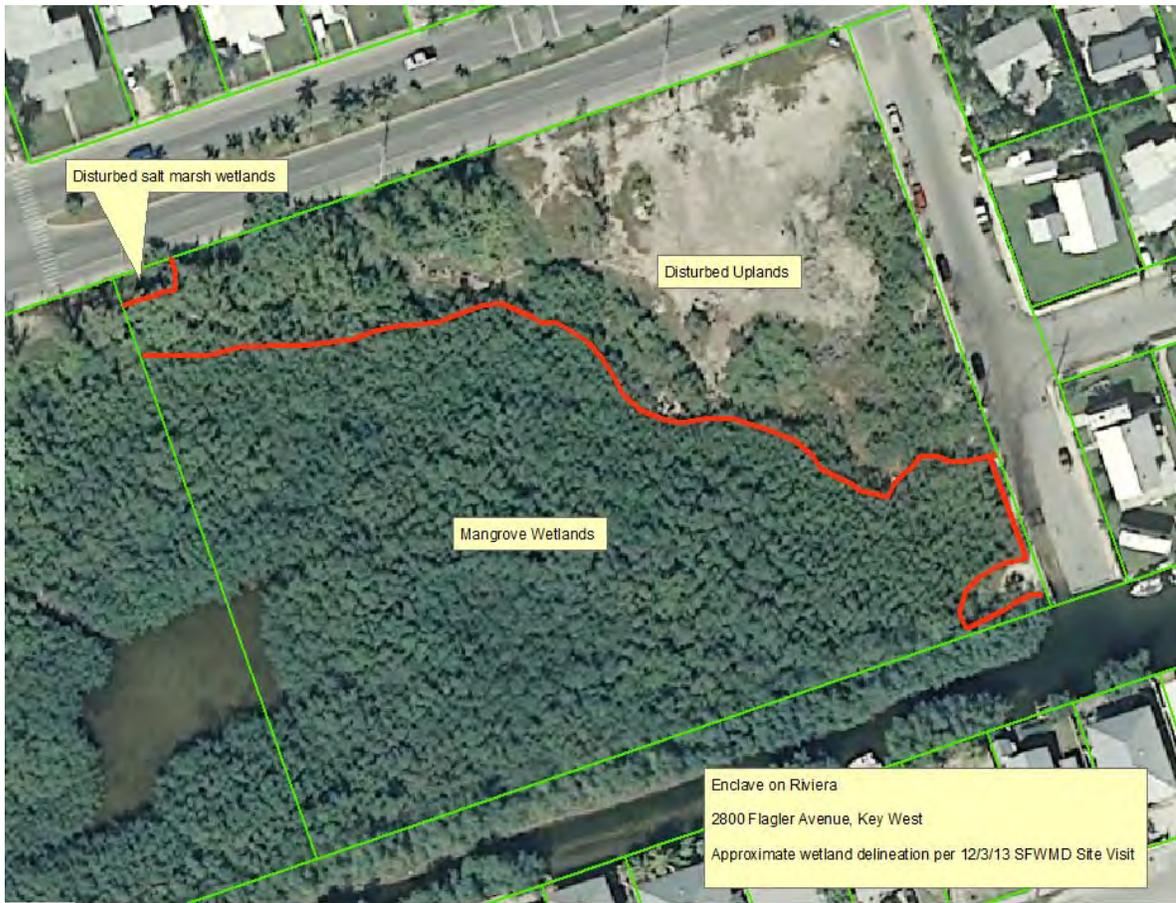
- We established a jurisdictional wetland line collaboratively. Flags were placed at the limit of wetlands and will form the basis for a wetland map / survey and site planning. The main wetland area is associated with the large mangrove swamp. A small patch of isolated salt marsh wetlands are located along Flagler to the west. Mitigation for impacts to this small wetland area will be required if impacted. See attached "draft" wetlands map based on the field review.
