**BENTHIC RESOURCE ASSESSMENT  
T-PIER IMPROVEMENTS AT MALLORY SQUARE  
CITY OF KEY WEST  
MONROE COUNTY, FLORIDA**

May 24, 2020

ATTACHMENT 2. BENTHIC SURVEY AREA PLAN

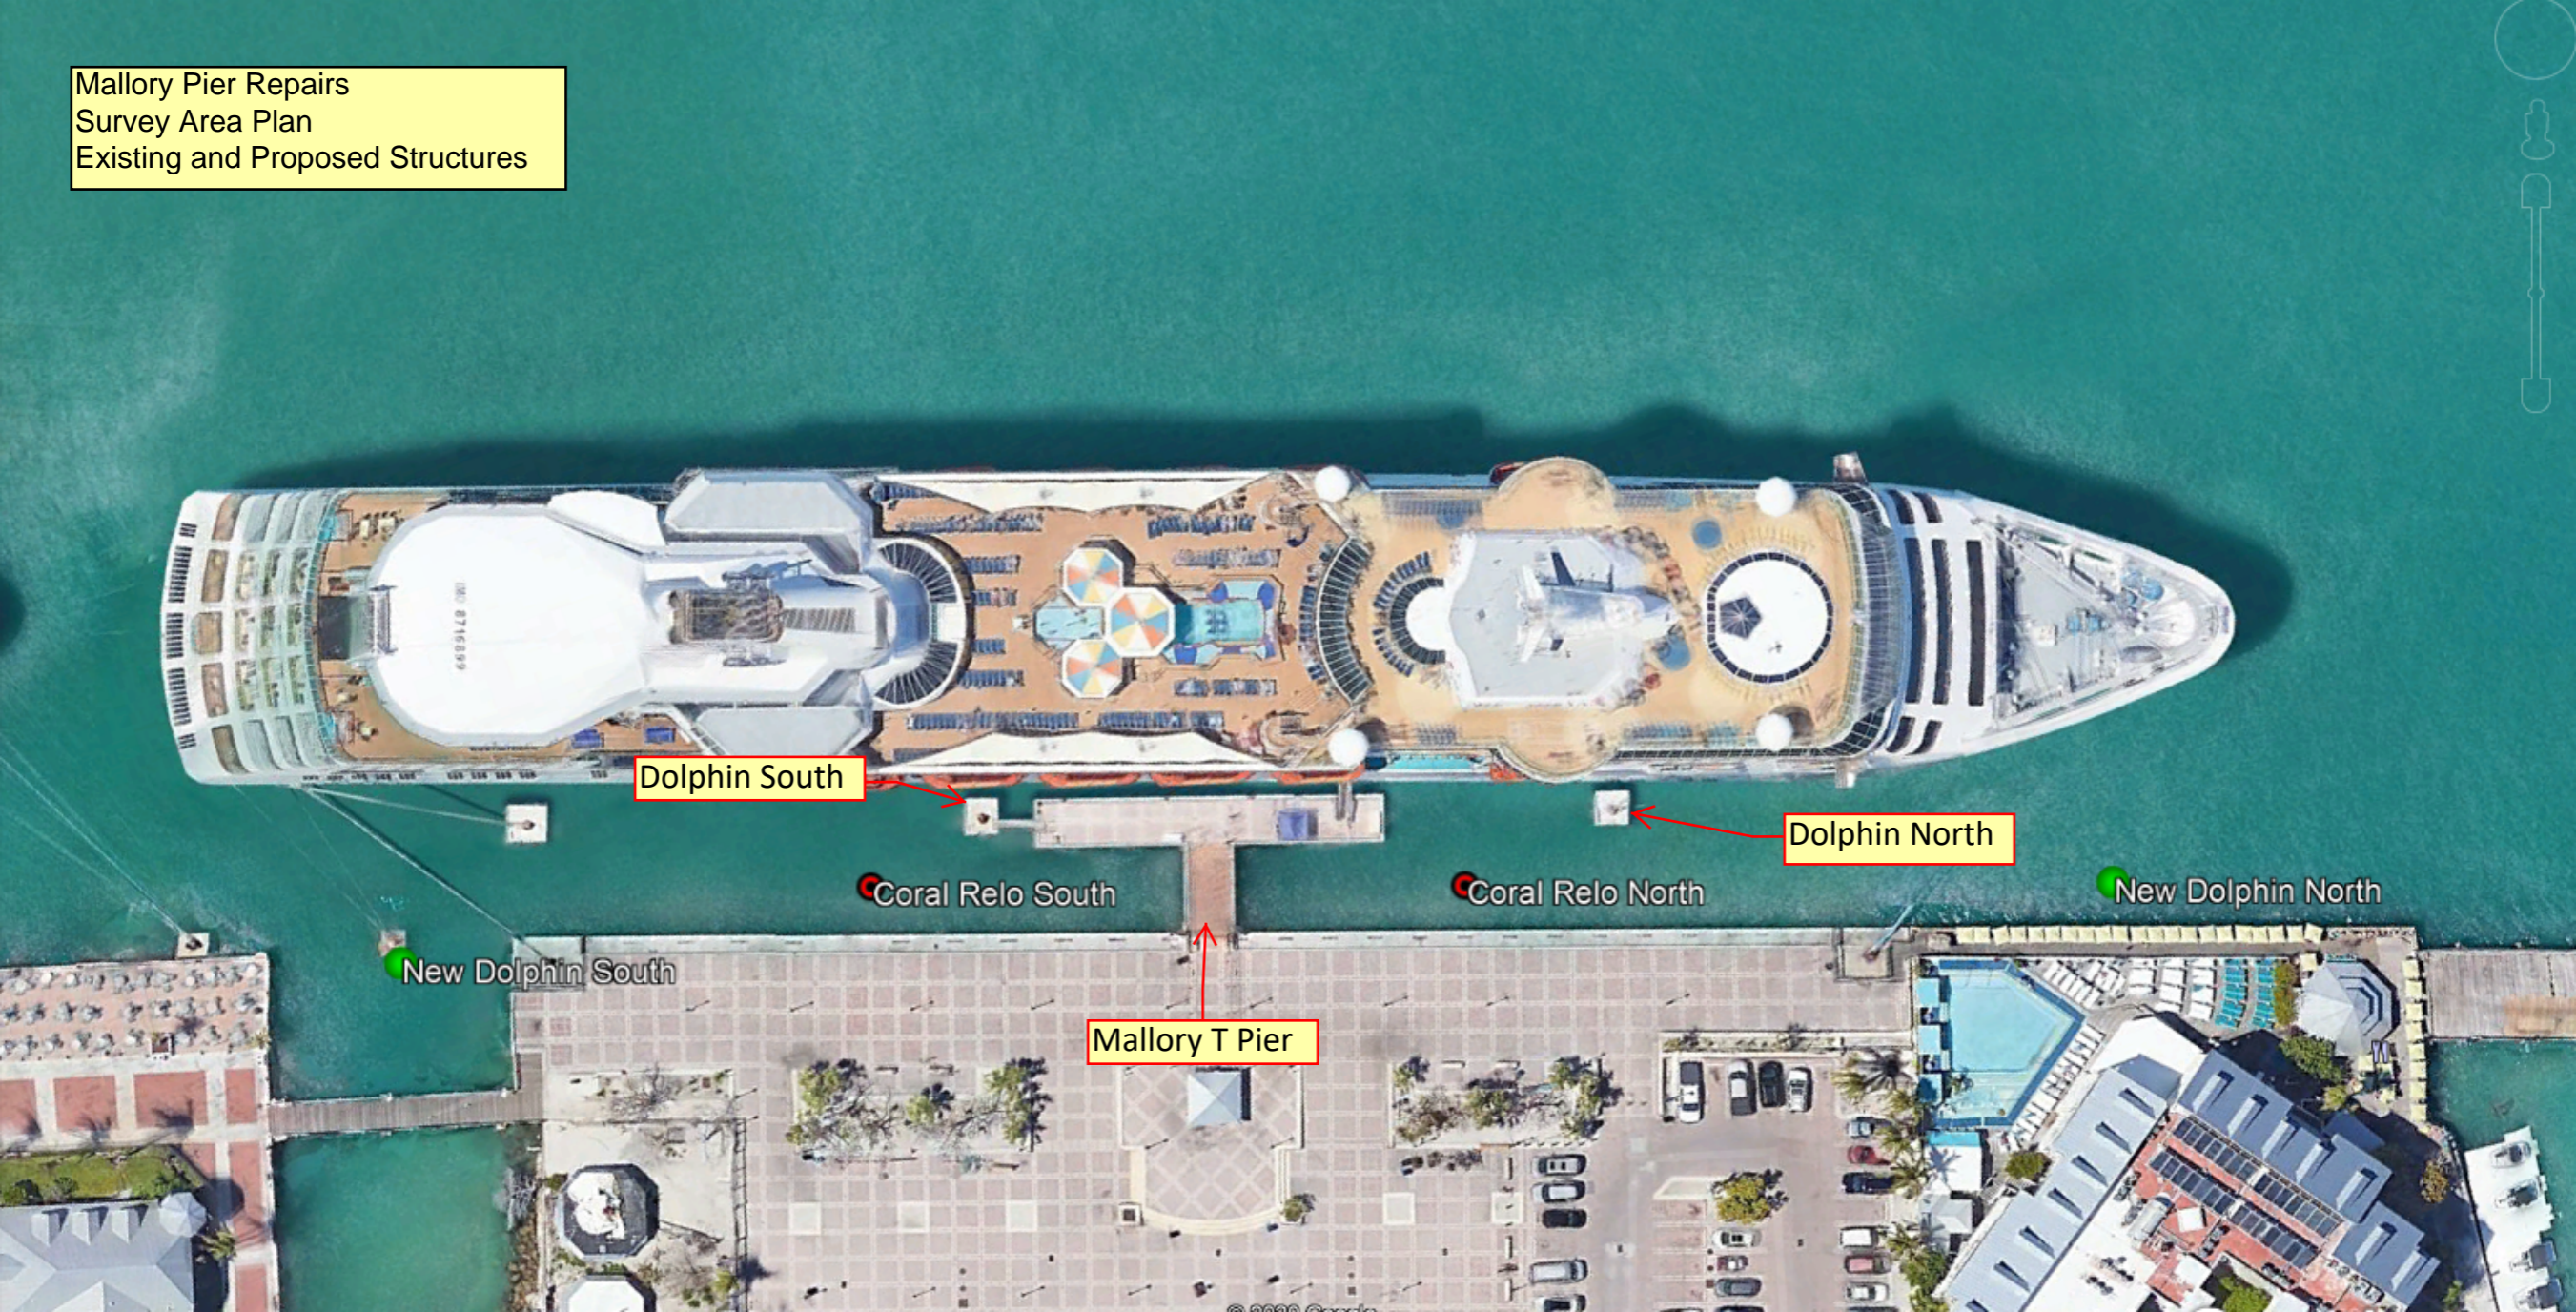
Mallory Pier Repairs  
Survey Area Plan  
Existing and Proposed Structures

Dolphin South

Dolphin North

Coral Relo South

Coral Relo North

New Dolphin North

New Dolphin South

Mallory T Pier

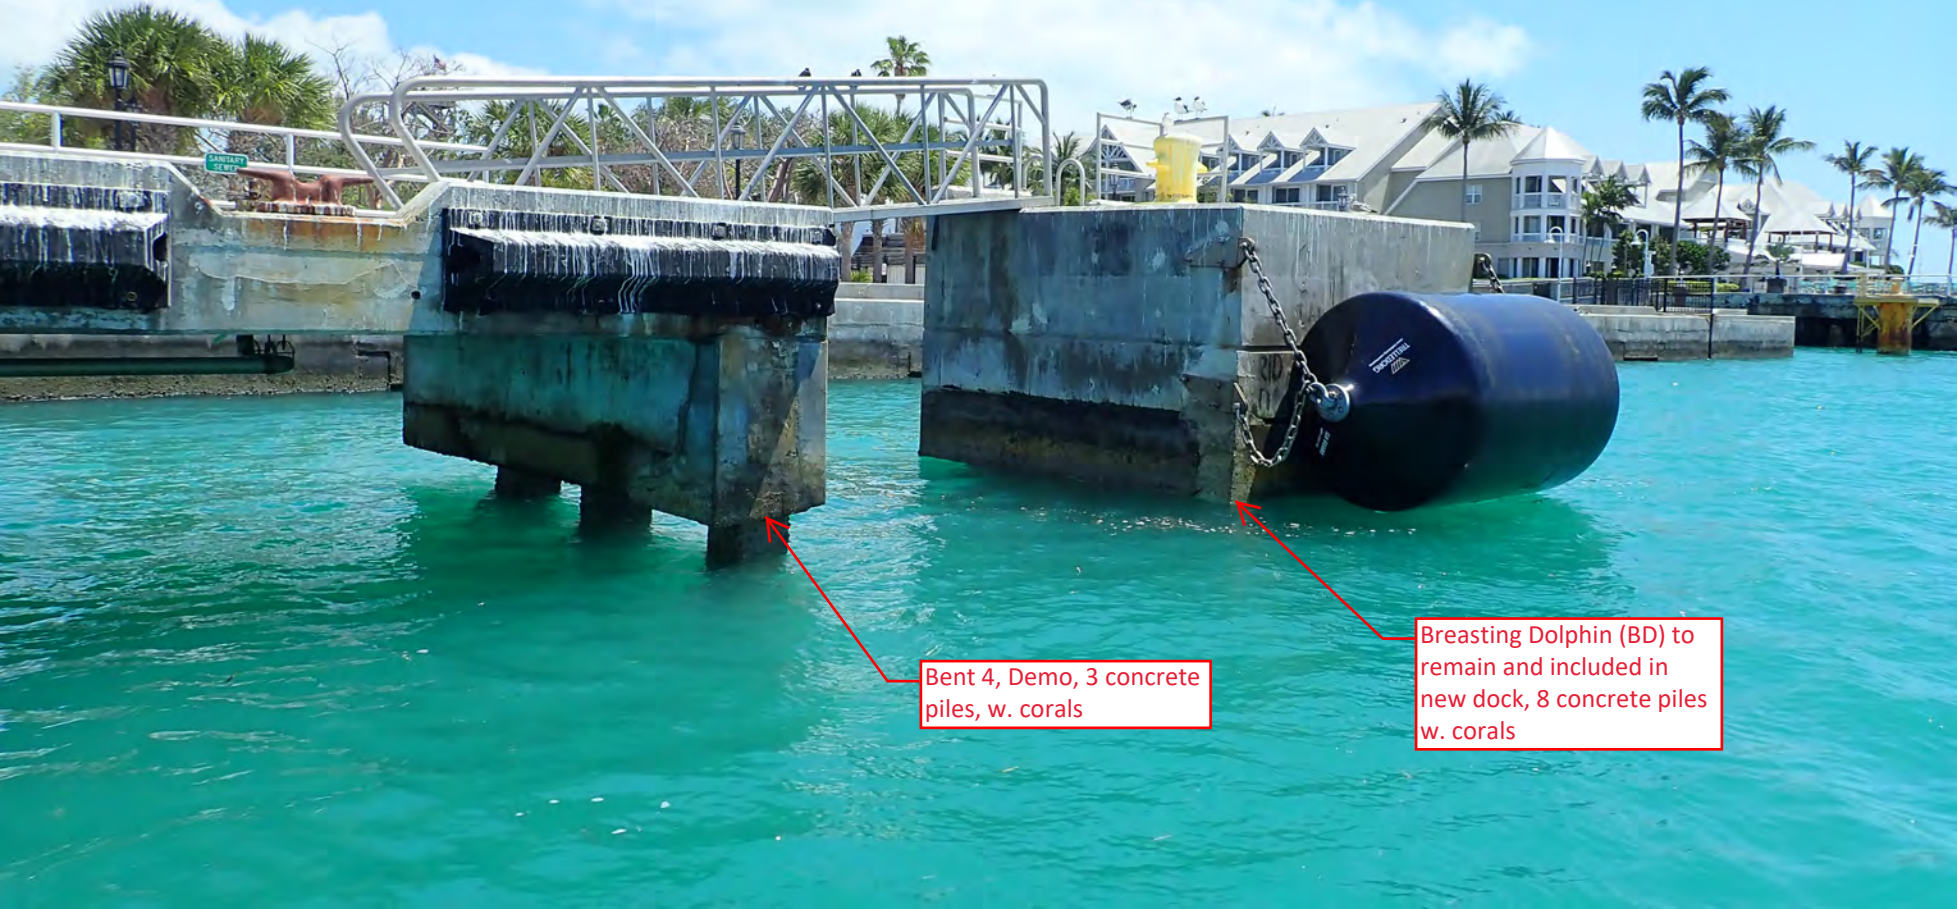
Mallory Pier Repairs  
Pier assessment locations

Bent 4, Demo, 3 concrete  
piles, w. corals

Breasting Dolphin (BD) to  
remain and included in  
new dock, 8 concrete piles  
w. corals

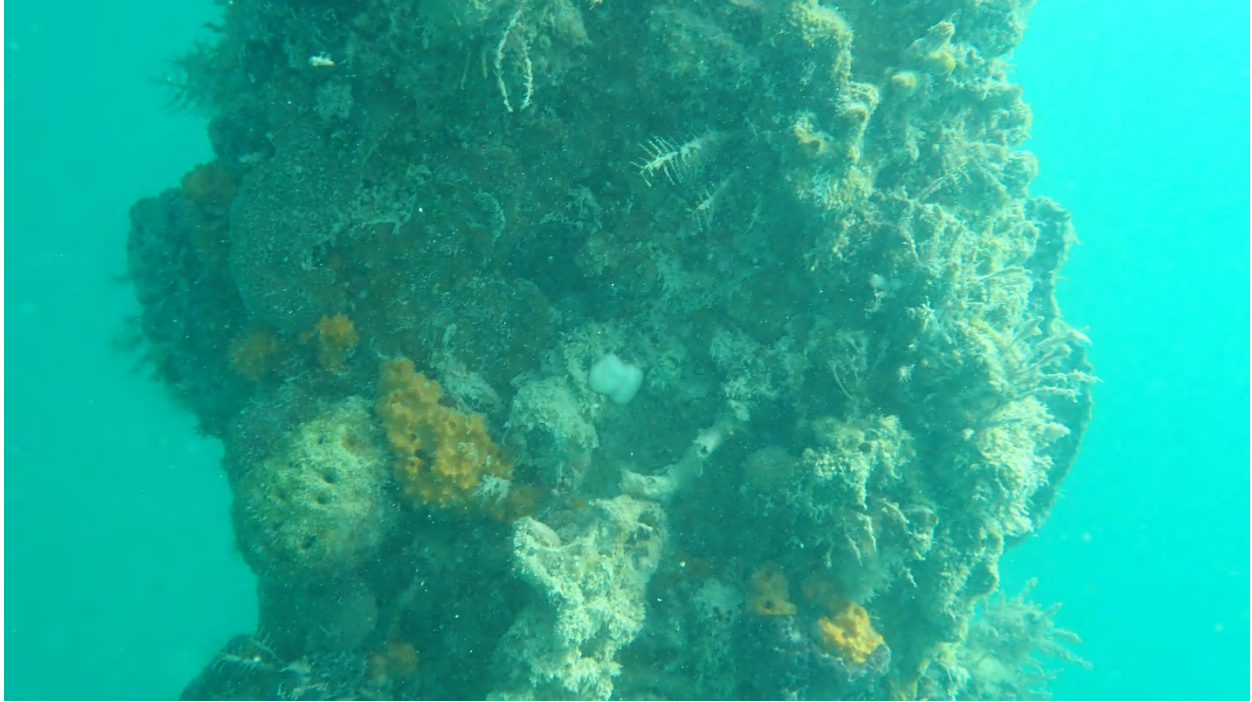
*Photo 1. Typical piling at Mallory Pier with dense cover of sponges and invertebrates.*

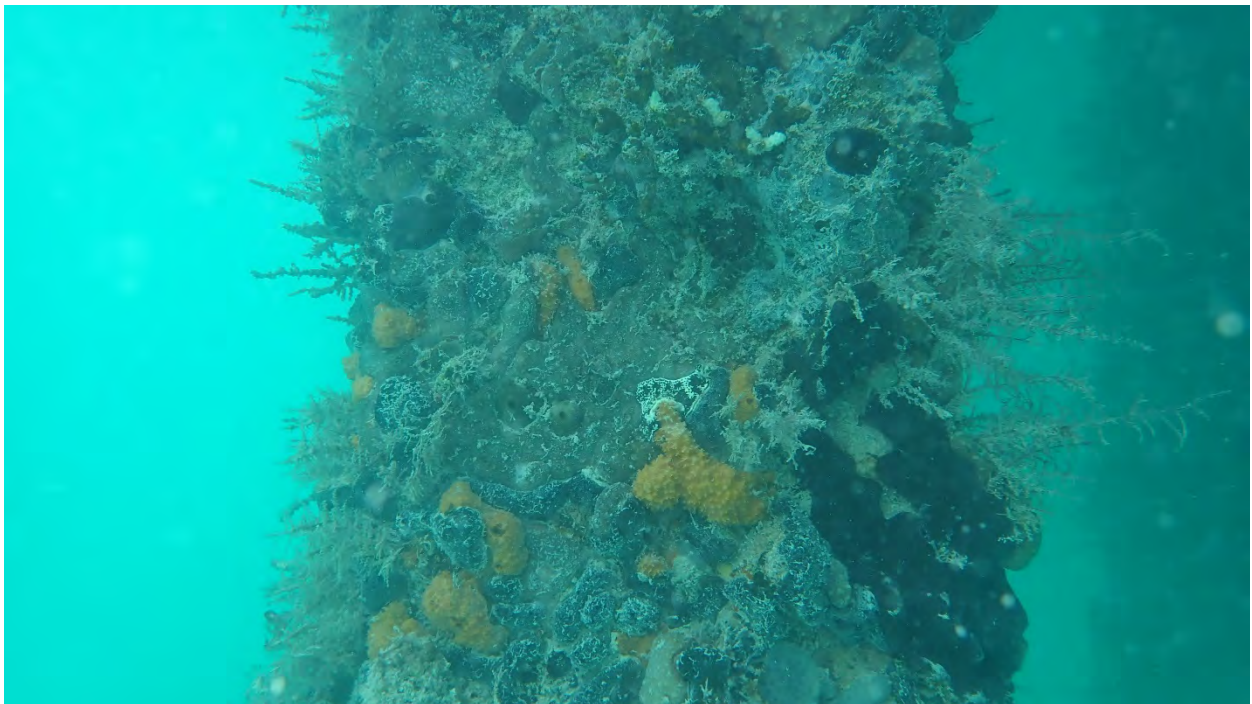
*Photo 2. Typical piling at Mallory Pier with dense cover of sponges and invertebrates.*

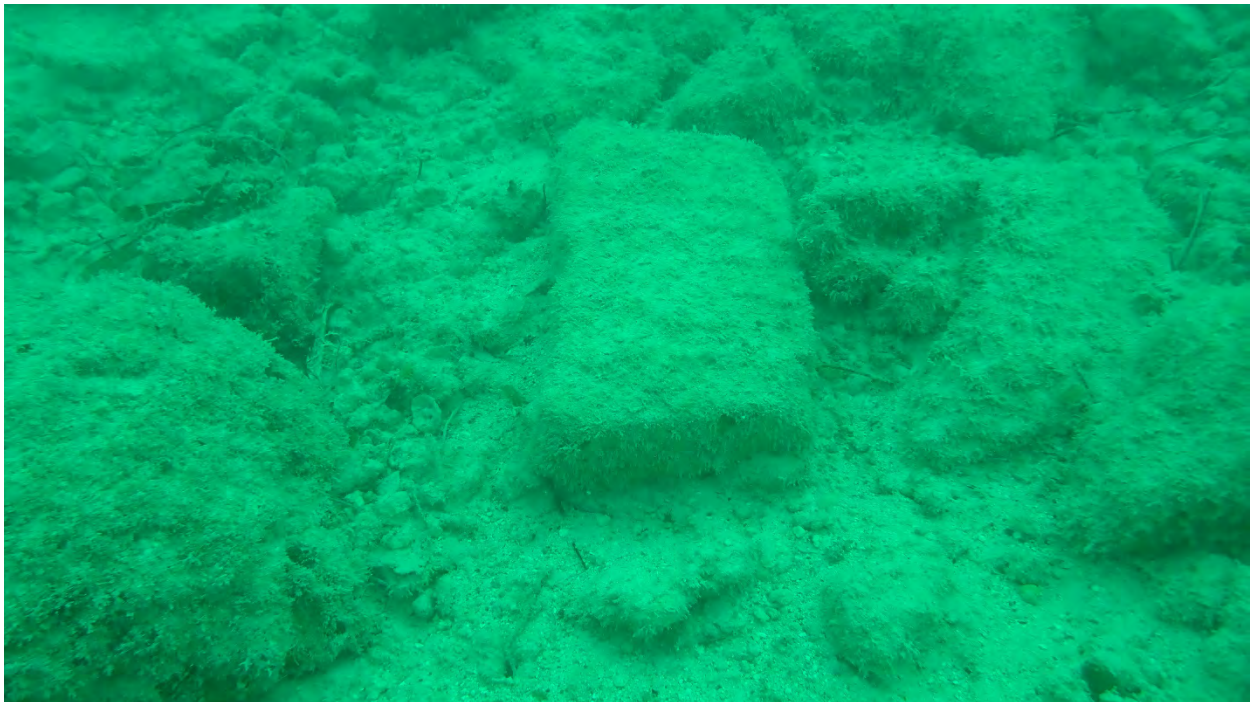
*Photo 4. Typical seafloor conditions over the majority of the seafloor survey area. The seafloor consists of sand and rubble as a result of high scour and currents.*

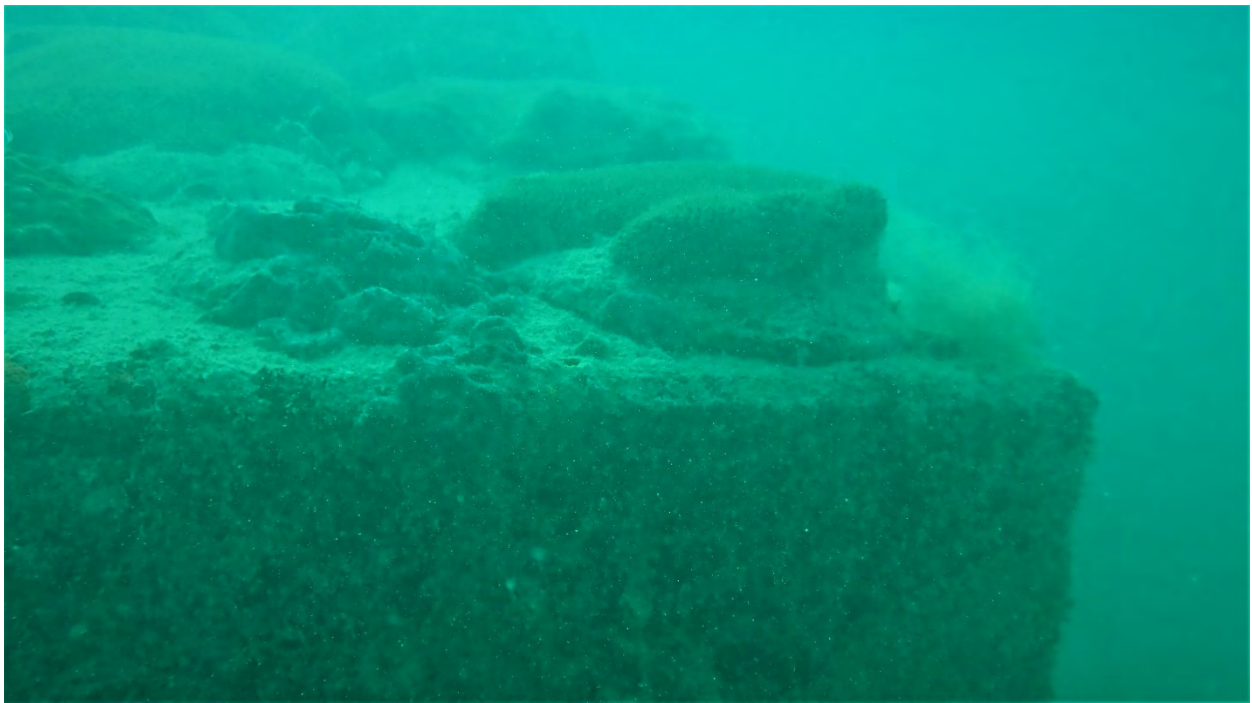
The debris within this survey area includes two coral relocation sites from a previous project at this location are present between the T-Pier and Mallory Pier, and consist of large concrete monoliths with substantial corals cemented to their upper surface. These two structures measure approximately 14' x 14' x 12' tall, extending well above the seafloor.

*Photo 6. Typical seafloor conditions within the survey area adjacent to the existing pier. This is one of two large concrete blocks appx. 14' x 14' x 12" tall and supports a previous coral relocation project.*

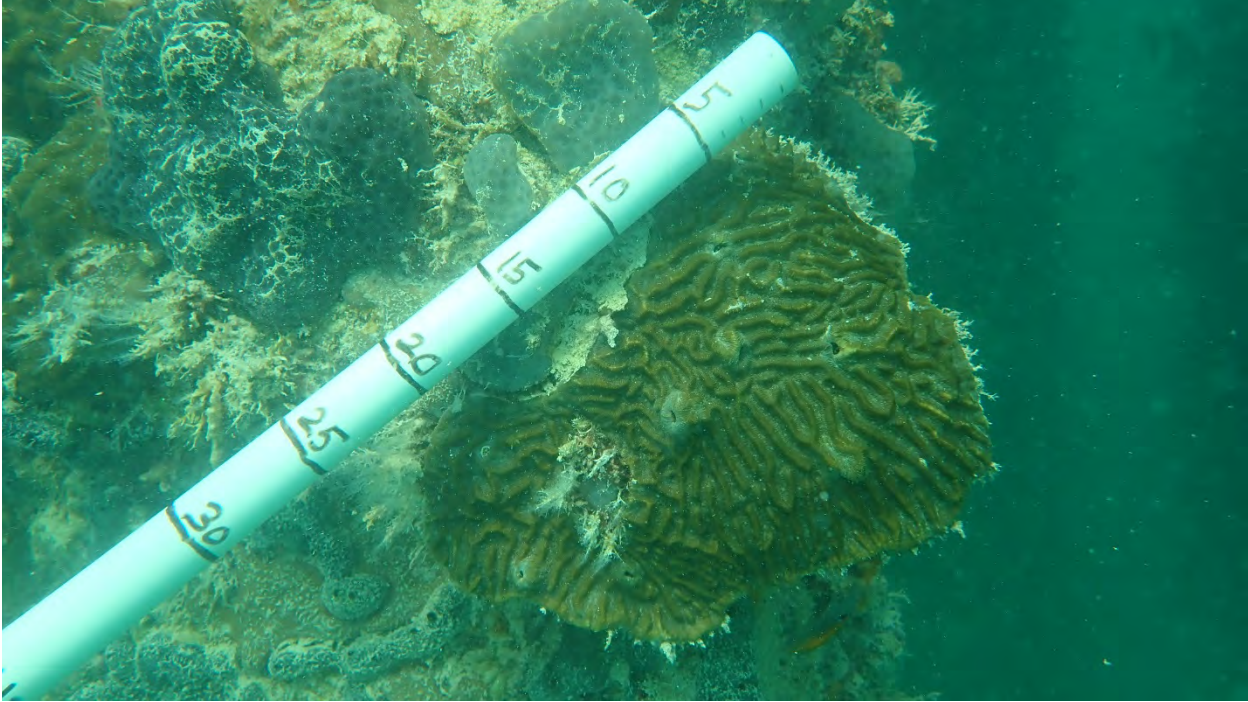
Photo 7. Typical coral attached to piling proposed for impact, *Pseudodiploria clivosa*.

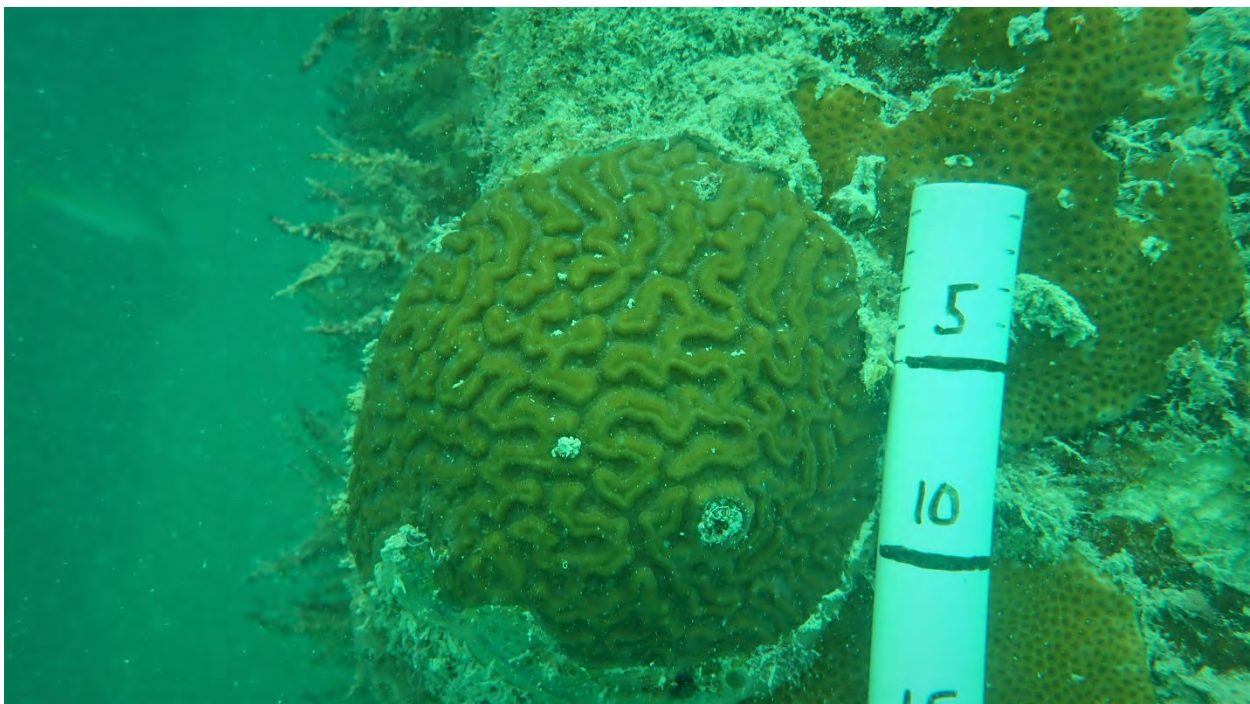
Photo 14. Typical coral attached to piling proposed for impact, *Colpophyllia natans*.

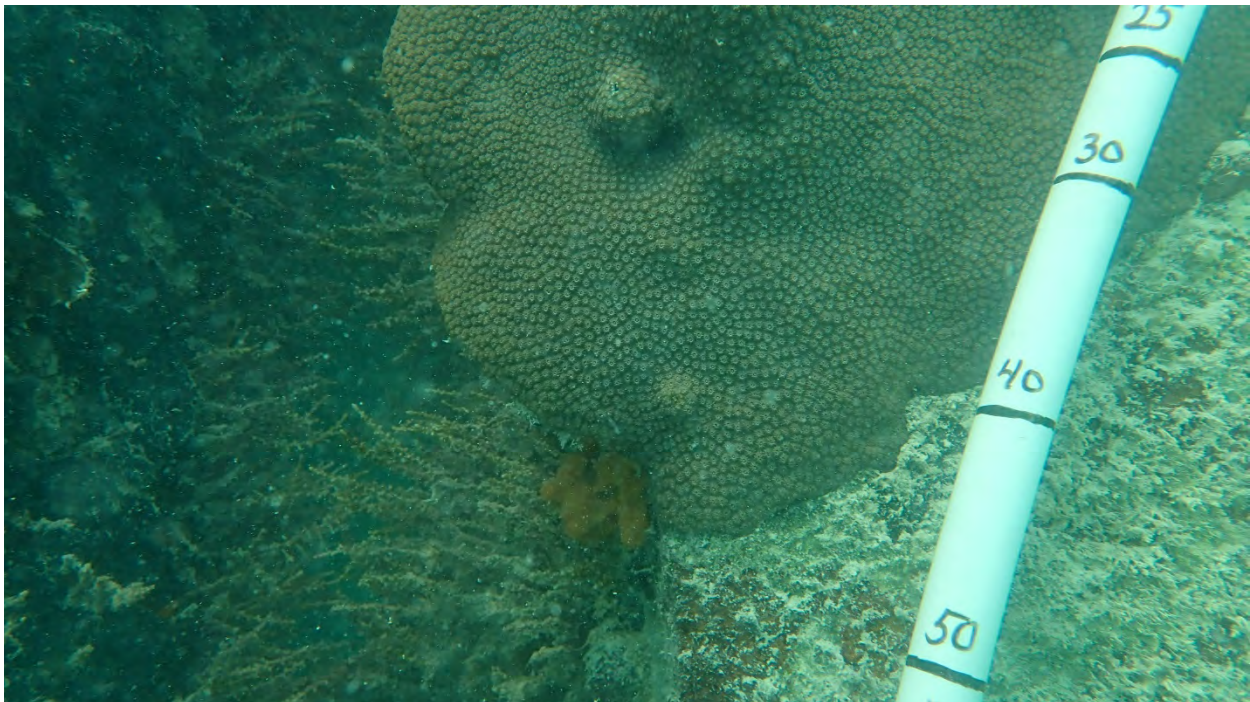
Based on their location within the project, it can be determined that approximately **205 coral colonies totaling approximately 54,775 cm<sup>2</sup>** will be directly impacted by the proposed project, including Federally-listed corals on the South Dolphin pilings. These include corals that are located in the area of proposed repairs, either attached to a piling proposed for demolition or attached to a piling on the South Dolphin that will be shaded by the proposed T-Pier expansion decking and likely suffer as a result (Tables 1 & 2). Corals in the remaining areas (seafloor debris, north and south relocation sites, and North Dolphin Existing) will need to be carefully avoided during construction to avoid secondary impacts resulting from construction.

Photo 16. Federally-listed *Orbicella faveolata* attached to the South Dolphin, pile 2, which will be impacted by the proposed project.

In order to proceed with permitting of this project, it is recommended that coordination with the Florida Keys National Marine Sanctuary be initiated to better understand potential project impacts, avoidance and mitigation strategies, construction operations, and the regulatory process required to proceed with the project.

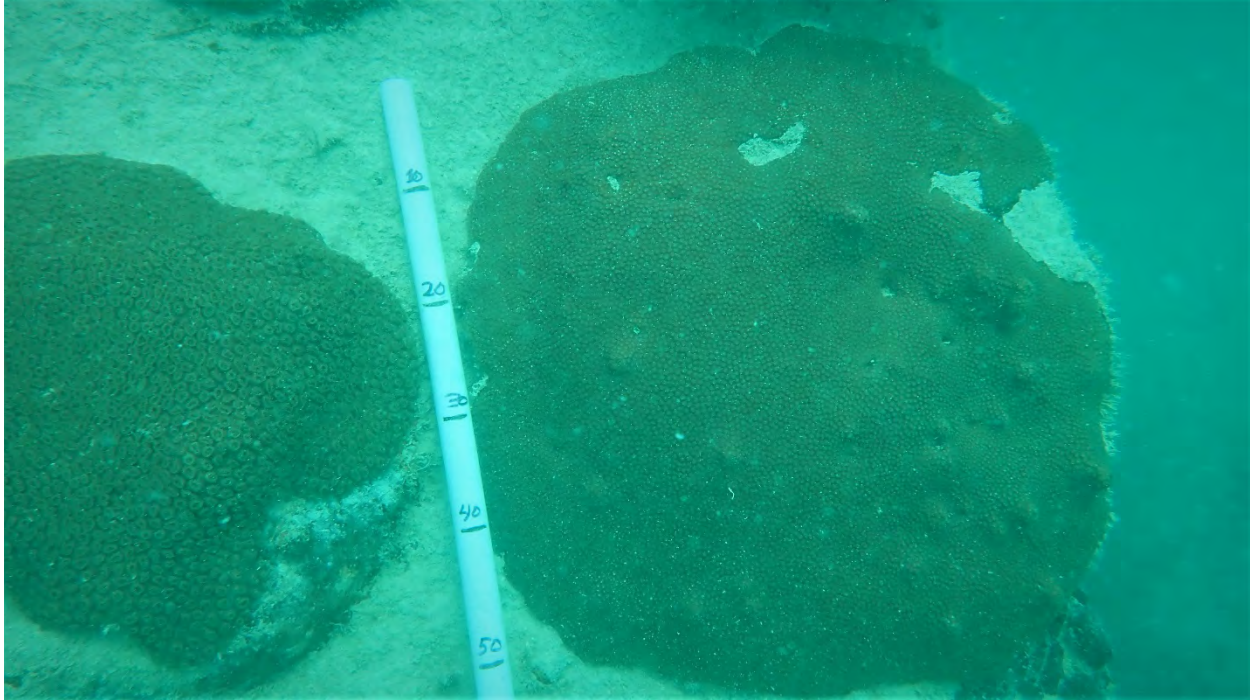
*Photo 17. Two large corals, Mav and Ofav at the Coral Relocation South site. Note most of these large corals are attached to the concrete block with cement.*

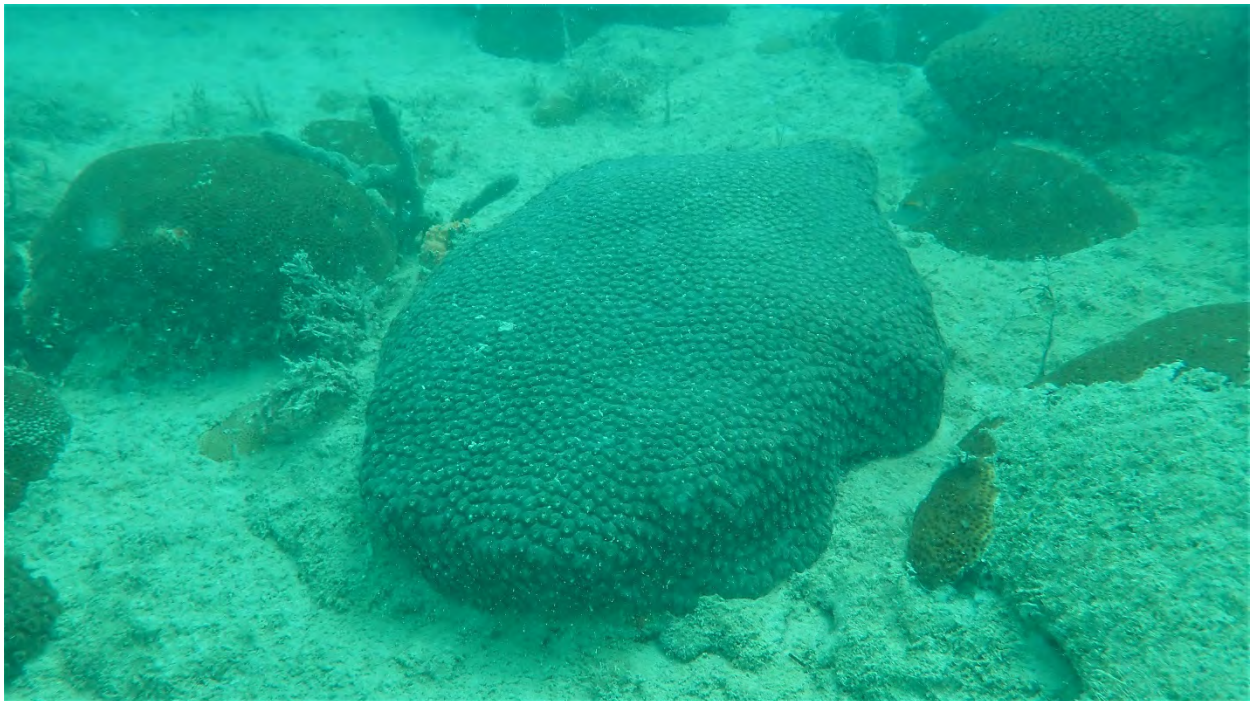
*Photo 18. Large corals including Mav and Ssid at the Coral Relocation South site. Note most of these large corals are attached to the concrete block with cement. .*
