THE SECRETARY
OF THE INTERIOR'S
STANDARDS FOR
THE TREATMENT
OF HISTORIC
PROPERTIES

WITH
GUIDELINES FOR
PRESERVING,
REHABILITATING,
RESTORING &
RECONSTRUCTING
HISTORIC
BUILDINGS

U.S. Department of the Interior
National Park Service
Technical Preservation Services

Windows

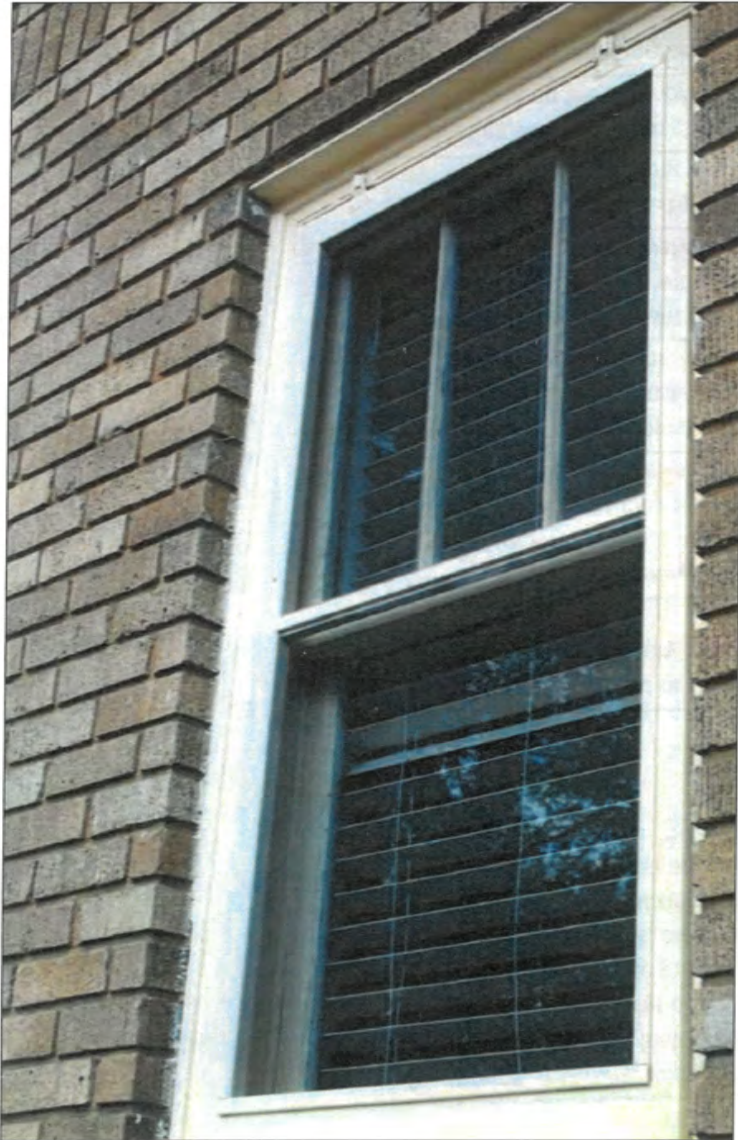
[10] Historic exterior storm windows preserve and help to insulate wood windows.

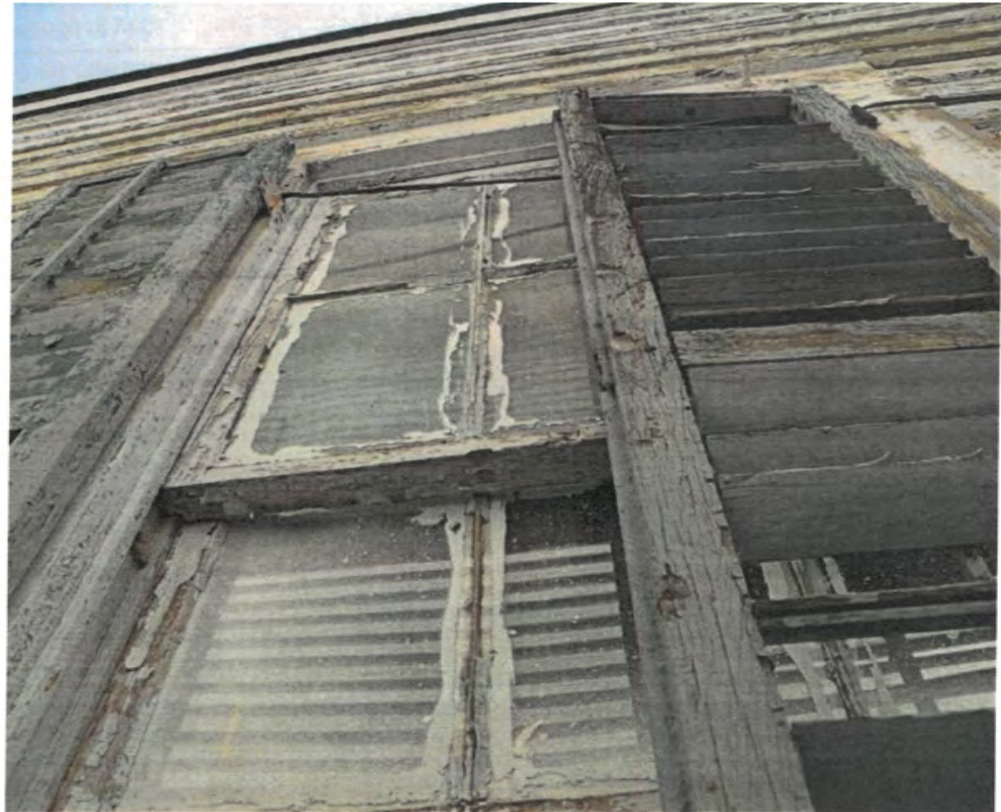
[11] Old and brittle glazing putty should be removed carefully before reputtying to keep window glazing weathertight.

Removing glazing putty that has failed and applying new putty; or, if glass is broken, carefully removing all putty, replacing the glass, and reputtying.	
Installing new glass to replace broken glass which has the same visual characteristics as the historic glass.	
Replacing in kind an entire window that is too deteriorated to repair (if the overall form and detailing are still evident) using the physical evidence as a model to reproduce the feature or when the replacement can be based on historic documentation. If using the same kind of material is not feasible, then a compatible substitute material may be considered.	Removing a character-defining window that is unrepairable or is not needed for the new use and blocking up the opening, or replacing it with a new window that does not match. Using substitute material for the replacement that does not convey the same appearance of the surviving components of the window or that is physically incompatible.

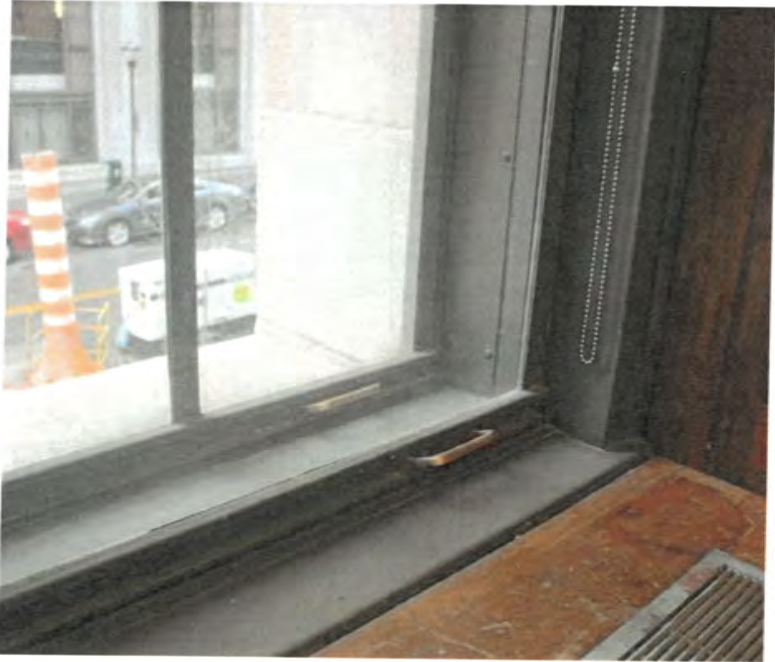
[18] The historic metal storm windows in this 1920s office building were retained and repaired during the rehabilitation project.

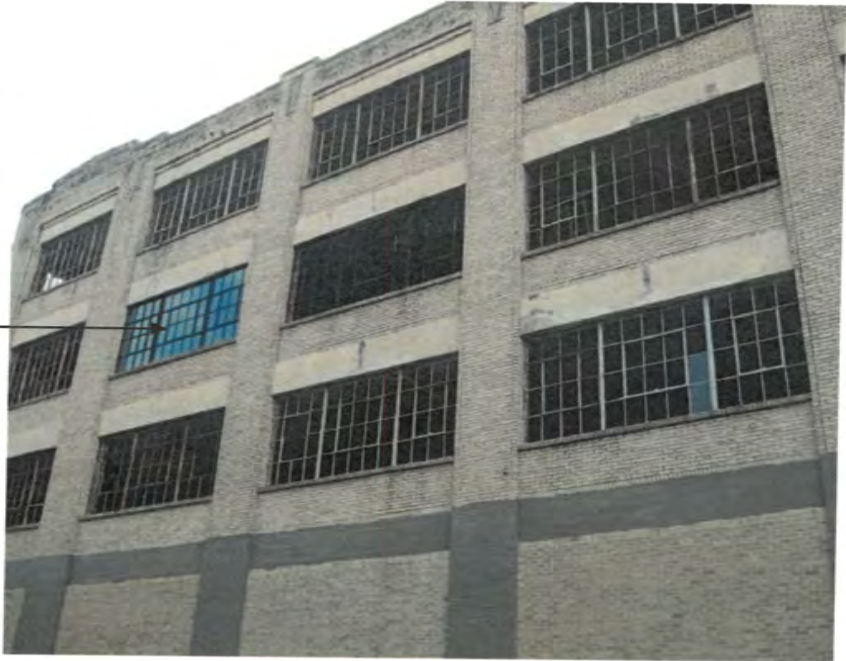
[19] Installing a mockup of a proposed replacement window can be helpful to evaluate how well the new windows will match the historic windows that are missing or too deteriorated to repair.

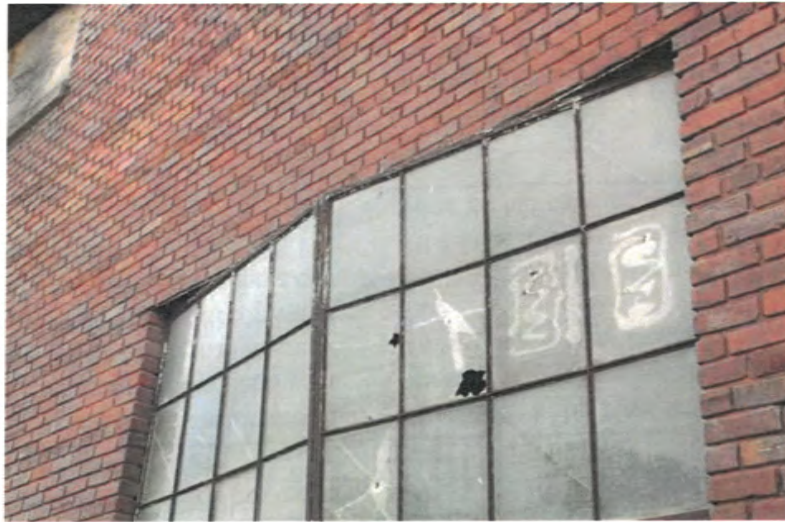
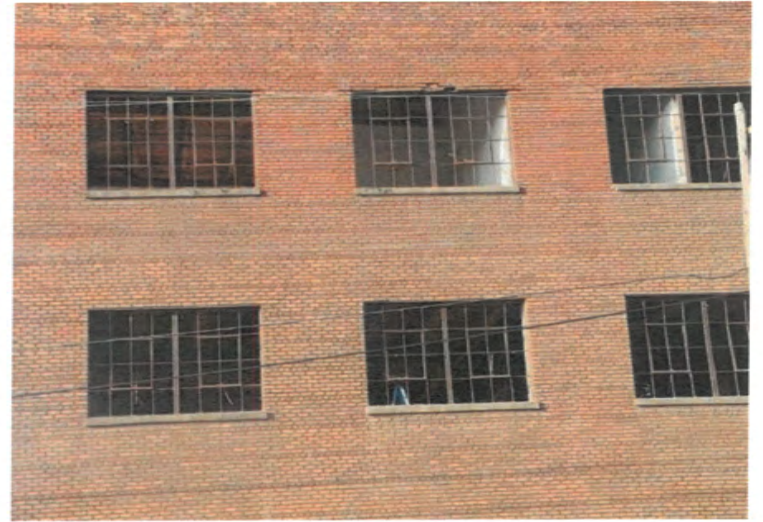
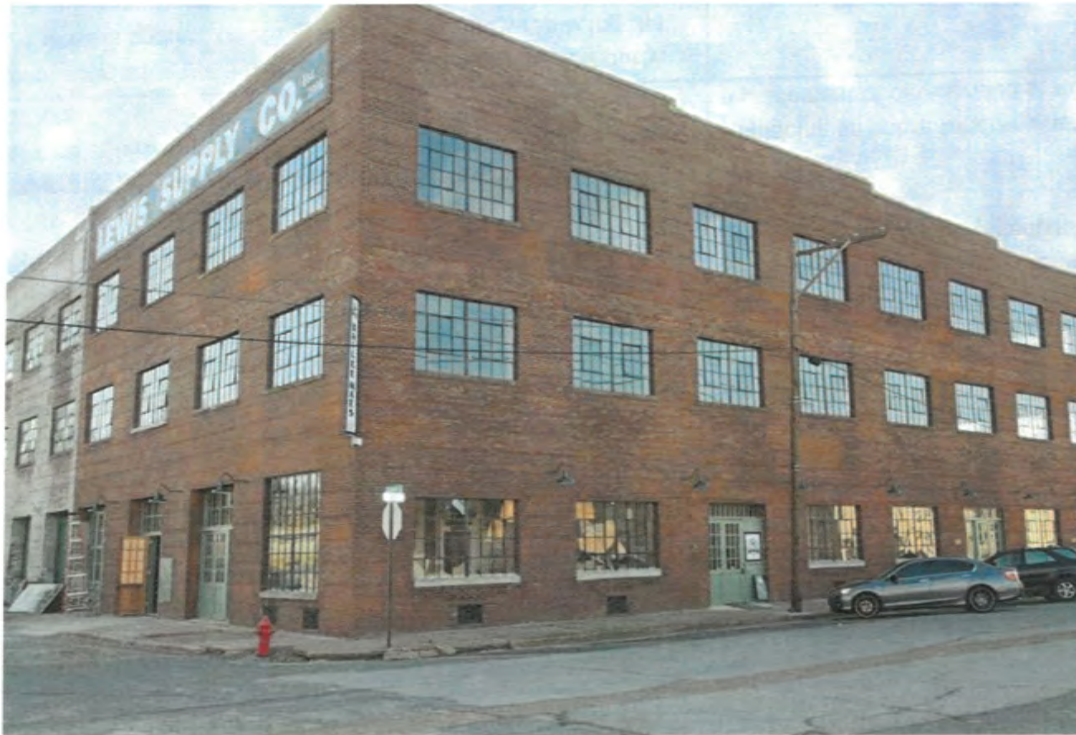
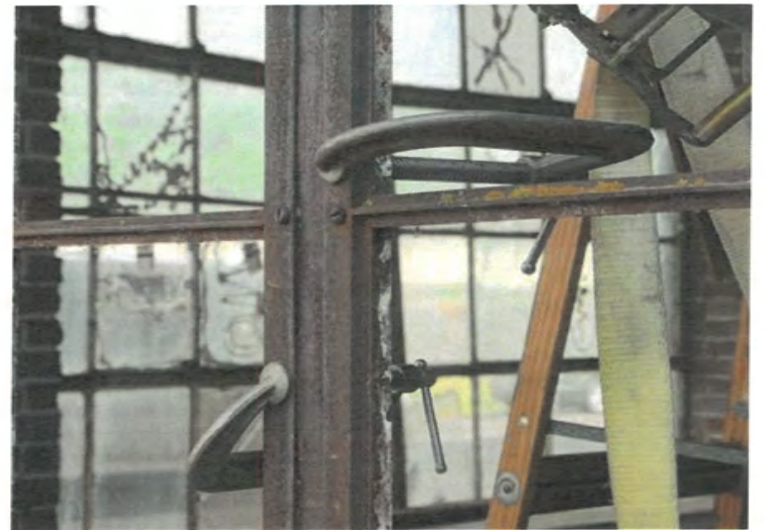
[20 a-d] The original steel windows in this industrial building were successfully repaired as part of the rehabilitation project (left).

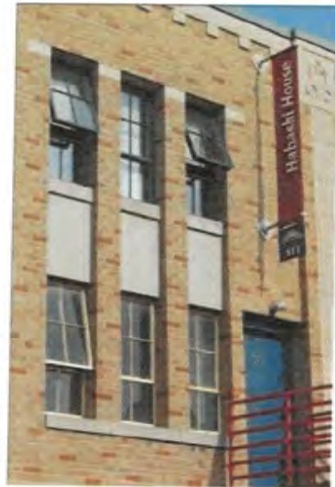
[21] The windows on the lower floor, which were too deteriorated to repair, were replaced with new steel windows matching the upper-floor historic windows that were retained.

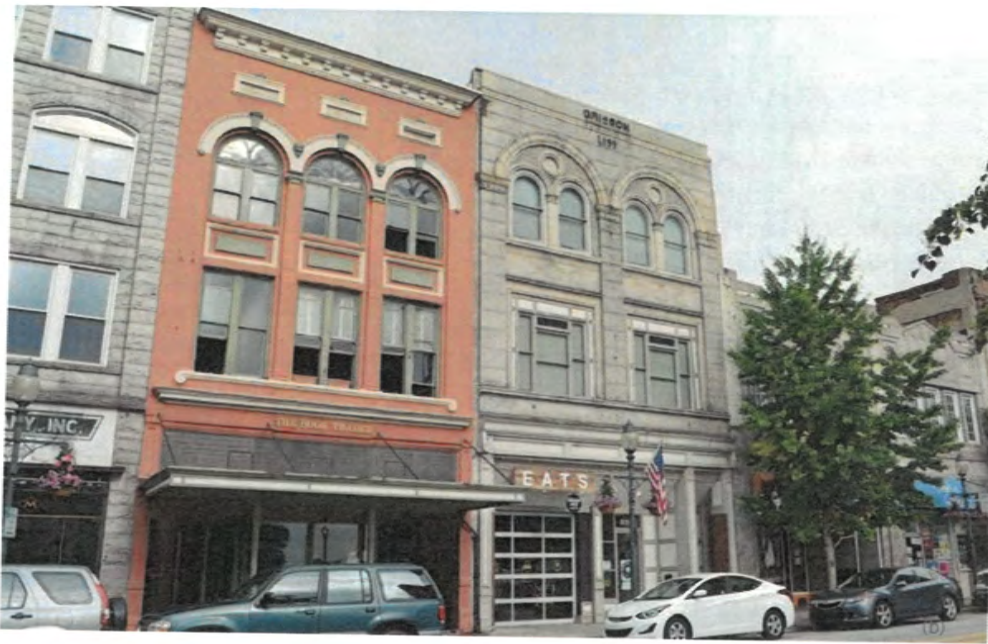
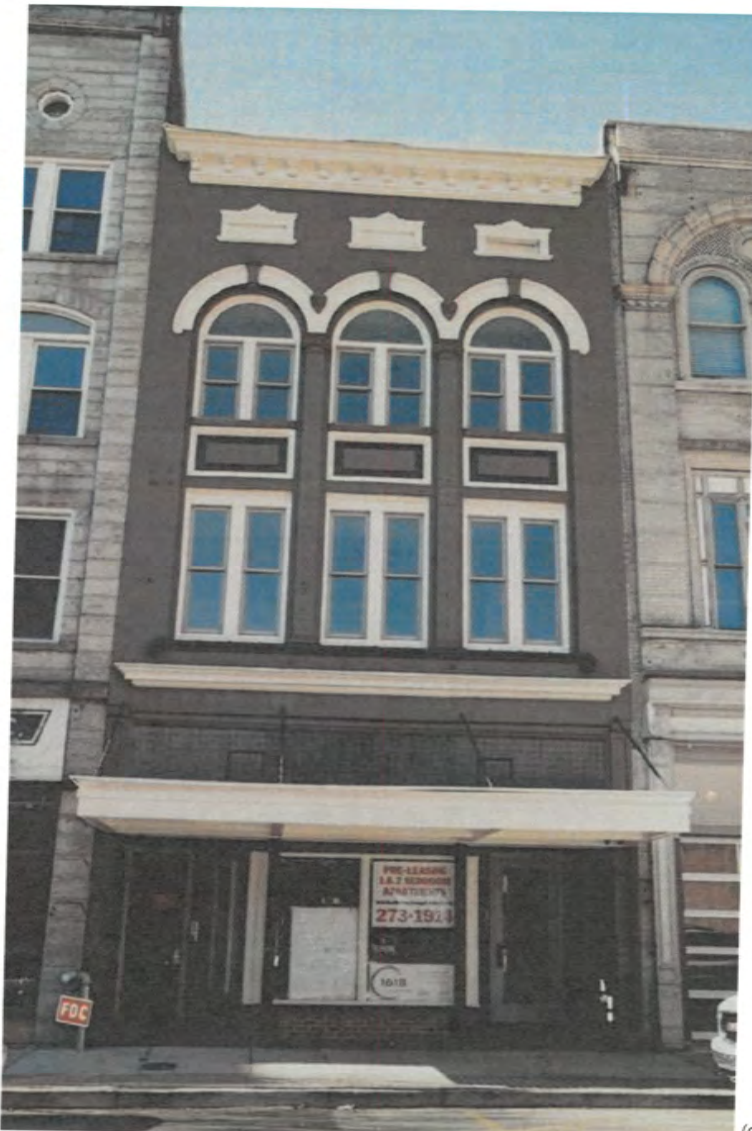
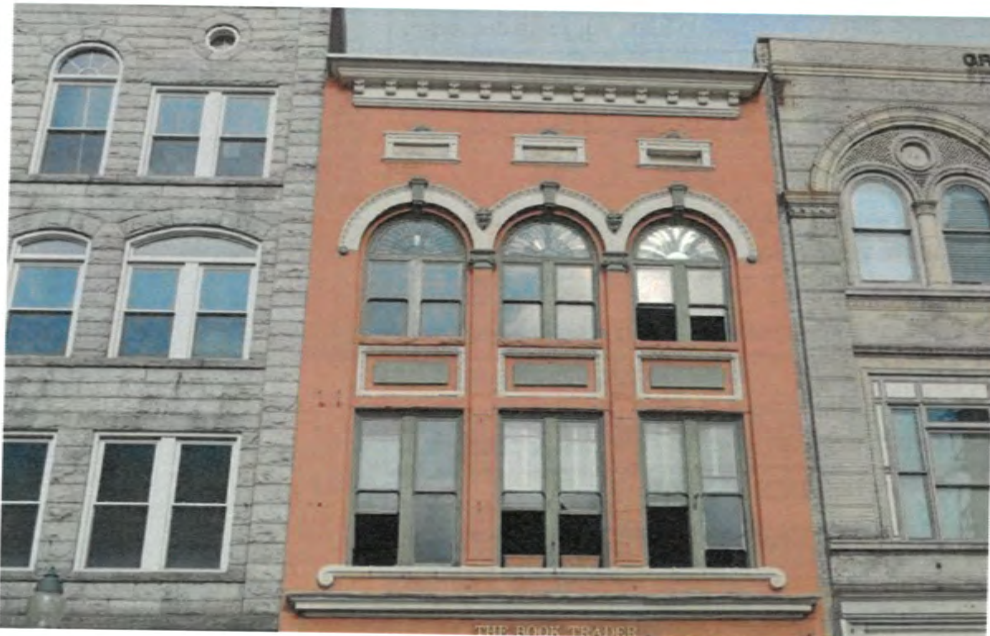
[22] **Not Recommended:** (a-b) The original wood windows in this late-19th-century building, which were highly decorative, could likely have been repaired and retained. (c) Instead, they were replaced with new windows that do not match the detailing of the historic windows and, therefore, do not meet the Standards (above).

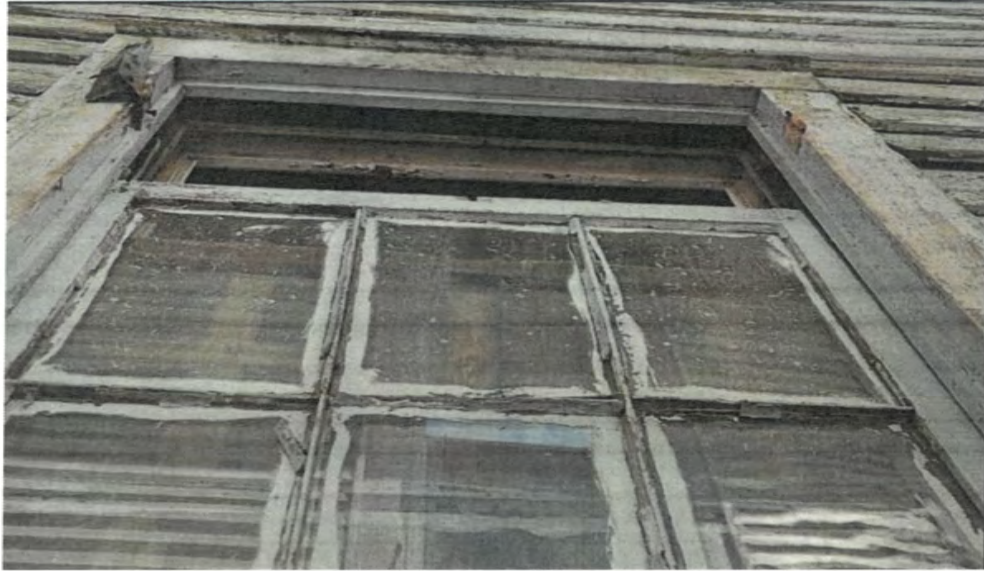
[23] (a) This deteriorated historic wood window was repaired and retained (b) in this rehabilitation project.

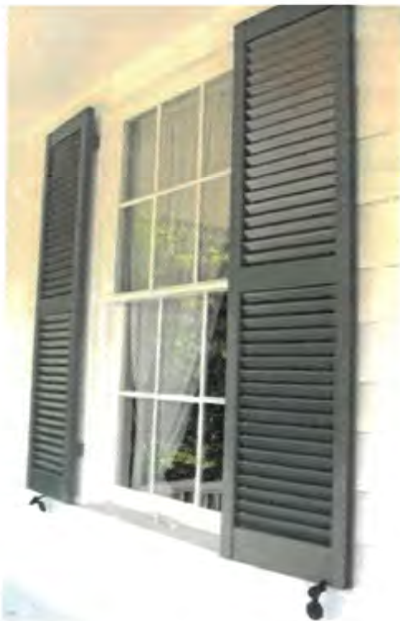
[9] Historic window and shutter hardware such as that shown here should be retained and repaired in a restoration project.
