PHASE I ENVIRONMENTAL SITE ASSESSMENT

101-111 Geraldine Street | Key West, Florida
PM Project Number 06-3668-0

**Re: Phase I Environmental Site Assessment of the
Former Key West Gas and Electric Company
Located at 101-111 Geraldine Street
Key West, Florida
PM Environmental, Inc. Project No. 06-3668-0**

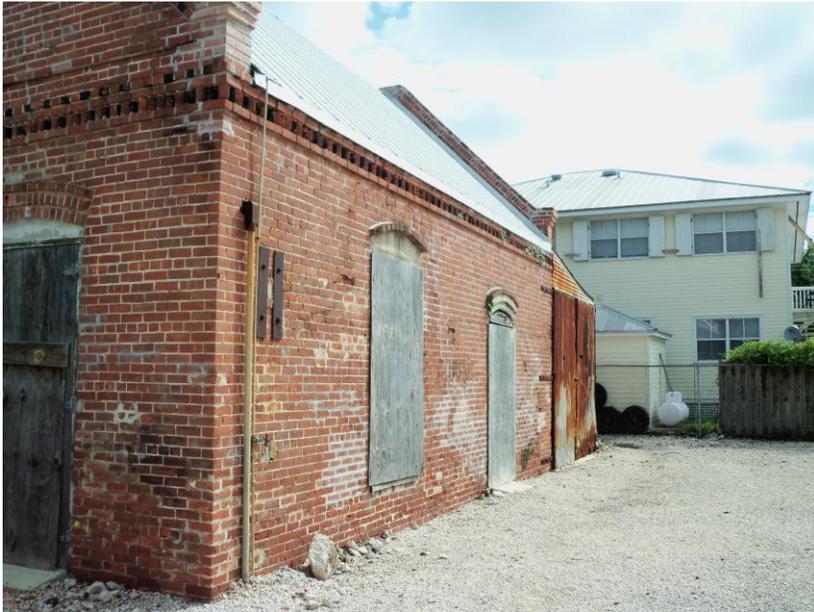
Photograph 3

View of the former machine shop building,
facing east.

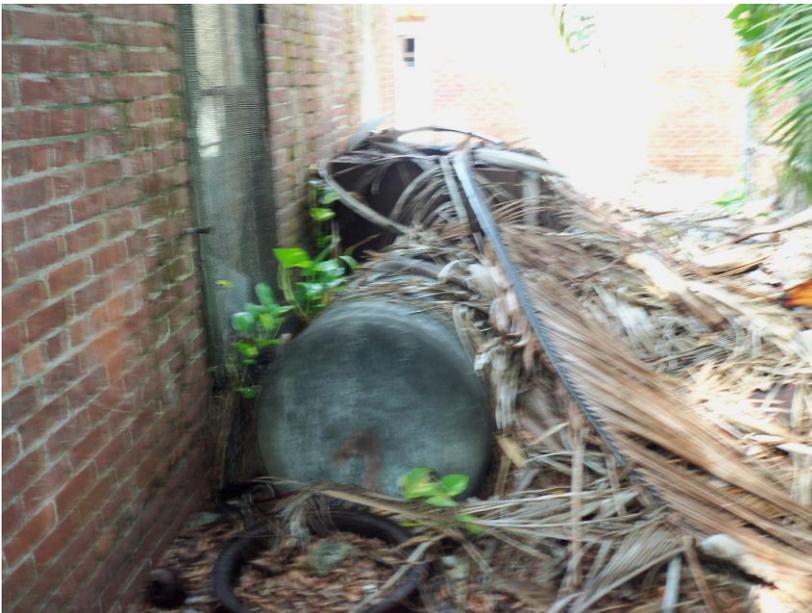
Photograph 6

Air Compressors: PM observed an apparent air compressor to the north of the machine shop building. The compressor had fallen over; however, PM did not observe evidence of significant staining in the vicinity of the compressor.

View of the apparent compressor to the north of the former machine shop building.

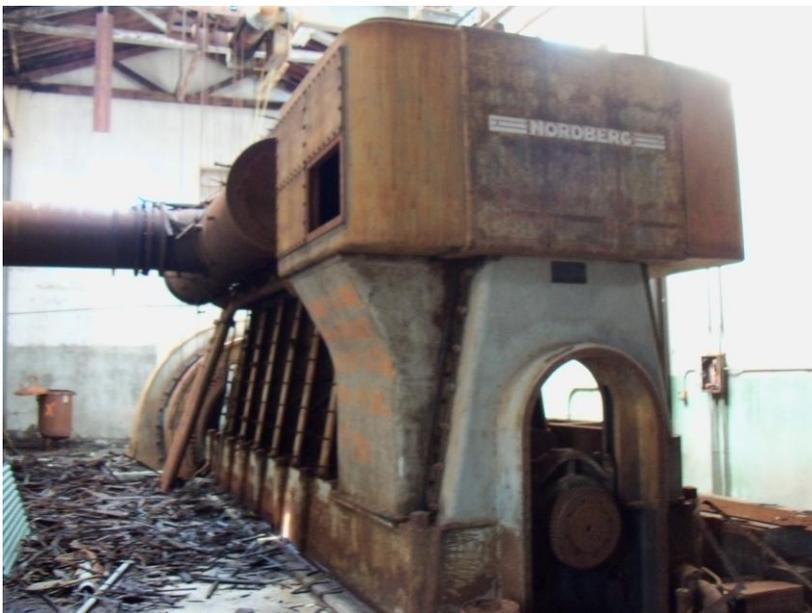
Photograph 8

Lathes, Screw Machines, etc.: A total of four turbine generators were observed within various portions of the main building. Three of the generators were surrounded by concrete lined pits.

View of a typical generator within the main building.

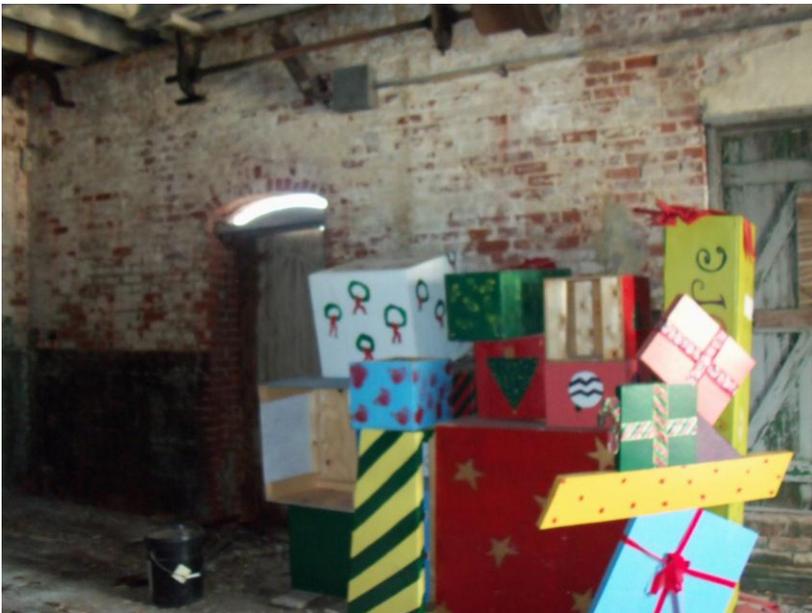
Photograph 14

- Former machine shops were identified on the property within the southwestern portion of the main building and within the machine shop. Machine shop operations typically involve the use of general hazardous substances and/or petroleum products. This time period preceded major environmental regulations and current waste management and disposal procedures. The historical waste management practices associated with the former machine shop operations are unknown and may be a source of subsurface contamination.

View of the interior of the former machine shop building.

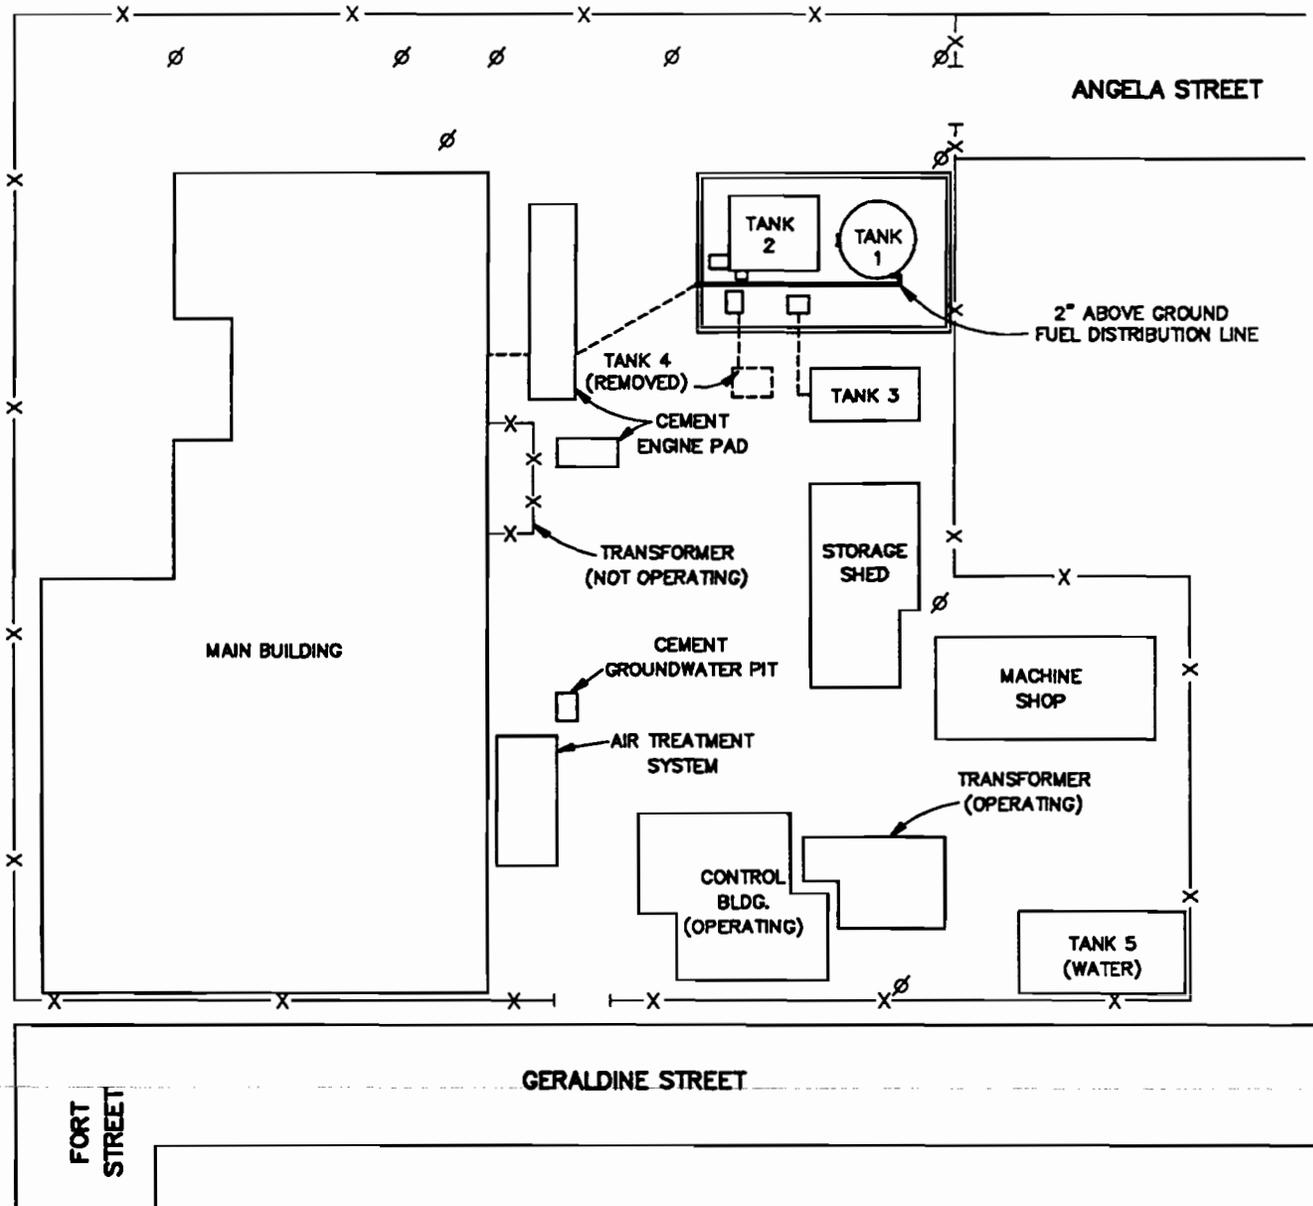
FIGURE 2-2
SITE PLAN

CITY ELECTRIC SYSTEM
 ABANDONED DIESEL PLANT
 ANGELA STREET
 KEY WEST, FLORIDA

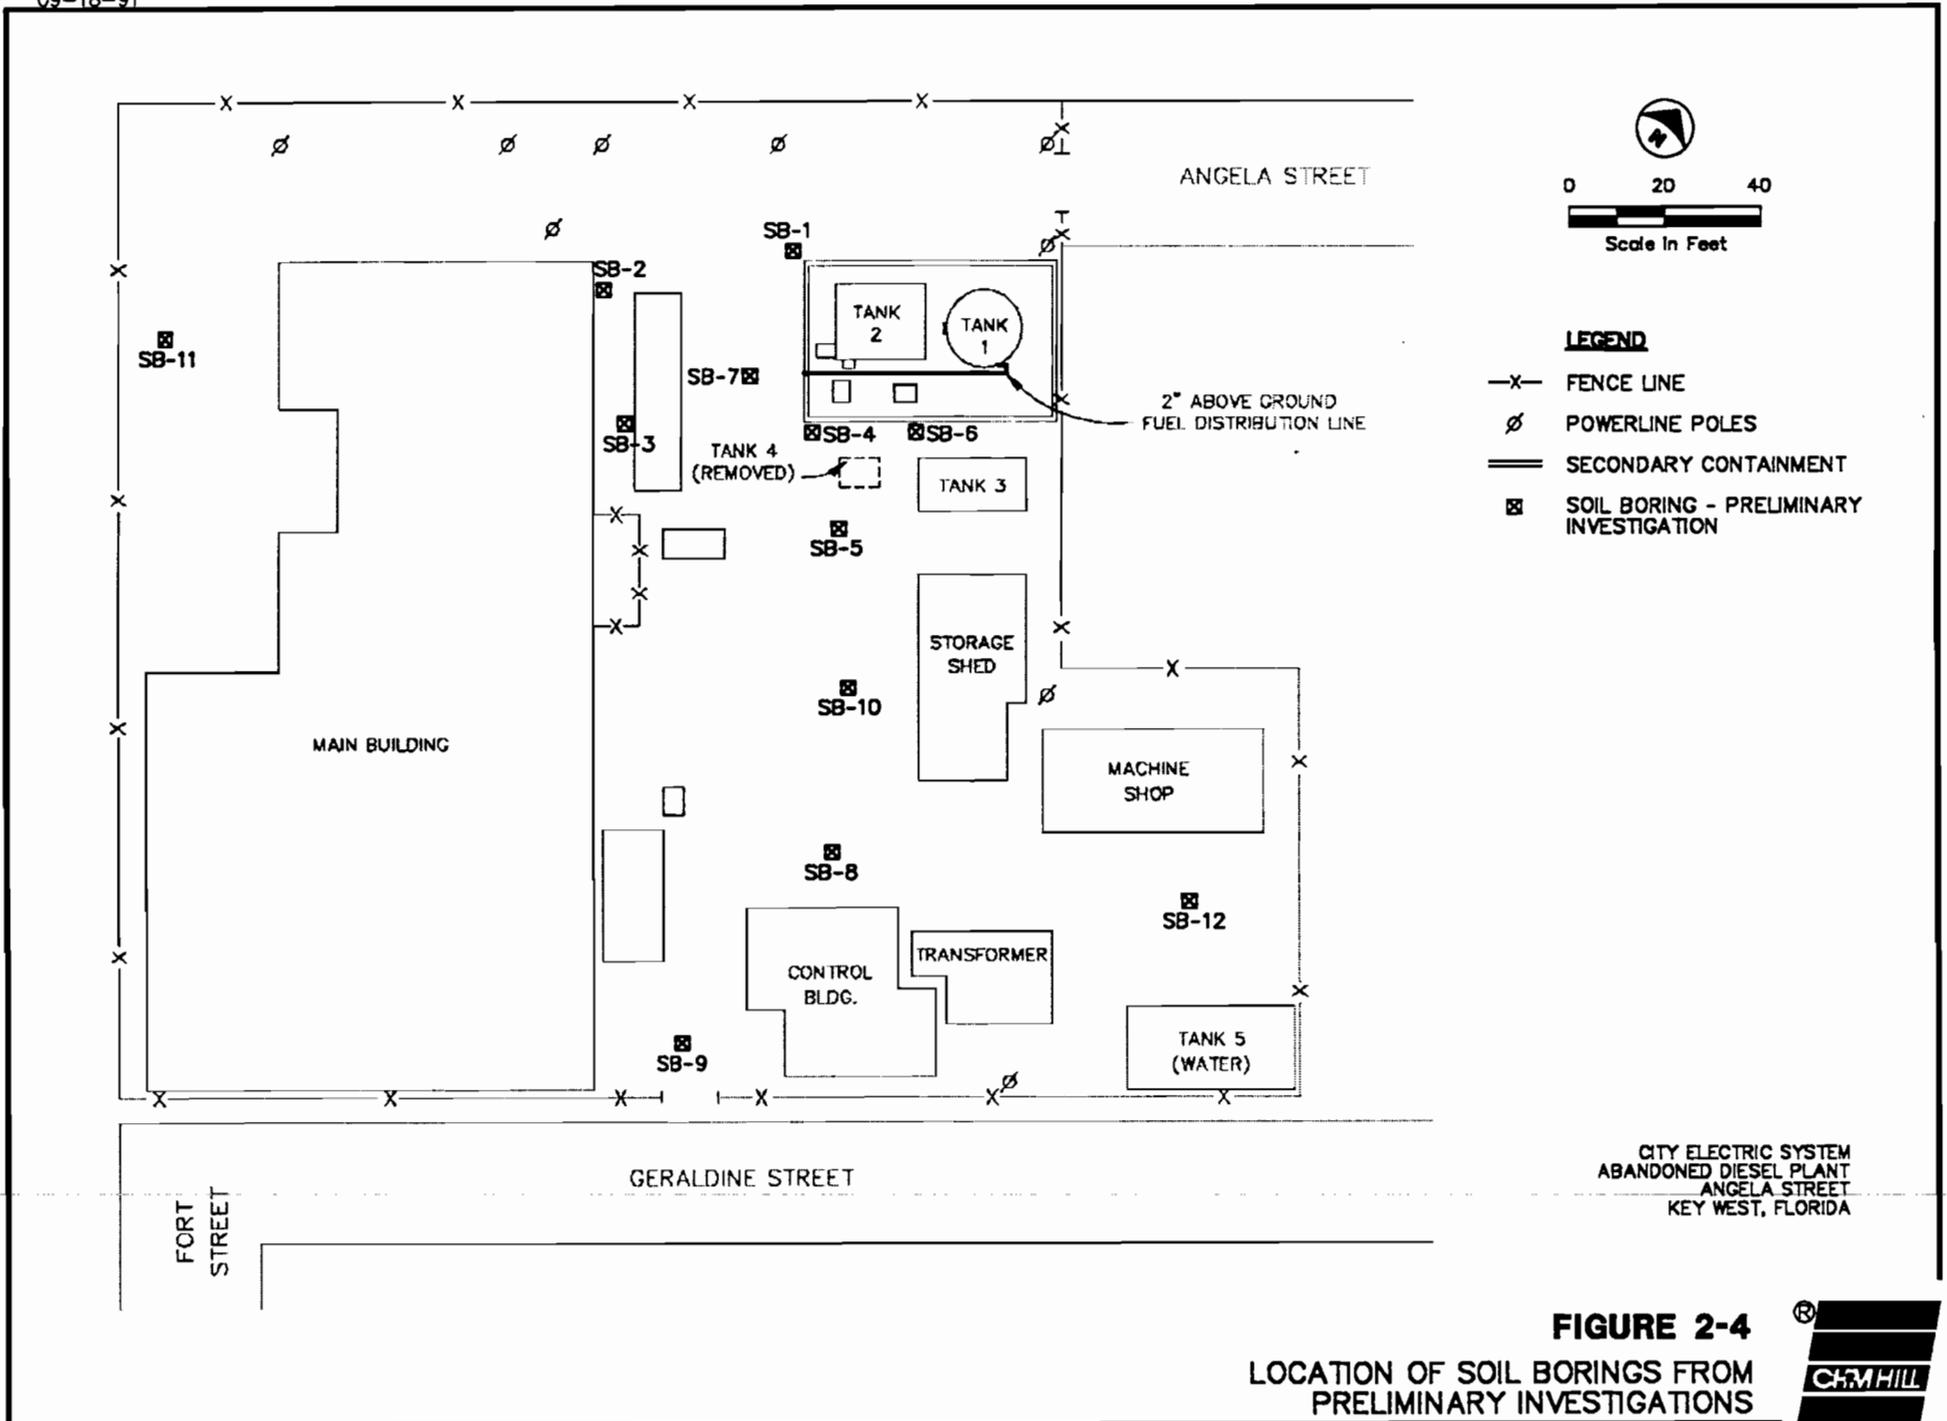
FIGURE 2-4

LOCATION OF SOIL BORINGS FROM
PRELIMINARY INVESTIGATIONS

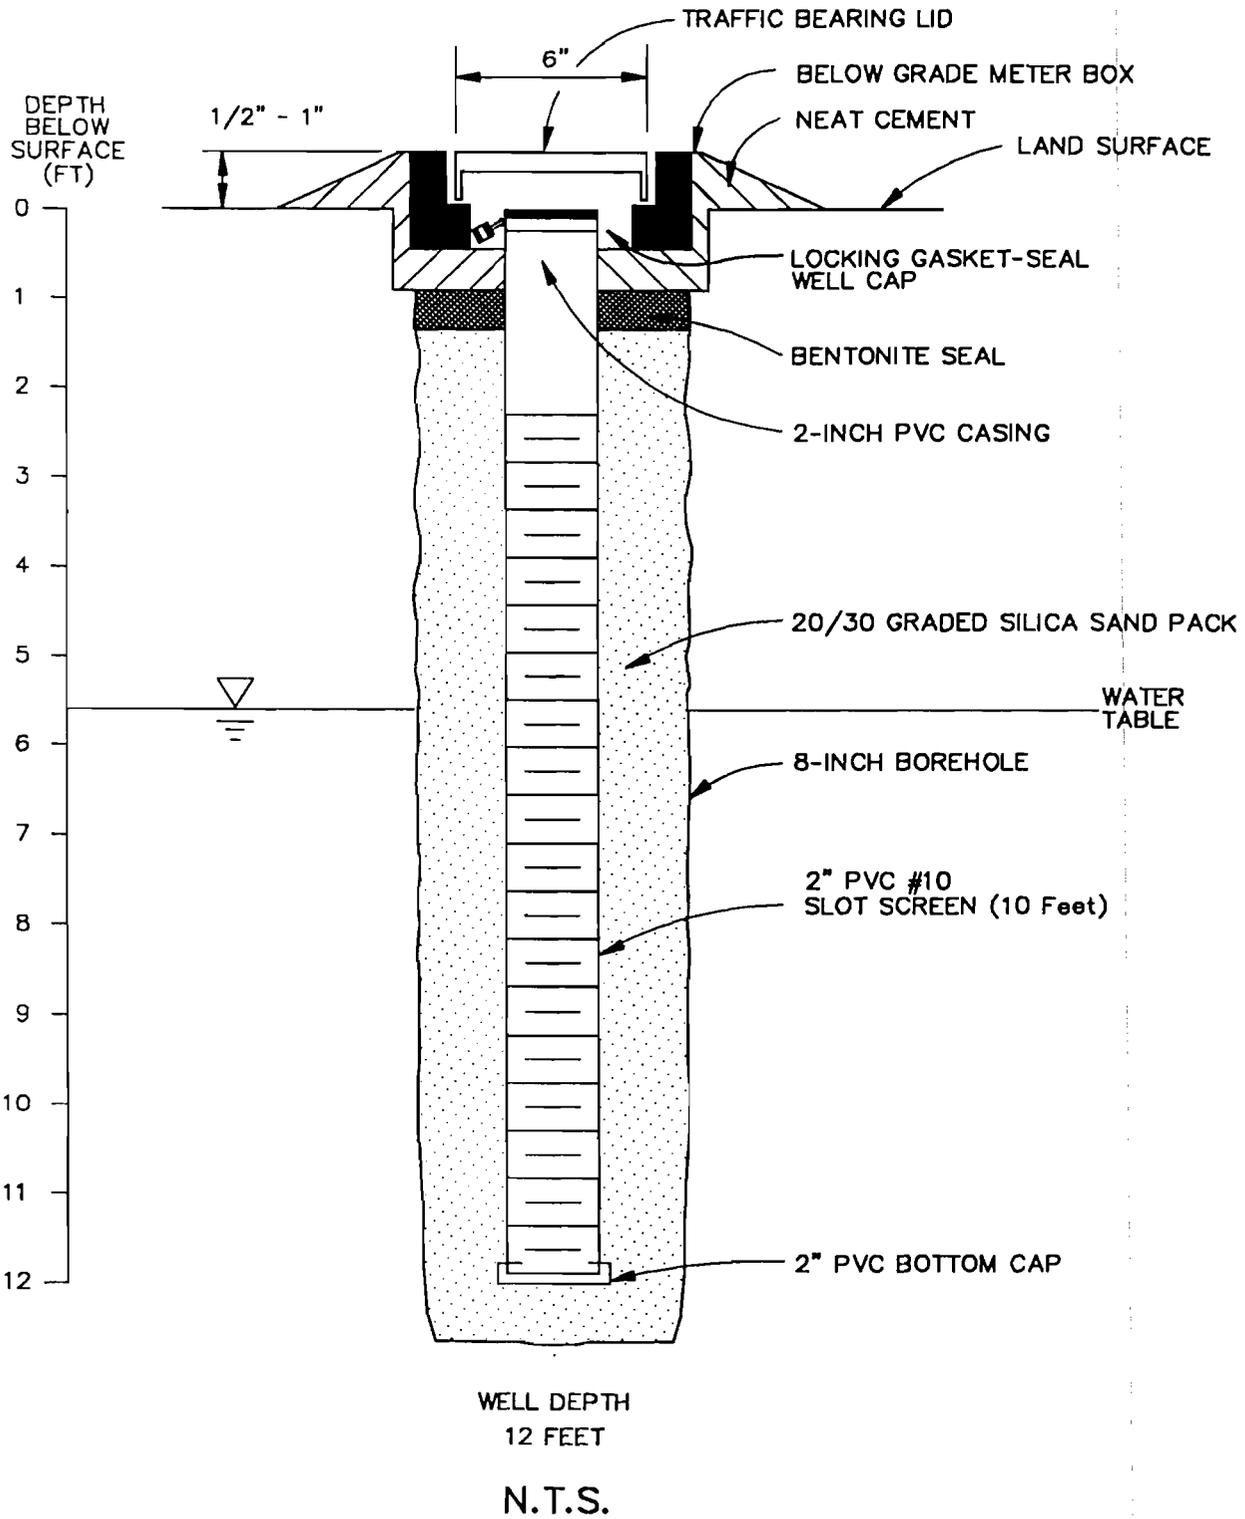
FIGURE 3-3
SHALLOW MONITOR WELL
CONSTRUCTION DIAGRAM

The three 2-inch-diameter monitor wells were installed to depths of approximately 12 feet bls using 8-inch-diameter hollow-stem augers. Ten feet of No. 10 slot polyvinyl chloride (PVC) well screen and 2 feet of Schedule 40 PVC riser pipe were used to construct the wells. The screened interval was approximately 2.0 to 12.0 feet bls. A clean, graded 20/30 silica sand pack was installed so that the tips of the screens were at least 2 feet above the water table at high tide. A 6-inch-thick bentonite seal was added on top of the sand pack, followed by cement grout to the surface. Below-grade meter boxes with 6-inch-diameter, traffic bearing covers were cemented in place. The covers were set approximately 1/2 to 1 inch above grade to prevent runoff from entering the meter box. A locking, gasket-sealed cover was placed on the top of the riser pipe. Locks were included on the wells. This method was also used for the installation of MW-1 through MW-5. A construction diagram for the shallow monitor wells is shown in Figure 3-3.

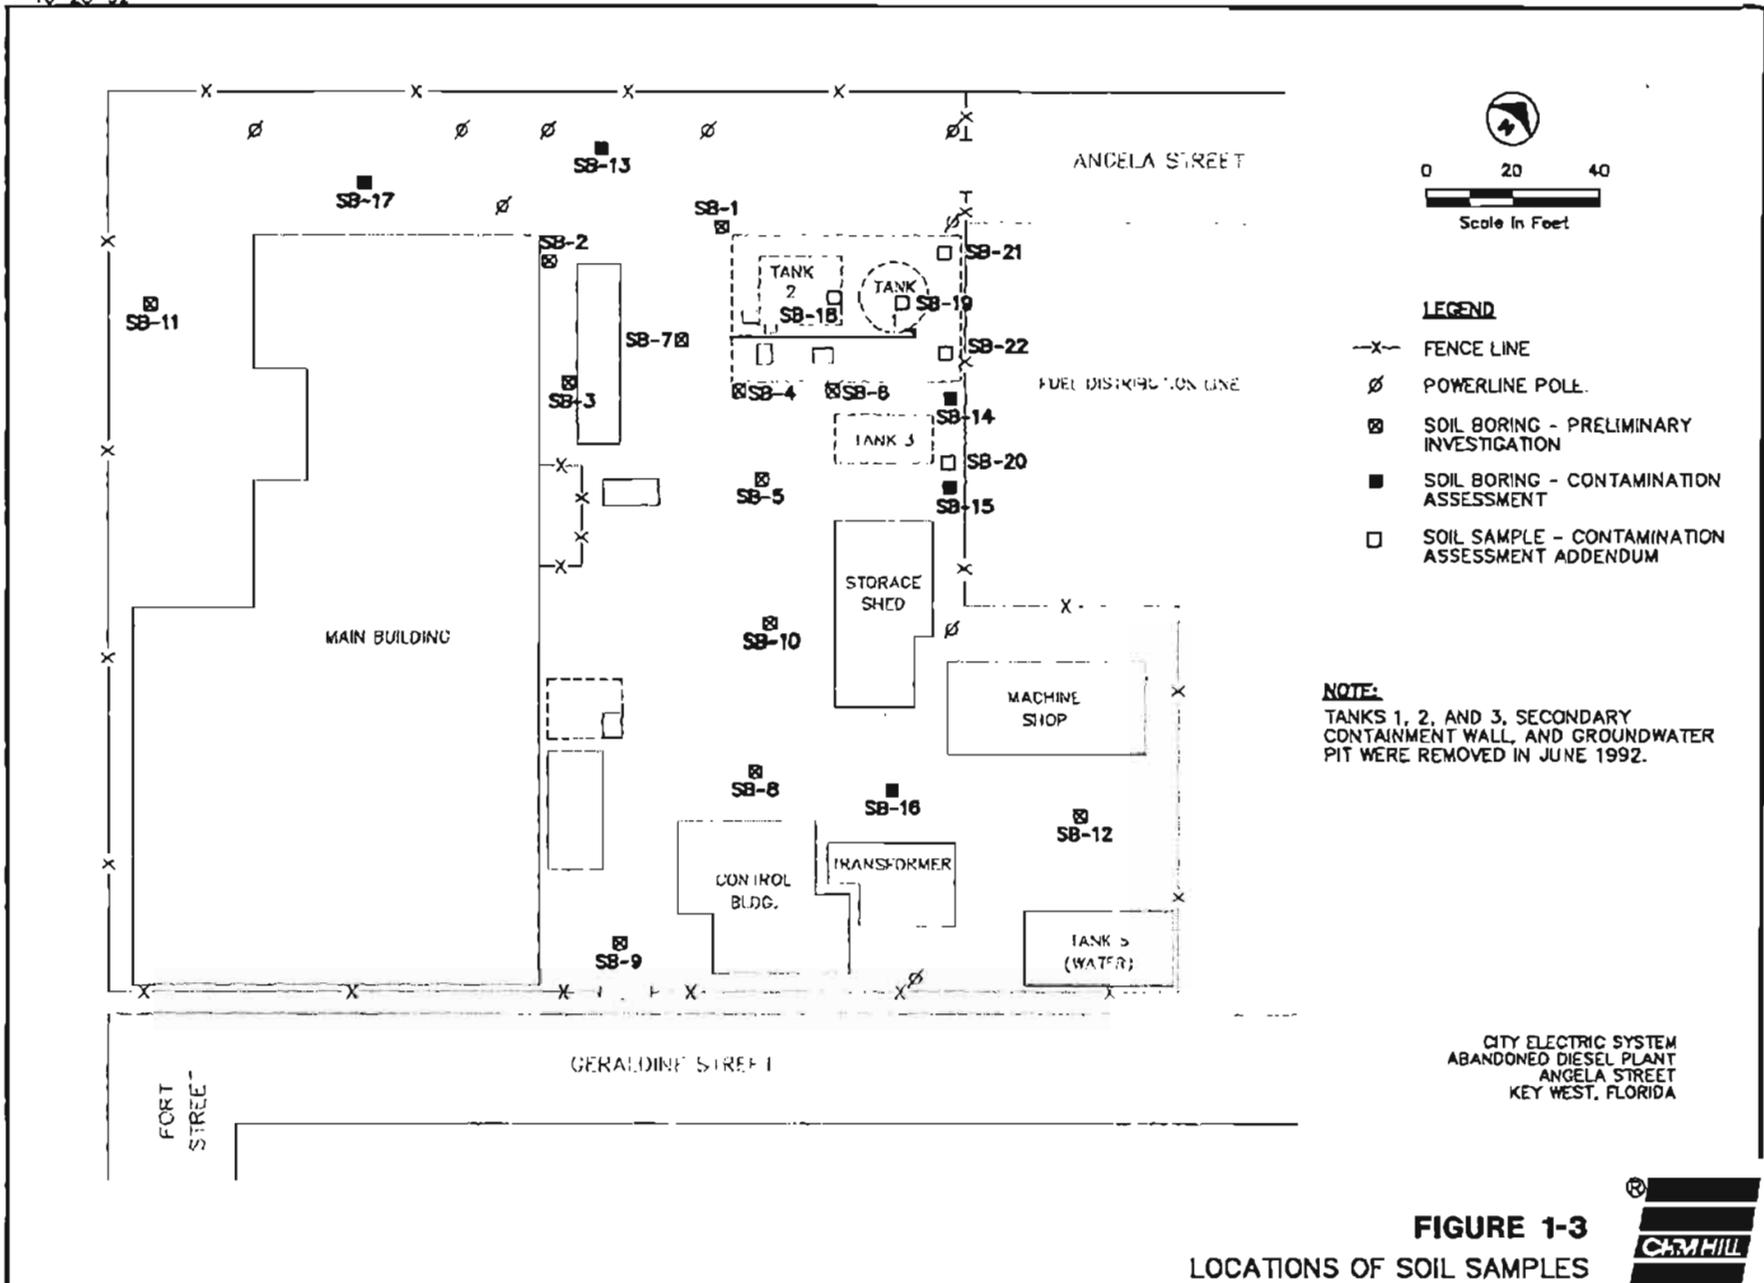
FIGURE 1-3
LOCATIONS OF SOIL SAMPLES

These analytical results support the conclusion that the soils are mainly affected by less volatile, less mobile, higher-molecular weight petroleum compounds. This conclusion is consistent with both the type of petroleum product which was used at this facility and the approximate age of the spill.

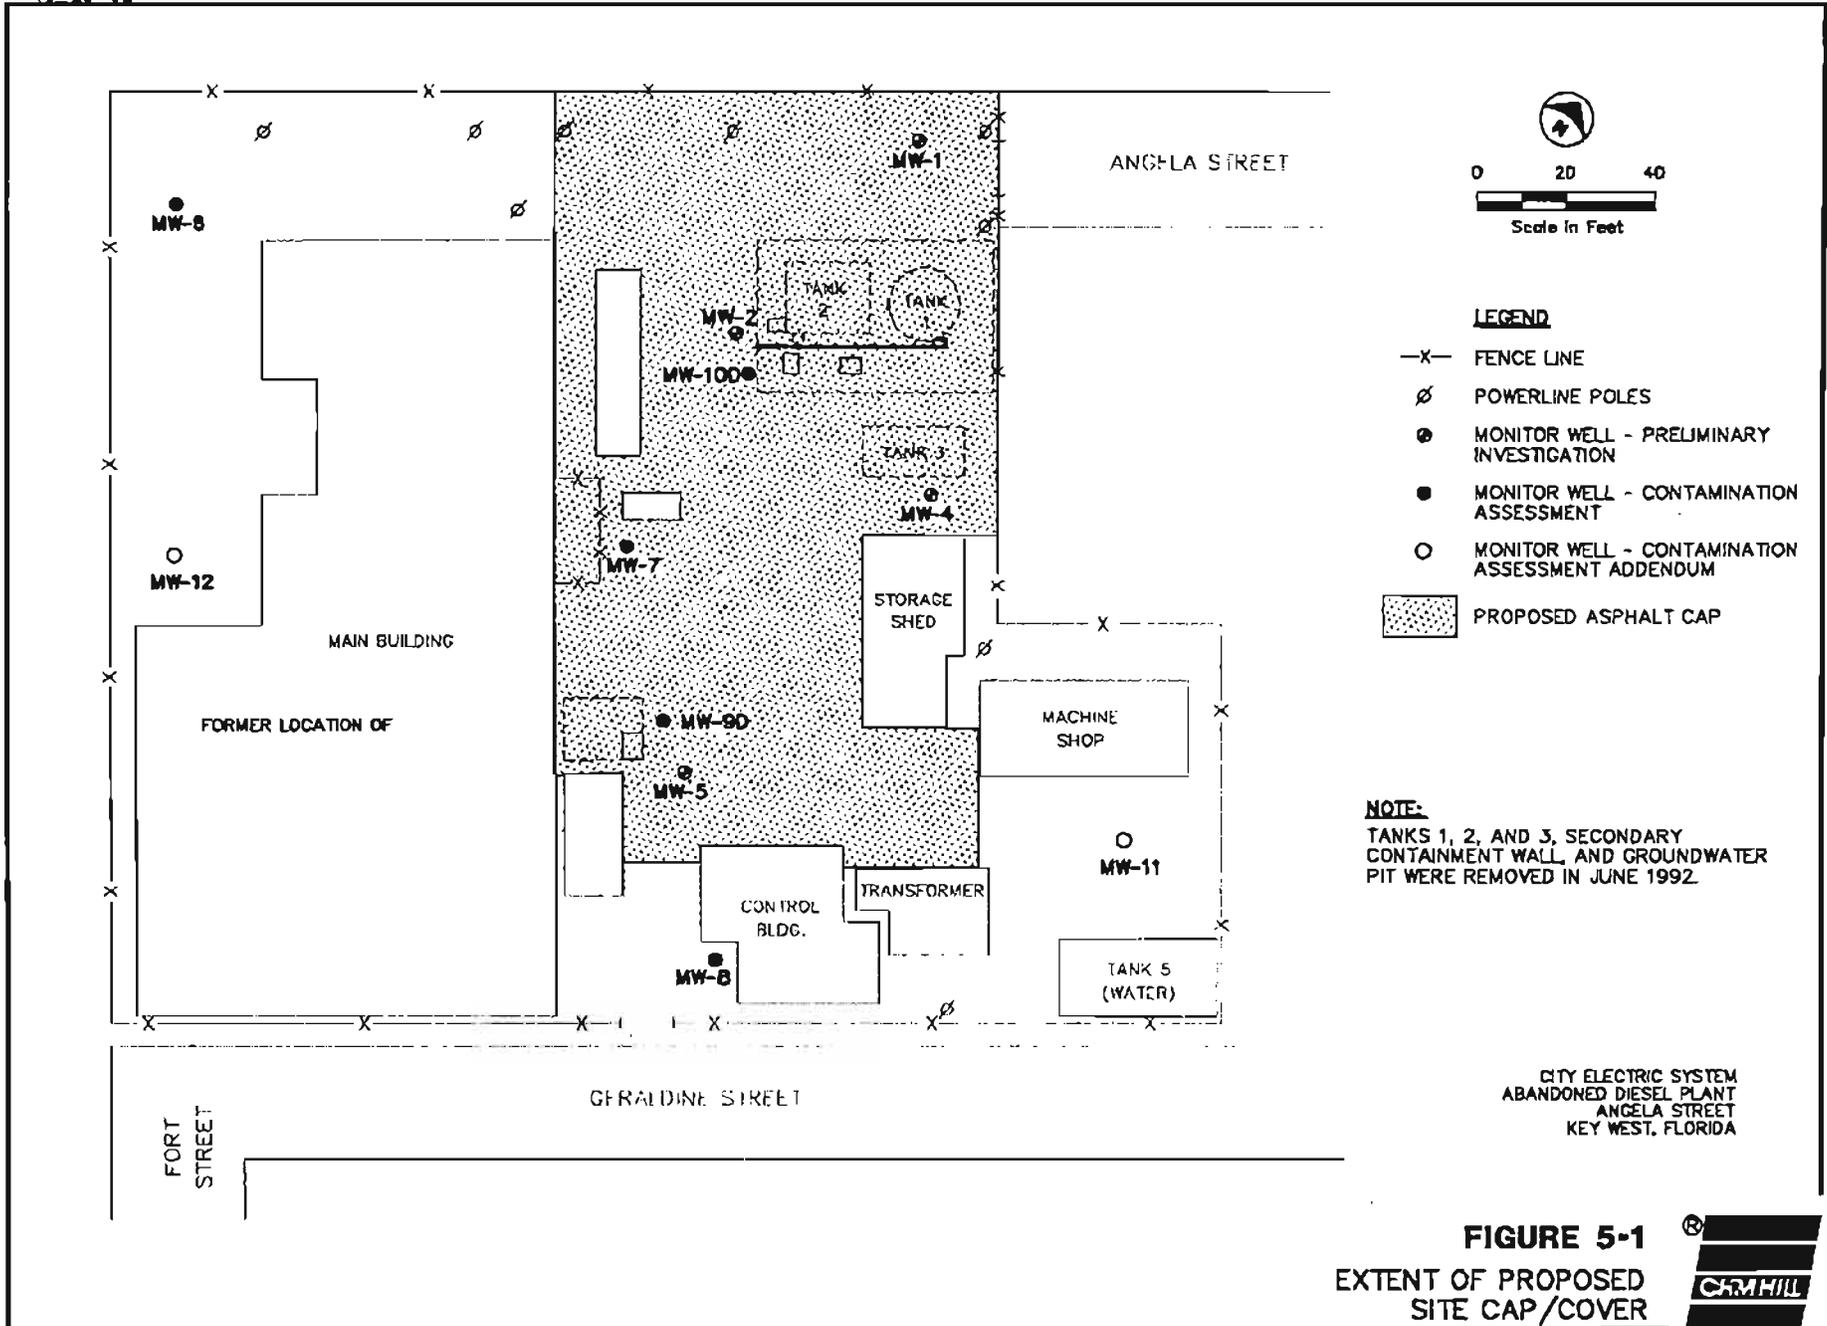
FIGURE 5-1
EXTENT OF PROPOSED
SITE CAP/COVER

The estimated capital cost for this option would be \$23,000 based on an estimate of \$14/yd² over the area of coverage (1,267 yd²). The impermeable cap/cover would be installed so as not to destroy existing monitor wells at the site. Maintenance activities for the impermeable cap/cover would be limited to the application of protective sealer on a periodic basis to maintain the integrity of the asphalt. Cost associated with this maintenance activity would be negligible. Appendix D provides a more detailed cost estimate.

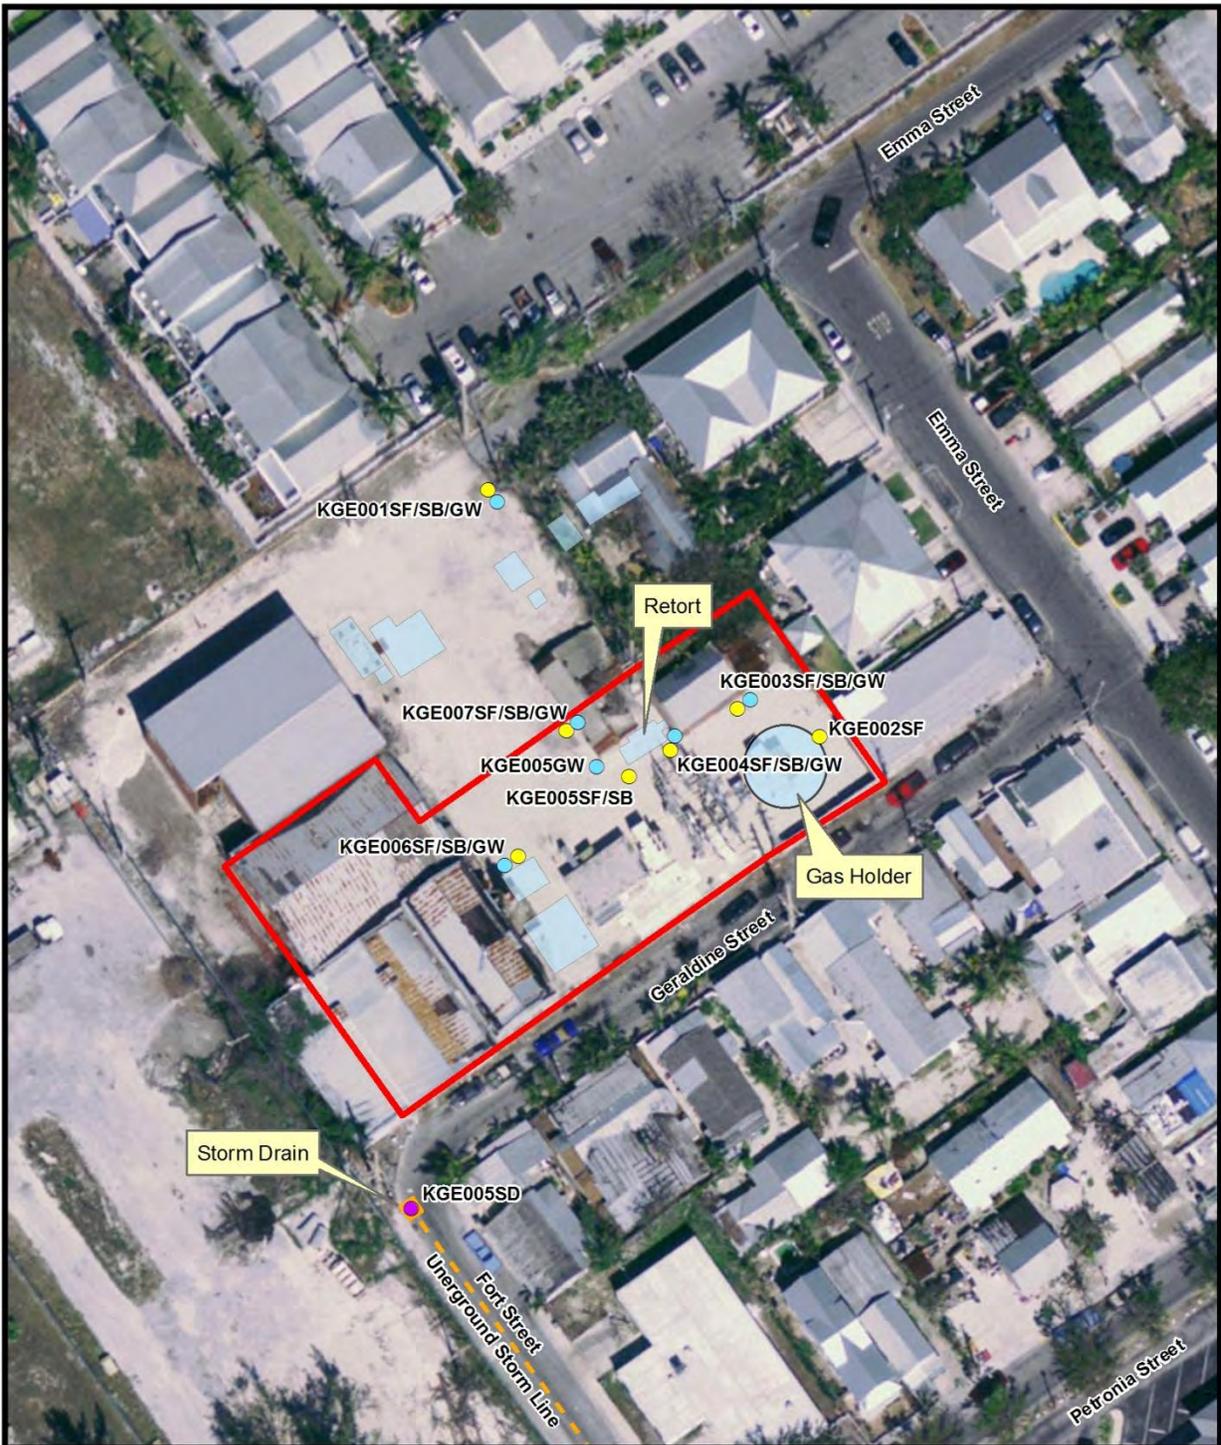
Key West Gas & Electric Company Site
Figure 3: EPA SESD Sample Location Map
 101-111 Geraldine Street / 709 Fort Street
 Key West, Monroe County, Florida 33040
 (2007 Aerial Imagery)
 Prepared by: B.K. McClain Date: 4/30/2012

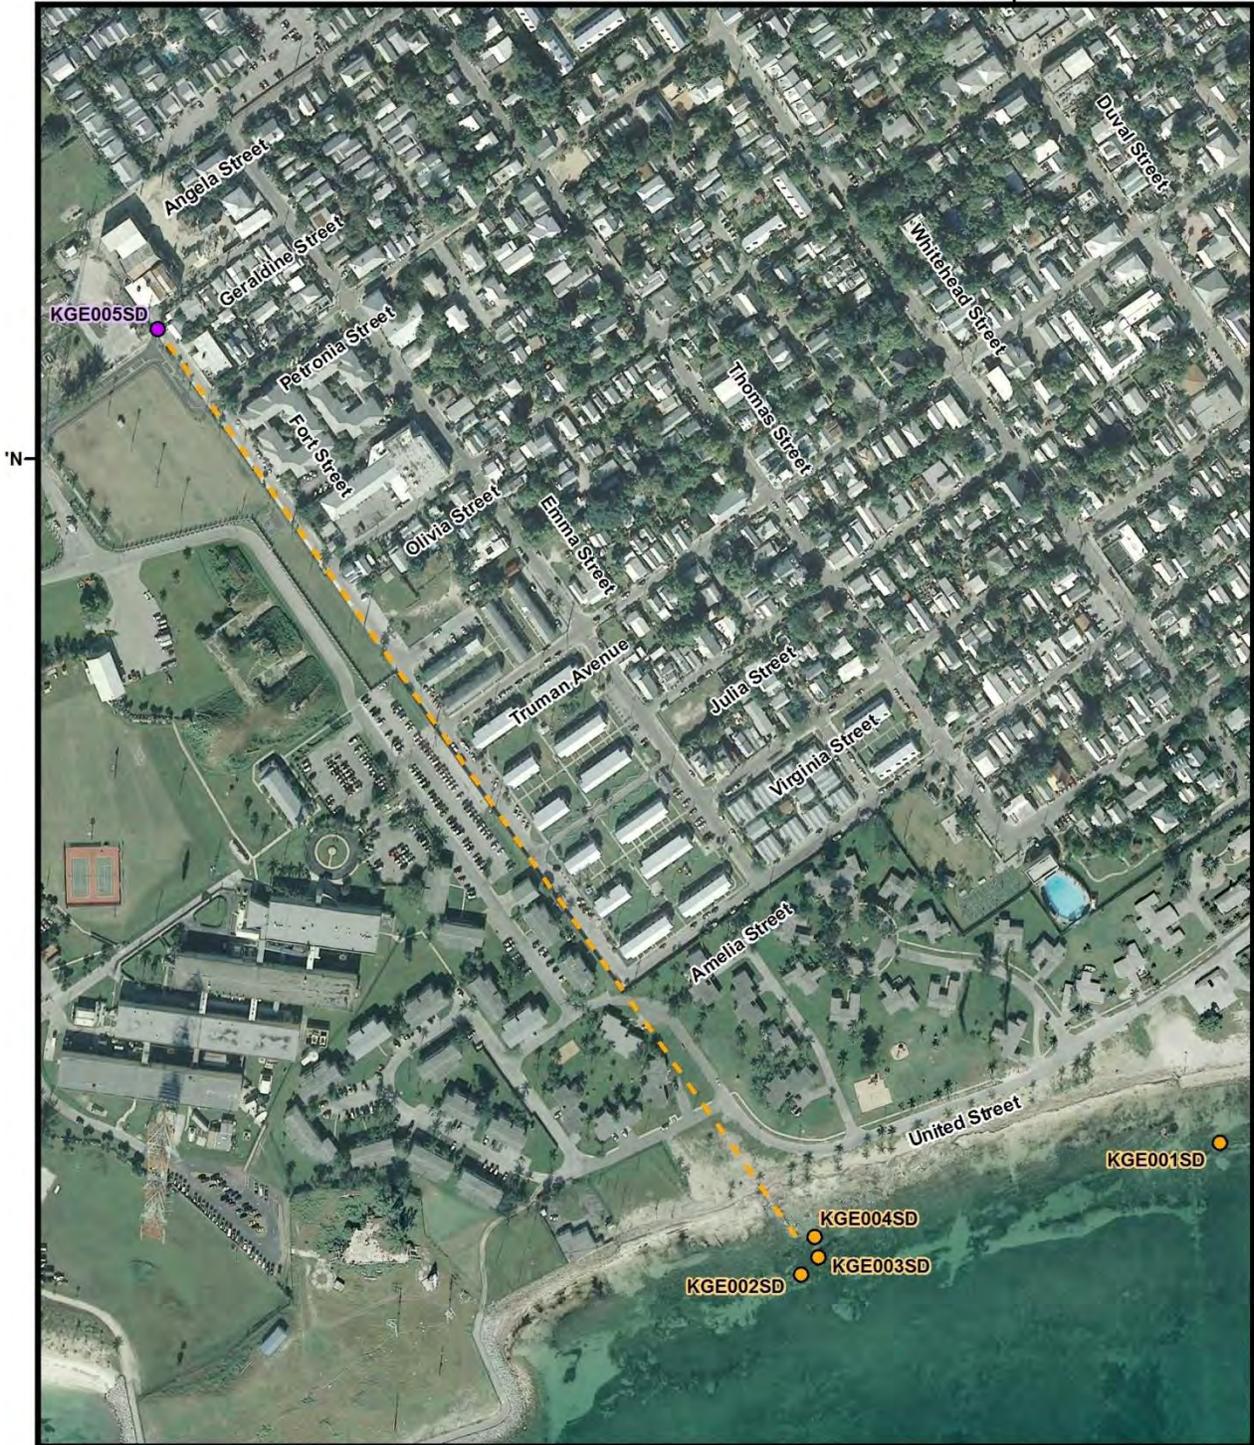
Five sediment samples were collected to assess possible impacts to surface water. The sediment samples were analyzed for VOCs, SVOCs, RCRA 8 Metals and Cyanide. One of the sediment samples (KGES005SD) was collected from the storm drain located near the intersection of Geraldine and Fort Streets. Three of the sediment samples (KGES002SD to KGES004SD) were collected from the Florida Straits adjacent to the Fort Street outfall pipe. A background sediment sample (KGES001SD) was collected from the Florida Straits further to the northeast. The sediment sample from the storm drain was collected using a decontaminated stainless steel ice scoop attached to a piece of metal conduit pipe. A Zodiac inflatable dinghy, procured from nearby EPA Ocean Survey Vessel Bold, was utilized to collect the sediment samples from the Florida Straits. The sediment samples from the Florida Straits were collected using a decontaminated Ponar dredge. The contents of the sampling device were transferred to a decontaminated Pyrex glass pan. The soil was thoroughly mixed to form a homogenous sample, prior to filling the appropriate sample containers. The aliquots for VOC analyses were collected directly from the sampling device using a 5 gram o2si Smart Solutions VOC sampling kit in accordance with EPA 5035 methodology. The mouth of the o2si Smart Solutions sampler was placed into the 40ml VOA vial containing the appropriate amount of distilled water or preservative (methanol). Due to the remote location of the site, the vials were subsequently placed into a small freezer and frozen to extend the normal 48 hour hold time. A breakdown of the sampling location rationale is presented in Table 2. The sampling locations are shown on Figure 5.

Key West Gas & Electric Company Site
Figure 5: EPA SEDS Offsite Sampling Location Map
101-111Geraldine Street / 709 Fort Street
Key West, Monroe County, Florida 33040
(2007 Aerial Imagery)
Prepared by: B.K. McClain Date: 4/30/2012
