ORDINANCE NO. 19-02

AN ORDINANCE OF THE CITY OF KEY WEST, FLORIDA, PURSUANT TO SECTION 1.08 OF THE CITY CHARTER, CALLING FOR A REFERENDUM AUTHORIZING THE CITY OF KEY WEST TO PURCHASE THE REAL PROPERTY LOCATED AT 3420 NORTHSIDE DRIVE, KEY WEST, FLORIDA AND COMMONLY REFERRED TO AS THE CITIZEN'S BUILDING FROM COOKE COMMUNICATIONS,LLC, FOR USE BY THE COMMUNITY SERVICES DEPARTMENT OF THE CITY OF KEY WEST OR OTHER CITY OF KEY WEST DEPARTMENTS; AUTHORIZING THE CITY CLERK TO TAKE ALL NECESSARY ACTION TO PLACE THIS MEASURE ON A SPECIAL BALLOT FOR APRIL 16, 2019; ~~AUTHORIZING THE CITY TO BORROW FUNDS TO BE UTILIZED FOR THE ACQUISITION;~~ PROVIDING FOR SEVERABILITY; PROVIDING FOR REPEAL OF INCONSISTENT PROVISIONS; PROVIDING FOR AN EFFECTIVE DATE

PHASE I ENVIRONMENTAL SITE ASSESSMENT
3420 Northside Drive
Key West, Florida

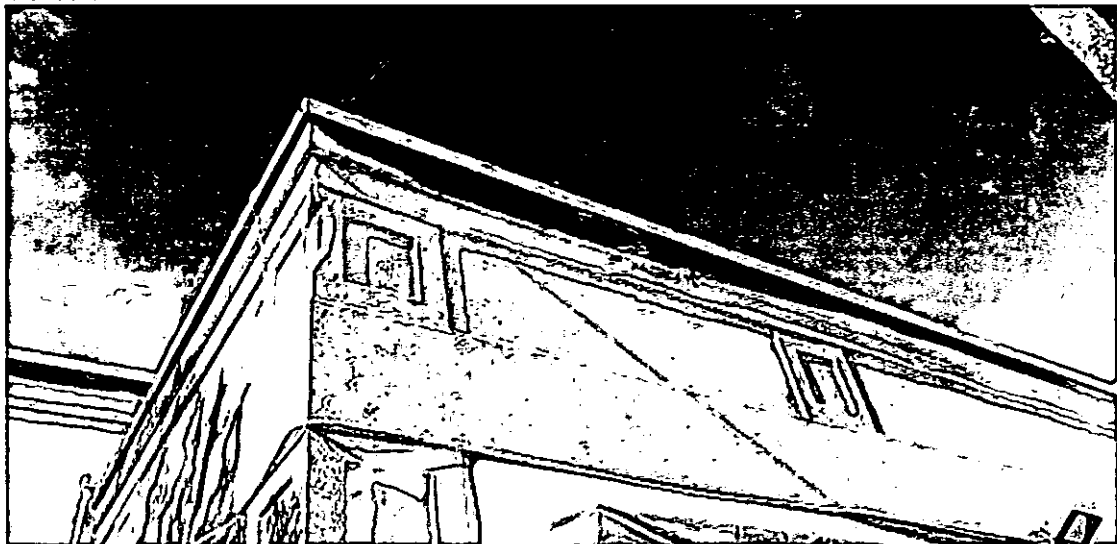
Figure 13. Exterior wall with small damage to the corner and surface (likely hurricane debris damage). Similar small damage in other locations. Cosmetic repairs are needed.

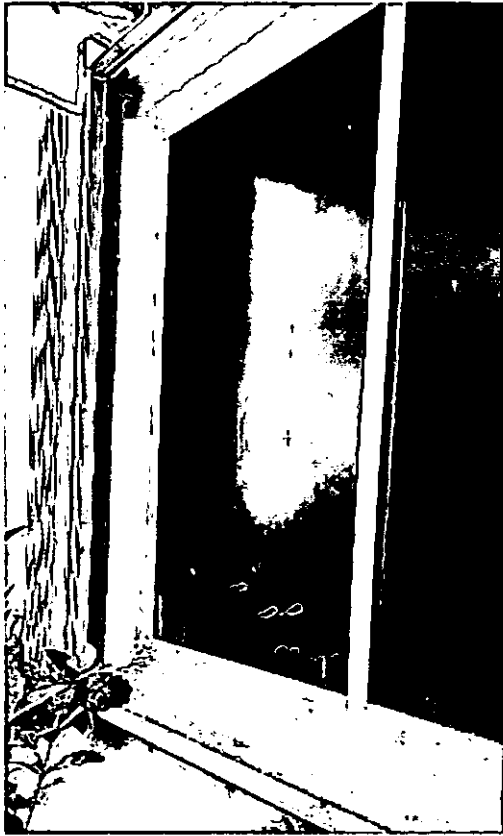
Figure 18. Broken outer pane of a double glass fenestration system in one location. Replacement of the glass is needed. Please note that some windows have black-out coating for privacy.

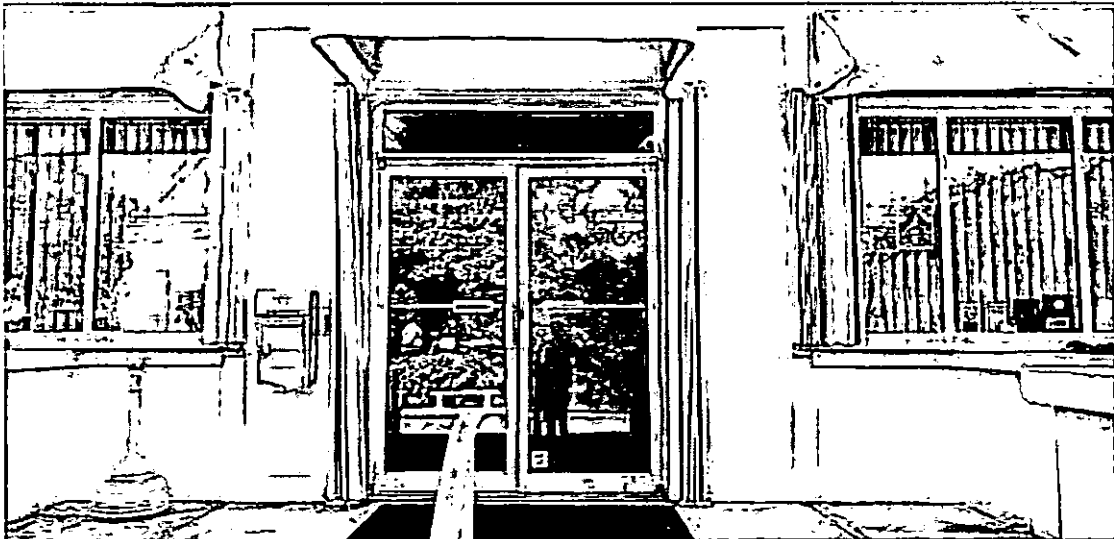
Figure 19. Front Entry Doors and windows.

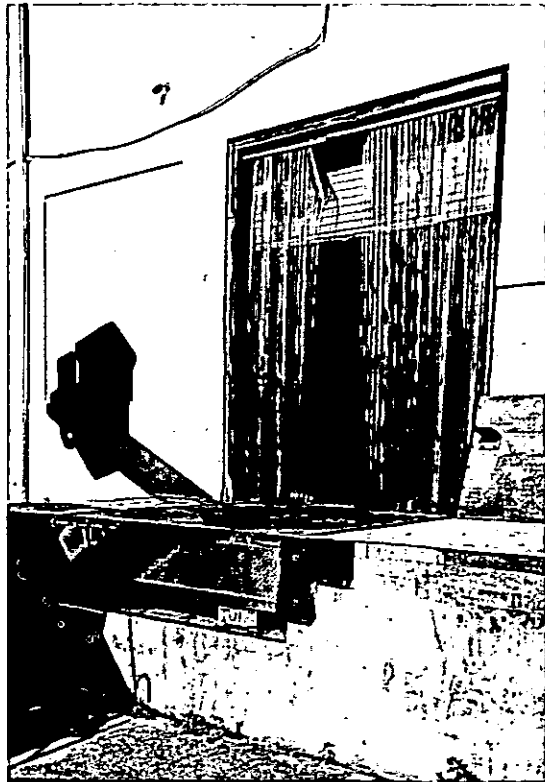
Figure 20. Rear loading dock with galvanized steel roll-up doors.

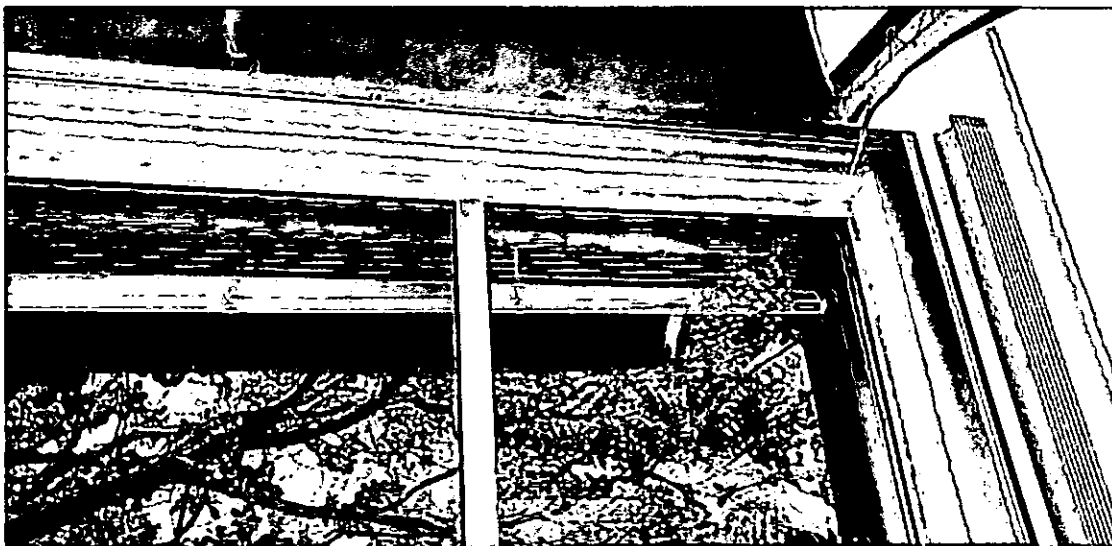
Figure 21. Signs of water intrusion - visible damage to the drywall trim of the window opening on the interior (likely prior new roofing installation).

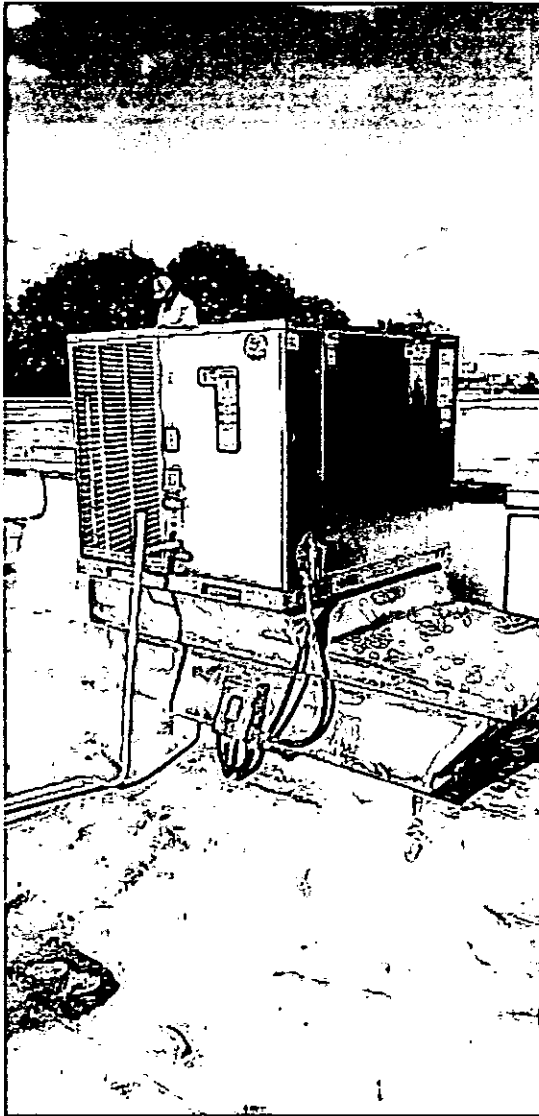
Figures 25&26. Rooftop package unit servicing rear end of the building. Unit manufactured and installed in 2016. Installation is adequate and unit equipment is likely to still be under manufacturer warranty.

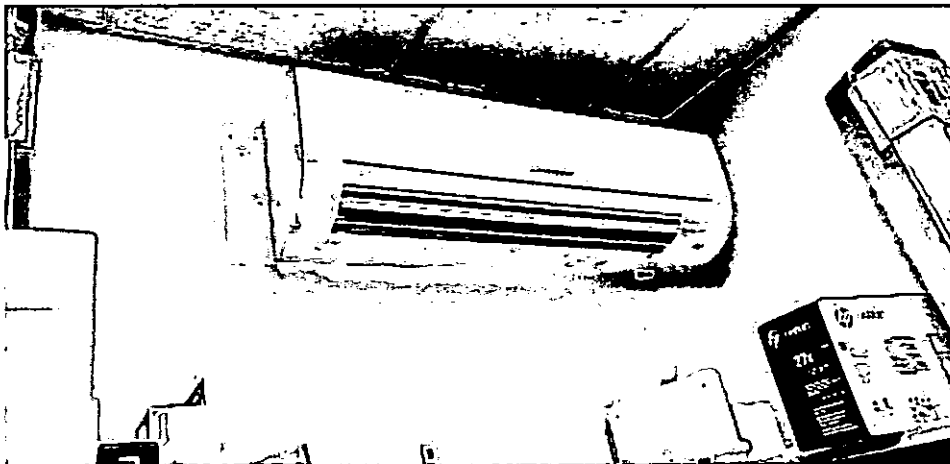
Figures 32&33. Minisplit unit servicing IT Server room (East Side of the building). Line insulation excessive sweating and waterlogging. The unit requires maintenance, all lines insulation needs to be replaced, coils cleaned, and refrigerant levels checked.

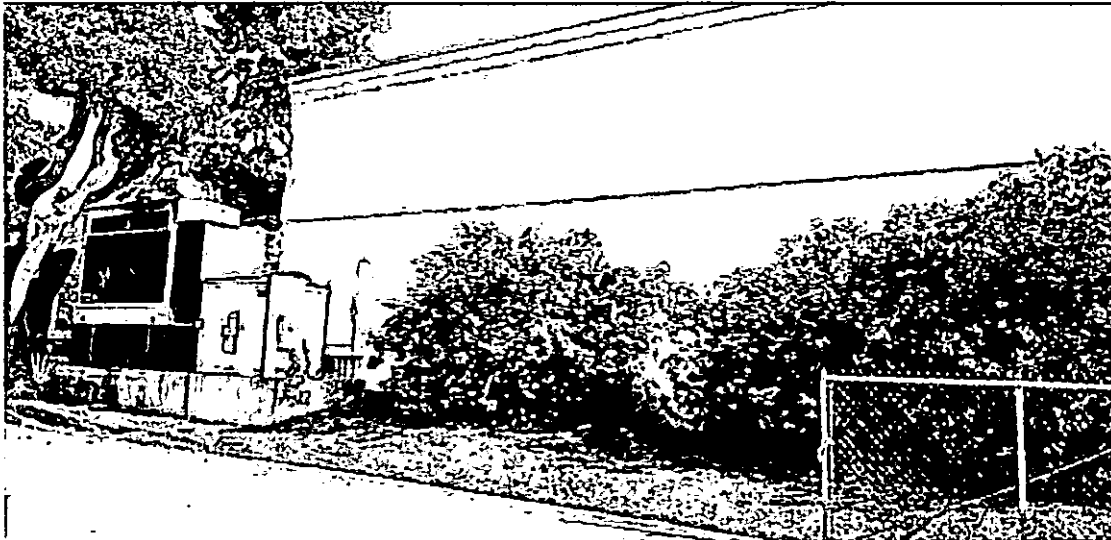
Building is supplied with 3-phase underground service feeders from North Side Drive to the onsite transformer and equipped with emergency back-up diesel fuel generator located on the West side of the building.

Figure 35. Concrete pad with belly-tank generator and transformer. Transfer switch and disconnect on the building wall behind.

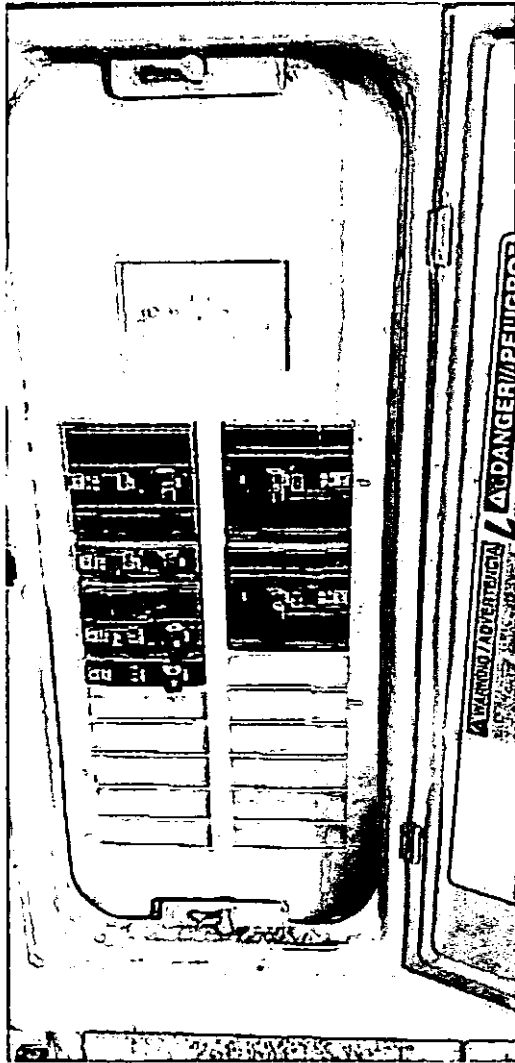
Figures 37&38. Multiple load centers are installed in various locations inside of the building with local breakers for lights, receptacles and various printing equipment. The condition of the electrical systems is good and serviceable. Few items require service or replacement (refer to Figure 39)..

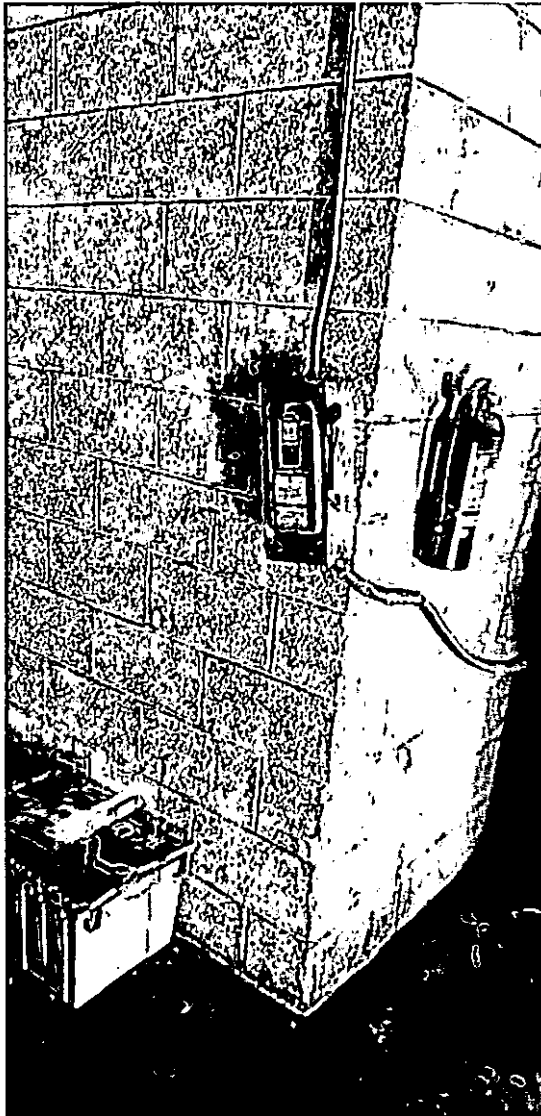
Figure 39. Example of the damaged disconnect enclosure and conduit (in the way of forklift traffic) needs to be moved, replaced or abandoned. The equipment connected may not be in service.

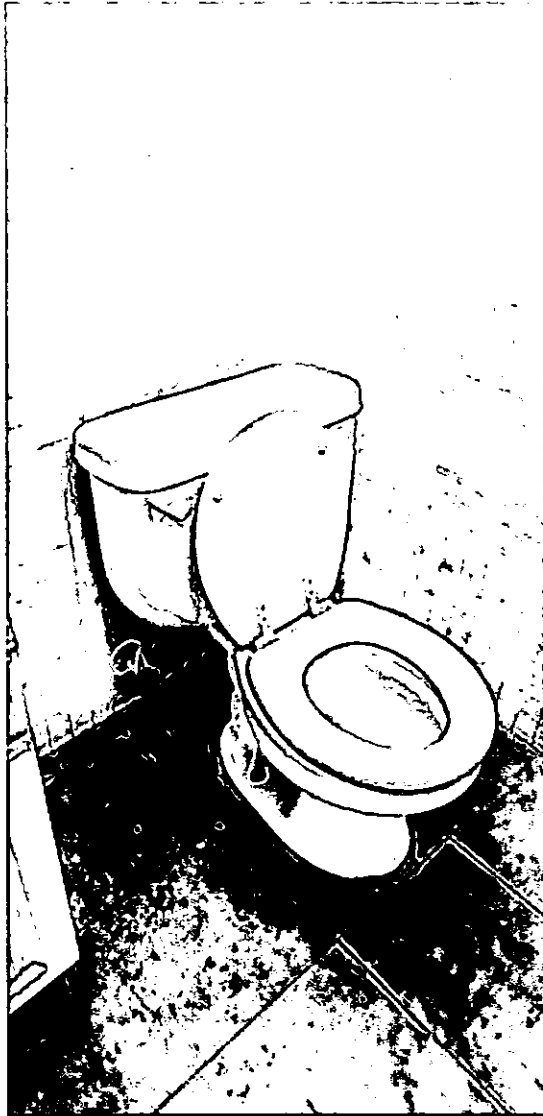
Figure 42. Plumbing fixtures and finishes. Adequate but require maintenance and improvements to finishes.
