Historic Architectural Review Commission Staff Report for Item 13

Address: Lazy Way Lane / Shrimptoat Sound Studio

Demolition of tie beams and parapet walls, timber piers, and wood frame roof due to extreme deterioration.

Structural Evaluation Report
for existing one-story commercial building

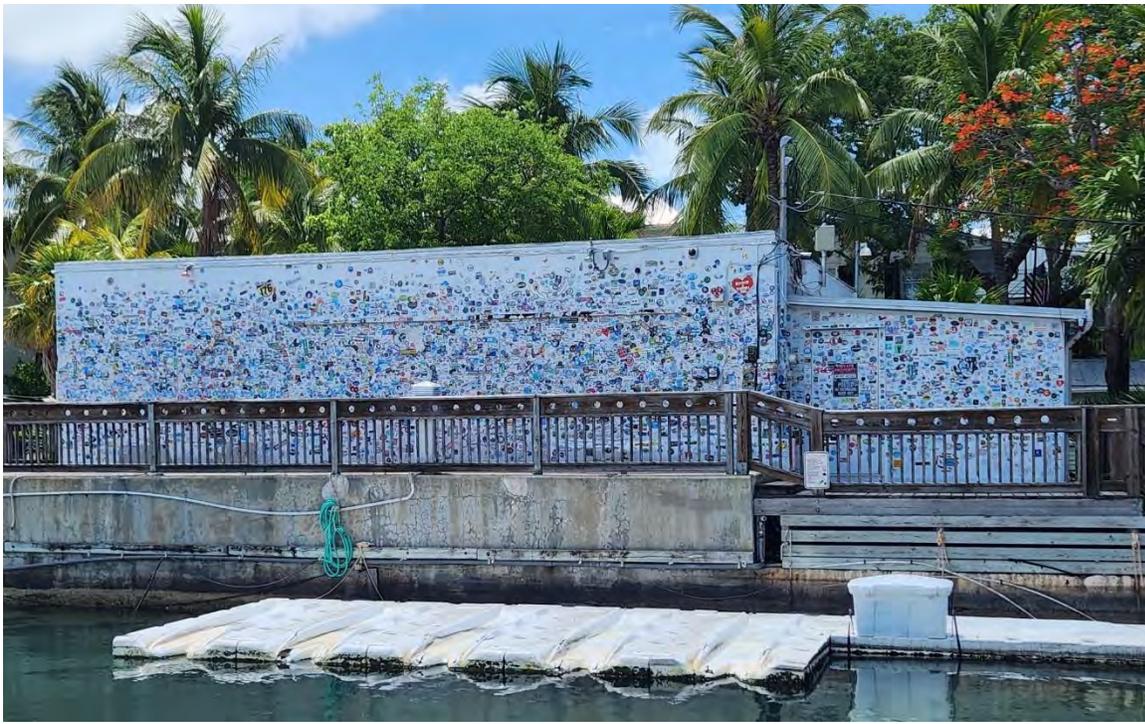
The building under review is not listed in the Historic Architectural Survey but is historic. The cmu structure with a frame add-on was built in 1955. Originally built as a fish house, the structure became a recording studio when in the 1970's Jimmy Buffett rented it to the city. The building currently shows severe structural deterioration on its tie beams, parapet wall, roofing system and footers. Openings have been closed due to the use of the structure. The north elevation has been vandalized with hundreds of stickers.

Current north elevation. Photograph by Janice Slivko.

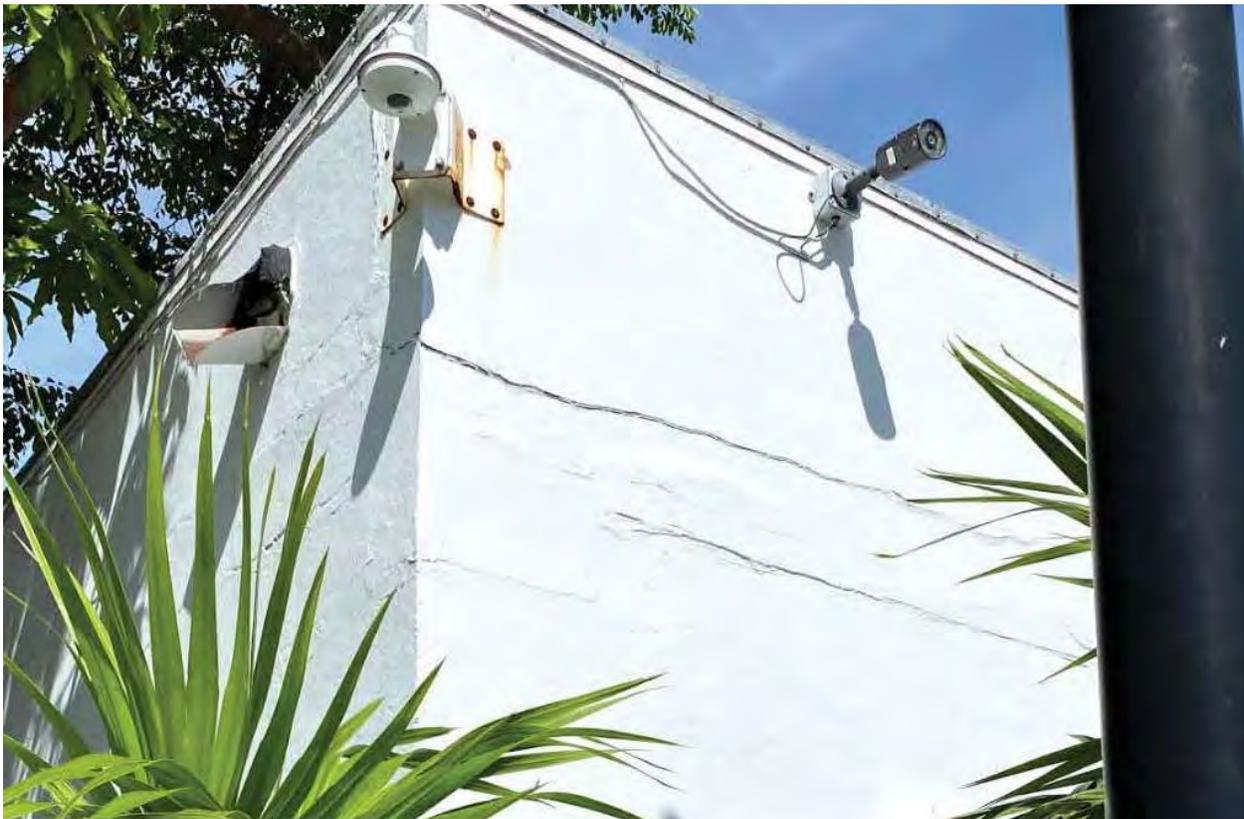
Detail of tie beam exterior condition.

After a site visit and review of the Structural Analysis Report from the applicant staff concurs with Engineer Mashtakov that the proposed structural elements under demolition review are irrevocable compromised by extreme deterioration. Current wood footers do not meet any code and must be replaced. Structural elements under review must be replaced to maintain the integrity of this iconic and historic building.

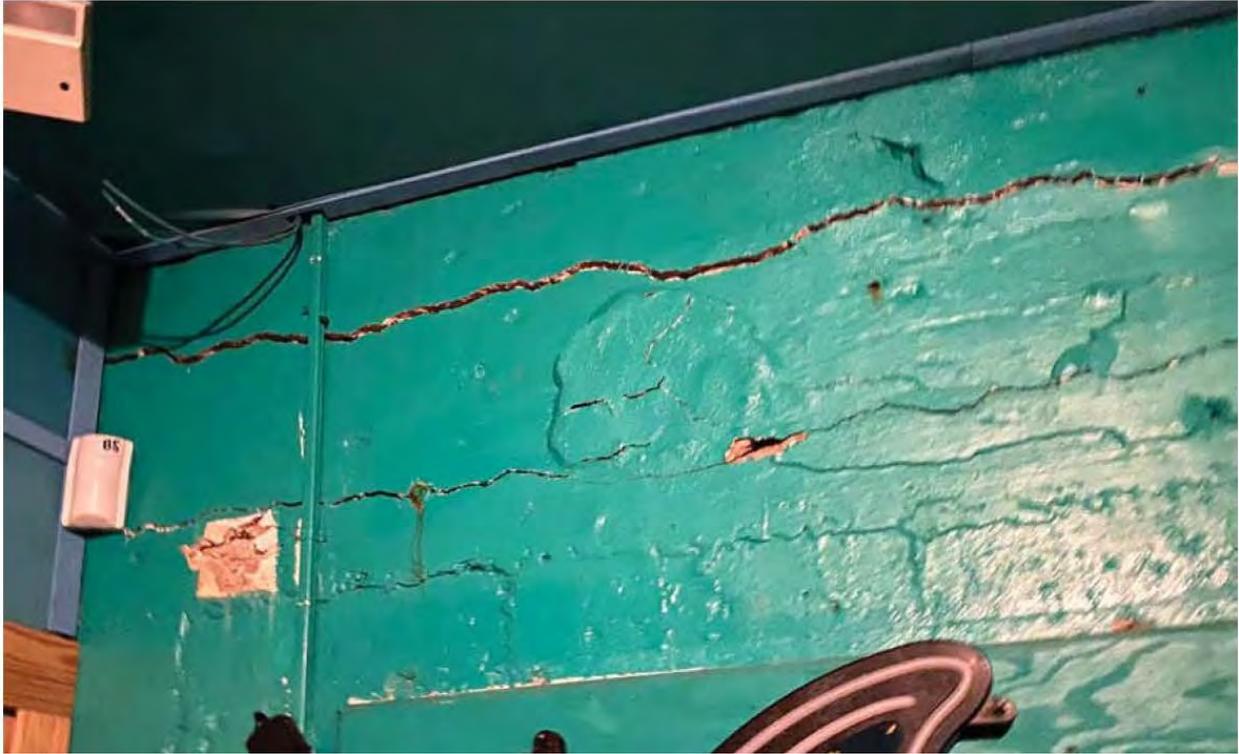
Interior detail.

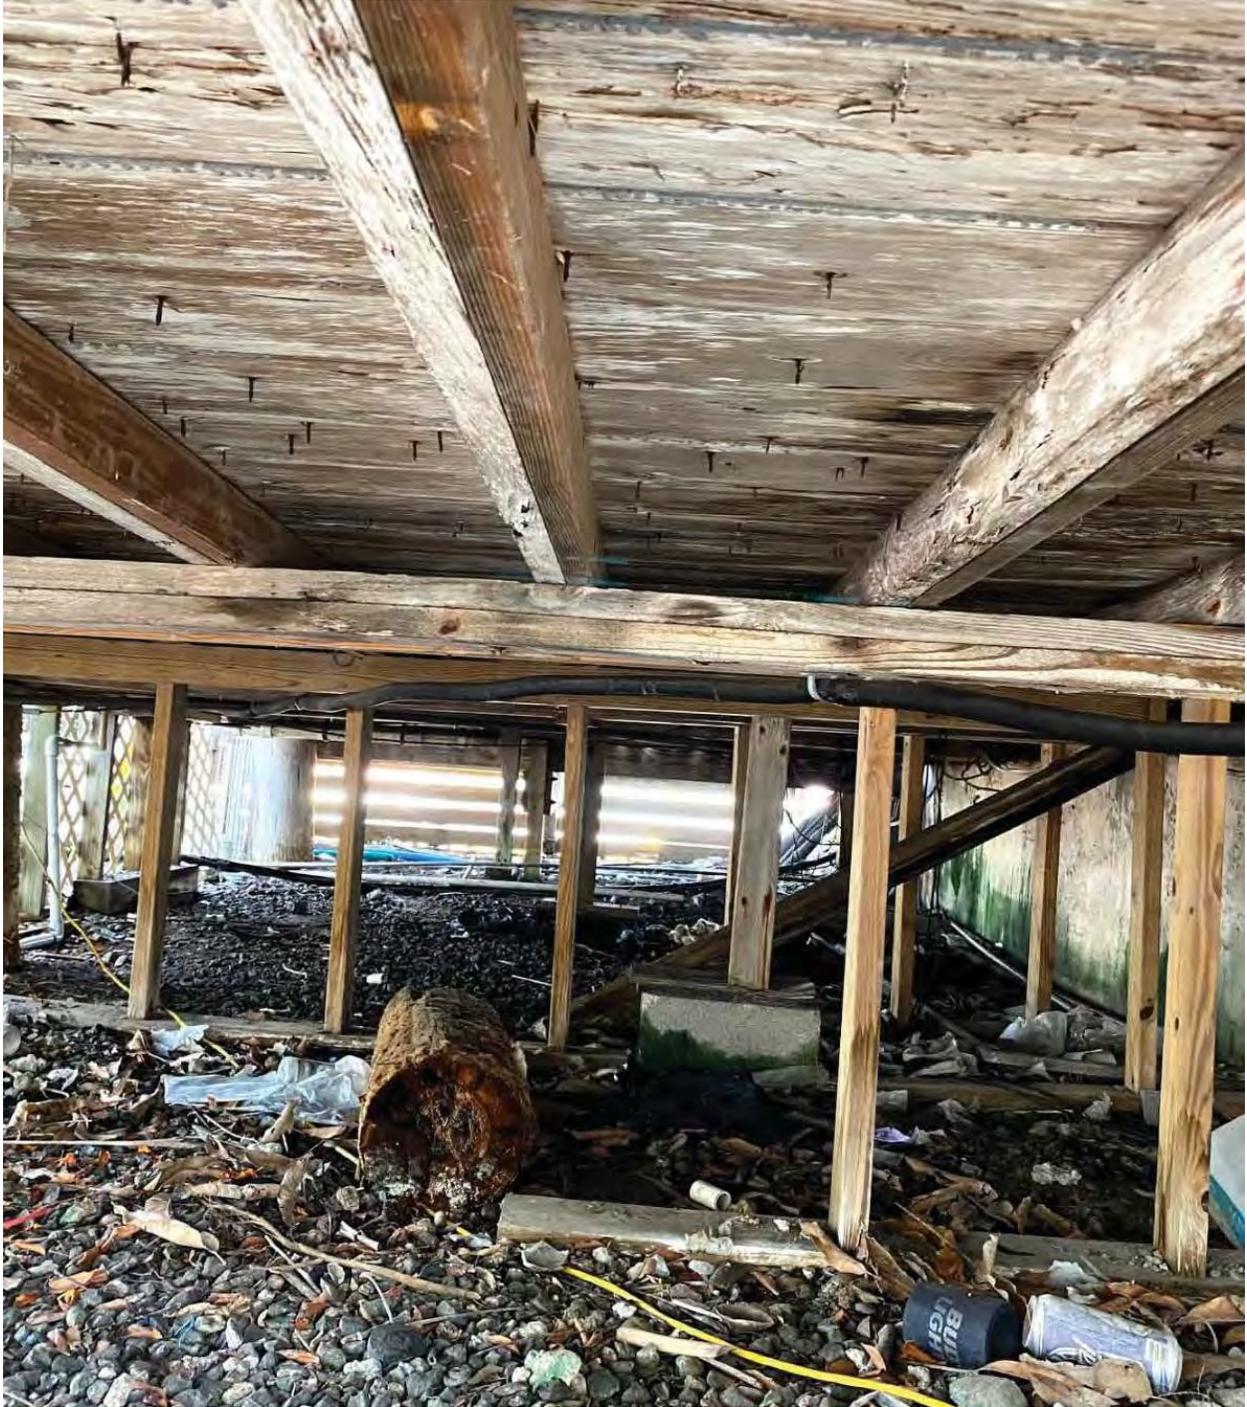
Footers supporting the wooden section of the building.

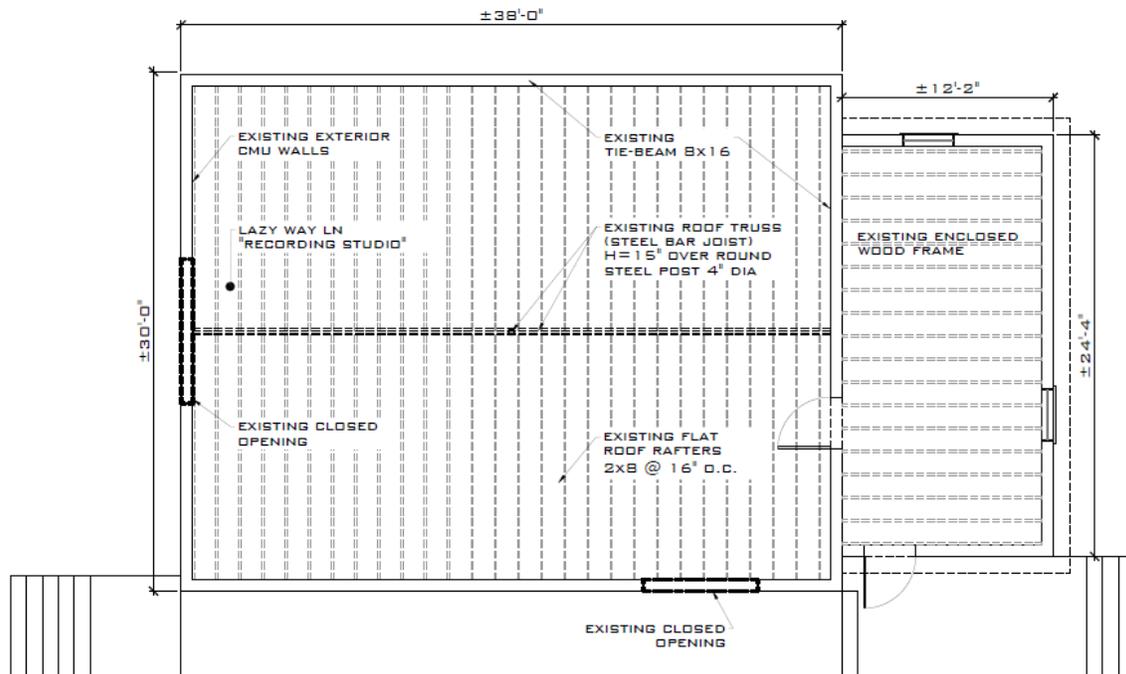
Figure 2a. Existing Structure Floor Plan

EXISTING FLOOR PLAN

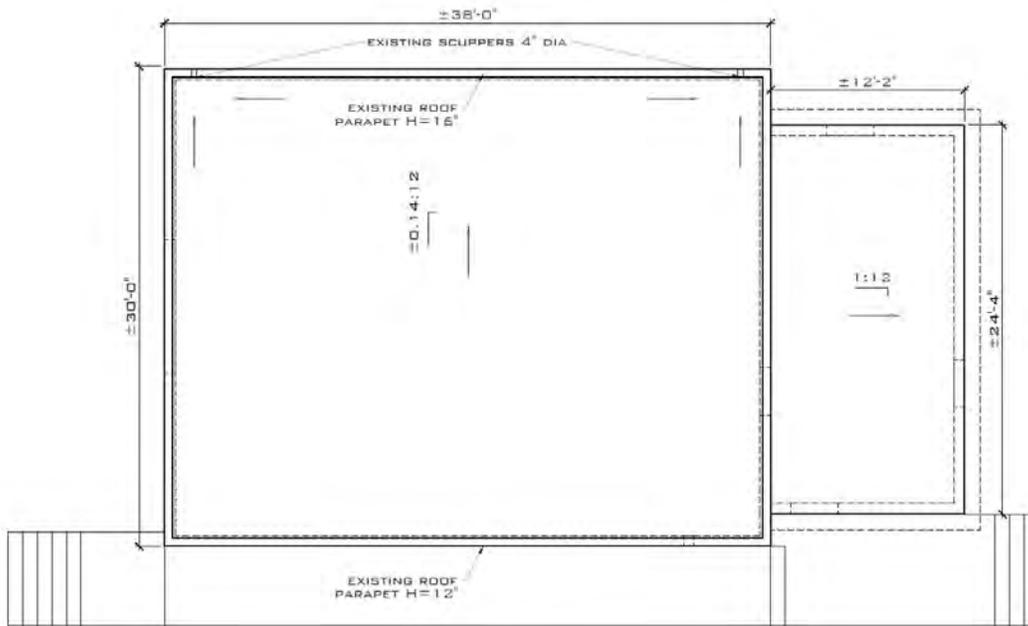
Figure 2b. Existing Structure Roof Plan

EXISTING ROOF PLAN
SCALE: NTS

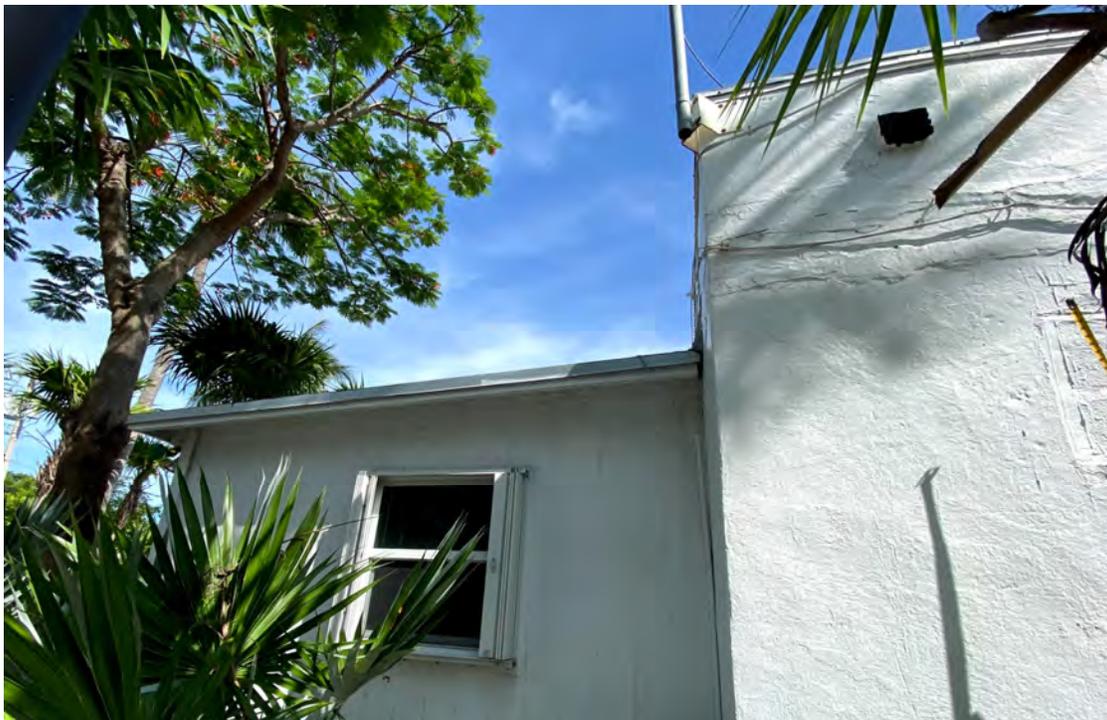
into concrete above the tie-beam. There are evident concrete cracks on the tie beam around main building perimeter.

Figure 3. Partial Rear Elevation. Visible concrete damage – cracks along tie-beam.

In my professional opinion overall condition of the building is poor. Concrete tie-beam around entire building perimeter needs to be replaced, due to the fact that parapet wall above the tie-beam is short it is very likely that it will not survive the demolition of the supporting tie-beam and blockwork will lose its integrity. New parapet wall cast together with the tie-beam is recommended. Roofing membrane around wall perimeter will require significant repairs with proper parapet wall termination – a complete roofing replacement is recommended.

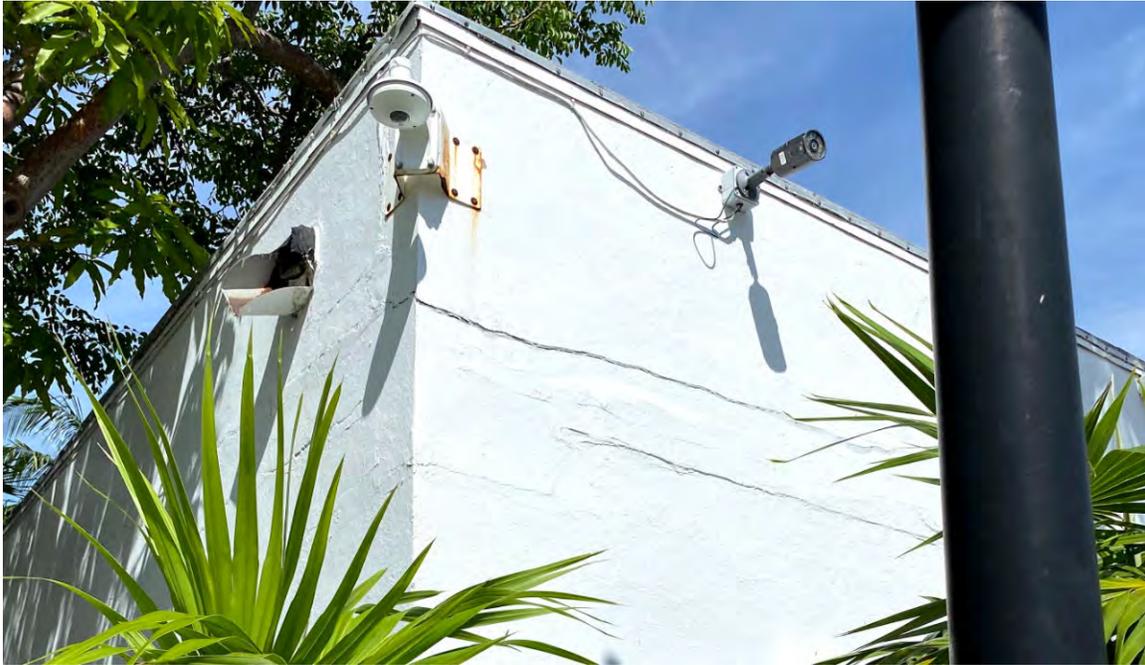
Figure 4. Partial left side elevation. More cracks in the tie-beam.

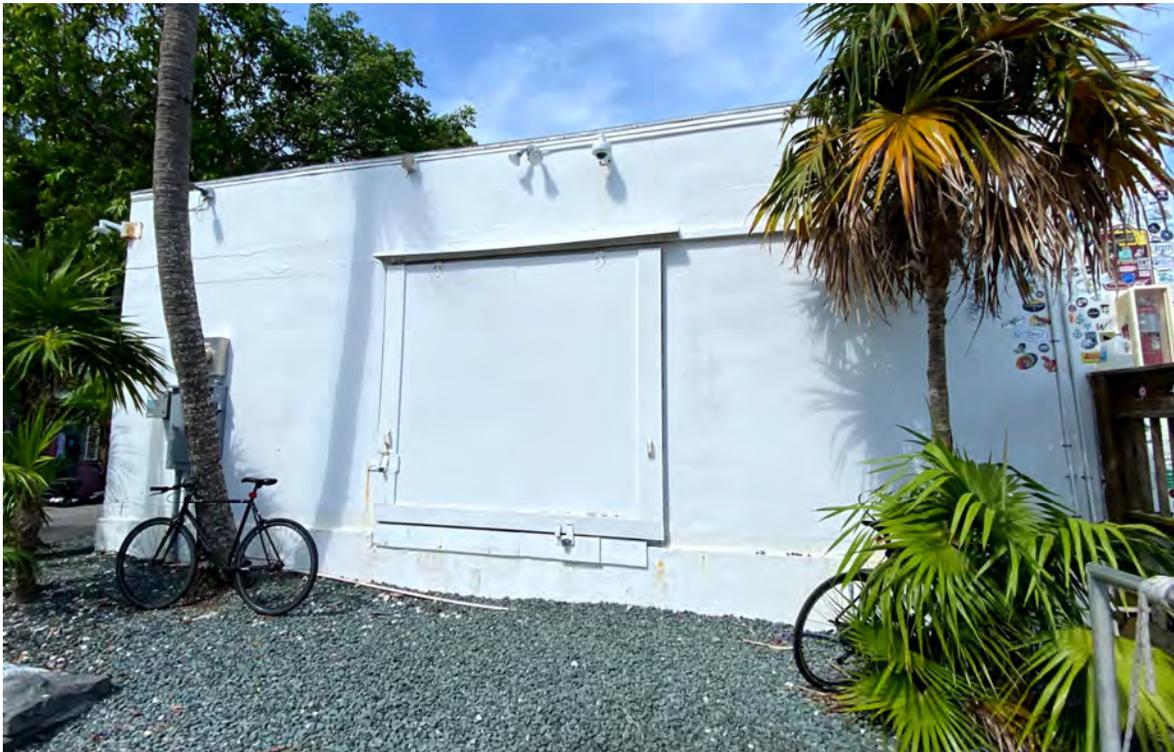
Figure 5. Left side elevation. Tie-beam with damage above decorative sliding doors.

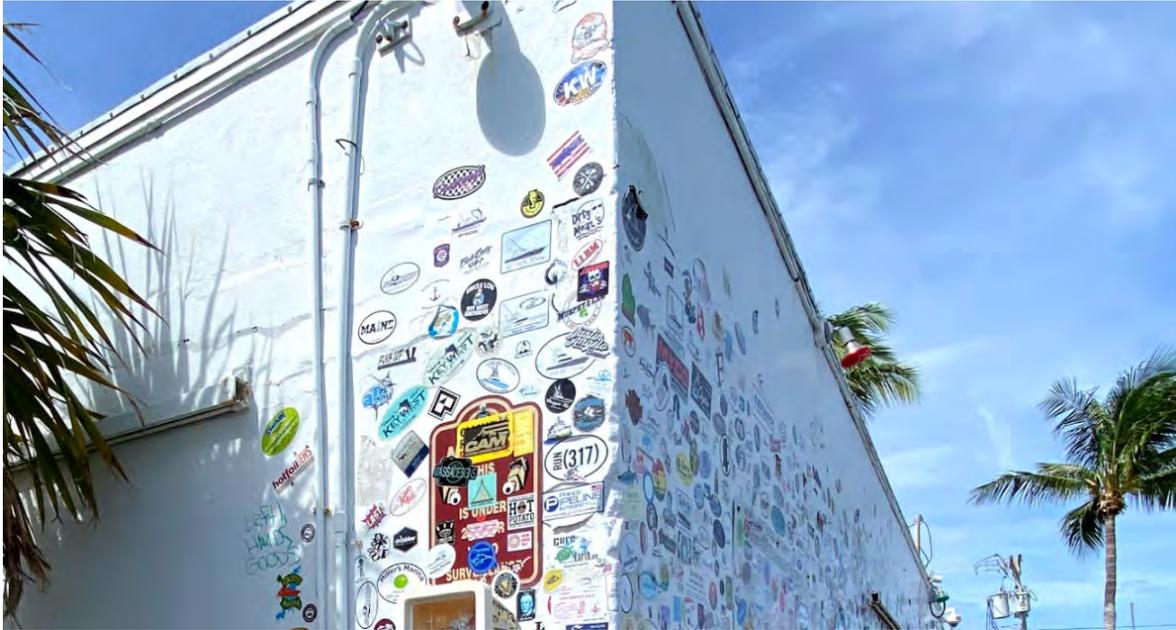
Figure 6. Partial Front Elevation. Tie-beam with damage around the main building perimeter.

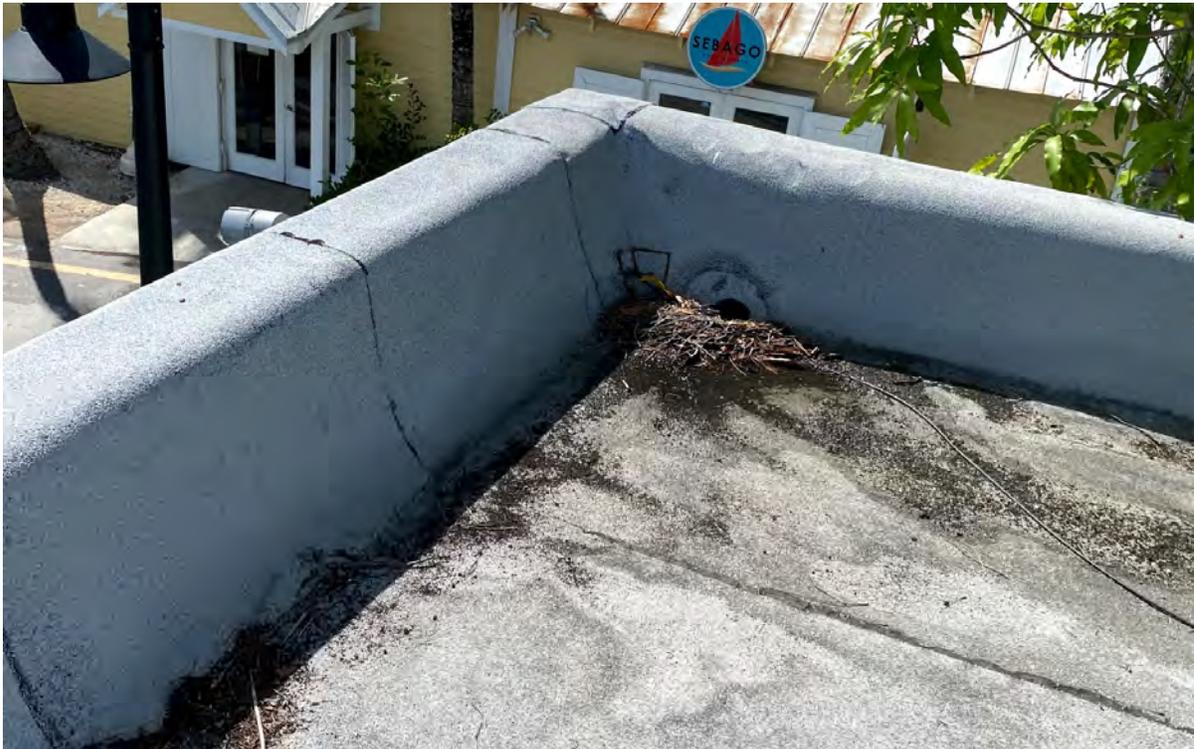
Figure 7. Existing roof scuppers are +/- 4" round pipe and undersized. Debris is clogging the drains and promote standing water along the South-East parapet wall. Recommending upsizing to 8x16 scuppers. Recently reinstalled 3-ply roofing is acceptable condition, however there is no sufficient pitch from the middle of the roof to the side scuppers and some standing water will remain and decrease roofing longevity. At the next re-roofing an installation of tapered insulation in form of "cricket" between two scuppers is recommended.

Currently the roof of the principal structure consists of a 3-ply membrane installed over low pitch roof deck with two scuppers of a small diameter (4"). The size of scuppers is prone to closing by debris and may result in standing water intrusion into interior or even damage to supporting structure. Our recommendation on upsizing to 8"x16" scuppers and installation of downspouts to direct water away from the walls. The steel trusses, posts and visible roof framing elements are in satisfactory condition.

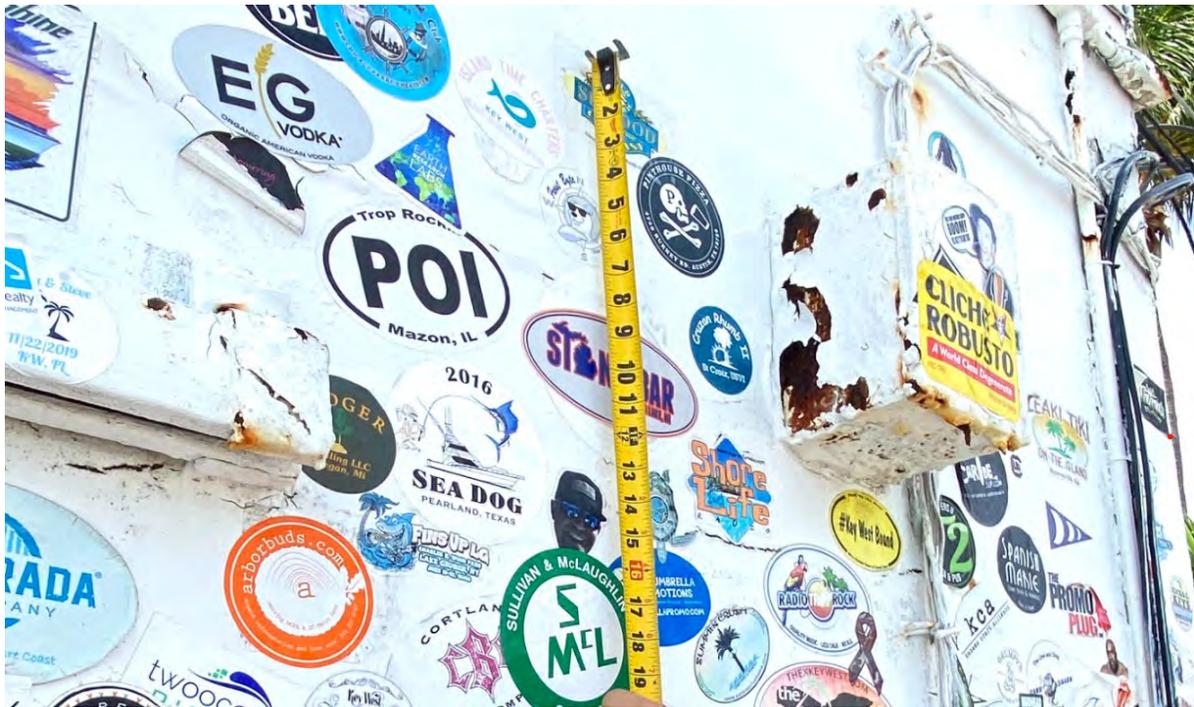
Figure 8. Partial Front elevation. Cracks outside on the tie-beam. Please note that exterior cracks were patched with stucco over time and are not as obvious.

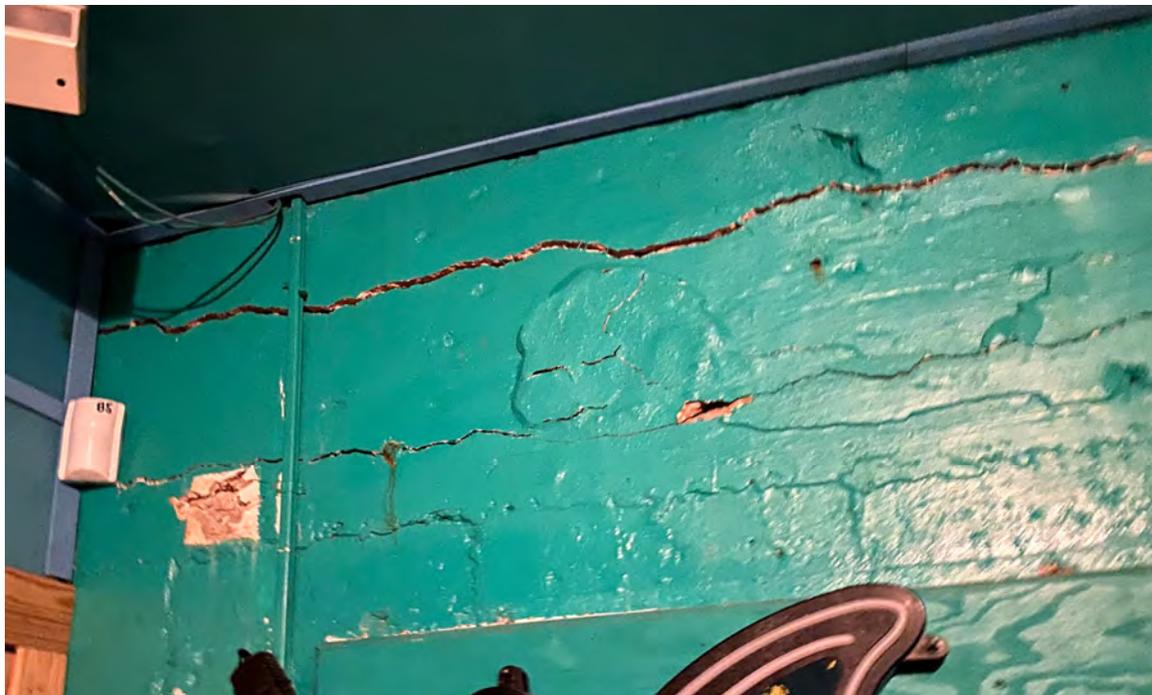
Figure 9. Heavy concrete damage, damaged tie beam (interior of the main building). Please note that on interior the cracks were not patched and are fully open.

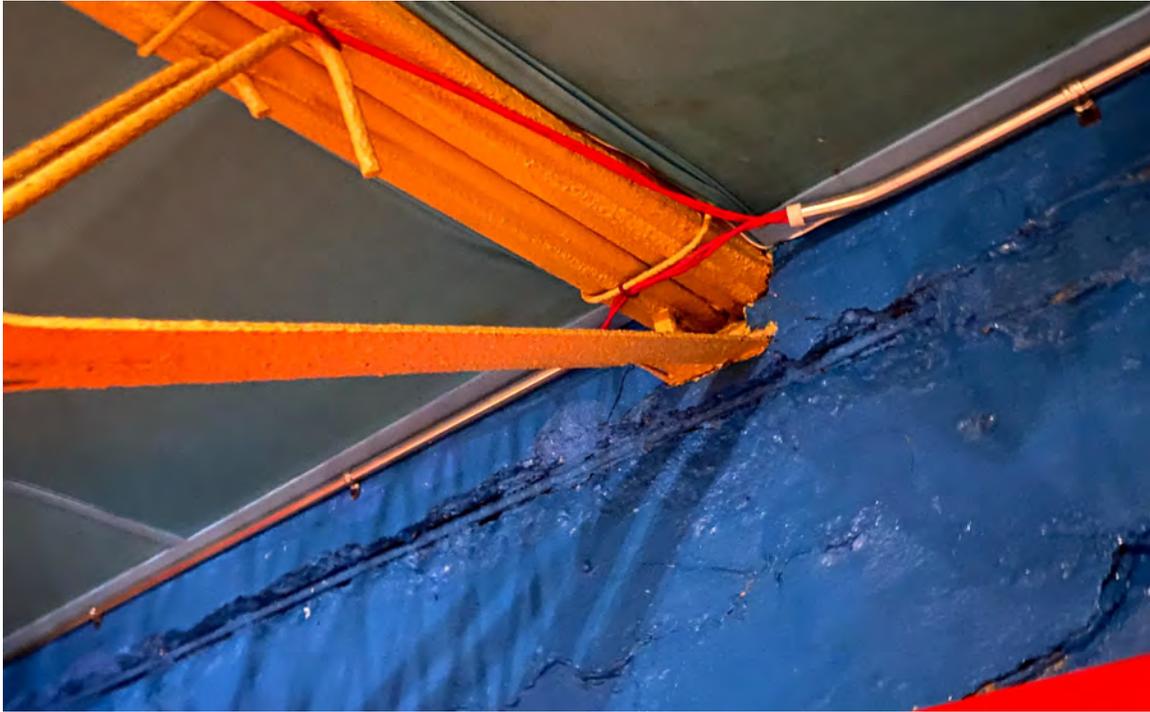
Figure 10. Main Building - Interior view with damaged top of tie-beam at bar joist support. The delaminating (spalling) concrete cover was removed and rebar painted.

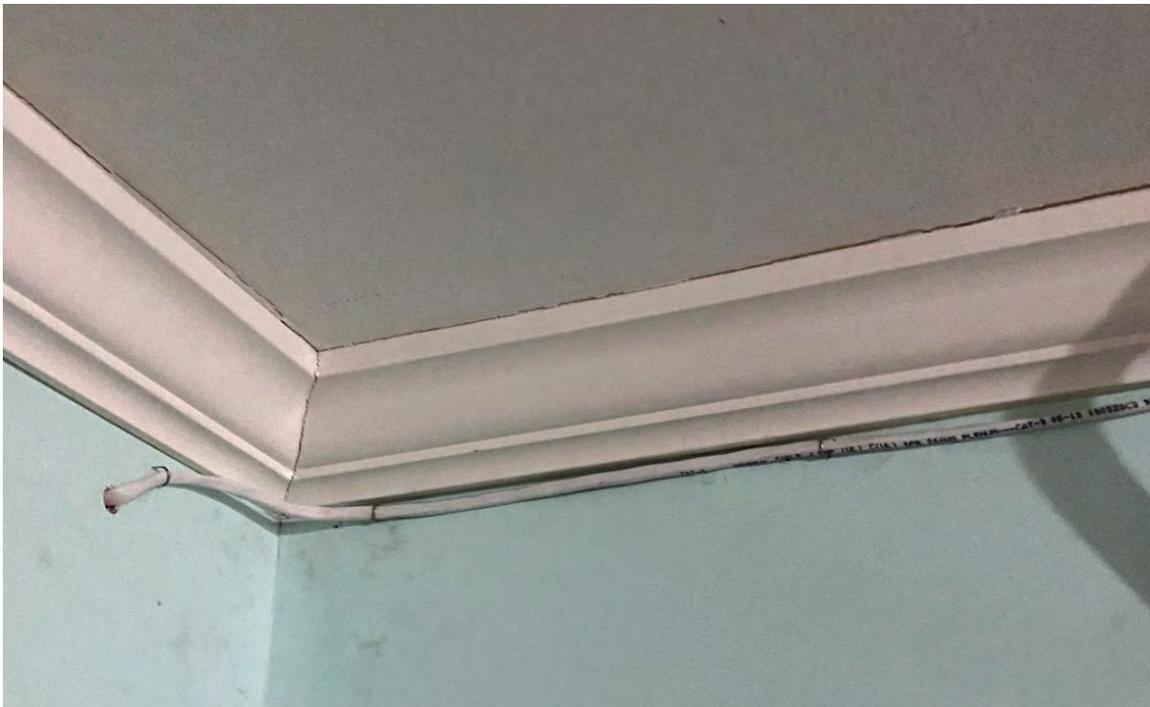
The wood frame shed is approximately 24.5ft by 12ft. Side addition height is approximately 7-8 ft. Roof pitch is $\pm 1:12$. Roof rafters are inaccessible 2x members covered with interior finishes. There are noticeable signs of foundation and framing failure, the addition is separating from the main structure.

Figure 11. Addition to main building – Visible ceiling cracks along CMU wall. The addition is leaning away.

In my professional opinion the majority of wood floor system and foundations of the side addition require replacement, which includes new concrete piers, new sill beam and new floor joists to be sistered with new members supported by new ledger. It would be advisable to replace the floor deck entirely at the same time – but this will require a complete replacement of the floor finishes and removal of all items from the space interior.

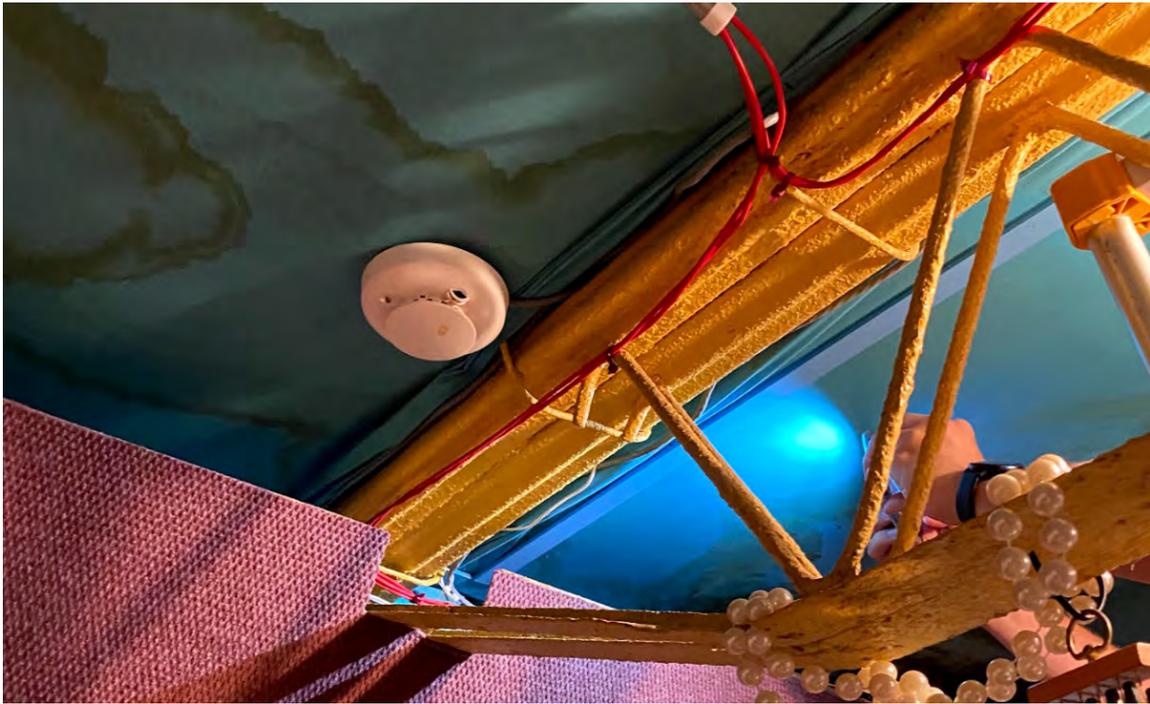
Figure 11. Main Building - Interior view. Existing truss support point over damaged tie-beam.

During the installation of new concrete tie-beam all roof framing above shall have temporary shoring from the interior.

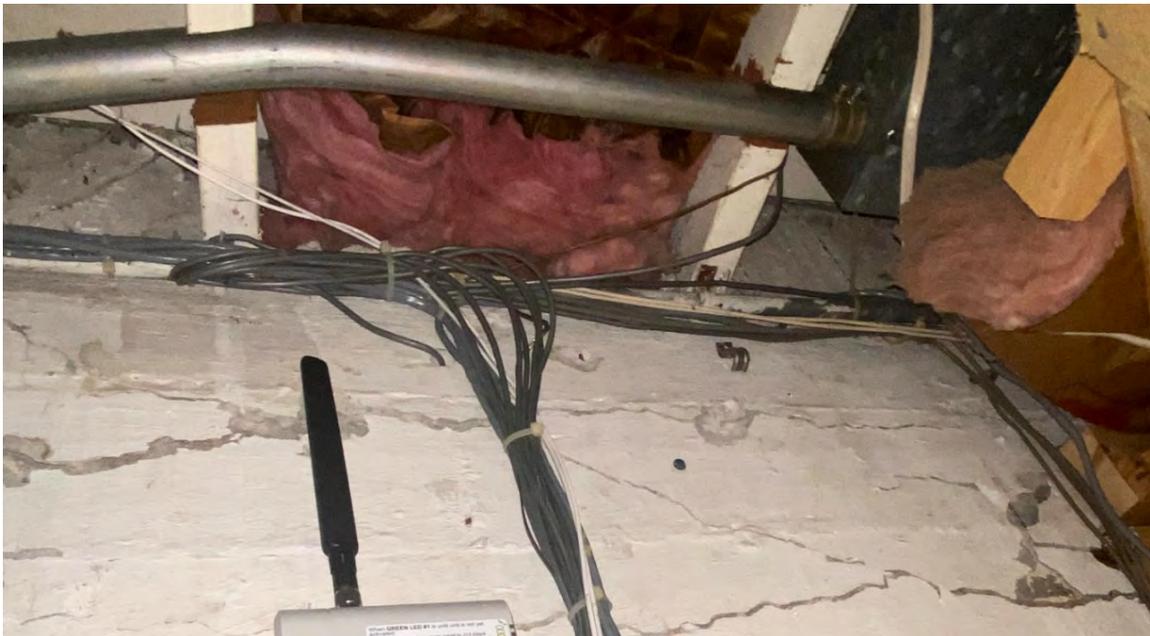
Figure 12. Main Building - Interior view with damaged tie-beam. Misc. damage to roof rafters by electrical conduit pipe.

Significant electrical conduit re-work will be needed since a lot of wiring is located along the tie-beam in need of replacement.

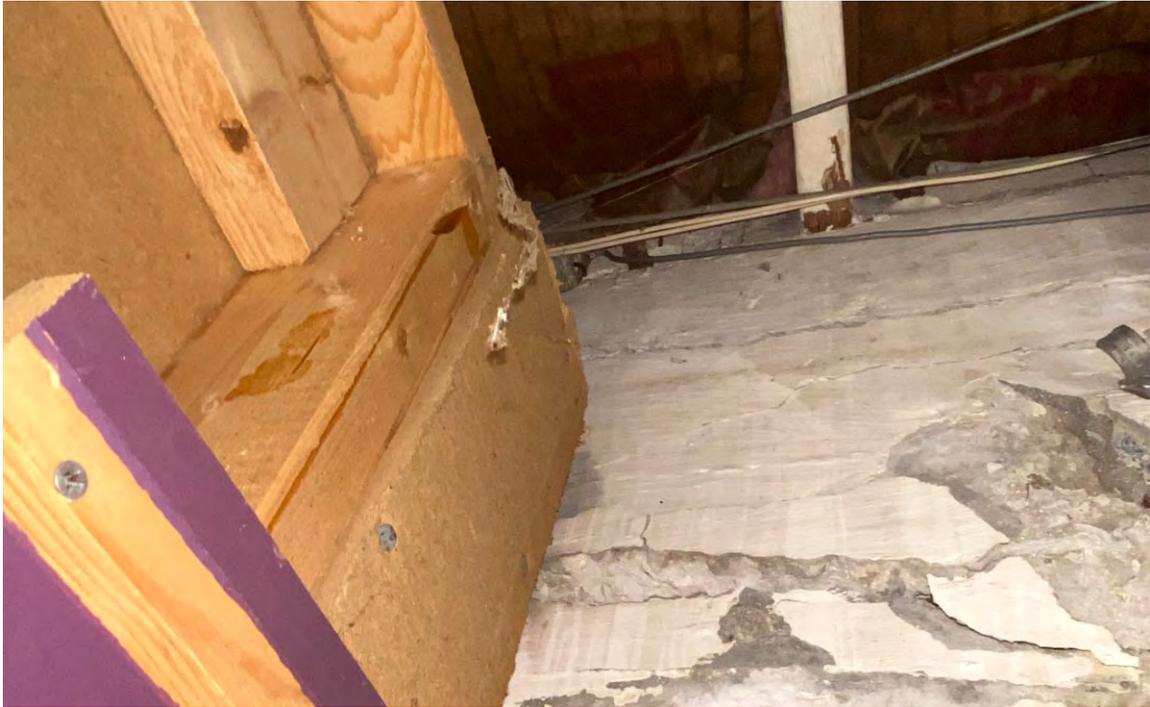
Figure 13. Main Building - Interior view with failing tie-beam.

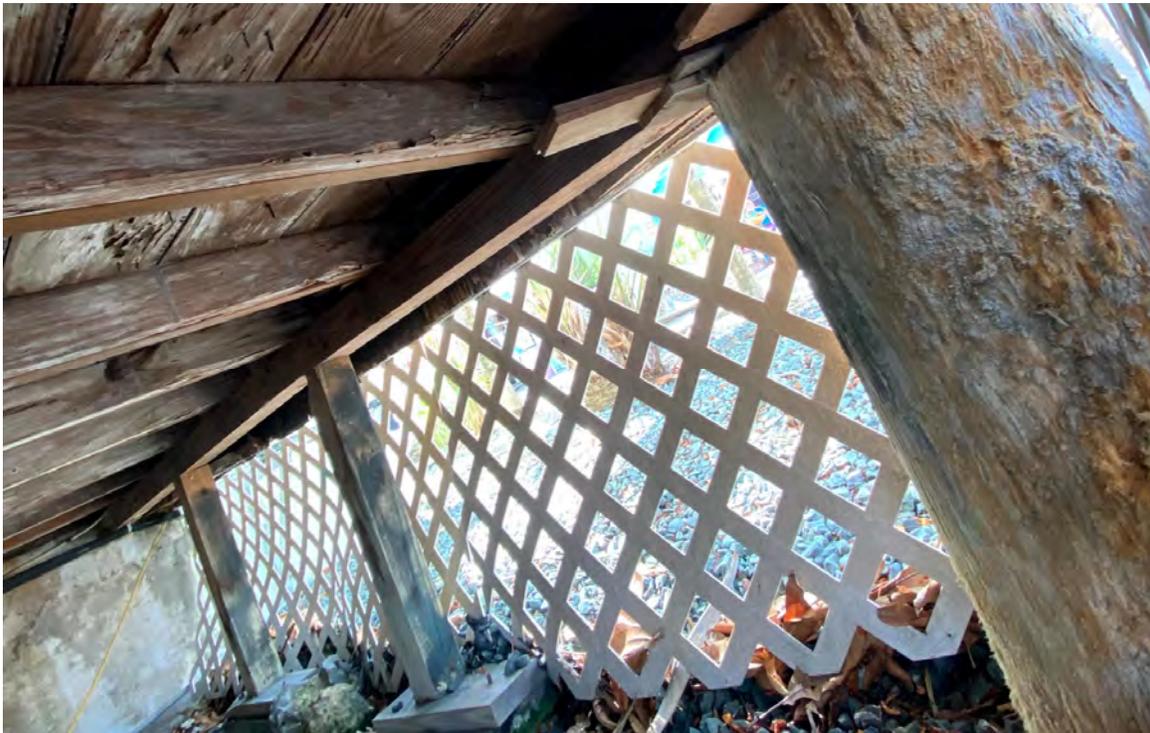
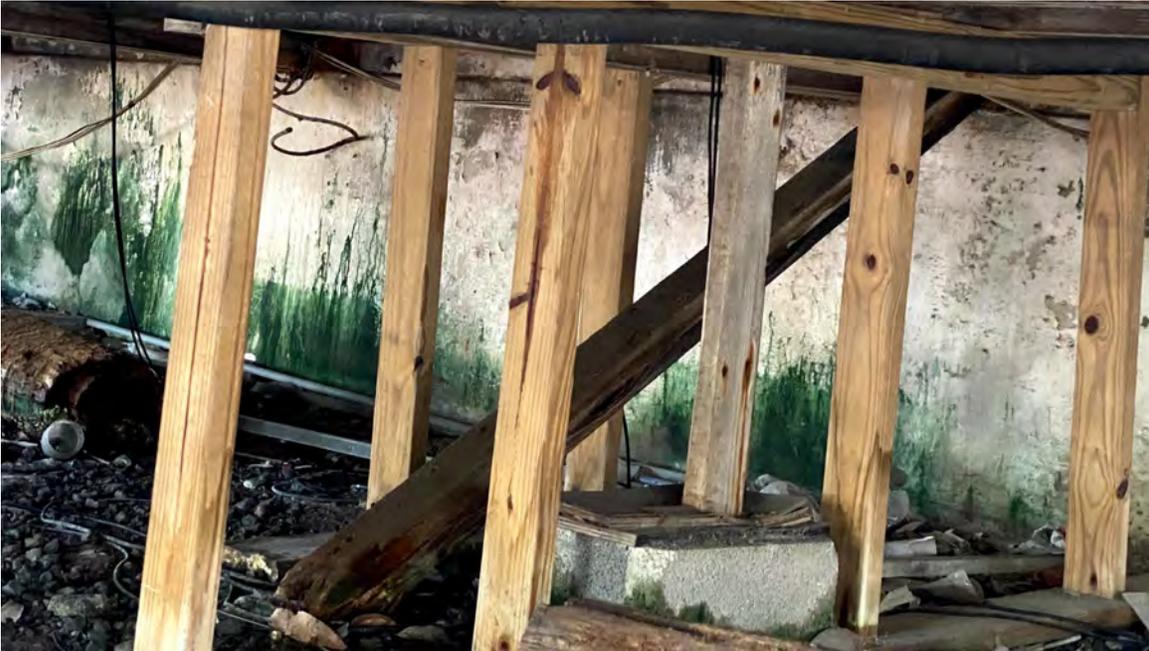
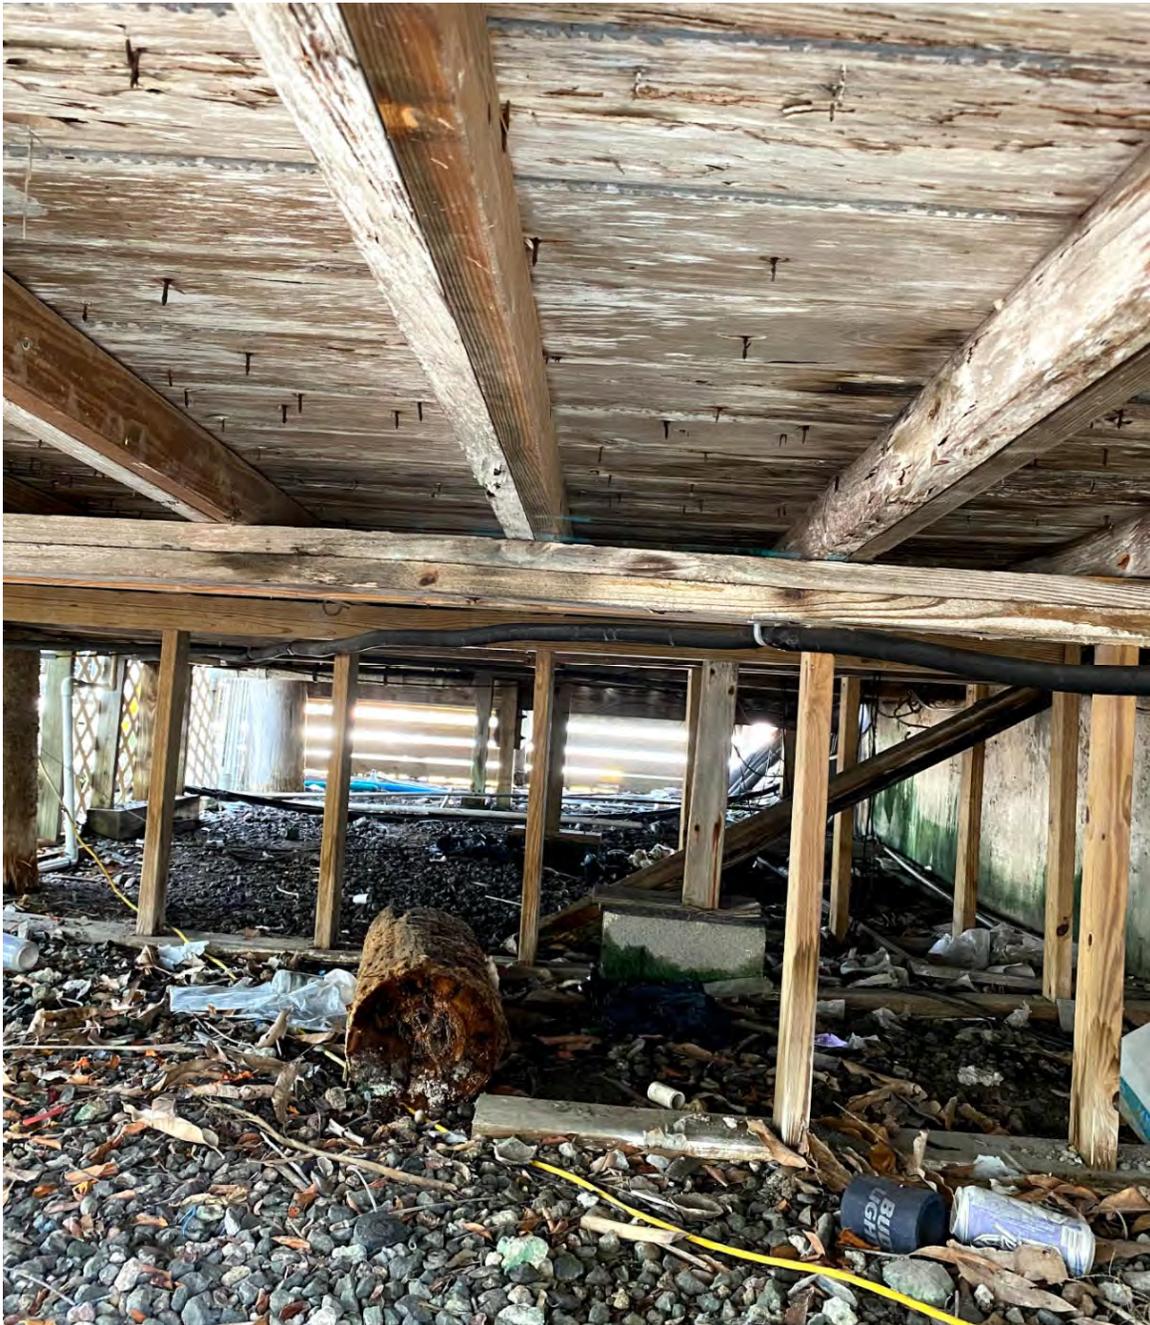
Figure 14. Addition to main building – Heavy damage of wood frame floor system. Perimeter sill beam is completely gone, and floor is supported by temporary shoring. Inadequate repairs of floor joists.

Figure 15. Same as above.

Figure 16. Same as above.

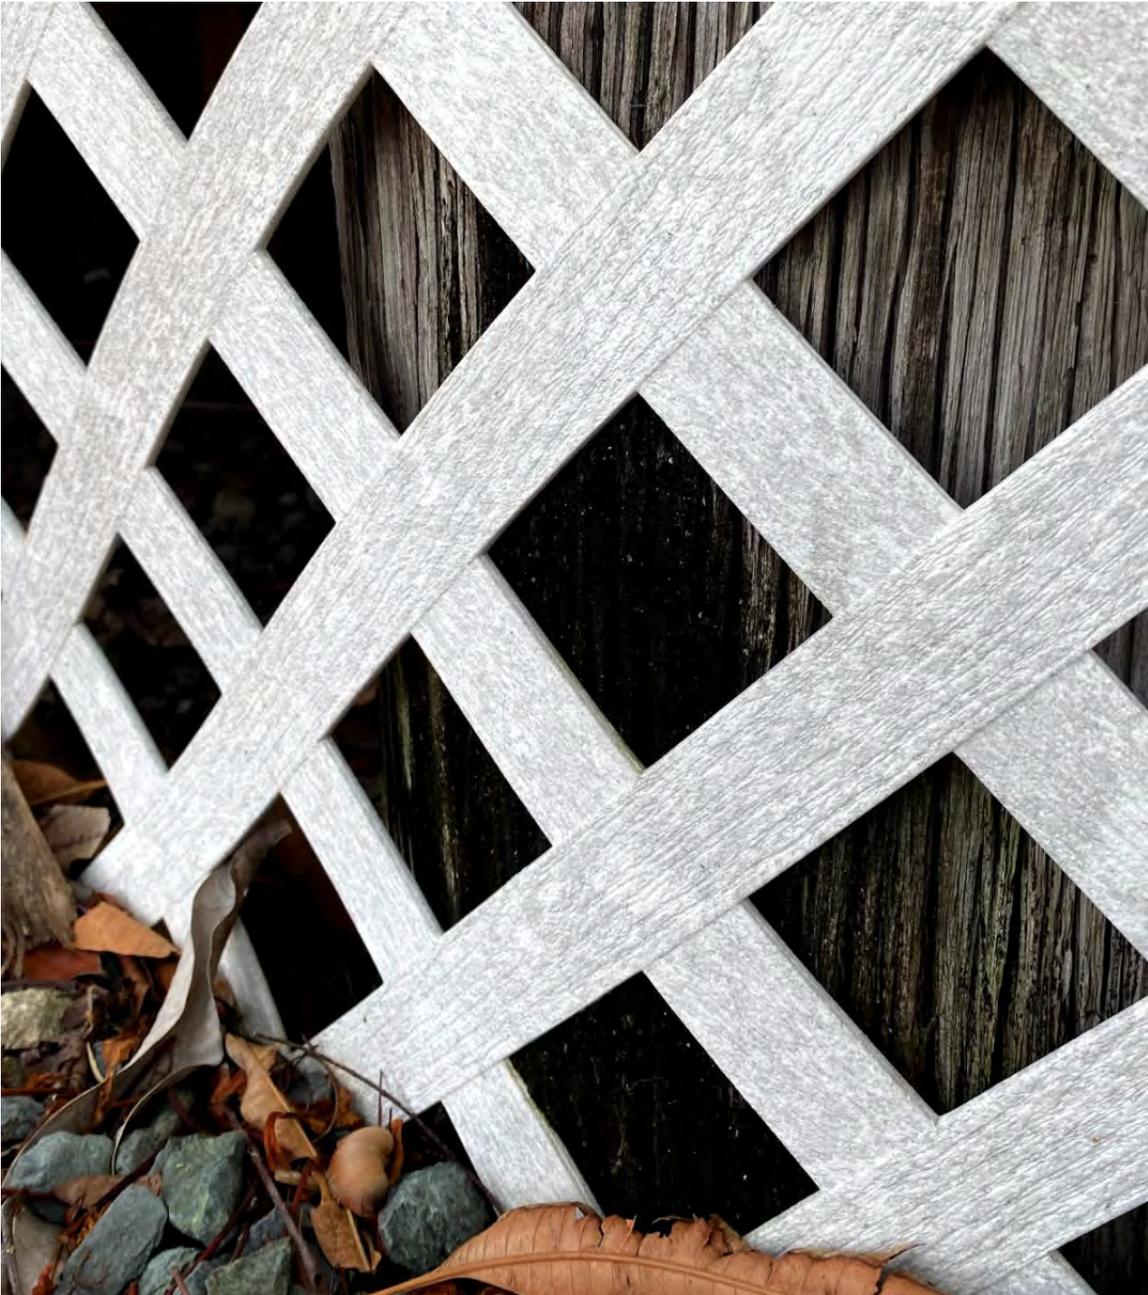
Figure 17. Damaged failing timber pile piers. In need of replacement.

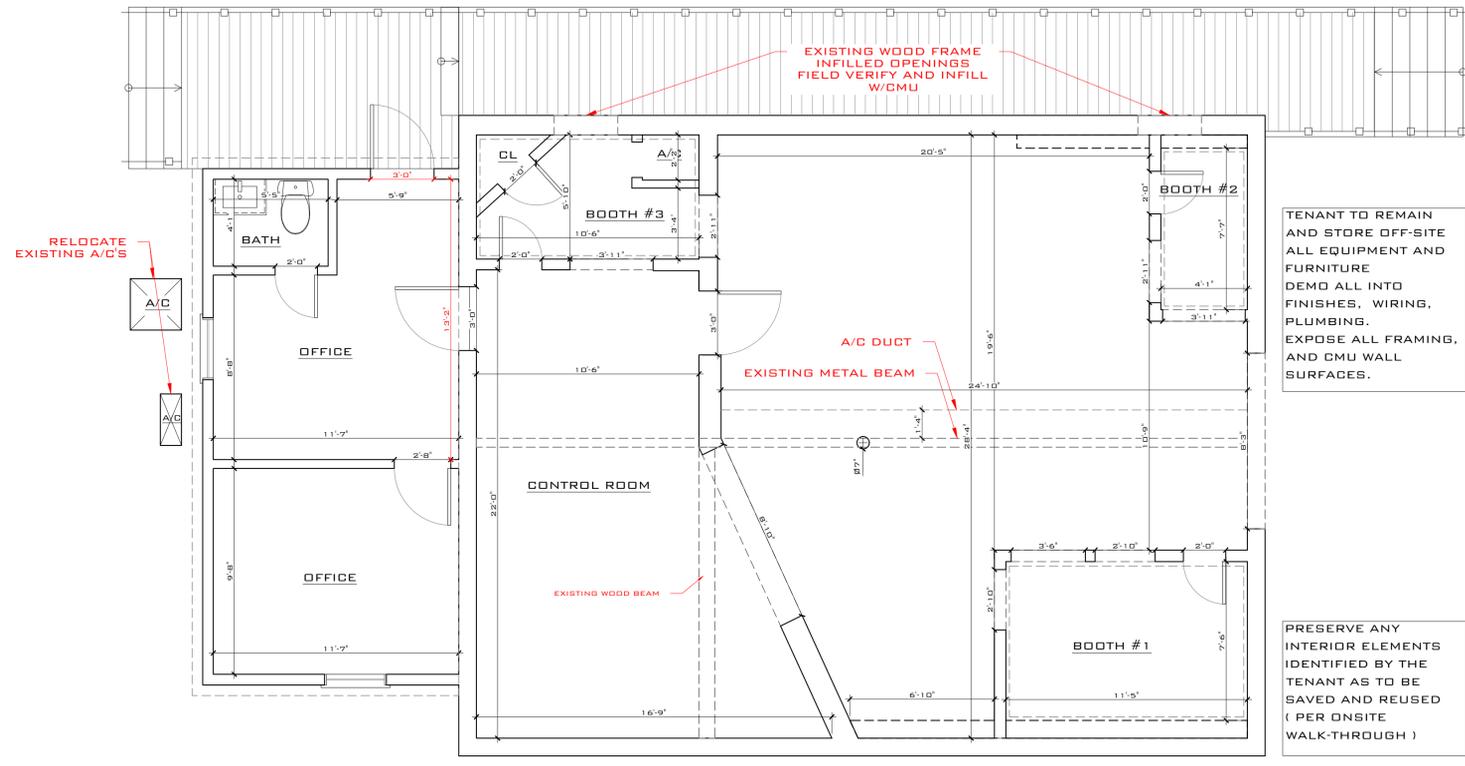
EXISTING FLOOR PLAN (RECORDING STUDIO)
SCALE: 3/8" = 1'-0"
