Historic Architectural Review Commission Staff Report for Item 13

Address: Lazy Way Lane / Shrimptoat Sound Studio

Demolition of tie beams and parapet walls, timber piers, and wood frame roof due to extreme deterioration.

Structural Evaluation Report
for existing one-story commercial building

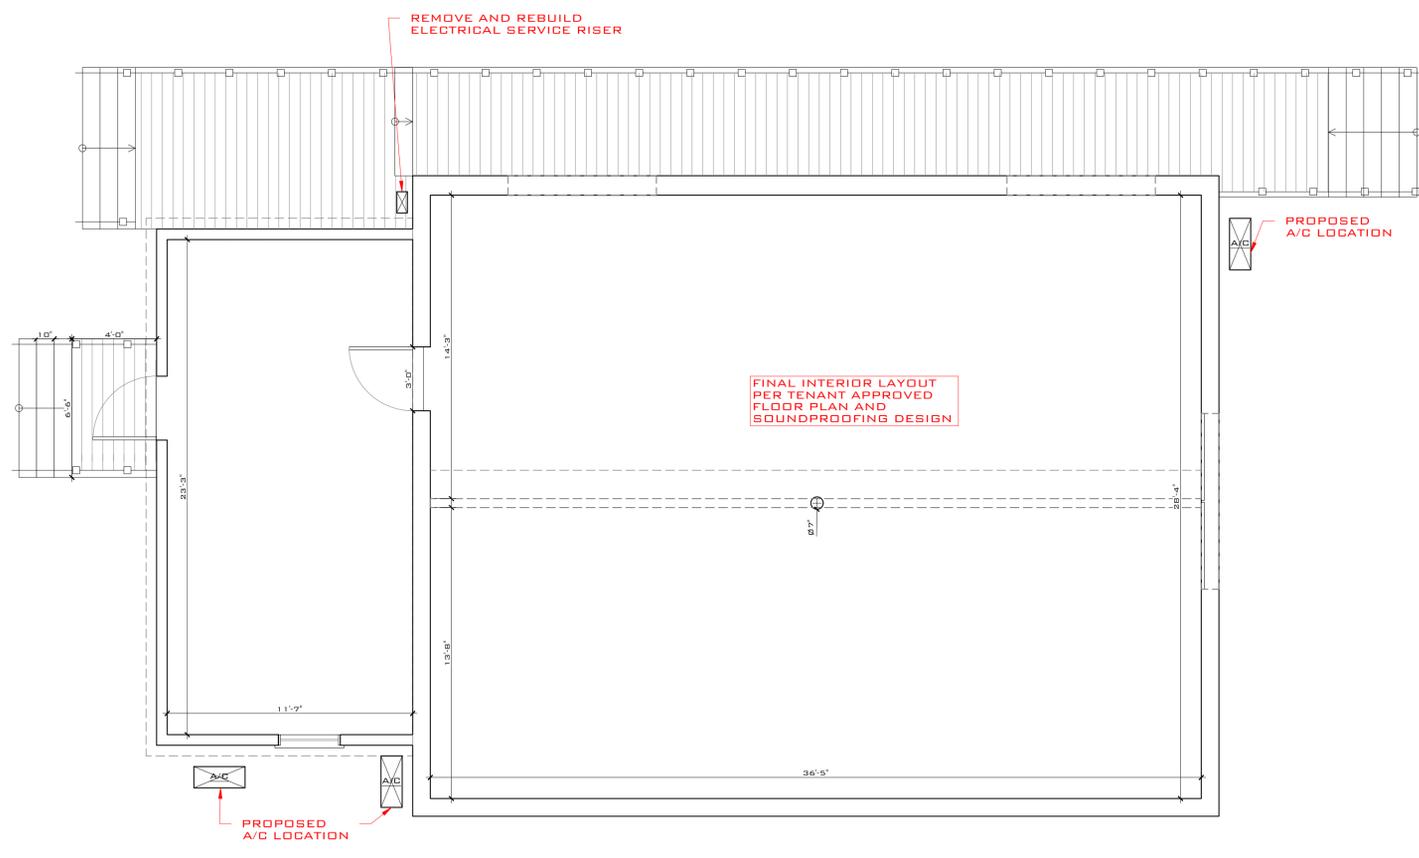
PROPOSED FLOOR PLAN (RECORDING STUDIO)
SCALE: 3/8" = 1'-0"

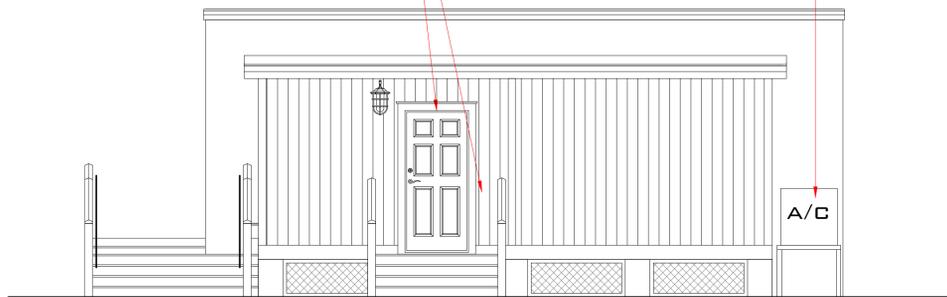
PROPOSED FRONT ELEVATION
 SCALE: 1/4" = 1'-0"

PROPOSED WOOD STAIRS & WOOD RAILING
 PROPOSED ALUMINUM FRAME DOOR
 PROPOSED A/C LOCATION

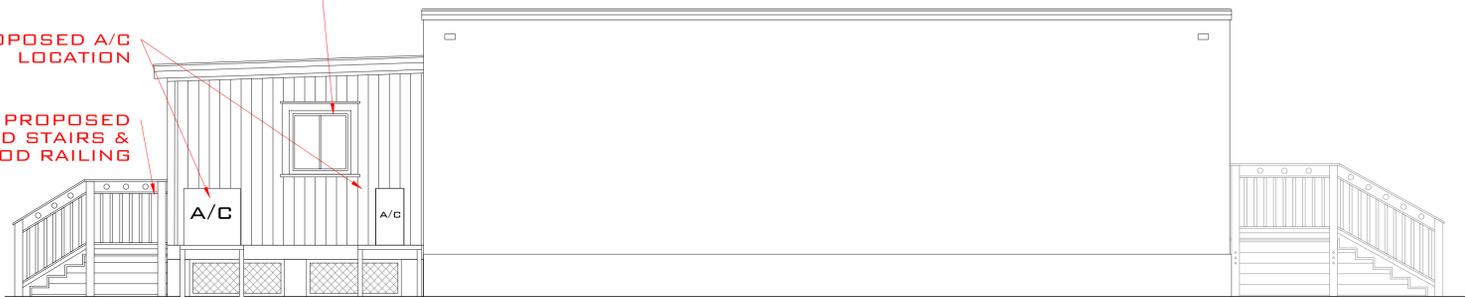
PROPOSED RIGHT ELEVATION
 SCALE: 1/4" = 1'-0"

PROPOSED ALUMINUM FRAME IMPACT WINDOW
 PROPOSED A/C LOCATION
 PROPOSED WOOD STAIRS & WOOD RAILING

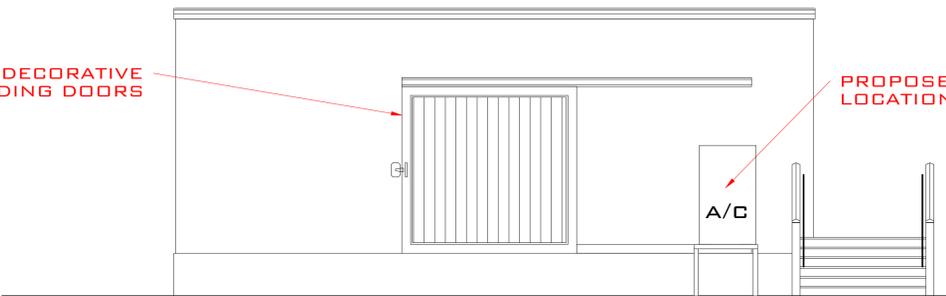
PROPOSED REAR ELEVATION
 SCALE: 1/4" = 1'-0"

PROPOSED DECORATIVE WOOD SLIDING DOORS

PROPOSED A/C LOCATION

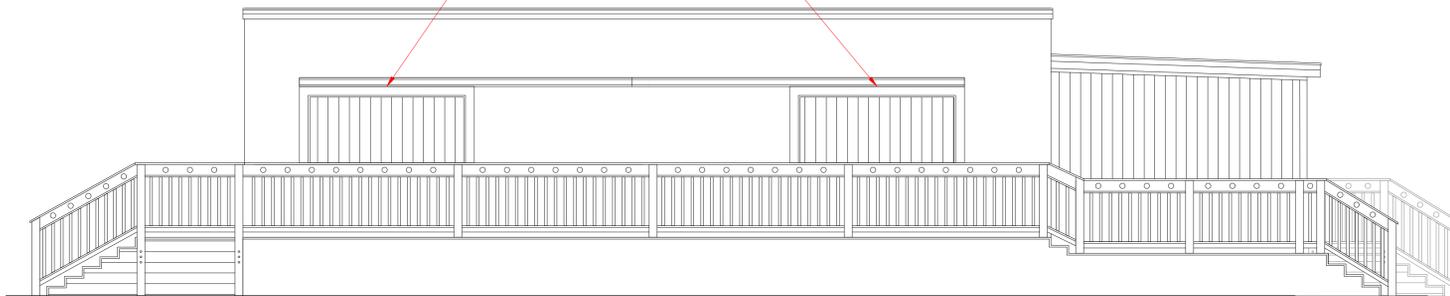
PROPOSED LEFT ELEVATION
 SCALE: 1/4" = 1'-0"

PROPOSED DECORATIVE WOOD SLIDING DOORS
