## STANDARDS FOR REHABILITATION & GUIDELINES FOR REHABILITATING HISTORIC BUILDINGS

# Rehabilitation

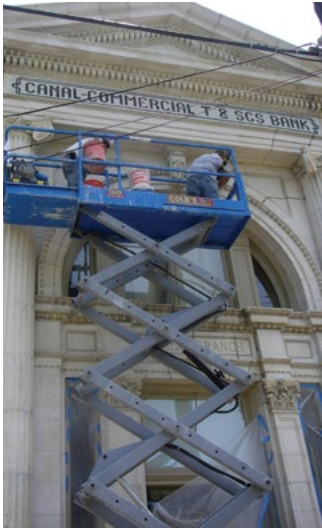
[1] An alkaline-based product is appropriate to use to clean historic marble because it will not damage the marble, which is acid sensitive.

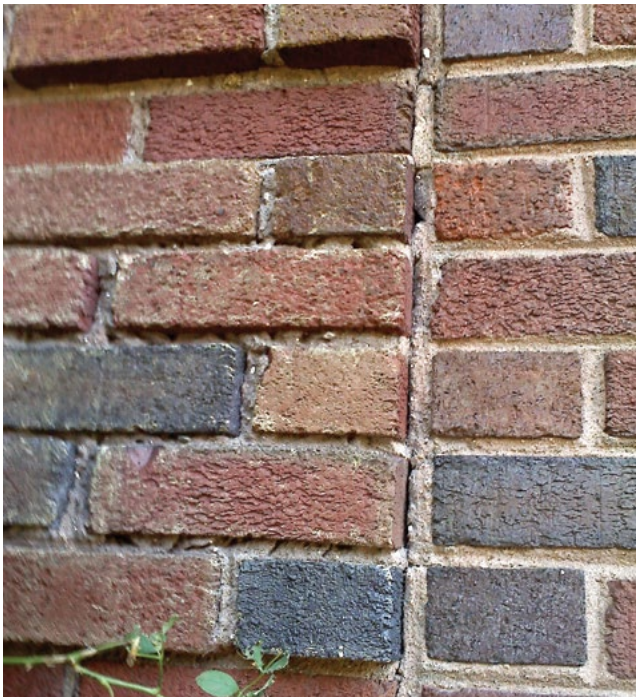
[4] **Not Recommended:**  
The quoins on the left side of the photo show that high-pressure abrasive blasting used to remove paint can damage even early 20th-century, hard-baked, textured brick and erode the mortar, whereas the same brick on the right, which was not abrasively cleaned, is undamaged.

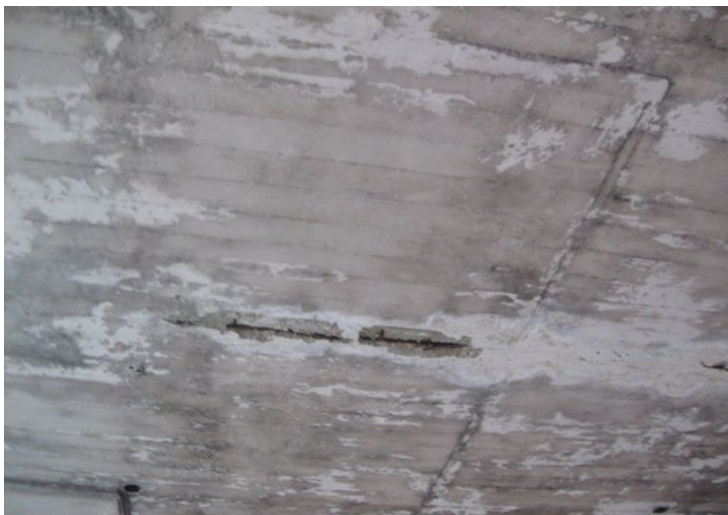
[5] Rebars in the reinforced concrete ceiling have rusted, causing the concrete to spall. The rebars must be cleaned of rust before the concrete can be patched.

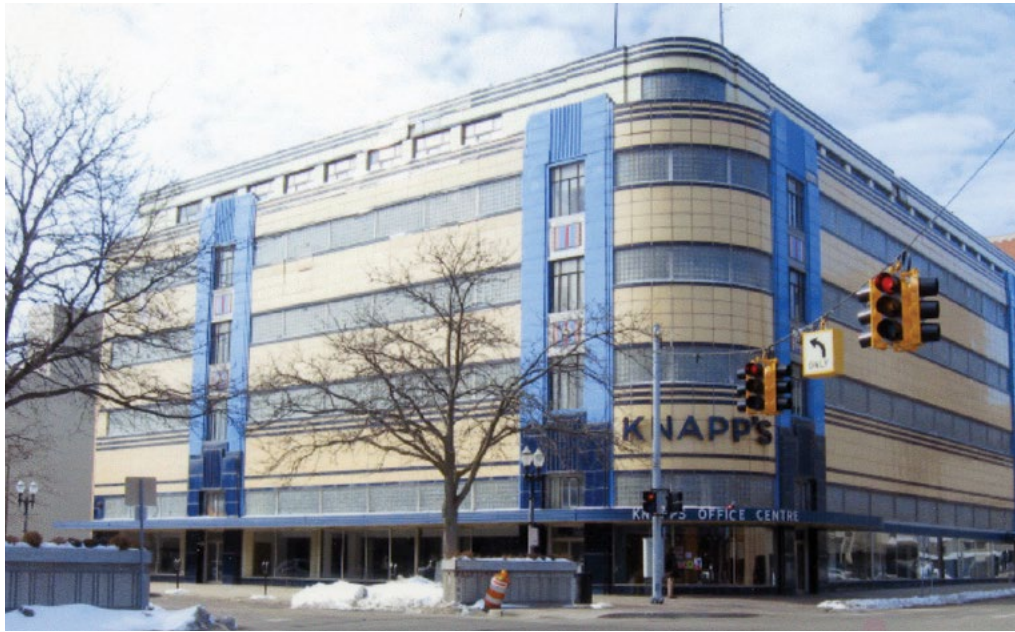
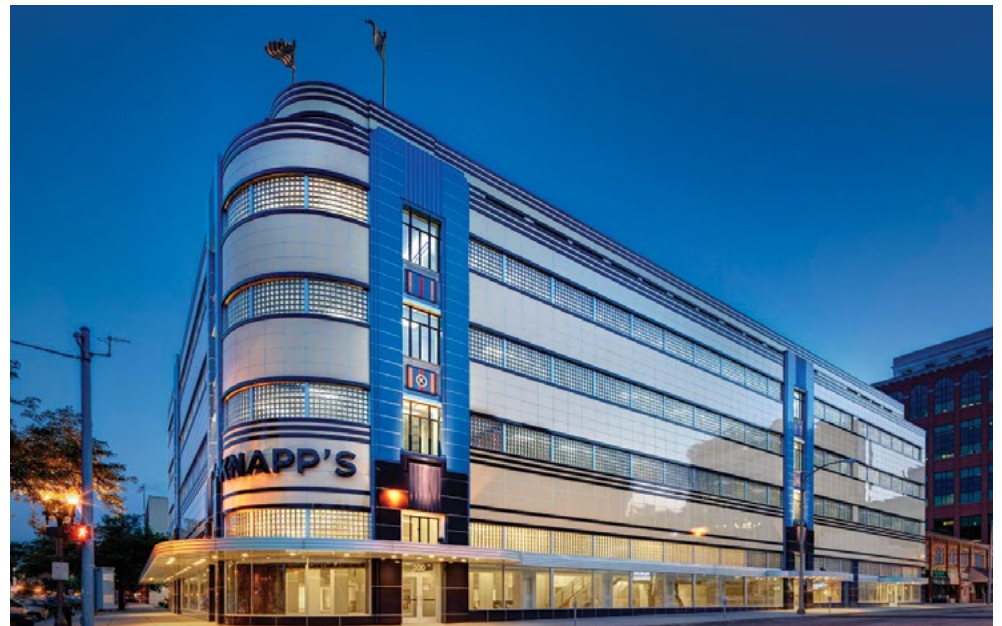
[7] (a) J.W. Knapp's Department Store, built 1937-38, in Lansing, MI, was constructed with a proprietary material named "Maul Macotta" made of enameled steel and cast-in-place concrete panels. Prior to its rehabilitation, a building inspection revealed that, due to a flaw in the original design and construction, the material was deteriorated beyond repair. The architects for the rehabilitation project devised a replacement system (b) consisting of enameled aluminum panels that matched the original colors (c). Photos and drawing (a-b): Quinn Evans Architects; Photo (c): James Haefner Photography.

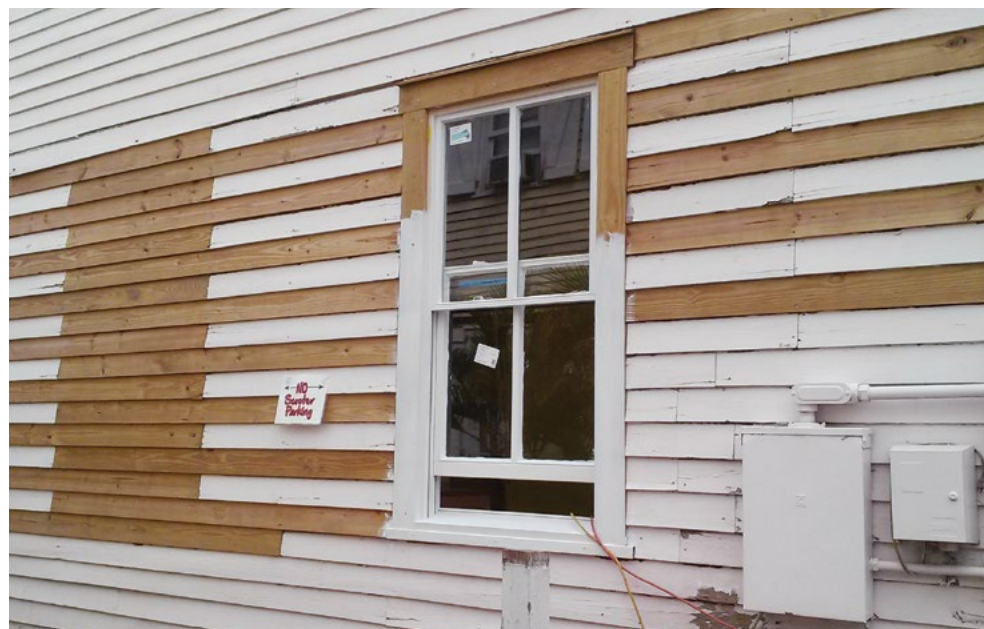
[8] Rotted clapboards have been replaced selectively with new wood siding to match the originals.

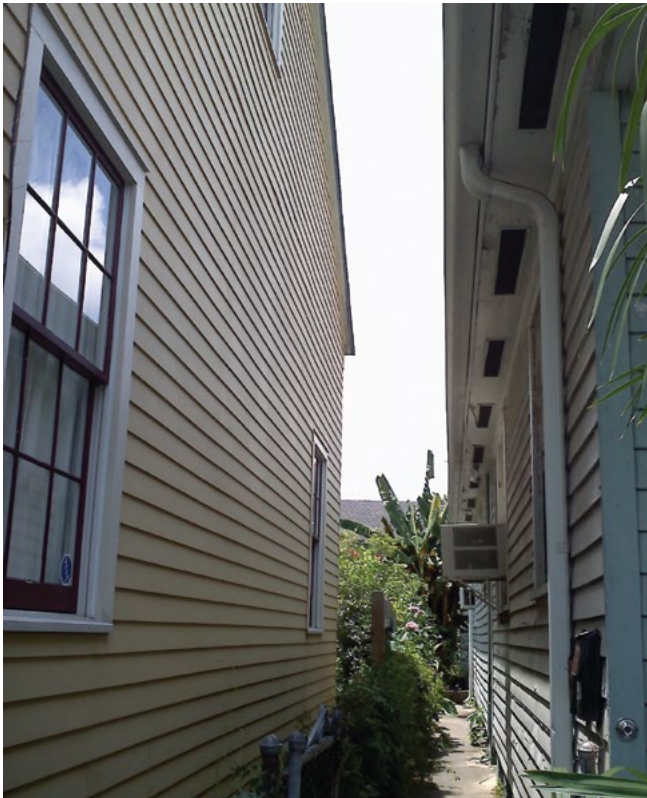
[9] Smooth-surfaced cementitious siding (left) may be used to replace deteriorated wood siding only on secondary elevations that have minimal visibility.

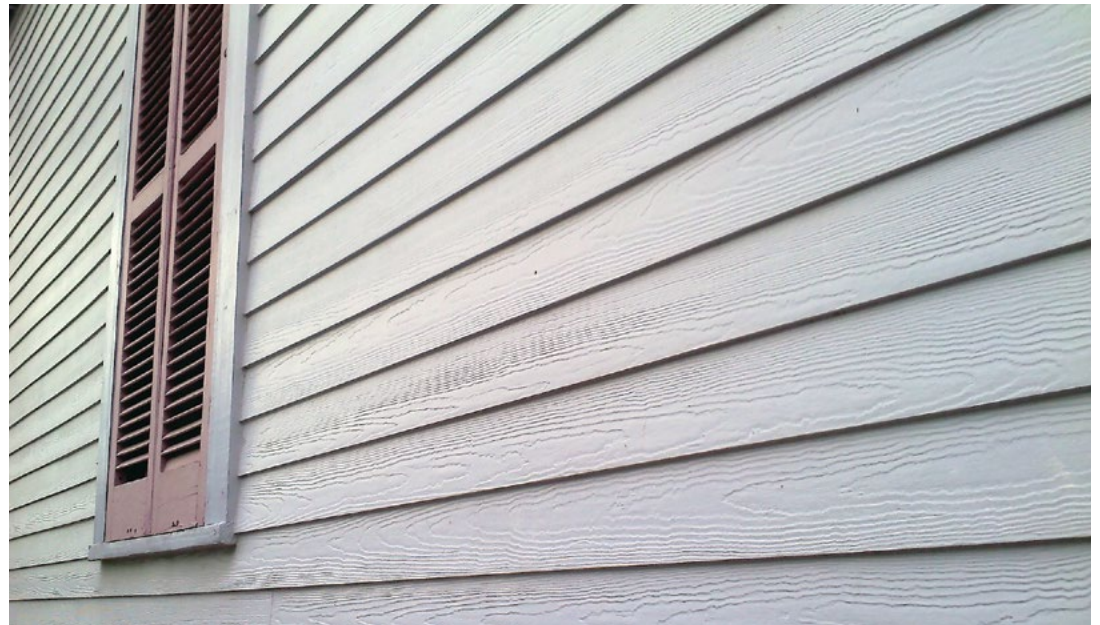
Cementitious siding with a raised wood-grain texture is not an appropriate material to replace historic wood siding, which has a smooth surface when painted.

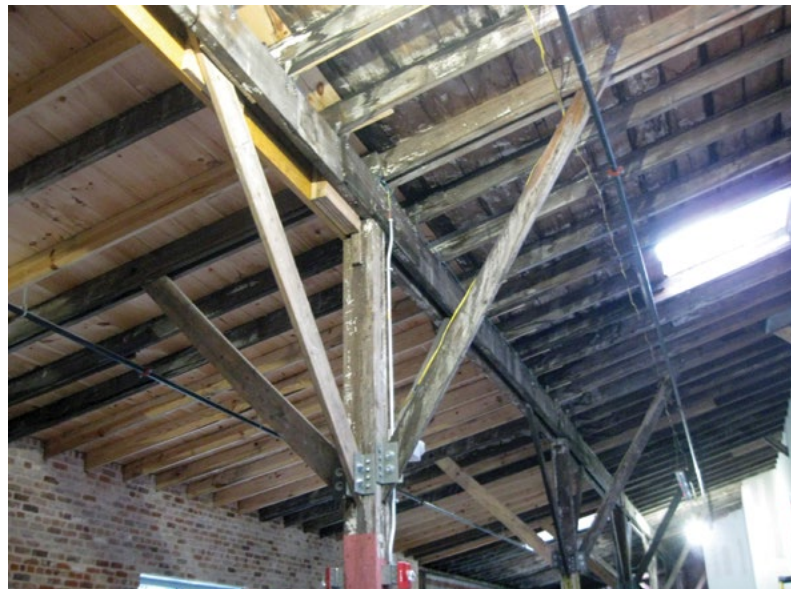
[17] New wood elements have been used selectively to replace rotted wood on the underside of the roof in this historic warehouse.

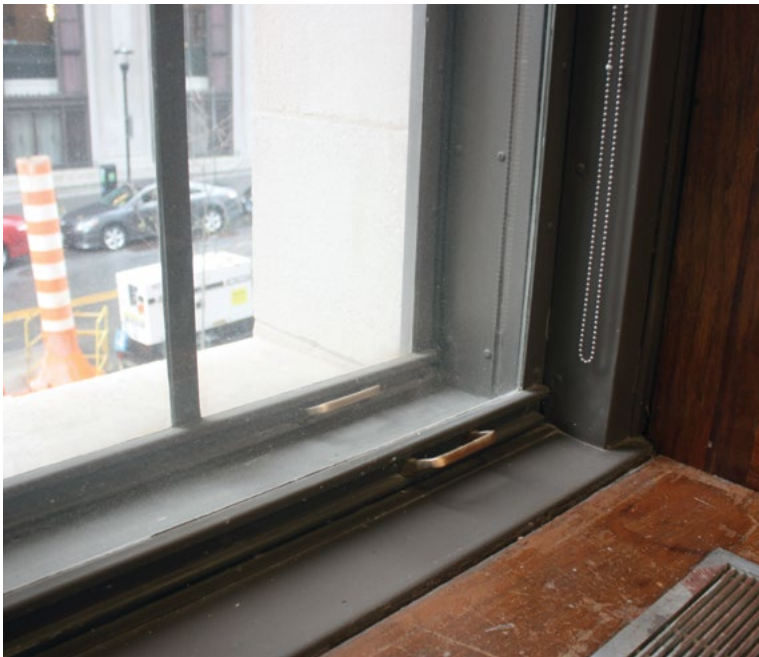
[18] The historic metal storm windows in this 1920s office building were retained and repaired during the rehabilitation project.

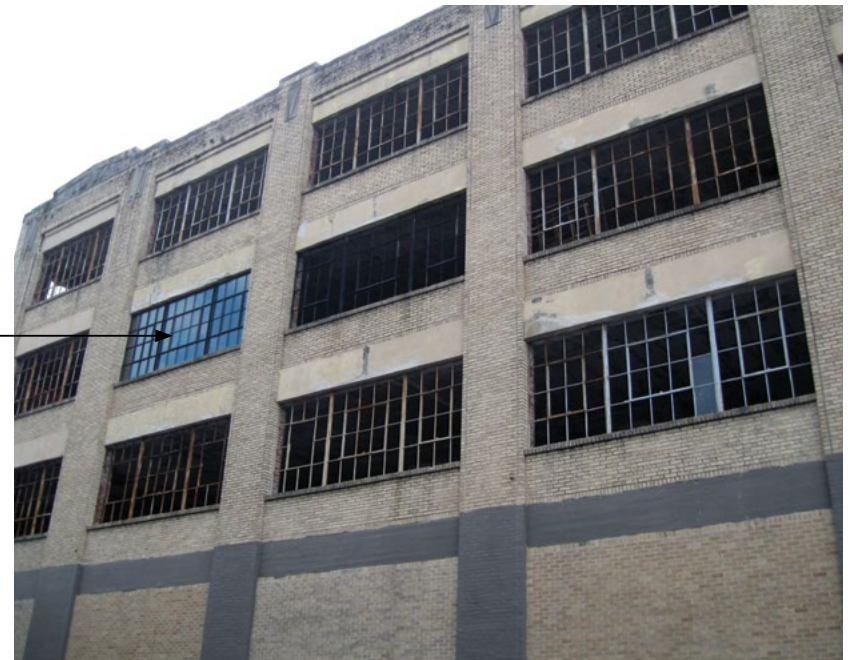
[19] Installing a mockup of a proposed replacement window can be helpful to evaluate how well the new windows will match the historic windows that are missing or too deteriorated to repair.

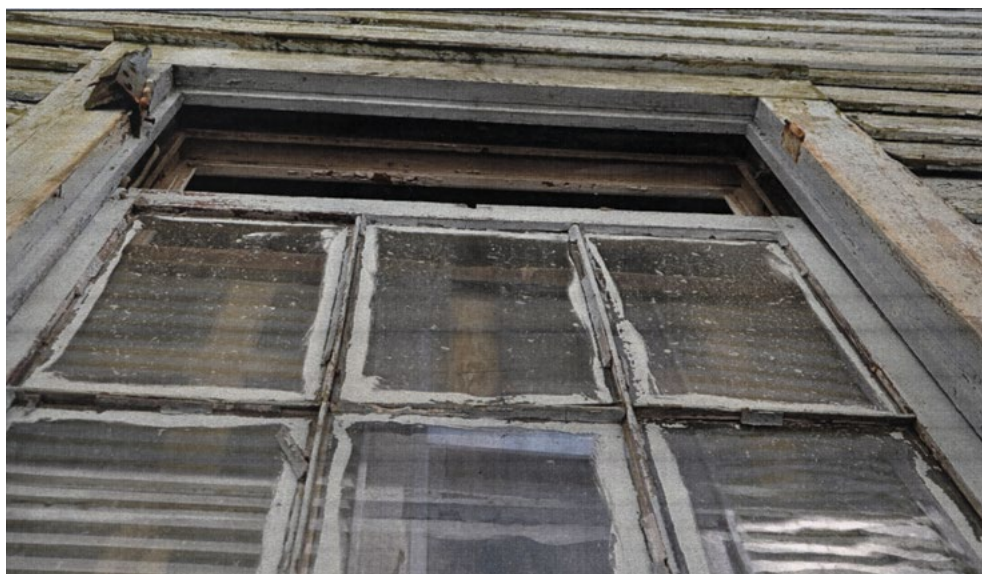
[23] (a) This deteriorated historic wood window was repaired and retained (b) in this rehabilitation project.

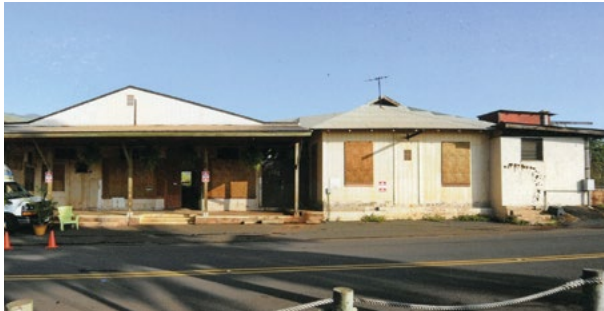
[29] The rehabilitation of the 1910 Māālaea General Store (a), which served the workers' camp at the Wailuku Sugar Company on the Hawaiian island of Maui, included the reconstruction of the original parapet (b).

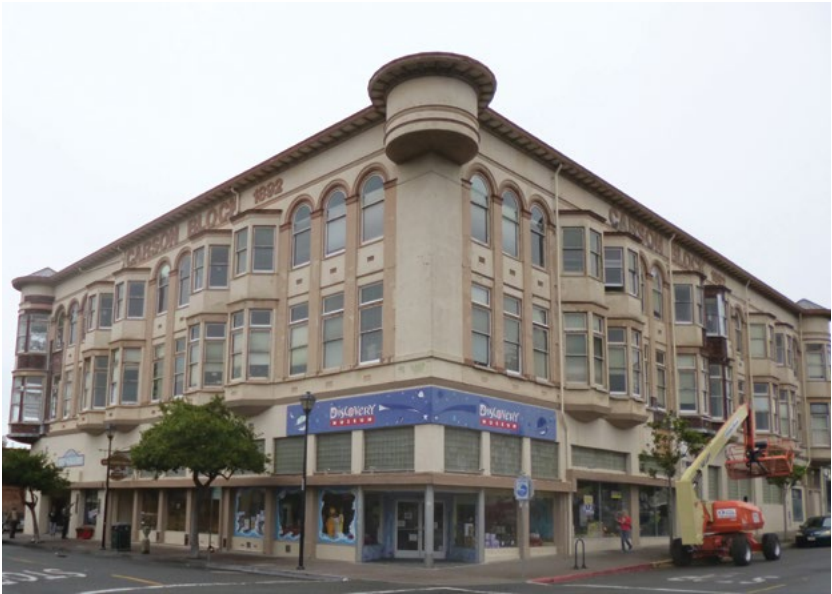
[32] (a-b) The rehabilitation of the 1892 Carson Block Building in Eureka, CA, for its owner, the Northern California Indian Development Council, included recreating the missing corner turret and sensitively introducing seismic reinforcement (c) shown here (opposite page) in a secondary upper floor office space. Photos: Page & Turnbull.

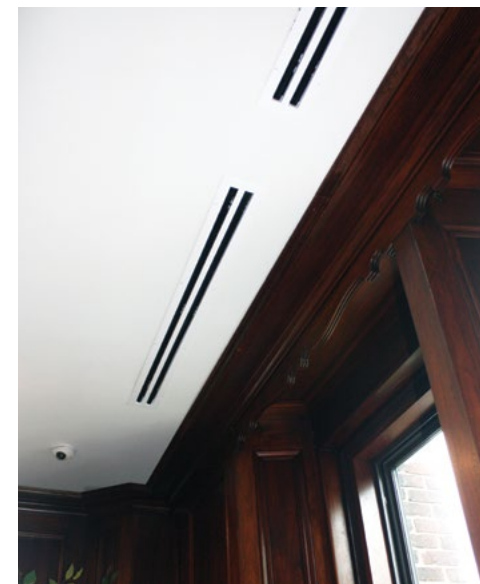
[34] The new ceiling ducts installed during the conversion of this historic office building into apartments are minimal in design and discretely placed above the windows.

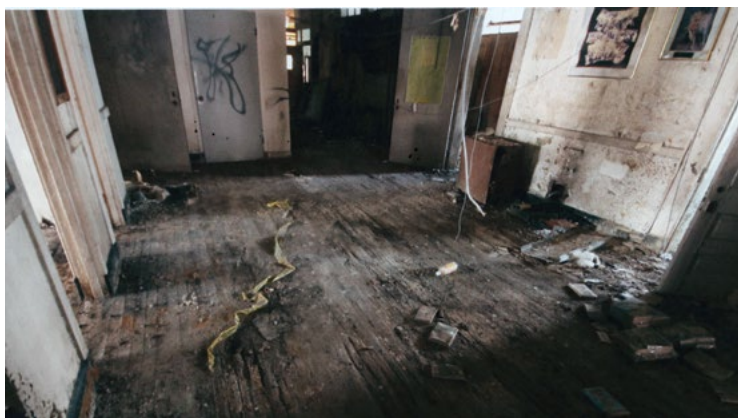
[35] (a) Although deteriorated, the historic school corridor, shown on the left, with its character-defining features, including doors and transoms, was retained and repaired as part of the rehabilitation project (b).

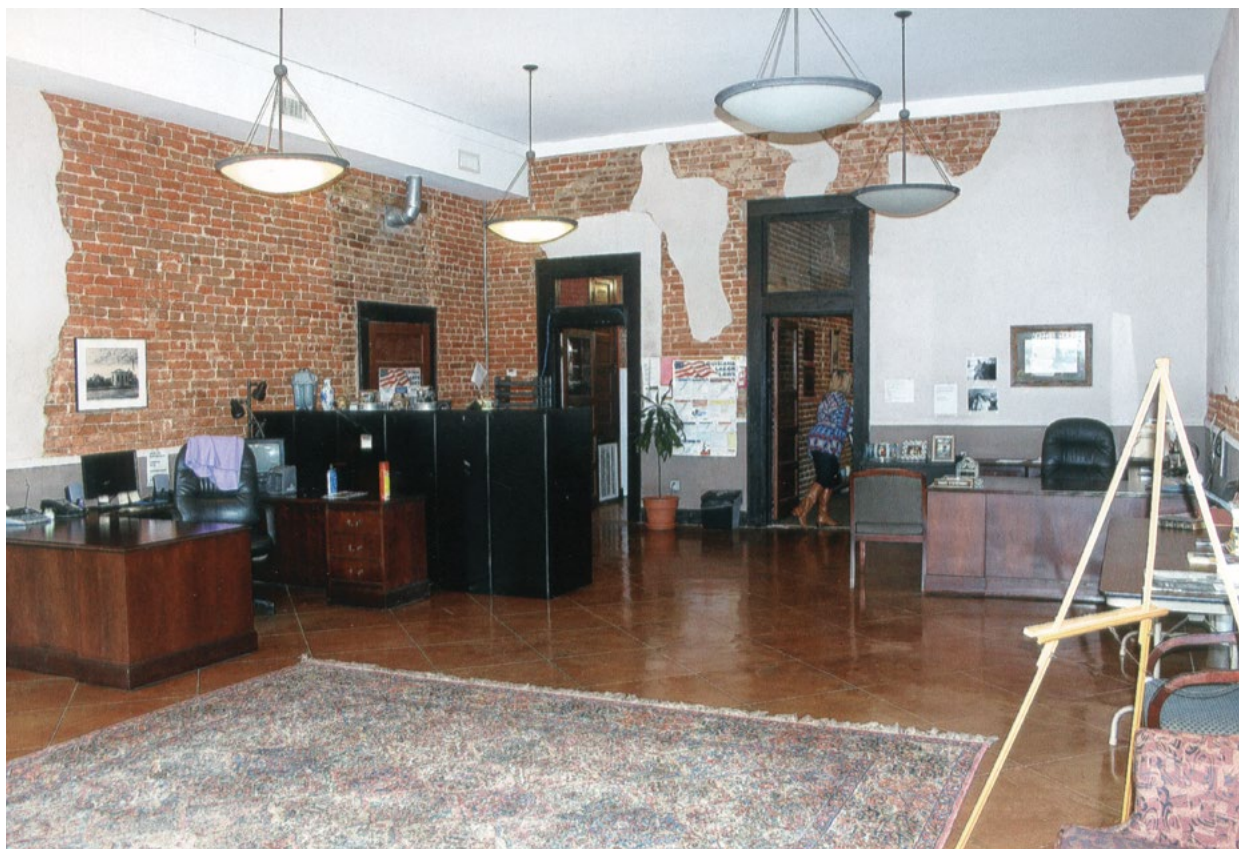
[41] **Not Recommended:** Leaving fragments of deteriorated or “sculpted” plaster is not a compatible treatment for either finished or unfinished interior spaces.

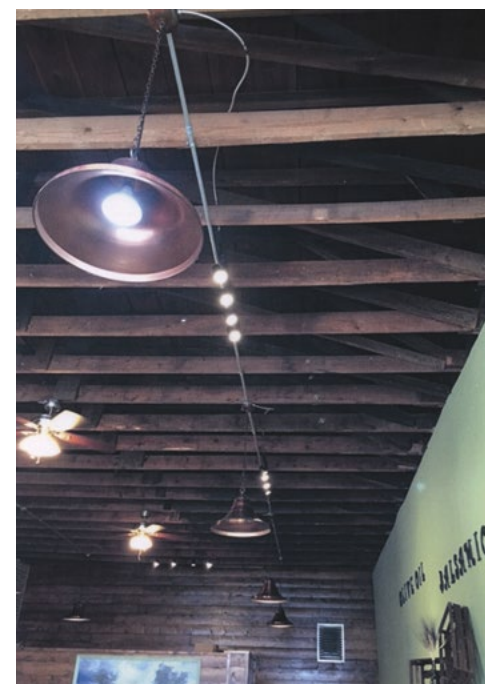
[40] **Not Recommended:** Removing a finished ceiling and leaving the structure exposed in a historic retail space does not meet the Standards for Rehabilitation.

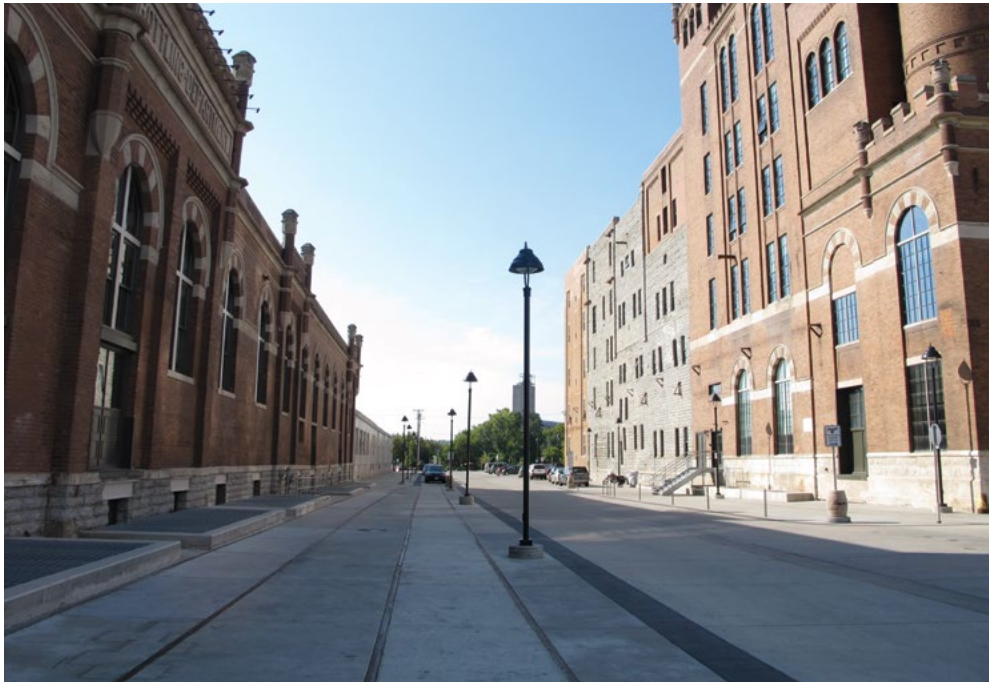
[43] The industrial character of the site was retained when this brewery complex was rehabilitated for residential use.

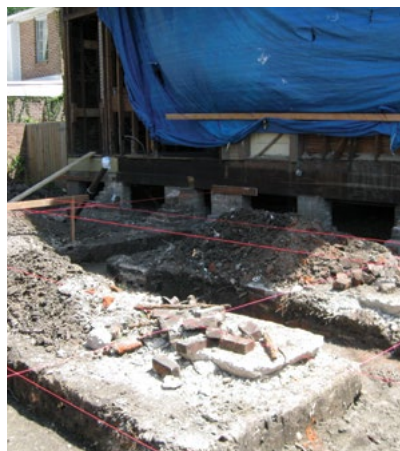
[45] Undertaking a survey to document archeological resources may be considered in some rehabilitation projects when a new exterior addition is planned.

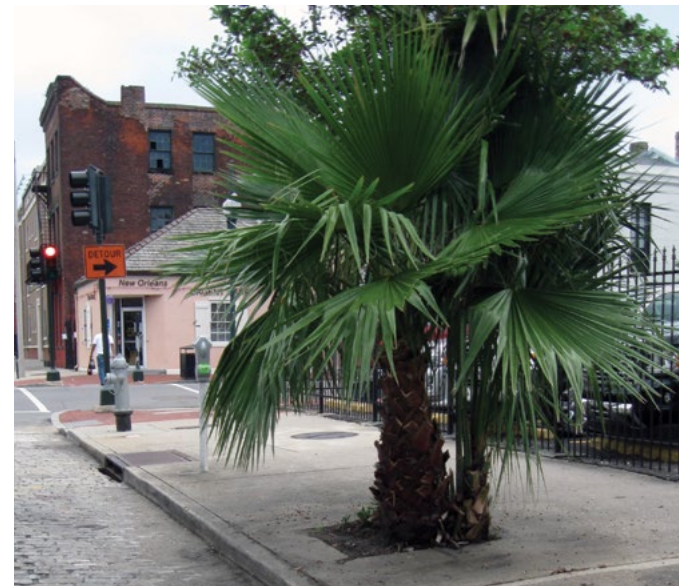
[47] Original paving stones contribute to the character of the historic setting and distinguish this block from other streets in the district.

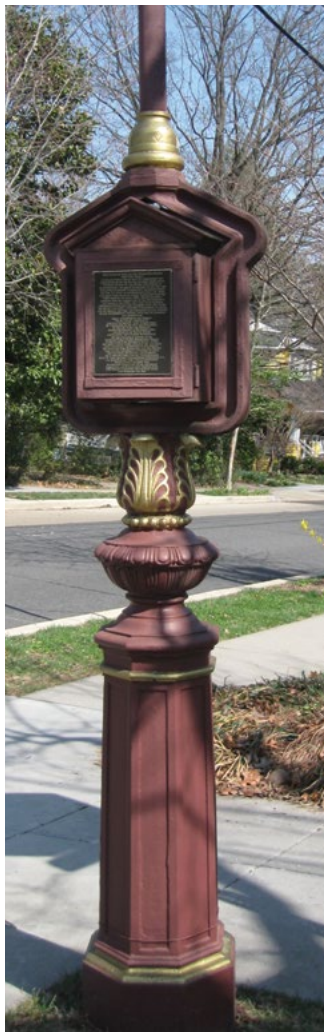
[48] Old police and fire call boxes, which are distinctive features in this historic district, have been retained, and now showcase work by local artists.

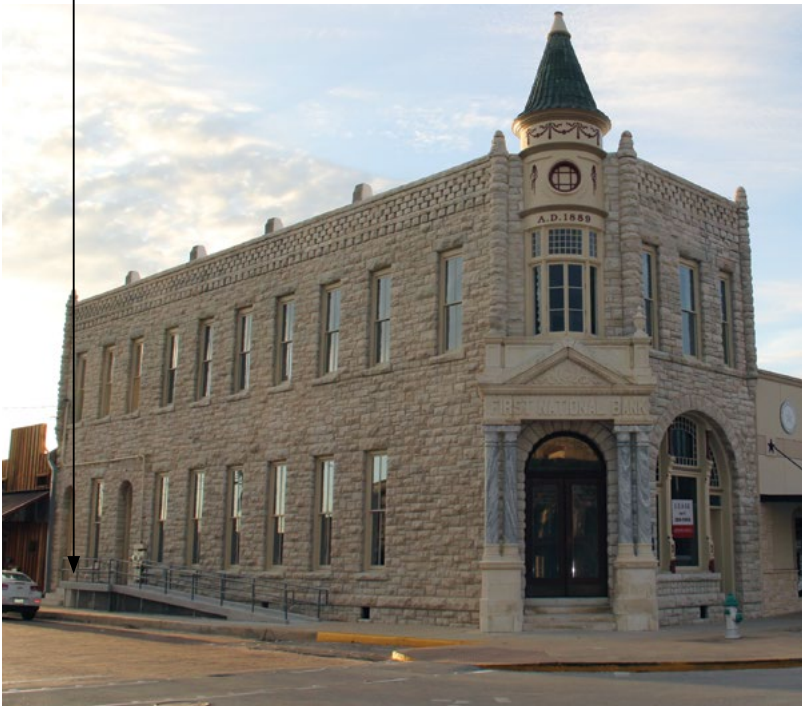
[52] The access ramp blends in with the stone façade of the First National Bank in Stephenville, TX, and is appropriately located on the side where it is does not impact the historic character of the building. Photo: Nancy McCoy, QuimbyMcCoy Preservation Architecture, LLP.

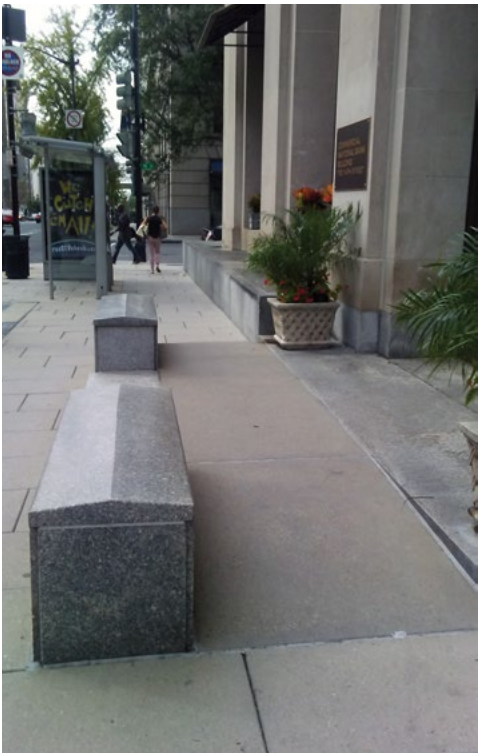
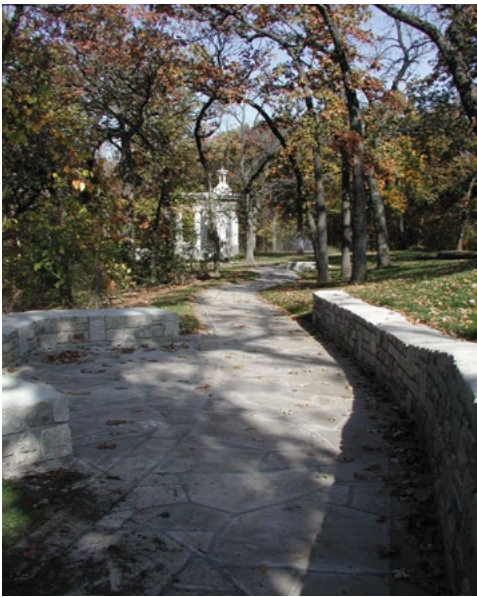
[53] This entrance ramp (right) is compatible with the historic character of this commercial building.

[54] The gently-sloped path in a historic park in Kansas City, MO, which accesses the memorial below, includes a rest area part way up the hill. Photo: STRATA Architecture + Preservation.

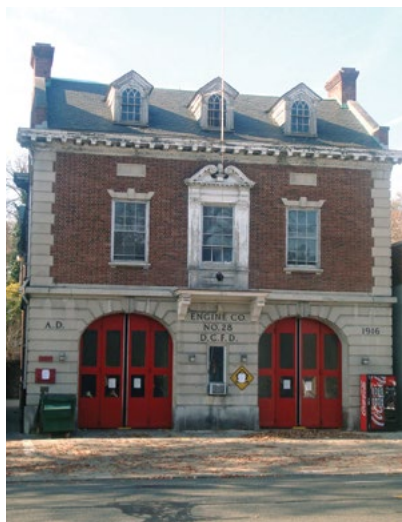
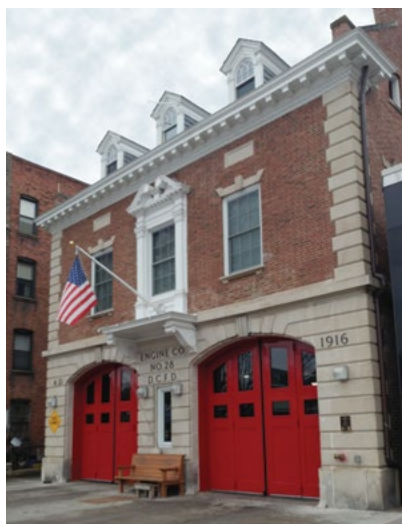
[56 a-b] In order to continue in its historic use, the door openings of this 1916 Colonial Revival-style fire station had to be widened to accommodate the larger size of modern fire trucks. Although this resulted in some change to the arched door surrounds, it is minimal and does not negatively impact the historic character of the building. (a) Above, before; Photo: Fire and Emergency Medical Services Department (FEMS), Washington, D.C.; below, after.

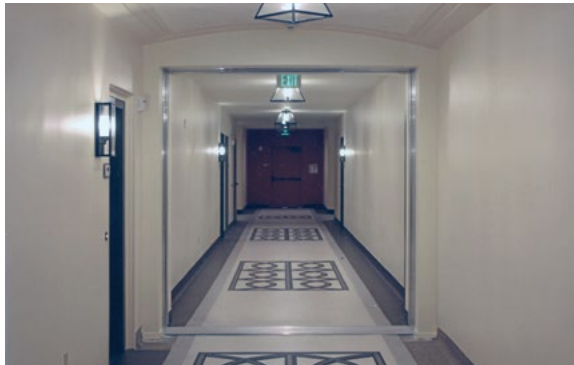
[58] Fire doors that retract into the walls have been installed here (not visible in photo) preserve the historic character of this corridor.

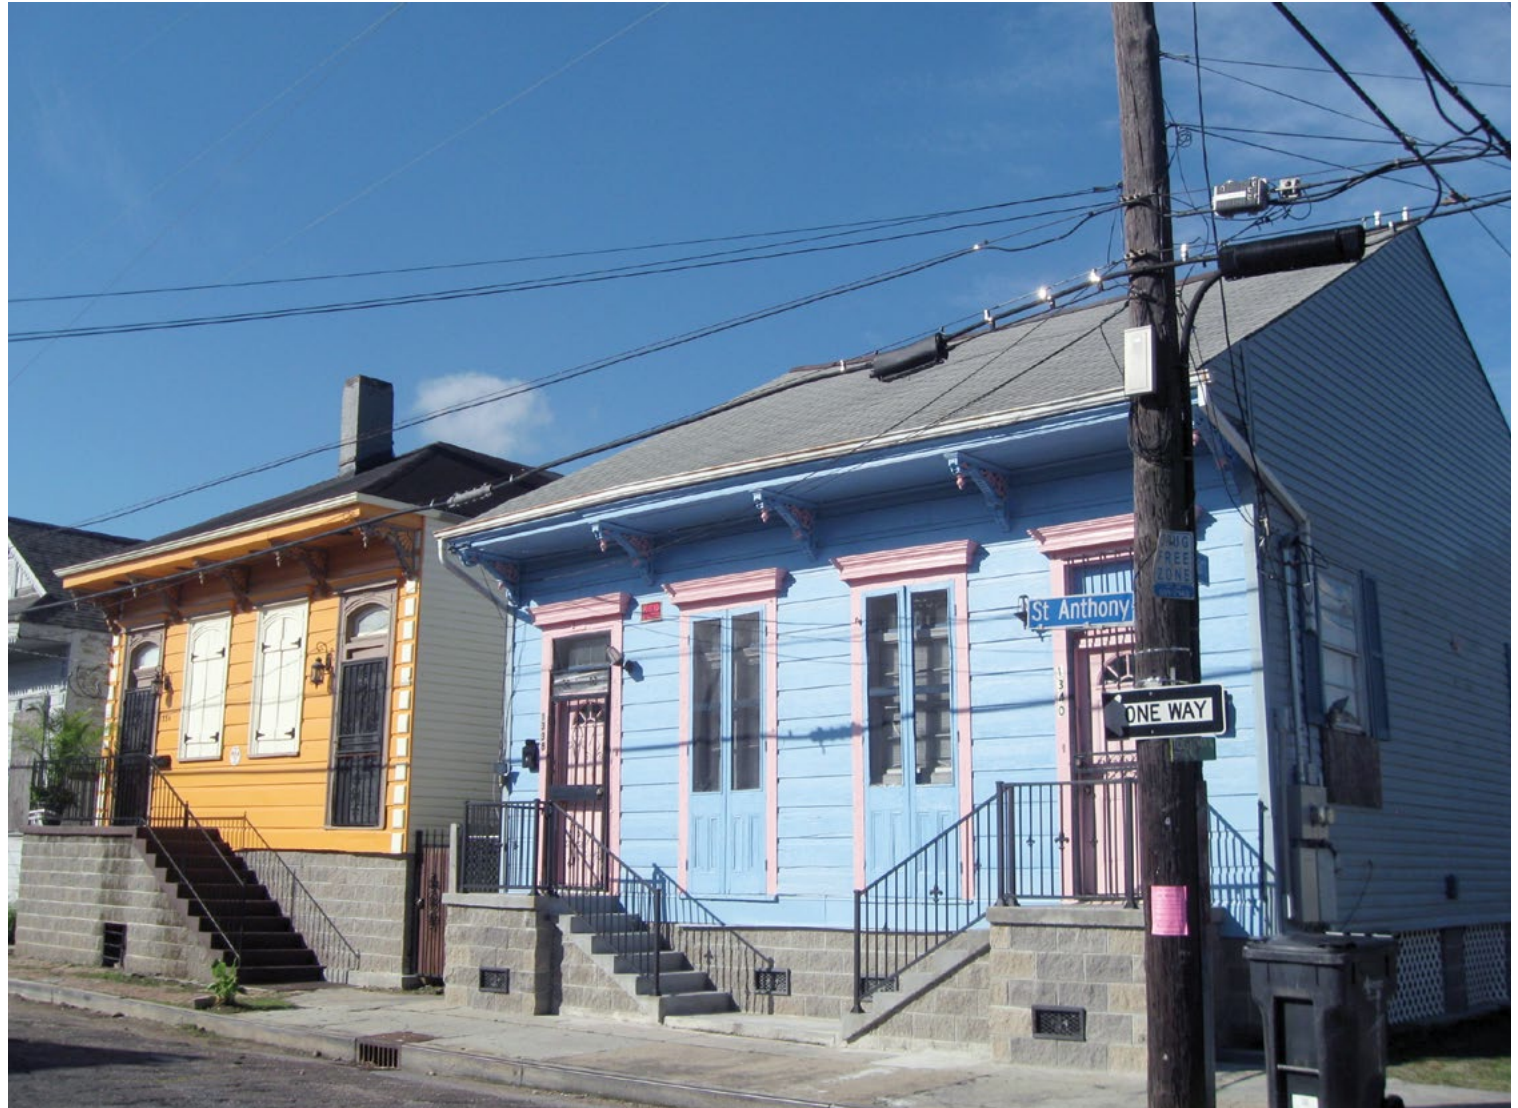
[60] In some instances, it may be necessary to elevate a historic building located in a floodplain to protect it. But this treatment is appropriate only if elevating the building will retain its historic character, including its relationship to the site, and its new height will be compatible with surrounding buildings if in a historic district. The house on the right, which has been raised only slightly, has retained its historic character. The house on the left has been raised several feet higher, resulting in a greater impact on the historic character of the house and the district.

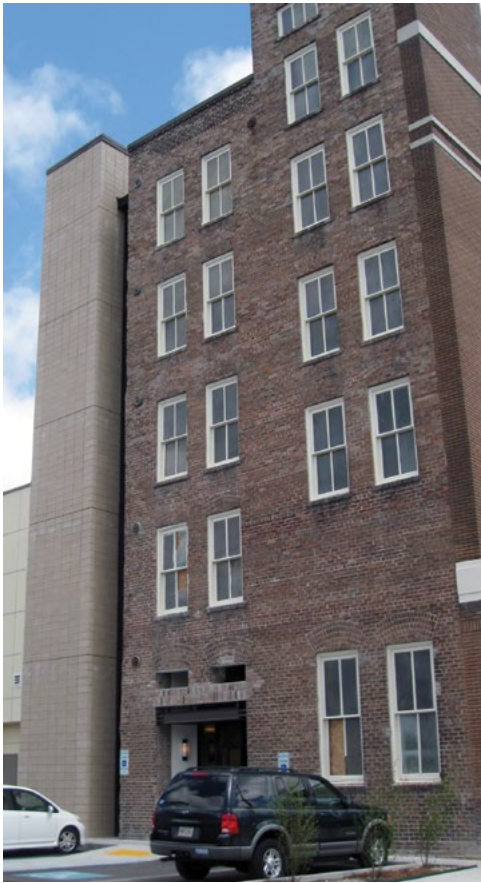
[62] The stair tower at the rear of this commercial building is a compatible new addition.

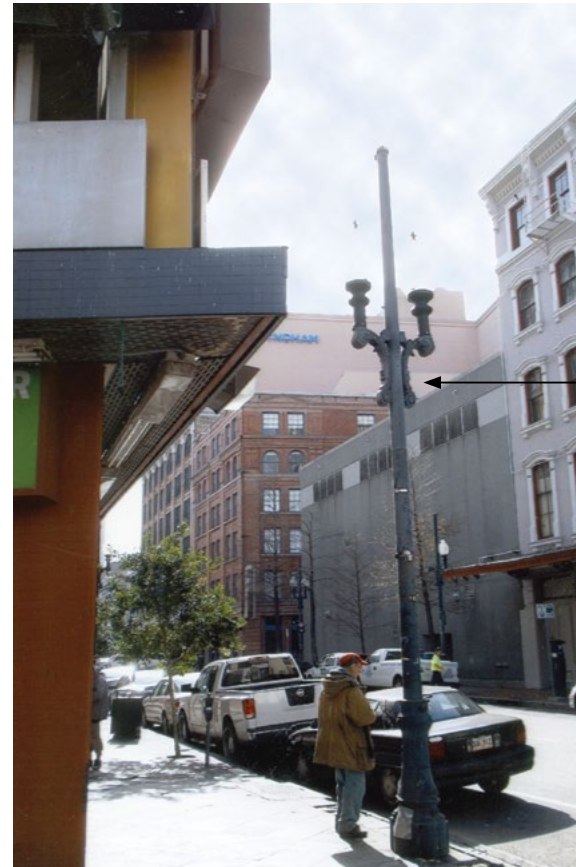
[ 63] (a) A mockup should be erected to demonstrate the visibility of a proposed rooftop addition and its potential impact on the historic building. Based on review of this mockup (orange marker), it was determined that the rooftop addition would meet the Standards (b). The addition is unobtrusive and blends in with the building behind it.

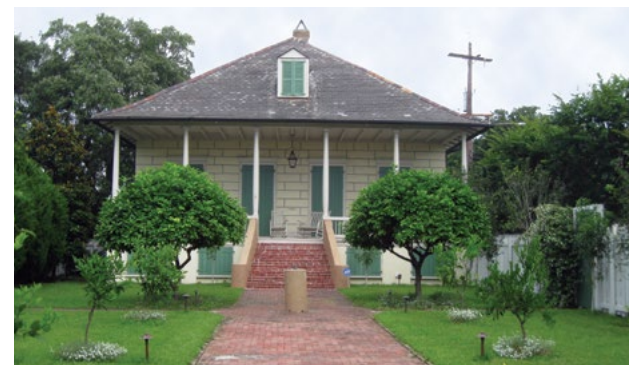
[65] (a) This (far left) is a compatible new outbuilding constructed on the site of a historic plantation house (b). Although traditional in design, it is built of wood to differentiate it from the historic house (which is scored stucco) located at the back of the site so as not to impact the historic house, and minimally visible from the public right-of-way (c).
