RESOLUTION NO. 13-295

A RESOLUTION OF THE CITY COMMISSION OF THE CITY OF KEY WEST, FLORIDA APPROVING TASK ORDER NO. 12.0D01.B FROM HAYES/CUMMING ARCHITECTS, PA IN AN AMOUNT NOT TO EXCEED \$199,720.00 FOR COMPLETE ARCHITECTURAL SERVICES INCLUDING CONCEPT DEVELOPMENT, ENVIRONMENTAL TESTING, PROGRAM DEVELOPMENT, PREPARATION OF RECORD DRAWINGS, SELECTIVE DEMOLITION DESIGN, FULL DESIGN AND CONSTRUCTION DOCUMENTS, BIDDING AND CONSTRUCTION OVERSIGHT OF THE FREDERICK DOUGLASS COMMUNITY CENTER; PROVIDING FOR AN EFFECTIVE DATE

RE: **Approval of a Task Order 12.0D01.B from Hayes Cumming Architects in the amount of \$199,720 for complete architectural services including concept development, environmental testing, program development, preparation of record drawings, selective demolition design, full design and construction documents, bidding, and construction oversight of the Frederick Douglass Community Center.**

**Frederick Douglas Recreation Center – Photographs
Limited Structural Assessment – Task A
McCarthy Project No. 13178**

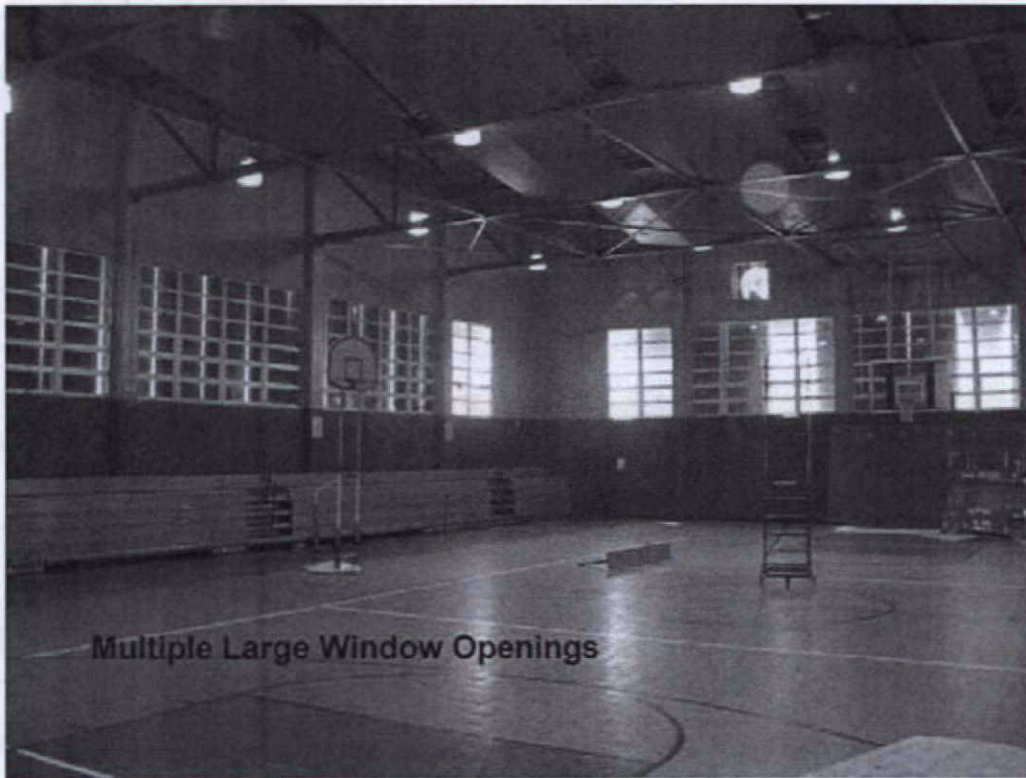
Photo #07

Multiple Large Window Openings
