RESOLUTION NO. 25-098

Subject: **File ID 25-3699 Waterfront Playhouse - Second Amendment to Lease  
extending the current lease term for an additional six-month period effective  
November 1, 2025.**

# Sunset Celebration at Mallory Square: Task 1 Discovery

## Existing Historic Building & Restroom Needs Assessment

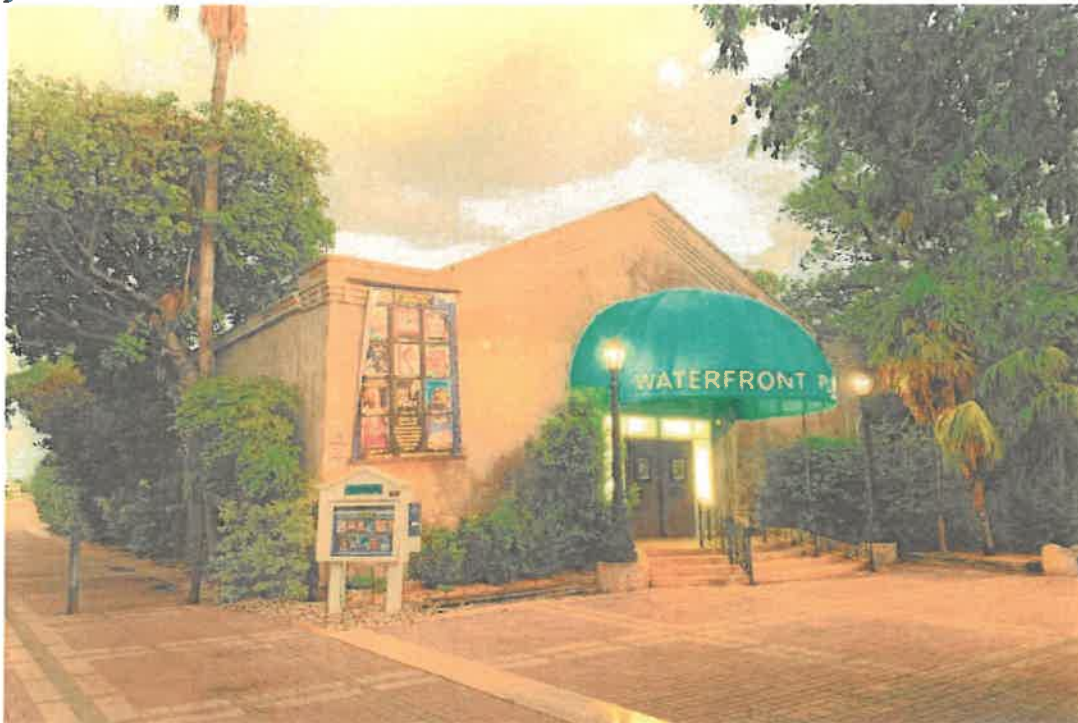
49. Tift and Mallory Warehouse / Waterfront Playhouse, east elevation, camera facing northwest.

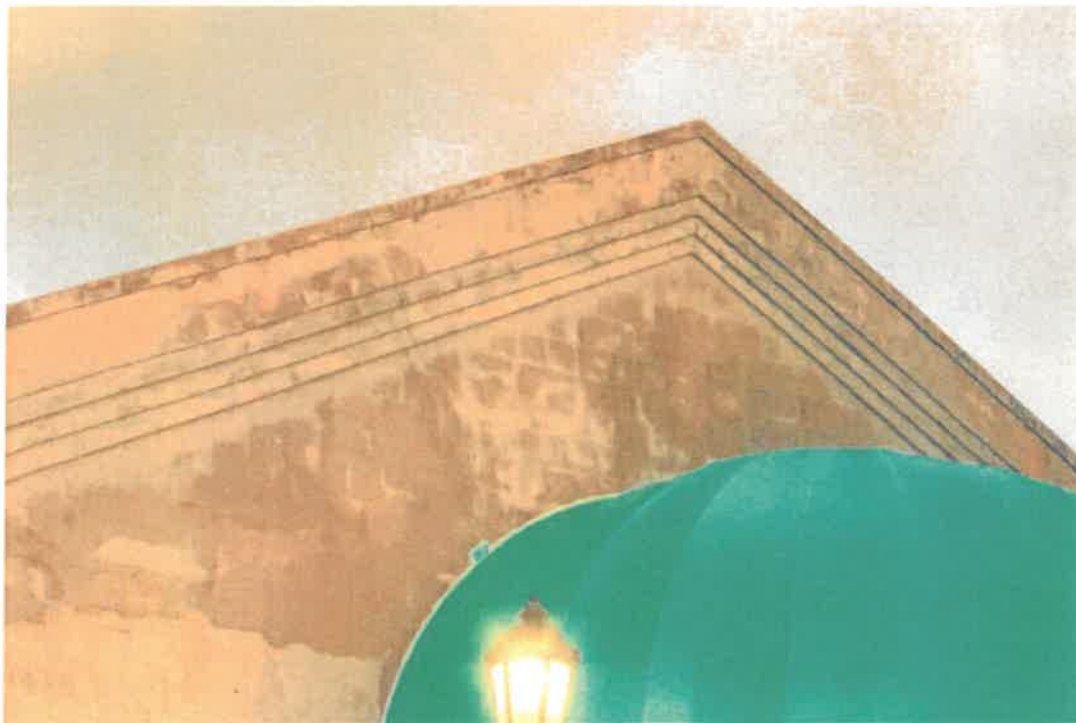
The parge coat is cracking and failing exposing sections of the limestone. The exposed sections of the limestone reveal the weathered condition of the stone and the mortar joints. There are several areas at the south elevation, where ferns and other vegetation are growing out of the wall. The stone at this location is discolored from bio growth and has mortar deterioration problems. The front (east) entry steps are also constructed of limestone finished with parge coat. The parge coat on the steps needs to be repaired.

50. Tift and Mallory Warehouse / Waterfront Playhouse, partial east elevation, camera facing northwest. Note saturation of parge coat and cracking.

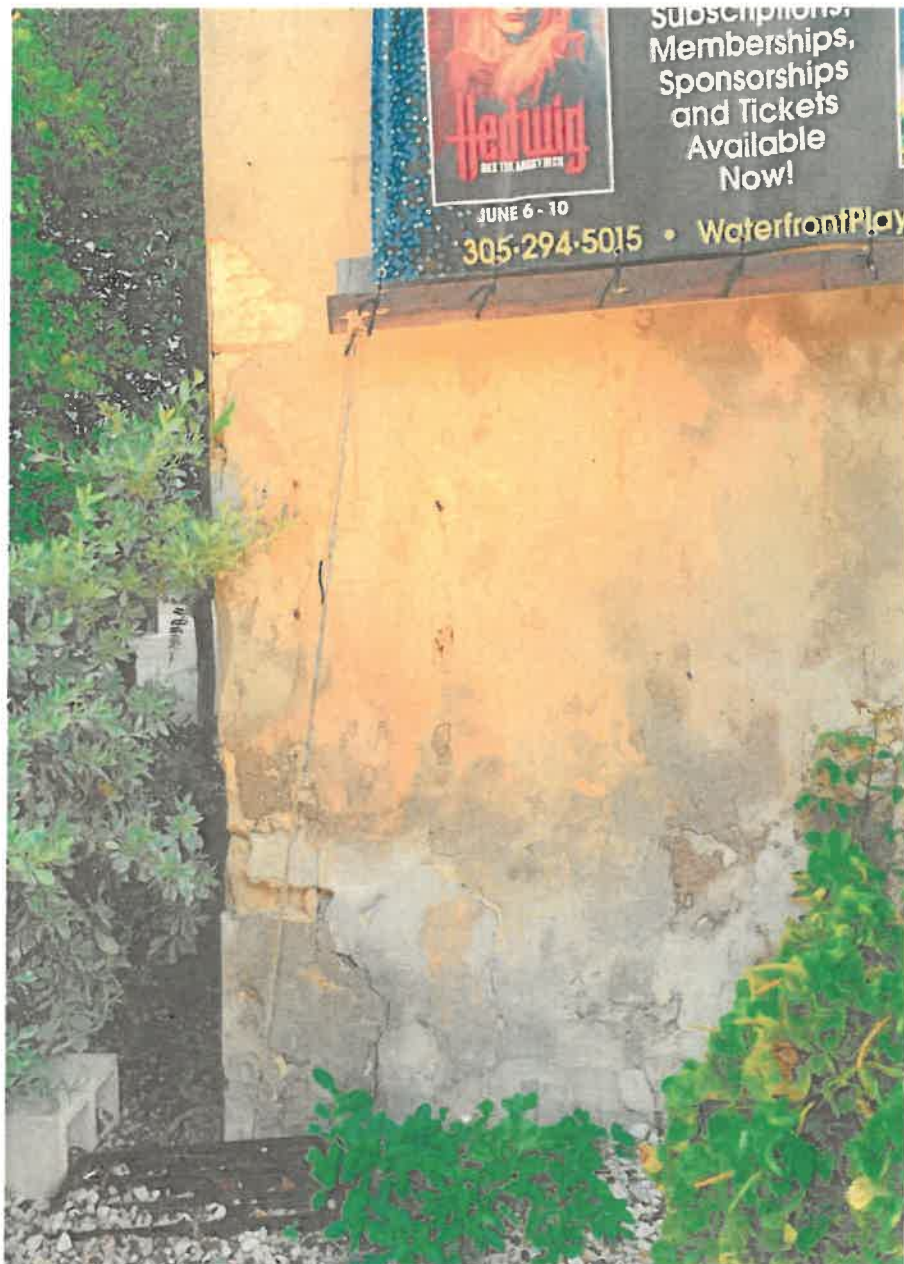
51. Tift and Mallory Warehouse / Waterfront Playhouse, partial east elevation, camera facing west. Note deterioration of parge coat and limestone.

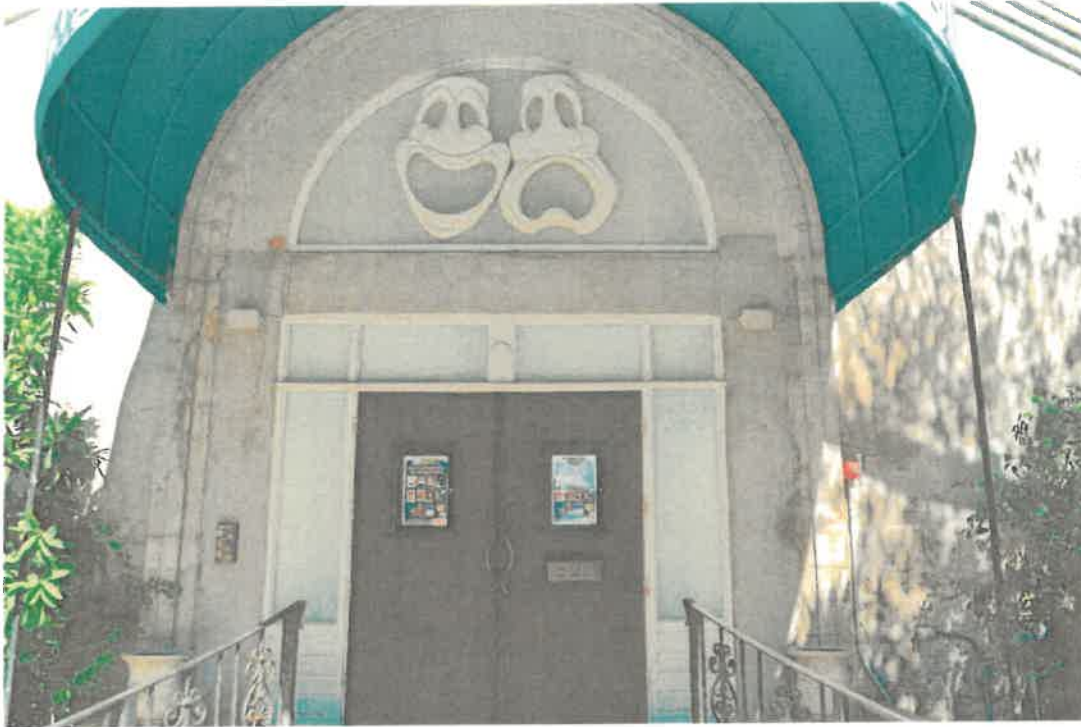
52. Tift and Mallory Warehouse / Waterfront Playhouse, partial east elevation, camera facing west.

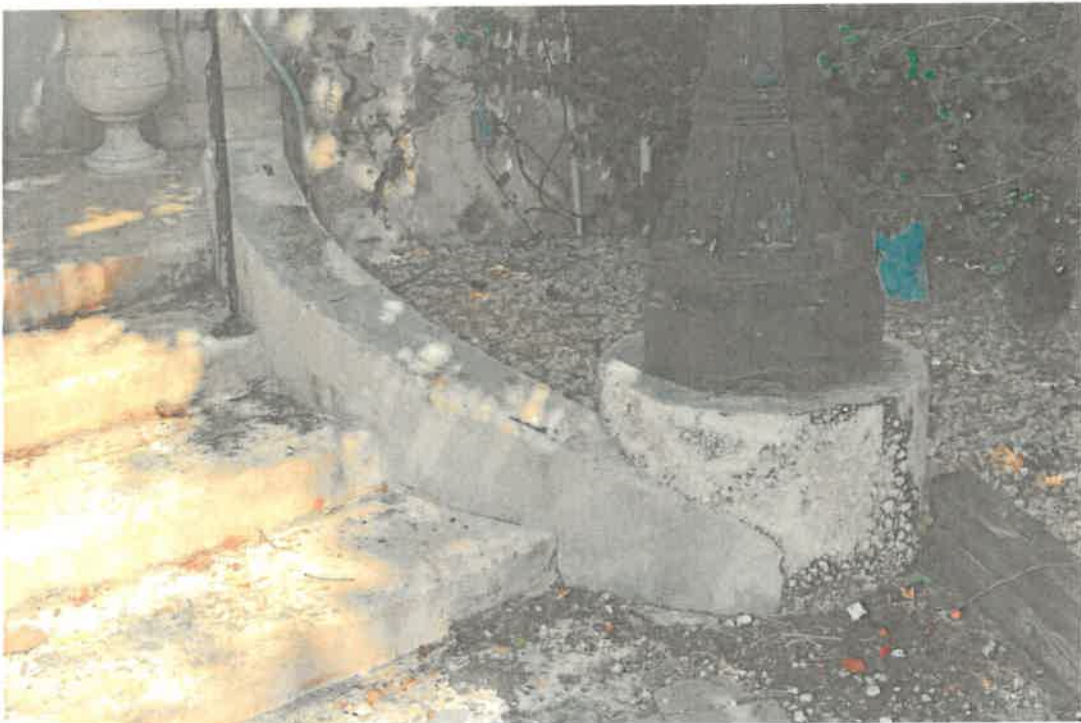
53. Tift and Mallory Warehouse / Waterfront Playhouse, front entry steps at east elevation, camera facing down and northwest. Note deterioration of steps.

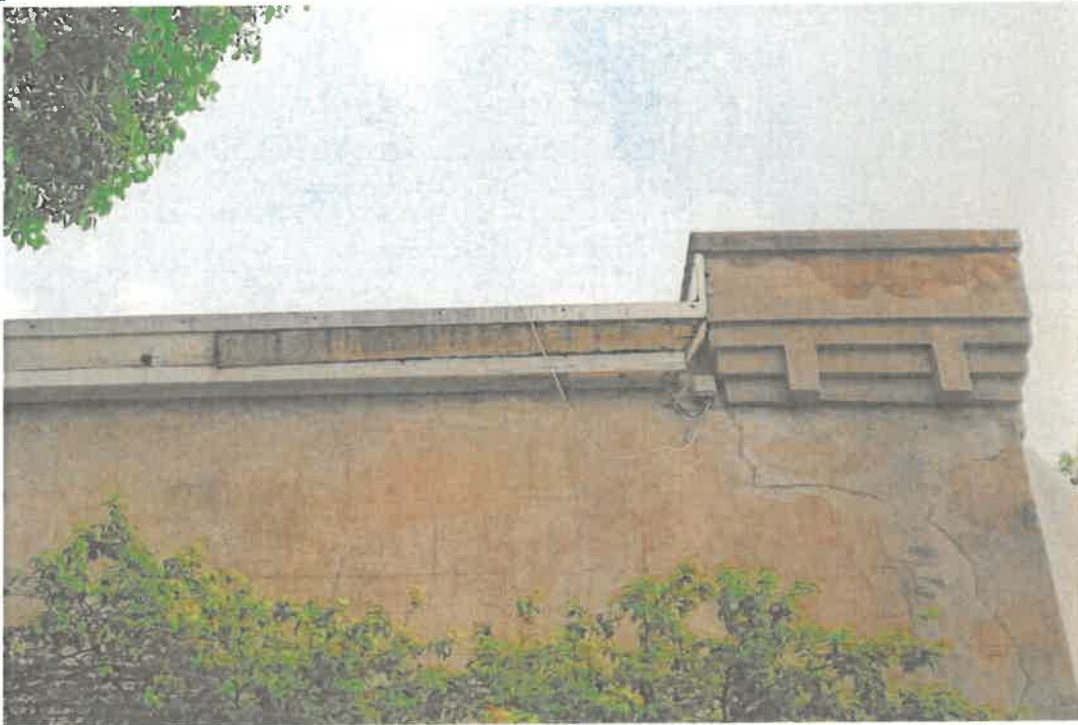
54. Tift and Mallory Warehouse / Waterfront Playhouse, partial south elevation. Note crack.

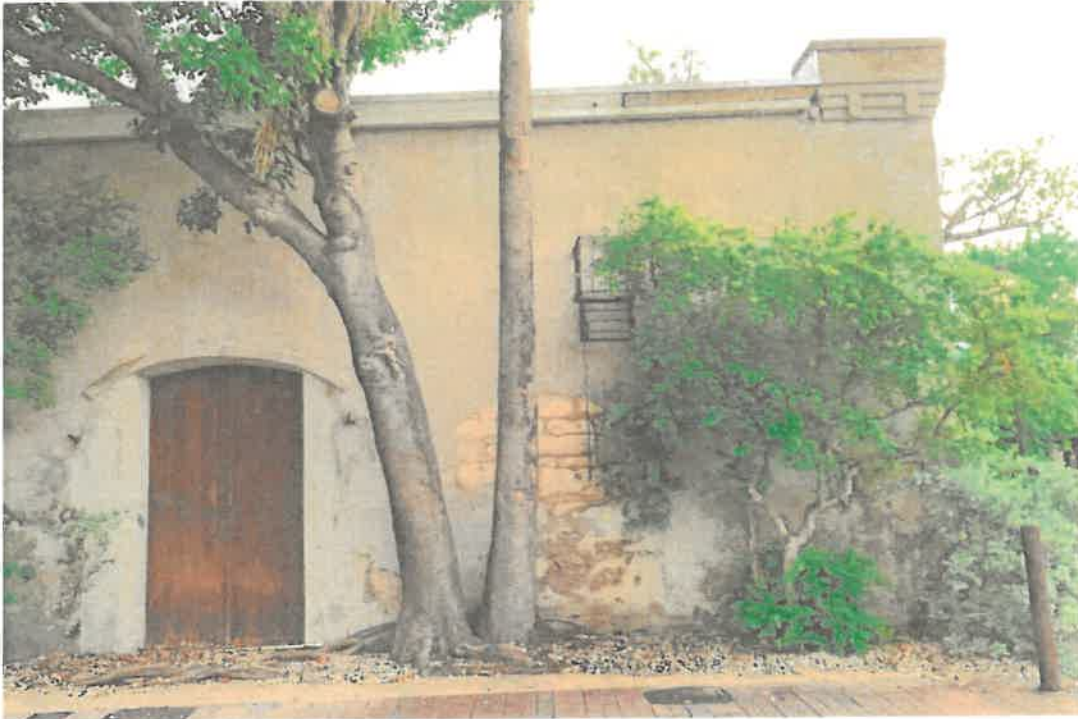
55. Tift and Mallory Warehouse / Waterfront Playhouse, partial south elevation. Note deteriorated parge coat and cracking.

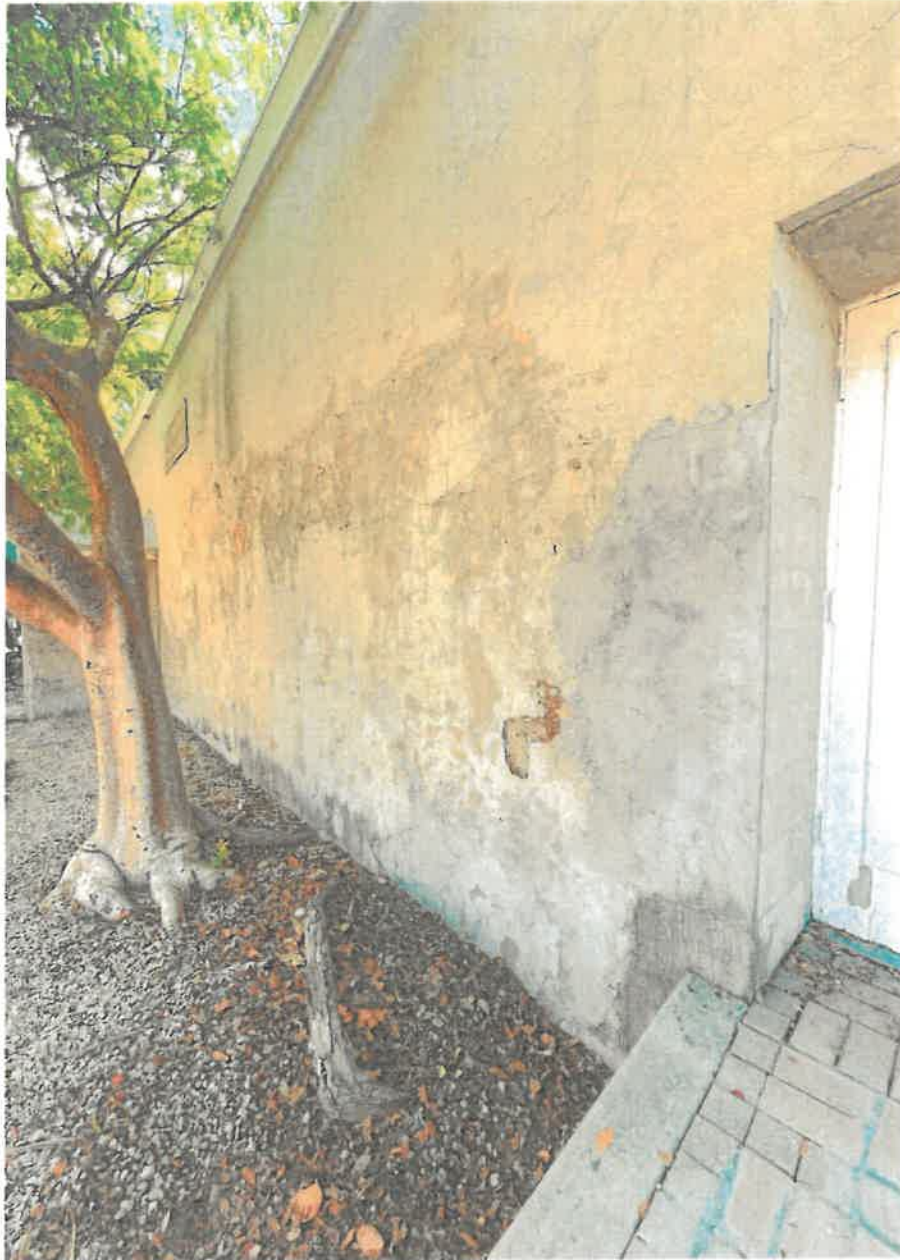
56. Tift and Mallory Warehouse / Waterfront Playhouse, partial west elevation.  
Note severe deterioration and failure of parge coat.

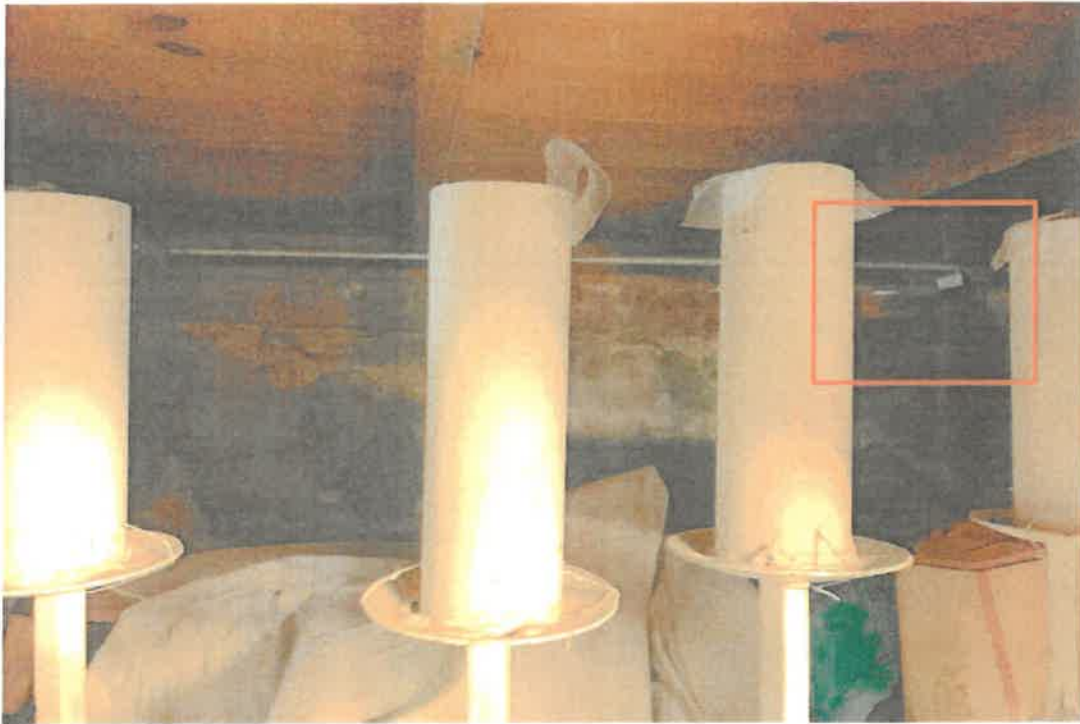
57. Tift and Mallory Warehouse / Waterfront Playhouse, attic, camera facing southwest. Note daylight along roofline.

- Inspecting the roof and roof edge for leaks.
- Repair and replace and rotted wood components like the door surrounds and frames.

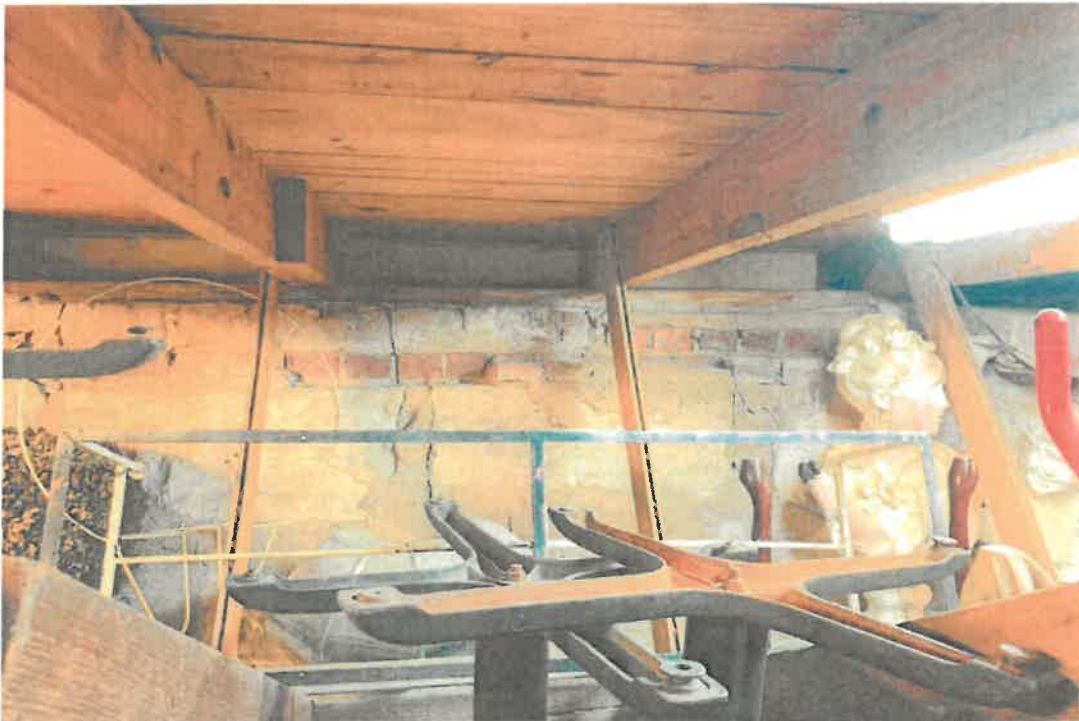
At the interior, the condition of the stone is worse than the exterior. Chunks of stone and stone dust fall to the floor and require cleaning every couple of weeks. The debris observed on the aisle carpet is about two months worth of deterioration. This is signifying an active problem that needs to be addressed immediately. Furthermore, cracks were observed along the top of the wall just below the roof framing.

58. Tift and Mallory Warehouse / Waterfront Playhouse, attic, camera facing west. Note cracks in top of wall and below roof framing.

- Prepare a comprehensive existing conditions assessment that includes:
  - Structural and Mechanical, Electrical and Plumbing Engineering Reports.
  - The Structural Engineering Report should include an analysis of the roof framing and evaluation of the condition of the interior and exterior wall surfaces.
  - An Accessibility Review to ensure compliance with the Americans with Disabilities Act.
  - A Flood Adaptation Review to ensure compliance with Chapter 34 Floods of the Key West Code of Ordinances, and the flood-resistant construction requirements of the Florida Building Code.
- Doors: Repair the doors as necessary to maintain their functionality.
- Install ADA accessible signage that directs one to an accessible entrance. The existing assessable entrance is sloped slightly downward, consider making improvements to level the surface.

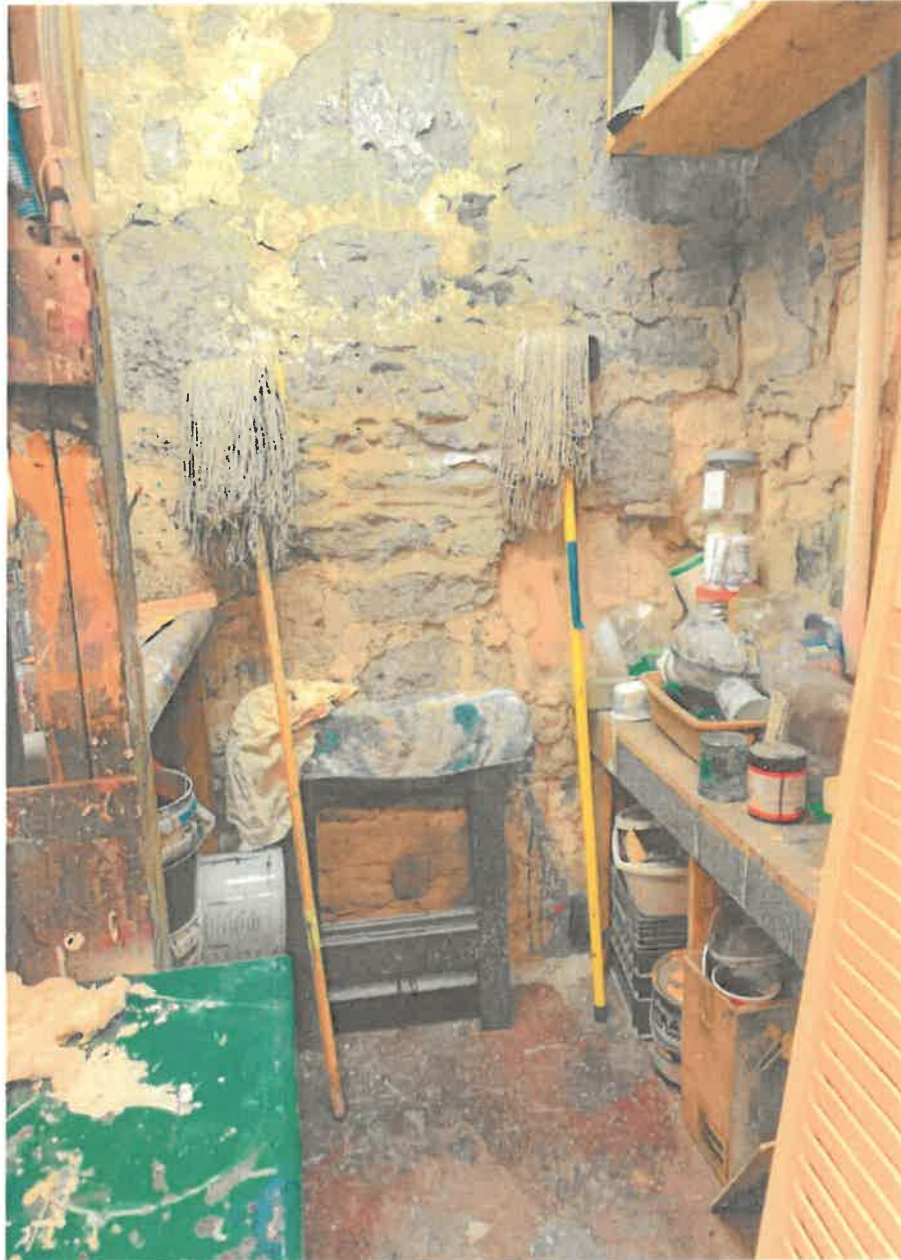
59. Tift and Mallory Warehouse / Waterfront Playhouse, interior, camera facing southwest. Example of conditions at south wall.

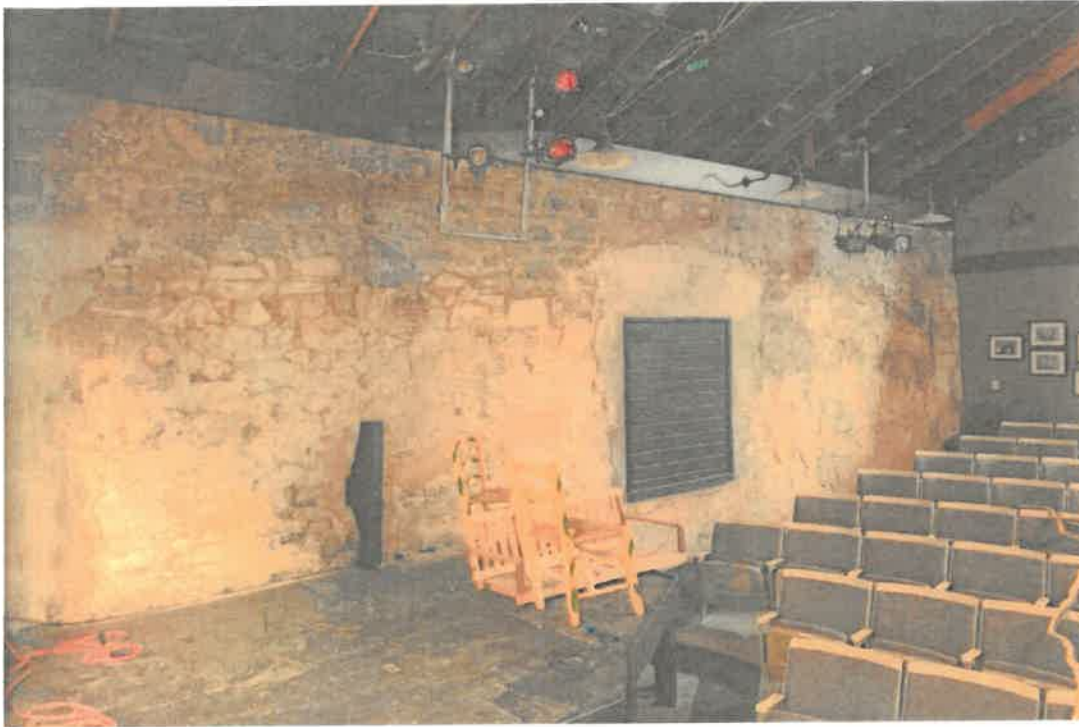
60. Tift and Mallory Warehouse / Waterfront Playhouse, interior, north wall, camera facing northeast.

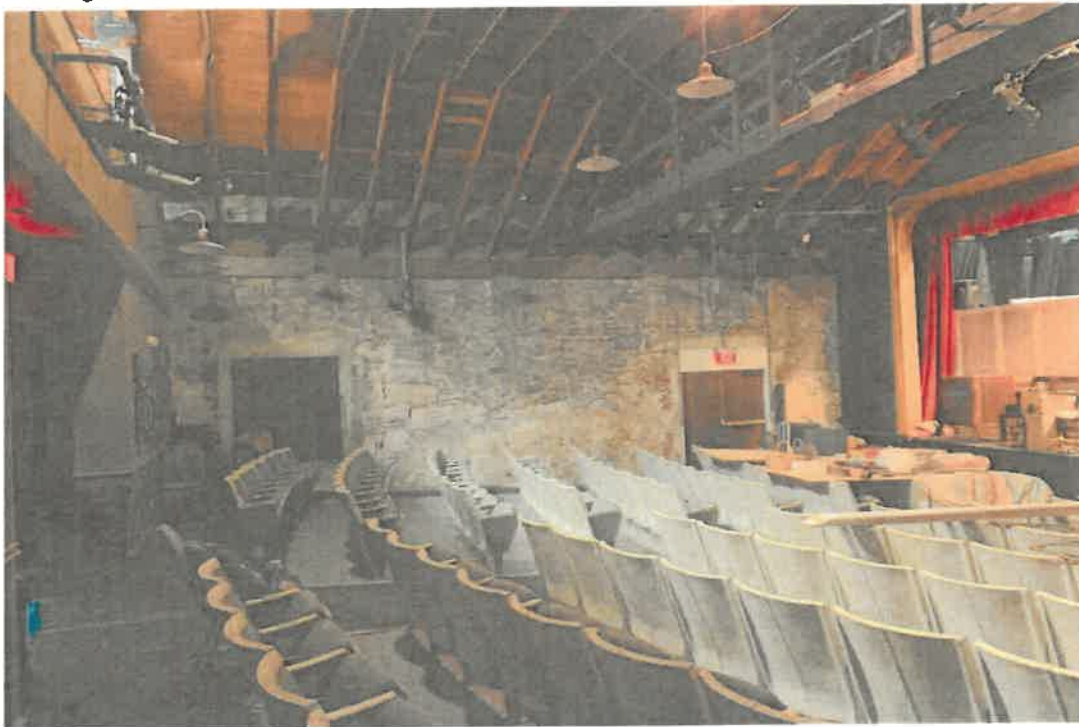
61. Tift and Mallory Warehouse / Waterfront Playhouse, interior, camera facing southwest.

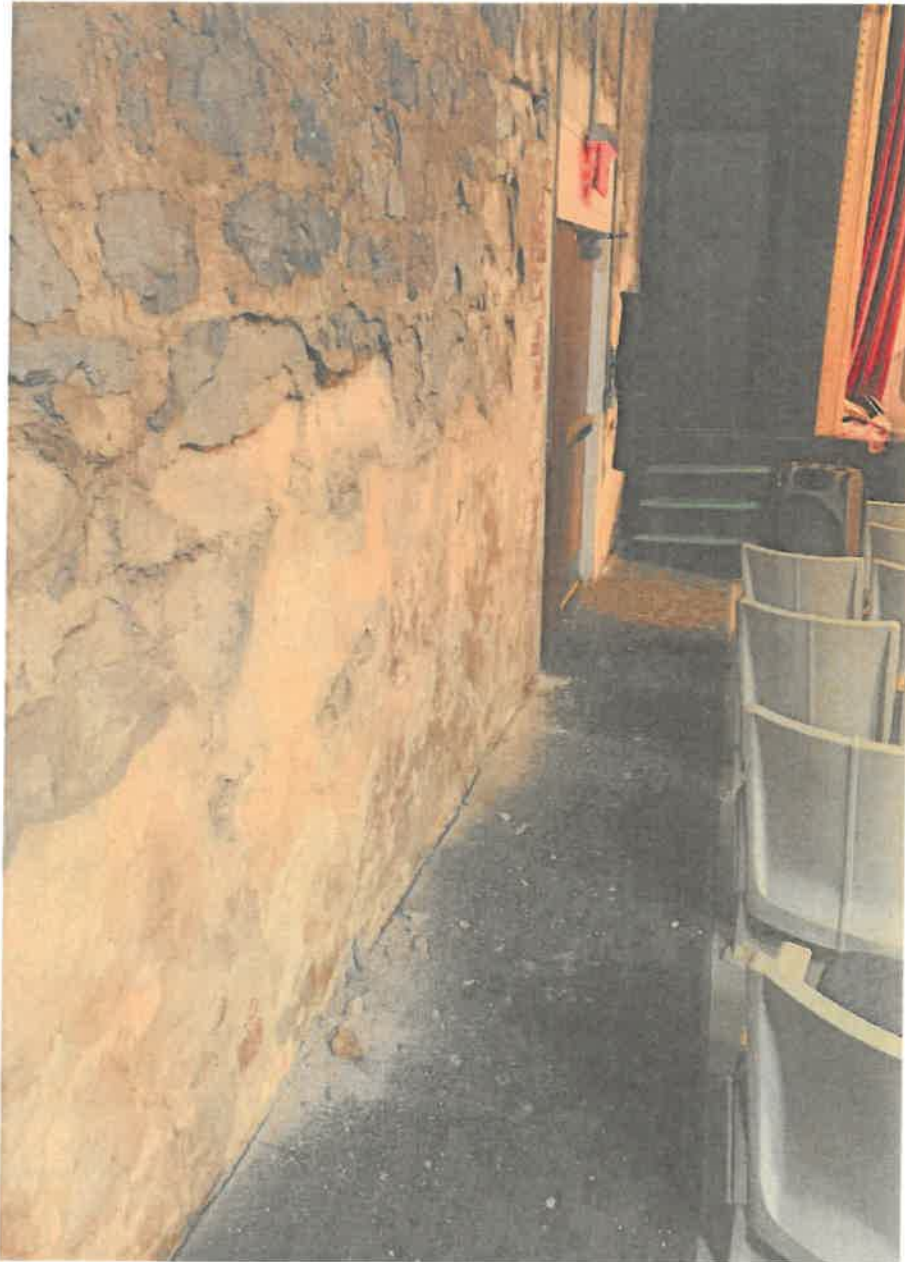
62. Tift and Mallory Warehouse / Waterfront Playhouse, south wall, camera facing down and southwest. Note deterioration of wall. Stone and mortar are on the carpet below.

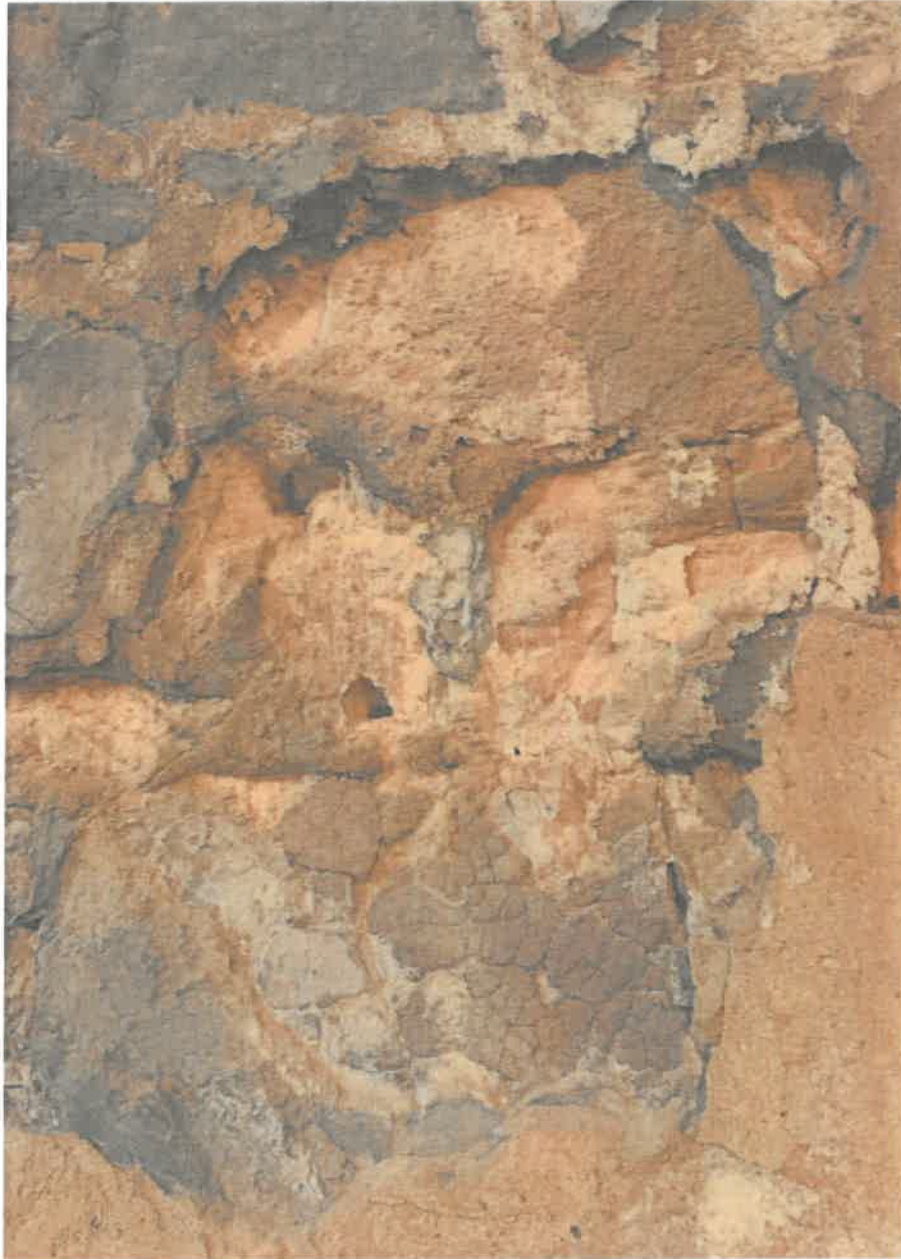
63. Tift and Mallory Warehouse / Waterfront Playhouse, south wall, camera facing south. Note severe deterioration of wall.
