**REPORT OF
PHASE I ENVIRONMENTAL SITE ASSESSMENT**

GLYNN ARCHER SCHOOL KEY WEST

**PROPERTY LOCATED AT:
1300 White Street
Key West, Florida 33040**

MACTEC Project No. 6783-10-2127

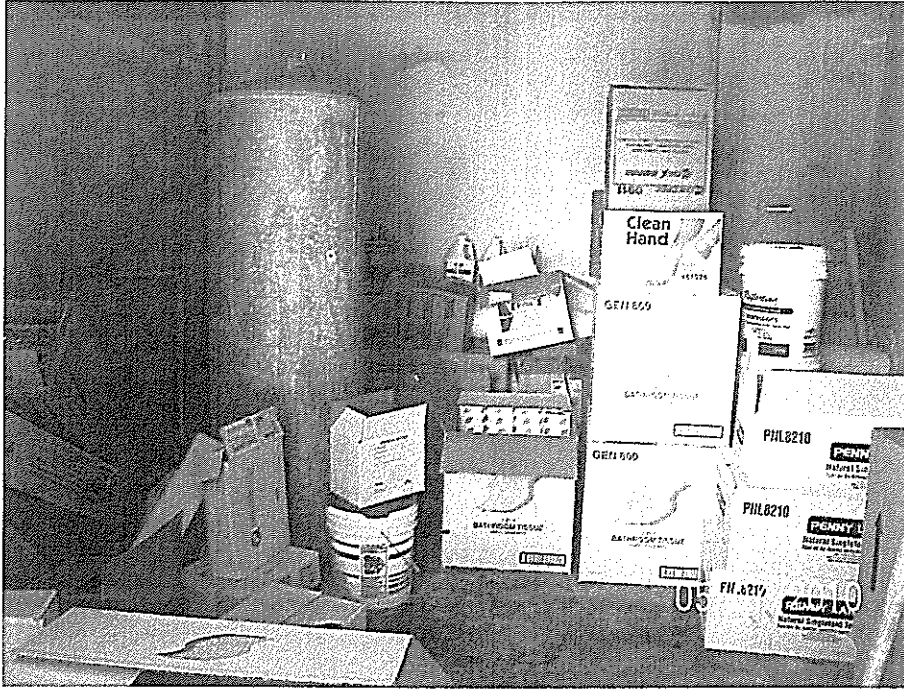
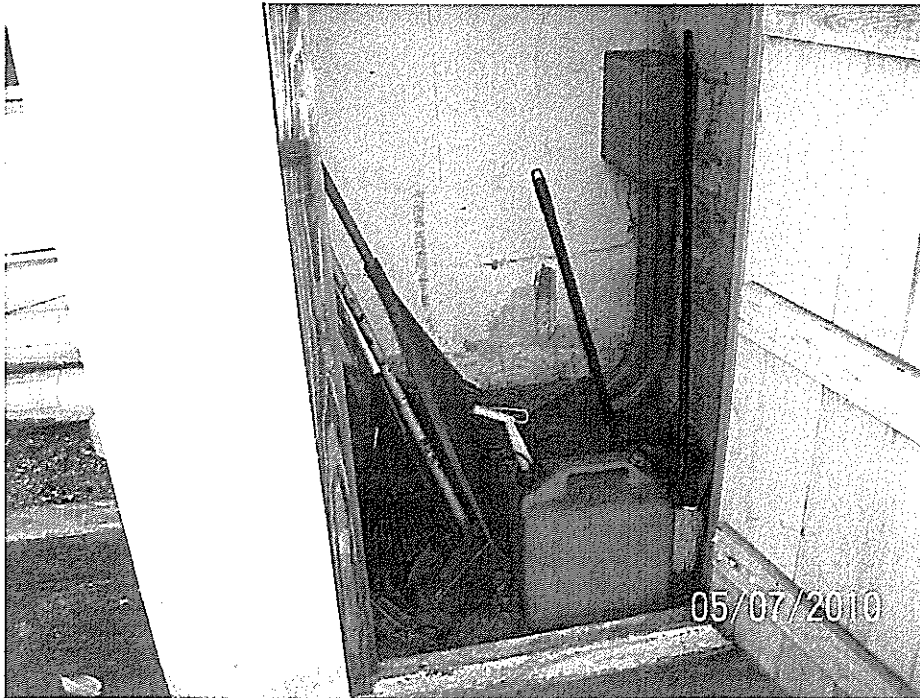
MACTEC did not see evidence of drums or hazardous materials/waste stored at the subject property. Commercial size containers of bleach, soap, and glue were observed in the storage areas.

Storage closets.
