**Preliminary Cost Projection**  
**Glynn Archer School Conversion**

August 12, 2010

**Glynn Archer School  
1300 White Street  
Key West, Florida 33040**

**May 5, 2010**

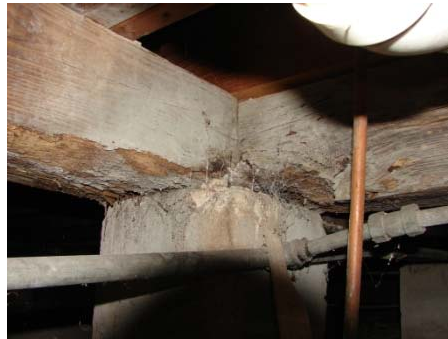
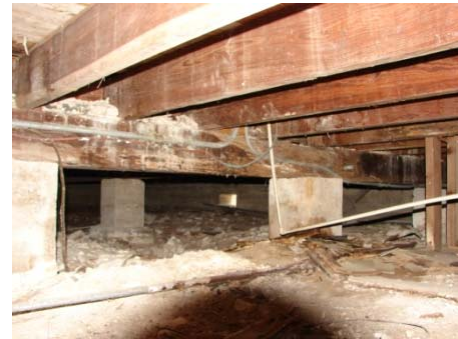
The floor girders were in poor condition. The floor girders were rotted underneath plumbed spaces and there was pest damaged throughout. The pest damage appeared to include damage from wood boring pests. There were damaged floor girders that require immediate replacement. The photographs below depict examples of this condition:

The two remaining buildings, Building A and Building B, are in average condition. There is concrete spalling damage but otherwise the building frame is in good condition. The condition of the floor framing on the first floor will likely make gutting the interiors of the buildings more feasible than repairing the damaged girders in place.

Building A requires concrete spalling repairs, floor framing repairs on the first floor, roof framing repairs and roof covering repairs / replacement. The concrete spalling repairs appear to be limited to the window openings and at the top corners of the building and should be repaired as soon as practicable. The floor framing repairs will likely include the replacement of the entire first floor framing system since the girders provide support for the floor joists and should be repaired immediately. The roof framing repairs could be accomplished in place without replacing the roof framing system and should be repaired as soon as practicable. The roof covering repairs could be accomplished as part of a maintenance program temporarily but the roof coverings should be replaced with new roof coverings within the next 3-5 years.

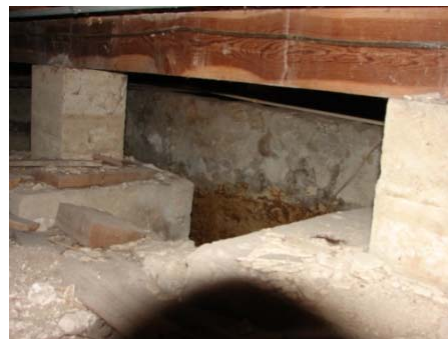
There were concrete structures underneath the building. The structures appeared to be cisterns. The structures should be removed or filled in place. The photograph below depicts an example of this condition:

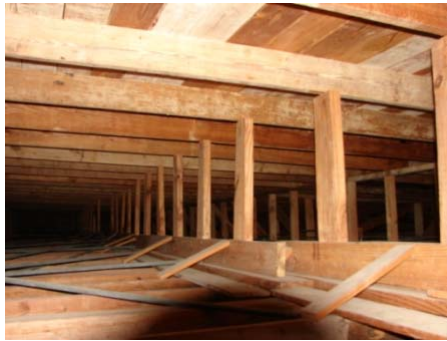
The roof framing was observed. The framing was sound but was not constructed to provide adequate resistance against hurricane force winds. There were no high wind tie-downs, metal connectors or bracing members. The photograph below depicts an example of this condition:

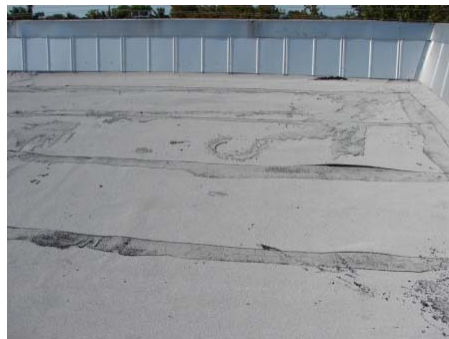
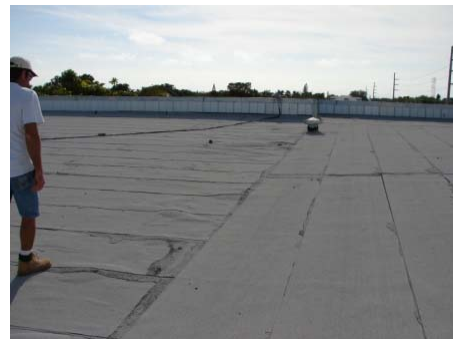
The roof coverings were in average to poor condition. There appeared to be pockets and areas of separation throughout the roof surface but no signs of significant leakage. The roof coverings may not require immediate repair but will likely require regular maintenance until the roof coverings are replaced. The photographs below depict examples of this condition:

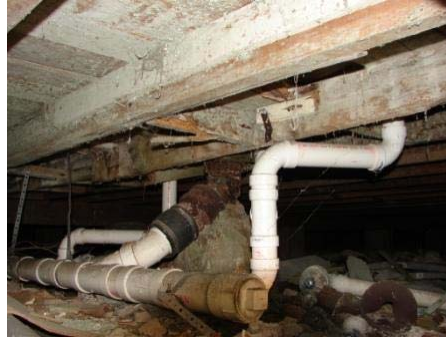
The wood floor joists and sheathing were in good condition except at the front of the building. The floor joists and sheathing at the front of the building were rotted and deteriorated. Some of the wood requires immediate replacement. The photograph below depicts an example of this condition:

Building B requires concrete spalling repairs, floor framing repairs on the first floor, roof framing repairs and roof covering repairs / replacement. The concrete spalling repairs appear to be limited to the window openings and at the top corners of the building and should be repaired as soon as practicable. The floor framing system shows signs of pest damage throughout and therefore should be replaced as soon as practicable. The roof framing repairs could be accomplished in place without replacing the roof framing system and should be repaired as soon as practicable. The roof covering repairs could be accomplished as part of a maintenance program temporarily but the roof coverings should be replaced with new roof coverings within the next 3-5 years.

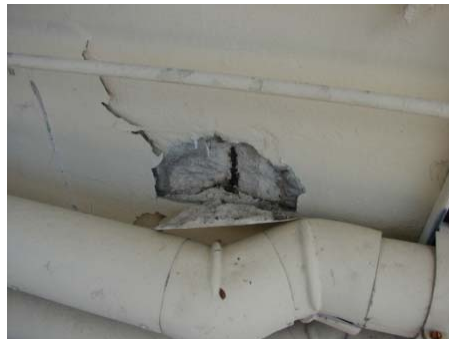
The interior and exterior wall surfaces of the building were observed. There was significant spalling damage observed at column locations and at various locations along the perimeter walls. The damage was observed throughout the building frame. The photographs below depict examples of this condition:

Building C requires concrete significant spalling repairs. The spalling damage in Building C was widespread and impacted the structural integrity of the building frame. It would likely be more feasible to demolish the building than to make the necessary repairs.

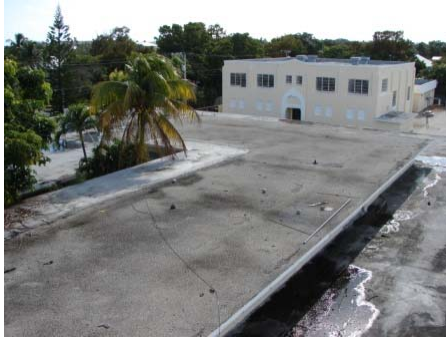
The roof coverings were in average to poor condition. There appeared to be pockets and areas of separation throughout the roof surface but no signs of significant leakage. The roof coverings may not require immediate repair but will likely require regular maintenance until the roof coverings are replaced. The photograph below depicts an example of this condition:

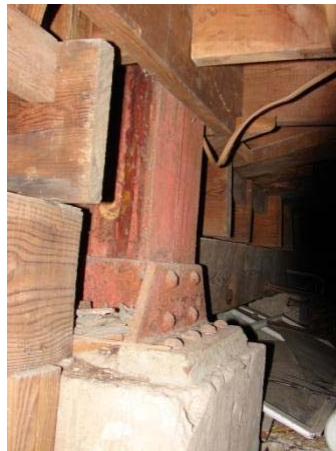
There were vertical steel columns that supported the roof structure. The columns were rusted. The rust damage did not appear to be significant enough to impact the structural capacity of the members but should be properly repaired to prevent further damage.

Building D requires concrete spalling repairs, floor framing repairs, column repairs, roof framing repairs and roof covering repairs / replacement. The concrete spalling repairs appear to be throughout the building frame and should be repaired as soon as practicable. The floor framing system and the roof framing system

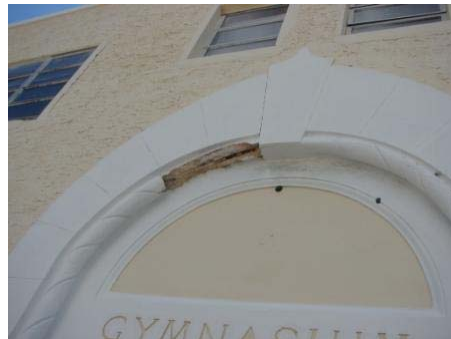
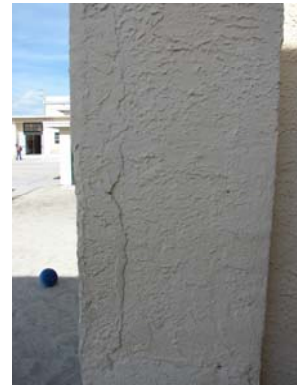
There was concrete spalling damage on the exterior walls. The damage was observed at the top of the building corners. The spalling damage should be repaired.

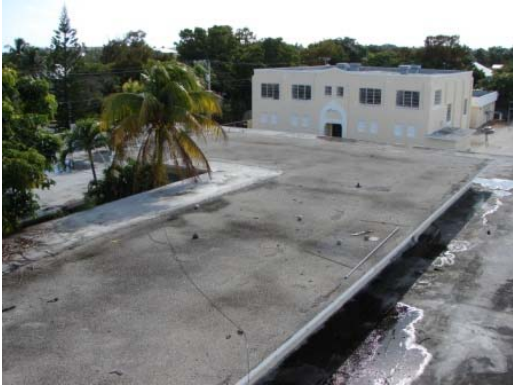
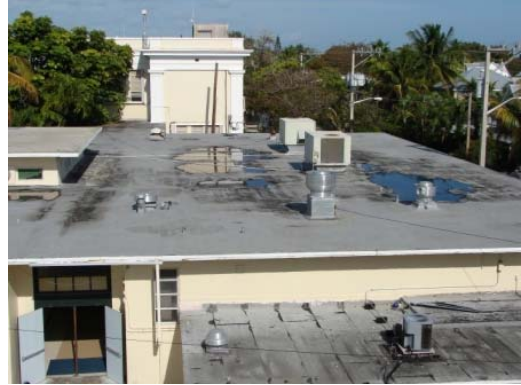
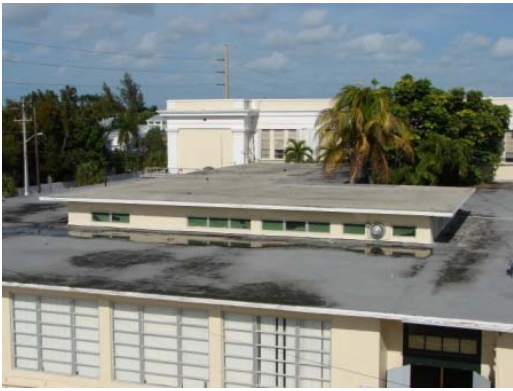
**ROOF COVERINGS**

Building C was originally constructed approximately 1955. The building frame and foundation were constructed of reinforced concrete members. The roof deck was constructed of steel bar joists and covered with modified bitumen and built-up roof covering materials.

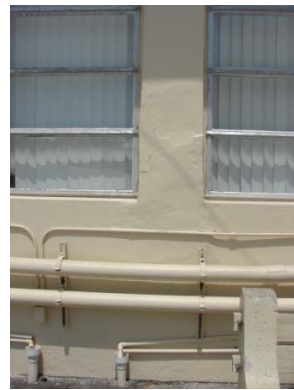
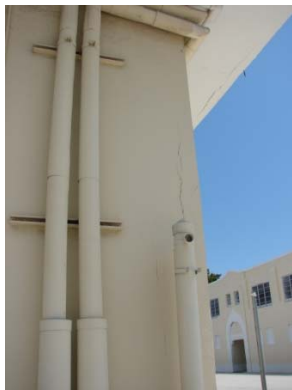
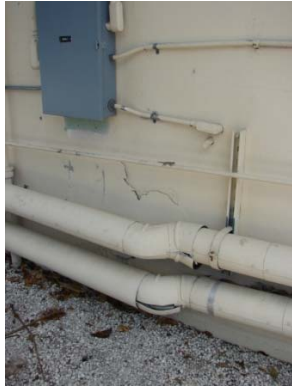
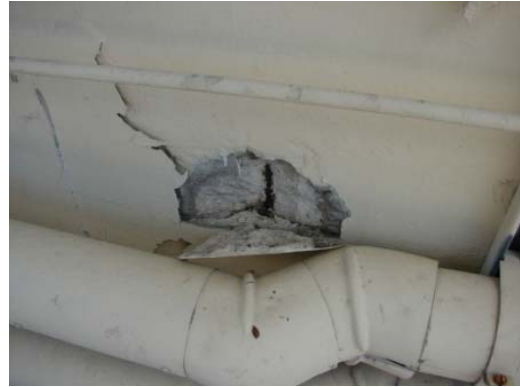
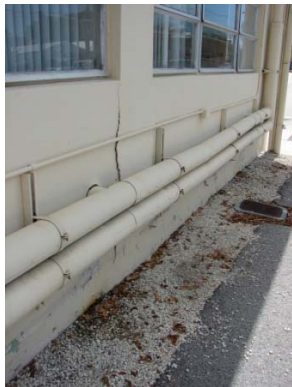
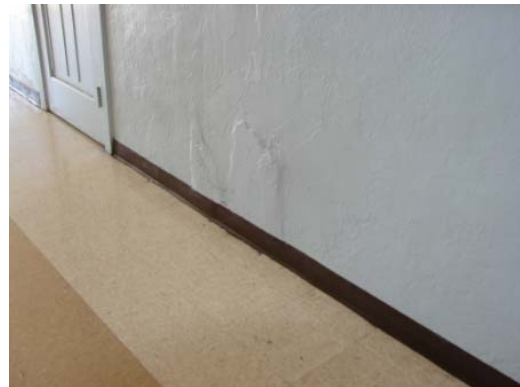
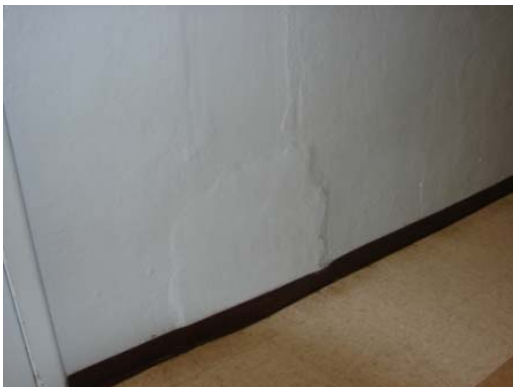
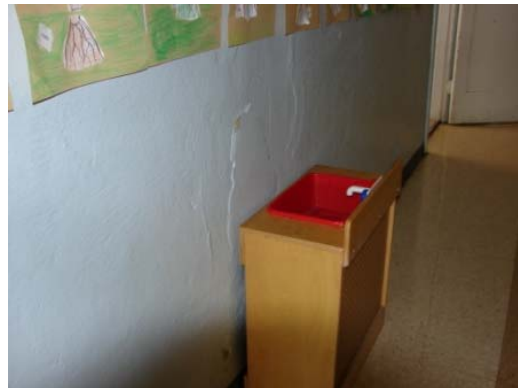
The buildings with the worst serviceability were Building C and Building D. The degree of concrete spalling damage at Building C would likely make demolition the more feasible alternative to repair. The deteriorated condition of the roof and floor framing members and the concrete spalling damage in Building D would likely make it more feasible to demolish but the historic nature of the building might prevent that possibility.

**SPALLING DAMAGE**

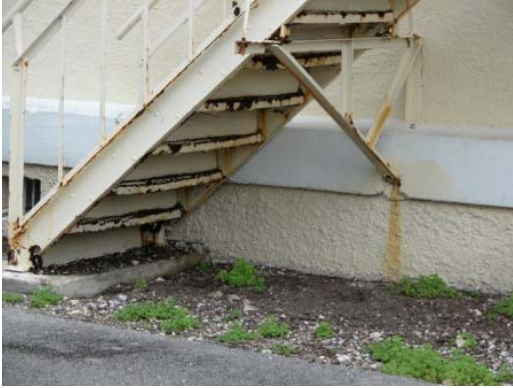
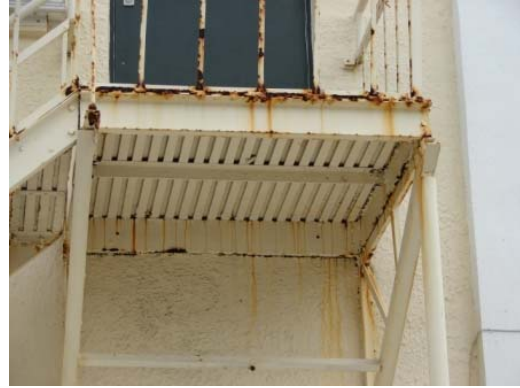
**EXTERIOR STAIRS**

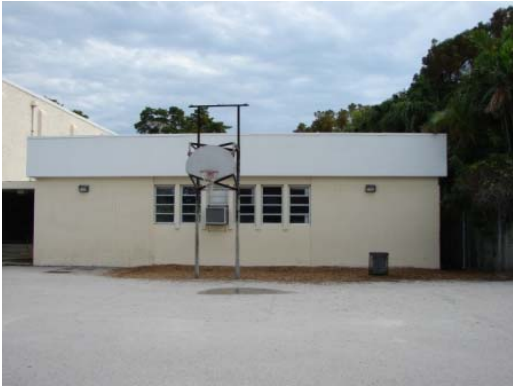
Building E – Picture 3

Building E appeared to be in good condition. There were no visible signs of damage observed to the building foundation or structural frame.
