# Disaster Mitigation for Historic Structures: Protection Strategies

PREPARED BY 1000 FRIENDS OF FLORIDA  
FLORIDA DEPARTMENT OF STATE, DIVISION OF HISTORICAL RESOURCES; FLORIDA DIVISION OF EMERGENCY MANAGEMENT

### CATEGORIES OF MITIGATION OPTIONS: WINDOWS

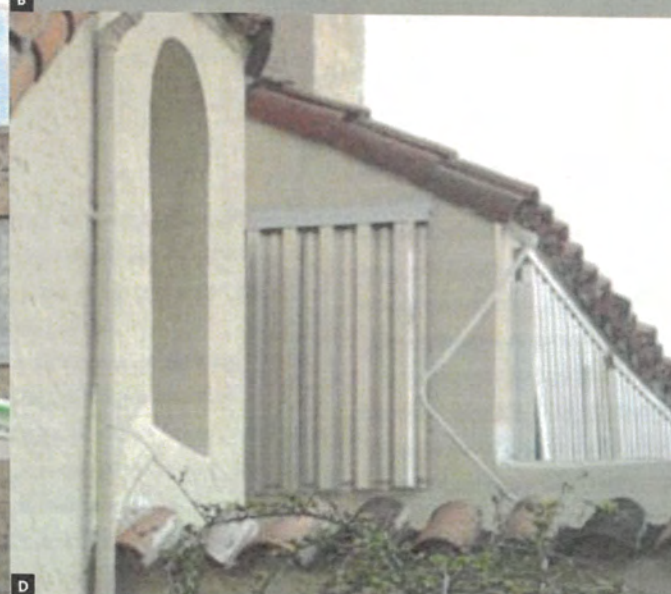
D

Upon initial installation of a storm panel unit, channels or tracks (images F, I, J, K; below; and

image D, page 24) are bolted into threaded inserts installed in the wall at the building's exterior. Often the head and sill channels for these panels are installed and left in place for the duration of hurricane season, facilitating easy installation of overlapping storm panels upon the approach of a storm. To reduce the visual impact of such installations, it is recommended that the head and sill channels be painted the same color as the finish material to which they are mounted. Direct wall mounting of storm panels is also available. Such panels must be stored when not in use. Storm panels are considered a compatible treatment for the protection of historic resources. However, they require significantly more preparation effort than flexible wind abatement systems or fabric panels and consideration should be given to the storage requirements, the weight of the panels and the effort required to install them, especially for upper story windows.

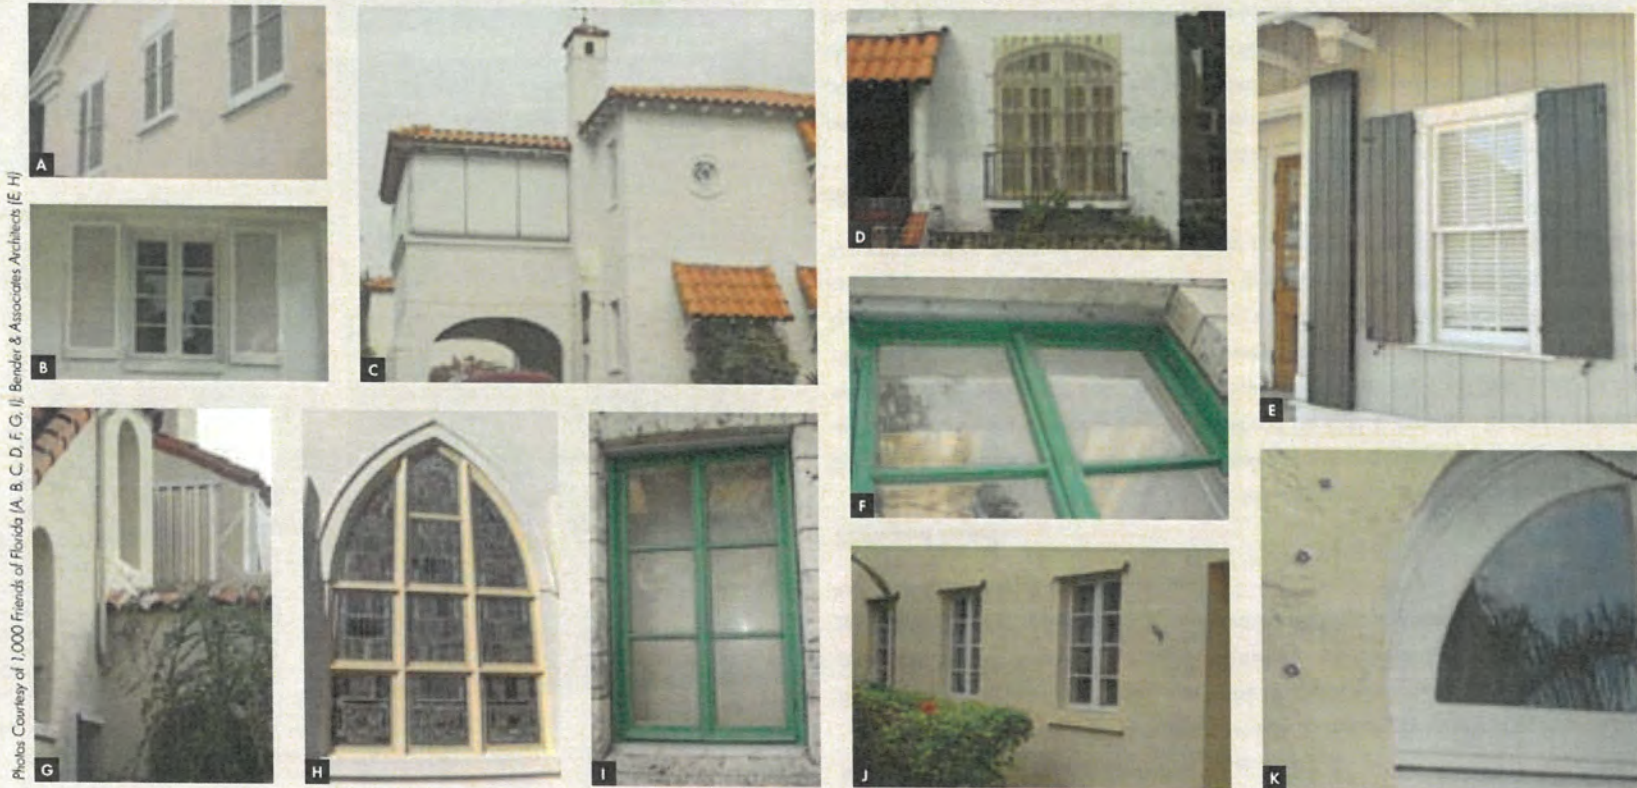
A) Closed Louvered Shutters; B) Open Louvered Shutters; C) Aluminum Awning Shutter; D) Removable Clear Polycarbonate Storm Panel; E) Solid Board Shutter; F) Concealed track above; G) Metal Storm Panel; H) Permanent 3/8" lexan® storm panels from the Southernmost Prayer and Faith Center Church, Key West; I) Track above & below; J) Painted Storm Track K) Direct mount storm panel attachment points can be hidden with colored plugs when not in use.

If shutters were not installed on the building historically, a fully demountable storm panel system is recommended. Storm panels are one of the most cost effective solutions for protection. However, they may not be the best for use on all historic resources as their installation may damage original building fabric. Storm panels can be constructed of aluminum, steel (image G below), or clear polycarbonate (Lexan®) panels (images D and H below) that are designed for temporary installation. Clear polycarbonate sheets are heavier and more costly than plywood, but are much more resistant to debris impacts and about as easy to cut and drill. They also have the added advantage of allowing sunlight into a "boarded up" building.

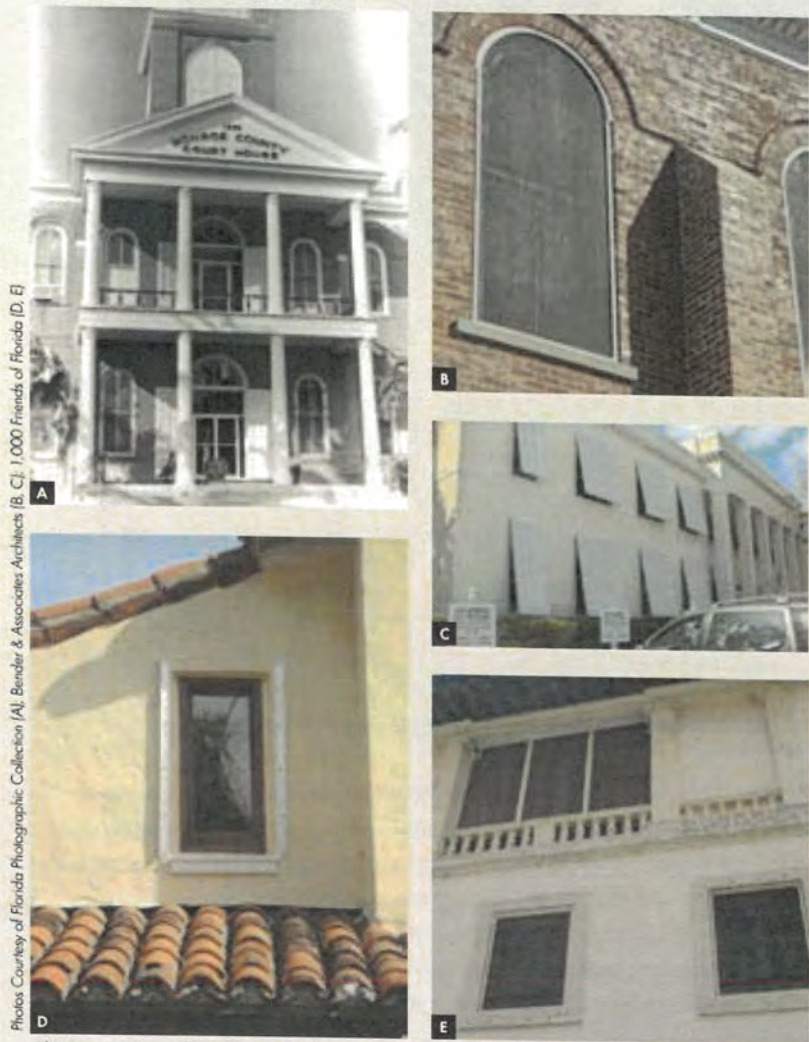
A) Monroe County Court House prior to installation of perforated metal panels; B) The permanent installation of perforated metal panels obscures the historic windows of the Monroe County Court House; C) Bahama Shutters from the Harvey Government Center, Key West; D) Unpainted Storm Panel Track; E) Perforated Metal Panel from the Vizcaya Museum & Gardens in Miami

These panels adversely affect the appearance of the building by largely obscuring the historic window, and also diminishing light to the interior, however they do provide effective protection. It is recommended that perforated metal panels are used as a temporary removable mitigation measure and that they are installed in a way as to minimize damage to the existing historic building fabric.

Used at the exterior of historic windows, perforated metal screens or panels will adversely affect appearance and historic character. However, the visual impact of such installation can be minimized by utilizing a frame which resembles those of the historic window screens found on the vast majority of historic buildings before the age of air conditioning.

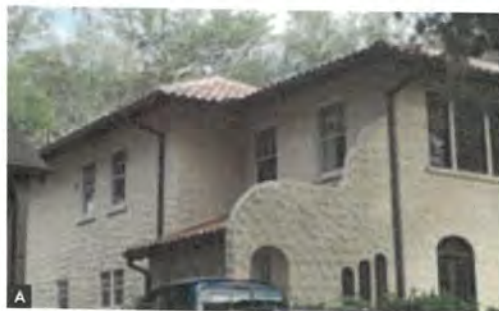
Replacement windows on side of residence.

historic single or double hung sash, casement, fixed, or awning windows found in many historic buildings. Replacement windows are typically made of aluminum to resist rot and pest infestation, but are also available in wood and steel. This is a desirable alternative to shutters and as a replacement for non-historic windows. Replacement windows on primary facades should match the material and design of the historic windows or as closely as possible. Vinyl and aluminum replacements may be considered on secondary facades, provided that the original casings are preserved, the original glazing pattern is maintained, and the profile and finish of the replacement window are similar to the historic window.

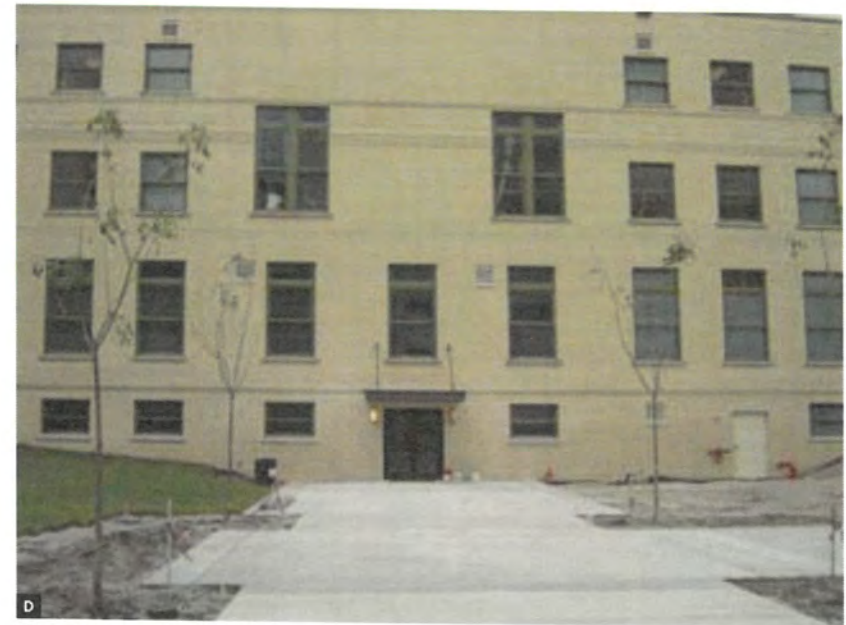
A) Restored West Elevation; B) East Elevation May 06; C) Existing Window Condition

D) Final Reconstruction East Elevation

In order to resolve the first challenge, a local company was found that built exact replicas of the existing windows with wood framing and impact glass. The assembly was tested and received Notice of Acceptance (NOA) approval. These windows were installed in the new east elevation CMU wall so there was no issue of attachment for this system.

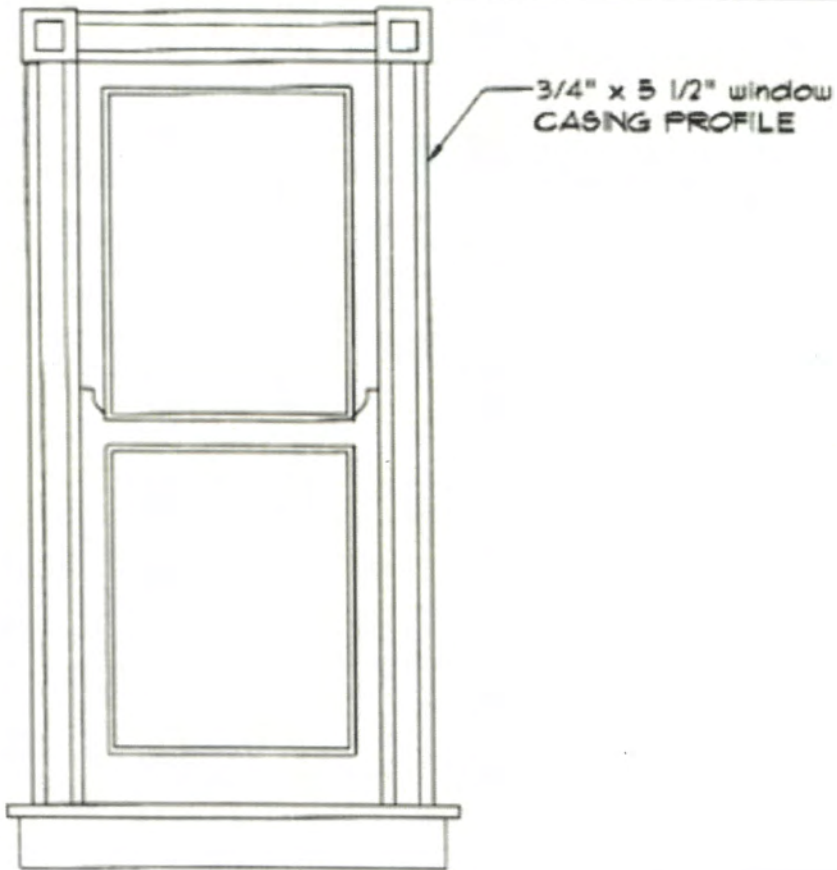
**A**

A) Elevation of Window on Interior Side of Opening; B) Reinforced Window Jam Detail; C) Window Sill Detail

The second challenge was addressed by providing structural support for the windows in the existing walls prior to re-installing the existing windows on the north, west and south elevations. The existing structure was primarily terra cotta block with brick exterior. In order to strengthen the surrounding structure, a detail was created to install inboard steel columns to be placed on both sides of the window openings. A steel header and steel sill were also provided in some cases. In other cases concrete headers and sills with concrete columns were installed on either side of the window opening. The reinforcing structure was attached to the concrete floors and ceilings.

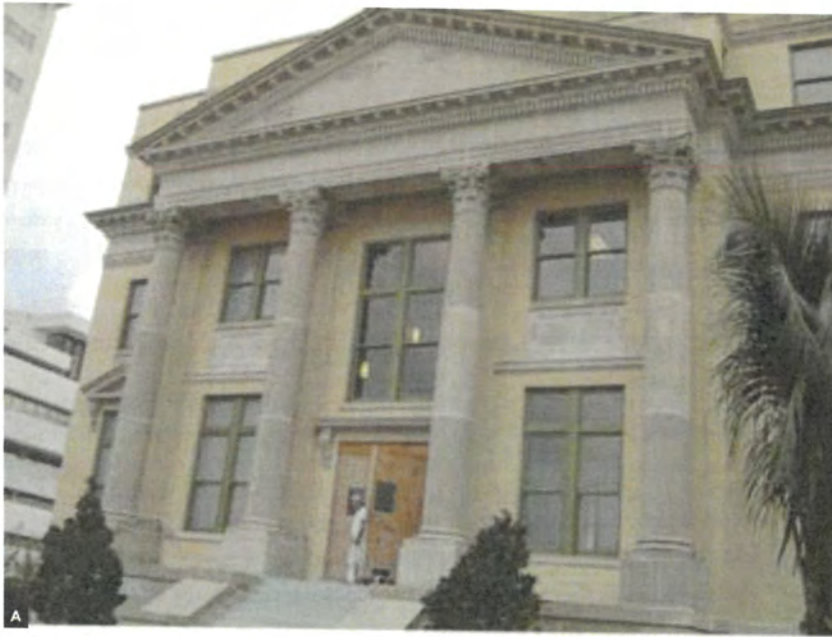
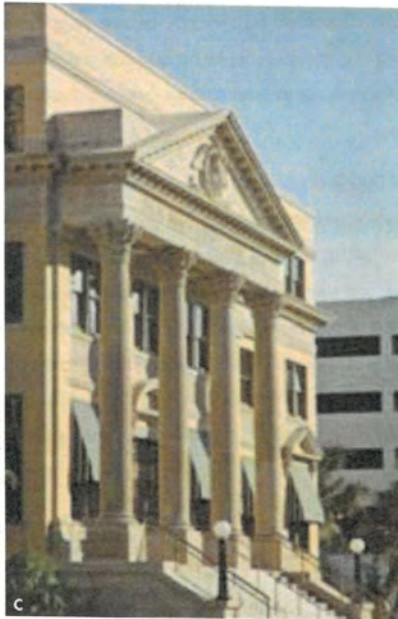
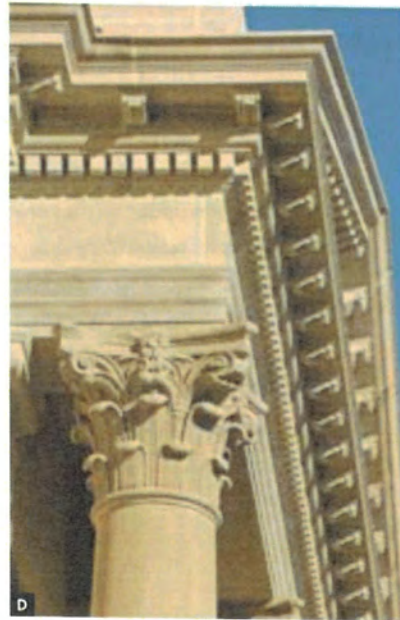
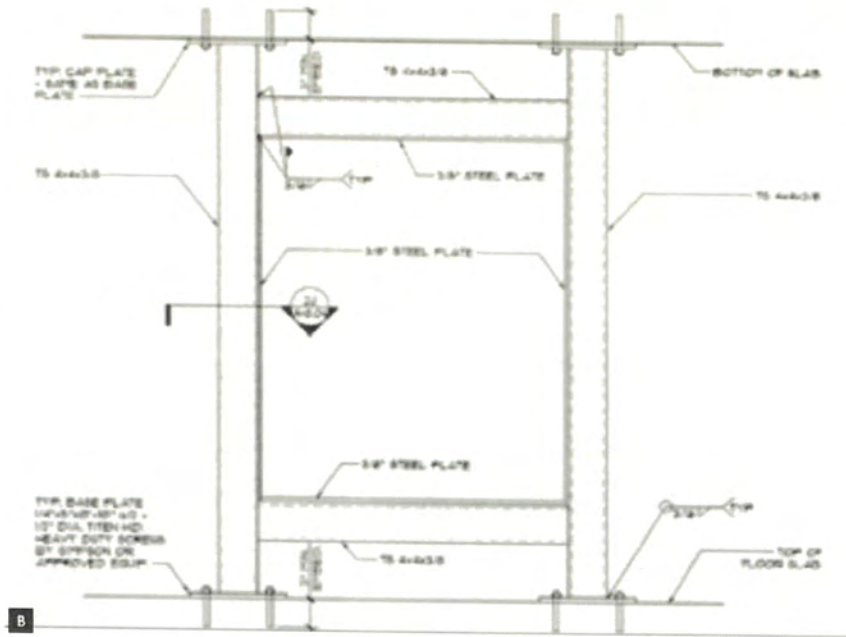
A) Restored Wood Windows (North Elevation); B) Window Opening Reinforcing Detail; C) Restored Wood Windows; D) Column Detail

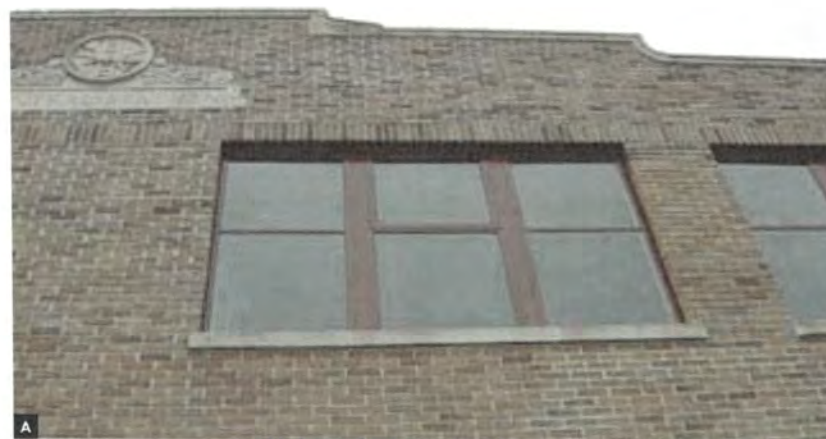
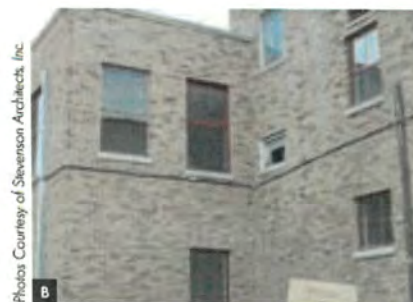
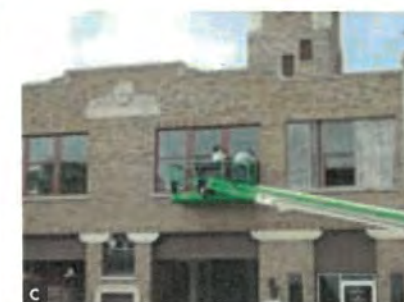
A) North-Window; B) West Wall After New Window; C) Window Installation on Facade

The second floor windows were designed with a slight offset between the upper projecting sash and the lower fixed sash to approximate the appearance of the original single hung sash. This satisfied the SHPO's concern that the windows match the original configuration as closely as possible, given the design constraints and limited availability of appropriate products to achieve the project goals.

The selected product, Jamestown 175, impact glass, windows met the project criteria. There were two installation conditions, the first floor windows were installed with masonry clips. The second floor windows were installed on pressure treated 2 x framing installed within the original brick masonry "pocket".
