N. ROOSEVELT PEDESTRIAN STUDY

PRESENTATION TO THE CITY OF KEY WEST COMMISSION

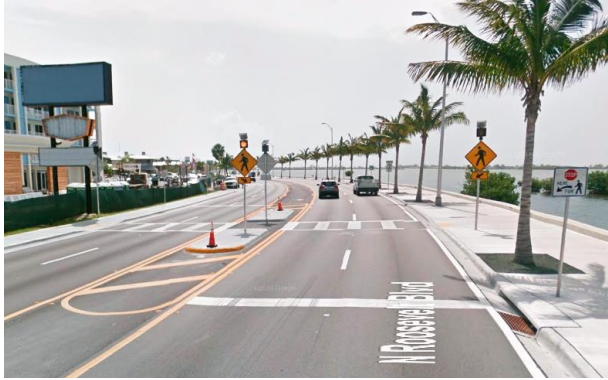
1. Crosswalk, north of SR 5 (24 North Hotel)

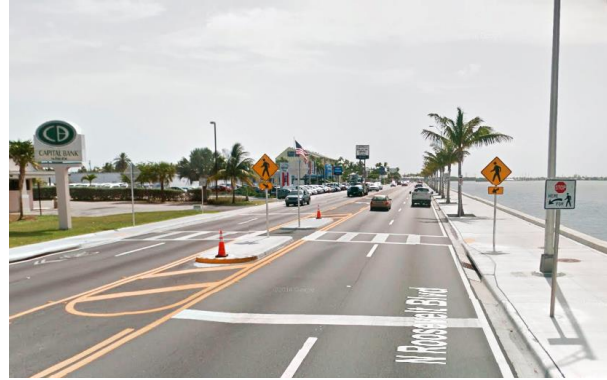
2. Crosswalk, front of Capital Bank

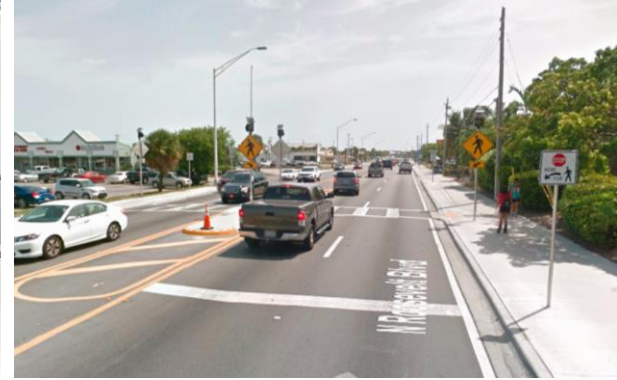
3. Crosswalk, west of Kennedy Drive
(Key Plaza Shopping Center)

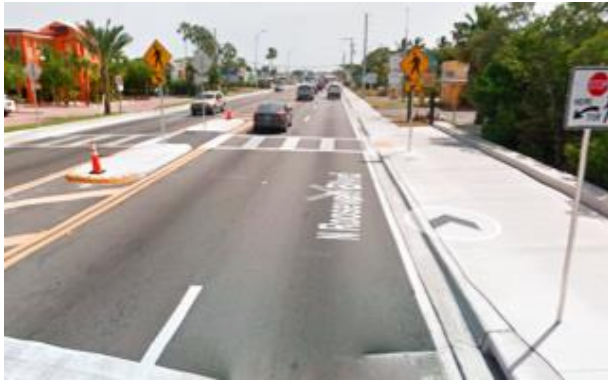
4. Crosswalk, west of Hilton Haven Road
(Fairfield Marriot)

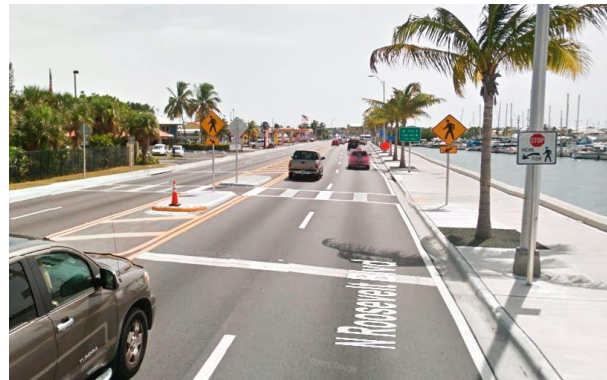
5. Crosswalk, west of 3 Street (USCIS Building)

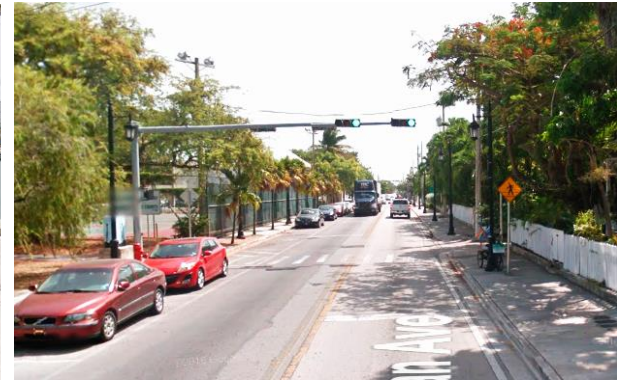
6. Signalized Crosswalk, north of Florida Street

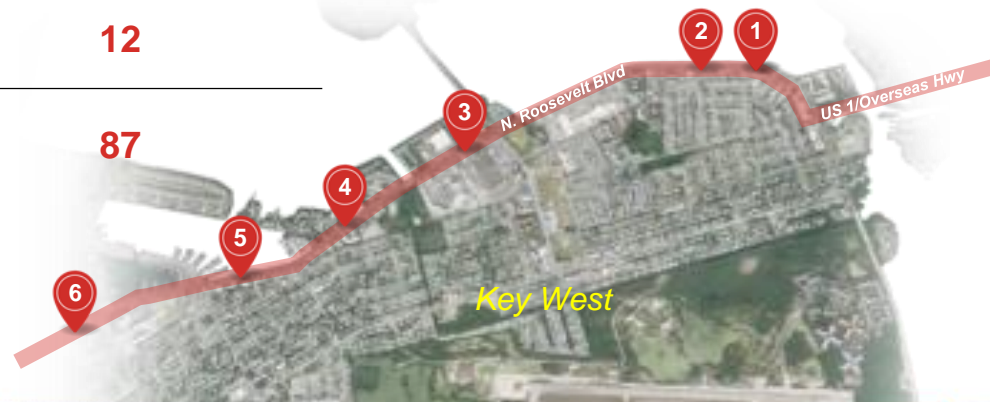
PEDESTRIAN/BICYCLE COUNTS

(HIGHEST HOUR)

Crosswalks	September 2016	January 2017

8-hour counts were performed
from Thursday to Saturday

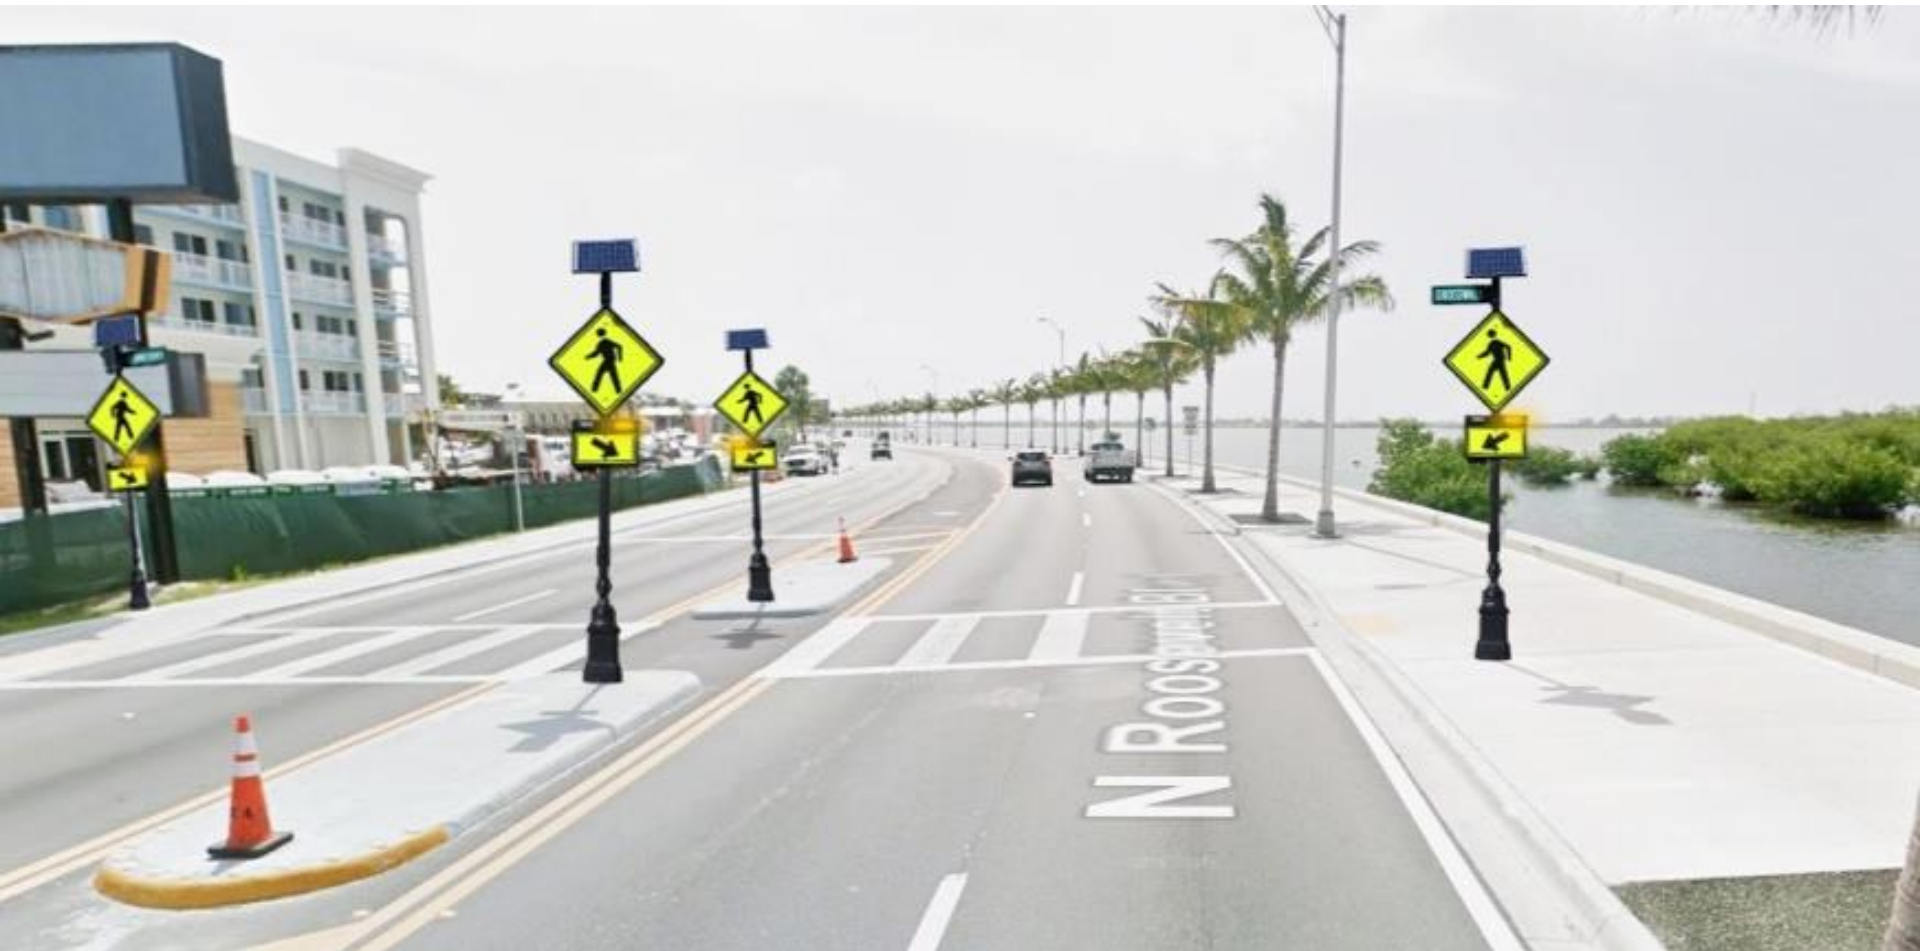
RECTANGULAR RAPID FLASHING BEACON (RRFB)

Crosswalk, north of SR 5 (24 North Hotel) RRFB RENDERING

- RRFB installation is recommended at the mid-block crosswalks for improving pedestrian safety that represents context-sensitive and a system-wide approach.
- Upgrade lighting at all 6 crosswalks.
- Monitor operations and compliance after RRFB implementation
