# 31 PRESERVATION BRIEFS

## Mothballing Historic Buildings

Sharon C. Park, AIA

U.S. Department of the Interior  
National Park Service  
Cultural Resources  
Heritage Preservation Services

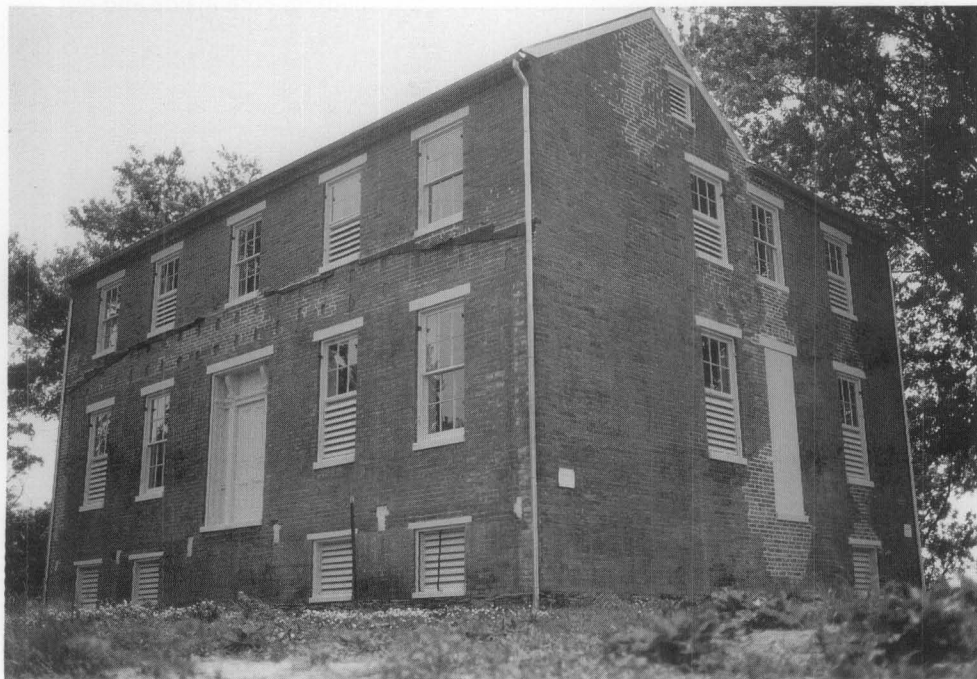
*Figure 1. Proper mothballing treatment: This building has been successfully mothballed for 10 years because the roof and walls were repaired and structurally stabilized, ventilation louvers were added, and the property is maintained. Photo: Charles E. Fisher, NPS.*

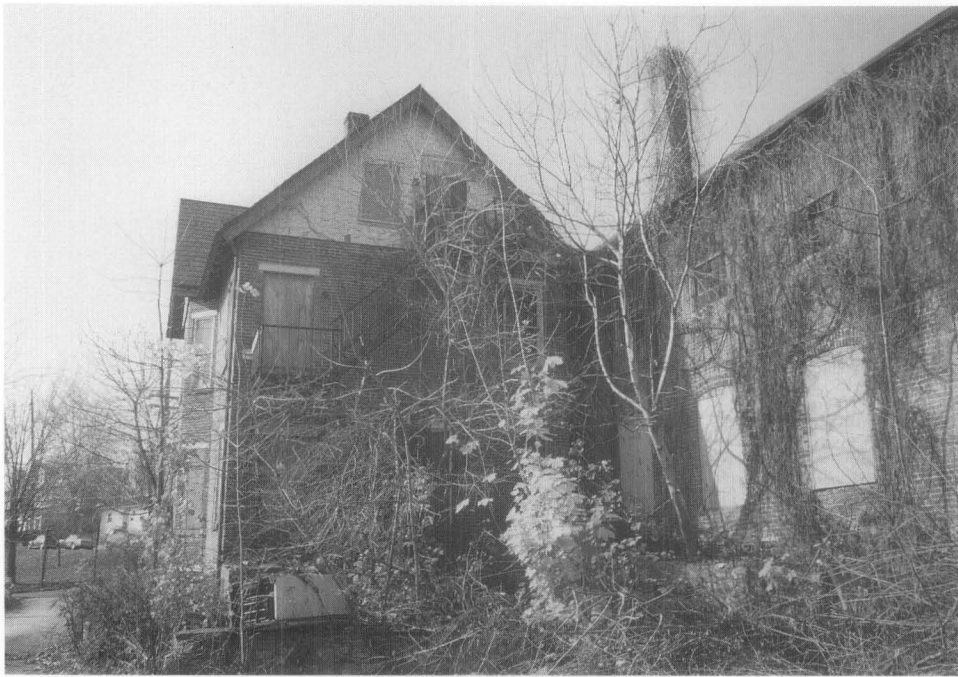
Figure 2. Improper treatment: Boarding up without adequate ventilation, lack of maintenance, and neglect of this property have accelerated deterioration. Photo; NPS file.

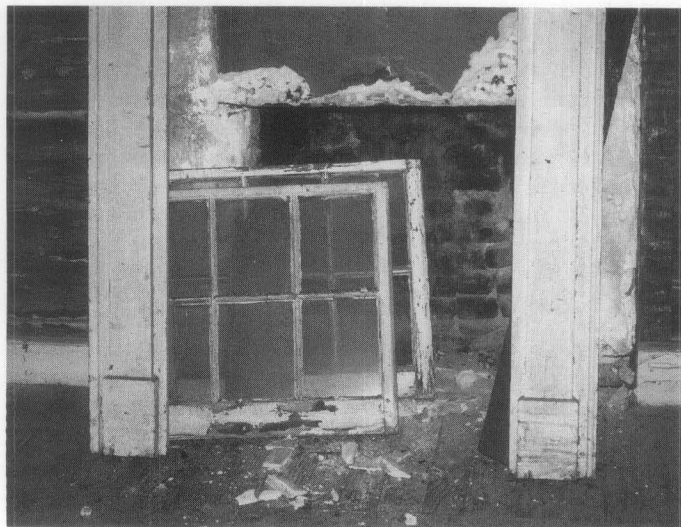
*Figure 5. Loose or detached elements should be identified, tagged and stored, preferably on site. Photo: NPS files.*

By understanding the history of the resource, significant elements, even though deteriorated, may be spared the trash pile. For that reason alone, any materials removed from the building or site as part of the stabilization effort should be carefully scrutinized and, if appearing historic, should be photographed, tagged with a number, inventoried, and safely stored, preferably in the building, for later retrieval (see fig. 5).

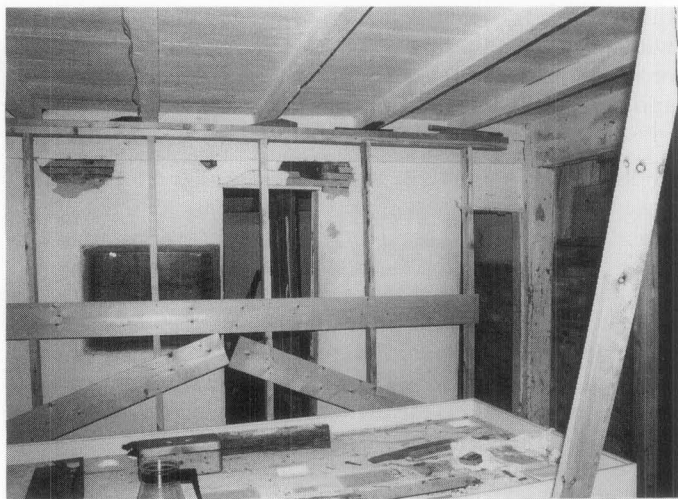
*Figure 6. Interior bracing which will last the duration of the mothballing will protect weakened structural members. Jethro Coffin House. Photo: John Milner Architects.*

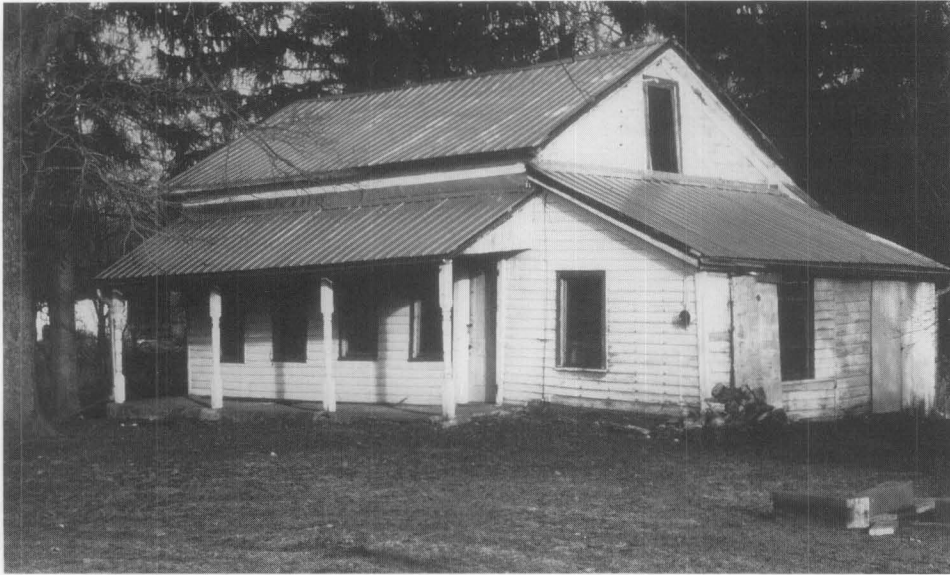
Figure 7. Non-historic materials are appropriate for mothballing projects when they are used to protect historic evidence remaining for future preservation. This lightweight aluminum channel frame and roofing covers the historic wooden shingle roof. Galvanized mesh panels secure the window openings from intrusion by raccoons and other unwanted guests. Photo: Williamsport Preservation Training Center, NPS.

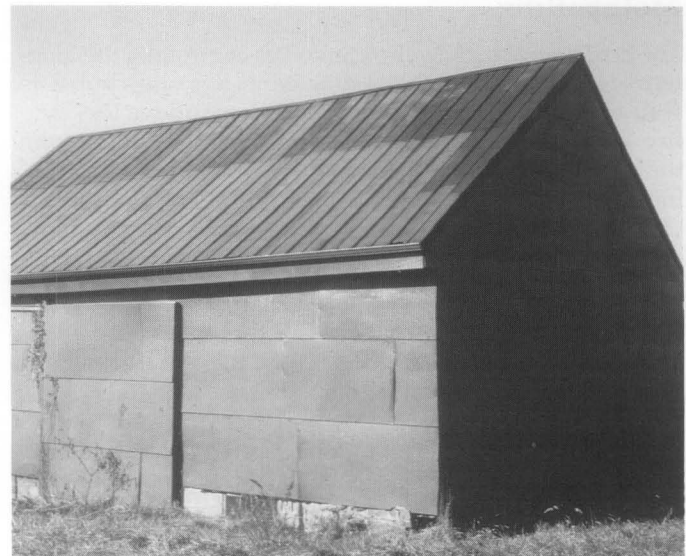
Figure 9. Severely deteriorated wooden siding on a farm building has been covered over with painted plywood panels as a temporary measure to eliminate moisture penetration to the interior. Foundation vents and loose floor boards allow air to circulate inside.

patterns or by installing panels over a frame of battens (see fig. 9). Generally, however, it is better to repair deteriorated features than to cover them over.

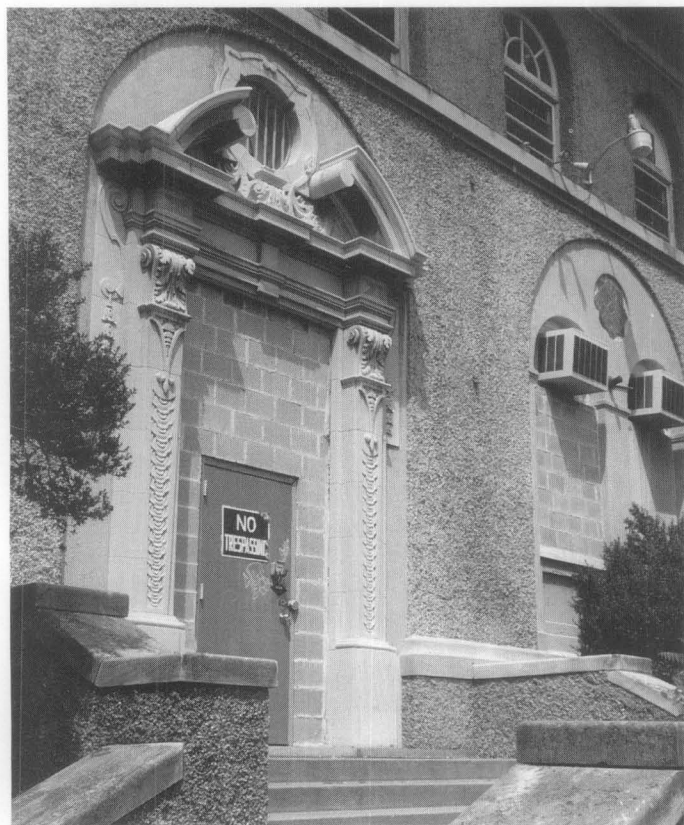
Figure 12. First floor openings have been filled with cinderblocks and doors, window sash and frames have been removed for safe keeping. Note the security light over the windows and the use of a security metal door with heavy duty locks. Photo: H. Ward Jandl, NPS.

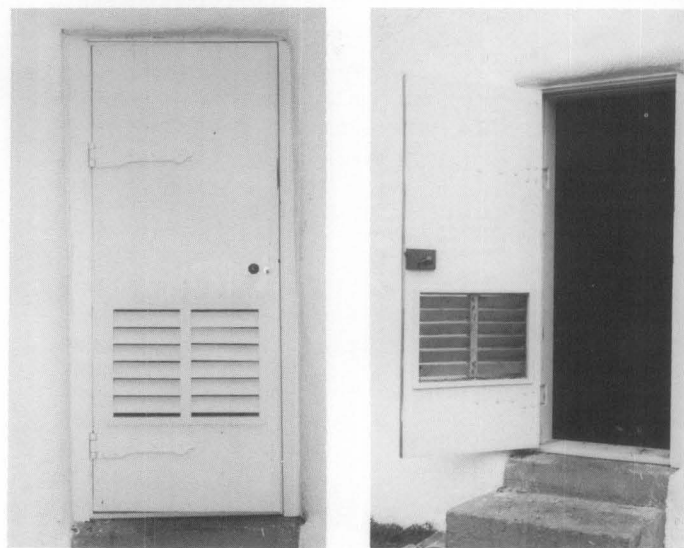
Figure 13. If historic doors would be damaged by adding extra locks, they should be removed and stored and new security doors added. At this lighthouse, the historic door has been replaced with a new door (seen both inside and outside) with an inset vent and new deadbolt locks. The heavy historic hinges have not been damaged. Photo: Williamsport Preservation Training Center, NPS.

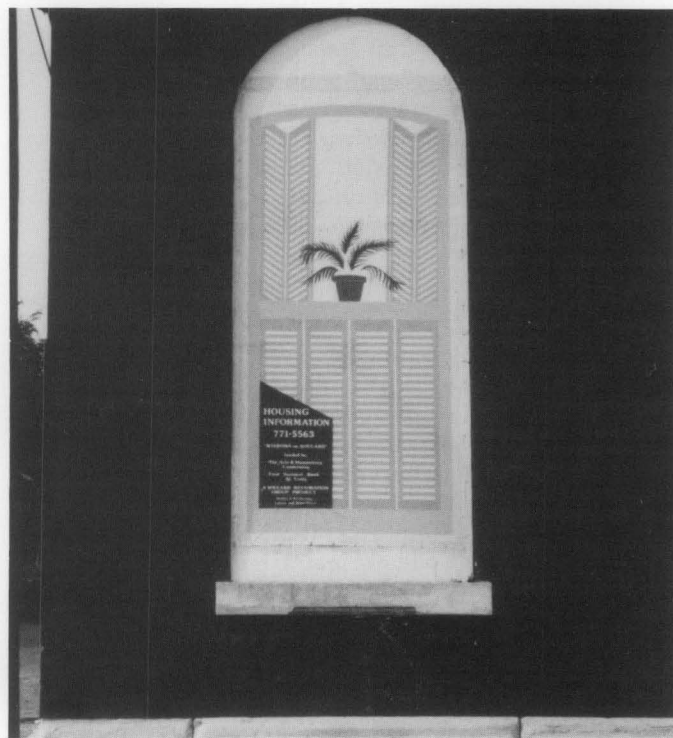
Figure 15. Painting trompe l'oeil scenes on plywood panels is a neighborhood friendly device. In addition, the small sign at the bottom left corner gives information for contacting the organization responsible for the care of the mothballed building. Photo: Lee H. Nelson, FAIA.

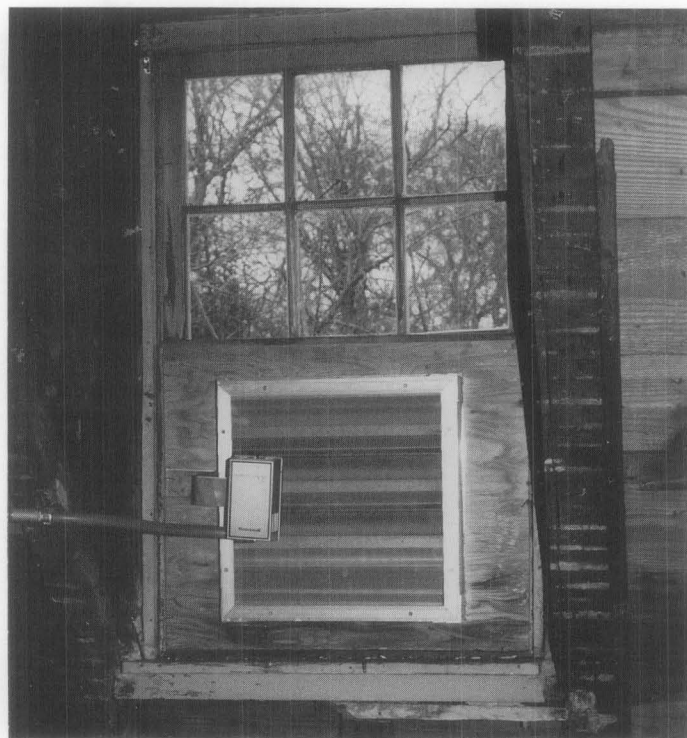
*Figure 21. This electric thermostat/humidistat mounted in the attic vent controls a modified ducted air/fan system. The unit uses temporary exposed sheet metal ducts to pull air through the building and exhaust it out of the basement. For over ten years this fan system in combination with 18" x 18" preformed louvers in selective windows has kept the interior dry and with good air exchanges.*

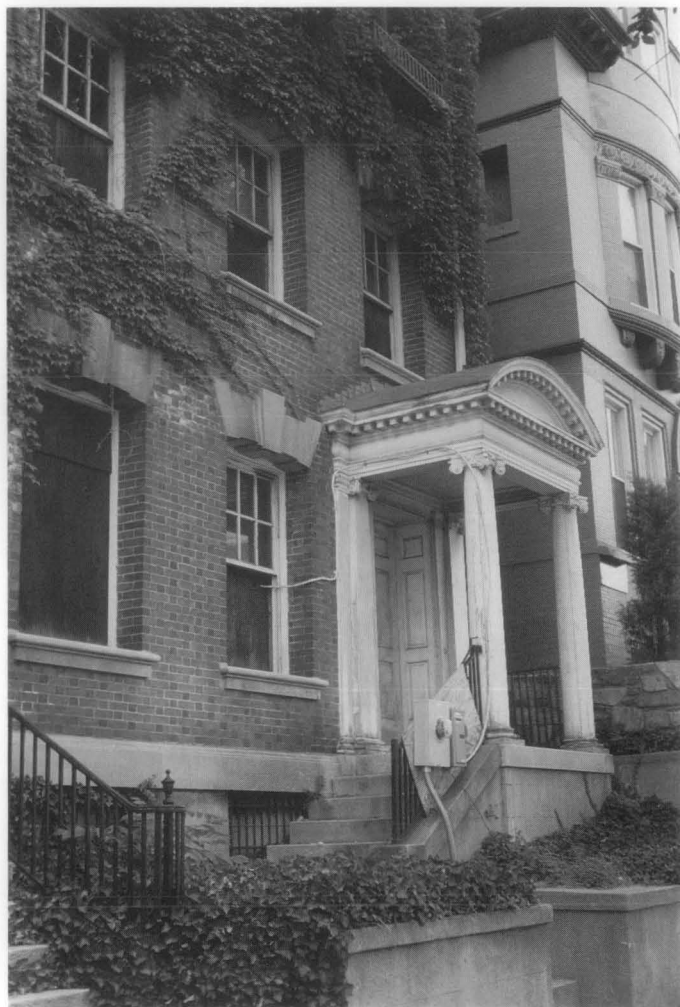
Figure 22. All systems except temporary electric have been shut off at this residence which has been mothballed over 20 years. An electric meter and 100 amp panel box have been set on a plywood panel at the front of the building. It is used for interior lighting and various alarm systems. The building, however, is showing signs of moisture problems with efflorescent stains on the masonry indicating the need for gutter maintenance and additional ventilation for the interior. The vegetation on the walls, although picturesque, traps moisture and is damaging to the masonry. Photo: H. Ward Jandl, NPS.

hazard, it is advisable to retain those which will help protect the property. Since the electrical needs will be limited in a vacant building, it is best to install a new temporary electric line and panel (100 amp) so that all the wiring is new and exposed. This will be much safer for the building, and allows easy access for reading the meter (see fig. 22).

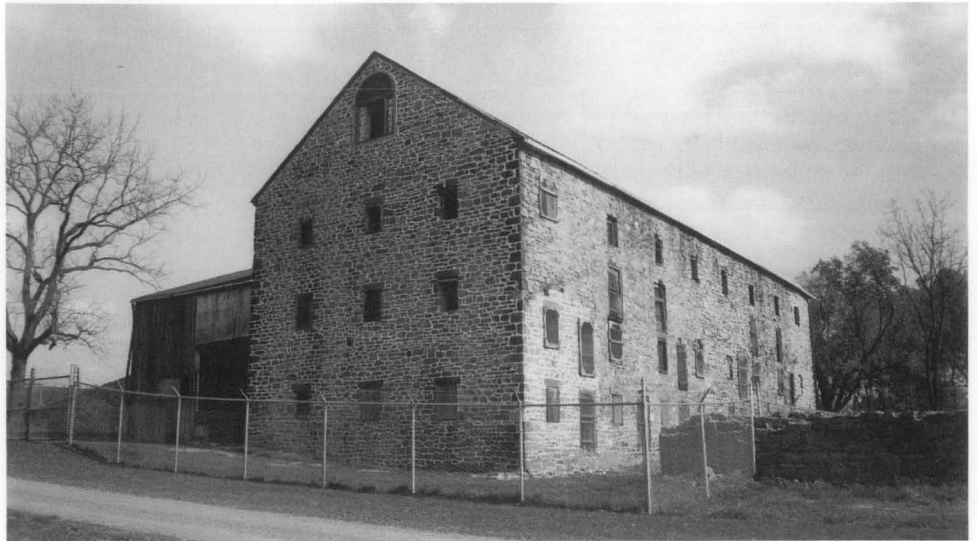
Figure 24. Once mothballed, a property must still be monitored and maintained. The openings in this historic barn has been modified with a combination of wood louvers and metal mesh panels which require little maintenance. The grounds are regularly mowed, even inside the chain link security fence. Photo: Williamsport Preservation Training Center, NPS.

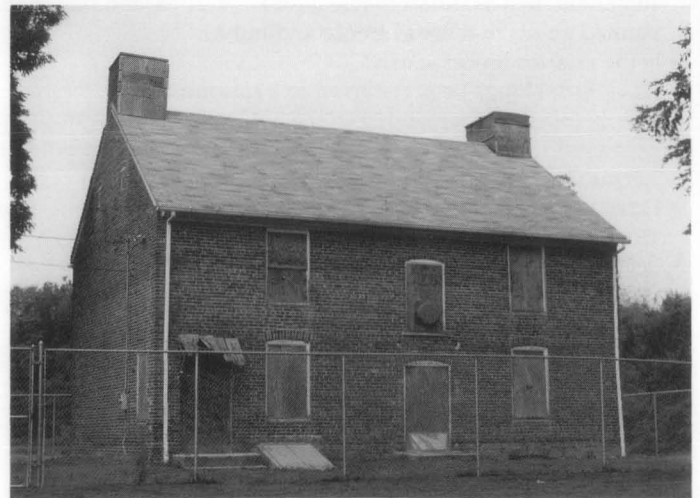
a. A view showing the exterior of the house in its mothballed condition.

Figure 25. Above is a summary of the tasks that were necessary in order to protect this significant property while restoration funds are raised. Photographs: Michael Mills; Ford Farewell Mills Gatsch Architects.

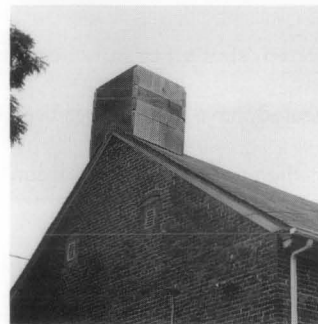
b. Plywood panels stabilize the chimneys. Note the gable vents.

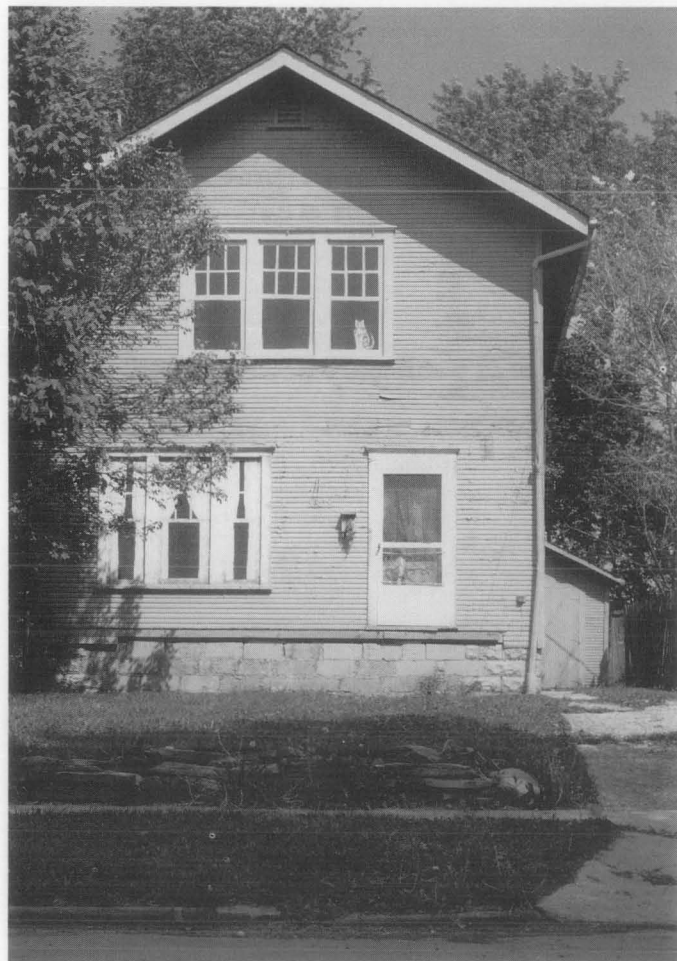
*Figure 27. This residential building blends into its neighborhood even though all the windows have been covered over and the front steps are missing. The grounds are maintained and the special attention to decoratively painting the window panels shows that the property is being well cared for until it can be rehabilitated. Photo: Ohio Historical Society.*
