MEMORANDUM

RE: 225 Olivia Street City-Right of Way

FROM: Karen DeMaria, Urban Forestry Manager, City of Key West

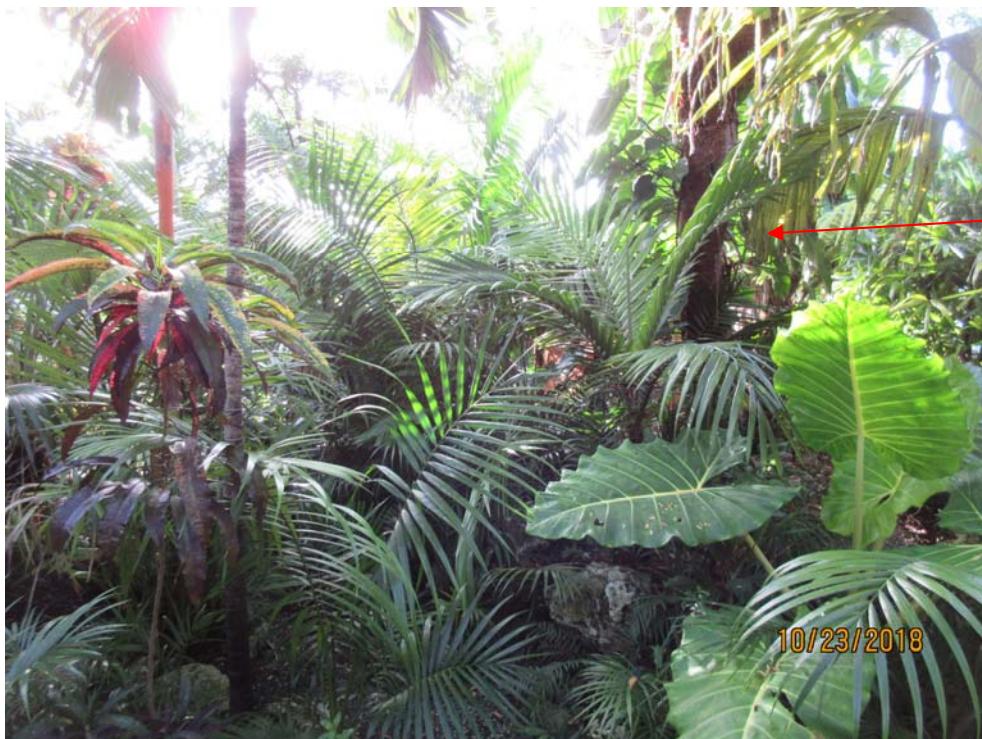
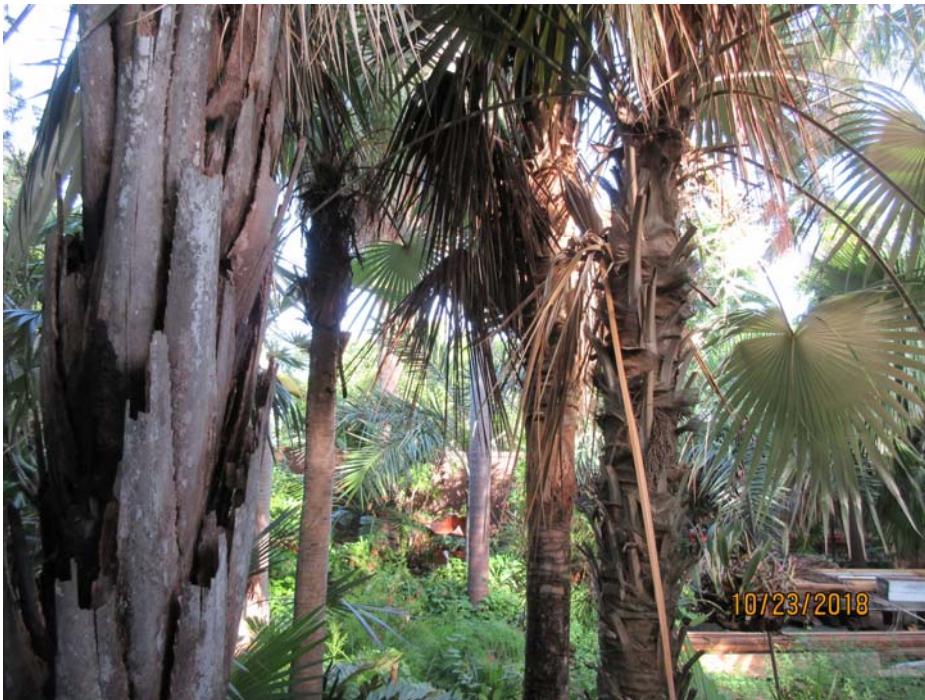
A site visit was done on 225 Olivia Street. This property had survey markers identifying the location of the sides of the right of way. Immediately next to the right of way area off Olivia Street there are two large diameter protected trees, a Spanish Lime and a Tamarind tree. Root protection measures would have to be done in this immediate area if vehicles are to drive in this area. Installation of a geomat type product would be recommended. Further down the right of way exists a large, protected Gumbo Limbo tree. This tree would be directly impacted by the creation of a roadway and its removal would require authorization from the Tree Commission. The tree at this time appears to be healthy.

Additionally on 225 Olivia Street in the right of way area, two regulated, tall palms were observed near the fence with 824 Thomas Street. The rest of the vegetation in the right of way area consisted of smaller, non native, not regulated palms and not regulated ornamental plants. Most of the smaller palms and vegetation could possibly be

transplanted but there might be some cost and logistic issues with trying to transplant the taller palms.

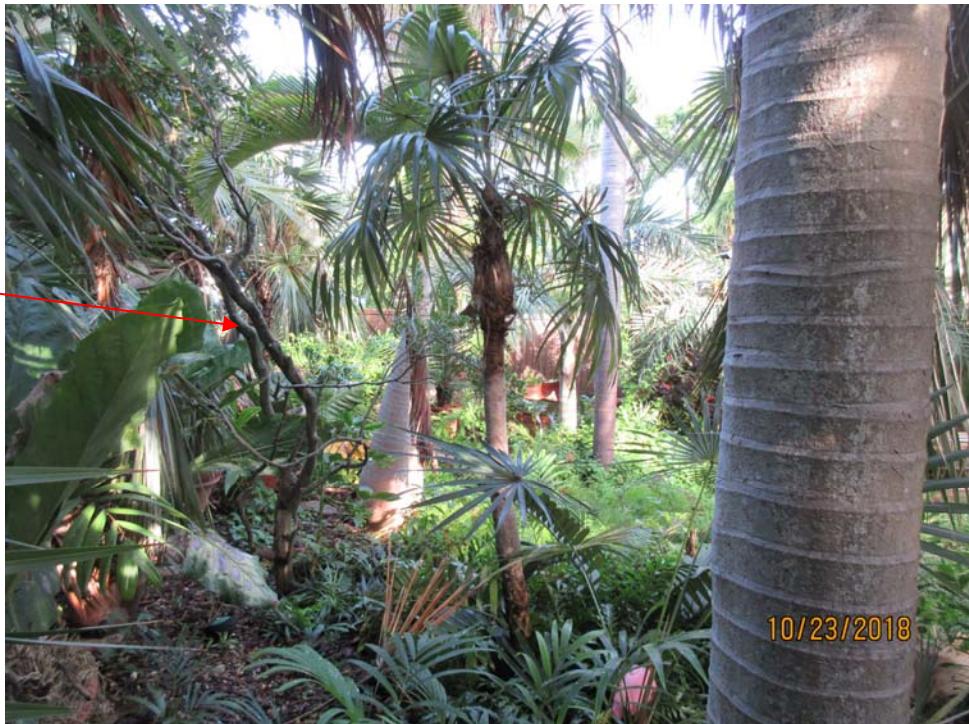
824 Thomas
Street

Standing on the right of way area on 225 Olivia Street and looking over the fence at 824 Thomas Street, at least nine (9+) regulated and protected palms and one, protected Joewood tree (State Listed Endangered Species) was observed within the right of way area. Some of the smaller palms could be transplanted but cost and logistics would have to be reviewed regarding the transplanting of the taller, larger palms and the Joewood tree.

Joewood

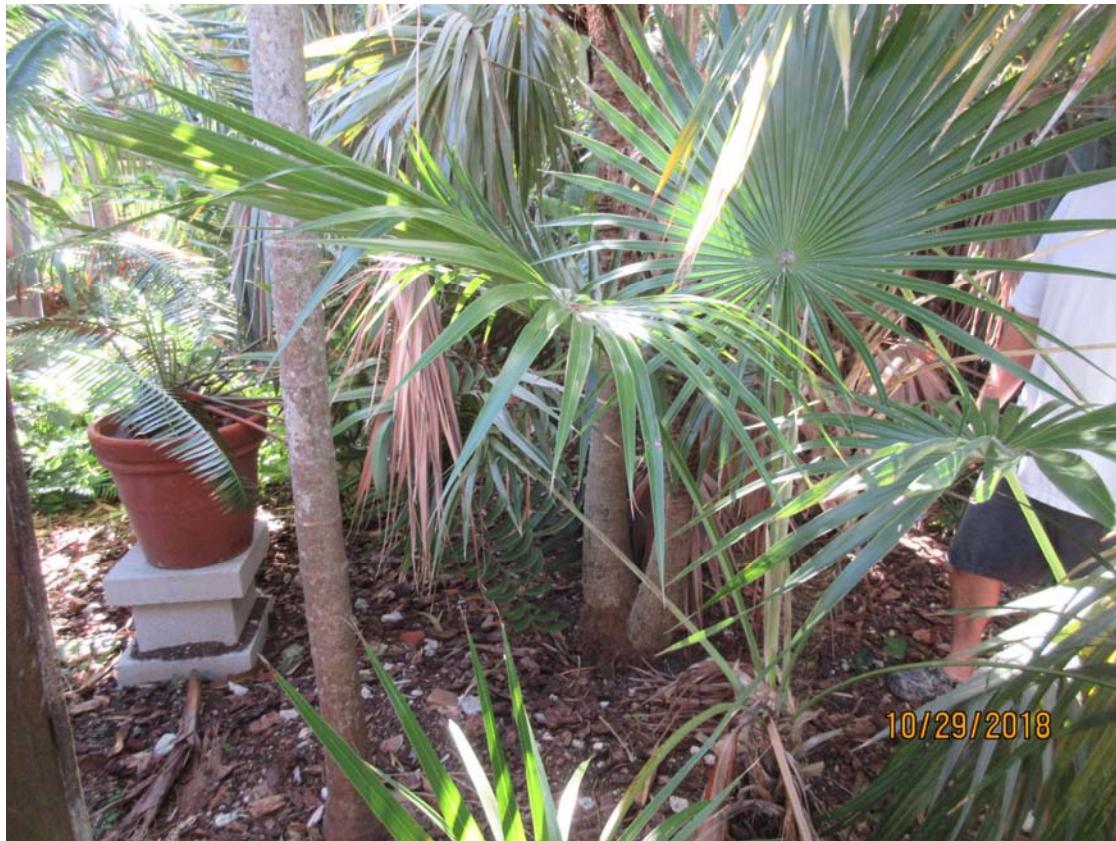
10/29/2018

View standing on the property corner with 824 and 822 Thomas Street in the right of way looking toward Olivia Street. The right of way in this area contains several protected and regulated palms including Thatch Palms, a State listed endangered species.

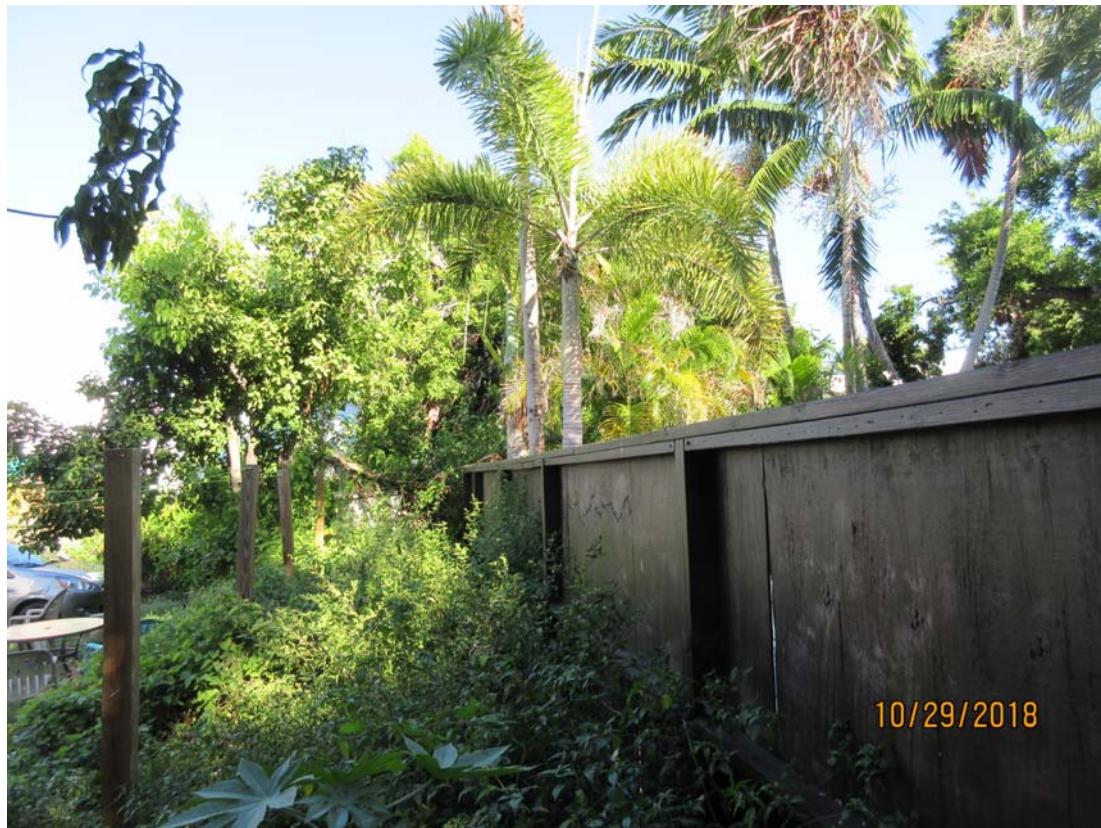
View of right of way area behind 822 Thomas Street and 1 Baptist Lane. There are no regulated or protected trees or palms in this area (wooden fence is built on the property line).
