**Historic Architectural Review Commission  
Staff Report for Item 4**

**Application Number:** H2019-0002

**Address:** #291 Front Street

Change existing wood doors to aluminum display windows on north façade at Building 1.

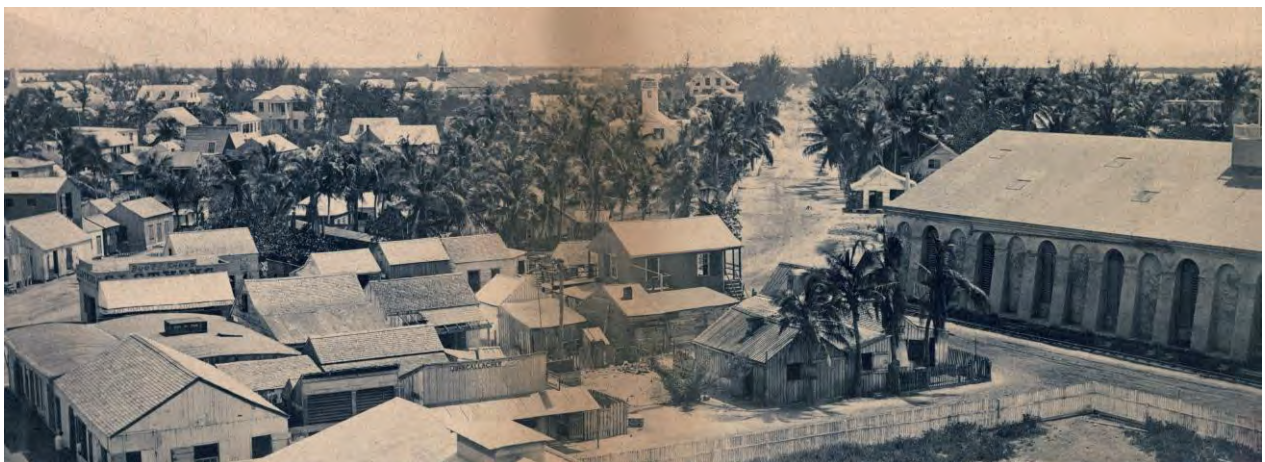
Originally, the building was designed with alternating recessed archways on its side elevations that had either solid walls of brick or steel louvers.

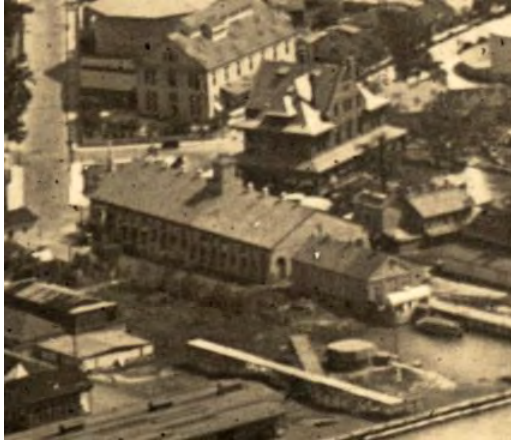
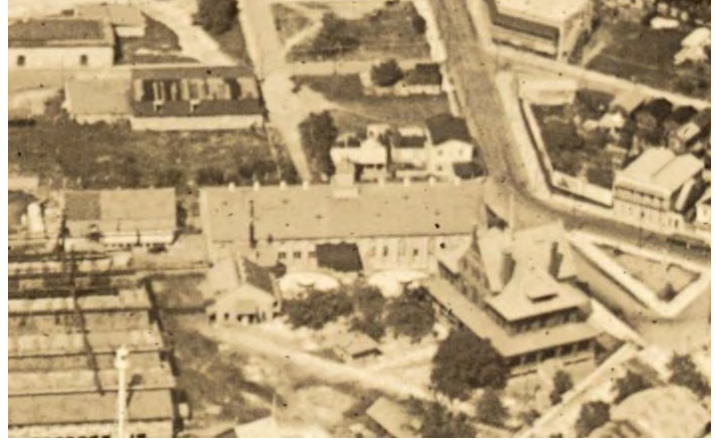
In the 1920s, the steel louvers on the sides were removed, and from photographic evidence, it appears that window fenestrations were installed in each recessed archway. The openings that were created were of differing sizes and heights, as if they were installed purely for function without considering the architecture of the building.

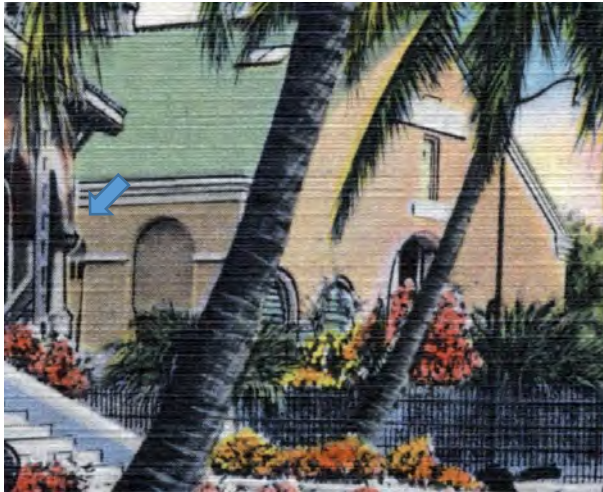
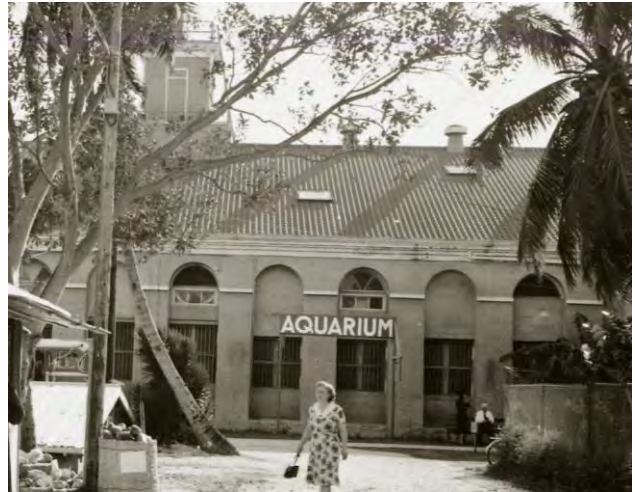
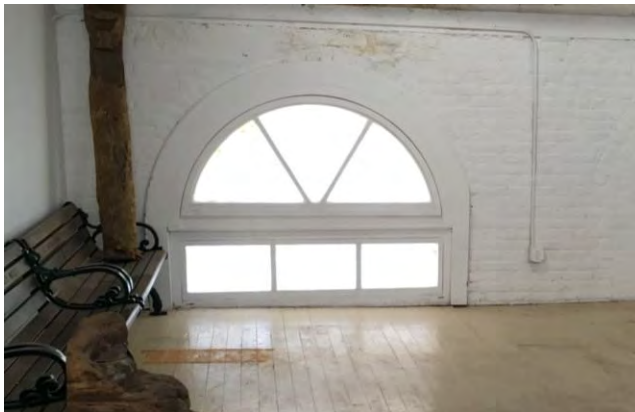
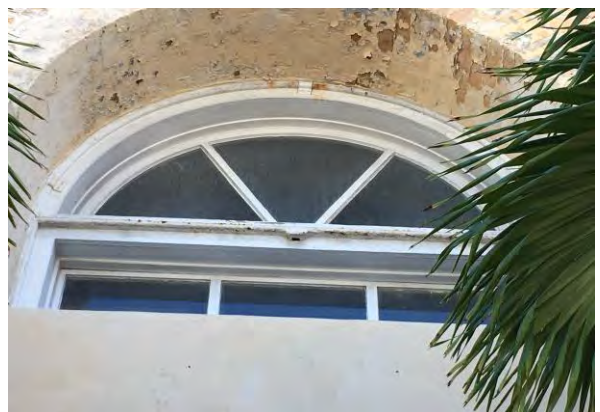
Staff believes that there might have been wood windows behind the steel louvers originally, as the front elevation contains historic 12/12 wood windows behind the steel louvers. Also, the recessed archways with the steel louvers have operable, fanlight windows in the arch. A postcard from the 1940s and a photo from the 1950s documents the fanlight windows above a three-light awning window, which is very similar to what exists today.

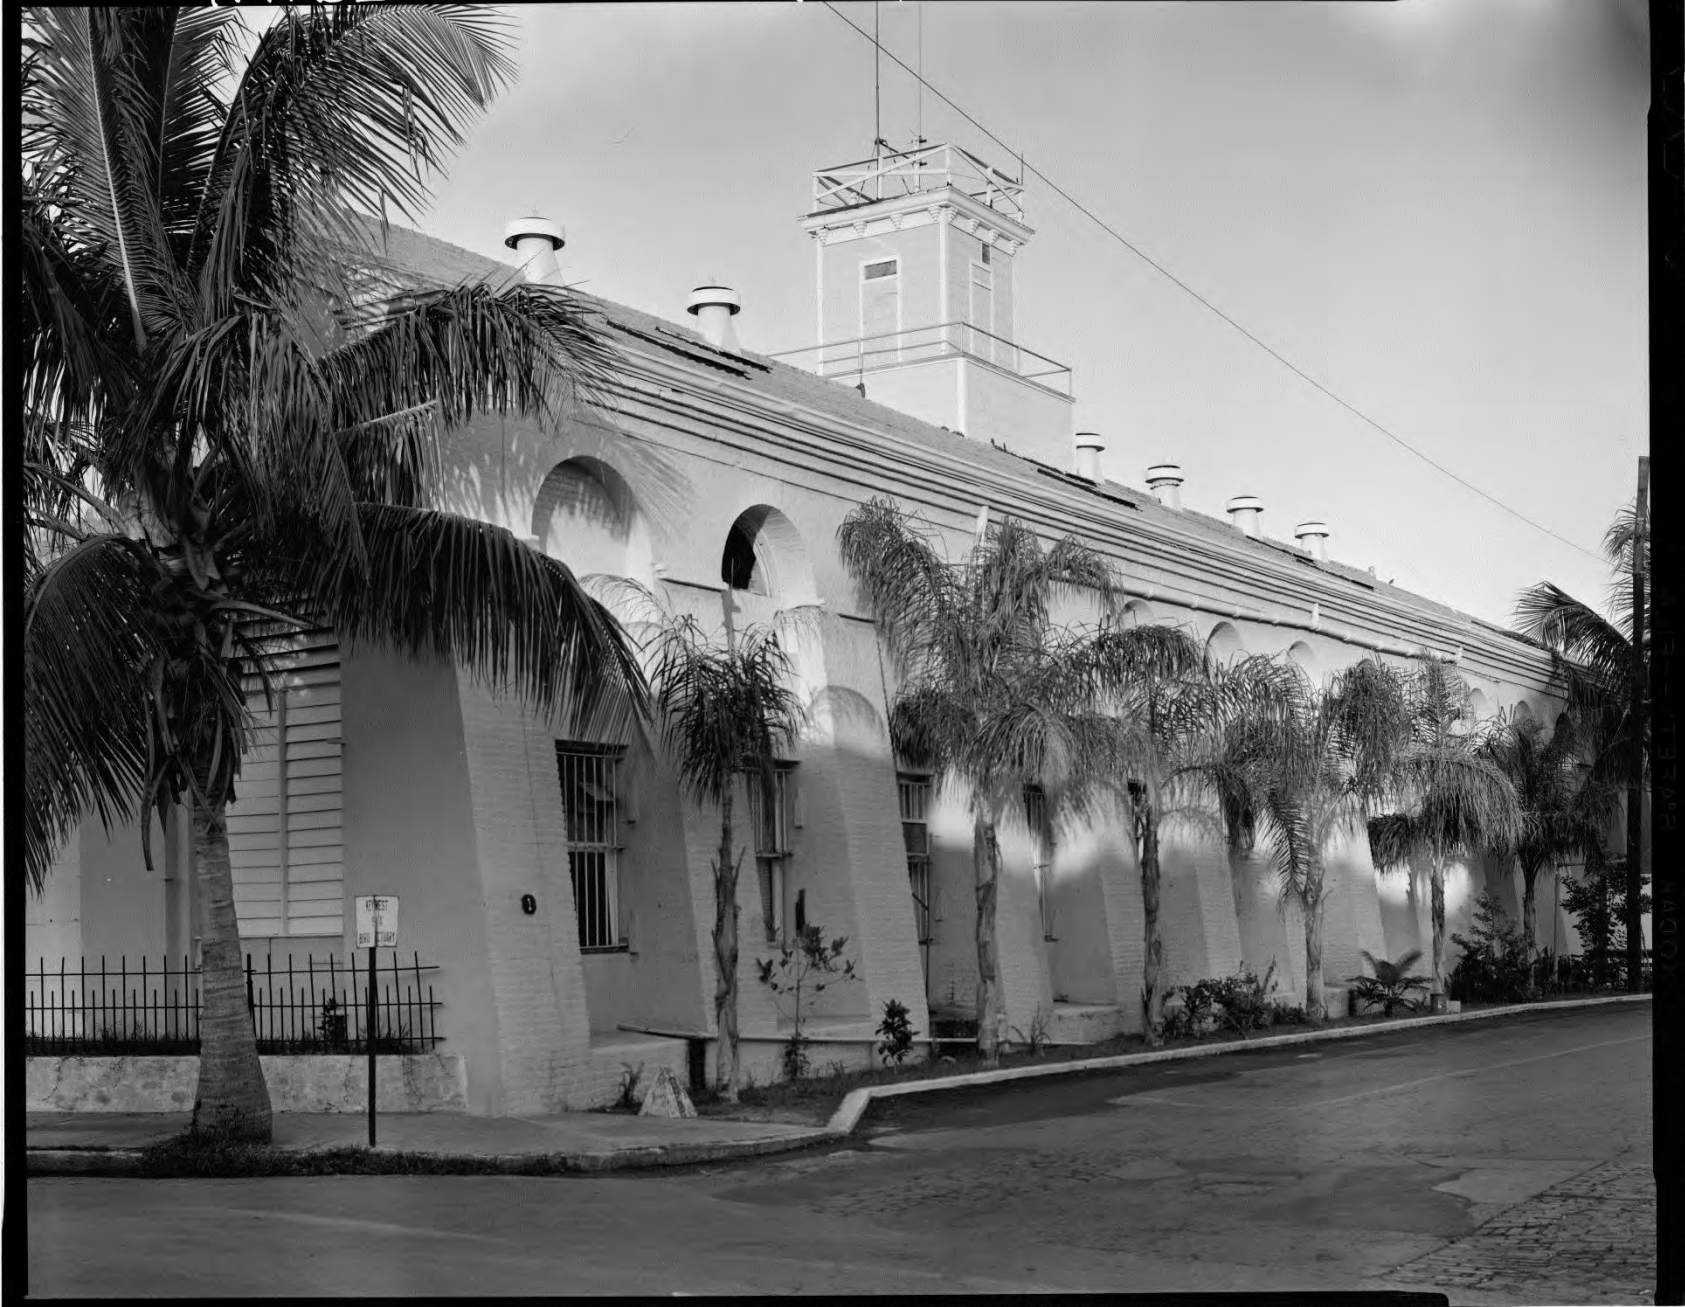
HABS NO. FLA-190-1

North Elevation, 1968. HABS Photo. Library of Congress.

Photographs from the 1960s and 1970s show that the side elevations (the north and south façades) had 2/2 wood windows in some of the openings (as well as glass block). At some point, in the 1980s or 1990s, 9/9 wood windows were installed on the south façade and the window openings on the north façade that are behind the Aquarium building. The rest of windows on the north façade were replaced with wood full-lite doors. At some point, two-light transom windows were installed over some of the doors on the north façade.

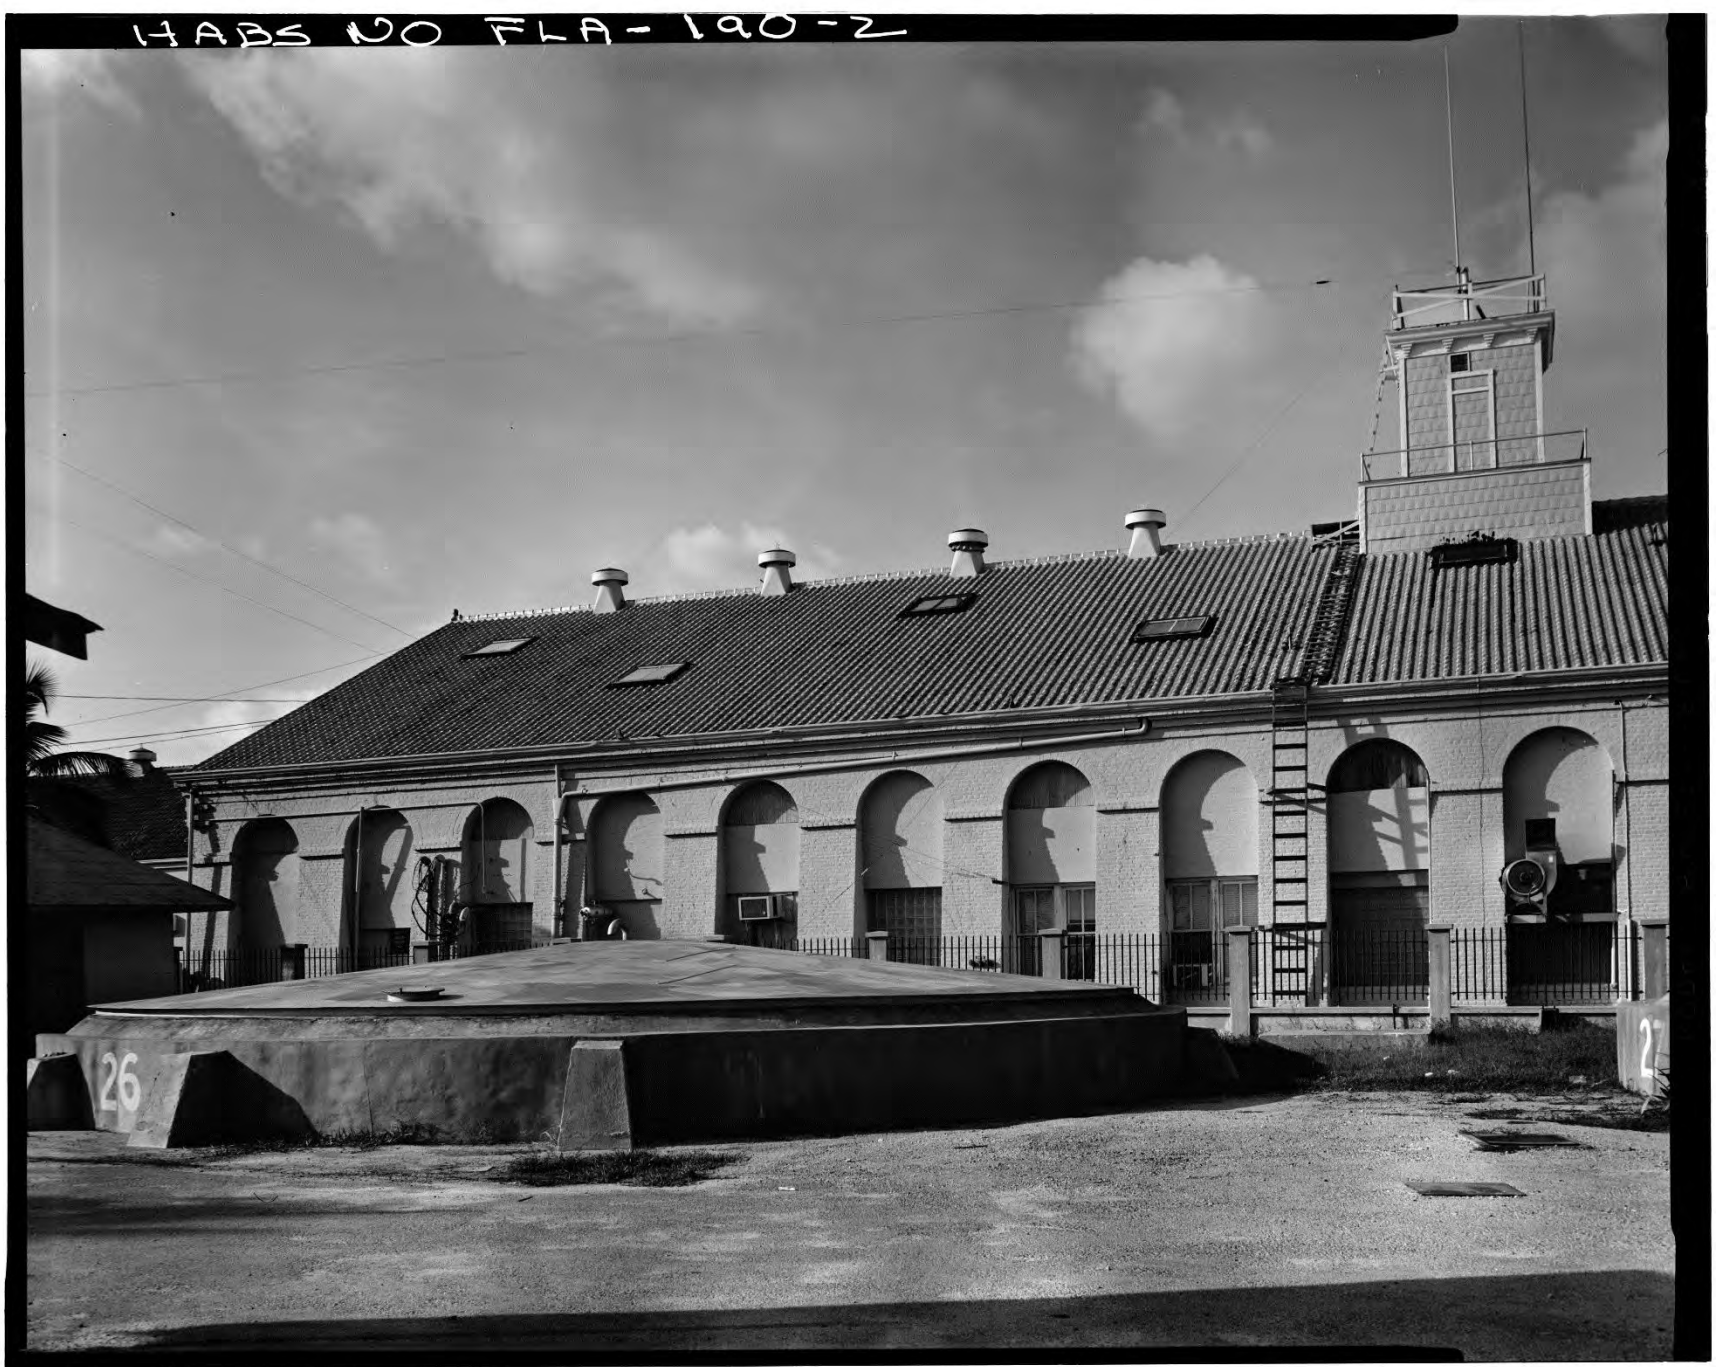
HABS NO FLA-190-2

South Elevation, 1968. HABS Photo. Library of Congress.

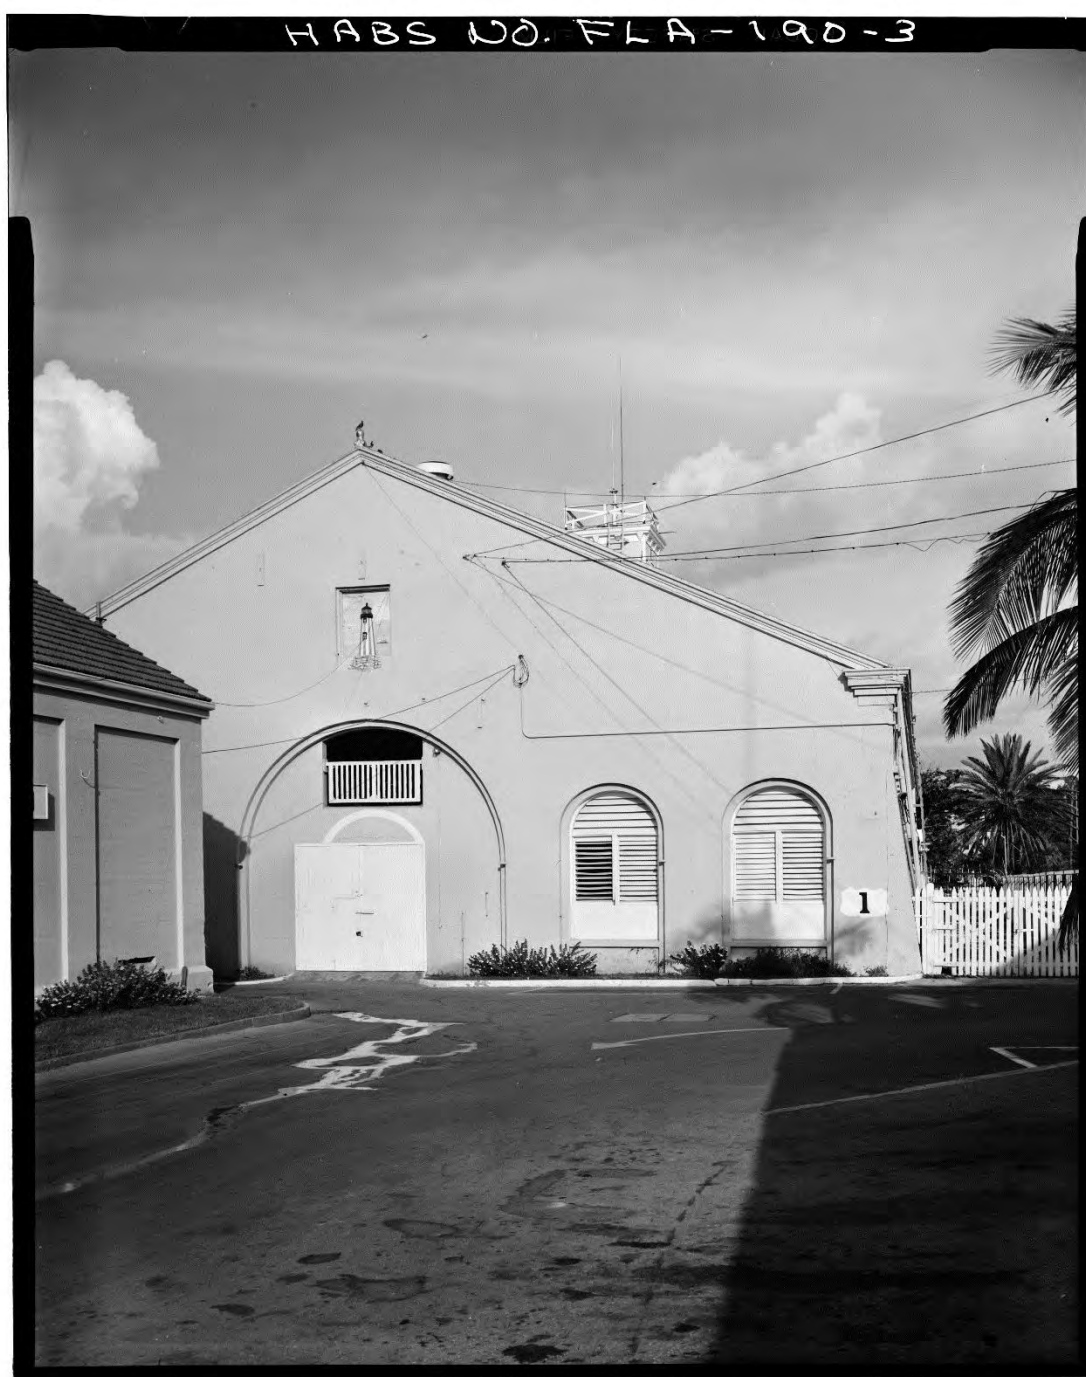
HABS NO. FLA-190-3

West Elevation, 1968. HABS Photo. Library of Congress.

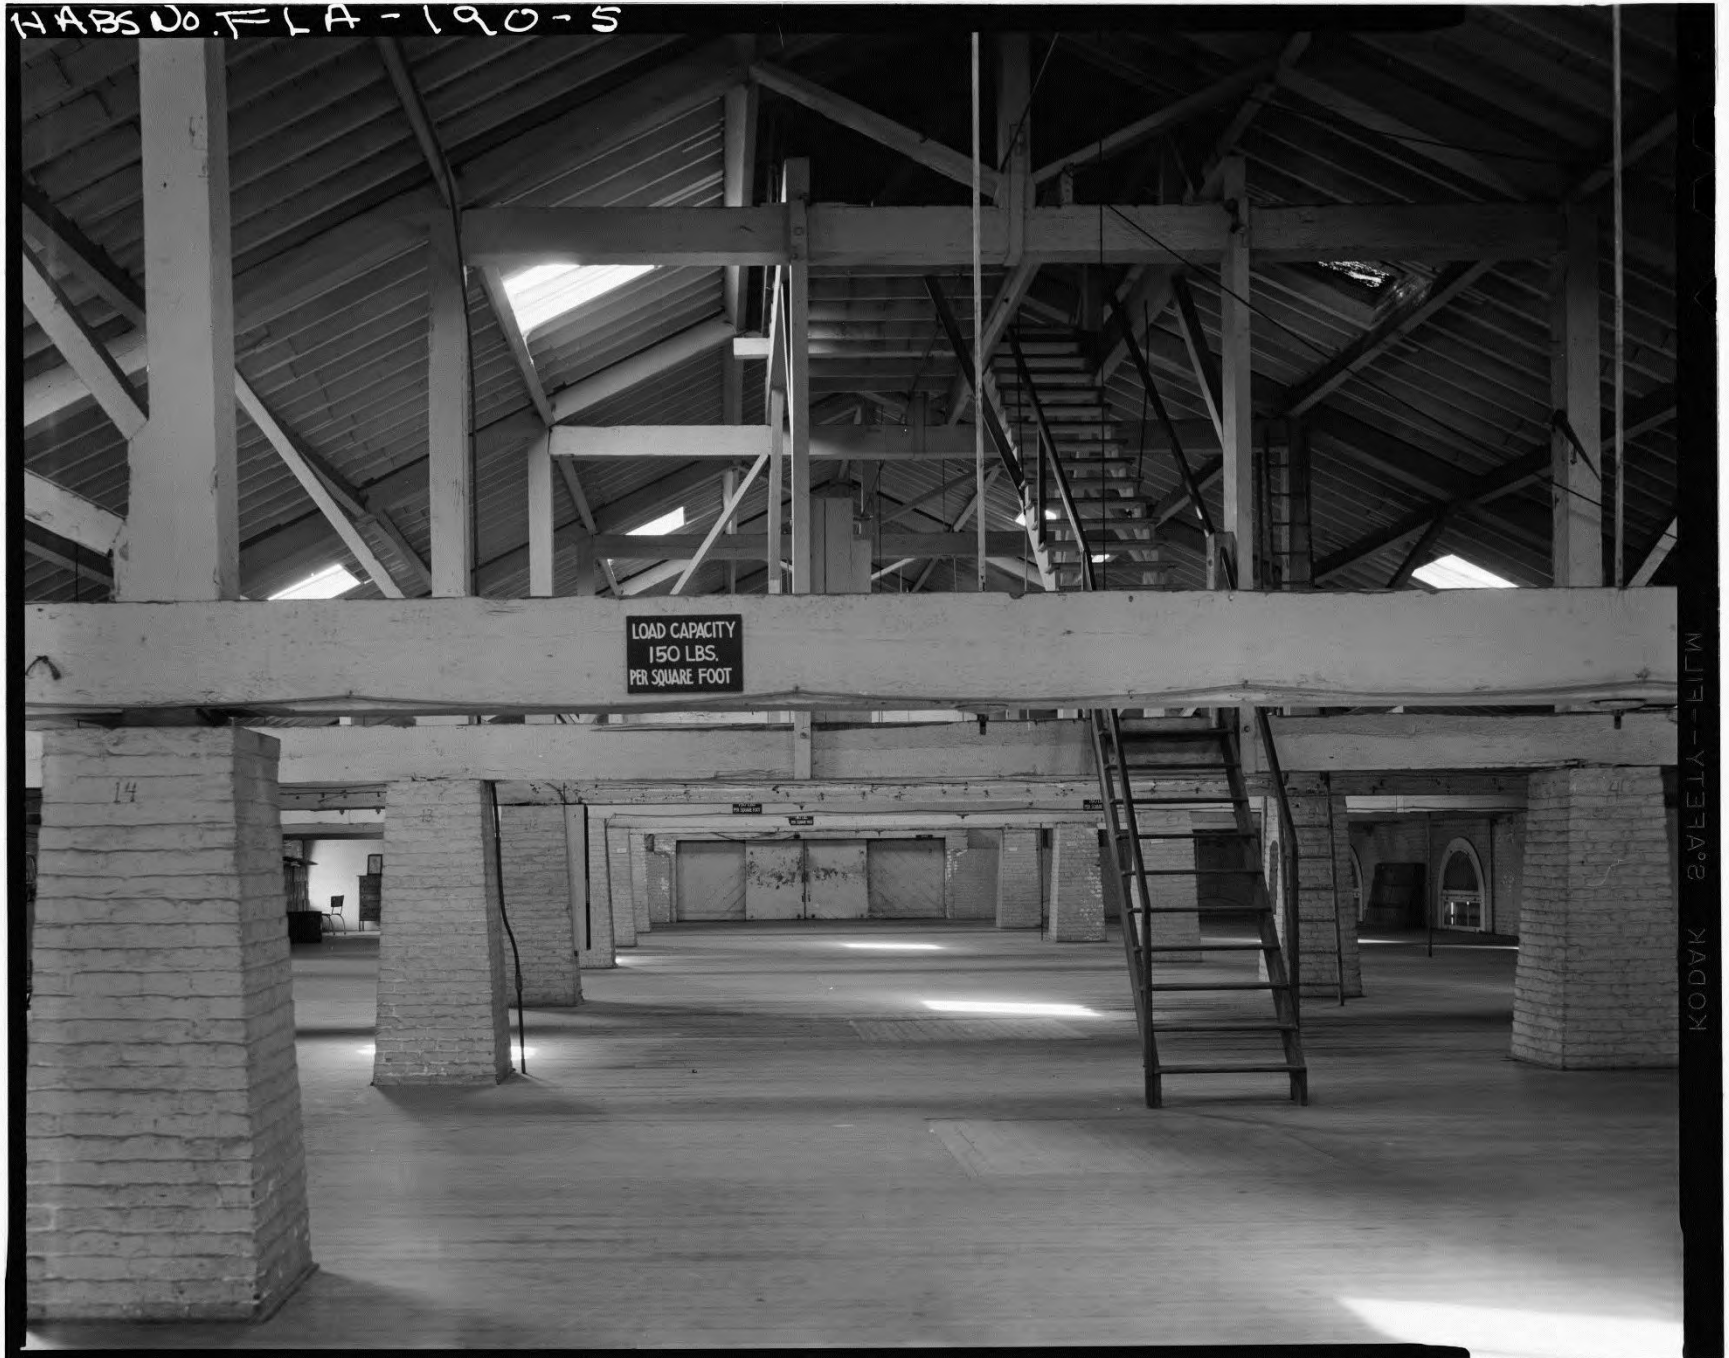
HABS No. FLA-190-5

Second Floor. Arch windows are visible, 1968. HABS Photo. Library of Congress.

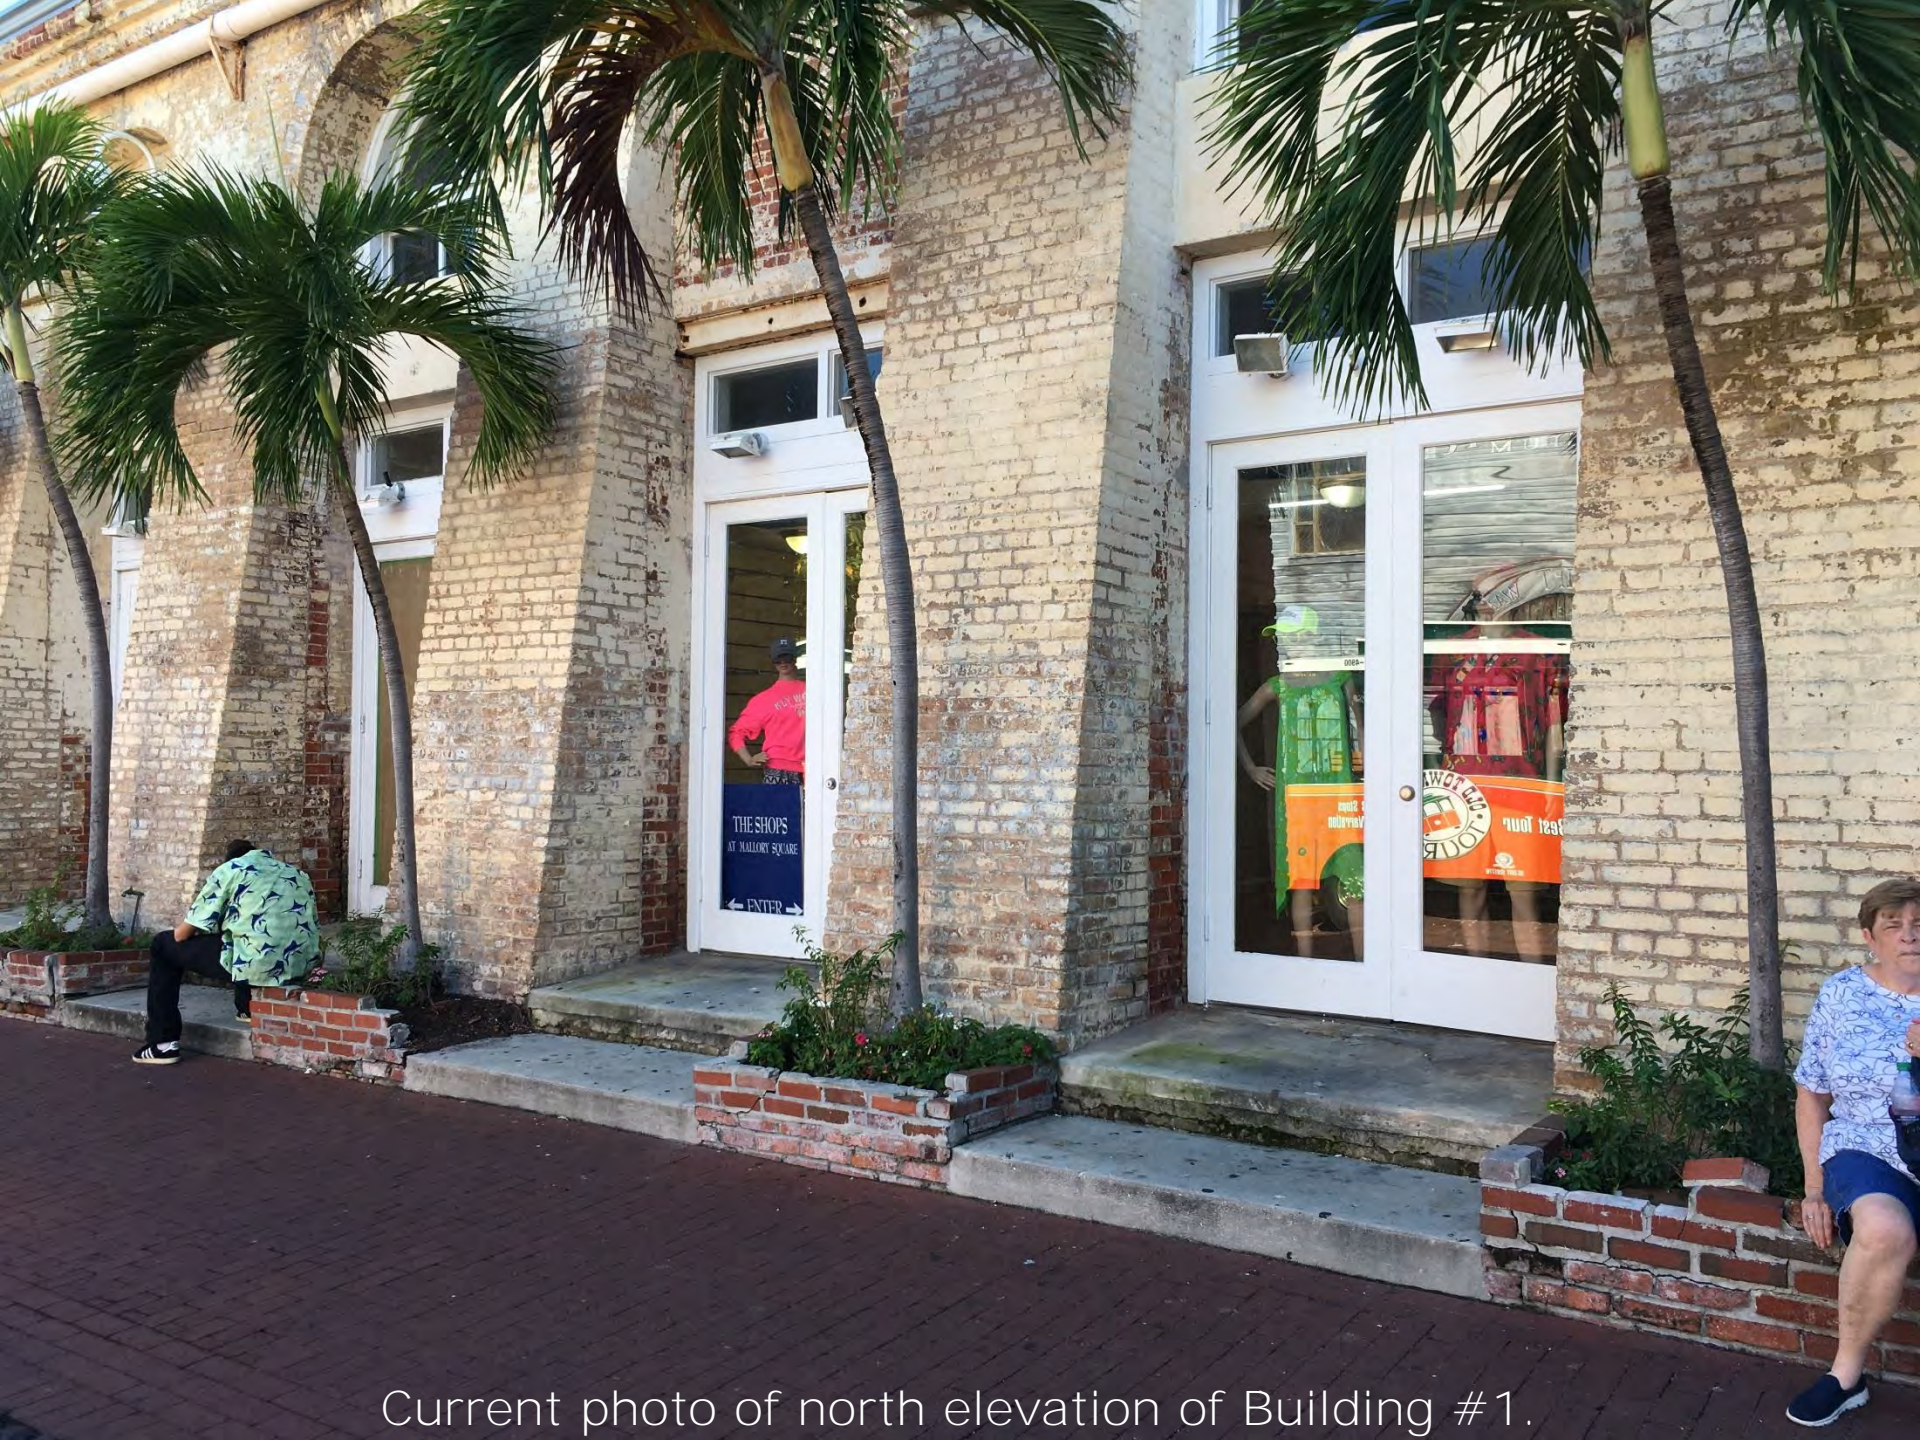
Current photo of north elevation of Building #1.

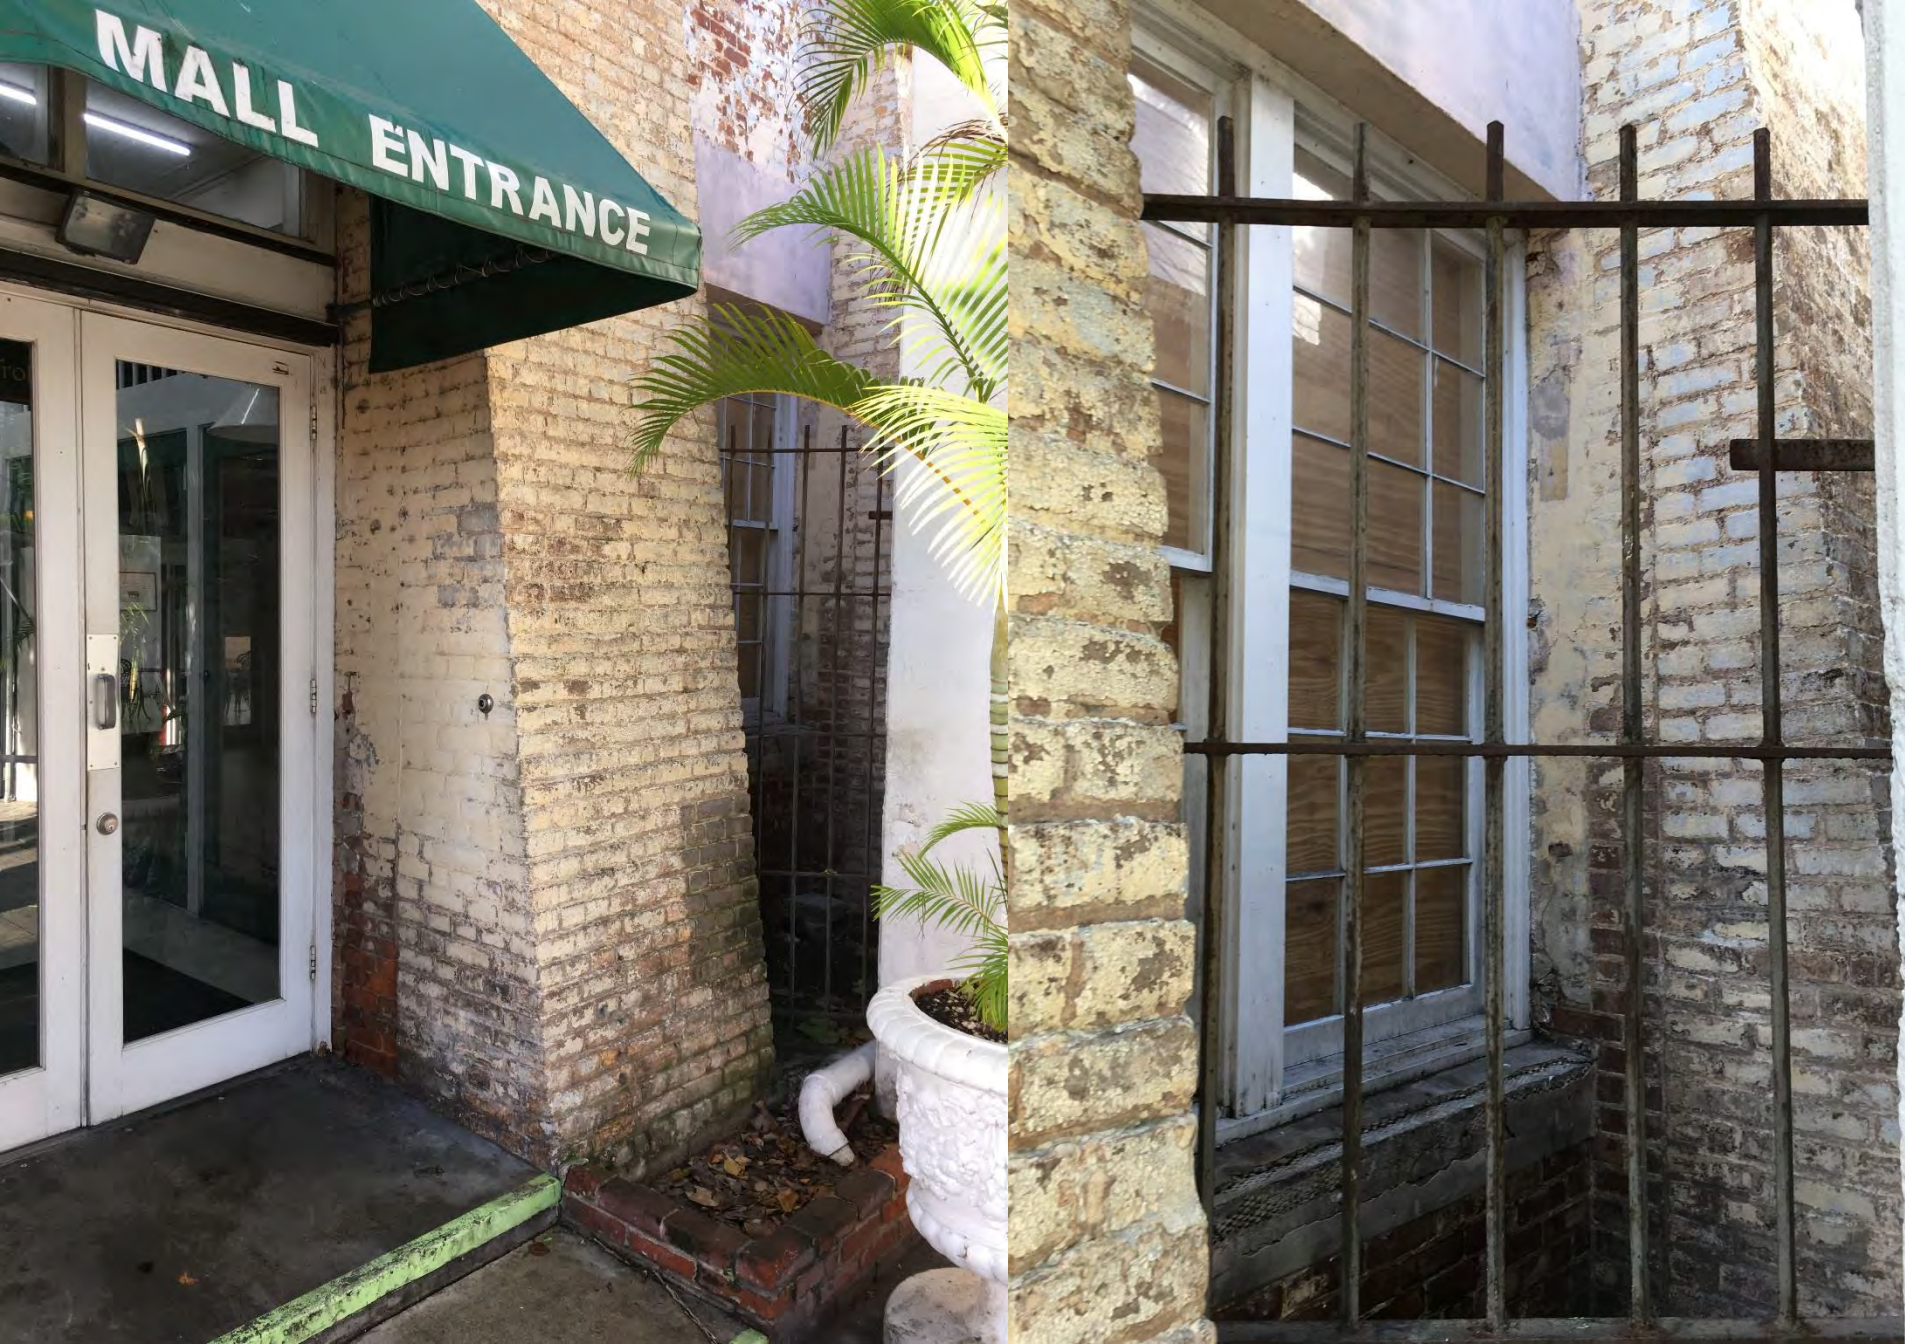
Photo showing non-historic 9/9 windows on the north elevation that are behind the Aquarium.

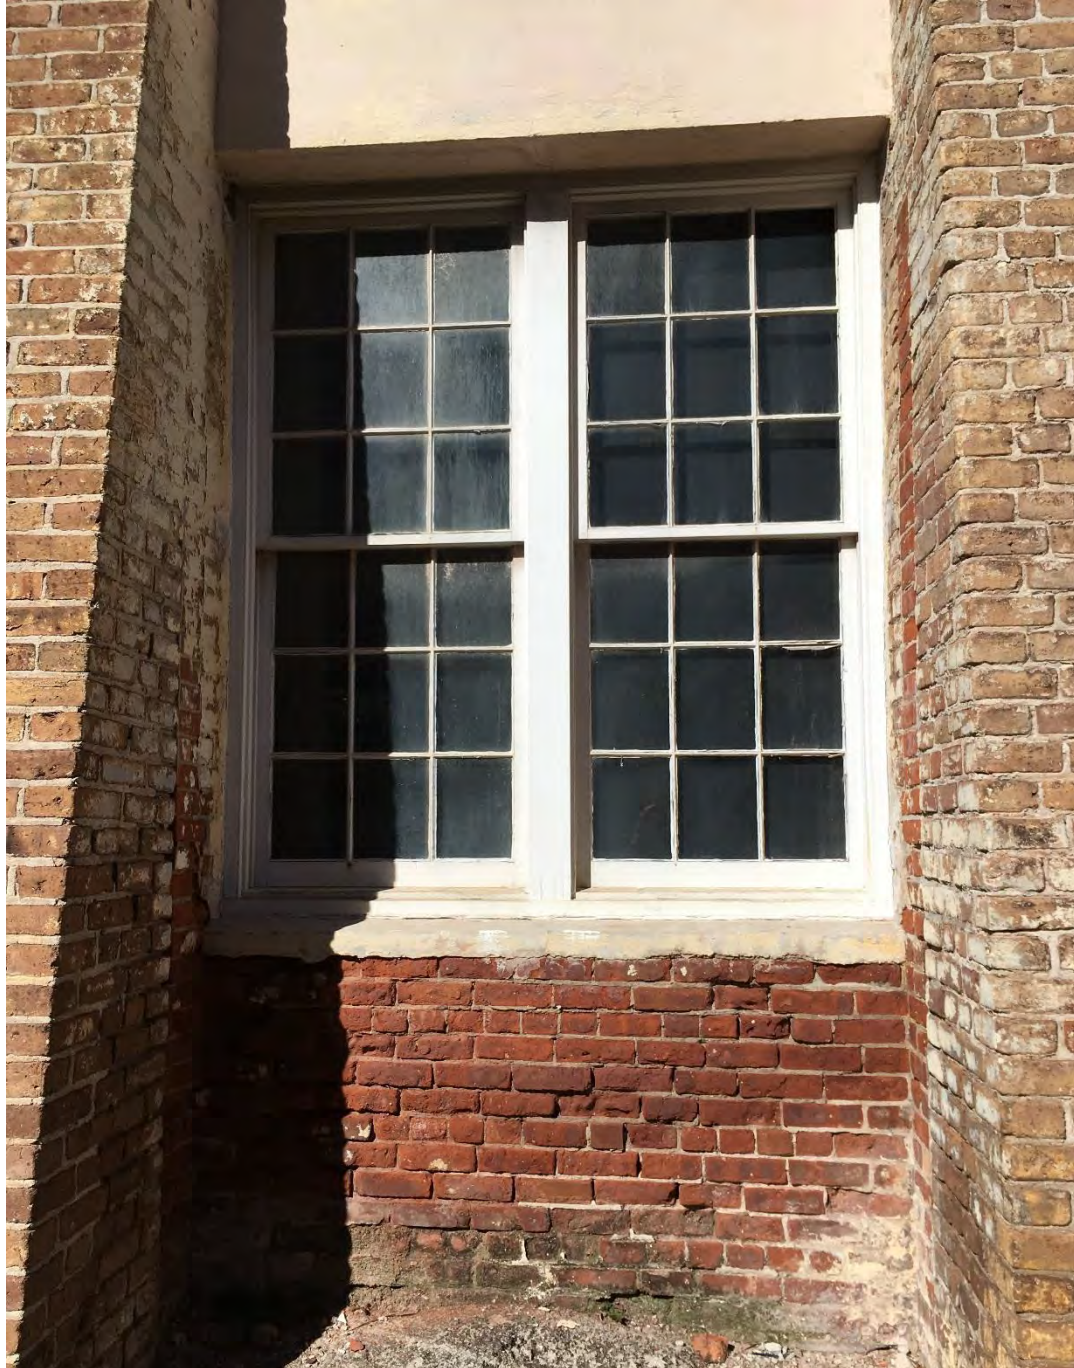
Photo of south elevation of Building #1, showing non-historic 9/9 windows.

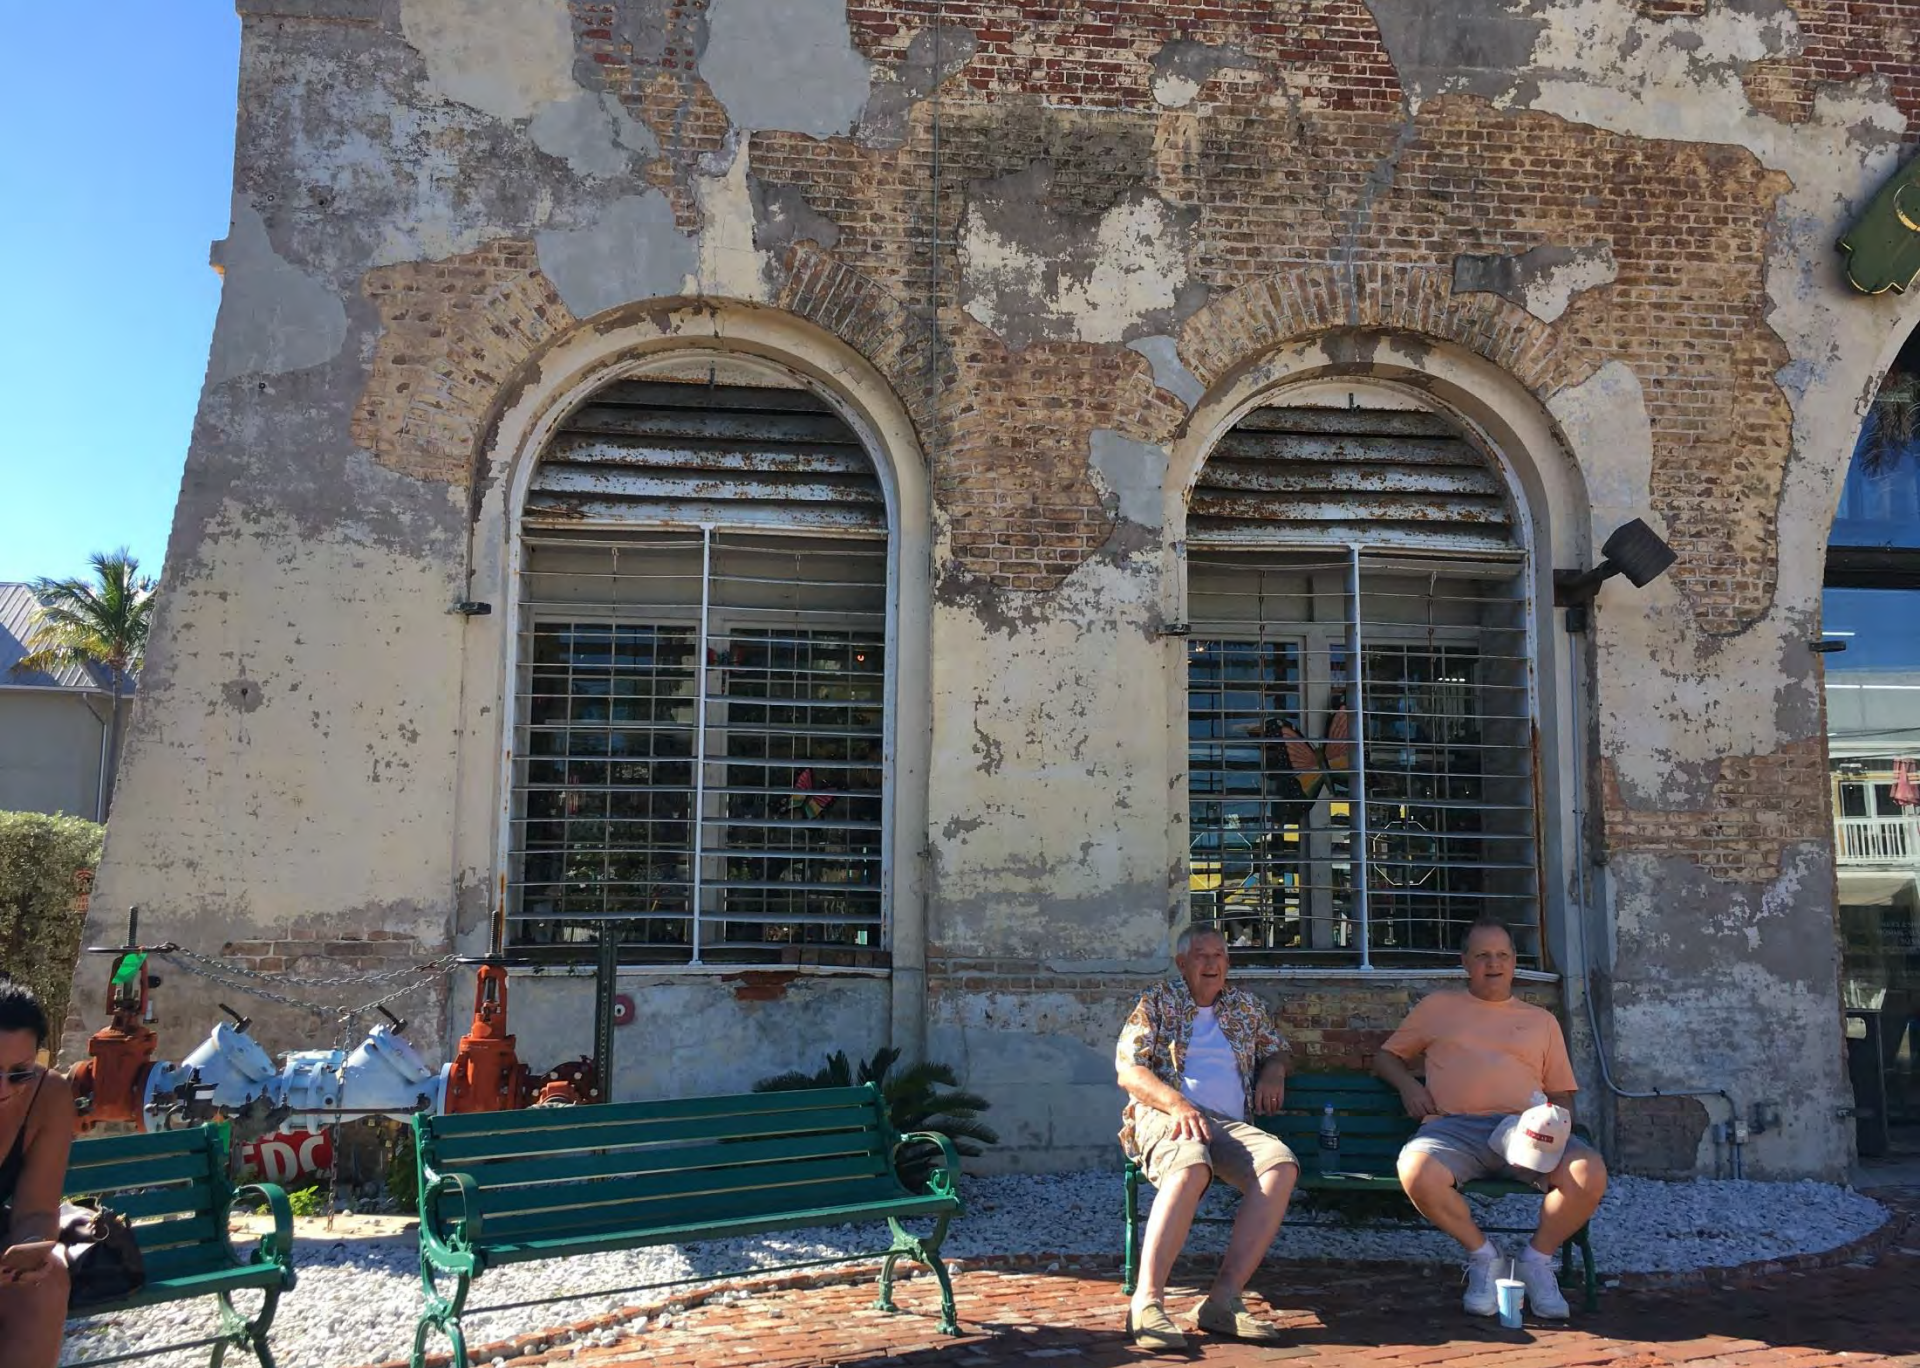
Historic 12/12 windows behind the steel louvers on east elevation of Building #1.

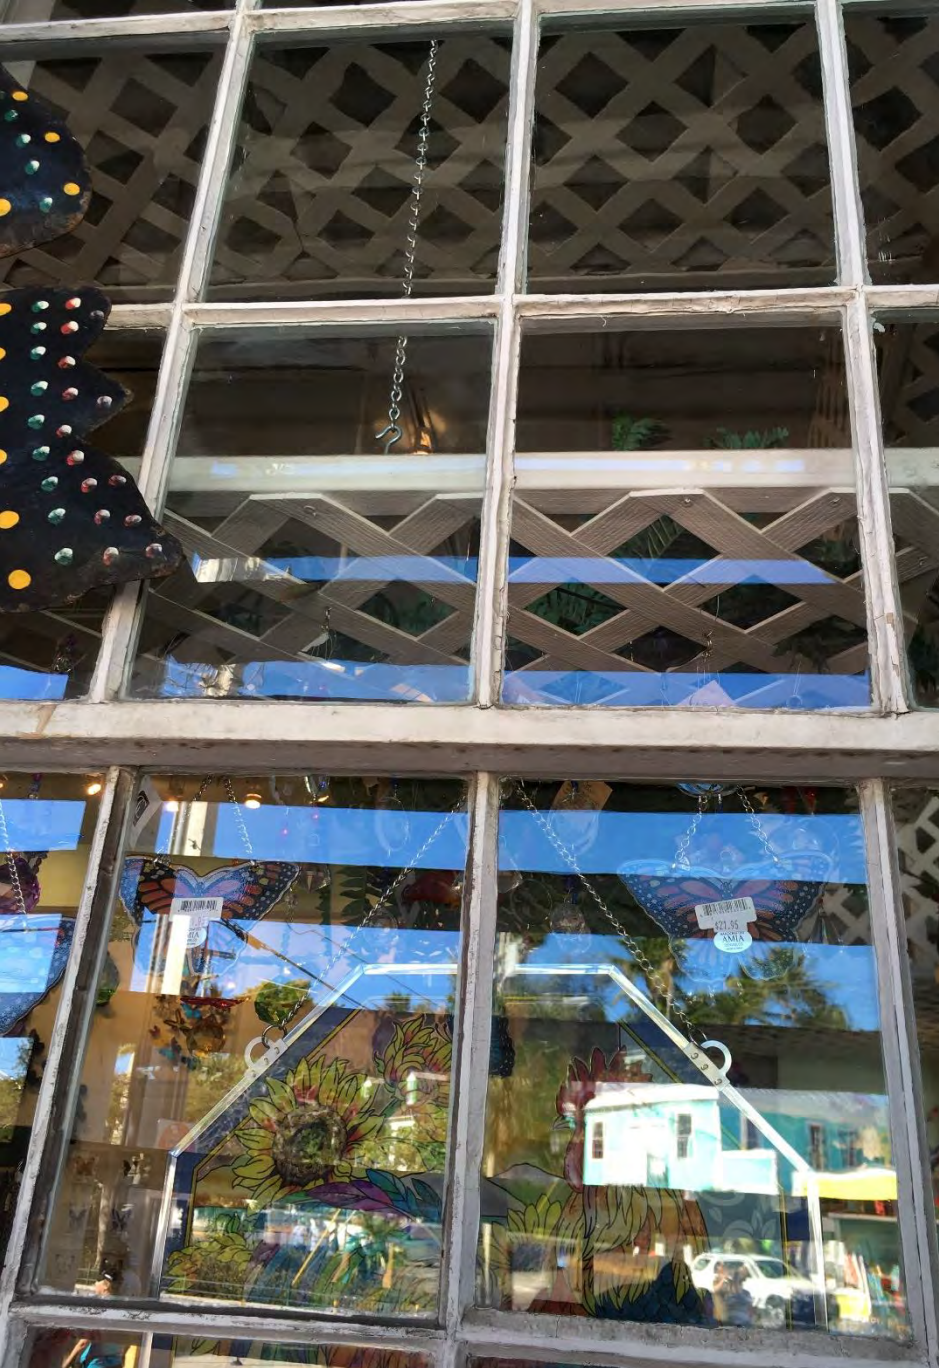
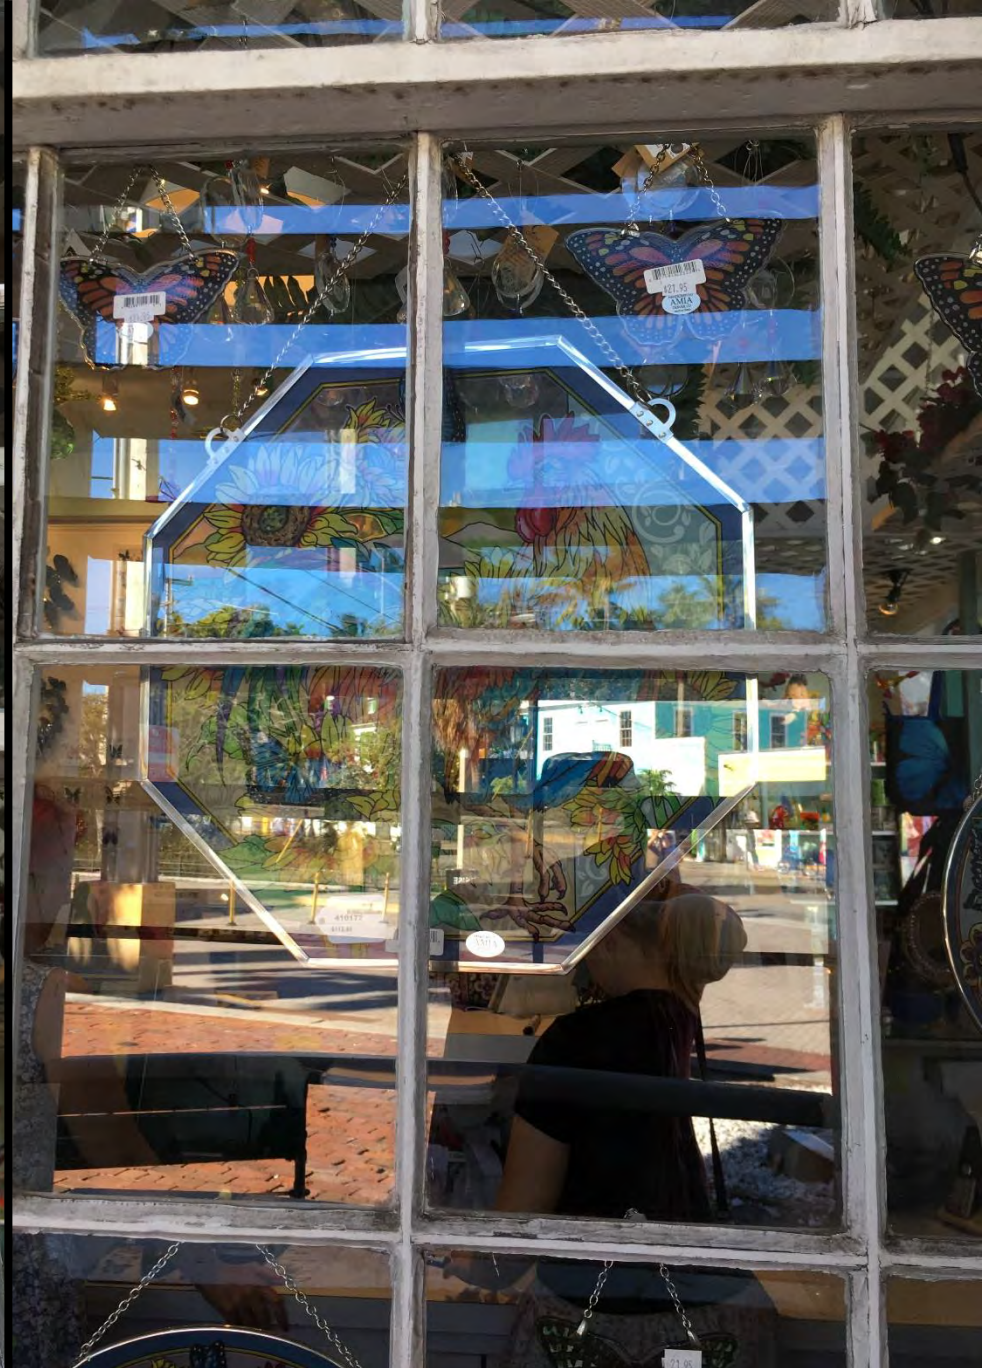
Closeup photo showing historic 12/12 windows on front elevation.
