**Historic Architectural Review Commission  
Staff Report for Item 4**

**Application Number:** H2019-0002

**Address:** #291 Front Street

Change existing wood doors to aluminum display windows on north façade at Building 1.

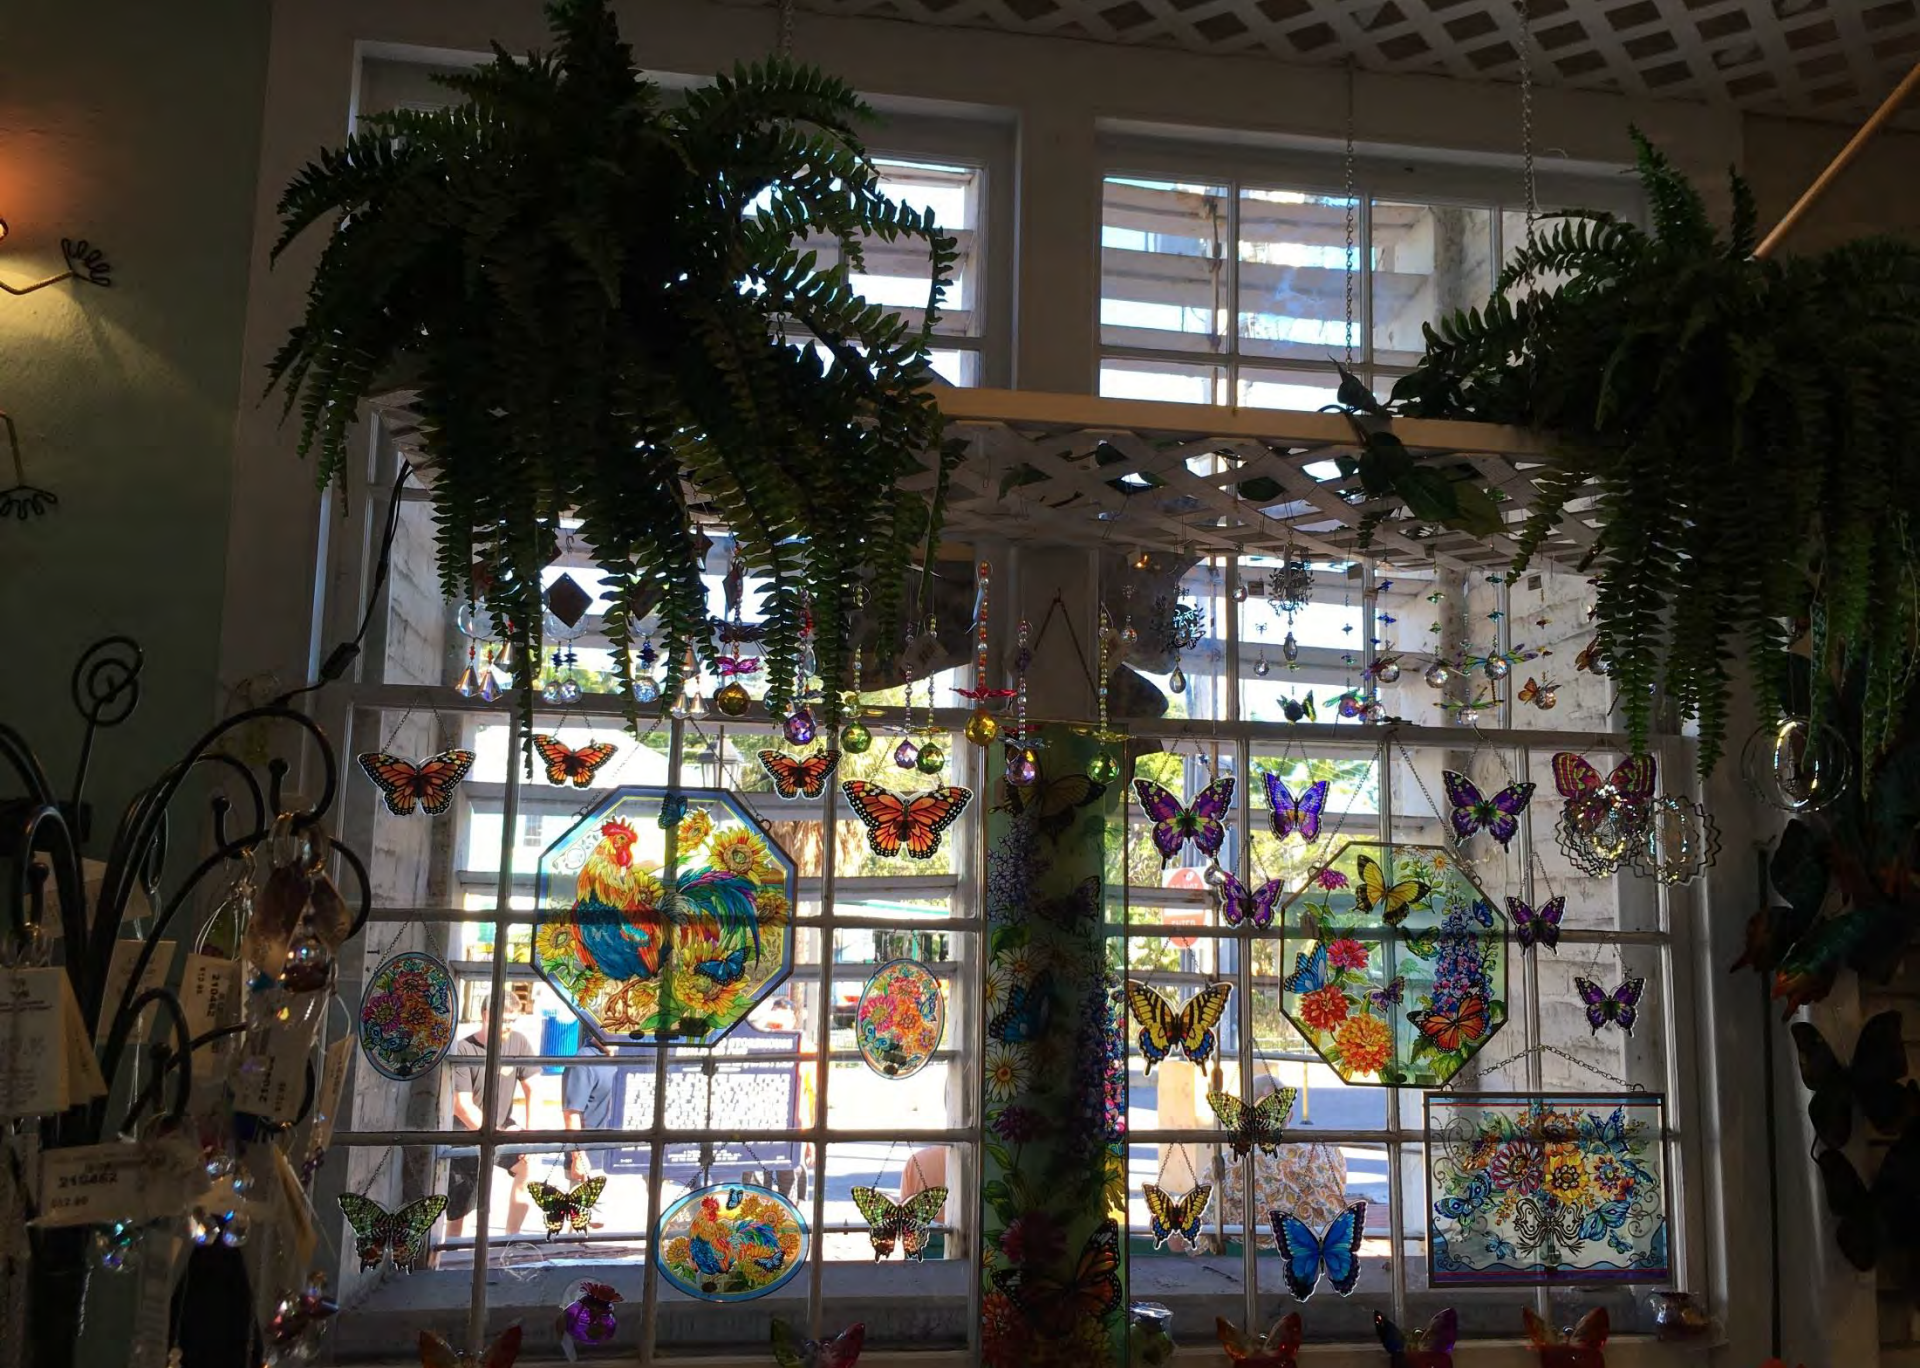
Photo showing historic 12/12 windows on east elevation of Building #1.

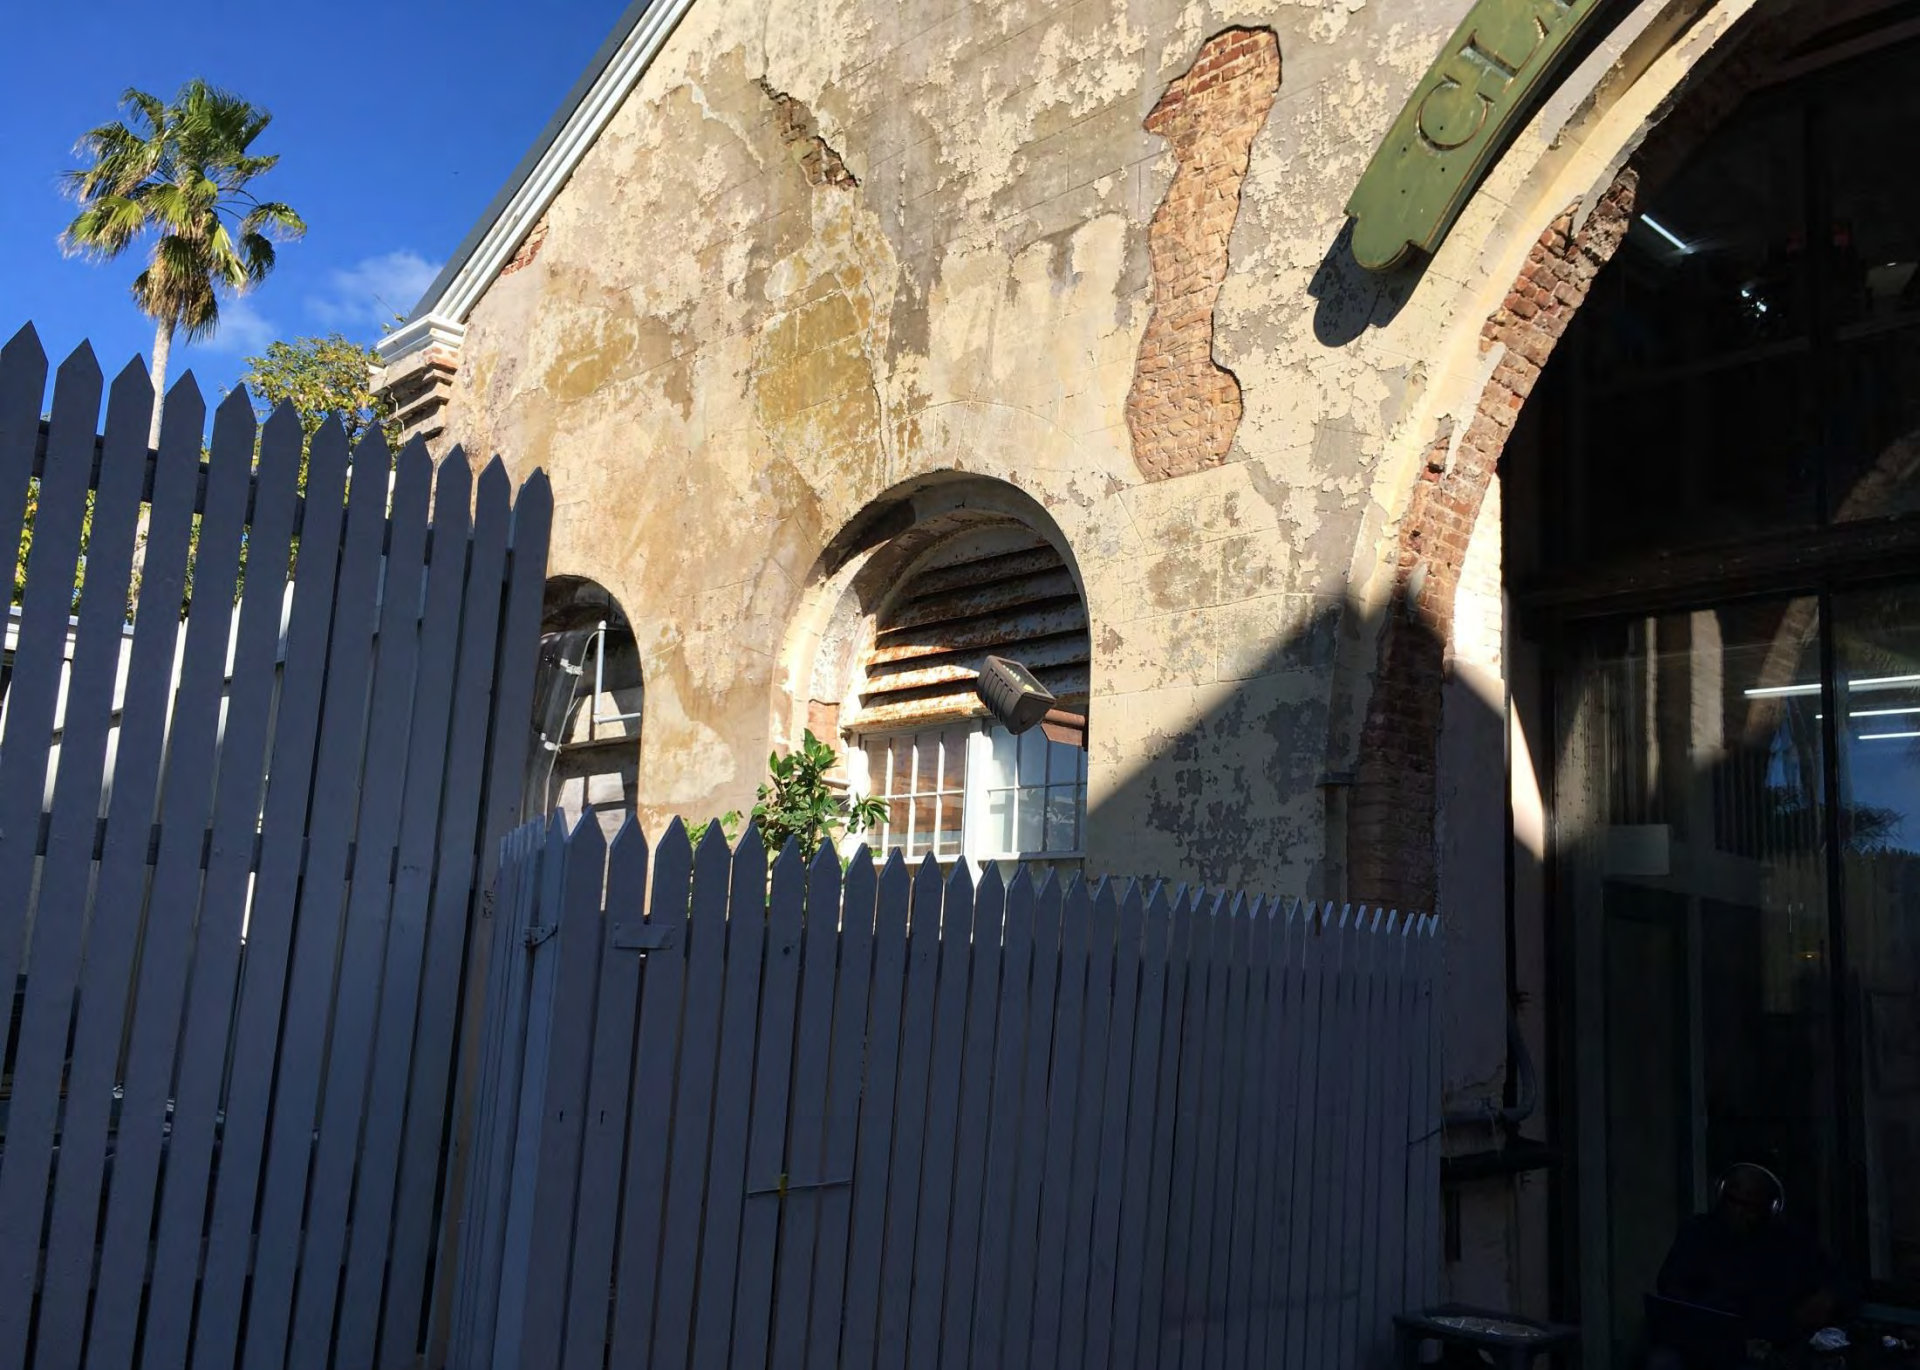
Photo showing non-historic 8/8 windows on west elevation of Building #1.

In the rear, the steel louvers were removed, and currently 8/8 wood windows are installed. In general, most of the non-historic wood windows and doors are deteriorated and need repair or replacement. The historic 12/12 wood windows appear to be in good condition.

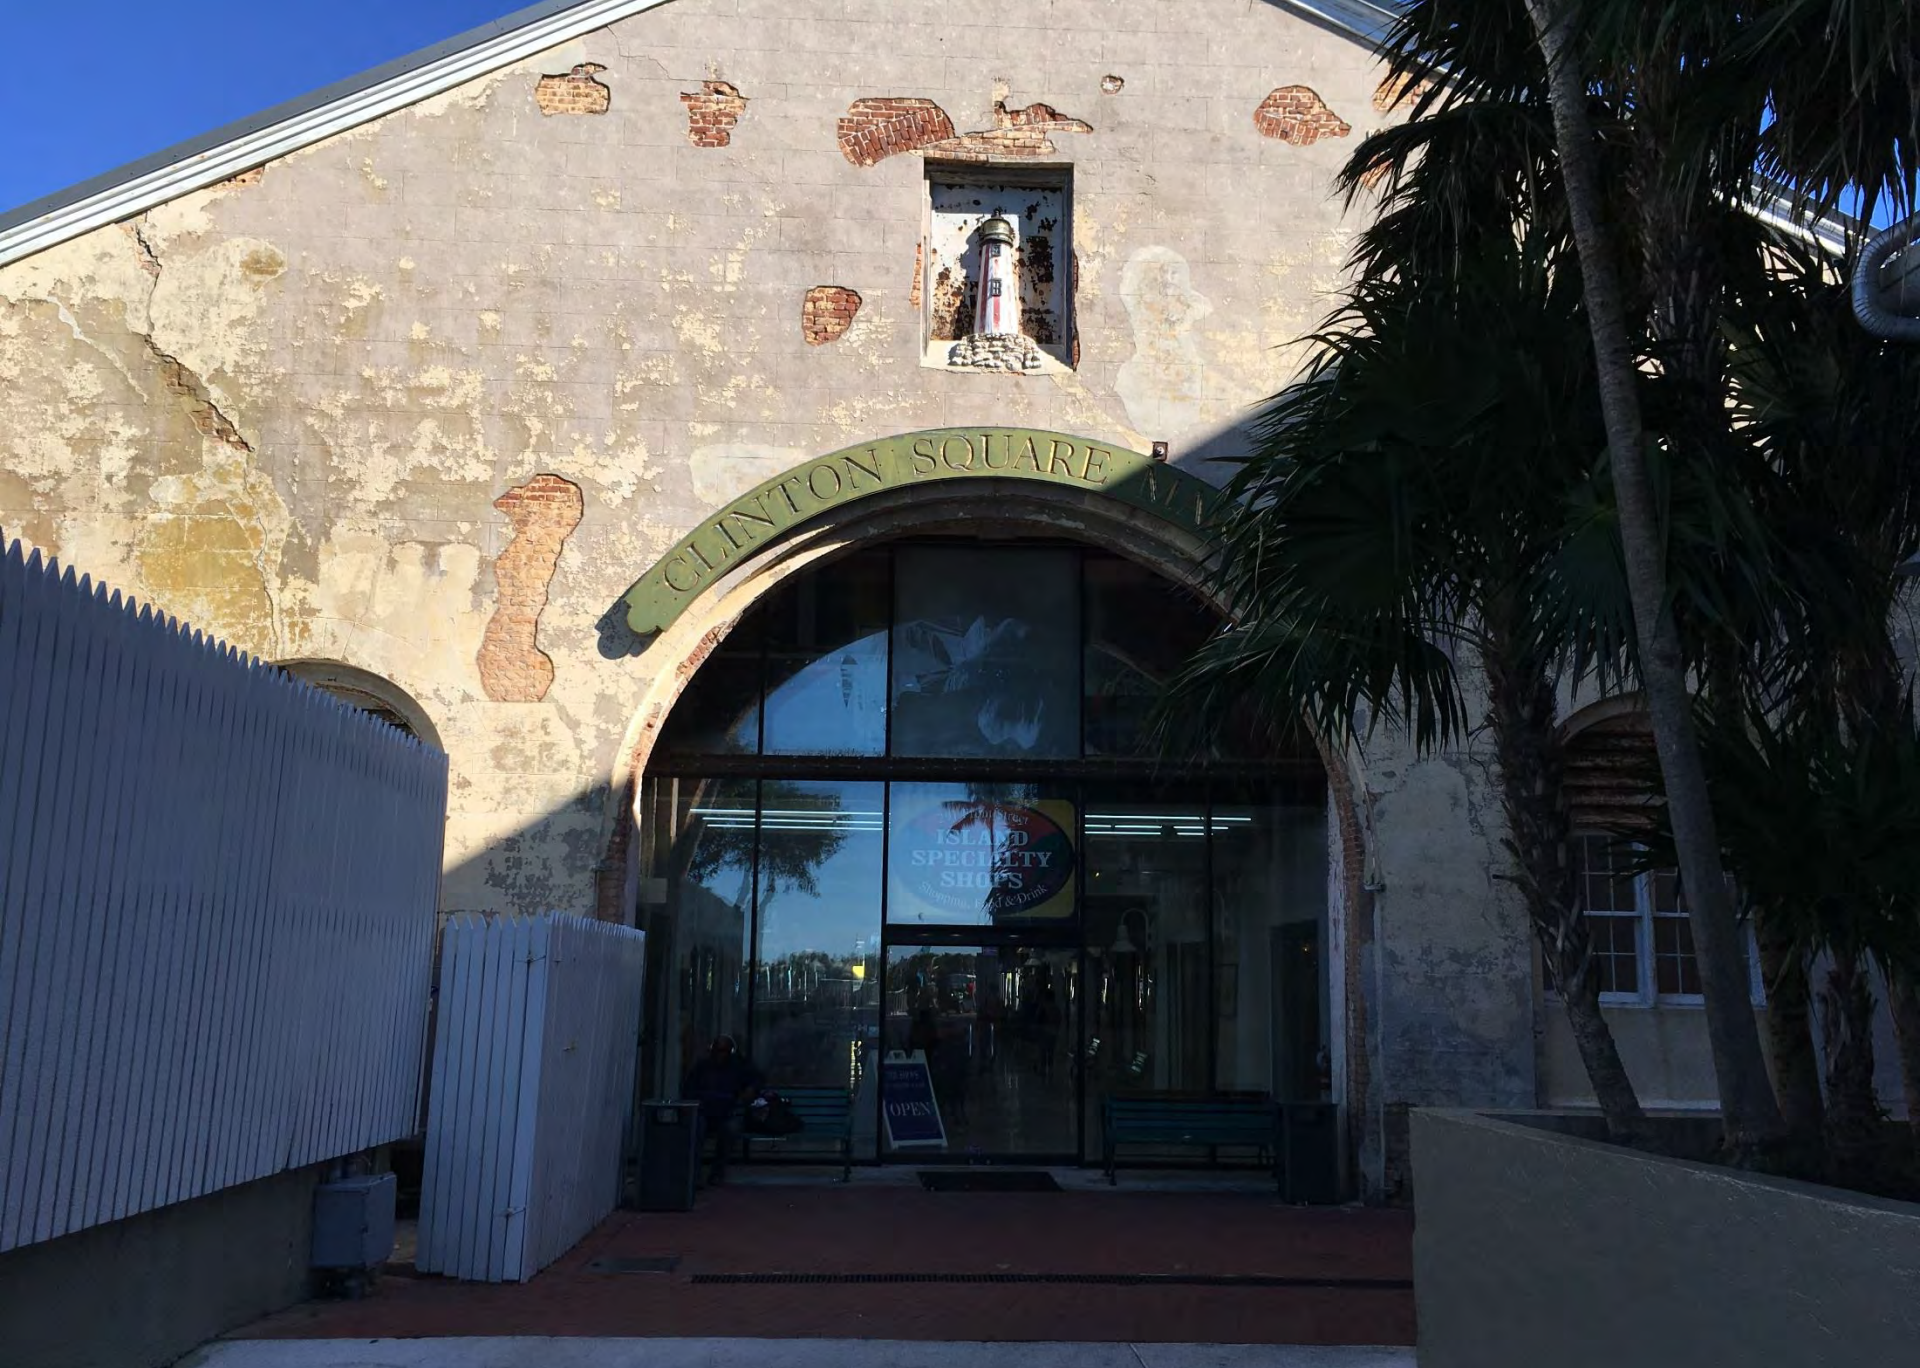
Photo showing non-historic 8/8 windows on west elevation of Building #1.

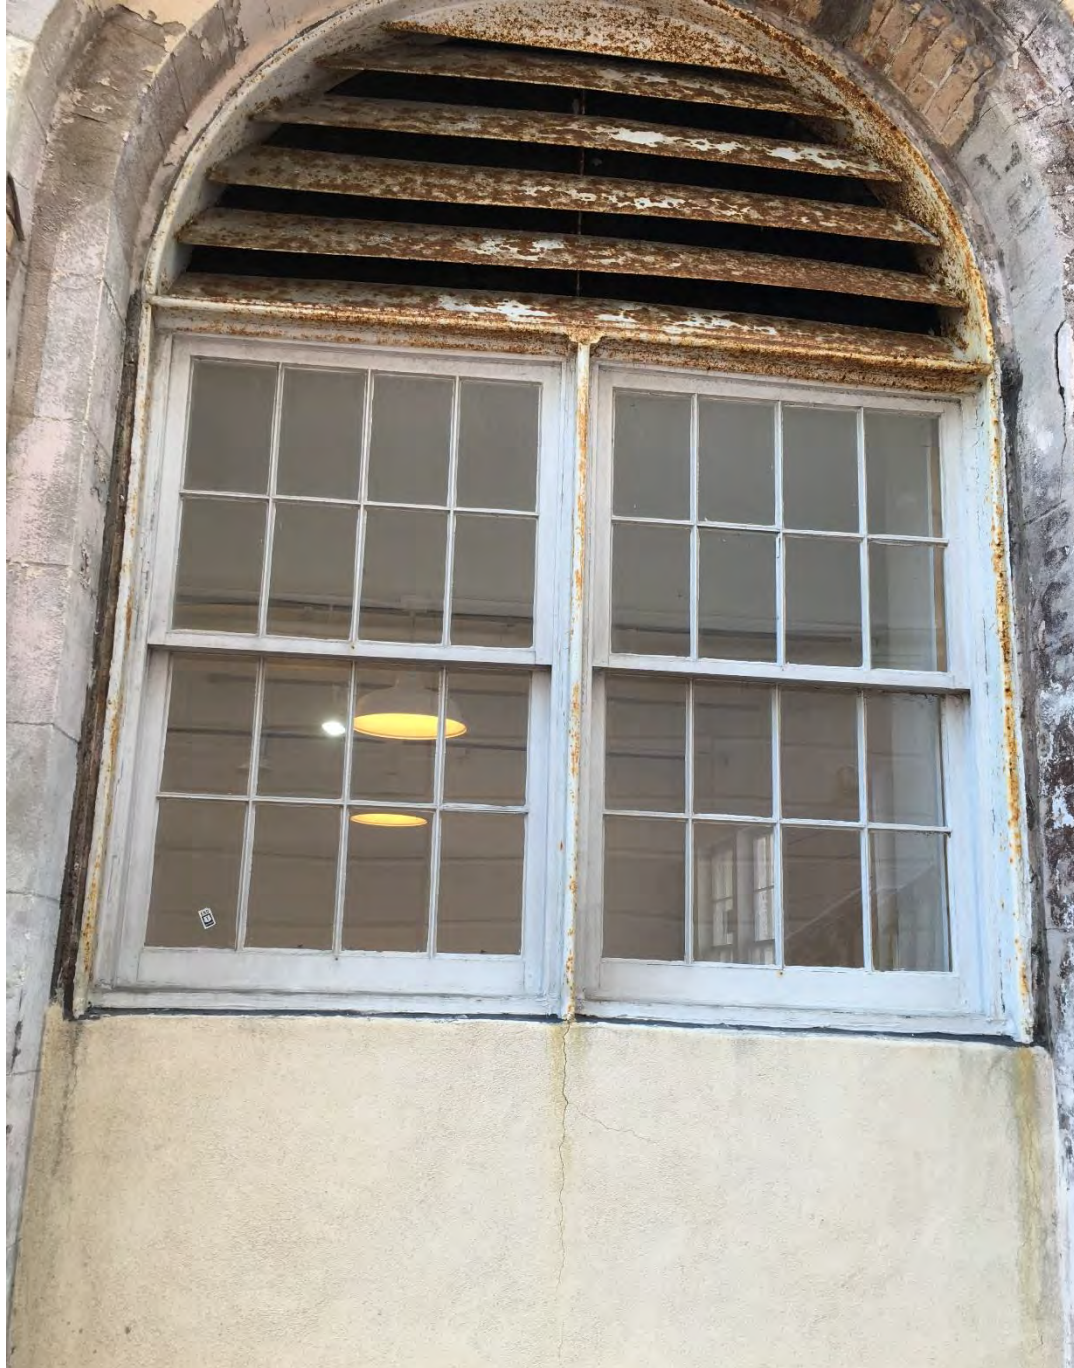
Photo showing non-historic 8/8 windows in west elevation of Building #1.

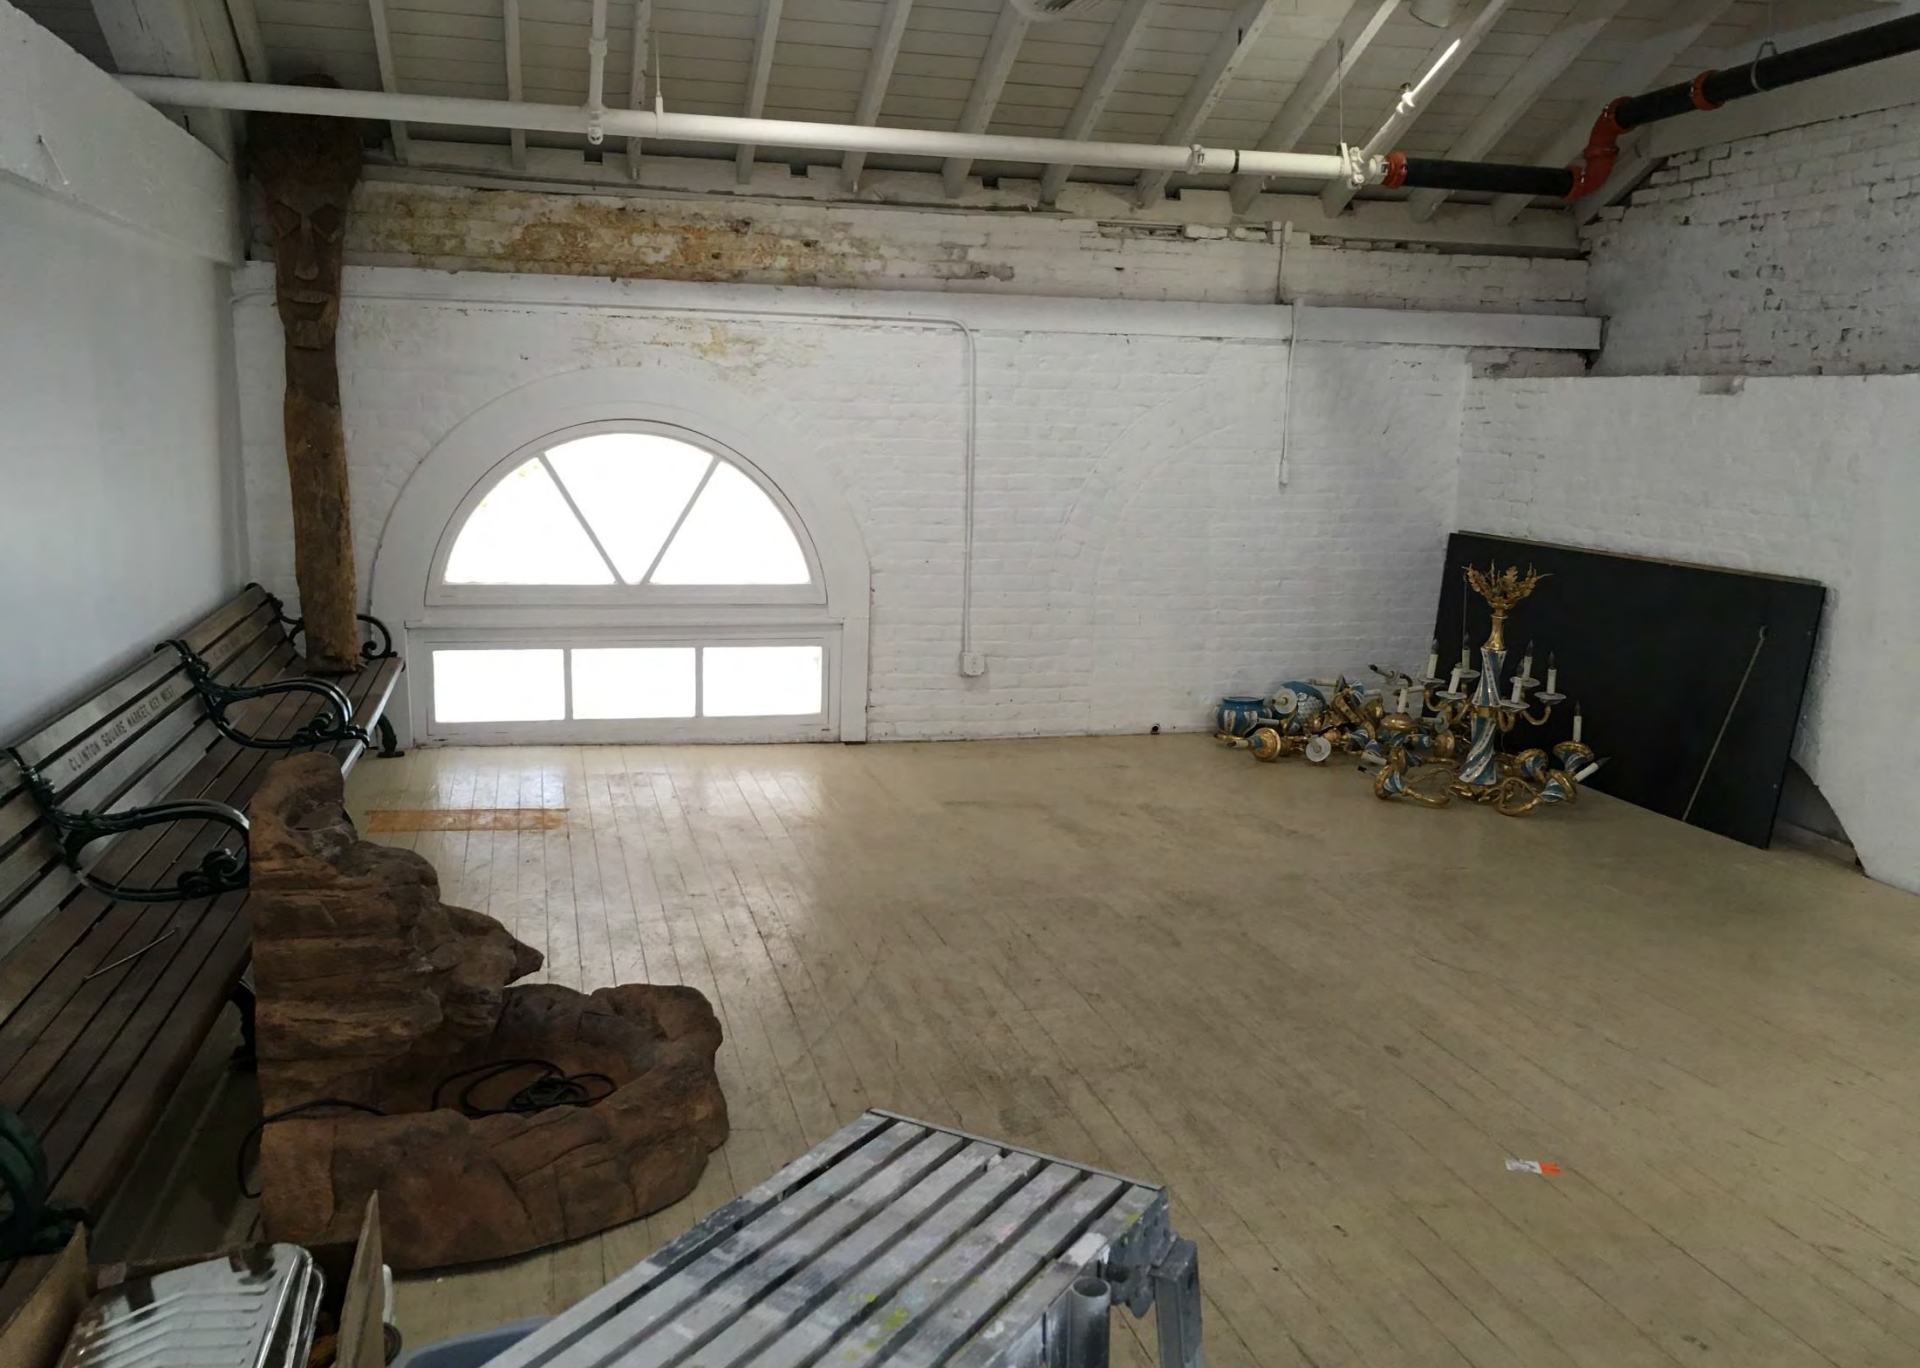
Photo showing interior view of arched windows in north elevation of Building #1.
