Single-Family Home Rainwater-Harvesting System Demonstration Project For Stormwater-Runoff Control and Utility-Water Saving

Hammerstrom, J. and T. Younos. 2014. Single-family home rainwater-harvesting system demonstration project for stormwater-runoff control and utility-water saving. The Cabell Brand Center Special Report No. 100-2014, 34 pp.

Abstract

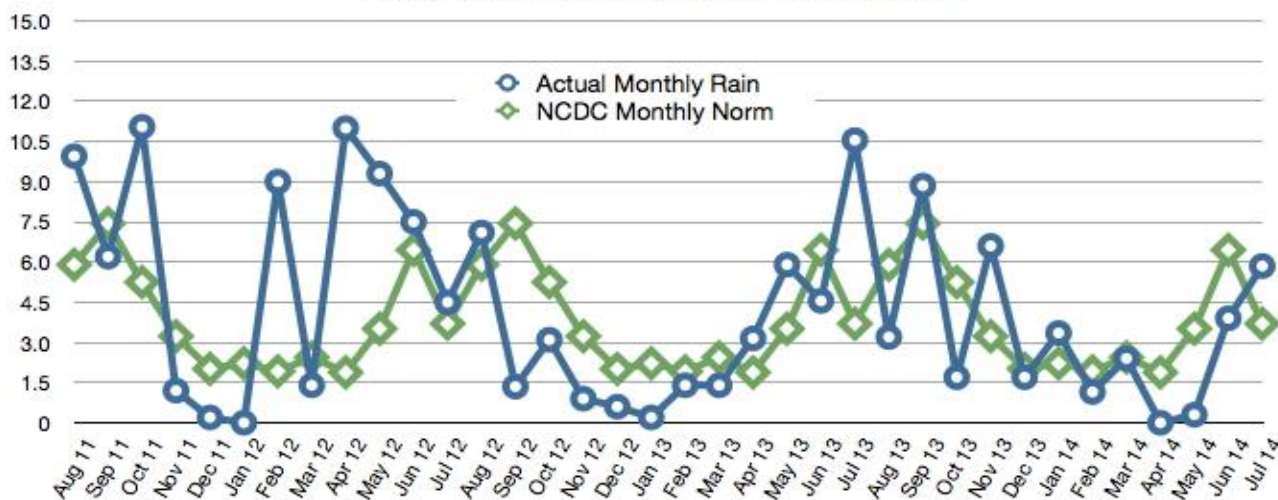
Figure 1 - Monthly Rainfall vs. NCDC Monthly Norm

Rainfall for the three-year study period (8/1/2011 to 8/1/2014) was measured regularly and after rain events, using a common garden rain gauge. According to the National Climatic Data Center (NCDC – www.ncdc.noaa.gov), the 30-Year (1981-2010) Monthly Normal precipitation for nearby Tavernier, Florida, was 45.95 inches. For the period of the study at the project demonstration site, the average annual rainfall was 50.2 inches per year. The rainfall (Figure 1) during this study did not follow the historical patterns in February through May 2012, when greater than average seasonal rain

fell. The longest periods without rain were 58 days between December 2011 and January 2012, 47 days between late March and mid May 2014 and 39 days in December through mid-January 2013.

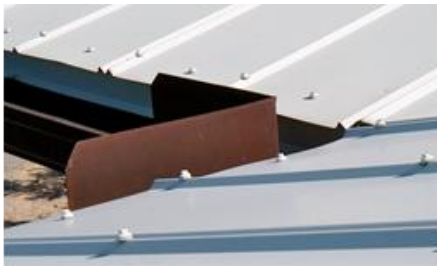
Figure 2

Components of the rainwater capture system include a 1,956 square-foot white metal Galvalume™ roof with 6-inch copper gutters and splash guards (Figure 2); Schedule 40 PVC downspouts and conveyance; a pre-filtration and first-flush system (Figure 3); calming inlets (Figure 4); and a 7,500-usable-gallon, ground-level poured concrete tank which is integrated into the concrete home structure (Figures 5a and 5b). The total volume of the storage tank is 10,000 gallons, with usable volume diminished by unusable water below the foot valves and dead space above the overflow. The tank is separated into two halves by an internal concrete wall with overflow gaps at the top, such that when the first half is full, rain overflows to the second half. When the second half is full, the tank overflows passively to a spreader swale (Figure 6).

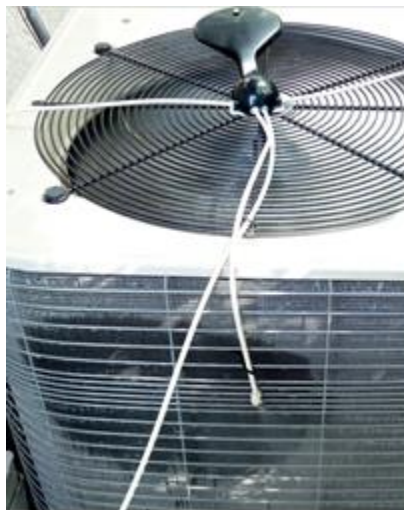
Figure 12

Onsite uses of treated rainwater include uses typical of a residence, from landscape and toilet flushing to ice making. The home is equipped with dual-flush toilets, with the low-flush and high-flush used normally for liquids and solids respectively, but the high flush being used for both purposes during the rainy season to accelerate consumption. In South Florida, the rainy season is also the hot season. Between May or June and November (depending on when the rains begin), rainwater was used as the source for a "Cool-N-Save" air conditioning pre-cooling mist system (Figure 12) to reduce energy consumption and to reduce overflows.

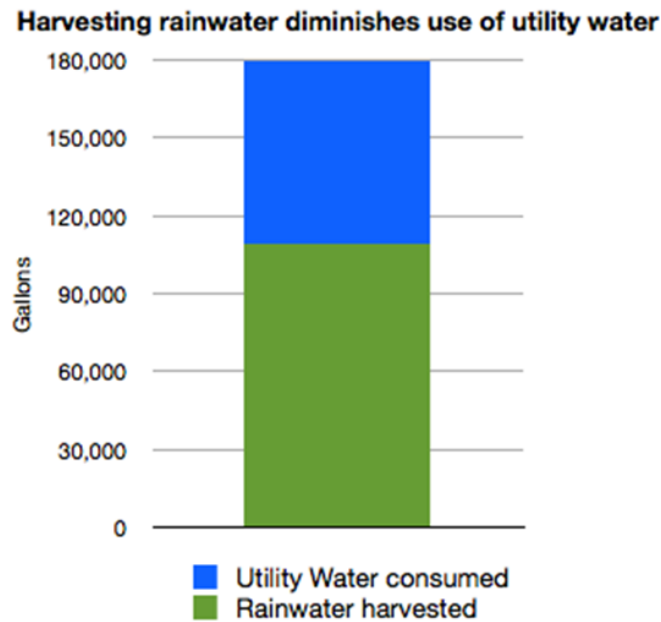
Figure 14 shows the impact of rainwater harvesting on utility water consumption. Of the total 183,077 gallons of water consumed during the three years, 108,850 gallons (59%) was provided by harvested rainwater. As a result of rainwater use, utility water consumption was 33.9 gallons per capita per day (gpcd) compared to the utility-wide average of 107 gallons per capita per day. Both treated rainwater and utility water were used during the study period and the combined total water usage was 83.6 gallons per day per capita, still below the average utility-wide consumption, but below that of water-conserving homes, due in part to the intentional accelerated consumption (creating tank capacity) to avoid potential runoff.

Figure 14. The impact of rainwater harvesting on utility water consumption

The greatest rainfall event (with the greatest overflow) during the 3-year period was 9.4 inches over a three-day period (July 15-18, 2013). During this event, 4,400 gallons of rainwater were captured and 4,950 gallons overflowed to the spreader swale. Because this was the greatest overflow event, additional storage capacity of 4,950 gallons, for a total of 12,450 gallons (4,950 + 7,500) could have stored all of the rainwater during the three-year study. Overall, total rainfall captured during the three-year demonstration period (150,500 gallons) was nearly the same as the total water consumed for the period (183,077 gallons), which means with a 12,450-gallon tank and modestly increased efficiency and conservation, total rainfall could have met all demands with nearly zero overflows.
