STAFF REPORT

RE: **1319 William Street & 1316 Royal Street
(permit application # TP2021-0002)**

FROM: Karen DeMaria, City of Key West Urban Forestry Manager

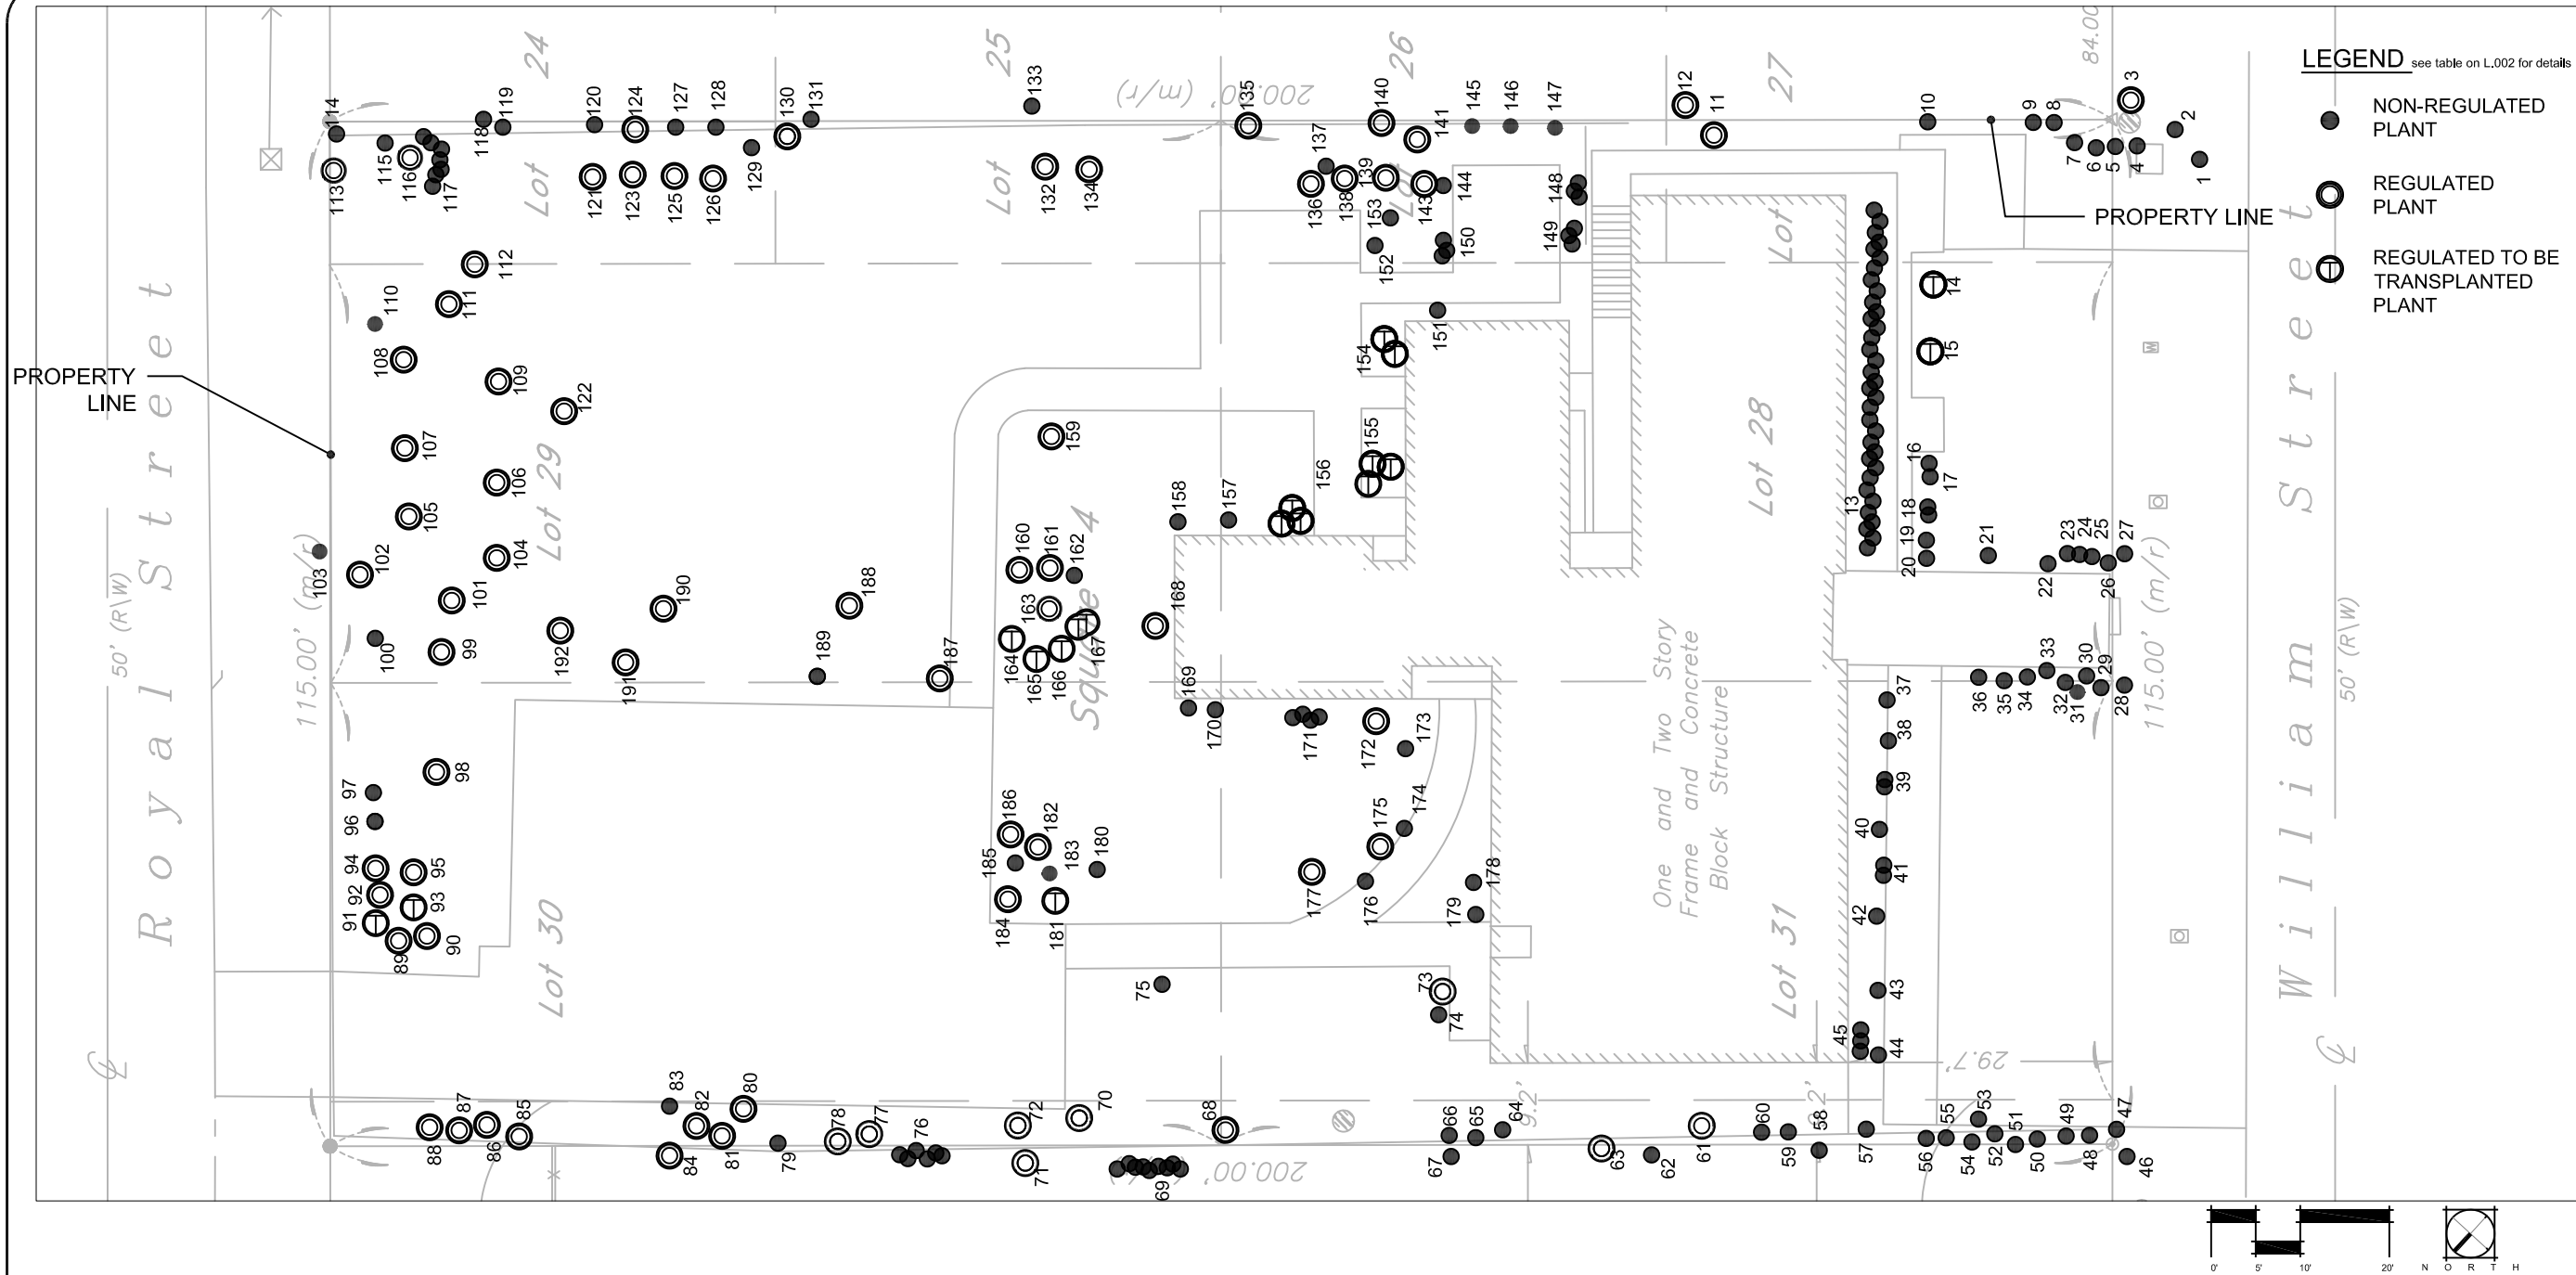
Common Name/Botanical Name	Size	Status	Cond	Remain/Remove/Transplant	Arborist Remarks
1 Ixora/Ixora coccinea	Shrub 6-8' oa	npr	good	Remain	photo 2
2 Ixora/Ixora coccinea	Shrub 6-8' oa	npr	good	Remain	
3 Gumbo Limbo/Bursea simaruba	16.7" dsh 18'x15'w	regulated	fair	Remain	
4 Ixora/Ixora coccinea	Shrub	npr	good	Remain	
5 Ixora/Ixora coccinea	Shrub	npr	good	Remain	
6 Ixora/Ixora coccinea	Shrub	npr	good	Remain	neighbors property, codominant @2', leaning south
7 Ixora/Ixora coccinea	Shrub	npr	good	Remain	
8 Pink Tabebuia/Tabebuia heterophylla	17.5" dsh 25'x15'w	npr	poor	Remain	
9 Pink Tabebuia/Tabebuia heterophylla	13.25" dsh 20'x10'w	npr	poor	Remain	
10 Pink Tabebuia/Tabebuia heterophylla	20" dsh 40'x20'w	npr	poor	Remain	
11 Jamaican Caper/Capparis cynophallophora	3.3" dsh 10-12'x8'w	regulated	good	Remain	shared tree, ccdominant branches with included bark, leaning south, in utility lines, topped, growing under concrete pad

12 Strangler Fig/Ficus aurea	6.33" dsh B 40'x30'w	regulated	good	Remain	
13 Green Island Ficus/Ficus microcarpa	Shrub 3' oa	npr	fair	Remain	
14 Christmas Palm/Adonidia merrillii	Double 13' oa	regulated	good	Transplant	
15 Christmas Palm/Adonidia merrillii	Double 13' oa	regulated	good	Transplant	
16 Plumbago/Ceratostigma plumbaginoides	Shrub	npr	good	Remain	in planter, 42'x4'
17 Arboricola/shefflera arboricola	Shrub	npr	good	Remain	
18 Christmas Palm/Adonidia merrillii	Triple 8' oa	npr	good	Remain	
19 Arboricola/shefflera arboricola	Shrub	npr	good	Remain	
20 Plumbago/plumbago ariculata	Shrub	npr	good	Remain	
21 Arboricola/shefflera arboricola	Shrub	npr	good	Remove	affected by prepposed plans
22 Bougainvillea species	Trellised	npr	poor	Remove	
23 Arboricola/shefflera arboricola	Shrub 3' oa	npr	good	Remove	
24 Arboricola/shefflera arboricola	Shrub 3' oa	npr	good	Remove	
25 Arboricola/shefflera arboricola	Shrub 3' oa	npr	good	Remove

26 Bougainvillea species	Trellised	npr	poor	Remove	affected by prepposed plans, poor condition
27 Golden Dewdrop/Duranta erecta	Shrub 4'x3'	npr	fair	Remove	
28 Golden Dewdrop/Duranta erecta	Shrub 4'x3'	npr	fair	Remove	
29 Bougainvillea species	Trellised	npr	poor	Remove	
30 Arboricola/shefflera arboricola	Shrub 3'x3'	npr	fair	Remove	
31 Arboricola/shefflera arboricola	Shrub 3'x3'	npr	fair	Remove	affected by prepposed plans
32 Arboricola/shefflera arboricola	Shrub 3'x3'	npr	fair	Remove	
33 Bougainvillea species	Trellised	npr	poor	Remove	
34 Arboricola/shefflera arboricola	Shrub 3'x3'	npr	fair	Remove	
35 Arboricola/shefflera arboricola	Shrub 3'x3'	npr	fair	Remove	
36 Arboricola/shefflera arboricola	Shrub 3'x3'	npr	fair	Remove	affected by prepposed plans
37 Draceana species/	Shrub	npr	fair	Remain	
38 Yucca/	Shrub 8' h	npr	fair	Remain	
39 Fishtail Palm/caryota mitis	18' h	npr	poor	Remove	
40 White Bird of Paradise/Strelitzia nicolai	4'x2' 2' h	npr	good	Remain

41 Ponytail Palm/Beaucarnea recurvata	5'x10'	npr	fair	Remain	remove, poor condition
42 Fishtail Palm/caryota mitis	6-7' h	npr	poor	Remove	
43 Fishtail Palm/caryota mitis	18' h	npr	poor	Remove	
44 Draceana species	Shrub 4' h	npr	fair	Remain	
45 Green Island Ficus/Ficus microcarpa	Shrub 3.5'x1'	npr	fair	Remain	
46 Pink Tabebuia/Tabebuia heterophylla	5.2" dsh 12'x5'w	npr	poor	Remain	leaning west, remain, outside property
47 Pink Tabebuia/Tabebuia heterophylla	15" dsh 25'x15'w	npr	poor	Remain	
48 Pink Tabebuia/Tabebuia heterophylla	6" dsh	npr	poor	Remain	
49 Pink Tabebuia/Tabebuia heterophylla	6.7" dsh	npr	poor	Remain	
50 Pink Tabebuia/Tabebuia heterophylla	5" dsh	npr	poor	Remain	
51 Pink Tabebuia/Tabebuia heterophylla	2" dsh	npr	poor	Remain	seedling, north side of fence, topped, remain, outside property
52 Pink Tabebuia/Tabebuia heterophylla	3" dsh	npr	poor	Remain	
53 Pink Tabebuia/Tabebuia heterophylla	8.5" dsh	npr	poor	Remain

54 Pink Tabebuia/Tabebuia heterophylla	5.5" dsh 25'x10'w	npr	poor	Remain	
55 Pink Tabebuia/Tabebuia heterophylla	14.75" dsh 35'x15'w	npr	poor	Remain	
56 Pink Tabebuia/Tabebuia heterophylla	1.75" dsh	npr	poor	Remain	seedling, north side of fence, through fence, remain, outside property
57 Neem/Azadirachta indica	2.5" dsh 12'x4'w	npr	poor	Remain	
58 Pink Tabebuia/Tabebuia heterophylla	10.5" dsh 23'x12'w	npr	poor	Remain	
59 Pink Tabebuia/Tabebuia heterophylla	3" dsh 20'x4'w	npr	poor	Remain	
60 Pink Tabebuia/Tabebuia heterophylla	4.2" dsh 22'x8'w	npr	poor	Remove	
61 Christmas Palm/Adonidia merrillii	Triple 10'-16' oa	regulated	fair	Remain	north side of fence, growing through fence, remain, outside property
62 Pink Tabebuia/Tabebuia heterophylla	14" dsh 30'x20'w	npr	poor	Remain	
63 Christmas Palm/Adonidia merrillii	20' h	regulated	fair	Remain	
64 Bamboo Plm/Chamaedorea seifrizii	Cluster 7 canes	npr	poor	Remove

65 Bamboo Plm/Chamaedorea seifrizii	Cluster 4 canes	npr	poor	Remove	
66 Bamboo Plm/Chamaedorea seifrizii	Cluster 8 canes	npr	poor	Remove	remove, poor condition
67 Pink Tabebuia/Tabebuia heterophylla	14" dsh 37'x15'w	npr	fair	Remain	
68 Sweet Acacia/Acacia farnesiana	14.6" dsh 12'x15'w	regulated	poor	Remove	
69 Areca Palm/Dypsis lutescens	Grouping 10'-12' oa	npr	fair	Remain	
70 Christmas Palm/Adonidia merrillii	Cluster 11 6-18' oa	regulated	fair	Remove	
71 Christmas Palm/Adonidia merrillii	Cluster of 8 20'-22' oa	regulated	fair	Remain	remove, affected by proposed design
72 Christmas Palm/Adonidia merrillii	Cluster of 5 8'-18' oa	regulated	fair	Remove	
73 Washingtonia Palm/Washingtonia robusta	40' oa	regulated	poor	Remove	
74 Pink Tabebuia/Tabebuia heterophylla	8" dsh 25'x10'w	npr	poor	Remove	
75 Pink Tabebuia/Tabebuia heterophylla	12" dsh 30'x20'w	npr	poor	Remove	
76 Areca Palm/Dypsis lutescens	Cluster 10'x6'w	npr	fair	Remain	north of fence outside property

77 Christmas Palm/Adonidia merrillii	18'-20' oa	regulated	good	Remove	
78 Frangipani/Plumeria	10.5" dsh 20'x18'w	regulated	fair	Remove	
79 Draceana species	Shrub 10'x5'w	npr	poor	Remain	
80 Gumbo Limbo/Bursea simaruba	10.6" dsh 20'x20'w	regulated	fair	Remain	
81 Gumbo Limbo/Bursea simaruba	3.3" dsh 18'x4'w	regulated	poor	Remove	4 codominant branches, remain, to be trimmed 4' CT
82 Satin Leaf/Chrysophyllum olidiforme	6" dsh 20'x8'w	regulated	poor	Remove	
83 Pink Tabebuia/Tabebuia heterophylla	20.2" dsh 22'x15'w	npr	poor	Remove	
84 Coconut Palm/cocos nucifera	35'-40' oa	regulated	fair	Remain	
85 Satin Leaf/Chrysophyllum olidiforme	5" dsh 10'x14'w	regulated	fair	Remain	
86 Gumbo Limbo/Bursea simaruba	9.5" dsh 20'x10'w	regulated	fair	Remain	leaving west
87 Jamaican Caper/Capparis cynophallophora	Multi 12" dsh 15'x10'w	regulated	fair	Remain	
88 Satin Leaf/Chrysophyllum olidiforme	4.4" dsh 13'h	regulated	poor	Remove

89 Royal Poiniana/Delonix regia	16.4" dsh 18'h 25'w	regulated	fair	Remain	
90 Jamaican Caper/Capparis cynophallophora	Multi 7.5" dsh 18'x8'w	regulated	fair	Remove	
91 Florida Thatch Palm/Thrinax radiata	8' oa	regulated	good	Transplant	transplant, see L3.00
92 Jamaican Caper/Capparis cynophallophora	Multi 2" dsh 10' oa	regulated	poor	Remove	
93 Florida Thatch Palm/Thrinax radiata	10' h	regulated	good	Transplant	
94 Jamaican Caper/Capparis cynophallophora	2" dsh	regulated	poor	Remove	
95 Jamaican Caper/Capparis cynophallophora	Multi 10" dsh 16'x8'w	regulated	fair	Remove	
96 Jamaican Caper/Capparis cynophallophora	Multi 1" dsh	npr	poor	Remove	through fence, remove, poor condition
97 Jamaican Caper/Capparis cynophallophora	.75" dsh 5' oa	npr	fair	Remove	
98 Jamaican Caper/Capparis cynophallophora	Multi 14" dsh 18'x15'w	regulated	fair	Remove	
99 Jamaican Caper/Capparis cynophallophora	Multi 12" dsh 14'0h	regulated	poor	Remove

101 Gumbo Limbo/Bursea simaruba	8.5" dsh 25'x8'w	regulated	good	Remain	remain, work with city arborist
102 Royal Poinciana/Delonix regia	21" dsh 18'x20'w	regulated	fair	Remain	remain Photo 11
103 Jamaican Caper/Capparis cynophallophora	.5" dsh	npr	poor	Remove	seedling, through fence, remove, poor condition
104 Small Leaf Clusia/Clusia guttifera	14" dsh 20'x8'w	regulated	poor	Remove	partially uprooted, remove
105 Small Leaf Clusia/Clusia guttifera	14.3" dsh 20'x20'w	regulated	poor	Remove	remove, poor condition
106 Small Leaf Clusia/Clusia guttifera	16" dsh 20'x15'w	regulated	poor	Remove	partially uprooted, remove, poor condition
107 Small Leaf Clusia/Clusia guttifera	12.7" dsh 18'x20'w	regulated	poor	Remove	remove
108 Royal Poinciana/Delonix regia	25" dsh 25'x25'w	regulated	fair	Remain	retain and protect
109 Small Leaf Clusia/Clusia guttifera	18" dsh 20'x20w	regulated	poor	Remove	uprooted, remove, poor condition

110 Jamaican Caper/Capparis cynophallophora	.5" dsh 7'x3'w	npr	fair	Remove	remove, no regulated, close proximity to 108
111 Fiji Fan Palm/Pritchardia pacifica	25' h	regulated	fair	Remove	remove, affected by proposed design
112 Gumbo Limbo/Bursea simaruba	4.7" dsh 14'x6'w	regulated	poor	Remove	topped, restricted growth due to overhead canopy, leaning south with dog leg, remove
113 Sabal Palm/Sabal palmetto	16' oa	regulated	poor	Remain	may require trimming to not conflict with utilities, city property
114 Pink Tabebuia/Tabebuia heterophylla	10" dsh 20'x10'w	npr	poor	Remove	remove, conflict with utilities, city property
115 Jamaican Caper/Capparis cynophallophora	.5"	npr	poor	Remove	seedling, remove, poor condition
116 Coconut Palm/cocos nucifera	40'	regulated	fair	Remain	retain and protect
117 Coconut Palm/cocos nucifera	Seedlings (5) 2'-4' oa	npr	good	Remove	remove, affected by proposed design
118 Brazilian Pepper/Schinus terebinthifolius	4" dsh	npr	poor	Remove	over fence, remove invasive

119 Pink Tabebuia/Tabebuia heterophylla	12" dsh 16'x8'w	npr	poor	Remove	uprooted, remove
120 Aralia/Polyscias	Shrub 3" dsh 12't 4'w	npr	poor	Remove	uprooted, broken, remove
121 Jamaican Caper/Capparis cynophallophora	18" dsh 18'x10'w	regulated	poor	Remove	partially uprooted, remove
122 Red Coco Plum/Chrysobalanus icaco v. red tip	7" dsh	regulated	poor	Remove	partially uprooted, remove
123 Jamaican Caper/Capparis cynophallophora	6" dsh 18'x10'w	regulated	poor	Remove	uprooted, remove
124 Gumbo Limbo/Bursea simaruba	1.3" dsh 8'-9'oa	regulated	poor	Remain	seedling, remain, outside property
125 Jamaican Caper/Capparis cynophallophora	15" dsh 18'x20'w	regulated	poor	Remove	uprooted,, damaged, remove
126 Jamaican Caper/Capparis cynophallophora	14.6" dsh	regulated	poor	Remove	partially uprooted, remove
127 Pink Tabebuia/Tabebuia heterophylla	6" dsh 18'x8'w	npr	poor	Remain	through fence, remain, outside property

128 Surinam Cherry/Eugenia uniflora	Shrub 1" dsh 4'-5'oa	npr	poor	Remain	remain, outside property, invasive exotic
129 Veitchia/Veitchia spec.	<10 ft CT	npr	good	Remove	remove, affected by proposed design
130 Pink Tabebuia/Tabebuia heterophylla	27" dsh 32'x15'w	regulated	poor	Remain	retain and protect
131 Bamboo Palm/Chamaedorea seifrizii	2 canes 12' oa	npr	poor	Remove	remove, poor condition
132 Jamaican Caper/Capparis cynophallophora	multi 10" dsh 18'x6'w	regulated	poor	Remove	partially uprooted, remove
133 Pink Tabebuia/Tabebuia heterophylla	16.5" dsh	npr	poor	Remain	neighbor property south side of fence, on fence, 16.5" dia. branch growing north into property 12', remove limb Photo 13
134 Jamaican Caper/Capparis cynophallophora	12" dsh 12'x10'w	regulated	poor	Remove	uprooted, remove
135 Jamaican Caper/Capparis cynophallophora	3" dsh 15'x5'w	regulated	poor	Remain	through fence, remain
136 Small Leaf Clusia/Clusia guttifera	6.7" dsh 10'x10'w	regulated	poor	Remove	partially uprooted, topped, remove

137 Pink Tabebuia/Tabebuia heterophylla	3.4" dsh 16'x6'w	npr	poor	Remove	remove, invasive exotic
138 Small Leaf Clusia/Clusia guttifera	7.5" dsh 15'x20'w	regulated	poor	Remove	uprooted, through fence, remove
139 Royal Poinciana/Delonix regia	7.1" dsh 30'x15'w	regulated	fair	Remain	retain and protect
140 Christmas Palm/Adonidia merrillii	18' oa	regulated	good	Remain	Remain , outside property
141 Gumbo Limbo/Bursea simaruba	18.1" dsh 30'x20'w	regulated	fair	Remain	on fence, leaning south at utility pole, remain, heavy maintenance trim Photo 14
142 NOT USED					
143 Small Leaf Clusia/Clusia guttifera	6.2" dsh 10'x8'w	regulated	poor	Remove	partially uprooted, remove
144 Draceana species	Shrub 7'x5'w	npr	poor	Remove	remove, not regulated, affected by proposed design
145 Myrsine/Rapanea punctata	<1" dsh Shrub 6'-10' h	npr	poor	Remain	Remain , outside property
146 Myrsine/Rapanea punctata	<1" dsh Shrub 6'-10' h	npr	poor	Remain	Remain , outside property

147 Myrsine/Rapanea punctata	<1" dsh Shrub 6'-10' h	npr	poor	Remain	Remain , outside property
148 Areca Palm/Dypsis lutescens	3 canes 7'-8'	npr	fair	Remove	remove, not regulated, affected by proposed design
149 Areca Palm/Dypsis lutescens	4 canes 8'-10'	npr	fair	Remove	remove, not regulated, affected by proposed design
150 Areca Palm/Dypsis lutescens	10-14'oa 10 canes	npr	fair	Remove	remove, not regulated, affected by proposed design
151 Pink Tabebuia/Tabebuia heterophylla	5" dsh 18'x4'w	npr	poor	Remove	on roof, roots under structure, remove
152 Bamboo Palm/Chamaedorea seifrizii	5 canes 4' h	npr	poor	Remove	remove, poor condition
153 Christmas Palm/Adonidia merrillii	6' oa	npr	good	Remove	remove, not regulated, affected by proposed design
154 Keys Thatch Palm/Leucothrinax morrisii	double 8',3' h	regulated	good	Transplant	transplant, see L3.00
155 Keys Thatch Palm/Leucothrinax morrisii	triple, 6'-11' h	regulated	good	Transplant	transplant, see L3.00

156 Keys Thatch Palm/Leucothrinax morrisii	triple 5'-6' h	regulated	good	Transplant	transplant, see L3.00
157 Pink Tabebuia/Tabebuia heterophylla	13.6" @base 30'x10'w	npr	poor	Remove	remove, invasive exotic
158 Pink Tabebuia/Tabebuia heterophylla	11.3" dsh 30'x20'w	npr	poor	Remove	remove, invasive exotic
159 Washingtonia Palm/Washingtonia robusta	40' oa	regulated	poor	Remove	remove, poor condition
160 Jamaican Caper/Capparis cynophallophora	2" dsh 5.5'x5'w	regulated	poor	Remove	hedged, remove
161 Gumbo Limbo/Bursea simaruba	6.5" dsh 15'x12'w	regulated	poor	Remove	leaning south, under canopy, remove
162 Washingtonia Palm/Washingtonia robusta	4'oa	npr	poor	Remove	remove, invasive exotic
163 Raintree Tree/Samanea saman	25' @3'h	regulated	poor	Remove	tree in decline, sunscald, fungus, dead limbs, remove Photo 15, 16, 17, 18
164 Green Thatch Palm/Thrinax radiata	5' oa	regulated	good	Transplant	transplant, see L3.00 Photo 19

165 Green Thatch Palm/Thrinax radiata	6' oa	regulated	good	Transplant	transplant, see L3.00
166 Green Thatch Palm/Thrinax radiata	6' oa	regulated	good	Transplant	transplant, see L3.00
167 Green Thatch Palm/Thrinax radiata	6' oa	regulated	good	Transplant	clump, transplant, see L3.00
168 Fiddle Wood/Citharexylum spinosum	7.3" dsh 13'x10'w	regulated	poor	Remove	remove, poor condition
169 Pink Tabebuia/Tabebuia heterophylla	5.8" dsh 20'x8'w	npr	poor	Remove	remove, invasive exotic
170 Pink Tabebuia/Tabebuia heterophylla	2.7" dsh 13'x6'w	npr	poor	Remove	remove, invasive exotic
171 Pygmy Date Palm/Phoenix roebellenii	Triple 6'-12' oa	npr	poor	Remove	remove, poor condition
172 Mahogany/Swietenia mahogoni	9.7" dsh 20'x12'w	regulated	poor	Remove	remove, poor condition
173 Pink Tabebuia/Tabebuia heterophylla	9" dsh 20'x8'w	npr	poor	Remove	remove, invasive exotic
174 Pink Tabebuia/Tabebuia heterophylla	4.7" dsh 25'x6'w	npr	poor	Remove	remove, invasive exotic

175 Gumbo Limbo/Bursea simaruba	6.4" dsh 18'x10'w	regulated	poor	Remove	codominant branches, remove Photo 20
176 Pink Tabebuia/Tabebuia heterophylla	8.4" dsh 25'x12'w	npr	poor	Remove	remove, invasive exotic
177 Gumbo Limbo/Bursea simaruba	8.5" dsh 8'x20'w	regulated	poor	Remove	remove, poor condition
178 Pink Tabebuia/Tabebuia heterophylla	5.2" dsh 18'x6'w	npr	poor	Remove	leaning south, remove
179 Pink Tabebuia/Tabebuia heterophylla	8.9" dsh 23'x12'w	npr	poor	Remove	under concrete walkway, remove
180 Crinum Lilly/Crinum spp.	2 plants 3' oa	npr	fair	Remove	remove
181 Green Thatch Palm/Thrinax radiata	6' oa	regulated	good	Transplant	transplant, see L3.00
182 Lignum Vitae/Guaicum sanctum	7.5" dsh 8'x12'w	regulated	fair	Remain	Retain and protect, root prune

Recommendation: Recommend approval of the Final Landscape Plan With Tree Removal at 1319 William and 1316 Royal Streets to include the removal of 8-Small Leaf Clusia (#104, #105, #106, #107, #109, #136, #138, and #143), 3-Red Coco Plum (#122, #187, and #191), 1-Fiddle Wood (#168), 1-Frangipani (#78), 5-Gumbo Limbo (#81, #112, #161, #175, and #177), 14-Jamaican Caper (#90, #92, #94, #95, #98, #99, #121, #123, #125, #126, #132, #134, #160, and #186), 1-Mahogany (#172), 1-Raintree (#163), 2-Satin Leaf (#82 and #88), 2-Silver Buttonwood (#188 and #192), 1-Sweet Acacia (#68), 1-White Stopper (#184), 3-Christmas Palms (#70, #72, and #77), 1-Fiji Fan Palm (#111), 1-Royal Palm (#190), and 2-Washingtonia Palms (#73 and #159) to be replaced with 248.3 caliper inches of approved dicot trees, FL#1 from the approved list and 7 approved palms, minimum 4 ft tall each palm, to be planted onsite and the transplantation on site of 2-Christmas Palms (#14 and #15), 7-Thatch Palms, Florida (#91, #93, #164, #165, #166, #167, and #181), and 3-Thatch Palms, Keys (#154, #155, and #156).
