Stock Island Landfill
Gas and Water Sampling Brief

Upon request, the Utilities Department looked at the gas and water sampling activities at or around the Stock Island Landfill. We were also asked to provide any first-hand knowledge of other landfill mining or reuse projects that might give insight to the project.

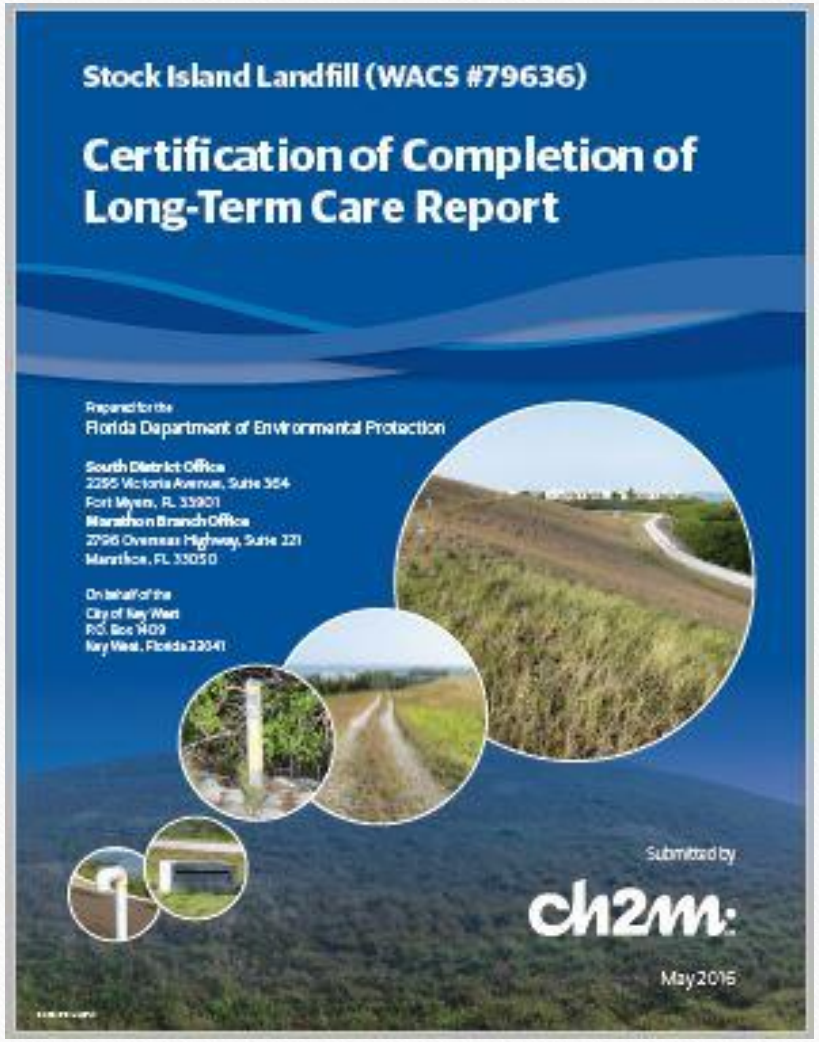
Results of gas vent sampling in May 2016 by City of Key West contractors CH2M for Closure Report.

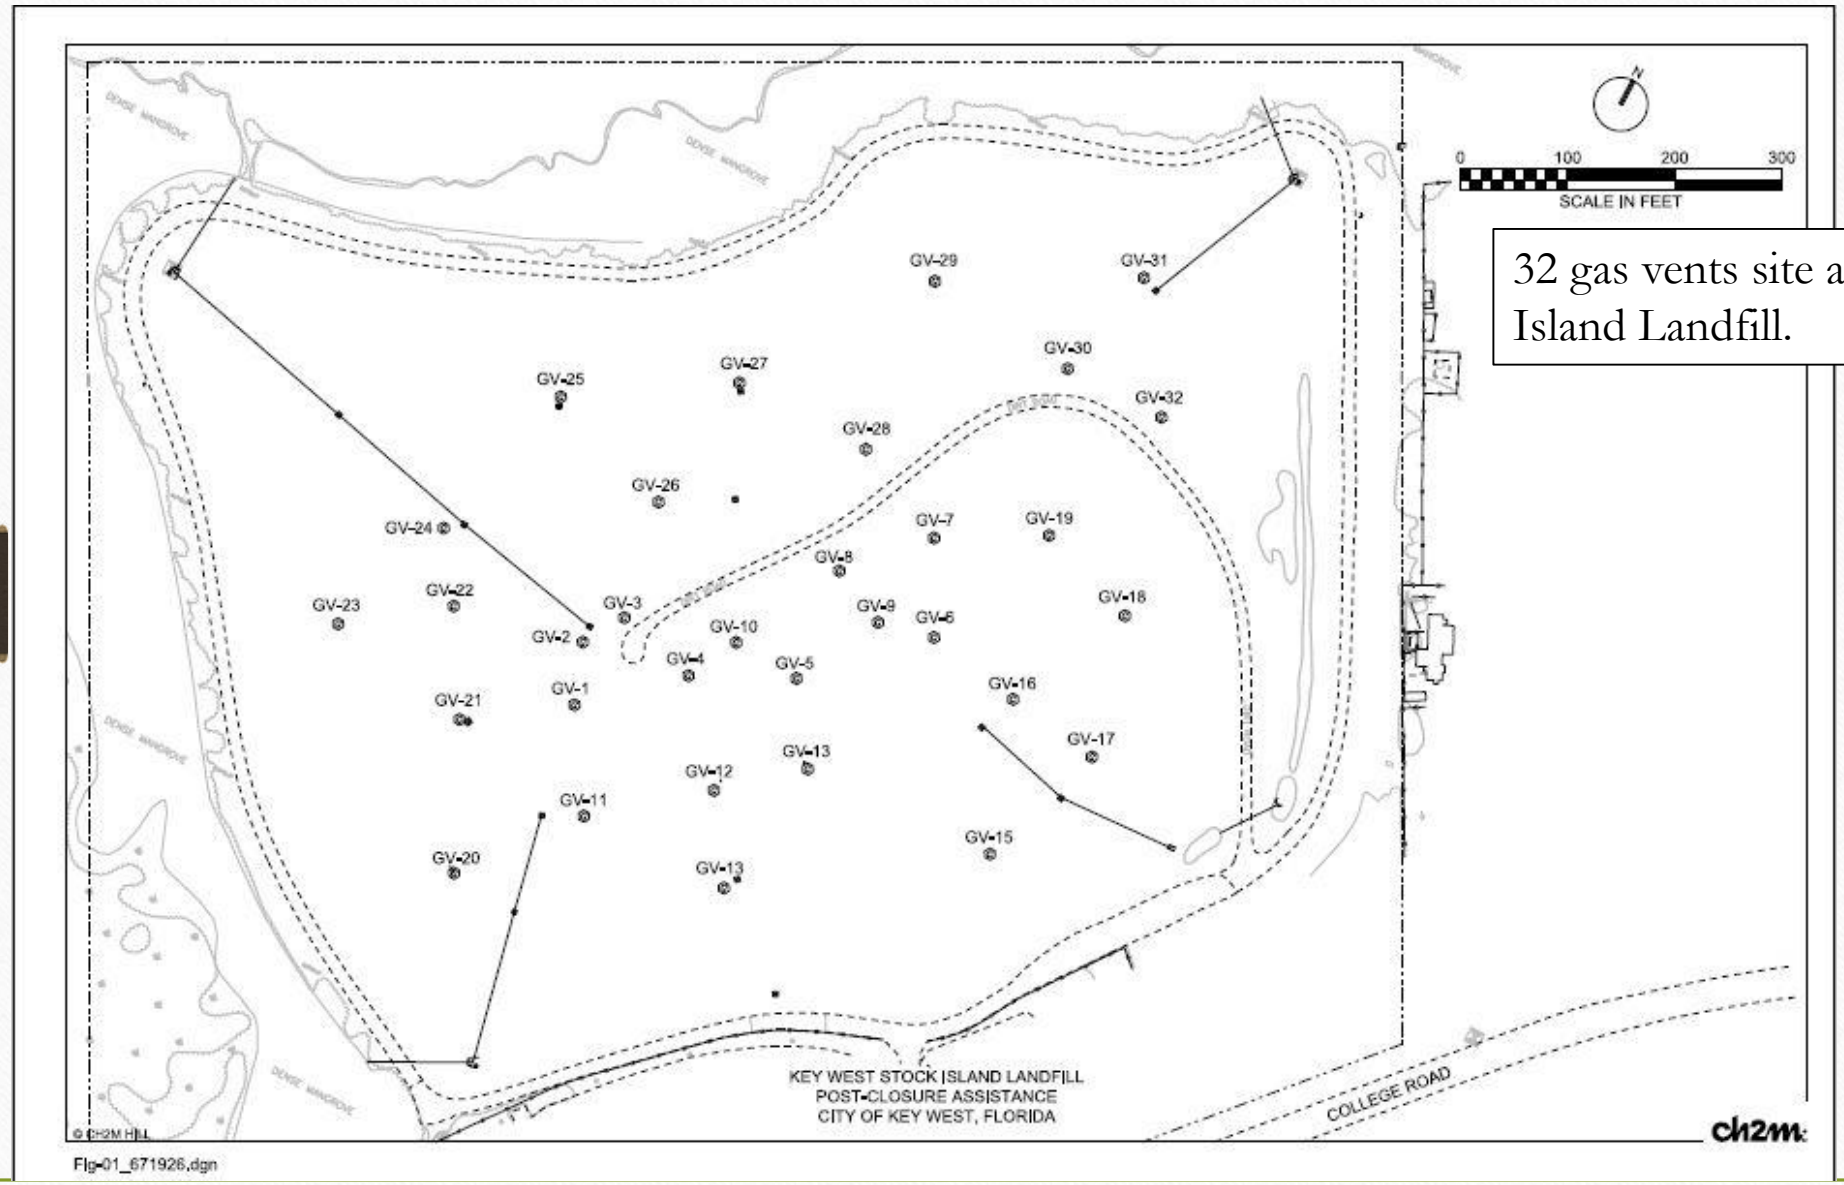
32 gas vents site at Stock Island Landfill.

Landfill Gas Vents GV-1 through GV-7, all located on the landfill peak, showed methane readings of > 100% LEL (% of the lower explosive limit for methane), when sampled directly from the vent. GV-1 through GV-7 were also the only vents to produce hydrogen sulfide readings, ranging from 1.3 to 6.9 ppm. GV-22, GV-26, and GV-29 yielded % LEL readings 30%, 4%, and 25% respectively.

Returned to vents 1-7 before 2:30pm, sampled a second time, yielding results of between 0 and 5 % LEL, significantly lower than initial sampling results.

It was hypothesized that the apparent decrease in venting could be associated with local tidal fluctuations, as the site is bordered by seawater on two sides and in close proximity on a third side. Initial comparisons of field measurements with NOAA tidal charts (Exhibit 5) supported this hypothesis and prompted development of a secondary testing plan.
