REPORT OF MARINE SURVEY

VALUATION APPRAISAL INSPECTION of the vessel

**" KEY WEST FIRE BOAT"
2003 Boston Whaler Guardian**

**PREPARED EXCLUSIVELY FOR:
Key West Fire Department
City of Key West**

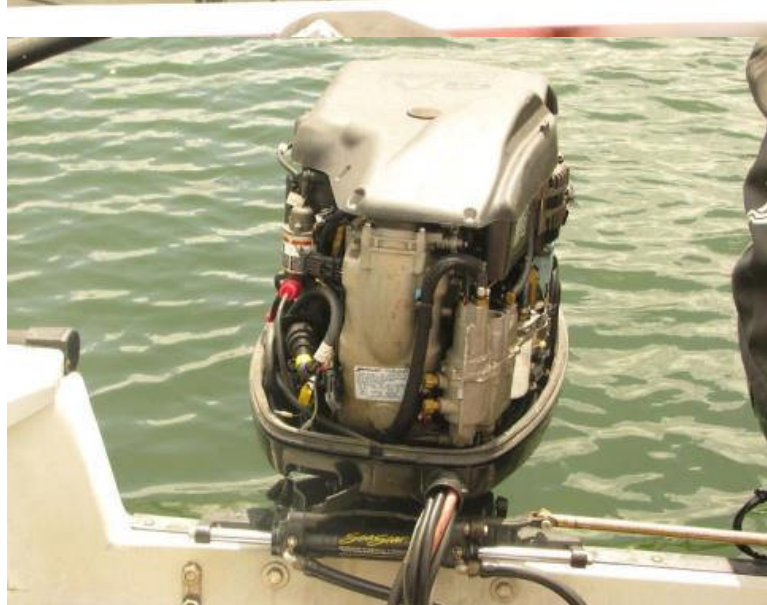
Condition summary: Engines appear to be in good condition however there are indications of lack of maintenance.

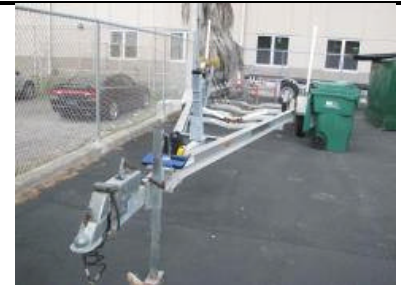
Continental dual axle trailer. Aluminum construction.

Not seen. Manufacturers information label UV damaged.

Aluminum frame
in good
condition.
Suspension
springs rusted.
Unknown if surge
brake is in
operating
condition. Tires
are in good
condition.

Recommend
springs be
inspected before
next use.
