STAFF REPORT

DATE: February 26, 2016

RE: **1664 Dunlap Drive-Poinciana Gardens**
(permit application # T16-7794)

FROM: Karen DeMaria, City of Key West Urban Forestry Manager

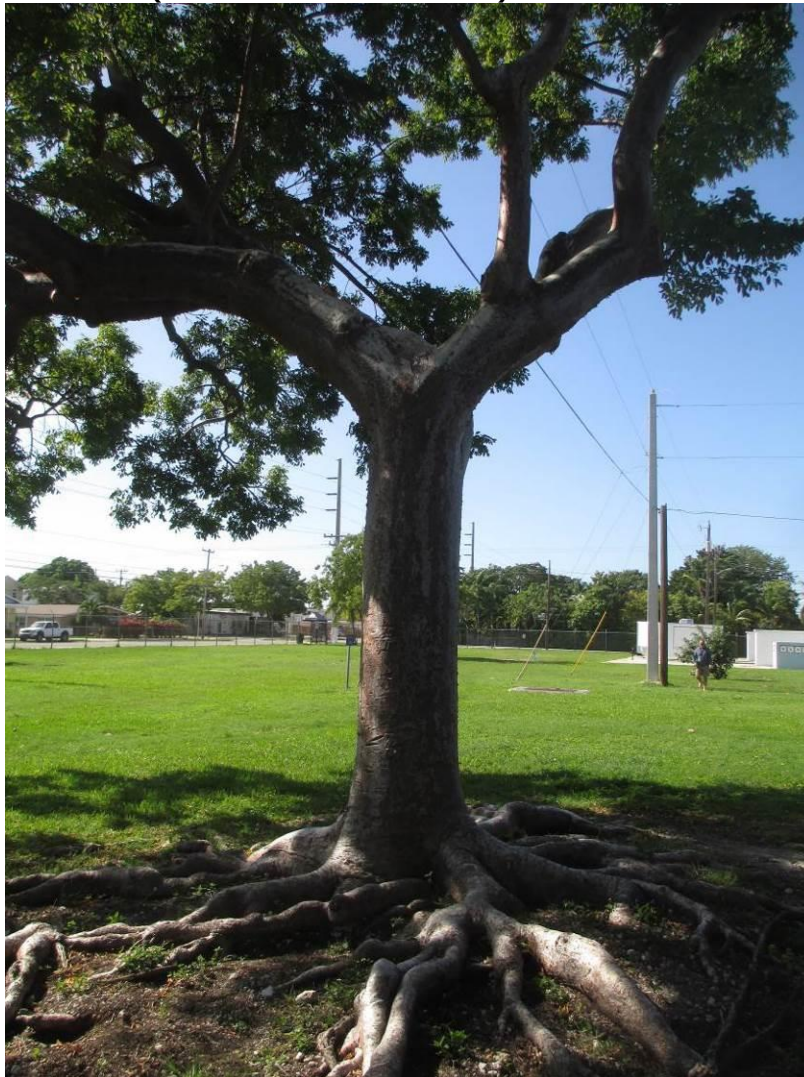
Tree #1: Gumbo Limbo (*Bursera simaruba*)

Condition: 60% (fair, a large tree, lots of exposed surface roots, some crossed branches in canopy)

Value x Diameter = 25 replacement caliper inches

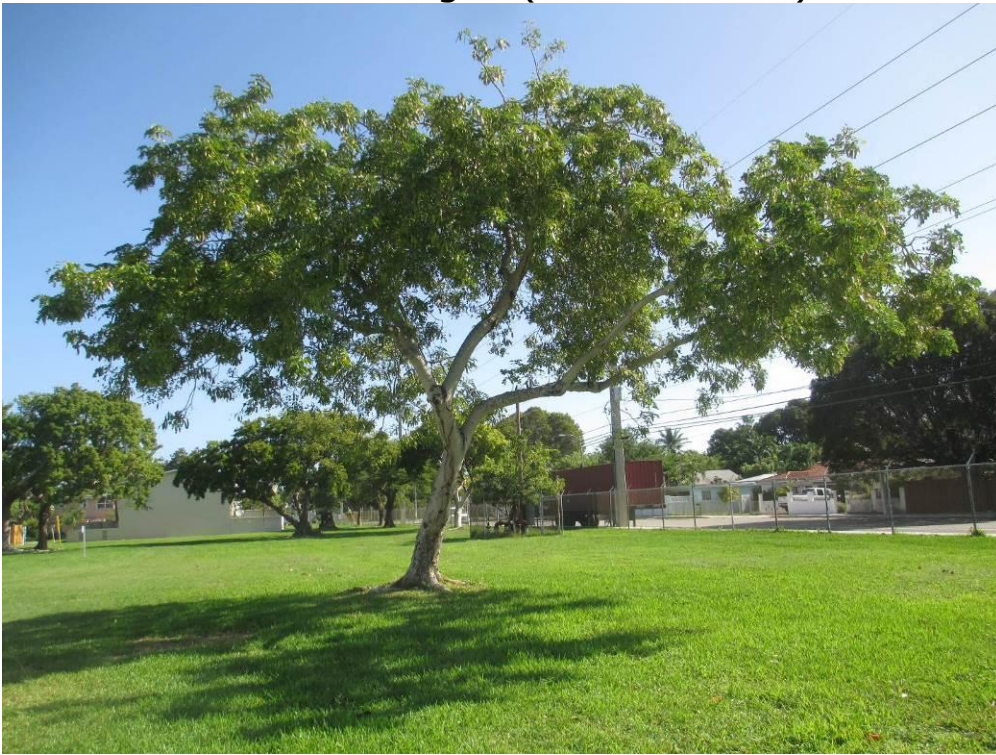
Tree #2: Woman's Tongue (*Albizia lebbek*)

Diameter: 16"
(less than 24"
dbh, no permit
required for
removal)
