BUILDING INSPECTION REPORT

Report Number
315

Margaret Street Turtle
Kraals Site
Key West, FL
33040

Inspection Date: **07/27/2015**

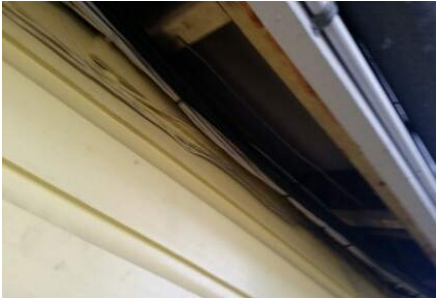
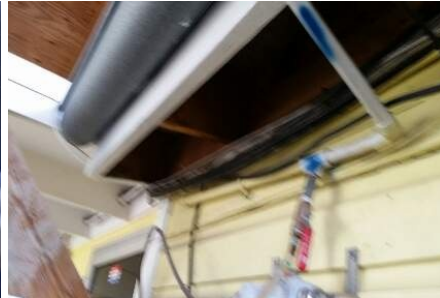
6.

Location: Exterior Ice Machine area **System:** Roof **Condition:** Soffit is missing

Explanation: Soffit protection is observed to be missing.

Impact Consequences: The soffit areas at roof edges are vulnerable to water infiltration and pest intrusion if not adequately sealed. Adding and or restoring soffit in this area is recommended.

Recommended Action: Install

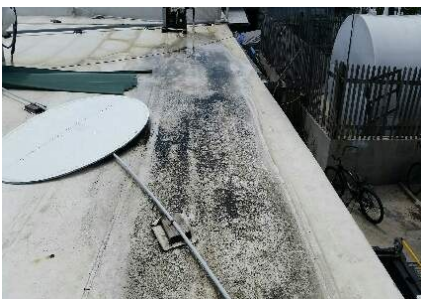
7.

Location: Roof **System:** Roof **Condition:** Water ponding on roof surface is observed

Explanation: Active water ponding is observed on the roof surface. Poor roof surface drainage increases the risk of leakage and can reduce the life expectancy of the roof.

Impact Consequences: Flat and low-slope roofs should be sufficiently sloped such that all water will drain from its surface. Water that ponds on the surface will add to the weight loading at the affected area which will over time enlarge this area and compound the problem. Leaks are most likely to occur at seams that are immersed in

water. Correction to the roof surface profile is required. A roofing specialist should be consulted to assess for current condition and for requirements and costs for remedial action.

Recommended Action: Replace consult specialist

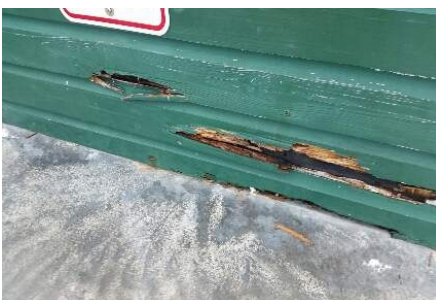
17.

Location: Lower Dining Deck **System:** Exterior **Condition:** Rot observed on wood elements

Explanation: Wood elements that display rot should be replaced

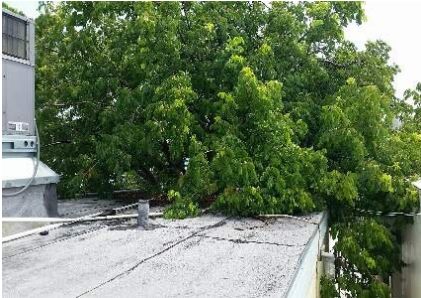
26.

Location: Roof **System:** Exterior **Condition:** Tree branches are too near to the roof surface

Explanation: Roof surfaces can be damaged by tree branches in close proximity to the roof cover.

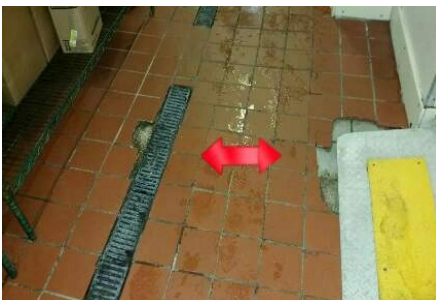
4.

Location: Walk In Cooler Hallway **System:** Interior **Condition:** Trip hazard in floor surface

Explanation: The floor surface has an abrupt change in height where different floor finishes abut. This condition has a variation that is sufficiently great as to present a potential trip hazard.

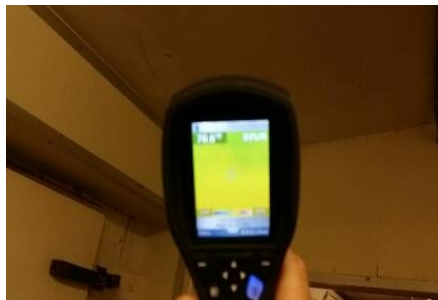
6.

Location: Walk In Cooler Hallway **System:** Interior **Condition:** DRY Ceiling Stain Roof Leak

Explanation: A stain on a ceiling surface is observed to test low for moisture content using moisture meters or thermal imaging camera. The source of the moisture intrusion is suspected to be from a past roof leak which may or may not have been repaired.

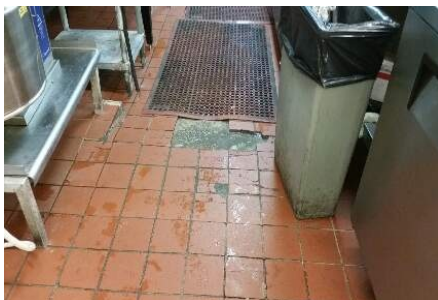
20.

Location: Kitchen **System:** Interior **Condition:** Floor is uneven

Explanation: Visible ridges depressions or hollows are observed in the floor surface. This condition is typically due to unevenness in the subfloor. Ridges are typically due to a mismatch in height at the edges of subflooring materials. Depressions are typically due to insufficient support at the edges of the subflooring wood members. Hollows are typically due to a local area of damage in the subfloor.

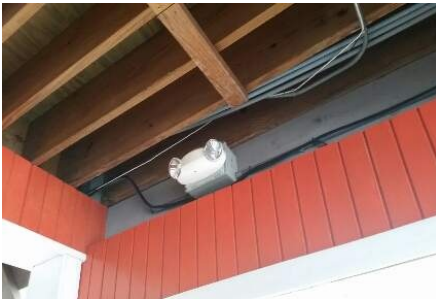
30.

Location: Lower Dining Deck **System:** Interior **Condition:** Failed Flood Light Test

Explanation: The flood light failed to illuminate upon restricting the power source or using the test button.

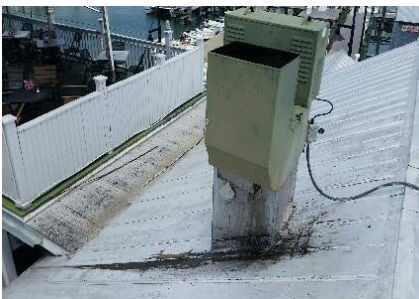
2.

Location: Roof **System:** Insulation Ventilation **Condition:** Grease Build Up At Vent Outlet

Explanation: The ventilation system output area is observed to have grease build up from commercial cooking equipment exhaust.

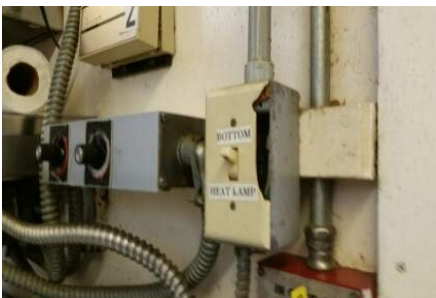
1.

Location: Kitchen **System:** Electrical **Condition:** Damaged electrical switch cover
Explanation: Electrical switches installed require protection from water entry and contaminants.
Impact Consequences: A switch with a missing or damaged cover is subject to damage and deterioration if its protection has been compromised. Switches displaying damage or deterioration should be immediately replaced and a suitable cover installed.

Recommended Action: Repair

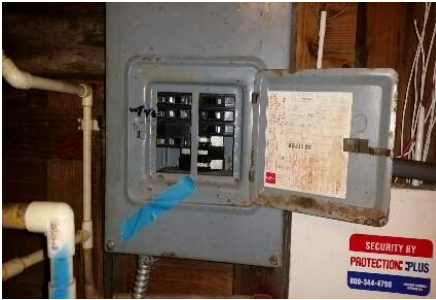
13.

Location: Storage Room **System:** Electrical **Condition:** Panel cover screws are missing on the electrical panel

Explanation: All screws for electrical panel covers should be installed to assure that the cover is properly located and securely attached. Screws used to secure the cover must be of the type supplied by the manufacturer which have tips that are blunted to prevent the piercing of wires when turning the screws into place.

Impact Consequences: The conditions should be deemed as a safety issue requiring corrective action by an electrician.

Recommended Action: Repair

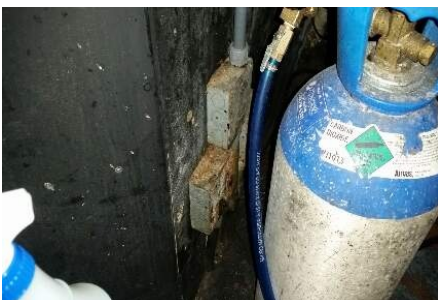
20.

Location: Interior Bar **System:** Electrical **Condition:** Deteriorated Junction Box

Explanation: A junction box is observed to be deteriorated

Impact Consequences: Deteriorated junction boxes should be replaced in order to prevent electrical hazards. Consult a licensed electrical contractor regarding safe installation of junction boxes.

Recommended Action: Replace
[Click here to find out more about this item](#)

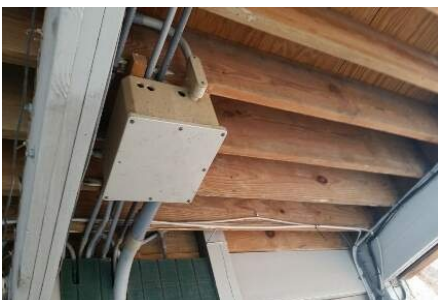
31.

Location: Lower Dining Deck **System:** Electrical **Condition:** Open Knock Outs Of Junction Box

Explanation: The junction box is observed to have missing or open knock outs.

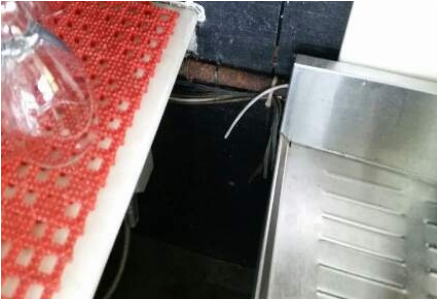
35.

Location: Exterior Bar **System:** Electrical **Condition:** Damaged or Missing Conduit

Explanation: Electrical conduit is observed to be missing or damaged.

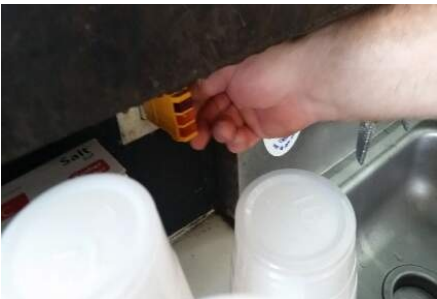
36.

Location: Exterior Bar **System:** Electrical **Condition:** Receptacle has loose socket contacts

Explanation: Looseness is observed in socket tension when a plug is inserted into an outlet.
