STAFF REPORT

DATE: August 1, 2017

RE: **1300 Atlantic Boulevard (C.B. Harvey Rest Beach Park)
(permit application # T17-8522)**

FROM: Karen DeMaria, City of Key West Urban Forestry Manager

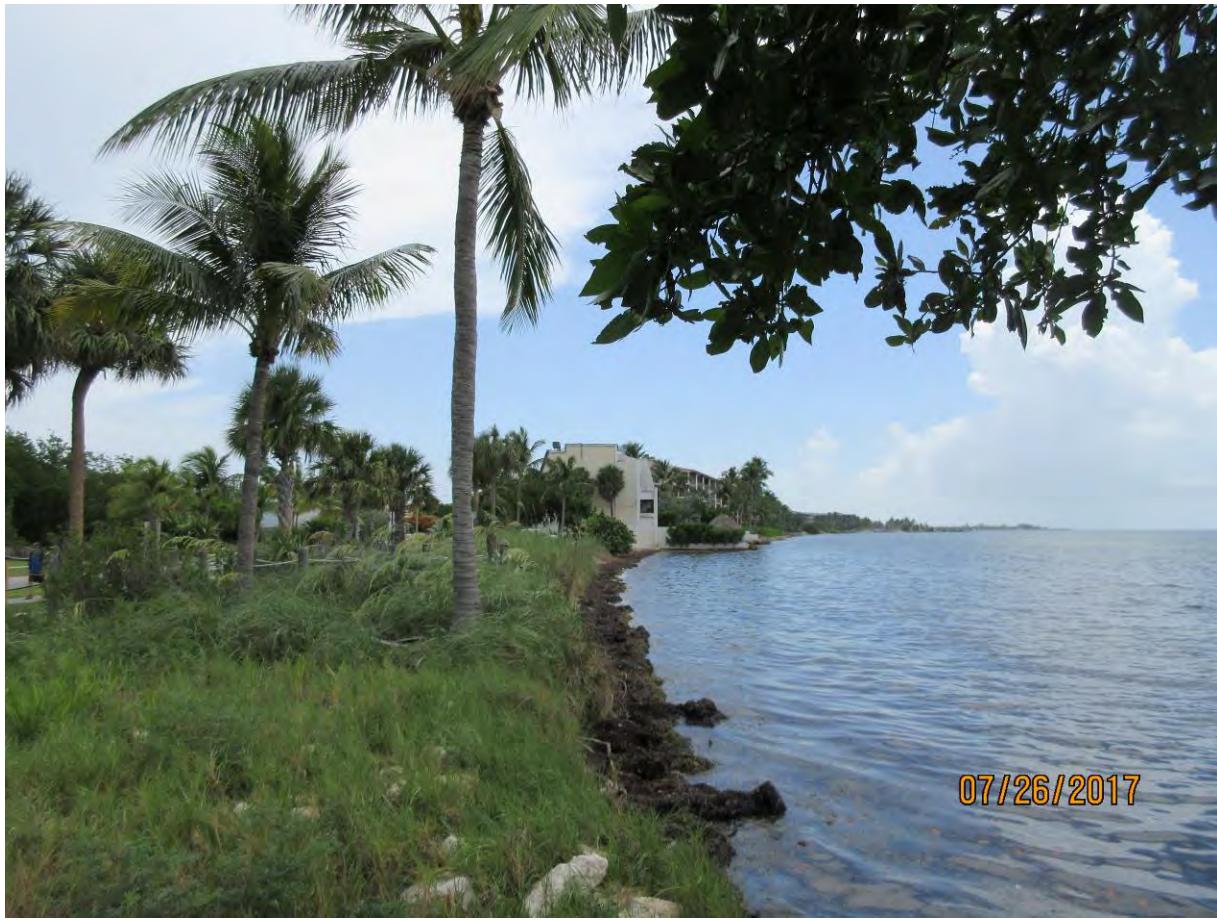
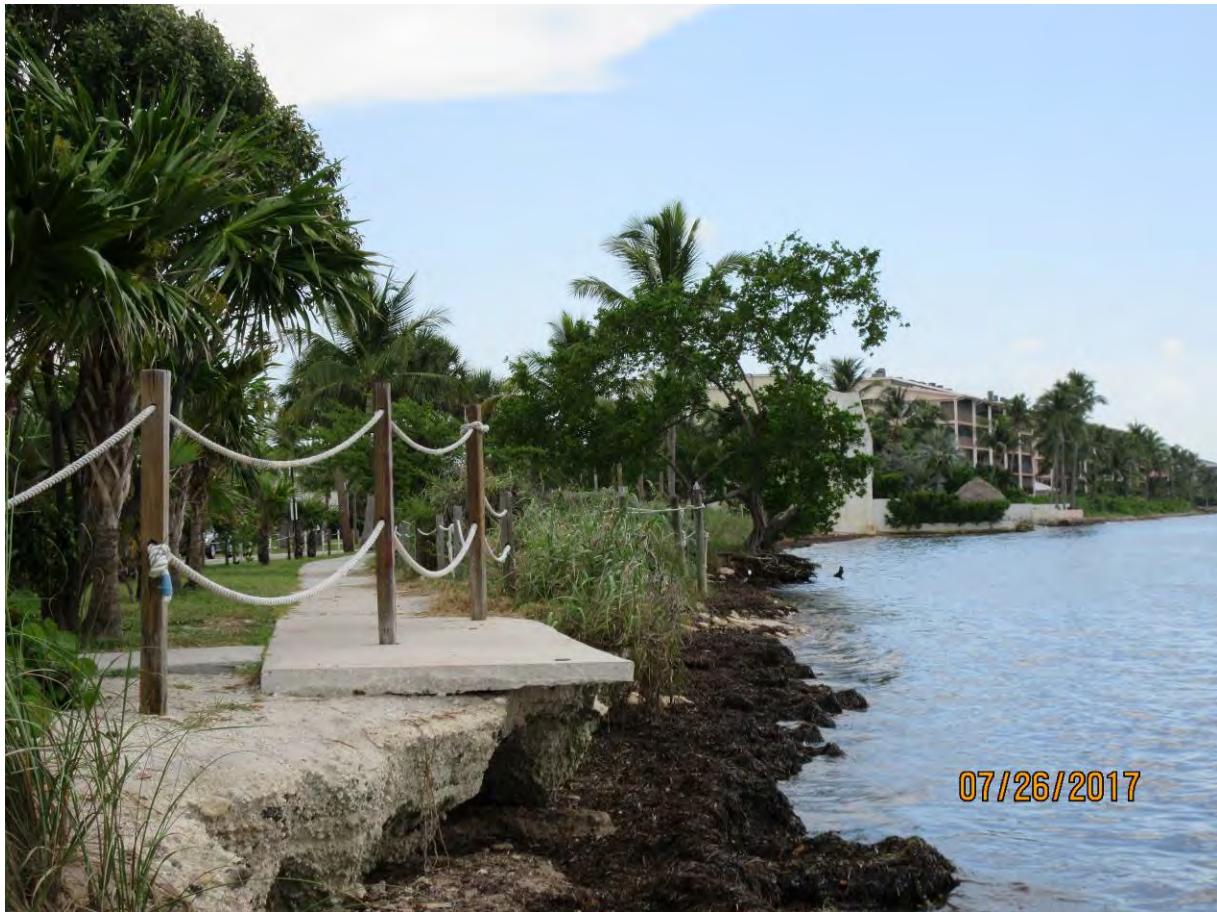
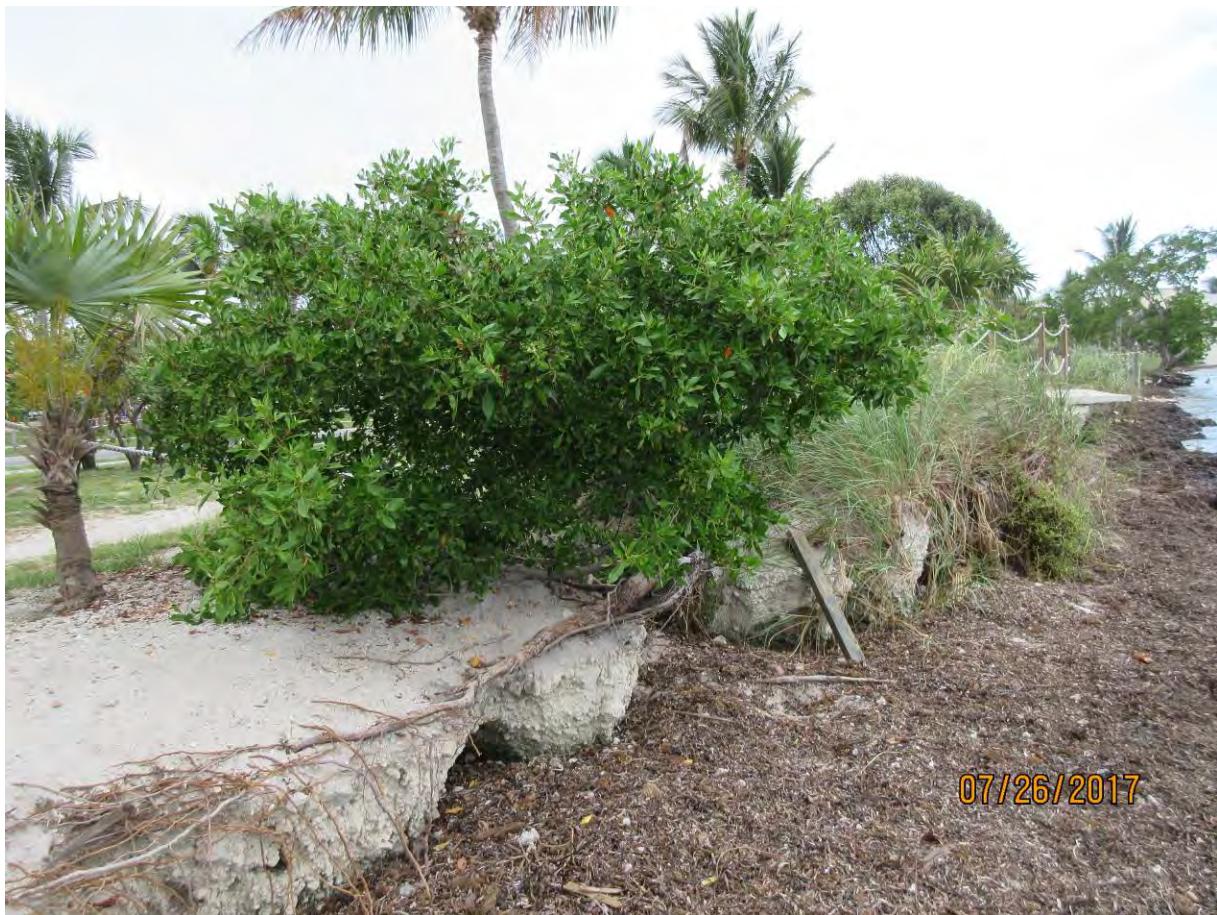
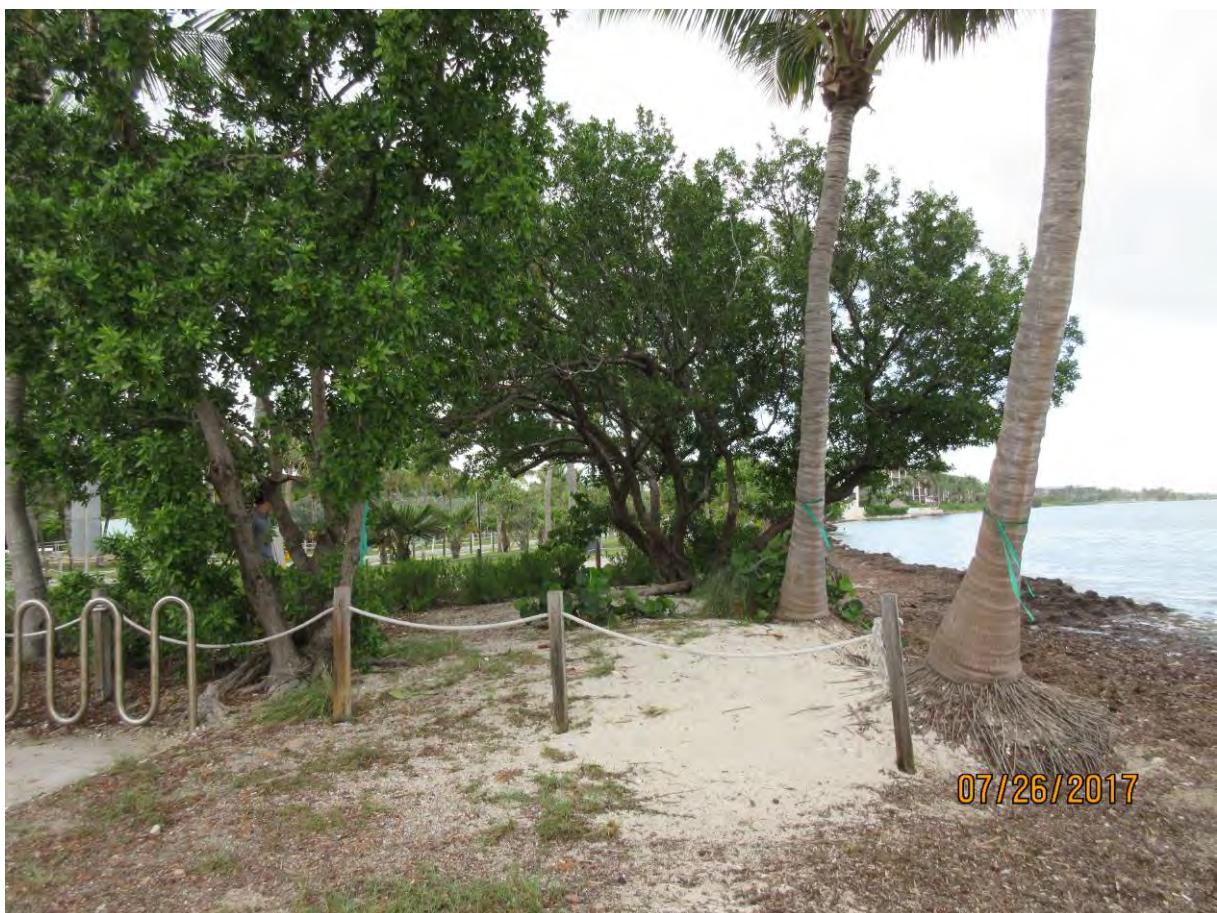
Tree #2A:

Tree Species: Buttonwood (*Conocarpus erectus*)

Diameter: 14.9"

Location: 90%

Species: 100% (on protected tree list)

Condition: 60% (fair, co-dominant trunks)

Total Average Value = 83%

Value x Diameter = 12.3 replacement caliper inches

NOTE: It might be possible to do a heavy maintenance trim on this tree to remove one of the main branches. A final decision will be made once site is staged for work.

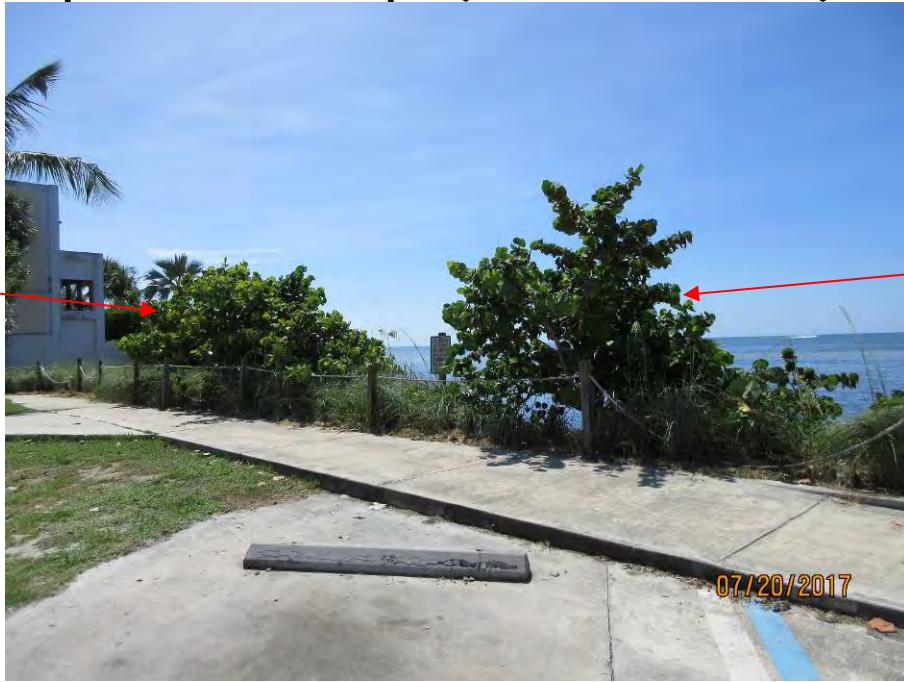
Tree #9:

Tree Species: Sea Grape (*Coccoloba uvifera*)

Diameter: 16.5"

Location: 60% (on dune edge, continual erosion will expose roots and cause death of tree)

Condition: 80% (good, sprawling tree structure-typical dune/beach tree)

It appears that this tree is in the middle of the work area. It is not known at this time whether the tree can successfully be transplanted.

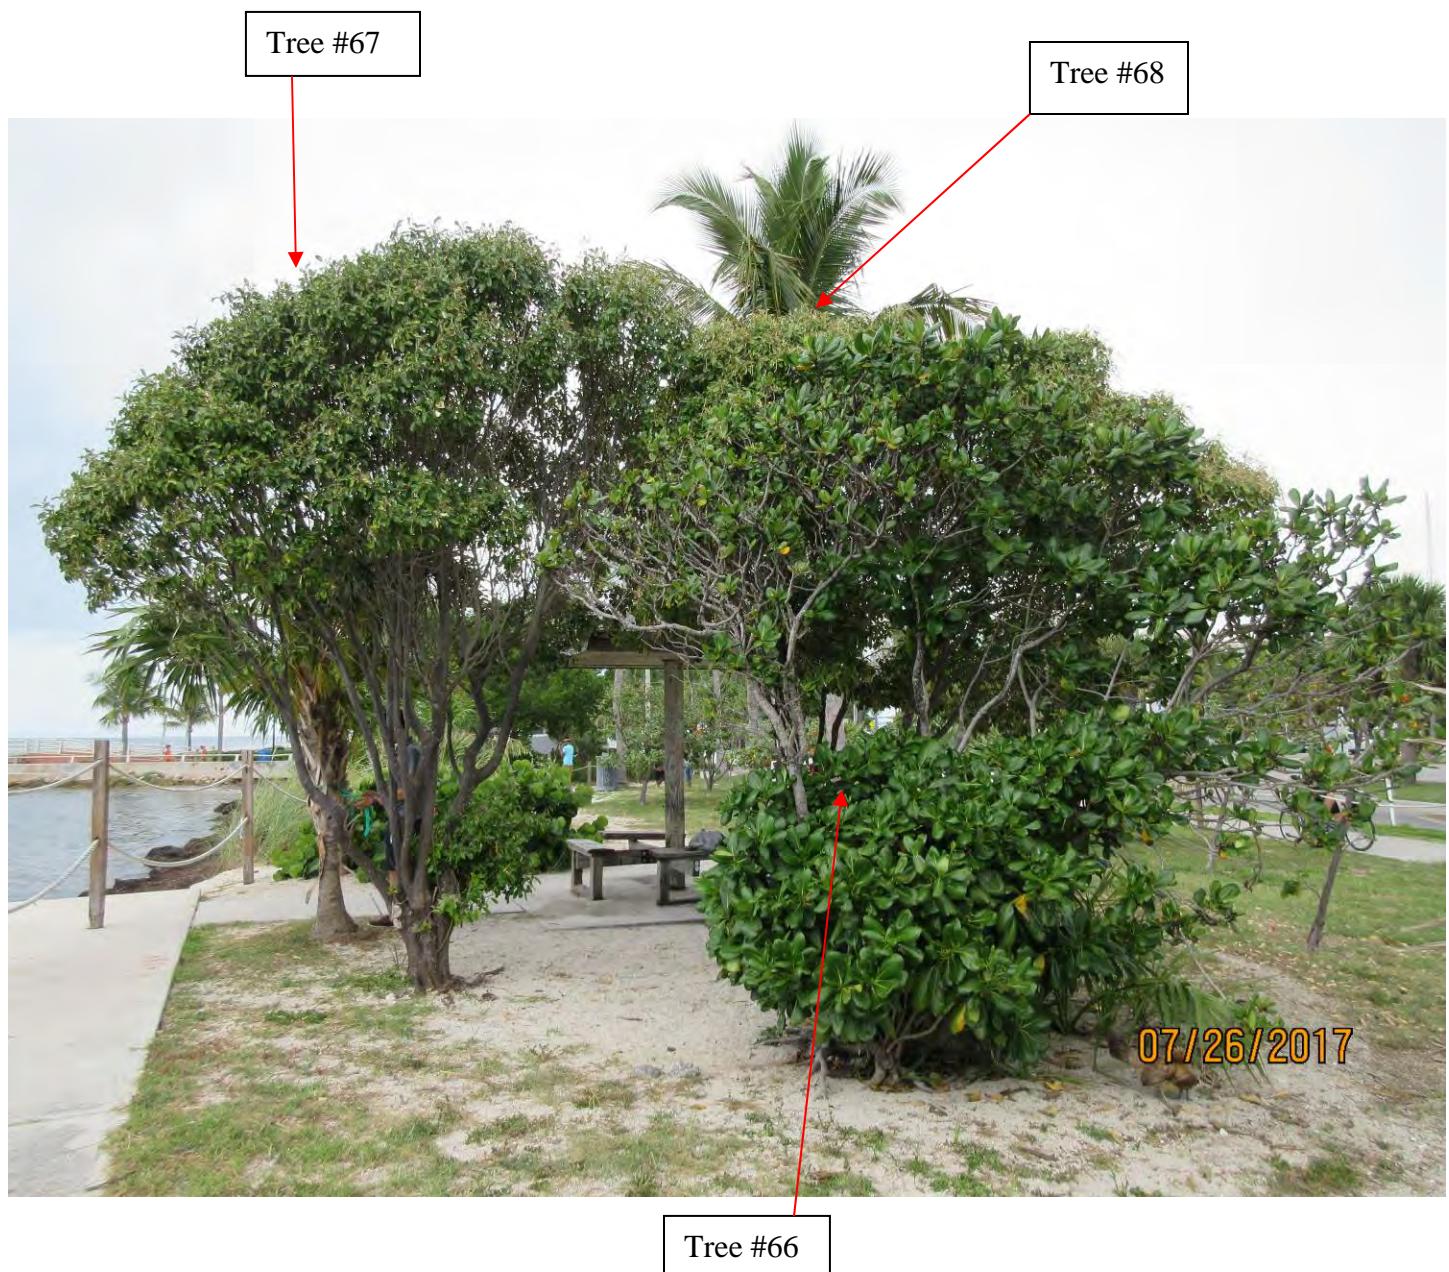
Tree #67:

Tree Species: Jamaican Caper (*Capparis cynophallophora*)

Diameter: 21"

Condition: 80% (good)

It appears that this tree is in the middle of the work area. It is not known at this time whether the tree can successfully be transplanted.

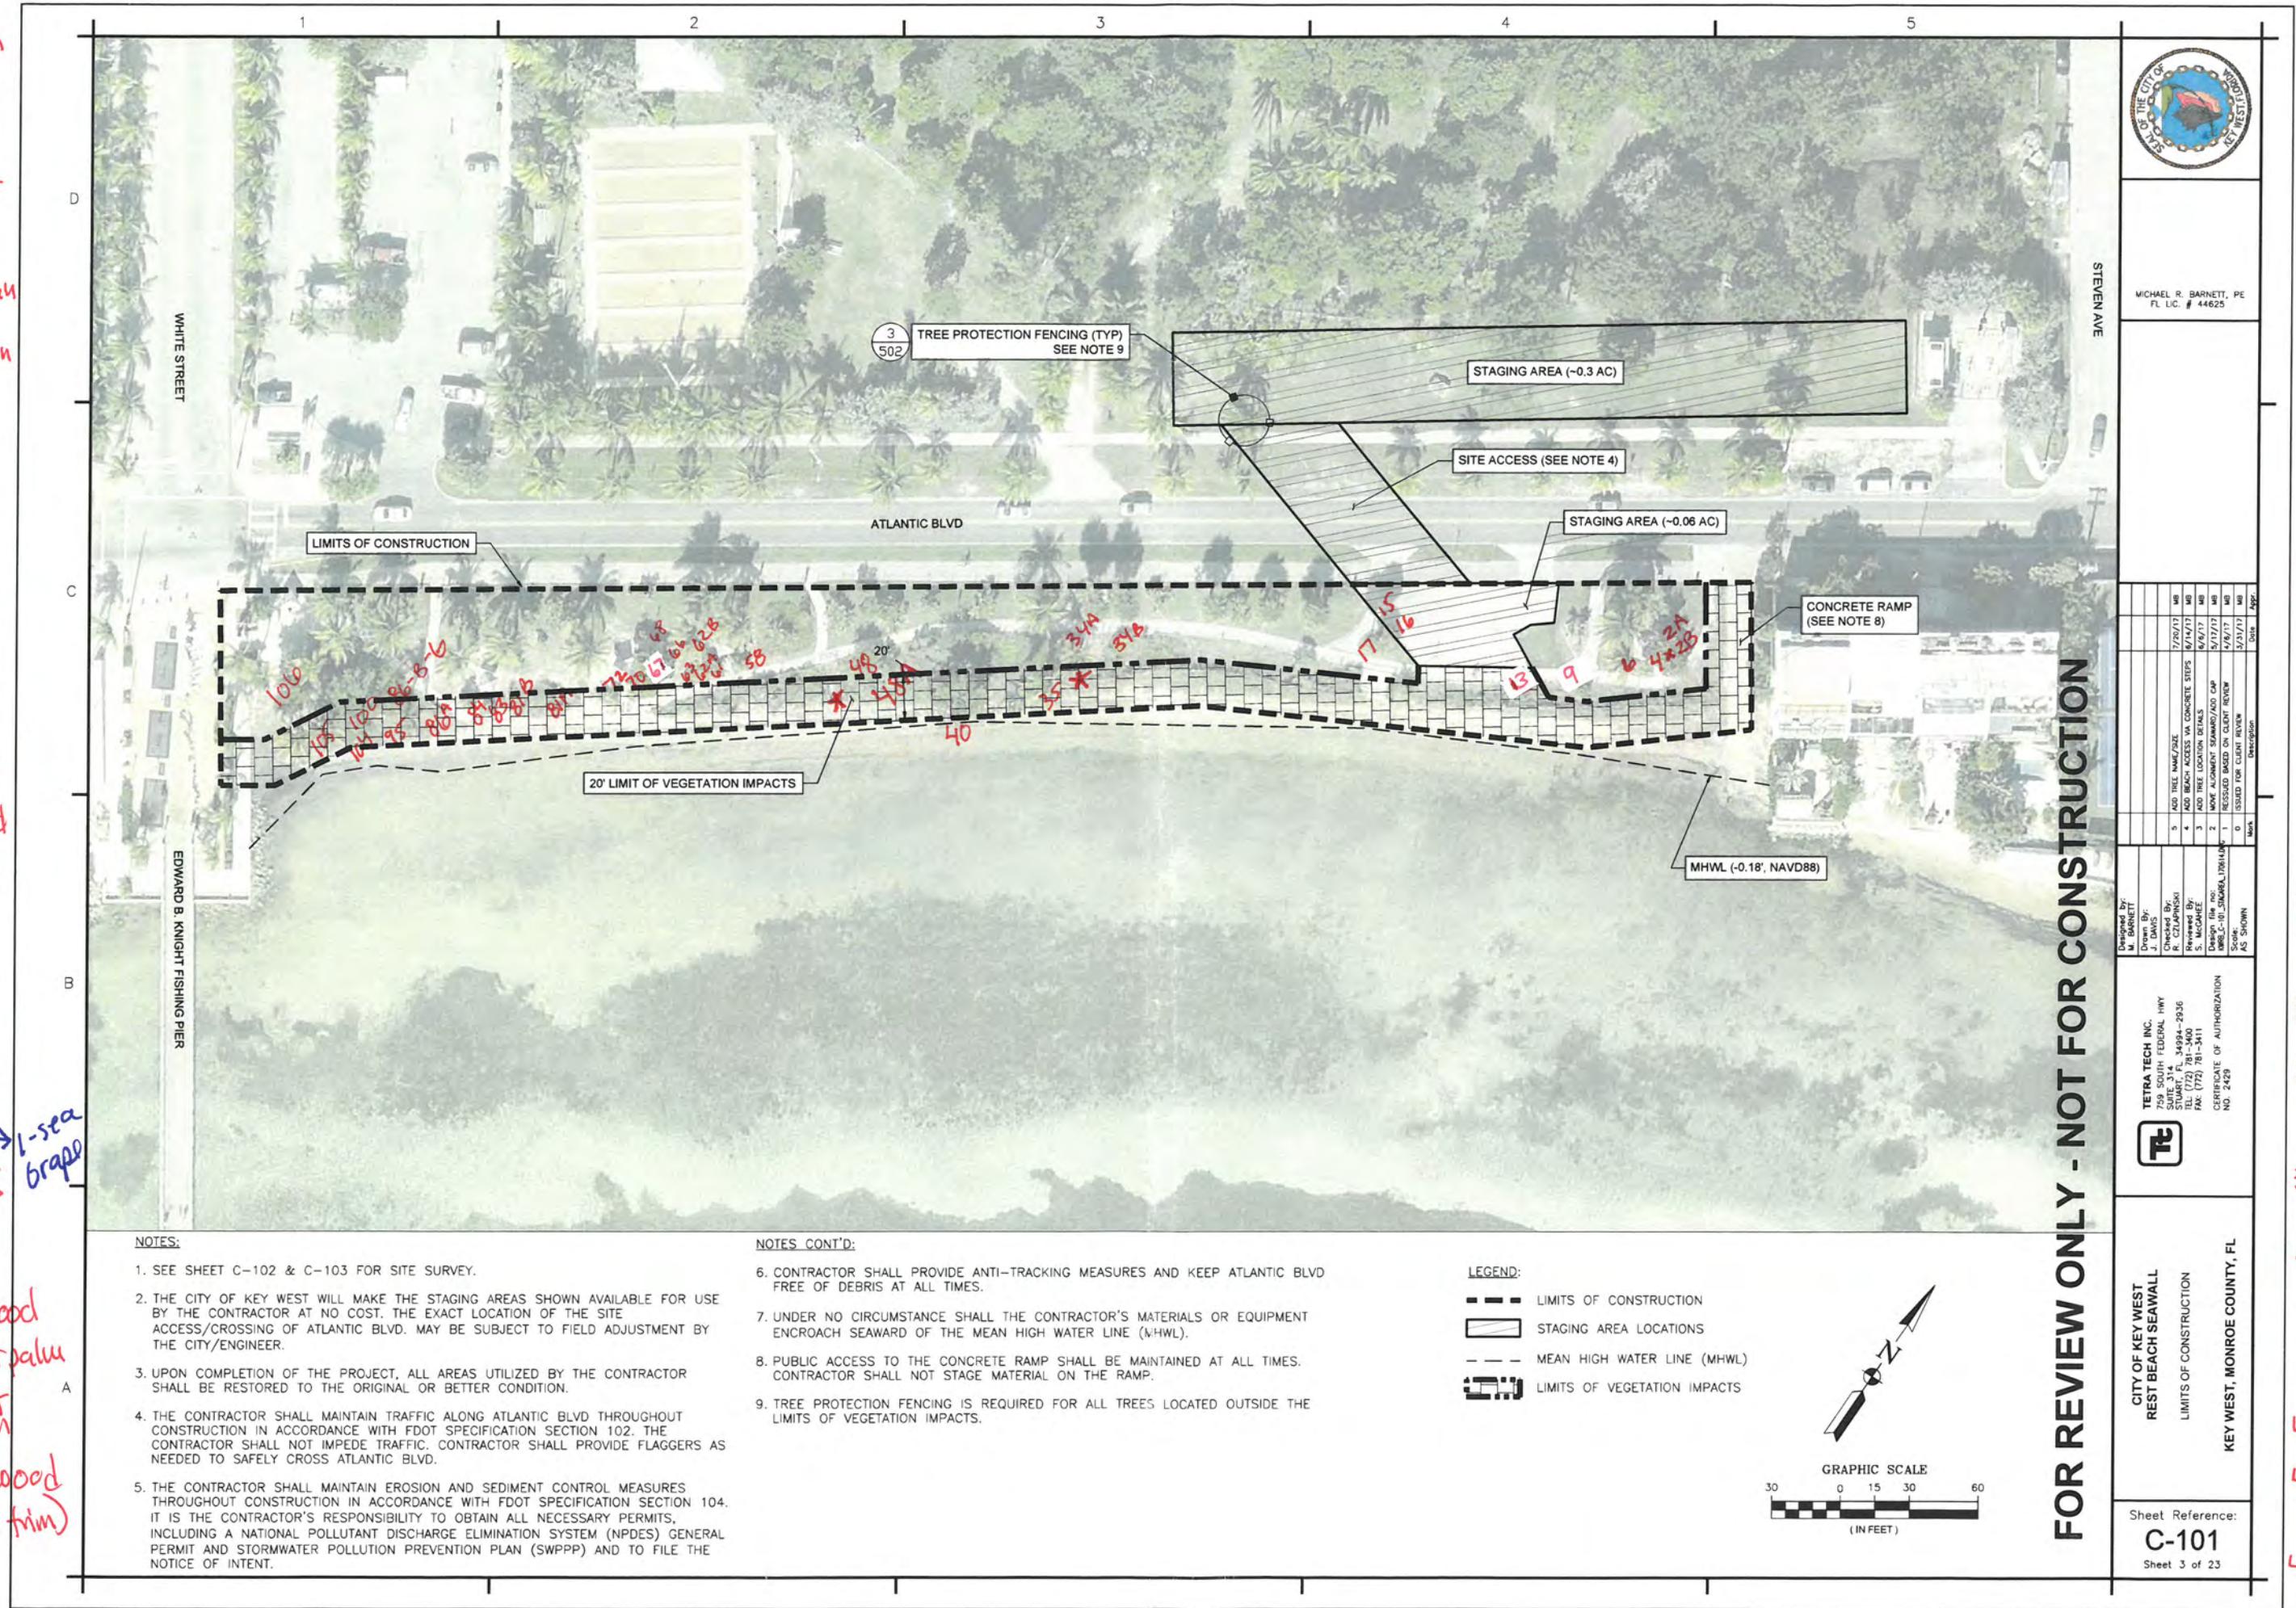
58
 61 Thatch
 62A Palms
 62B /
 63 /
 66 Seven Yr
 Apple
 tree
 67 Jamaican
 Caper
 68 Jamaican
 Caper
 70 Thatch
 Palm
 72 Thatch
 Palm
 (Seagrape
 Shrub-not
 regulated)
 81A Thatch
 palm
 (buttonwood
 Shrub-not
 regulated)
 81B Thatch
 Palm
 83 Thatch
 Palm
 84 Thatch
 Palm
 86 Thatch
 Palm
 86B - L →
 5-Thatch
 b-F palms
 75 coconut
 Palm
 100 buttonwo
 .04 coconut
 05 coconut
 palm
 06 butchco
 (maintenance
 ?)
 /
