Key West Historic Diesel Electric Plant Complex

Enid Torregrosa-Silva
Kelly Perkins

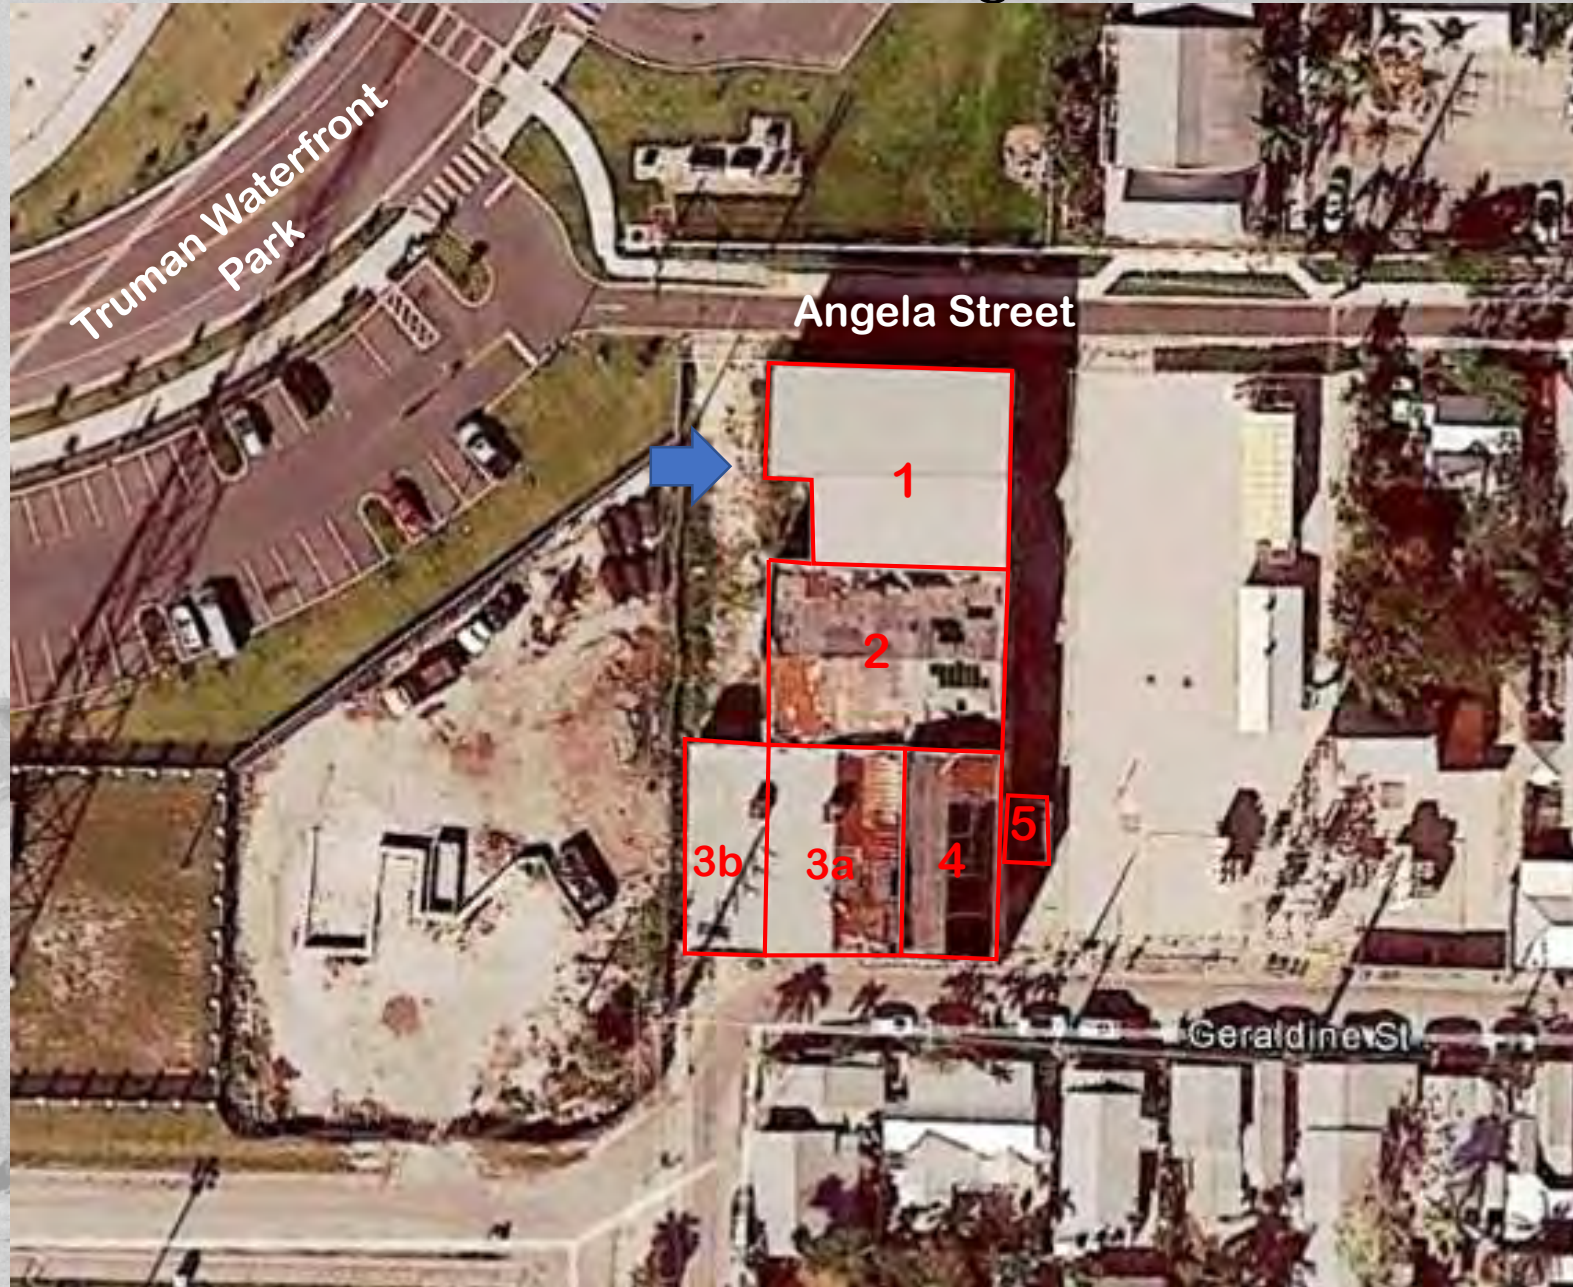
- First appears on the 1926 Sanborn map, meaning it was constructed between 1912 and 1926.
- Building 1 had the roof redone after Wilma hit in 2005, and is considered to be in the best condition according to the AES Structural Report. It was not condemned by Chief Building Official.

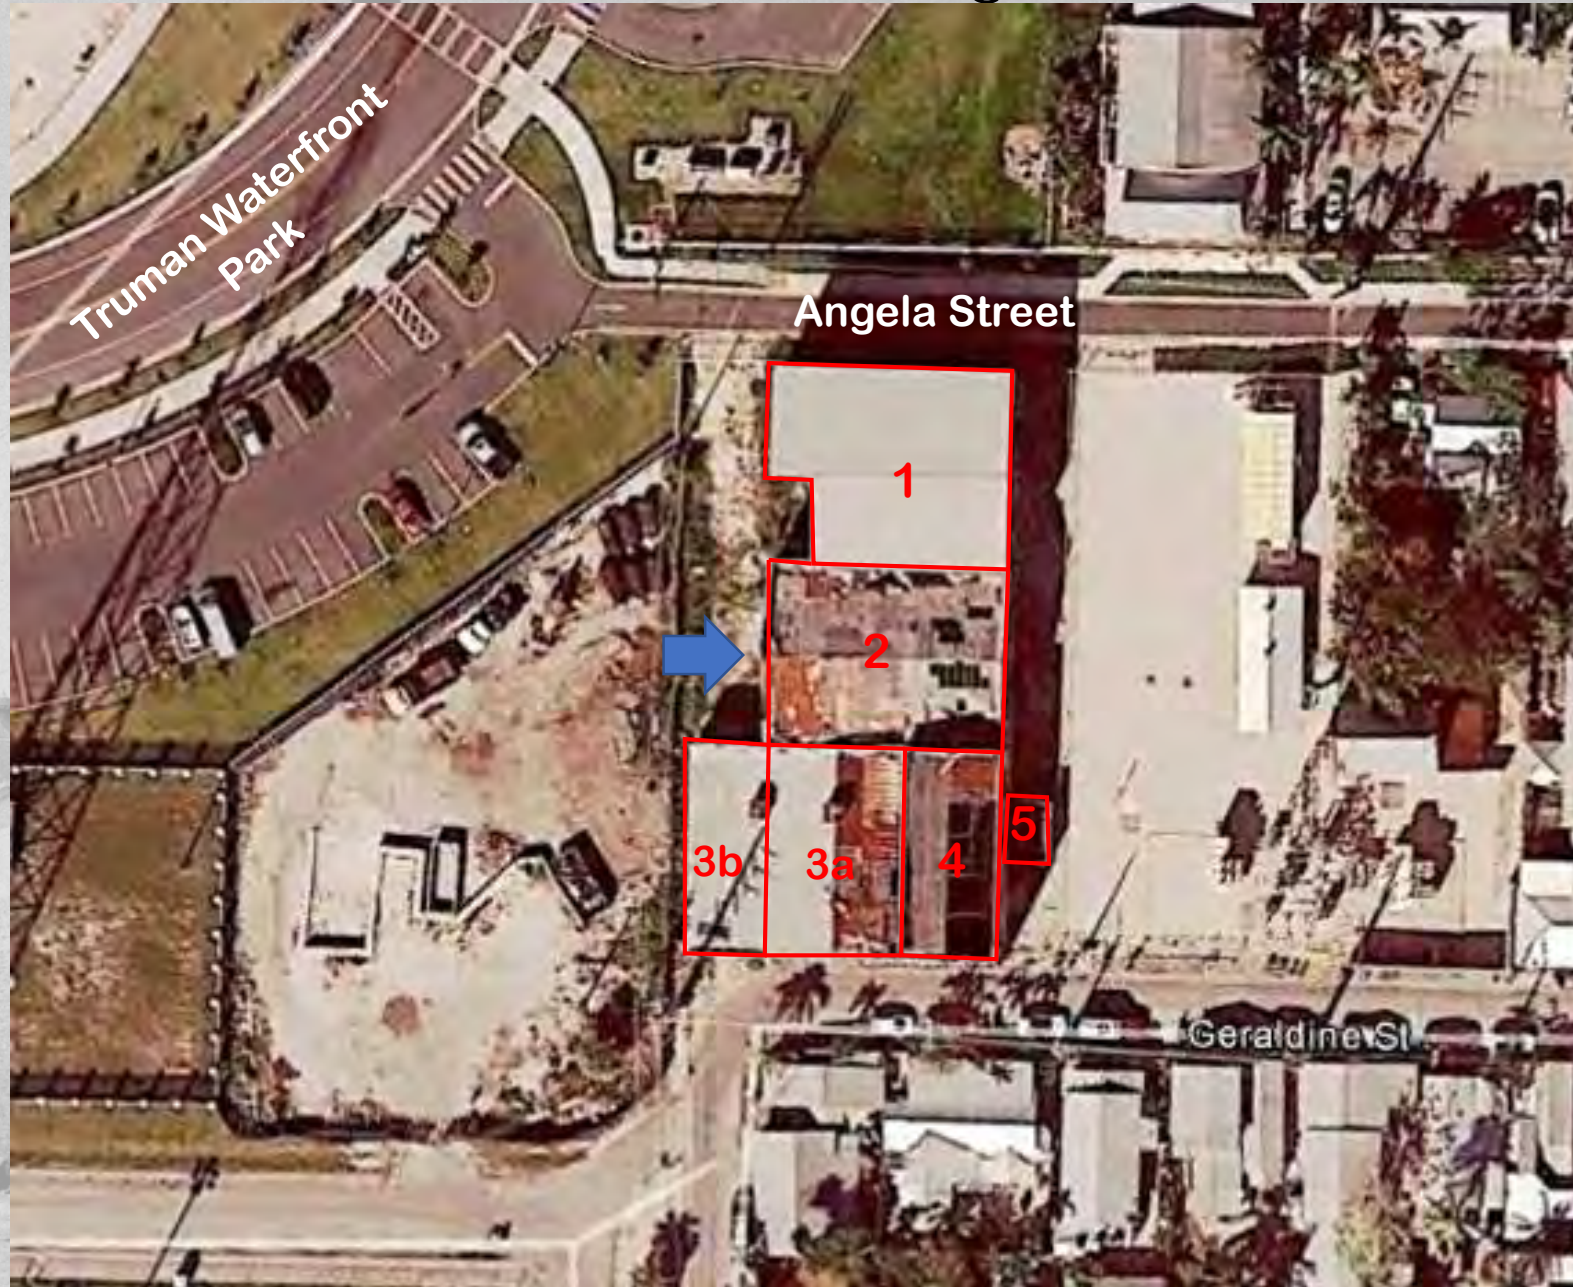
Building 2

- Part of the original complex, constructed in the 1880s.
- The building was considered to be in “much worse condition” than Building 1. It was not condemned by Chief Building Official.

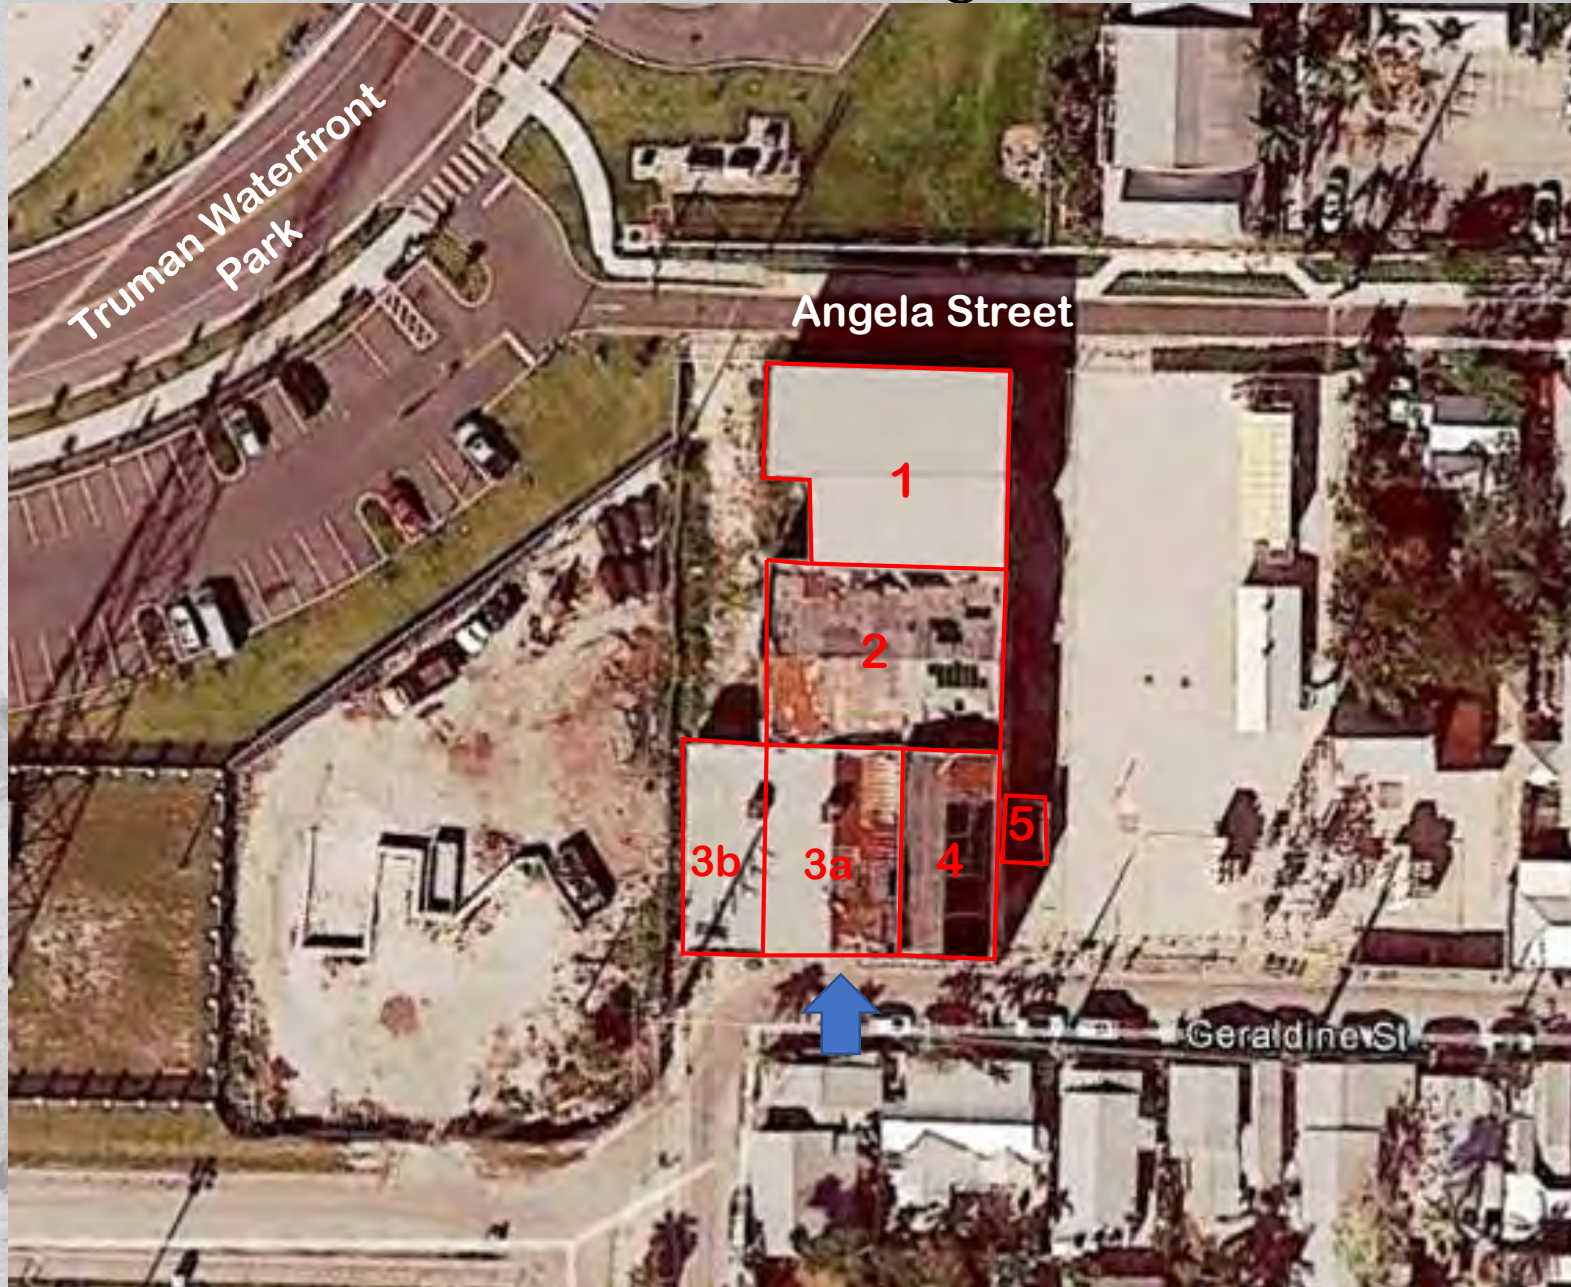
Building 3a

- Part of the original complex, first appearing on the 1892 Sanborn map.
- The building was originally a one story brick structure with classical detailing. The October 1909 hurricane destroyed the façade on Geraldine Street.

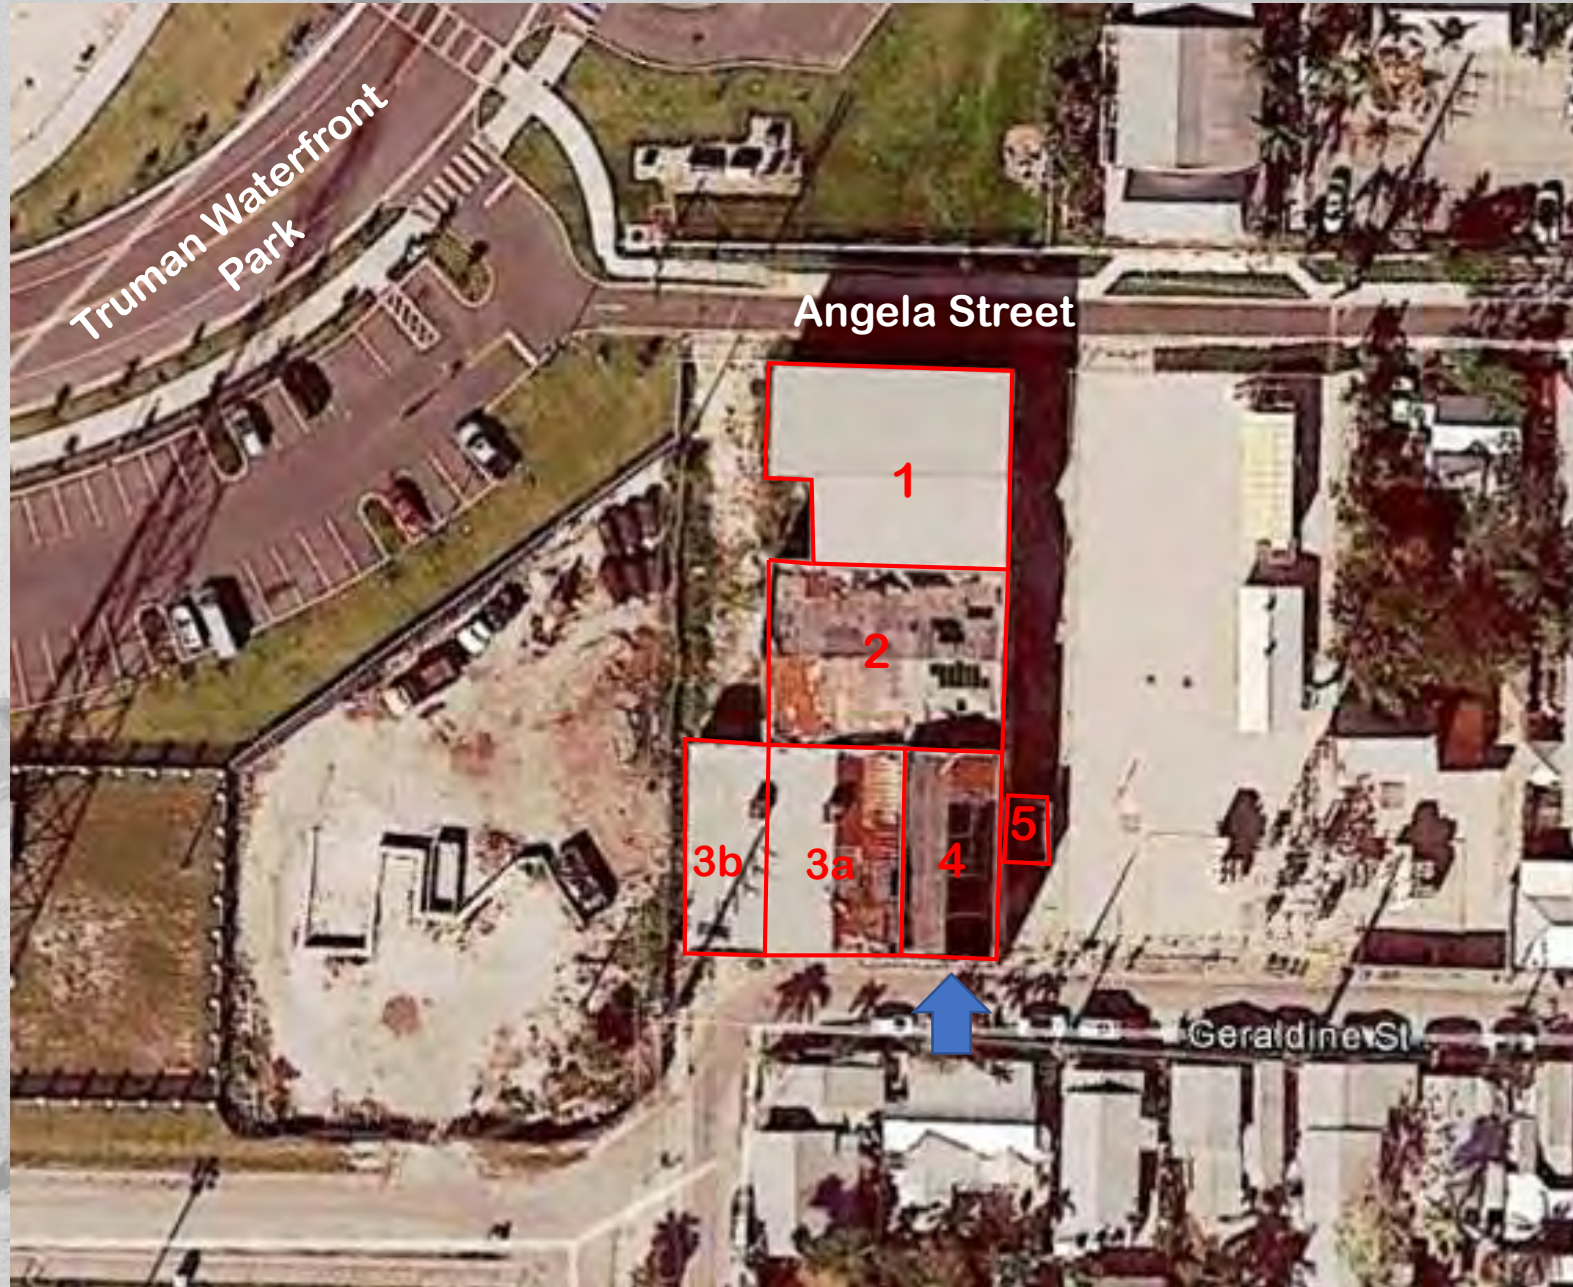
Building 4

- Constructed between 1892 and 1899. The structure was originally a shorter two-story building made entirely of brick with a rear wood structure that held a water tower and other equipment.
- The 1909 and 1910 Hurricanes destroyed the roof, and the structure was expanded with a steeper pitched roof in 1910.

- By the 1950s, building was expanded to a taller building using concrete as the material for the second floor. The concrete was poured with forms. The second story windows were steel with blue glass.
- Considered to be in the worst condition out of the four buildings in the AES Structural Report. It was condemned by the Chief Building Official.

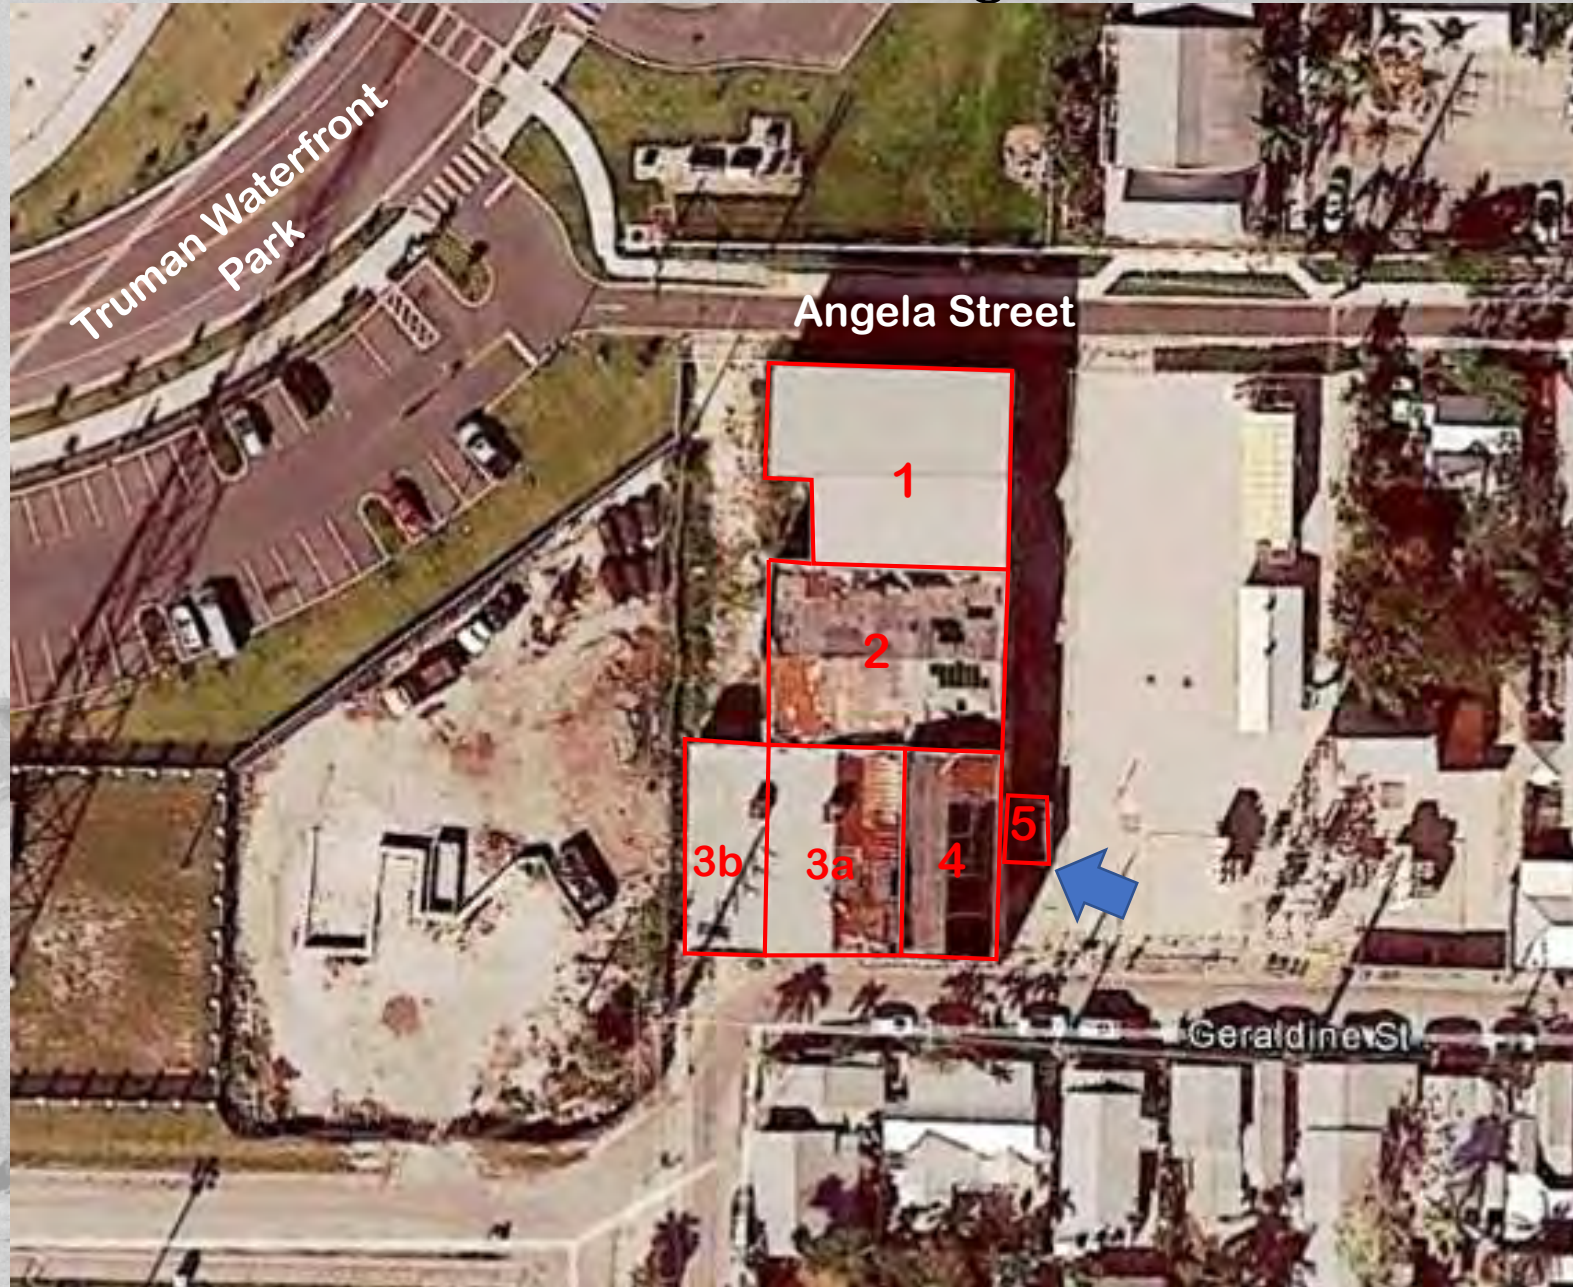
Building 5

- Appears in a 1950s photograph of the complex, making it historic. It currently blocks eastern access of the complex.
- Staff finds no significance in this building.
- The building was stated to be in “good condition” by the AES Structural Report, but demolition was recommended. It was condemned by Chief Building Official.
