Key West Historic Diesel Electric Plant Complex

Enid Torregrosa-Silva
Kelly Perkins

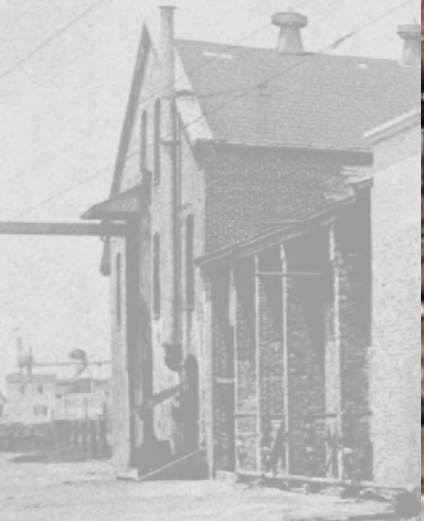
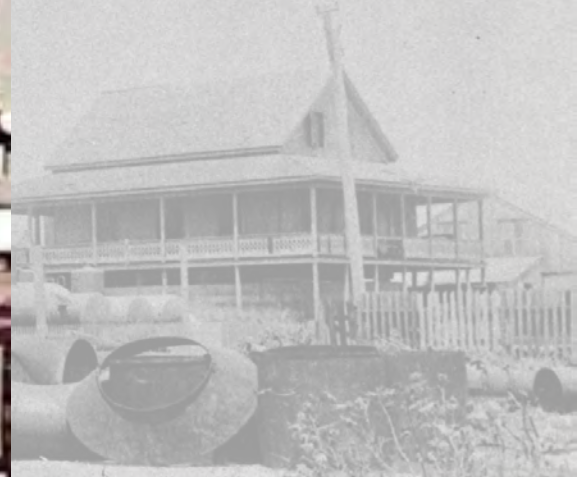
- First appears on the 1926 Sanborn map, meaning it was constructed between 1912 and 1926.
- Building 1 had the roof redone after Wilma hit in 2005, and is considered to be in the best condition according to the AES Structural Report. It was not condemned by Chief Building Official.

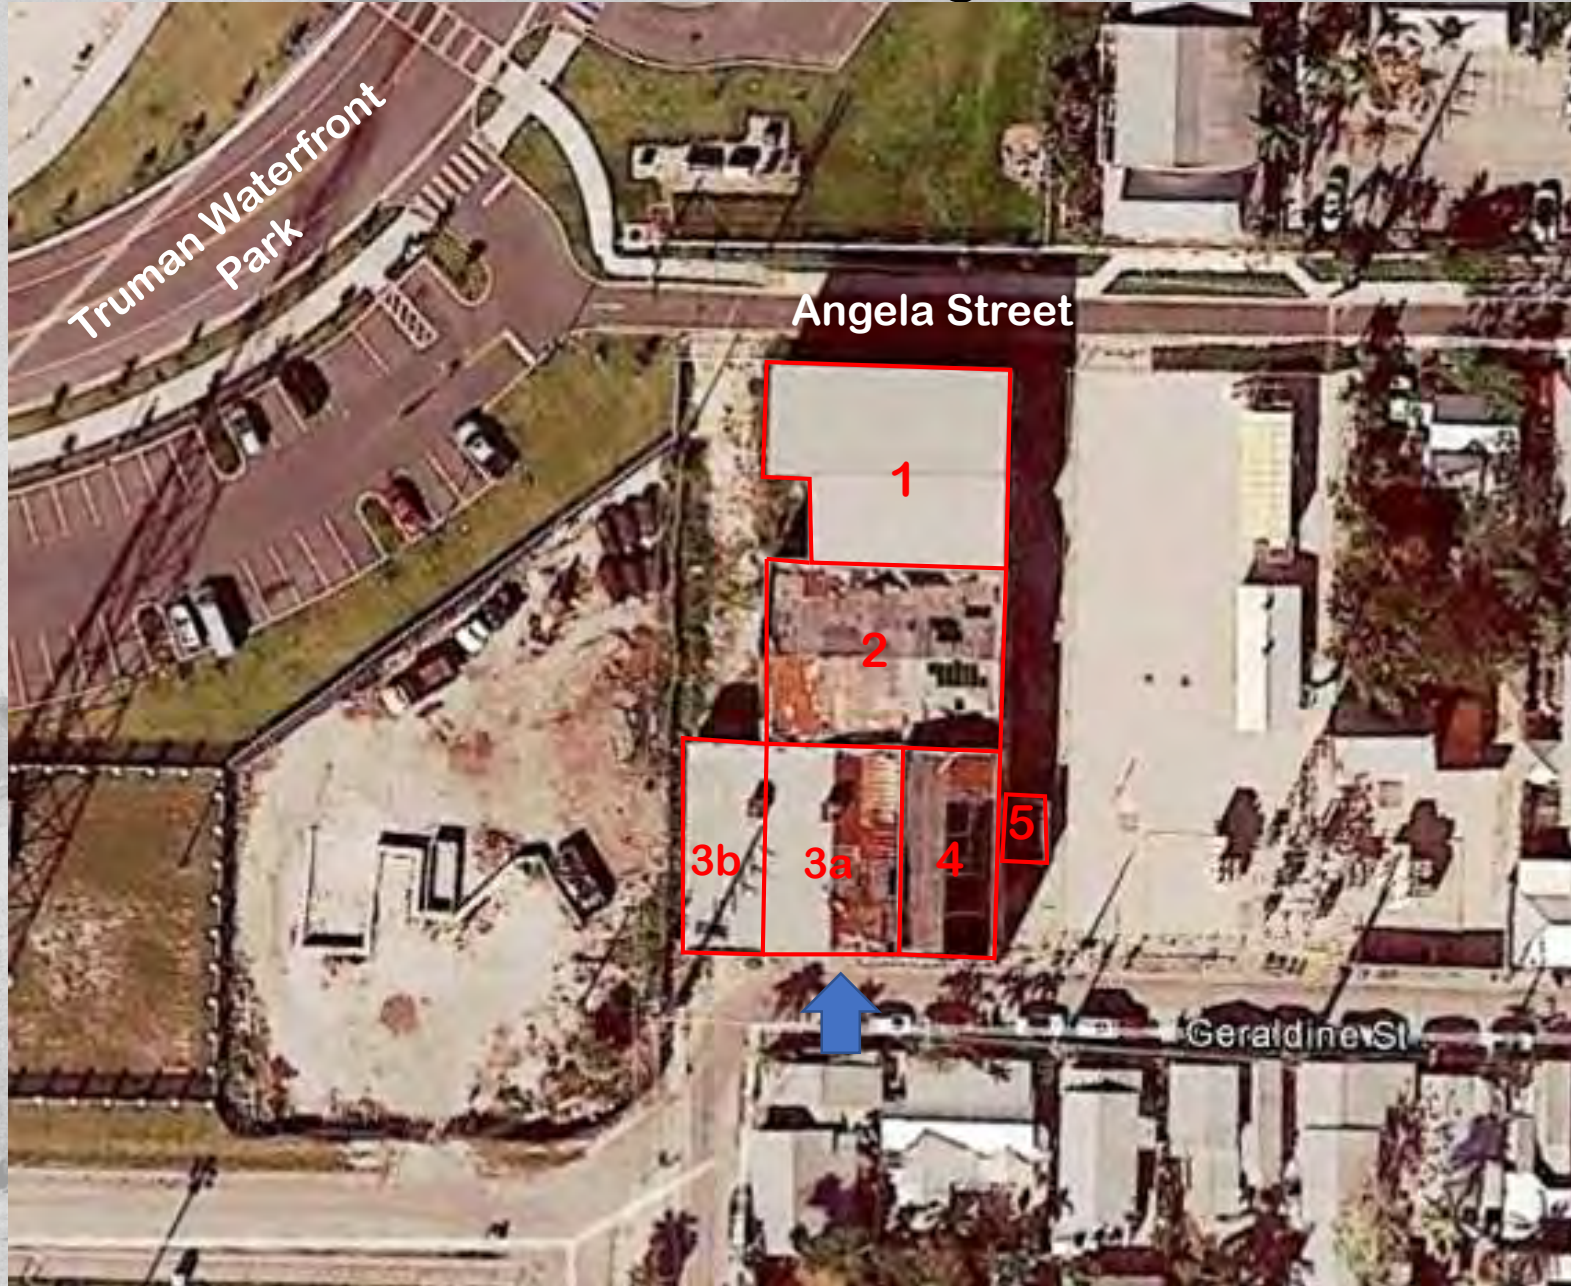
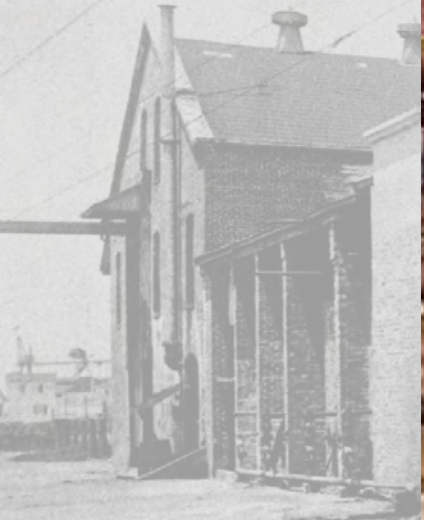
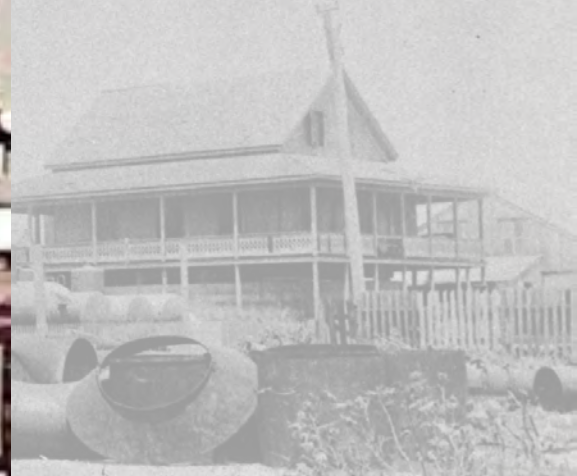
Building 3a

- Part of the original complex, first appearing on the 1892 Sanborn map.
- The building was originally a one story brick structure with classical detailing. The October 1909 hurricane destroyed the façade on Geraldine Street.

- In 1910, the new buttressed façade was constructed. The side of the building had a buttressed, brick wall as well. At some point, the roof was extended to be flush with the buttressed façade, and the right bay entrance was closed in with CMU.
- The AES Structural Report stated that Building 3 (including 3a and 3b) is in better condition than Building 2 and Building 4. It was condemned by the Chief Building Officer.
