# Structural Condition Assessment Key West Diesel Plant Key West, Florida

AES Project No. 316-048  
August 3, 2016

Re: Structural Condition Assessment  
Key West Diesel Plant  
Key West, Florida

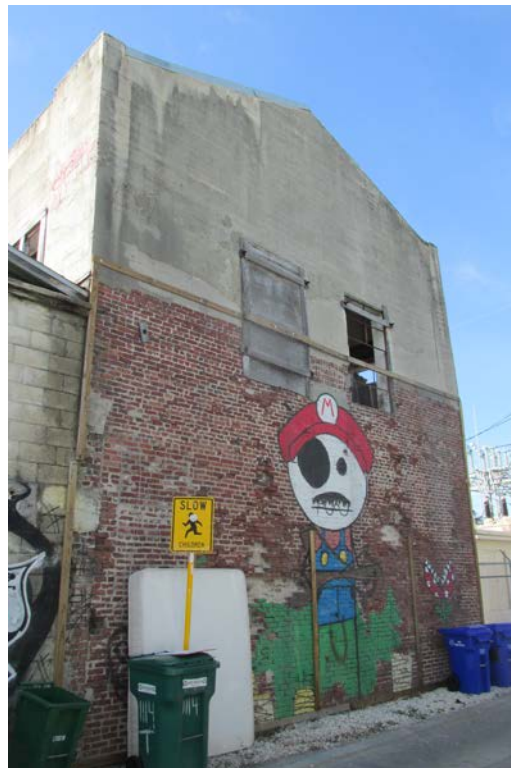
PHOTOGRAPH 6 (BUILDING IV)

The abandoned Diesel Plant consists of four (4) connected one-story, buildings with the three (3) eastern buildings housing four (4) electric dynamos and the southwestern building having a lower roof that probably housed a shop and support spaces. The northernmost eastern building (Building I) houses one (1) dynamo and consists of a high new pre-engineered wood truss framed roof with plywood sheathing and metal roofing supported by perimeter multi-wythe brick walls and interior steel beams and columns (see Photographs 1 and 2). The easternmost center building (Building II) houses two (2) dynamos and consists of metal roofing on plywood sheathing, on wood joists and beams supported by heavy timber trusses and steel beams and columns that support crane beams (see Photographs 3 and 4). The heavy timber roof trusses are supported by perimeter multi-wythe brick walls. The southernmost eastern building (Building IV) houses one (1) dynamo and consists of metal roofing on wood sheathing on wood joists and beams supported by heavy timber trusses, and perimeter low multi-wythe brick walls and upper concrete walls (see Photographs 5 and 6).

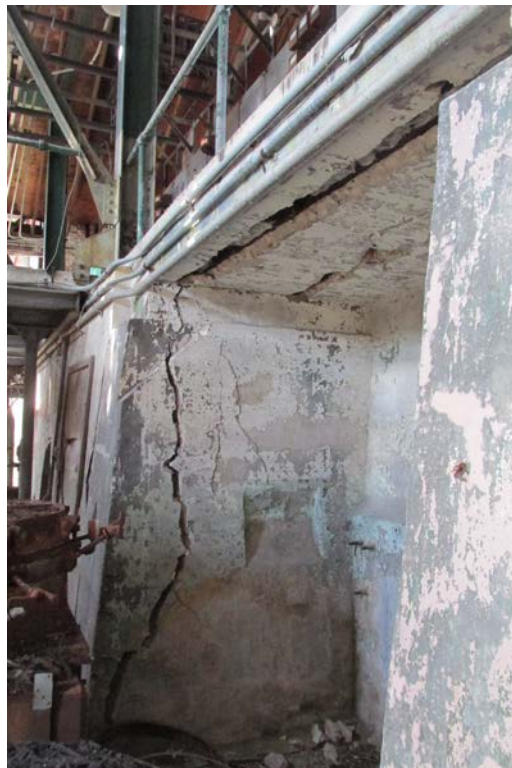
PHOTOGRAPH 32 (BUILDING II)

The stair to the concrete platform has badly corroded stair stringer bases with more than 20% material loss and the concrete platform has extensive large concrete spalls with exposed corroding reinforcing (see Photographs 31, 32 and 33). The exterior masonry walls are in good condition, but there are numerous cracks, corroded embedments, deteriorated mortar, deteriorated face brick, infilled arch brick with no lintel, large areas of missing brick, corroding lintels and brick cracks with vegetation (see Photographs 34, 35, 36, 37, 38 and 39).

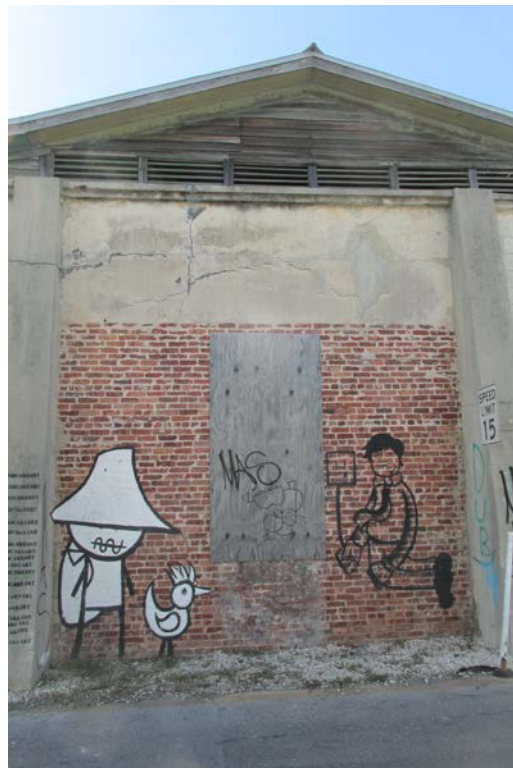
PHOTOGRAPH 48 (BUILDING III)

- III. The southwestern building (Building III) is in worse condition than Building I, but in better condition than the Building II and Building IV. The western metal roof is in good condition with several areas of corroded metal roofing and corroded roofing screws. The eastern metal roof is in poor condition with areas of missing roofing, extensive metal roofing deterioration and areas of deteriorated wood decking (see Photograph 46). The roof wood joists, beams, steel beams and columns are in good condition with surficial steel corrosion on the steel members and a deteriorated wood beam kicker (see Photograph 47). The slab on grade is cracked and uneven and the exterior high concrete has large areas of spalling concrete and a spalling concrete lintel (see Photographs 48 and 49). The exterior CMU and brick has several cracks, corroded embedments and delaminating stucco.
