Structural Condition Assessment Key West Diesel Plant

Key West, Florida

> AES Project No. 316-048 August 3, 2016

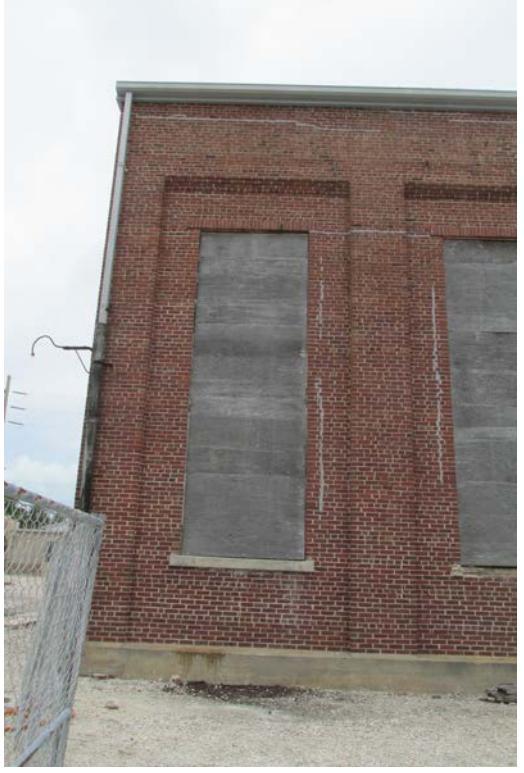
PHOTOGRAPH 17 (BUILDING I)

The exterior masonry walls are in good condition but there are numerous cracks, corroded embedments, deteriorated mortar, corroded lintels, deteriorated face brick, brick cracks with vegetation and random cracks in the concrete water table (see Photographs 17, 18, 19, 20, 21, 22 and 23). At the western return metal panel wall, there is a badly corroded angle purlin and a large column spall with corroded reinforcing and an area of missing metal wall panel (see Photographs 24, 25 and 26). The remaining metal panels are corroded and in poor condition (see Photograph 27).

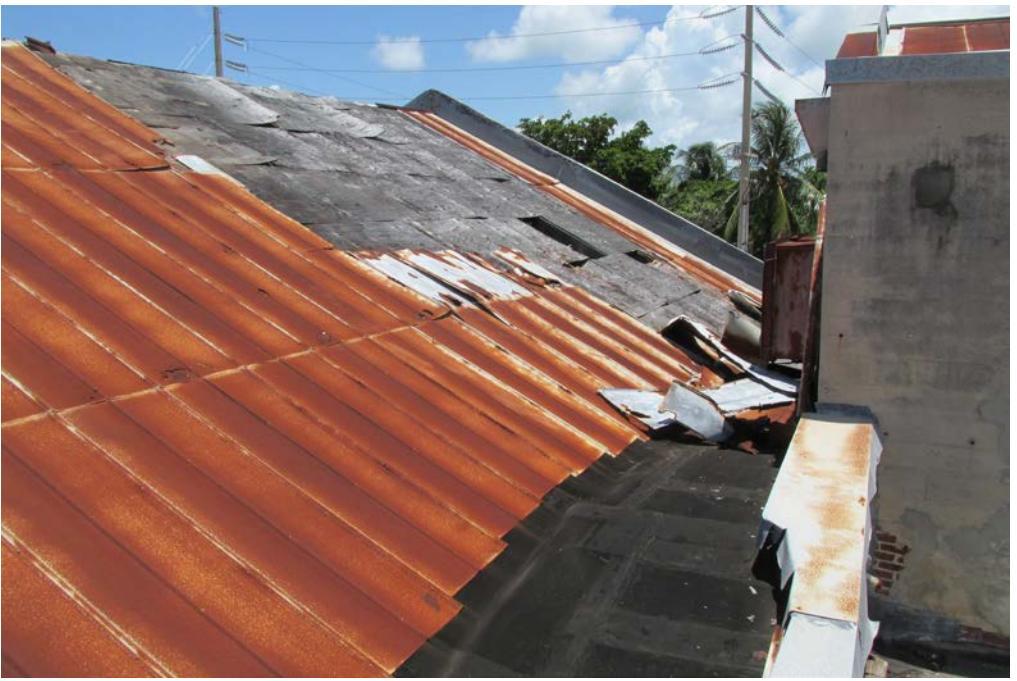
PHOTOGRAPH 28 (BUILDING II)

II. The eastern center building (Building II) is in much worse condition than the Building I with metal roofing in extremely poor condition with large areas of missing metal roofing and large areas of deteriorated roof decking (see Photograph 28). The roof wood structure is in good condition as well as the steel structure with surficial corrosion except for several badly corroded columns and post bases with more than 20% material loss (see Photographs 29 and 30).

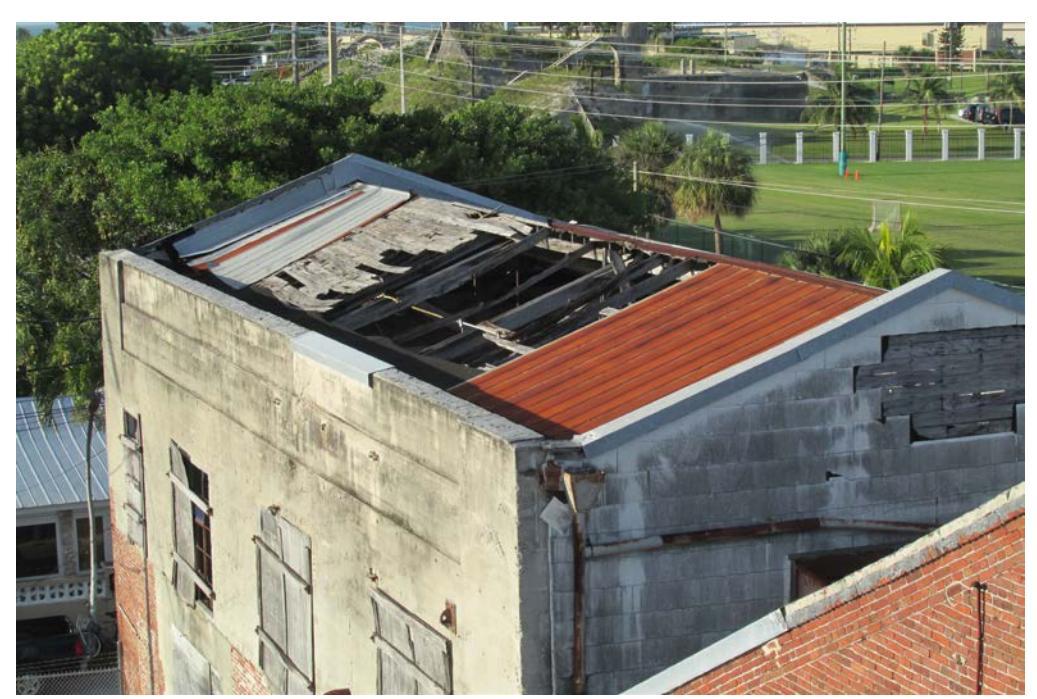
PHOTOGRAPH 40 (BUILDING IV)

- IV. The southernmost eastern building (Building IV) is in worse condition than Building II with a large area of missing metal roofing and wood sheathing, a deteriorated bottom roof truss chord and a wall opening with numerous loose and missing bricks with bricks falling (see Photographs 40, 41 and 42). The wood roof joists are in poor condition but the wood trusses appear in good condition. The steel structure is in good condition with surficial corrosion but many of the steel column bases are severely corroded with more than 20% material loss (see Photograph 43). The exterior masonry walls are in good condition but there are numerous cracks, corroded embedments, deteriorated mortar and loose and missing face brick. The upper concrete walls have large areas of honey combed concrete and an area of spalled concrete with corroded reinforcing (see Photographs 44 and 45).

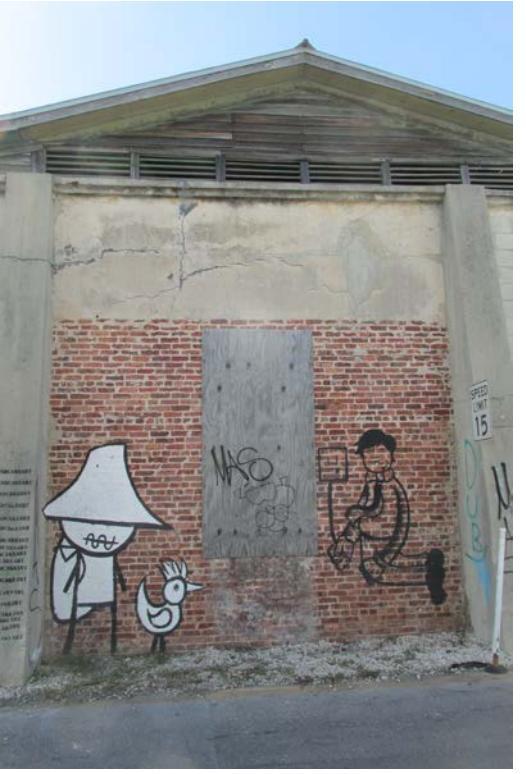
PHOTOGRAPH 48 (BUILDING III)

- III. The southwestern building (Building III) is in worse condition than Building I, but in better condition than the Building II and Building IV. The western metal roof is in good condition with several areas of corroded metal roofing and corroded roofing screws. The eastern metal roof is in poor condition with areas of missing roofing, extensive metal roofing deterioration and areas of deteriorated wood decking (see Photograph 46). The roof wood joists, beams, steel beams and columns are in good condition with surficial steel corrosion on the steel members and a deteriorated wood beam kicker (see Photograph 47). The slab on grade is cracked and uneven and the exterior high concrete has large areas of spalling concrete and a spalling concrete lintel (see Photographs 48 and 49). The exterior CMU and brick has several cracks, corroded embedments and delaminating stucco.

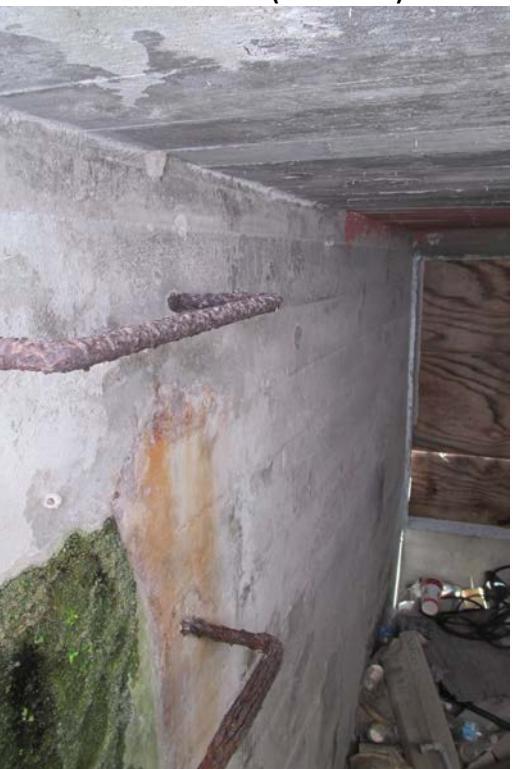
PHOTOGRAPH 50 (BUILDING V)

- V. The concrete exhaust building (Building V) is in good condition with corroded steel ladders; a badly corroded pipe support, a cracked housekeeping pad and a hairline crack in the roof parapet (see Photographs 50, 51, 52 and 53). The exterior pit and chute walls are in poor condition with cracked and spalling concrete with corroding reinforcing (see Photograph 54). All of the interior pits are full of water and breeding mosquitos. The interior trench and pit edge angles are in poor condition and badly corroded (see Photograph 55). All of the dynamos are in poor condition and badly corroded (see Photograph 56).

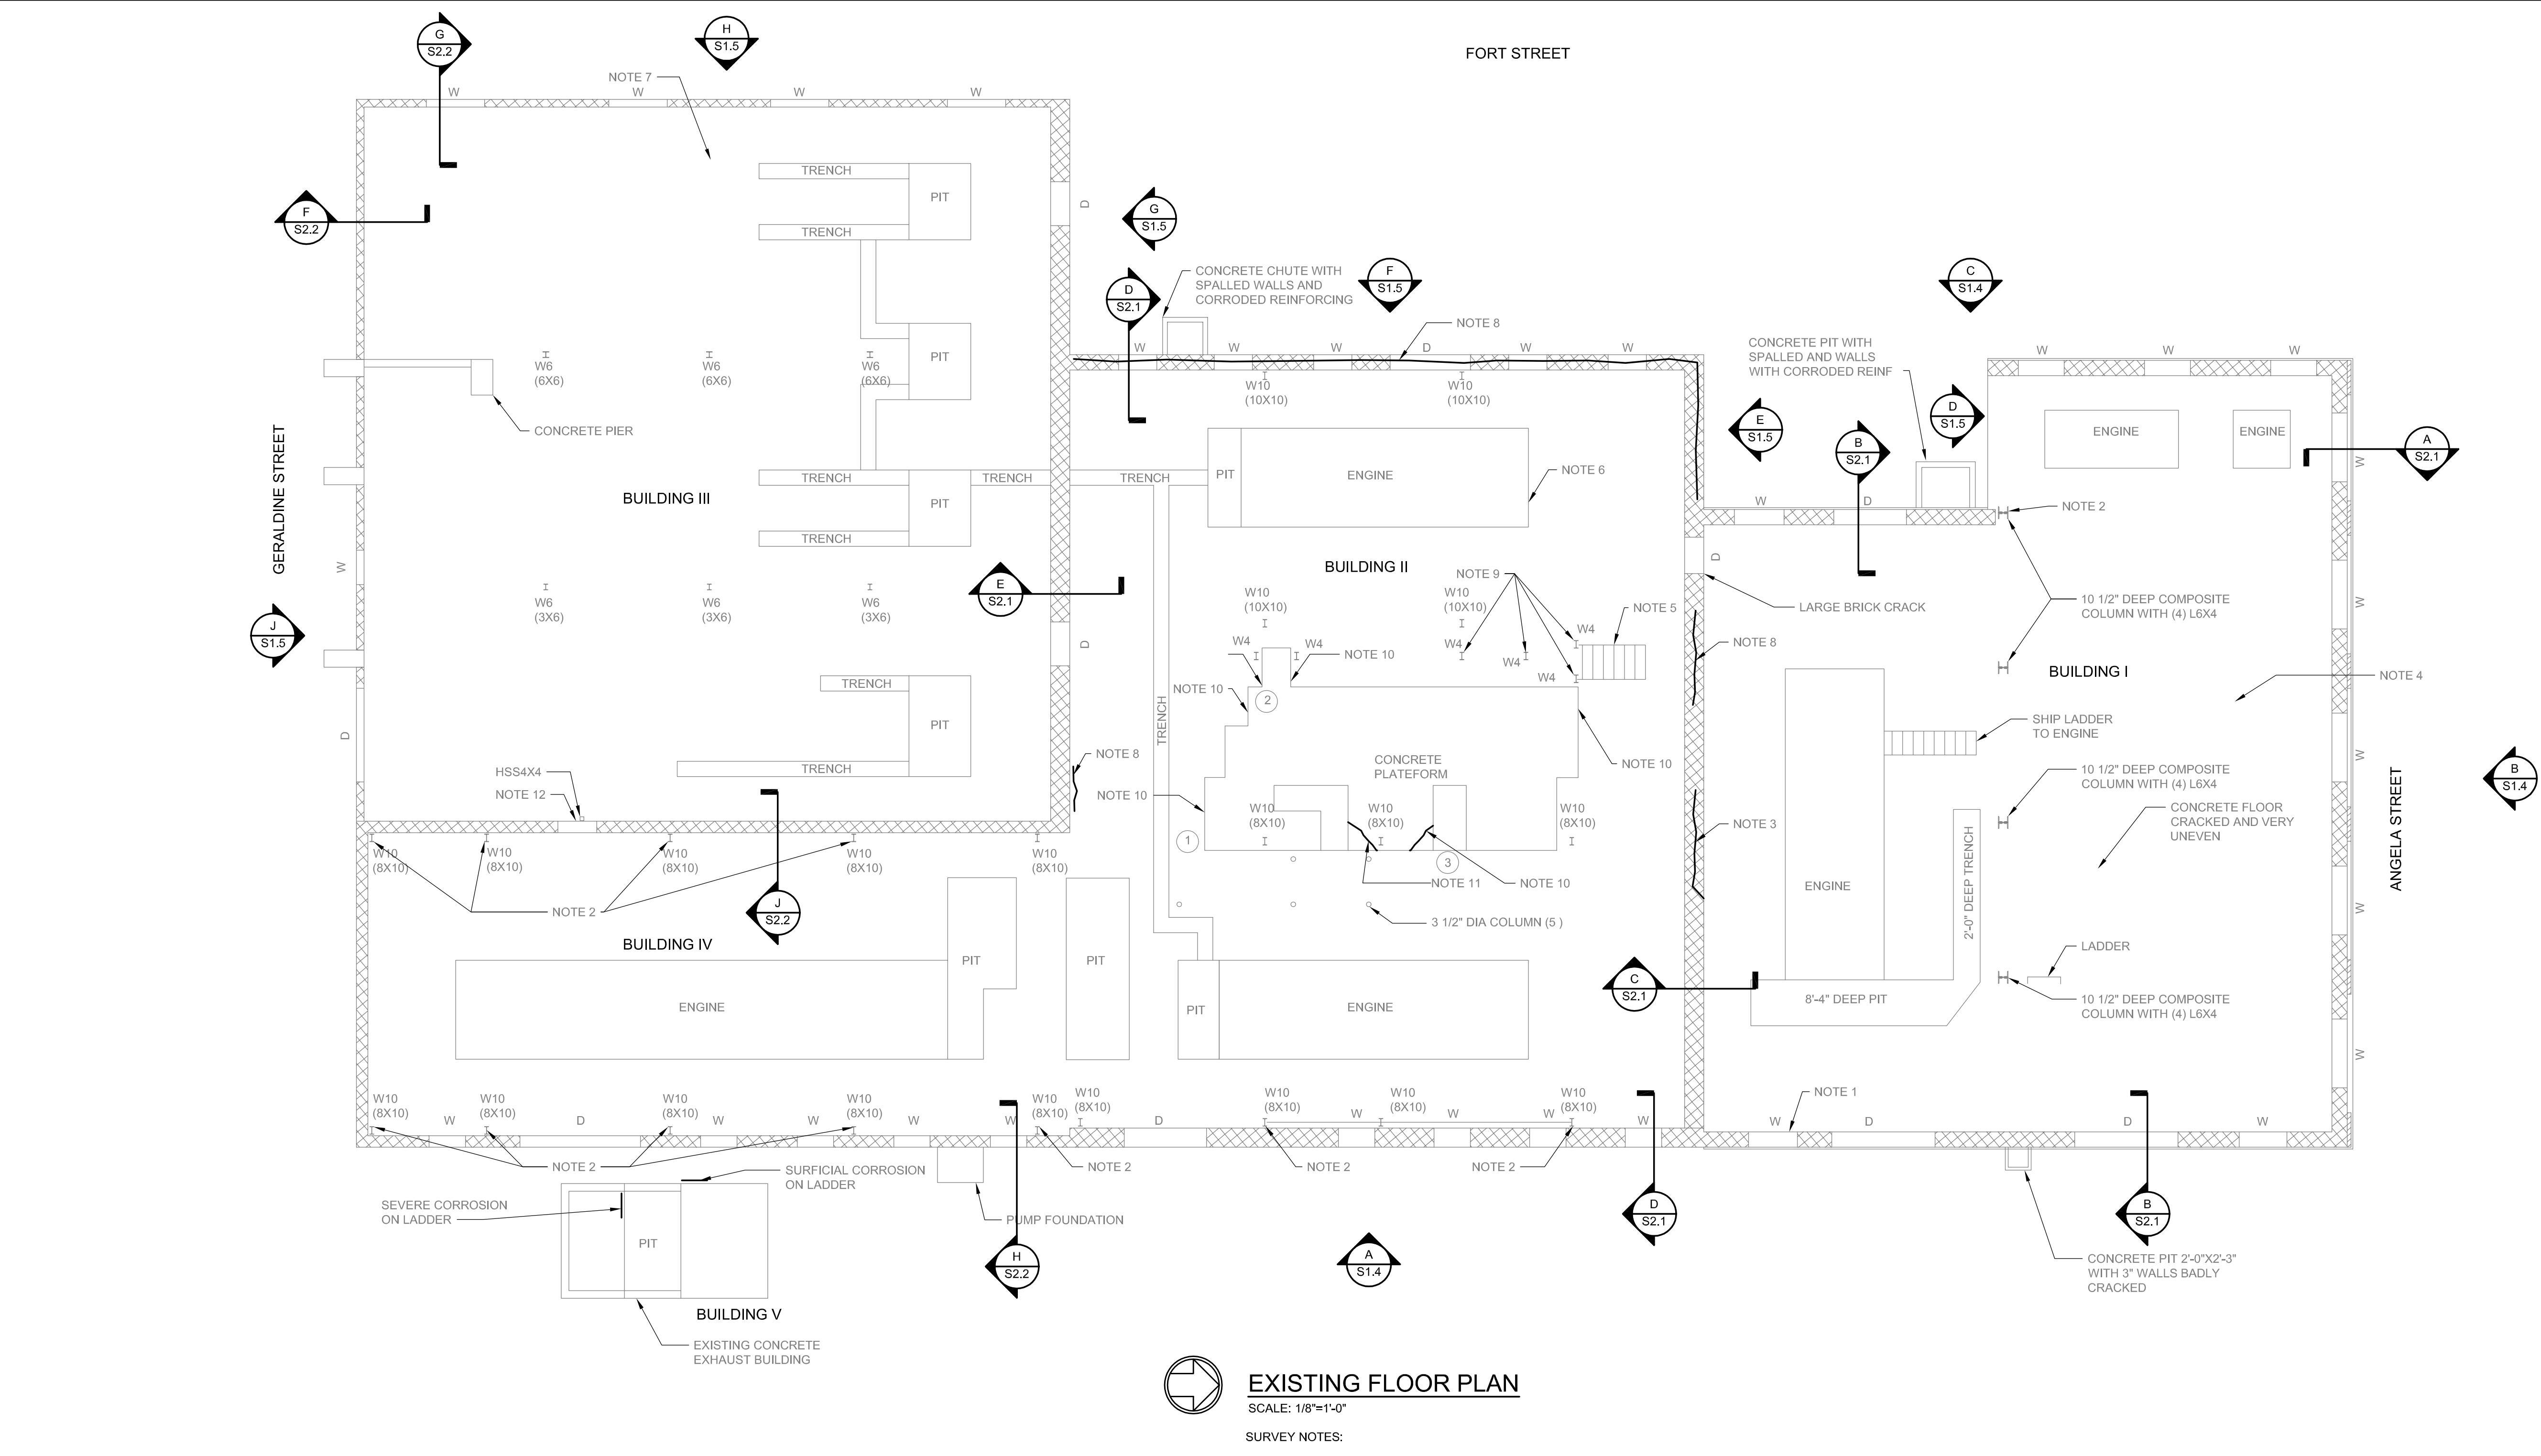
- 1. DETERIORATED FACE OF BRICK
- 2. BADLY CORRODED COLUMN BASE AND OR COLUMN
- 3. CRACKS IN BRICK AT WALL PENETRATIONS AND ELEVATED OPENINGS
- 4. CONCRETE FLOOR CRACKED AND UNEVEN
- 5. BADLY CORRODED STAIR STRINGERS AT BASE OF STAIR
- 6. TRENCH AND PIT EDGE ANGLE BADLY CORRODED
- 7. CONCRETE FLOOR CRACKED AND UNEVEN TRENCH AND PIT EDGE ANGLES ARE BADLY CORRODED
- 8. DETERIORATED MORTAR JOINTS
- 9. BADLY CORRODED POST BASE
- 10. LARGE SPALL WITH EXPOSED CORRODING REINFORCING
- 11. SEVERE CRACK AT CONCRETE BASE
- 12. BADLY DETERIORATED BRICK AT WALL OPENING
- 13. SURFICIAL CORROSION ON ALL STRUCTURAL STEEL.
- (#) CARBONATION AND CHLORIDE TEST
