RESOLUTION NO. 18-088

## **ORDER TO REPAIR, ALTER, OR IMPROVE BUILDINGS**

# Structural Condition Assessment Key West Diesel Plant Key West, Florida

Re: Structural Condition Assessment  
Key West Diesel Plant  
Key West, Florida

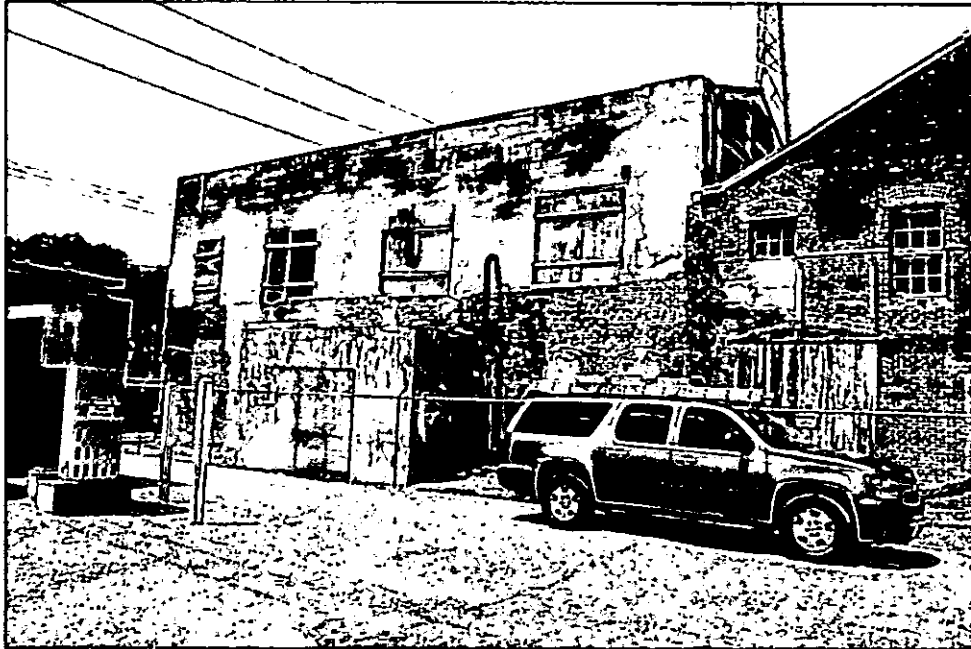
PHOTOGRAPH 5 (BUILDING IV AND V)

The abandoned Diesel Plant consists of four (4) connected one-story, buildings with the three (3) eastern buildings housing four (4) electric dynamos and the southwestern building having a lower roof that probably housed a shop and support spaces. The northernmost eastern building (Building I) houses one (1) dynamo and consists of a high new pre-engineered wood truss framed roof with plywood sheathing and metal roofing supported by perimeter multi-wythe brick walls and interior steel beams and columns (see Photographs 1 and 2). The easternmost center building (Building II) houses two (2) dynamos and consists of metal roofing on plywood sheathing, on wood joists and beams supported by heavy timber trusses and steel beams and columns that support crane beams (see Photographs 3 and 4). The heavy timber roof trusses are supported by perimeter multi-wythe brick walls. The southernmost eastern building (Building IV) houses one (1) dynamo and consists of metal roofing on wood sheathing on wood joists and beams supported by heavy timber trusses, and perimeter low multi-wythe brick walls and upper concrete walls (see Photographs 5 and 6).

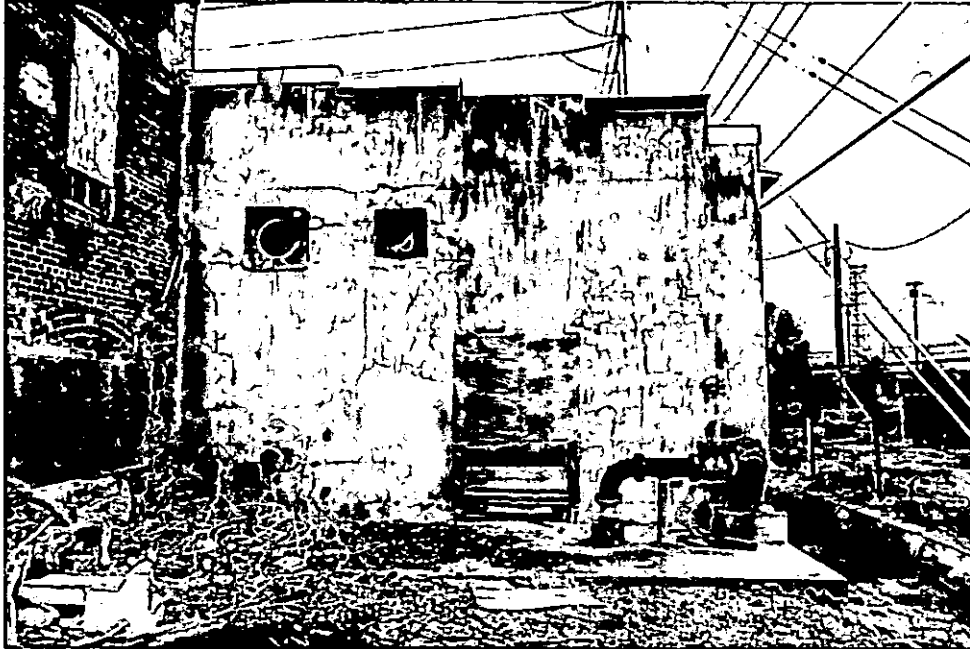
PHOTOGRAPH 9 (BUILDING III)

Below the roof structure is a gantry crane supported by a steel crane beam and steel columns independent of the perimeter brick walls. To the east of this building is an exterior concrete exhaust structure (Building V), which consists of a concrete roof slab with concrete parapets supported by concrete walls (see Photographs 7 and 8). The southwestern building (Building III) consists of metal roofing on wood sheathing on wood joists, and beams supported by interior steel beams and columns and perimeter multi-wythe brick walls, CMU walls and concrete walls (see Photographs 9 and 10).

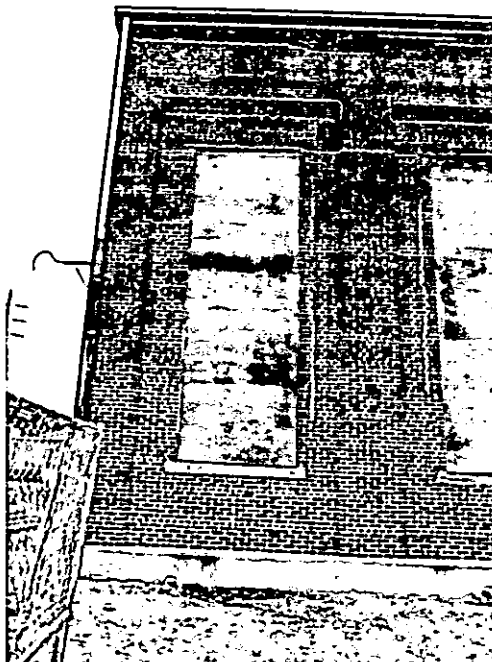
PHOTOGRAPH 17 (BUILDING I)

The exterior masonry walls are in good condition but there are numerous cracks, corroded embedments, deteriorated mortar, corroded lintels, deteriorated face brick, brick cracks with vegetation and random cracks in the concrete water table (see Photographs 17, 18, 19, 20, 21, 22 and 23). At the western return metal panel wall, there is a badly corroded angle purlin and a large column spall with corroded reinforcing and an area of missing metal wall panel (see Photographs 24, 25 and 26). The remaining metal panels are corroded and in poor condition (see Photograph 27).

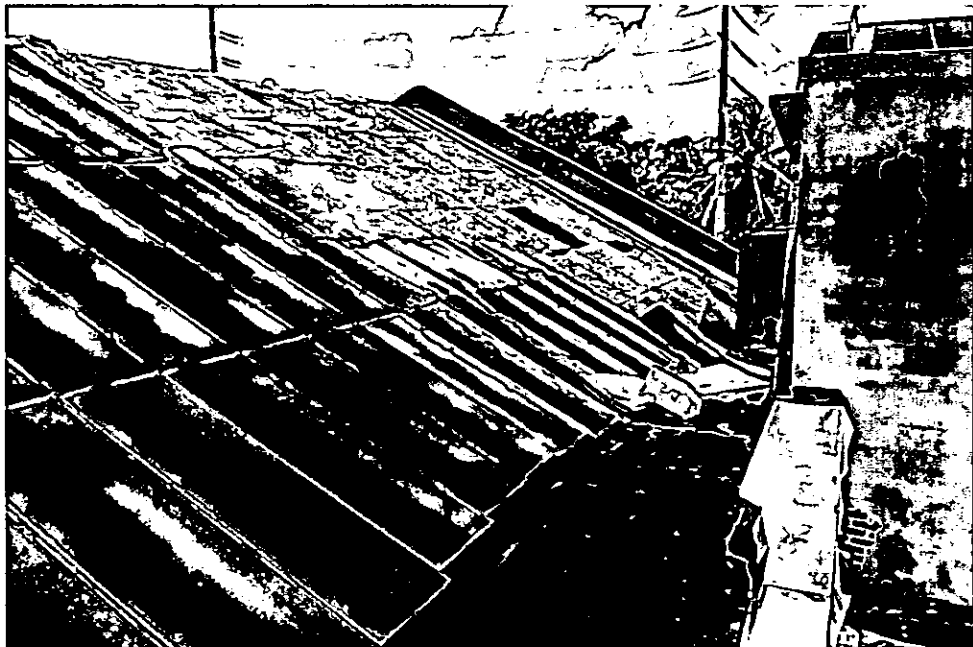
PHOTOGRAPH 28 (BUILDING II)

- II. The eastern center building (Building II) is in much worse condition than the Building I with metal roofing in extremely poor condition with large areas of missing metal roofing and large areas of deteriorated roof decking (see Photograph 28). The roof wood structure is in good condition as well as the steel structure with surficial corrosion except for several badly corroded columns and post bases with more than 20% material loss (see Photographs 29 and 30).

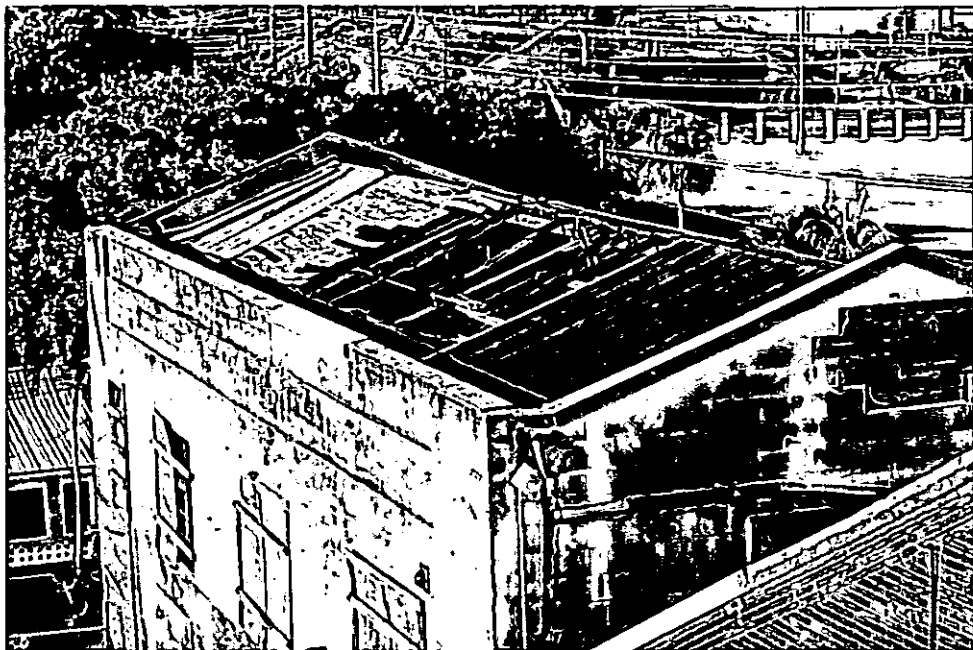
PHOTOGRAPH 40 (BUILDING IV)

- IV. The southernmost eastern building (Building IV) is in worse condition than Building II with a large area of missing metal roofing and wood sheathing, a deteriorated bottom roof truss chord and a wall opening with numerous loose and missing bricks with bricks falling (see Photographs 40, 41 and 42). The wood roof joists are in poor condition but the wood trusses appear in good condition. The steel structure is in good condition with surficial corrosion but many of the steel column bases are severely corroded with more than 20% material loss (see Photograph 43). The exterior masonry walls are in good condition but there are numerous cracks, corroded embedments, deteriorated mortar and loose and missing face brick. The upper concrete walls have large areas of honey combed concrete and an area of spalled concrete with corroded reinforcing (see Photographs 44 and 45).

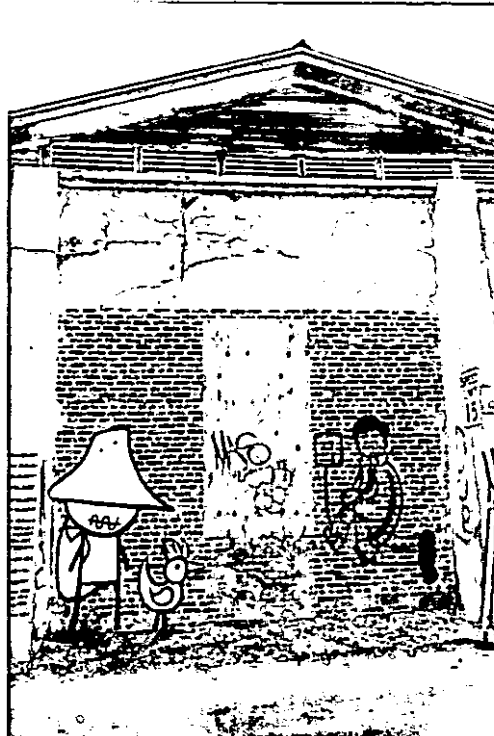
PHOTOGRAPH 48 (BUILDING III)

- III. The southwestern building (Building III) is in worse condition than Building I, but in better condition than the Building II and Building IV. The western metal roof is in good condition with several areas of corroded metal roofing and corroded roofing screws. The eastern metal roof is in poor condition with areas of missing roofing, extensive metal roofing deterioration and areas of deteriorated wood decking (see Photograph 46). The roof wood joists, beams, steel beams and columns are in good condition with surficial steel corrosion on the steel members and a deteriorated wood beam kicker (see Photograph 47). The slab on grade is cracked and uneven and the exterior high concrete has large areas of spalling concrete and a spalling concrete lintel (see Photographs 48 and 49). The exterior CMU and brick has several cracks, corroded embedments and delaminating stucco.
