**Subject: Key West Bight Marina Pile Assessment
From Dock H1 through Dock A**

CITY OF KEY WEST
PORT & MARINE SERVICES

KEY WEST BIGHT MARINA
DOCK AND PIER PILE ASSESSMENT REPORT

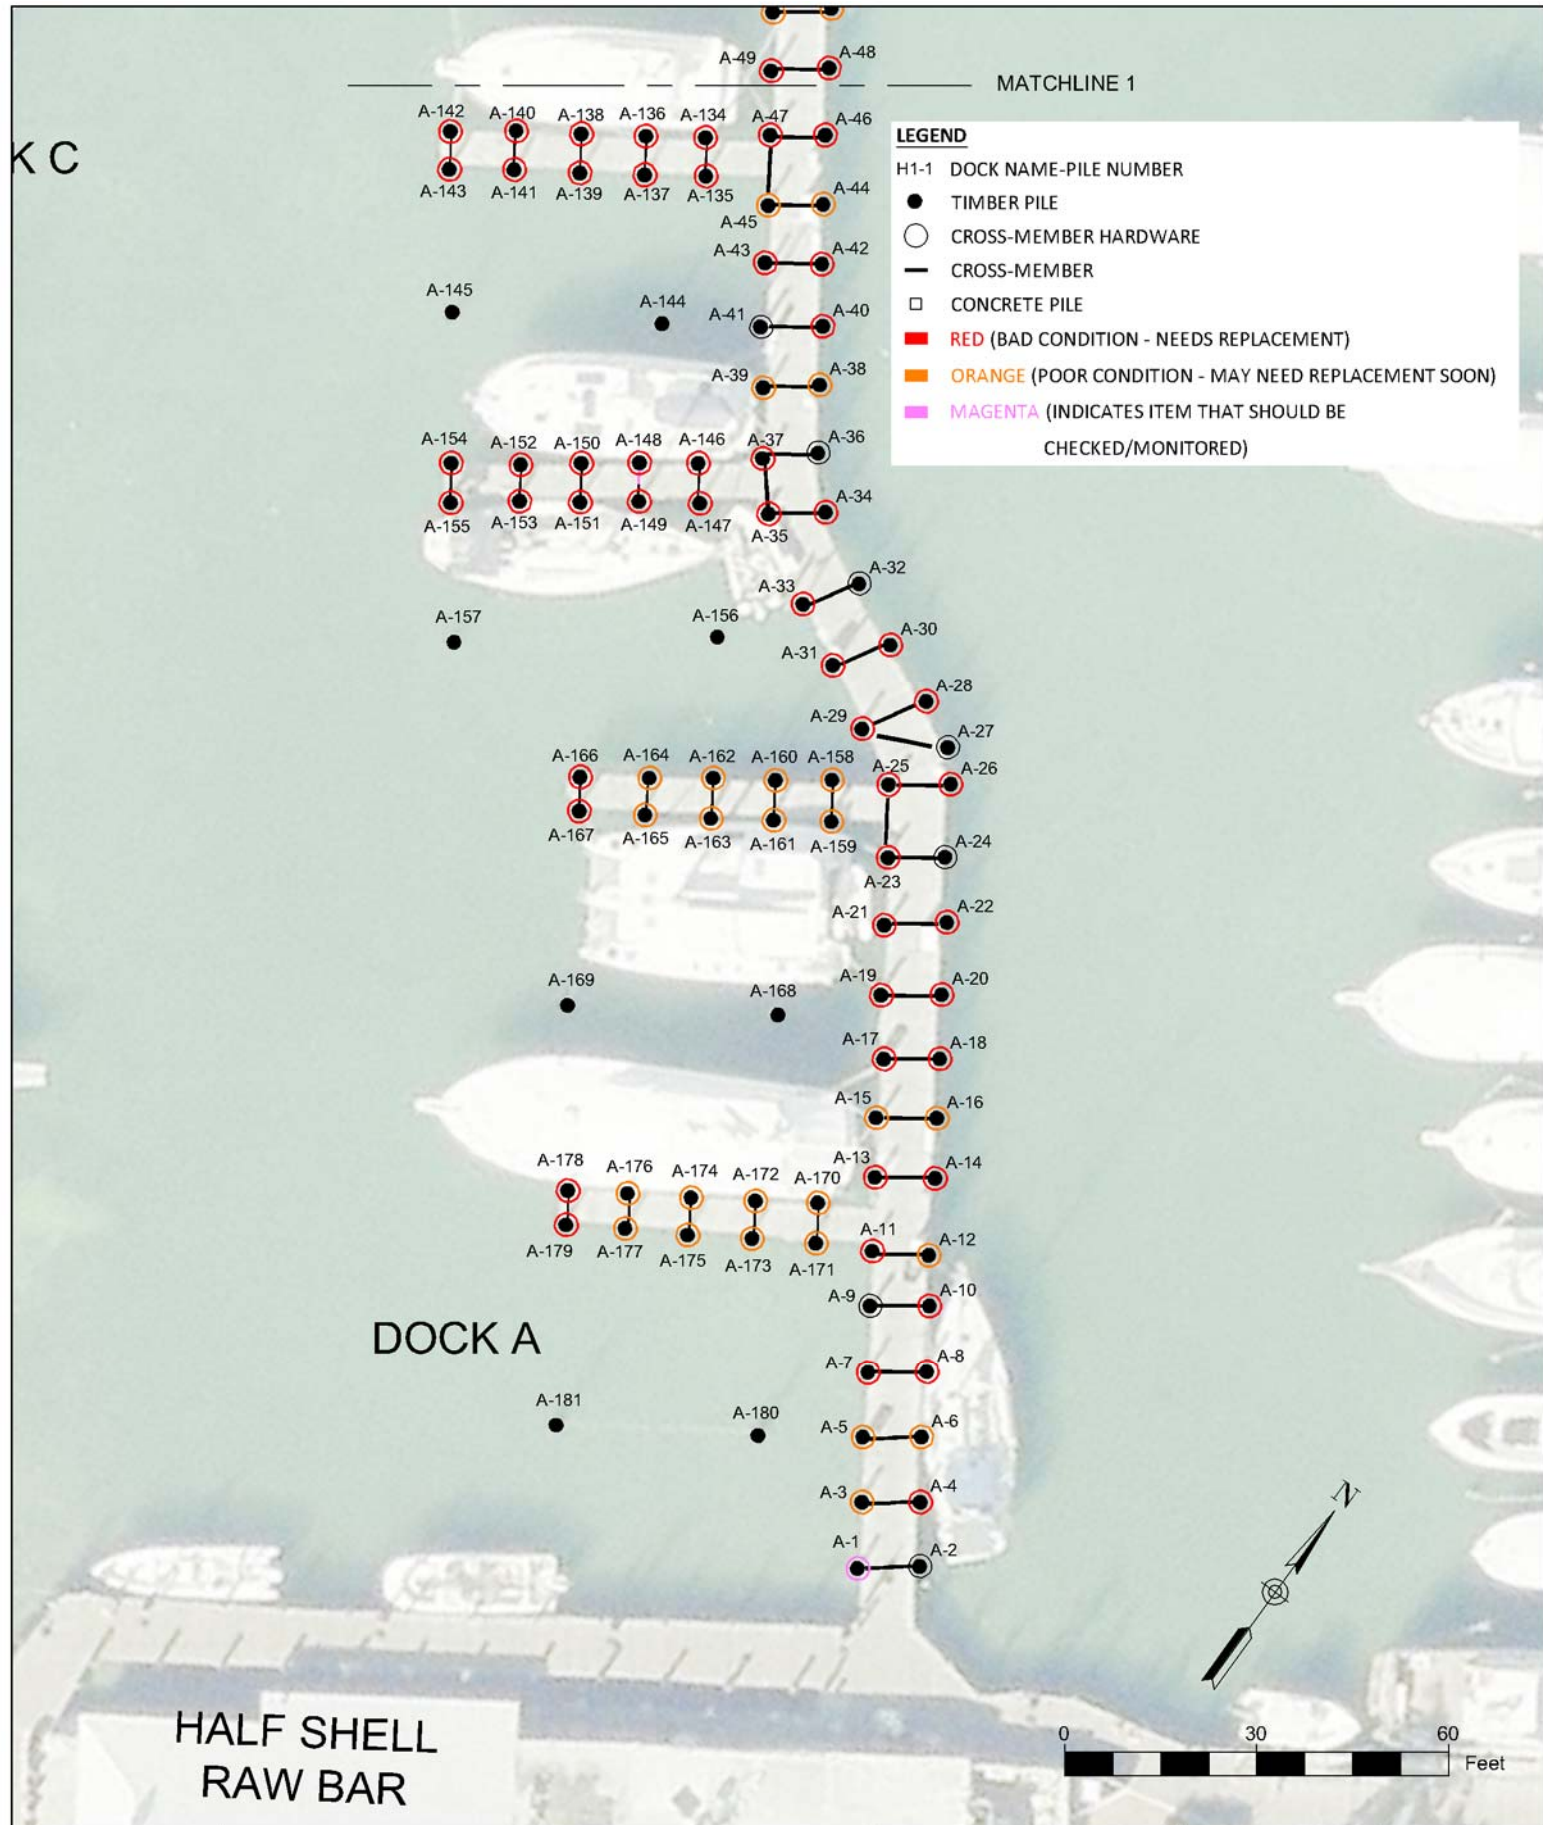
DOCK A PLAN VIEW

Dock A consisted of timber support piles, both horizontal and diagonal cross-members, and mooring piles. The condition of all the piles was found to be satisfactory (no major deficiencies noted for any of the piles). As shown in Figure 2 and Figure 3, however, there were various cross-member hardware that were galvanized steel and showed signs of minor to heavy corrosion. The galvanized corroded hardware was mainly contained to the horizontal cross-member connections, along with a few observed on the diagonal cross-members. Figure 4 shows the view of a typical component with galvanized corroded hardware. At least 149 connection points had the corroded galvanized hardware, making the number of bolts/all-threads that would need to be replaced approximately 298. Refer to Table 1 below for the summary of Harbor Walk deficiencies and to Appendix A for the condition descriptions of all components inspected.

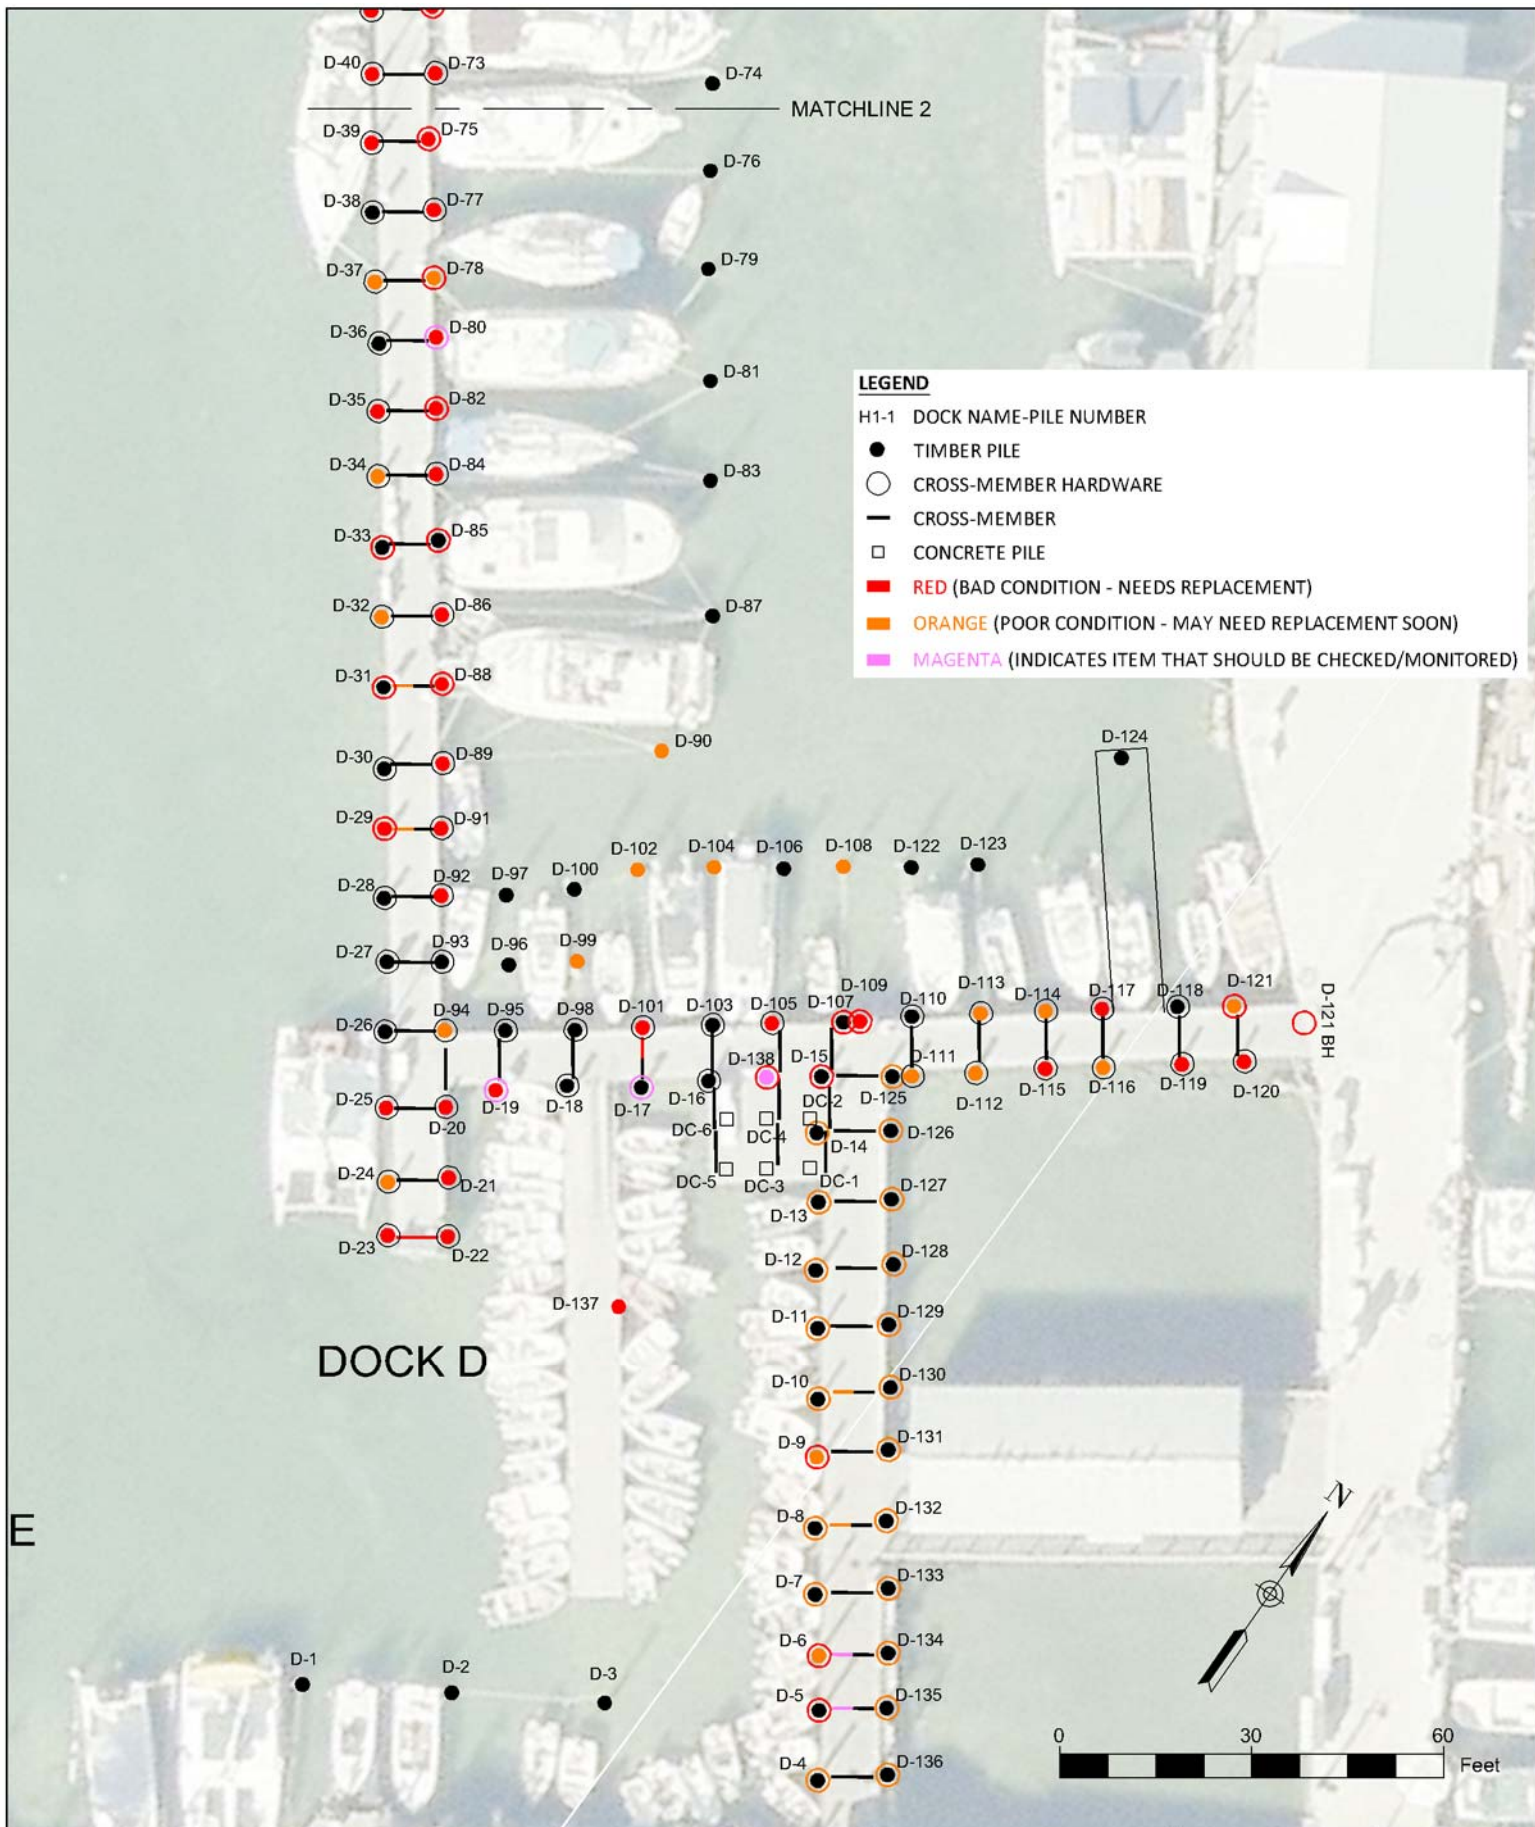
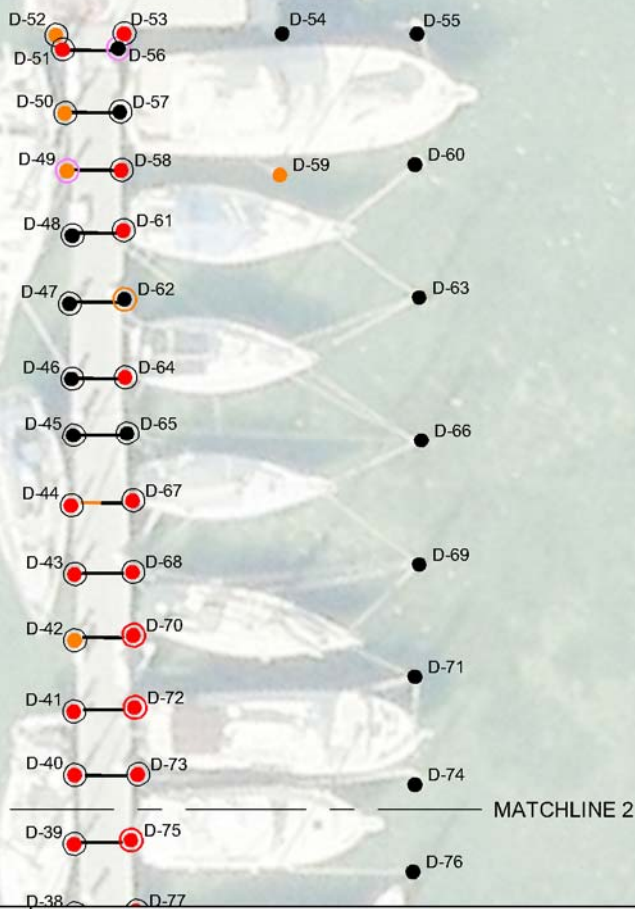
DOCK D PLAN VIEW

Based on the full assessment of each dock and pier, the major deficiencies are most apparent in the condition of Dock D. Dock D contained the majority of all bad piles due to the rotting of the various piles at the waterline. The condition of these piles presents a danger to the safety of this structure, and should be remedied by the replacement of the affected piles. Of secondary concern is the state of the galvanized steel connection hardware still being utilized throughout much of the marina. The galvanized hardware shows signs of corrosion that may lead to a failure of structural components throughout some of the existing docks.

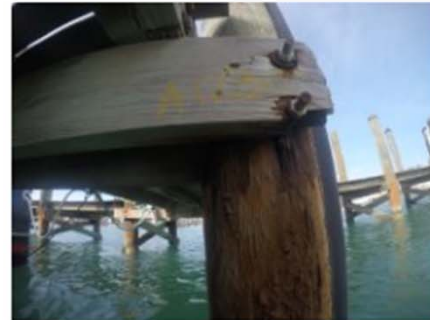
A-123.1

Figure 4: Pile A-123 with Corroding Galvanized Bolt Connections

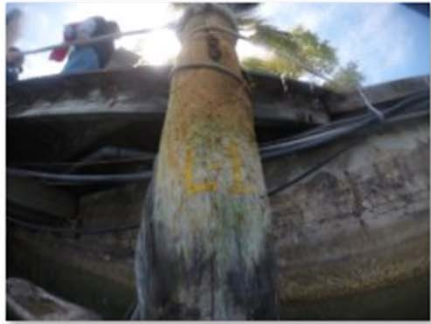
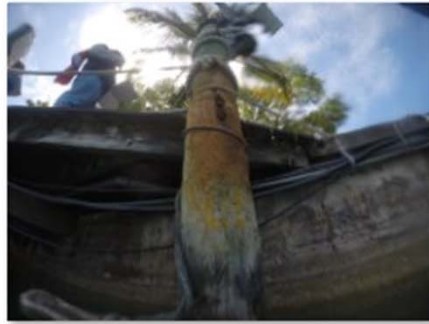
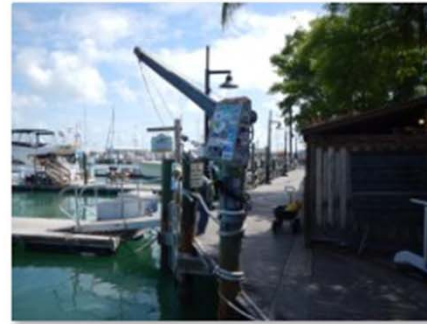
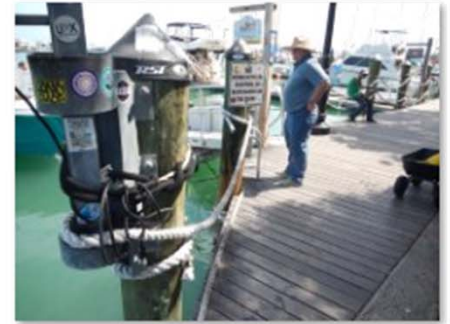
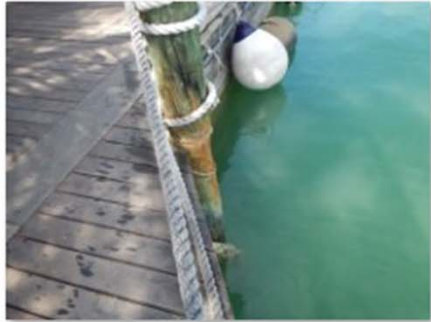
L-1.1

HARBOR WALK												
	Pile Condition		Horizontal Member		H-Hardware		Diagonal Member		D-Hardware		Misc.	Notes
L-1	OK	Note	OK	-	SS OK	Note	NA	-	NA	-	-	Pile badly shaved; x5 SS bolts at pile (typical L-1 to L-22)
L-2	OK	-	OK	-	SS OK	-	NA	-	NA	-	-	Bulkhead has SS hardware in good condition (typical L-2 to L-24)
L-3	OK	"s"	OK	-	SS OK	-	NA	-	NA	-	GA CO	Extra non-structural horizontal beam with GA CO hardware
L-4	OK	Note	OK	-	SS OK	-	NA	-	NA	-	-	Top of pile cracking and shaved at waterline
L-5	OK	-	OK	-	SS OK	-	NA	-	NA	-	-	
L-6	OK	-	OK	-	SS OK	-	NA	-	NA	-	-	
L-7	OK	-	OK	-	SS OK	-	NA	-	NA	-	-	
L-8	OK	-	OK	-	SS OK	-	NA	-	NA	-	-	
L-9	OK	-	OK	-	SS OK	-	NA	-	NA	-	-	
L-10	OK	-	OK	-	SS OK	-	NA	-	NA	-	-	
L-11	OK	-	OK	-	SS OK	-	NA	-	NA	-	-	
L-12	OK	Note	OK	-	SS OK	-	NA	-	NA	-	-	Two piles: broken cut-off pile with usual hardware to horizontal, and new pile attached to bulkhead
L-13	OK	"s"	OK	-	SS OK	-	NA	-	NA	-	-	
L-14	OK	-	OK	-	SS OK	-	NA	-	NA	-	-

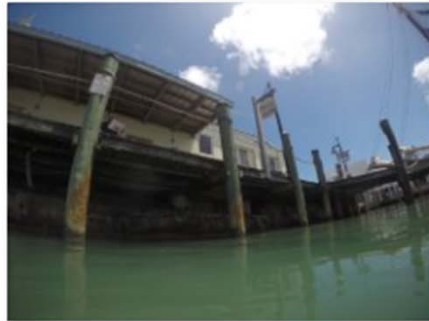
L-32.1

L-32	OK	-	OK	-	SS OK	-	NA	-	NA	-	-	Missing SS hardware to boardwalk
L-33	OK	-	OK	-	SS OK	-	NA	-	NA	-	-	
L-34	OK	-	OK	-	SS OK	-	NA	-	NA	-	-	
L-35	OK	-	OK	-	SS OK	-	NA	-	NA	-	-	
L-36	OK	"s"	OK	-	SS OK	-	NA	-	NA	-	-	Dock E corner
L-37	OK	-	OK	-	SS OK	-	NA	-	NA	-	GA CO	Dock E corner; Bulkhead connection changes to combination x2 SS and x1 GA CO hardware (typical L-37 to L-44)
L-38	OK	-	OK	-	SS OK	-	NA	-	NA	-	GA CO	
L-39	OK	-	OK	-	SS OK	-	NA	-	NA	-	GA CO	
L-40	OK	-	OK	-	SS OK	-	NA	-	NA	-	GA CO	
L-41	OK	-	OK	-	SS OK	-	NA	-	NA	-	GA CO	
L-42	OK	-	OK	-	SS OK	Note	NA	-	NA	-	GA CO	SS hardware missing nut/washer, also loose components
L-43	OK	-	OK	-	SS OK	-	NA	-	NA	-	GA CO	
L-44	OK	-	OK	-	SS OK	-	NA	-	NA	-	GA CO	
L-45	OK	-	OK	-	SS OK	-	NA	-	NA	-	-	Bulkhead connection changes to SS, some with rust staining (typical L-45 to L-54)
L-46	OK	-	OK	-	SS OK	-	NA	-	NA	-	-	
L-47	OK	-	OK	-	SS OK	-	NA	-	NA	-	-	
L-48	OK	-	OK	-	SS OK	-	NA	-	NA	-	-

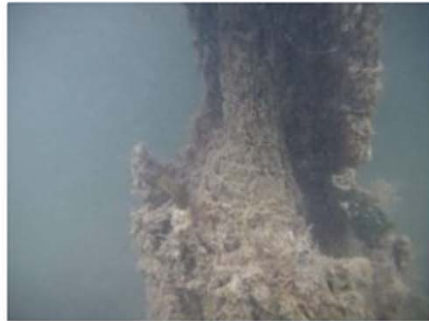
L-50.2

L-49	OK	-	OK	-	SS OK	-	NA	-	NA	-	-	
L-50	Rot	Note	OK	-	SS OK	-	NA	-	NA	-	-	Large void/heavy rot at waterline (approx. 5% of pile left)
L-51	OK	-	OK	-	SS OK	Note	NA	-	NA	-	-	Missing x2 SS nuts/washers on one side
L-52	OK	-	OK	-	SS OK	-	NA	-	NA	-	-	
L-53	Poor	"s"	OK	-	SS OK	-	NA	-	NA	-	-	Pile shaved approximately 1-1/2"
L-54	OK	-	OK	-	SS OK	-	NA	-	NA	-	-	
L-55	OK	-	OK	-	GA SC	-	NA	-	NA	-	-	
L-56	OK	-	OK	-	SS OK	"r"	NA	-	NA	-	-	
L-57	OK	-	OK	-	SS OK	-	NA	-	NA	-	-	
L-58	OK	-	OK	-	SS OK	-	NA	-	NA	-	-	
L-59	OK	-	OK	-	SS OK	Note	NA	-	NA	-	-	SS hardware not coming out from one side, and loose
L-60	OK	-	OK	-	SS OK	-	NA	-	NA	-	-	
L-61	OK	-	OK	-	SS OK	-	NA	-	NA	-	-
