BUILDING INSPECTION REPORT

Report Number
315

Margaret Street Turtle
Kraals Site
Key West, FL
33040

Inspection Date: **07/27/2015**

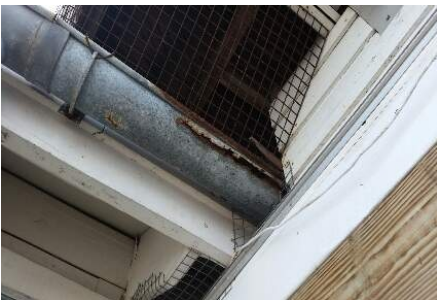
1.

Location: Lower Dining Deck **System:** Roof **Condition:** Gutter is deteriorated

Explanation: A gutter is observed to be in a deteriorated condition. Repairs are required to restore the gutter to its functional condition.

Impact Consequences: Gutters are a key component in the controlled drainage of run-off water away from the building exterior elements. Gutters that do not perform as intended may result in saturation of soils near the foundation which in turn can result in basement moisture or leakage issues. Repair should include restoring the gutters their intended condition and assuring that water freely flows and drains from the gutter.

Recommended Action: Repair or replace

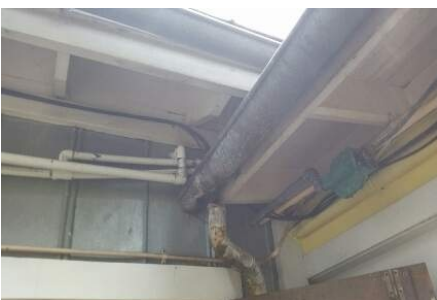
2.

Location: Exterior Rear **System:** Roof **Condition:** Gutter is deteriorated

Explanation: A gutter is observed to be in a deteriorated condition. Repairs are required to restore the gutter to its functional condition.

Impact Consequences: Gutters are a key component in the controlled drainage of run-off water away from the building exterior elements. Gutters that do not perform as intended may result in saturation of soils near the foundation which in turn can result in basement moisture or leakage issues. Repair should include restoring the gutters their intended condition and assuring that water freely flows and drains from the gutter.

Recommended Action: Repair or replace

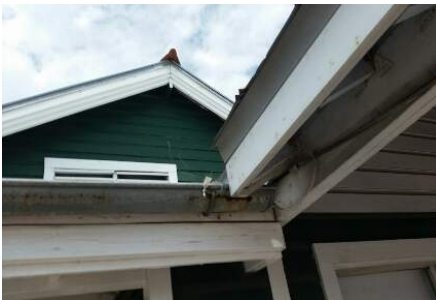
4.

Location: Restaurant Entrance **System:** Roof **Condition:** Gutter is deteriorated

Explanation: A gutter is observed to be in a deteriorated condition. Repairs are required to restore the gutter to its functional condition.

Impact Consequences: Gutters are a key component in the controlled drainage of run-off water away from the building exterior elements. Gutters that do not perform as intended may result in saturation of soils near the foundation which in turn can result in basement moisture or leakage issues. Repair should include restoring the gutters their intended condition and assuring that water freely flows and drains from the gutter.

Recommended Action: Repair or replace

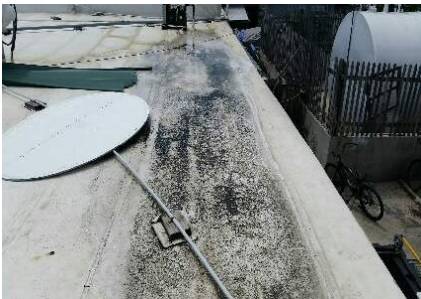
7.

Location: Roof **System:** Roof **Condition:** Water ponding on roof surface is observed

Explanation: Active water ponding is observed on the roof surface. Poor roof surface drainage increases the risk of leakage and can reduce the life expectancy of the roof.

Impact Consequences: Flat and low-slope roofs should be sufficiently sloped such that all water will drain from its surface. Water that ponds on the surface will add to the weight loading at the affected area which will over time enlarge this area and compound the problem. Leaks are most likely to occur at seams that are immersed in

water. Correction to the roof surface profile is required. A roofing specialist should be consulted to assess for current condition and for requirements and costs for remedial action.

Recommended Action: Replace consult specialist

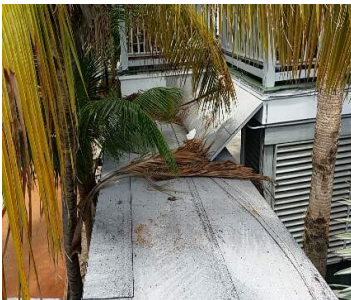
11.

Location: Roof **System:** Roof **Condition:** Debris On Roof

Explanation: Debris is observed on the roof surface.

Impact Consequences: The roof surface should be kept free of debris in order to protect the roof material. Debris on the roof will promote faster deterioration of the installed roof covering.

Recommended Action: Review

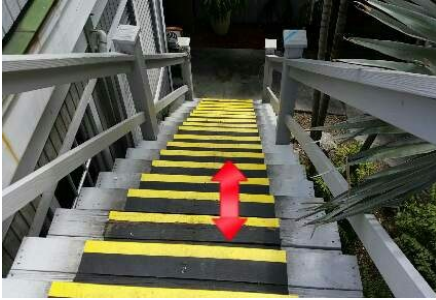
7.

Location: Tower Bar Stairway **System:** Exterior **Condition:** Exterior wood steps have loose tread(s)

Explanation: One or more of the step treads is noted to be loose. Loose treads present a risk of injury to people traversing the stairs.

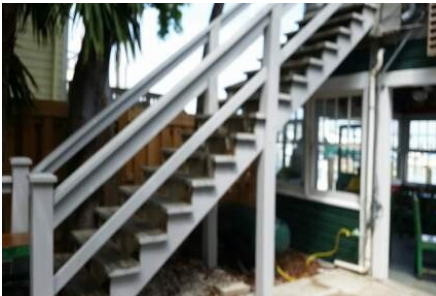
8.

Location: Upper Dining Deck **System:** Exterior **Condition:** Exterior wood steps have bouncy tread(s)

Explanation: One or more of the step treads is noted to move or bounce when walked upon. This condition is indicative of insufficient support under the treads.

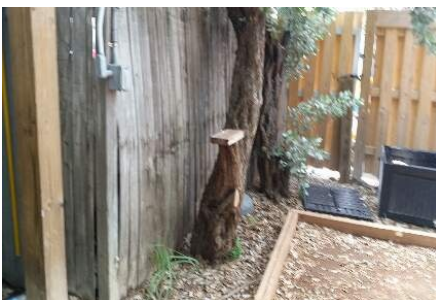
11.

Location: Exterior Rear **System:** Exterior **Condition:** Exterior fence is deteriorated

Explanation: The fence displays conditions of deterioration and is in need of repair.

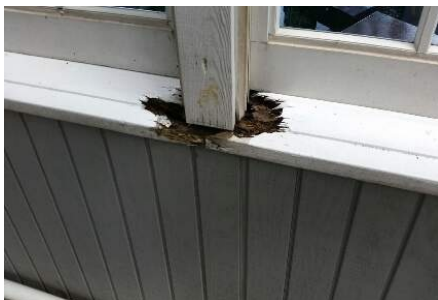
16.

Location: Lower Dining Deck **System:** Exterior **Condition:** Exterior window frame and or sill is rotted

Explanation: Deterioration of the window frame and or sill is noted with rot observed.

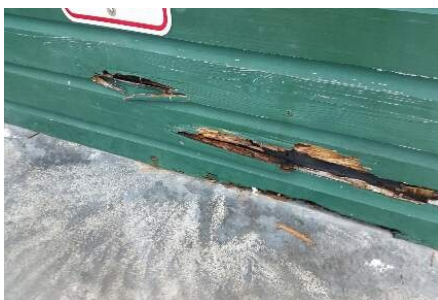
17.

Location: Lower Dining Deck **System:** Exterior **Condition:** Rot observed on wood elements

Explanation: Wood elements that display rot should be replaced

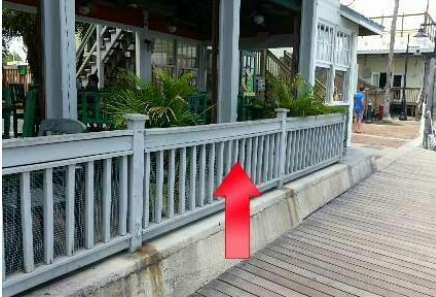
18.

Location: Lower Dining Deck **System:** Exterior **Condition:** Exterior deck railing is shaky

Explanation: Exterior deck railings should be installed and maintained so as to be sufficiently secured to prevent failure or detachment under normal use. Shaky deck railings are an indication that the railings are deteriorating and in need of corrective repairs or replacement.

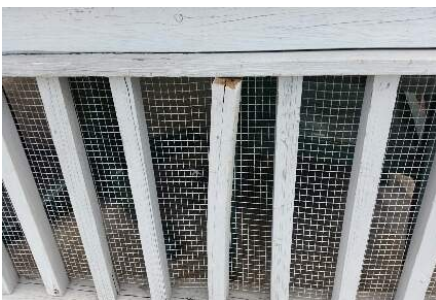
19.

Location: Lower Dining Deck **System:** Exterior **Condition:** Exterior deck railing is damaged

Explanation: Damage to the railing is noted.

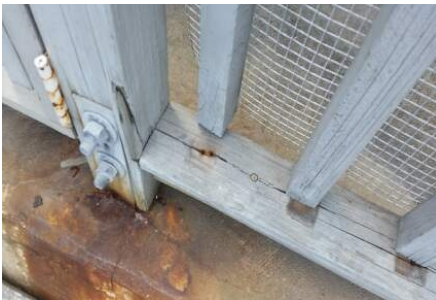
21.

Location: Lower Dining Deck **System:** Exterior **Condition:** Exterior deck railing is damaged

Explanation: Damage to the railing is noted.

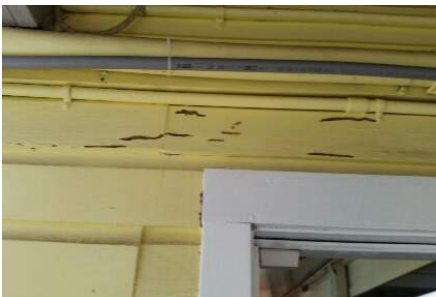
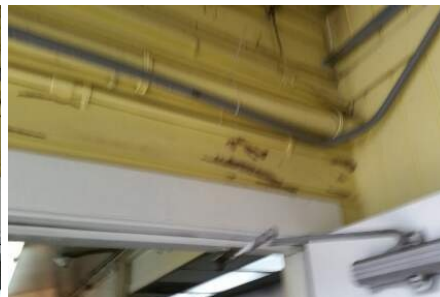
22.

Location: Exterior Rear **System:** Exterior **Condition:** Pests Observed On Exterior Of Building

Explanation: A condition promoting pest infestation is observed.

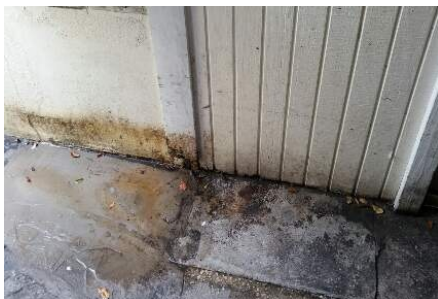
24.

Location: Exterior Ice Machine area **System:** Exterior **Condition:** Wood siding is rotted

Explanation: Rot is noted in portions of the exterior wood siding. Wood damaged by rot should be removed and replaced.

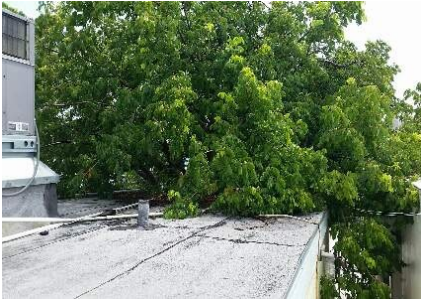
26.

Location: Roof **System:** Exterior **Condition:** Tree branches are too near to the roof surface

Explanation: Roof surfaces can be damaged by tree branches in close proximity to the roof cover.

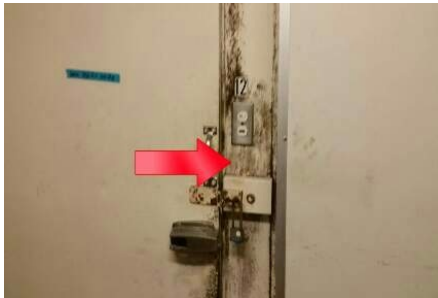
5.

Location: Walk In Cooler Hallway **System:** Interior **Condition:** Mold Suspected On Interior Surfaces

Explanation: Mold or Fungus is observed to be growing on interior surfaces.

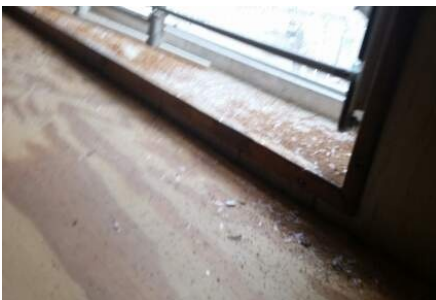
9.

Location: Accounting Office **System:** Interior **Condition:** Evidence of pest entry.

Explanation: There is indication of pest entry into the interior of the building.

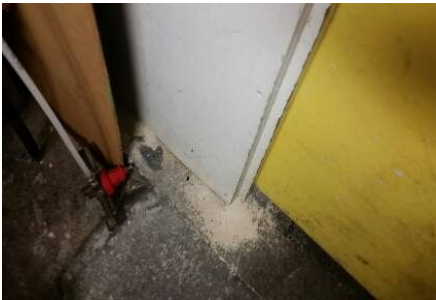
11.

Location: Office Storage Area **System:** Interior **Condition:** Evidence of pest entry.

Explanation: There is indication of pest entry into the interior of the building.

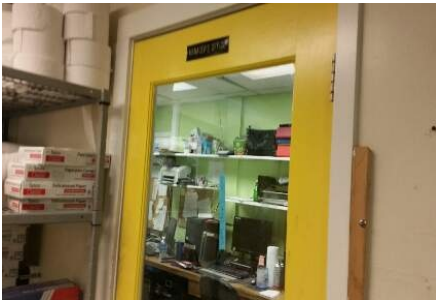
15.

Location: Office **System:** Interior **Condition:** Failed Flood Light Test

Explanation: The flood light failed to illuminate upon restricting the power source or using the test button.

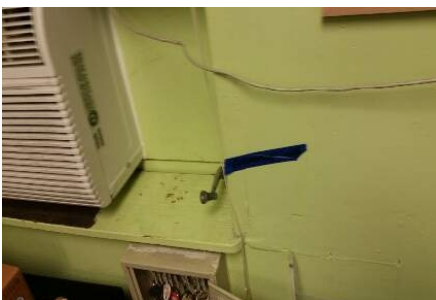
16.

Location: Office **System:** Interior **Condition:** WET Wall Stain Adjacent to Exterior Wall

Explanation: A stain on an interior wall surface is observed to test high for moisture content using moisture meters or thermal imaging camera. The source of the moisture intrusion is suspected to be from an active exterior wall leak.

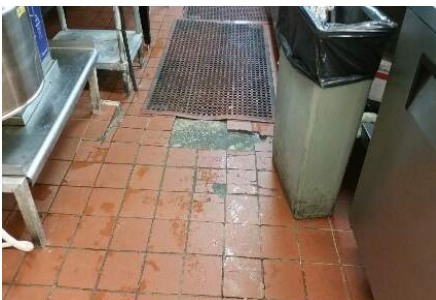
20.

Location: Kitchen **System:** Interior **Condition:** Floor is uneven

Explanation: Visible ridges depressions or hollows are observed in the floor surface. This condition is typically due to unevenness in the subfloor. Ridges are typically due to a mismatch in height at the edges of subflooring materials. Depressions are typically due to insufficient support at the edges of the subflooring wood members. Hollows are typically due to a local area of damage in the subfloor.

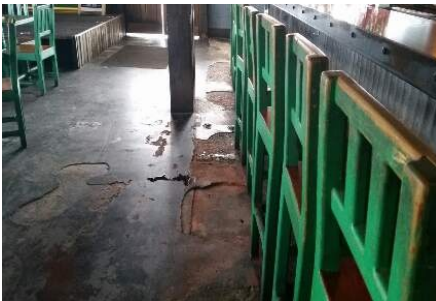
22.

Location: Interior Bar **System:** Interior **Condition:** Trip hazard in floor surface

Explanation: The floor surface has an abrupt change in height where different floor finishes abut. This condition has a variation that is sufficiently great as to present a potential trip hazard.

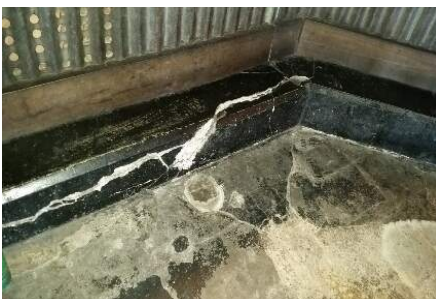
23.

Location: Interior Bar **System:** Interior **Condition:** Damaged trims

Explanation: A trim is noted to be damaged.

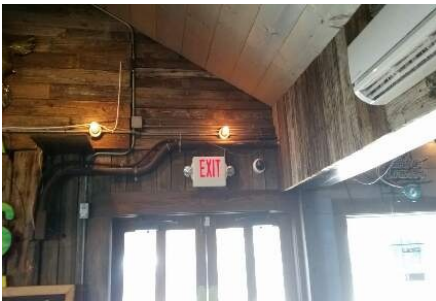
25.

Location: Restaurant Entrance **System:** Interior **Condition:** Failed Flood Light Test

Explanation: The flood light failed to illuminate upon restricting the power source or using the test button.

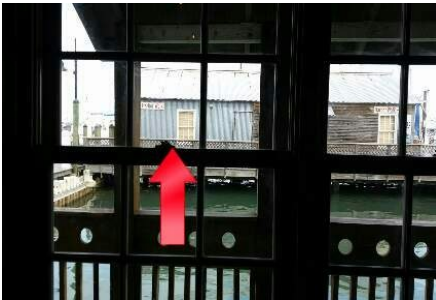
28.

Location: Restaurant Main Dining **System:** Interior **Condition:** Window has damaged hardware

Explanation: Hardware required for proper operation and function of the window is damaged. Window operation and performance considerations include: ability to restrict forced entry; ability to open and close with relative ease; ability to securely close and latch; ability to restrict entry of air water and pests.

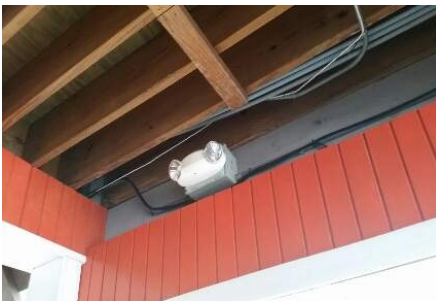
30.

Location: Lower Dining Deck **System:** Interior **Condition:** Failed Flood Light Test

Explanation: The flood light failed to illuminate upon restricting the power source or using the test button.

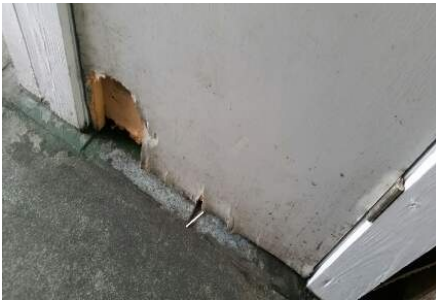
33.

Location: Exterior Bar **System:** Interior **Condition:** Damaged Closet Doors

Explanation: Closet doors are observed to be damaged

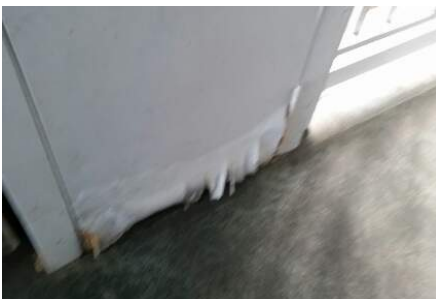
34.

Location: Exterior Bar **System:** Interior **Condition:** Damaged Closet Doors

Explanation: Closet doors are observed to be damaged

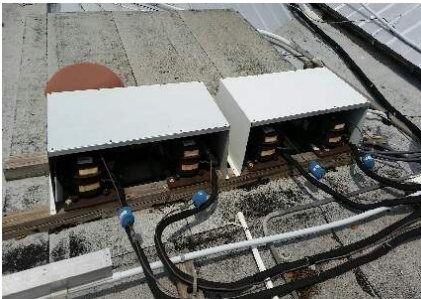
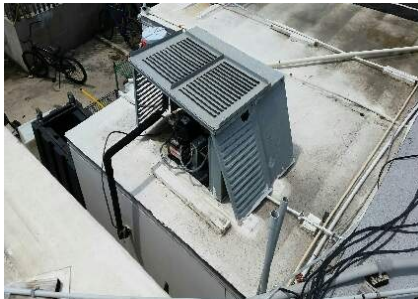
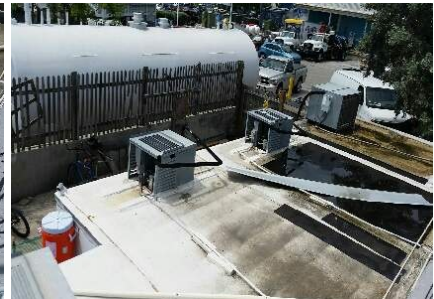
36.

Location: Roof **System:** Interior **Condition:** Refrigeration Unit Housing Damaged or Missing

Explanation: The protective housing cover of the refrigeration system is observed to be damaged or missing.

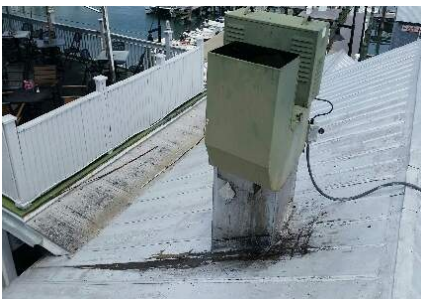
2.

Location: Roof **System:** Insulation Ventilation **Condition:** Grease Build Up At Vent Outlet

Explanation: The ventilation system output area is observed to have grease build up from commercial cooking equipment exhaust.

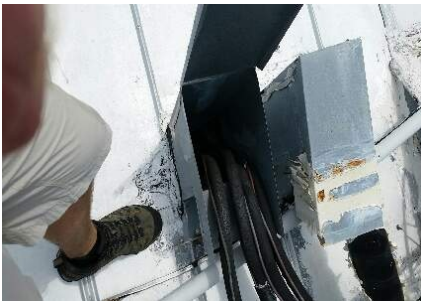
2.

Location: Roof **System:** Heating And Cooling **Condition:** Refrigerant Line Penetrations Not Sealed

Explanation: The exterior building penetrations for air conditioning refrigerant lines is not properly sealed.

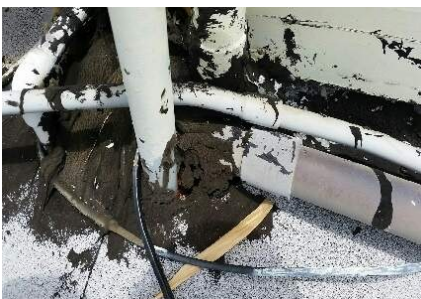
3.

Location: Roof **System:** Heating And Cooling **Condition:** Refrigerant Line Penetrations Not Sealed

Explanation: The exterior building penetrations for air conditioning refrigerant lines is not properly sealed.

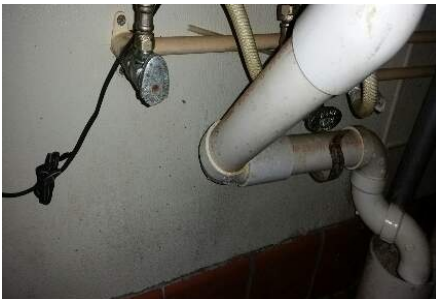
1.

Location: Walk In Cooler Hallway **System:** Plumbing **Condition:** Shut Off Valve Stuck

Explanation: Shut Off Valve is stuck or requires excessive force to operate

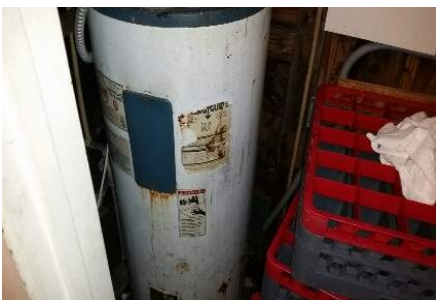
2.

Location: Storage Room **System:** Plumbing **Condition:** Water heater is leaking

Explanation: Water leakage of any amount is an indicator of current or developing problems with the water tank. Old water tanks generally rust at the bottom and minor leaks from perforation are a precursor to ultimate rupture failure of the tank.

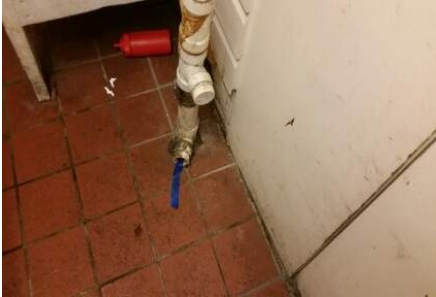
3.

Location: Storage Room **System:** Plumbing **Condition:** Drainage system has unsealed openings

Explanation: An opening in the drainage system is observed to not be sealed or is improperly sealed.

Impact Consequences: Unsealed openings may permit waste water leakage or flooding. Unsealed openings may result in sewer gases entering the building. The presence of sewer gas should be considered as a risk to health and if in sufficient density may present the risk of explosion. All unsealed openings in the drainage system should be sealed.

Recommended Action: Repair

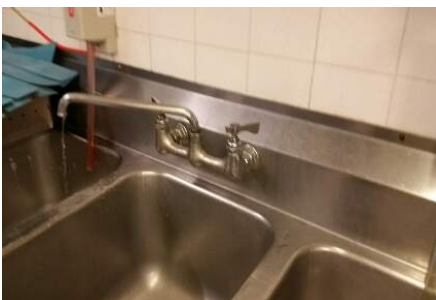
4.

Location: Kitchen **System:** Plumbing **Condition:** Faucet leaks

Explanation: A leak is observed at the taps during operation. Typical observations include leaks at the faucet body handles or spout.

Impact Consequences: Leaks at the handle spout or body of the faucet is an indication of a defective seal or component. Repair is often possible; replacement of the faucet may be required.

Recommended Action: Repair

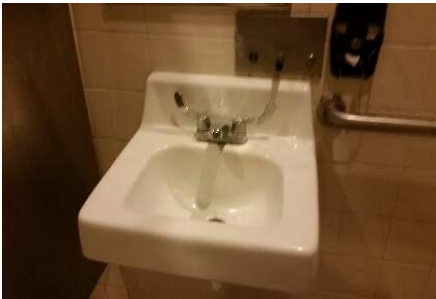
6.

Location: Mens Room **System:** Plumbing **Condition:** Sink is not secured to wall

Explanation: A sink is observed to be not securely attached at the wall.

Impact Consequences: A sink that is not securely attached and if not repaired may become detached from the wall. Costly repairs could result.

Recommended Action: Repair

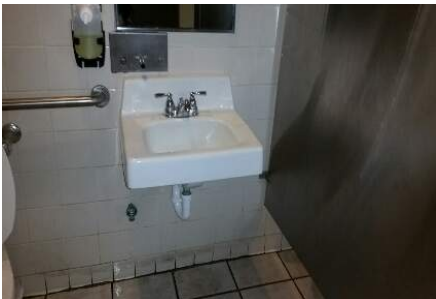
7.

Location: Womens Room **System:** Plumbing **Condition:** Sink is not secured to wall

Explanation: A sink is observed to be not securely attached at the wall.

Impact Consequences: A sink that is not securely attached and if not repaired may become detached from the wall. Costly repairs could result.

Recommended Action: Repair

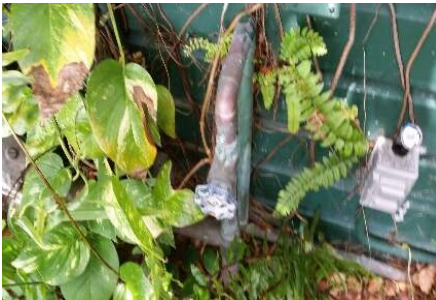
9.

Location: Restaurant Entrance **System:** Plumbing **Condition:** Obsolete Shut Off Valve

Explanation: The shut off valve is one observed to be an obsolete type due to high risk of malfunction or damage.

Impact Consequences: The shut off valve is provided in order to assist in restricting water service to the building or fixture. Obsolete shut off valves with known issues of malfunctioning or becoming easily damaged when operated should be replaced with more reliable fixtures. The Inspector did not perform a test of this shut off valve due to the high risk of damaging the valve. It is recommended to have a licensed plumber evaluate the shut off valve in order to consider replacing with a more reliable fixture.

Recommended Action: Consult

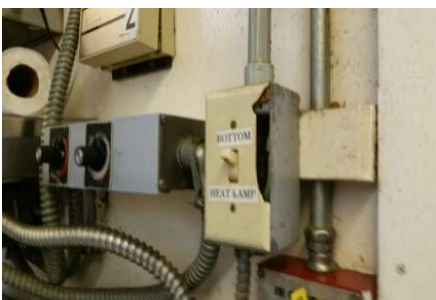
1.

Location: Kitchen **System:** Electrical **Condition:** Damaged electrical switch cover

Explanation: Electrical switches installed require protection from water entry and contaminants.

Impact Consequences: A switch with a missing or damaged cover is subject to damage and deterioration if its protection has been compromised. Switches displaying damage or deterioration should be immediately replaced and a suitable cover installed.

Recommended Action: Repair

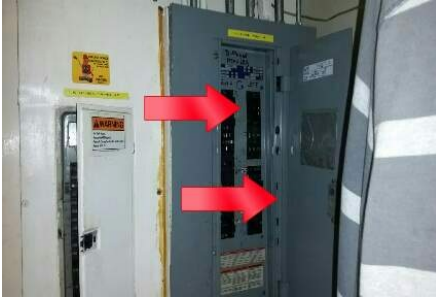
2.

Location: Walk In Cooler Hallway **System:** Electrical **Condition:** Panel cover screws are missing on the electrical panel

Explanation: All screws for electrical panel covers should be installed to assure that the cover is properly located and securely attached. Screws used to secure the cover must be of the type supplied by the manufacturer which have tips that are blunted to prevent the piercing of wires when turning the screws into place.

Impact Consequences: The conditions should be deemed as a safety issue requiring corrective action by an electrician.

Recommended Action: Repair

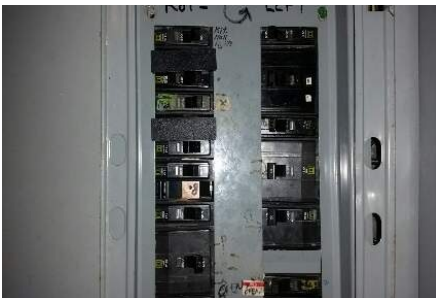
3.

Location: Walk In Cooler Hallway **System:** Electrical **Condition:** The panel cover has uncovered openings

Explanation: There should be no uncovered openings at the cover of the service panel to prevent accidental contact with live electrical components in the box.

Impact Consequences: This condition presents a risk of electrical shock and is a safety concern. Panel cover plugs can be purchased at an electrical supply and many hardware stores and should be installed to prevent accidental contact with live parts of the panel.

Recommended Action: Repair

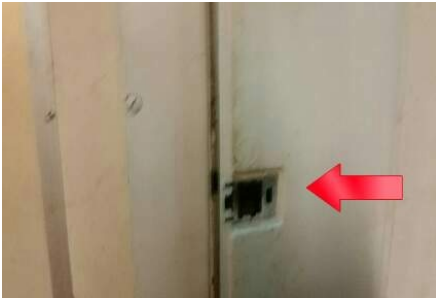
5.

Location: Walk In Cooler Hallway **System:** Electrical **Condition:** Damaged Panel Cover

Explanation: Panel cover is observed to be damaged.

Impact Consequences: The panel cover should latch securely when closed. The panel cover should have no gaps when closed as well. Damaged panel covers can pose a safety hazard to the occupants. Consult a licensed electrician for proper repair or installation of electrical distribution panels.

Recommended Action: Repair

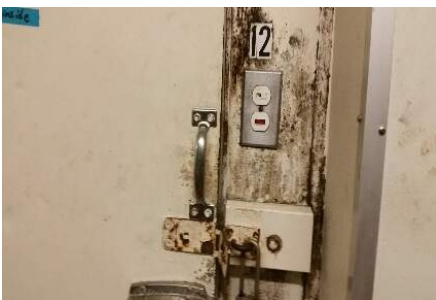
6.

Location: Walk In Cooler Hallway **System:** Electrical **Condition:** Electrical switch is damaged

Explanation: An electrical switch is observed to be damaged. The usual cause is due to impact or other form of mechanical action to fracture the insulation body of the switch.

Impact Consequences: An electrical switch that has been damaged may not operate as intended and may also have damage to its lever internal contacts or

external screws. Switches displaying any form of exterior damage should be replaced.

Recommended Action: Replace

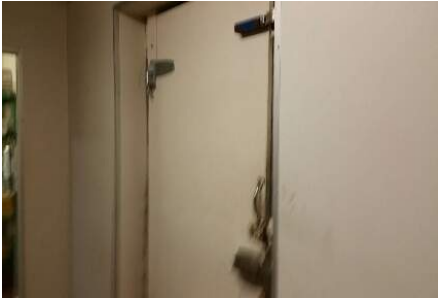
7.

Location: Walk In Cooler Hallway **System:** Electrical **Condition:** Electrical fixture is loose

Explanation: Light fixtures are required to be secured from or attached to a junction box. The observed fixture is not observed to be installed in a manner to assure a safe installation as well as meeting the manufacturer intent for installation.

Impact Consequences: Fixtures that have not been adequately secured present the risk of stress to the fixture and wiring. Such conditions should be considered as safety and fire risks.

Recommended Action: Repair

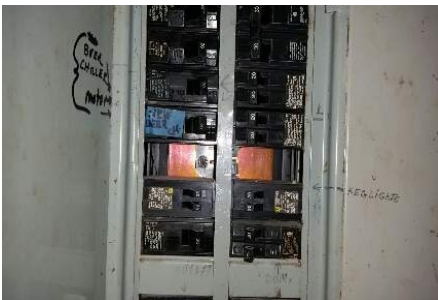
8.

Location: Office Storage Area **System:** Electrical **Condition:** The panel cover has uncovered openings

Explanation: There should be no uncovered openings at the cover of the service panel to prevent accidental contact with live electrical components in the box.

Impact Consequences: This condition presents a risk of electrical shock and is a safety concern. Panel cover plugs can be purchased at an electrical supply and many hardware stores and should be installed to prevent accidental contact with live parts of the panel.

Recommended Action: Repair

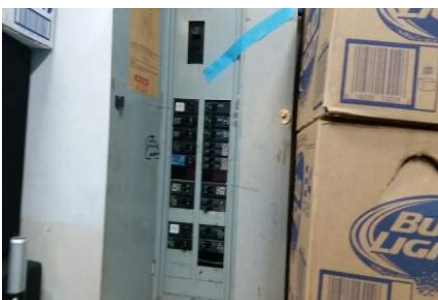
9.

Location: Office Storage Area **System:** Electrical **Condition:** Panel cover screws are missing on the electrical panel

Explanation: All screws for electrical panel covers should be installed to assure that the cover is properly located and securely attached. Screws used to secure the cover must be of the type supplied by the manufacturer which have tips that are blunted to prevent the piercing of wires when turning the screws into place.

Impact Consequences: The conditions should be deemed as a safety issue requiring corrective action by an electrician.

Recommended Action: Repair

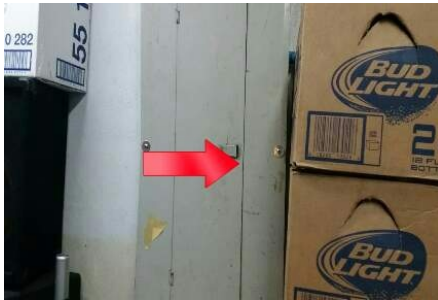
10.

Location: Office Storage Area **System:** Electrical **Condition:** Damaged Panel Cover

Explanation: Panel cover is observed to be damaged.

Impact Consequences: The panel cover should latch securely when closed. The panel cover should have no gaps when closed as well. Damaged panel covers can pose a safety hazard to the occupants. Consult a licensed electrician for proper repair or installation of electrical distribution panels.

Recommended Action: Repair

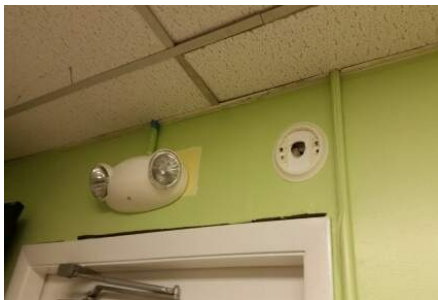
11.

Location: Office **System:** Electrical **Condition:** Detector [smoke fire or CO] is missing

Explanation: A smoke fire or carbon monoxide detector is observed to missing at its present location.

Impact Consequences: The absence of a smoke and or fire and or CO detector at a location circumvents the intent of providing the building occupants of an alert condition. As the detector is a safety device it is crucial that this device be installed in accordance with the manufacturer instructions. Immediate action should be taken to correct this condition to assure correct operation of this safety device.

Recommended Action: Install

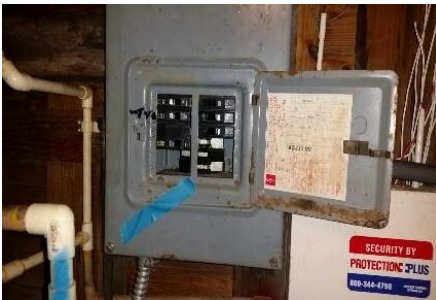
13.

Location: Storage Room **System:** Electrical **Condition:** Panel cover screws are missing on the electrical panel

Explanation: All screws for electrical panel covers should be installed to assure that the cover is properly located and securely attached. Screws used to secure the cover must be of the type supplied by the manufacturer which have tips that are blunted to prevent the piercing of wires when turning the screws into place.

Impact Consequences: The conditions should be deemed as a safety issue requiring corrective action by an electrician.

Recommended Action: Repair

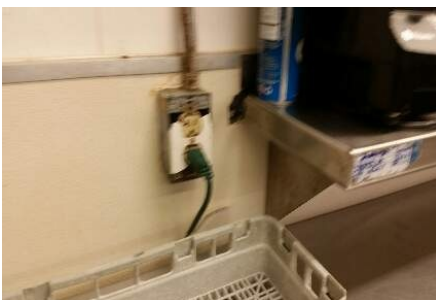
14.

Location: Kitchen **System:** Electrical **Condition:** An outlet has a damaged or missing receptacle cover

Explanation: Electrical outlets installed require protection from water entry contaminants and to prevent injury.

Impact Consequences: An outlet with a missing or damaged cover is subject to damage and deterioration. Receptacles displaying damage or deterioration should be

immediately replaced and a suitable cover installed.

Recommended Action: Repair

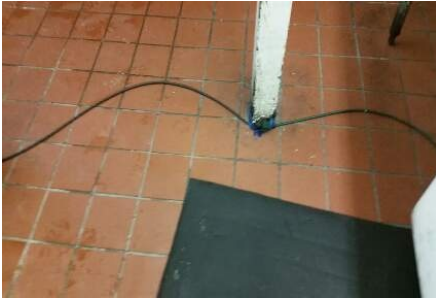
15.

Location: Kitchen **System:** Electrical **Condition:** Unsafe Wiring Installation

Explanation: Distribution wiring is installed in an unsafe manner or location.

Impact Consequences: Electrical wiring installed in an unsafe manner or location may pose a risk of fire or shock hazard. Consult a licensed electrician for proper installation of the observed wiring.

Recommended Action: Repair

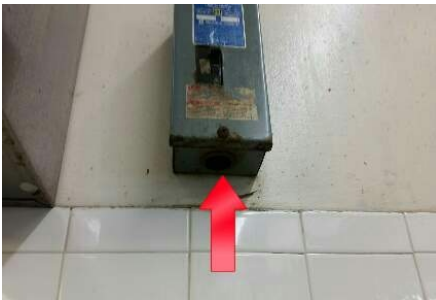
16.

Location: Kitchen **System:** Electrical **Condition:** The panel cover has uncovered openings

Explanation: There should be no uncovered openings at the cover of the service panel to prevent accidental contact with live electrical components in the box.

Impact Consequences: This condition presents a risk of electrical shock and is a safety concern. Panel cover plugs can be purchased at an electrical supply and many hardware stores and should be installed to prevent accidental contact with live parts of the panel.

Recommended Action: Repair

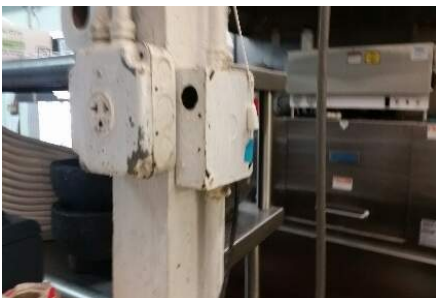
17.

Location: Kitchen **System:** Electrical **Condition:** Open Knock Outs Of Junction Box

Explanation: The junction box is observed to have missing or open knock outs.

to other components. When not connected to a conduit the openings should be sealed in order to prevent hazards.

Recommended Action: Repair

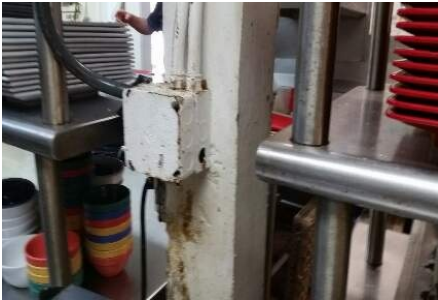
18.

Location: Kitchen **System:** Electrical **Condition:** Open Knock Outs Of Junction Box

Explanation: The junction box is observed to have missing or open knock outs.

Impact Consequences: These openings are designed to allow distribution of wiring to other components. When not connected to a conduit the openings should be sealed in order to prevent hazards.

Recommended Action: Repair

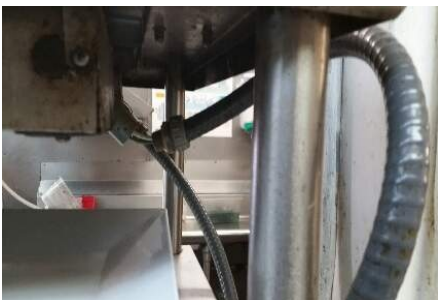
19.

Location: Kitchen **System:** Electrical **Condition:** Conduit Not Properly Connected

Explanation: The conduit as installed is not properly connected to a panel or junction box.

Impact Consequences: Connect the conduit to a junction box or panel in order to prevent damage to wiring and avoid electrical shock hazards.

Recommended Action: Repair

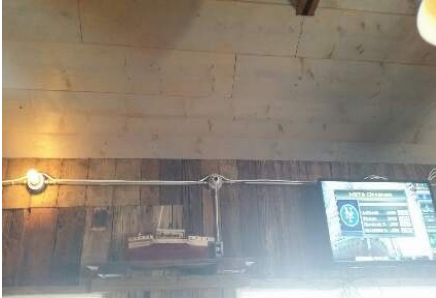
24.

Location: Restaurant Main Dining **System:** Electrical **Condition:** Electrical fixture is damaged

Explanation: An electrical fixture is observed to be damaged. The most frequent cause is due to impact.

Recommended Action: Replace

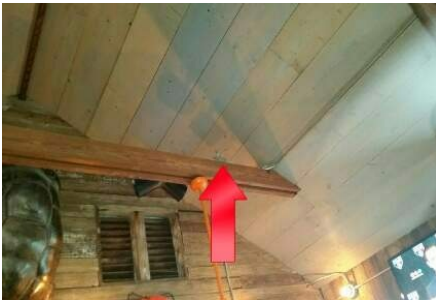
25.

Location: Restaurant Main Dining **System:** Electrical **Condition:** Damaged or Missing Cover Plate On Junction Box

Explanation: A protective cover plate is observed to be damaged or missing from an electrical junction box.

Recommended Action: Repair

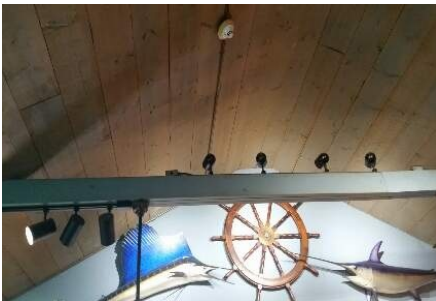
27.

Location: Gift Shop **System:** Electrical **Condition:** Open Knock Outs Of Junction Box

Explanation: The junction box is observed to have missing or open knock outs.

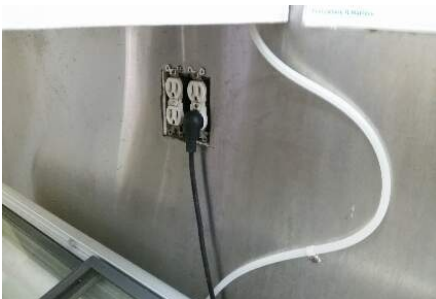
28.

Location: Kitchen **System:** Electrical **Condition:** Receptacle cover plate is missing

Explanation: A protective cover plate is missing from an electrical outlet.

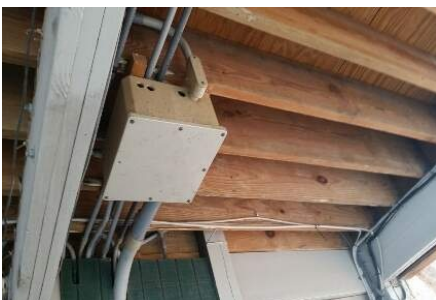
31.

Location: Lower Dining Deck **System:** Electrical **Condition:** Open Knock Outs Of Junction Box

Explanation: The junction box is observed to have missing or open knock outs.

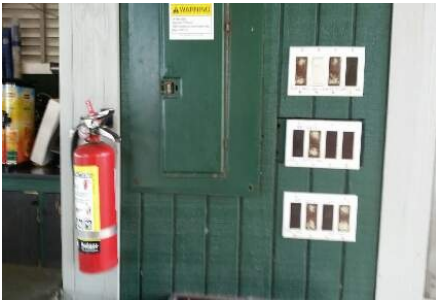
32.

Location: Lower Dining Deck **System:** Electrical **Condition:** Damaged Panel Cover

Explanation: Panel cover is observed to be damaged.

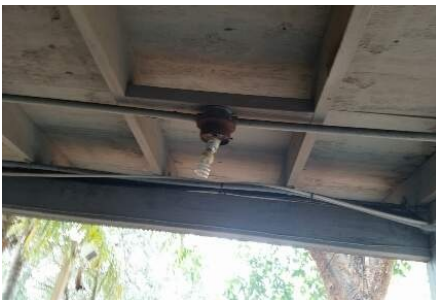
33.

Location: Lower Dining Deck **System:** Electrical **Condition:** Electrical fixture is damaged

Explanation: An electrical fixture is observed to be damaged. The most frequent cause is due to impact.

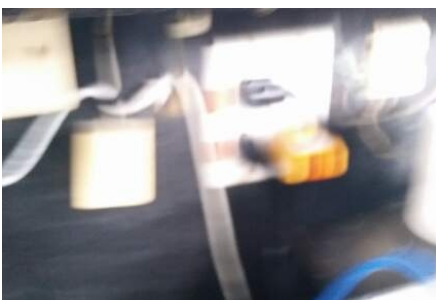
34.

Location: Exterior Bar **System:** Electrical **Condition:** Electrical outlet does not work

Explanation: An electrical outlet is observed to be inoperative.

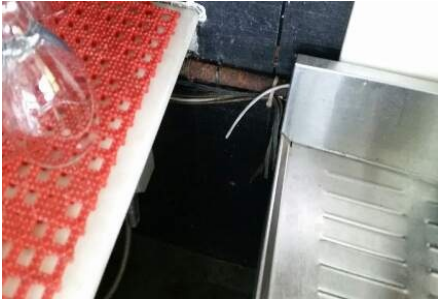
35.

Location: Exterior Bar **System:** Electrical **Condition:** Damaged or Missing Conduit

Explanation: Electrical conduit is observed to be missing or damaged.

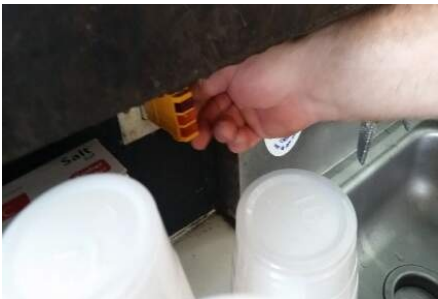
36.

Location: Exterior Bar **System:** Electrical **Condition:** Receptacle has loose socket contacts

Explanation: Looseness is observed in socket tension when a plug is inserted into an outlet.

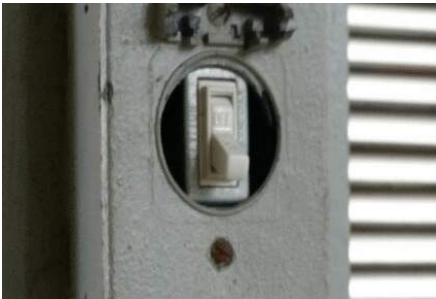
38.

Location: Exterior Rear **System:** Electrical **Condition:** An exterior switch has a missing cover plate

Explanation: Electrical switches installed in outdoor locations require protection from water entry and contaminants.

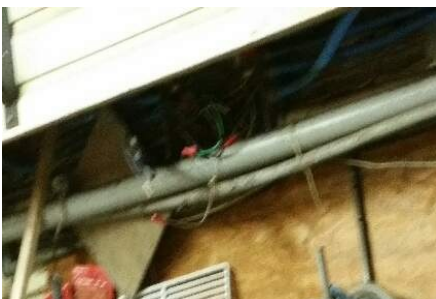
39.

Location: Exterior Rear **System:** Electrical **Condition:** Damaged or Missing Cover Plate On Junction Box

Explanation: A protective cover plate is observed to be damaged or missing from an electrical junction box.

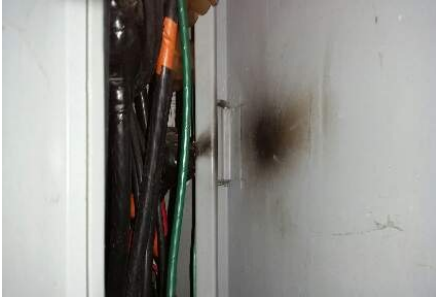
40.

Location: Exterior Rear **System:** Electrical **Condition:** The service panel is crowded by wiring

Explanation: The quantity of wiring in the service panel is excessive.

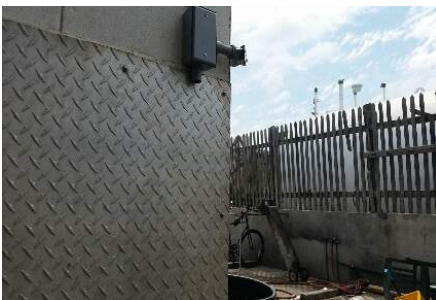
42.

Location: Exterior Rear **System:** Electrical **Condition:** Open Knock Outs Of Junction Box

Explanation: The junction box is observed to have missing or open knock outs.

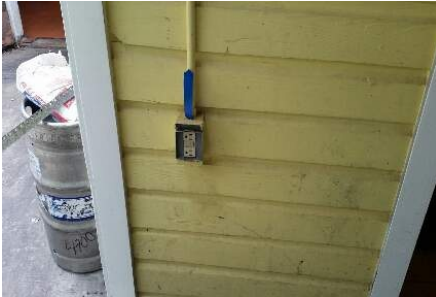
46.

Location: Exterior Rear **System:** Electrical **Condition:** An exterior outlet has a damaged receptacle cover

Explanation: Electrical outlets installed in outdoor locations require protection from water entry and contaminants.

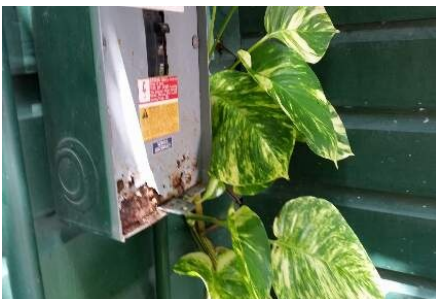
47.

Location: Restaurant Entrance **System:** Electrical **Condition:** Evidence of water at electrical distribution or sub panel.

Explanation: An electrical panel or sub panel displays the presence of current or past water infiltration into the panel or to its exterior

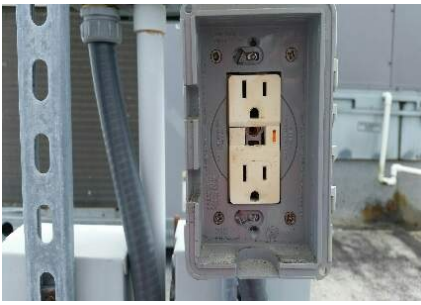
48.

Location: Roof **System:** Electrical **Condition:** Electrical outlet is damaged

Explanation: An electrical outlet is observed to be damaged. The usual cause is due to impact or other forms of mechanical action to fracture the insulating body of the outlet.

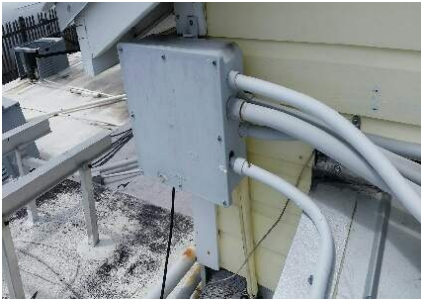
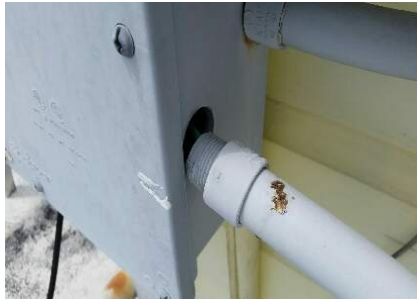
49.

Location: Roof **System:** Electrical **Condition:** Conduit Not Properly Secured

Explanation: The conduit installed in the noted location is not properly secured for damage prevention.

Impact Consequences: Exposed conduit should be properly secured in order to minimize movement and prevent damage.

Recommended Action: Repair

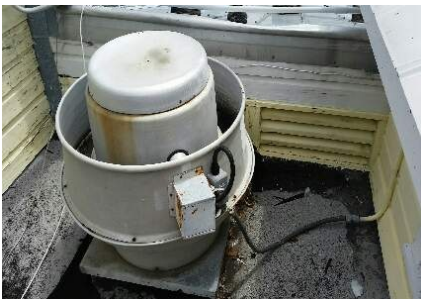
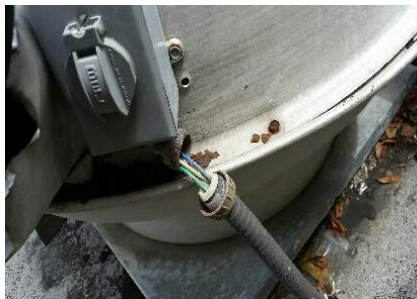
50.

Location: Roof **System:** Electrical **Condition:** Conduit Not Properly Connected

Explanation: The conduit as installed is not properly connected to a panel or junction box.

Impact Consequences: Connect the conduit to a junction box or panel in order to prevent damage to wiring and avoid electrical shock hazards.

Recommended Action: Repair
