## The Case for Demolition of Back/Sloped Roof Addition

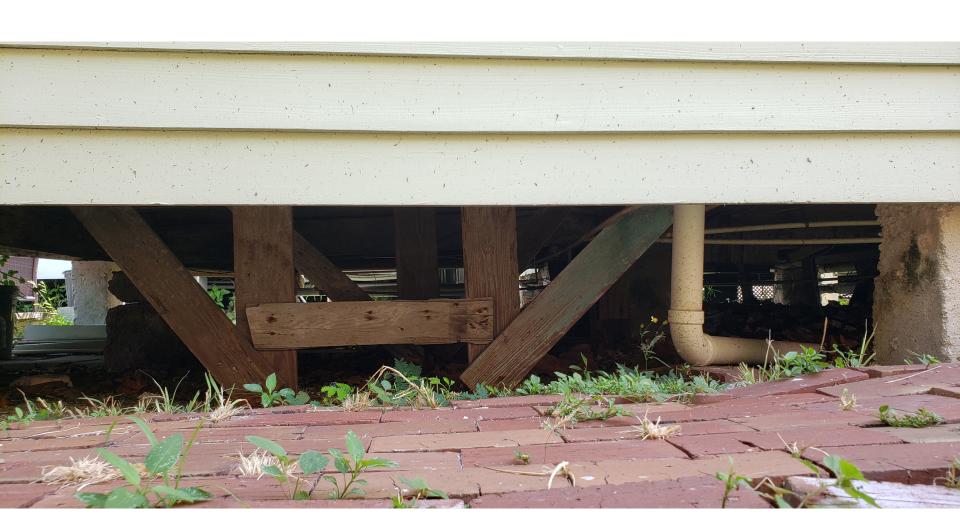
This suspension apparatus was built to support weight in the Kitchen and keep the washer/dryer & refrigerator from falling through to the ground.

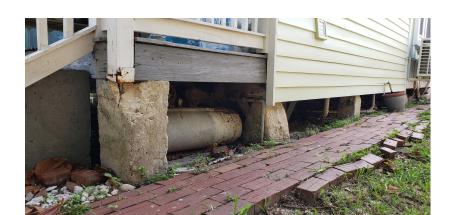
Support beams rotting on unstable piers, large boulder holding corner up.
