## Tree Removal Report

**PROPERTY:** 629 Dey St.

**APPLICATION NUMBER:** T2026-0125

**REQUEST:** The applicant is requesting removal of (2) Cuban Mahogany Trees (1) Gumbo Limbo Tree.

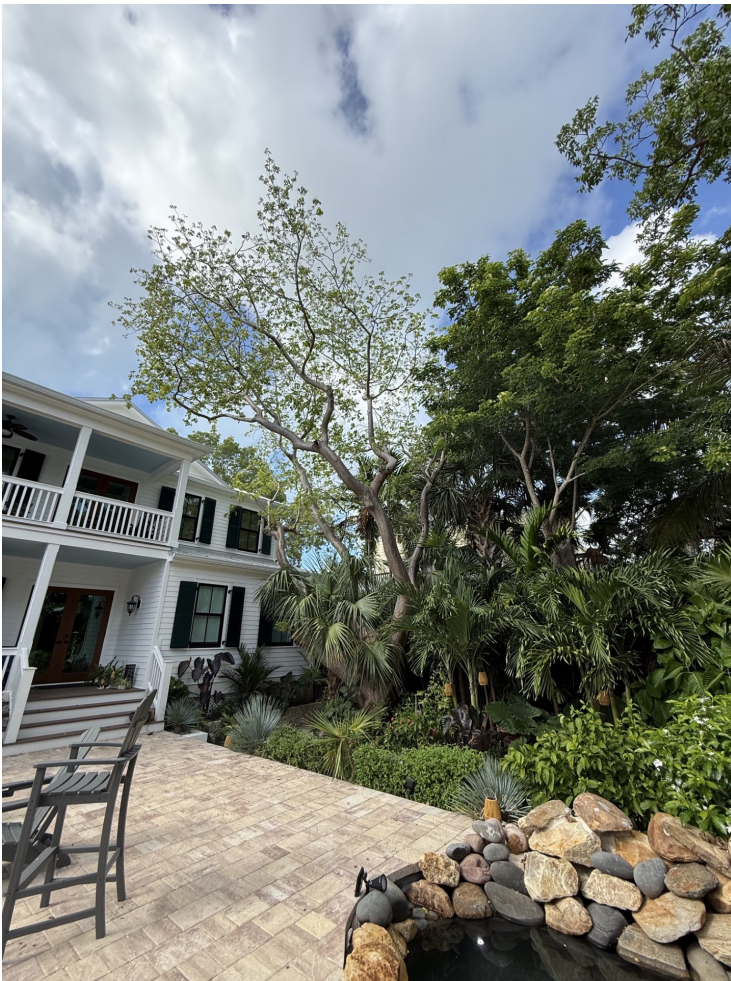
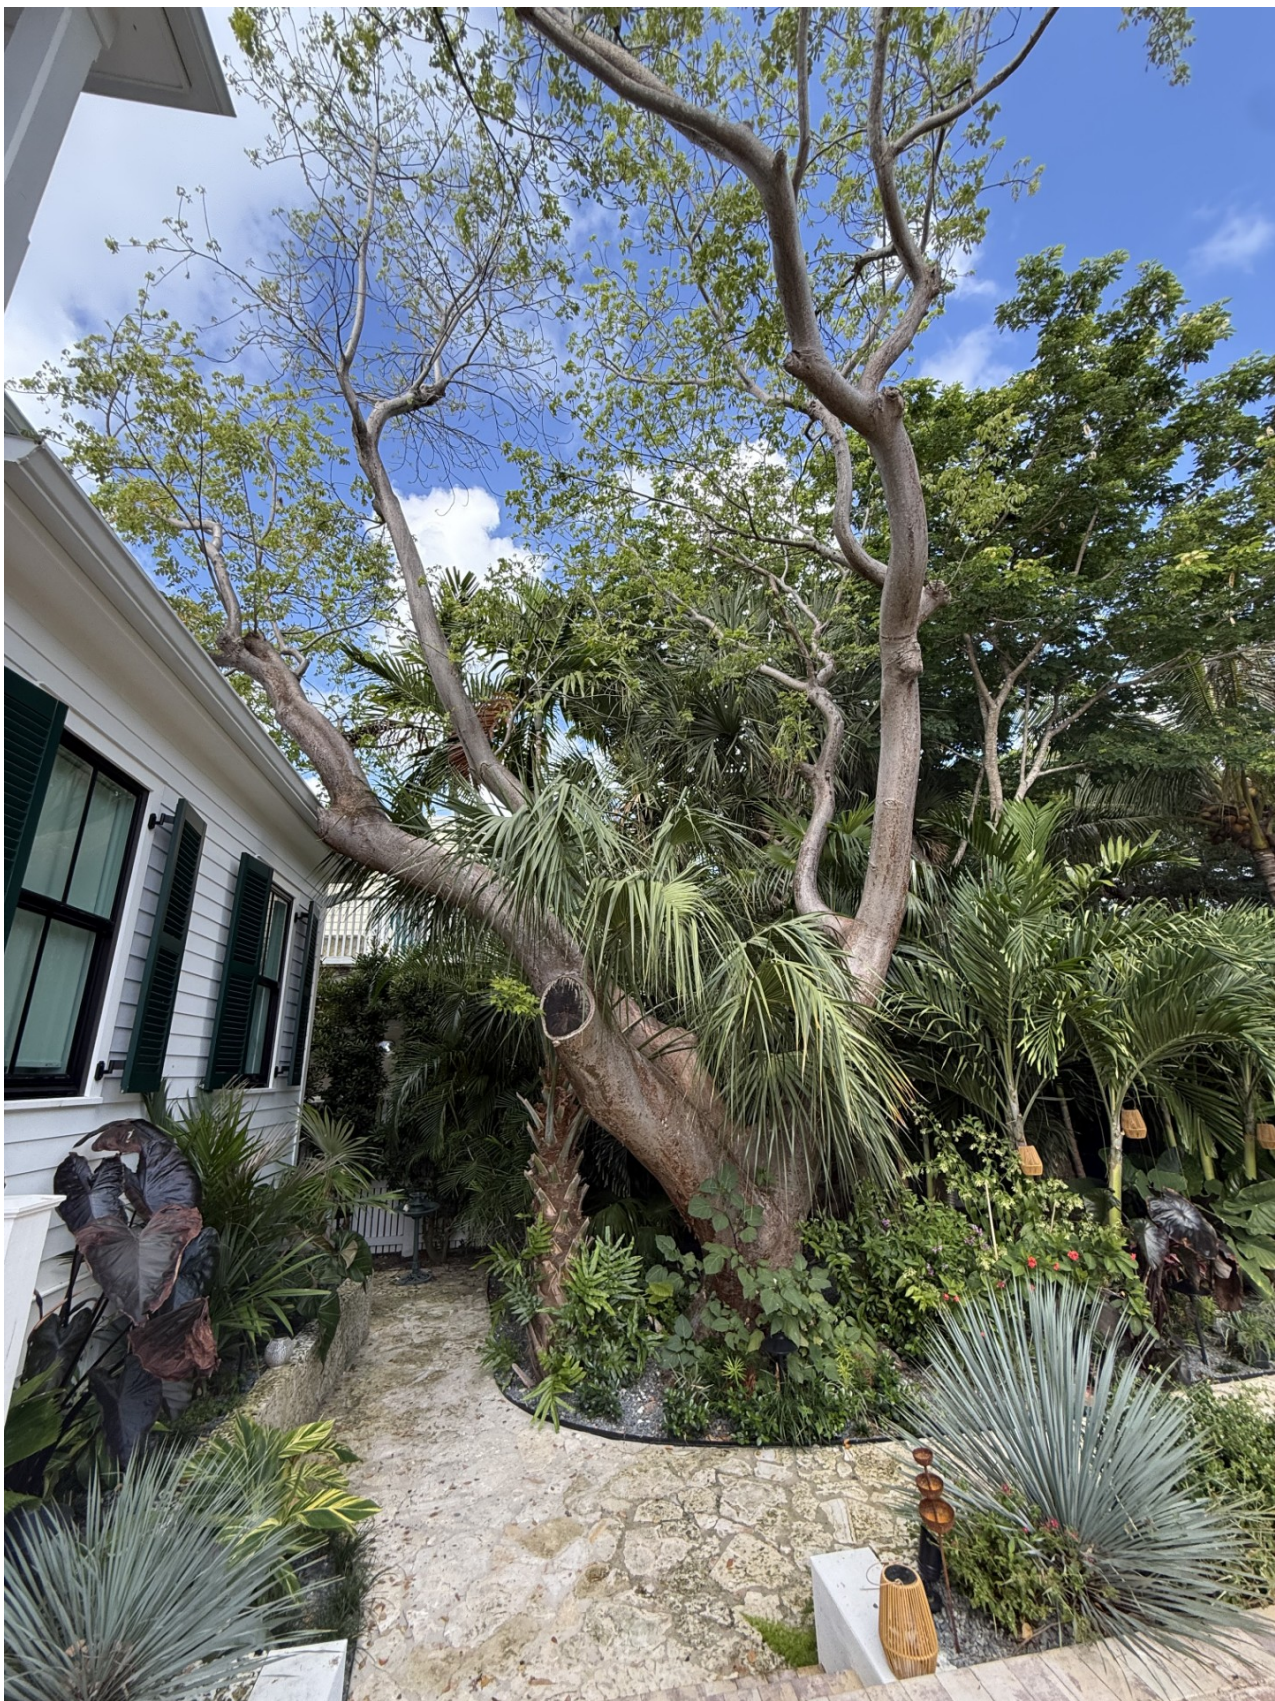
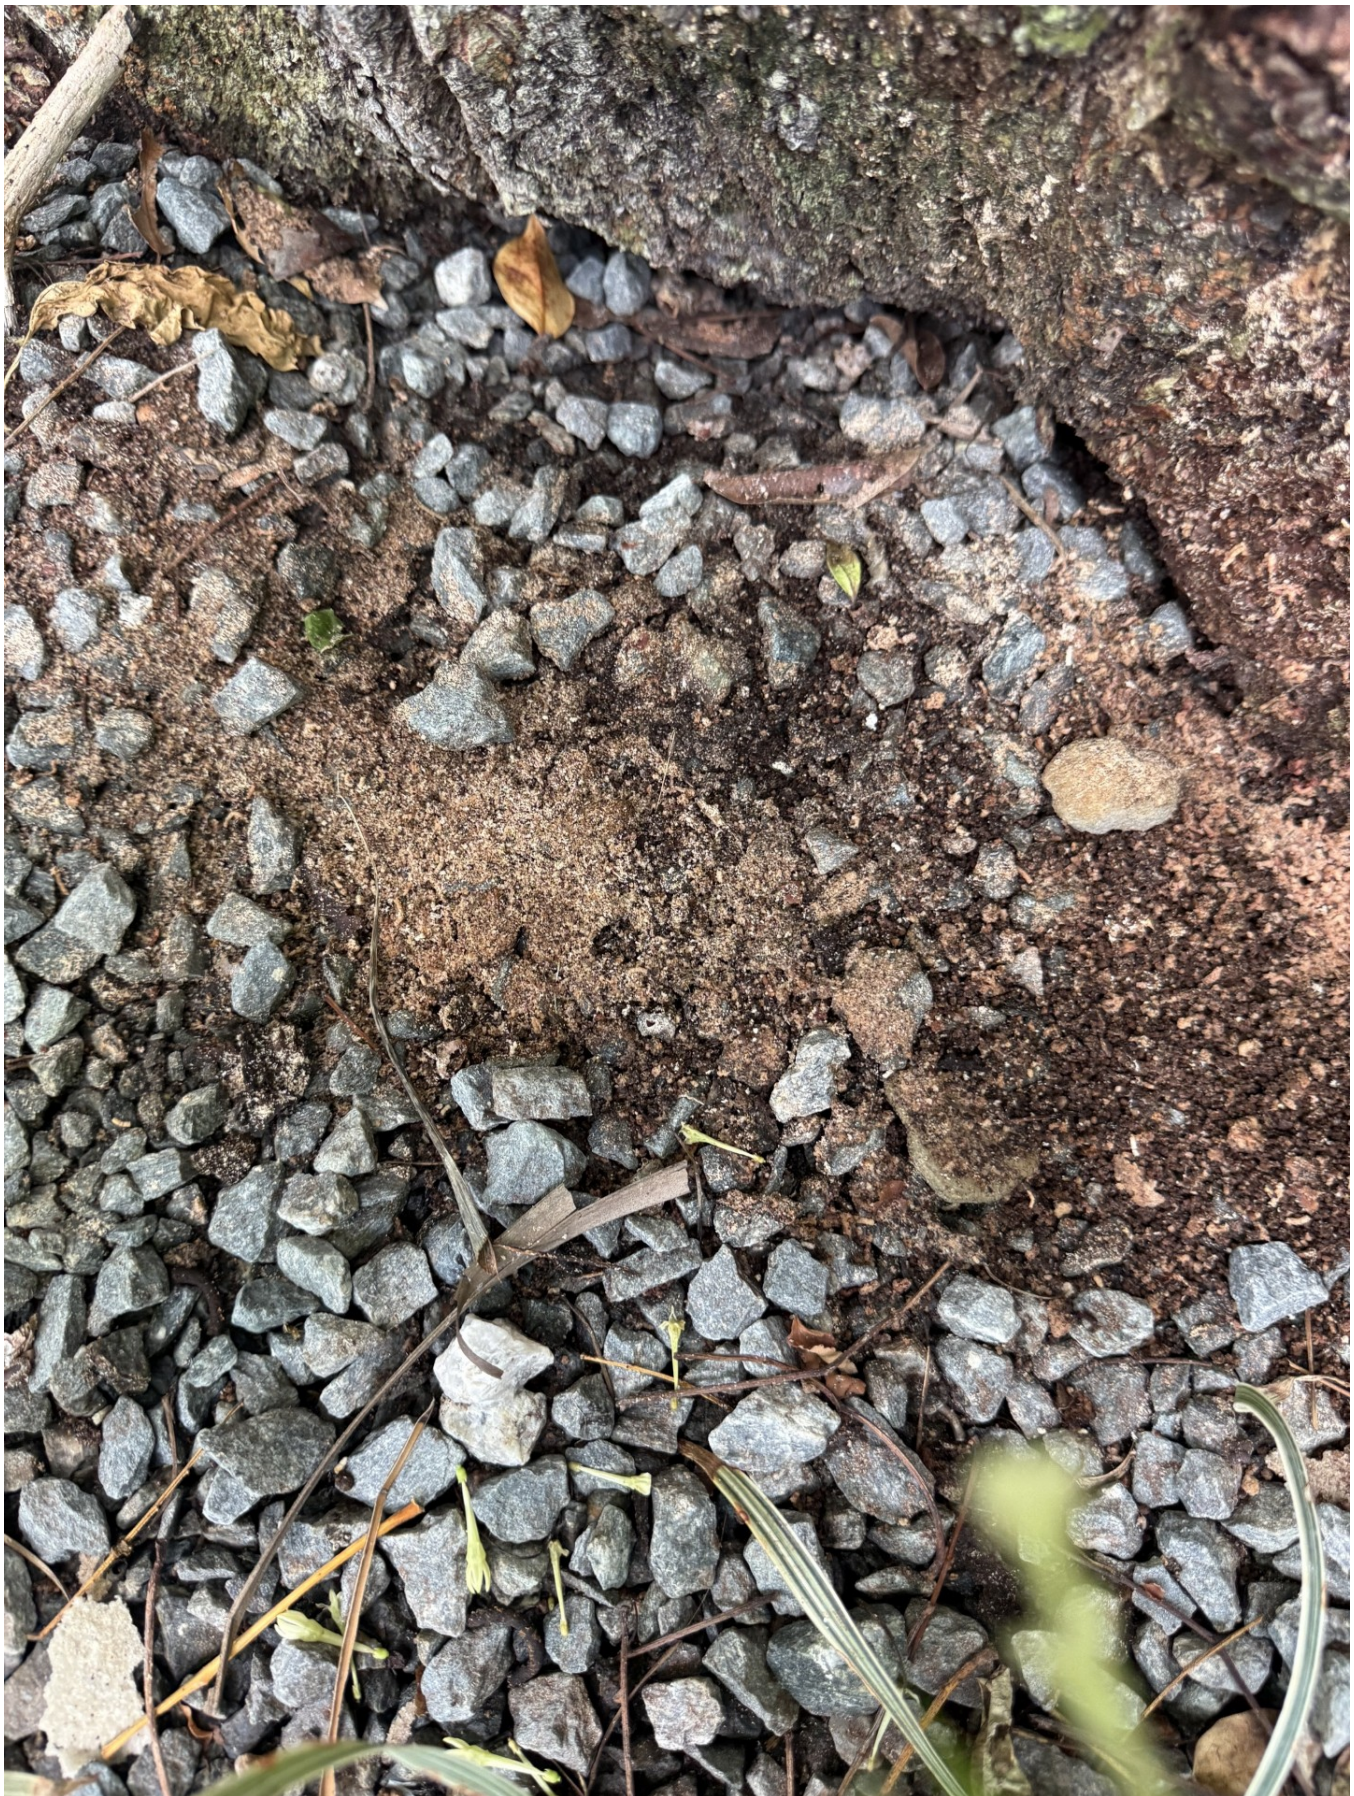
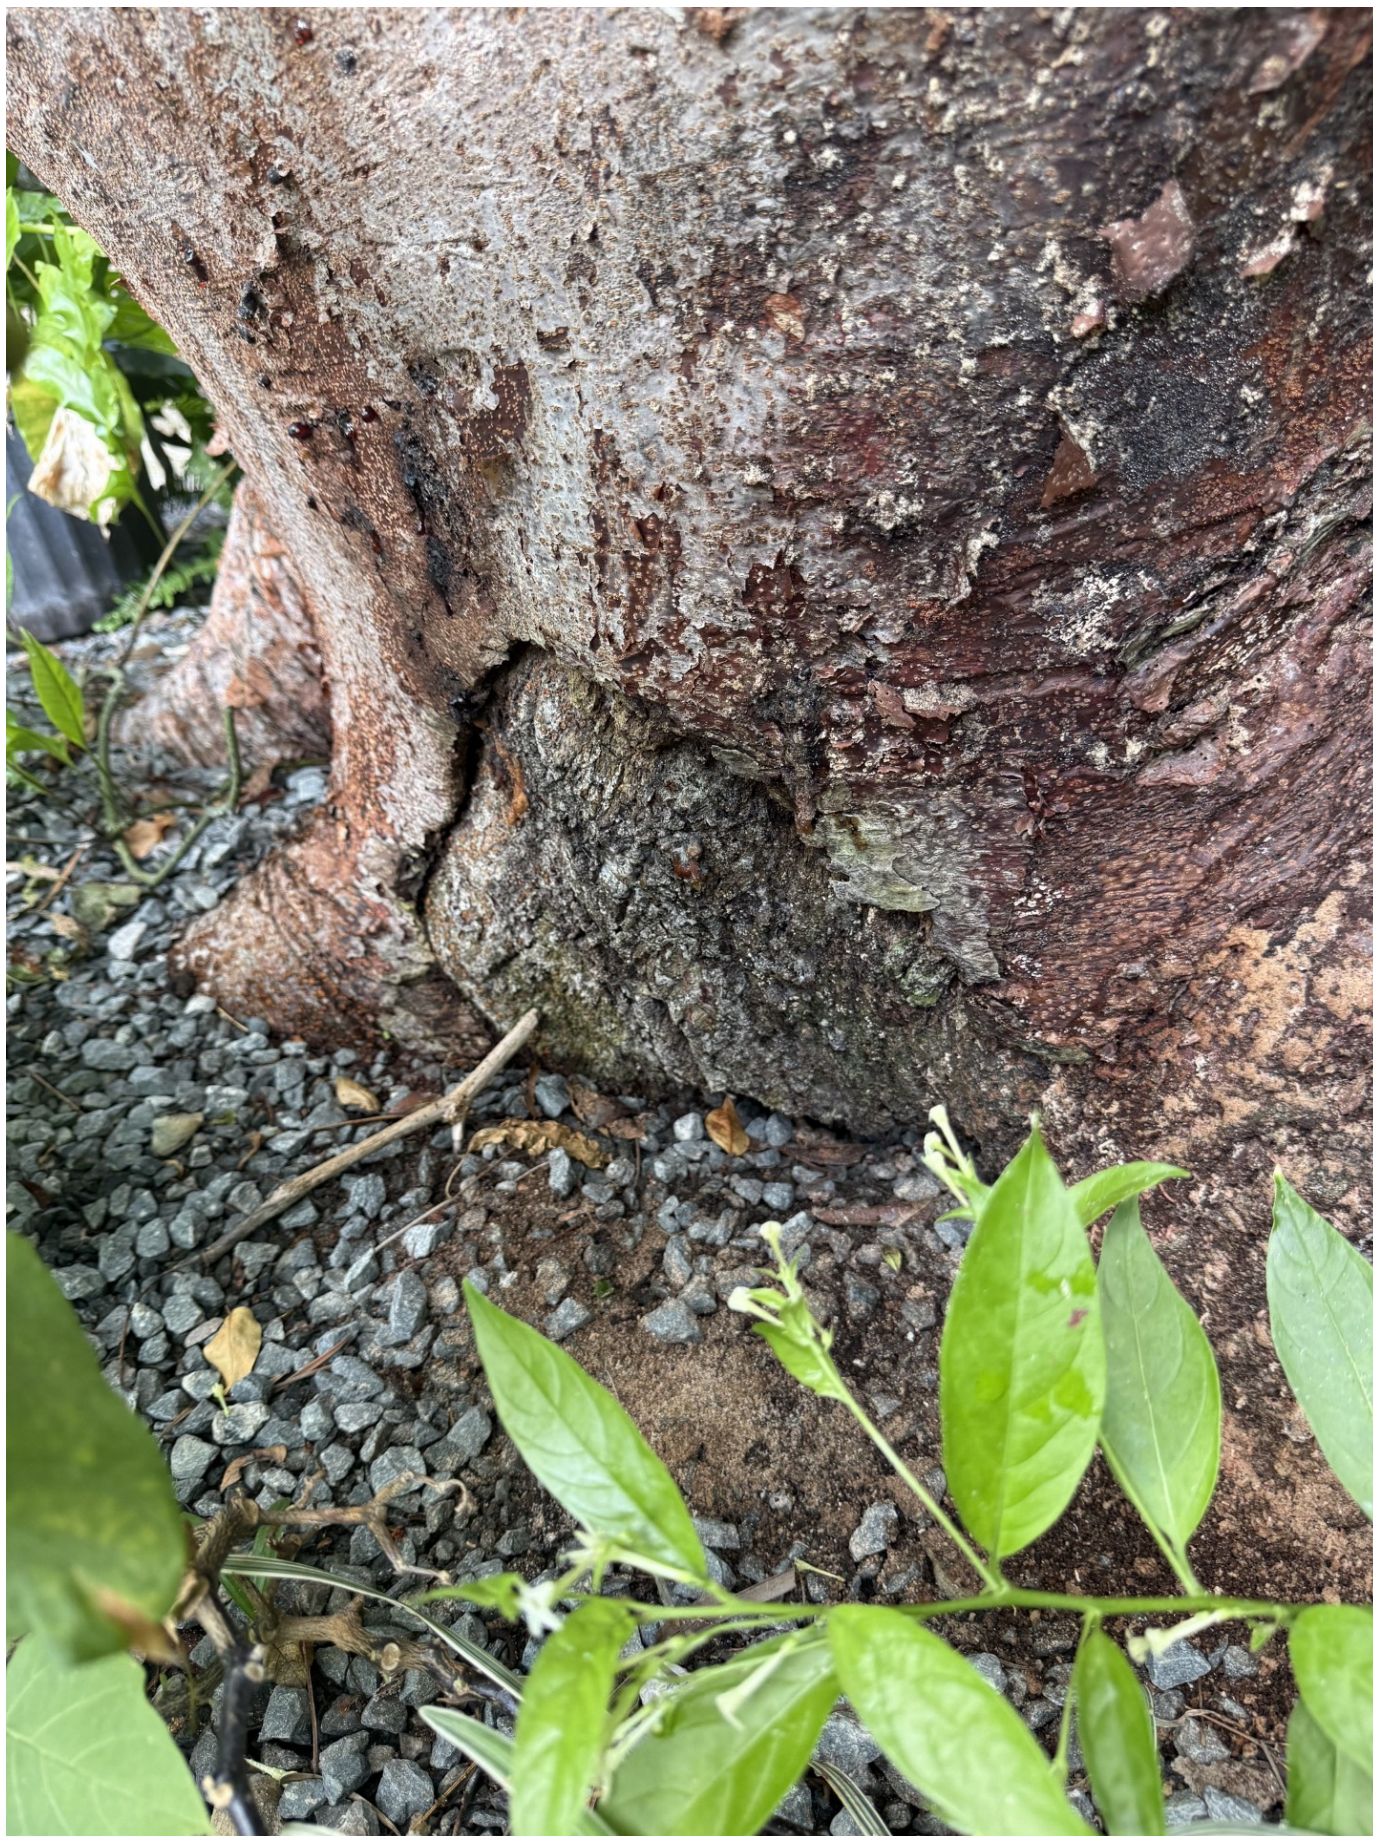
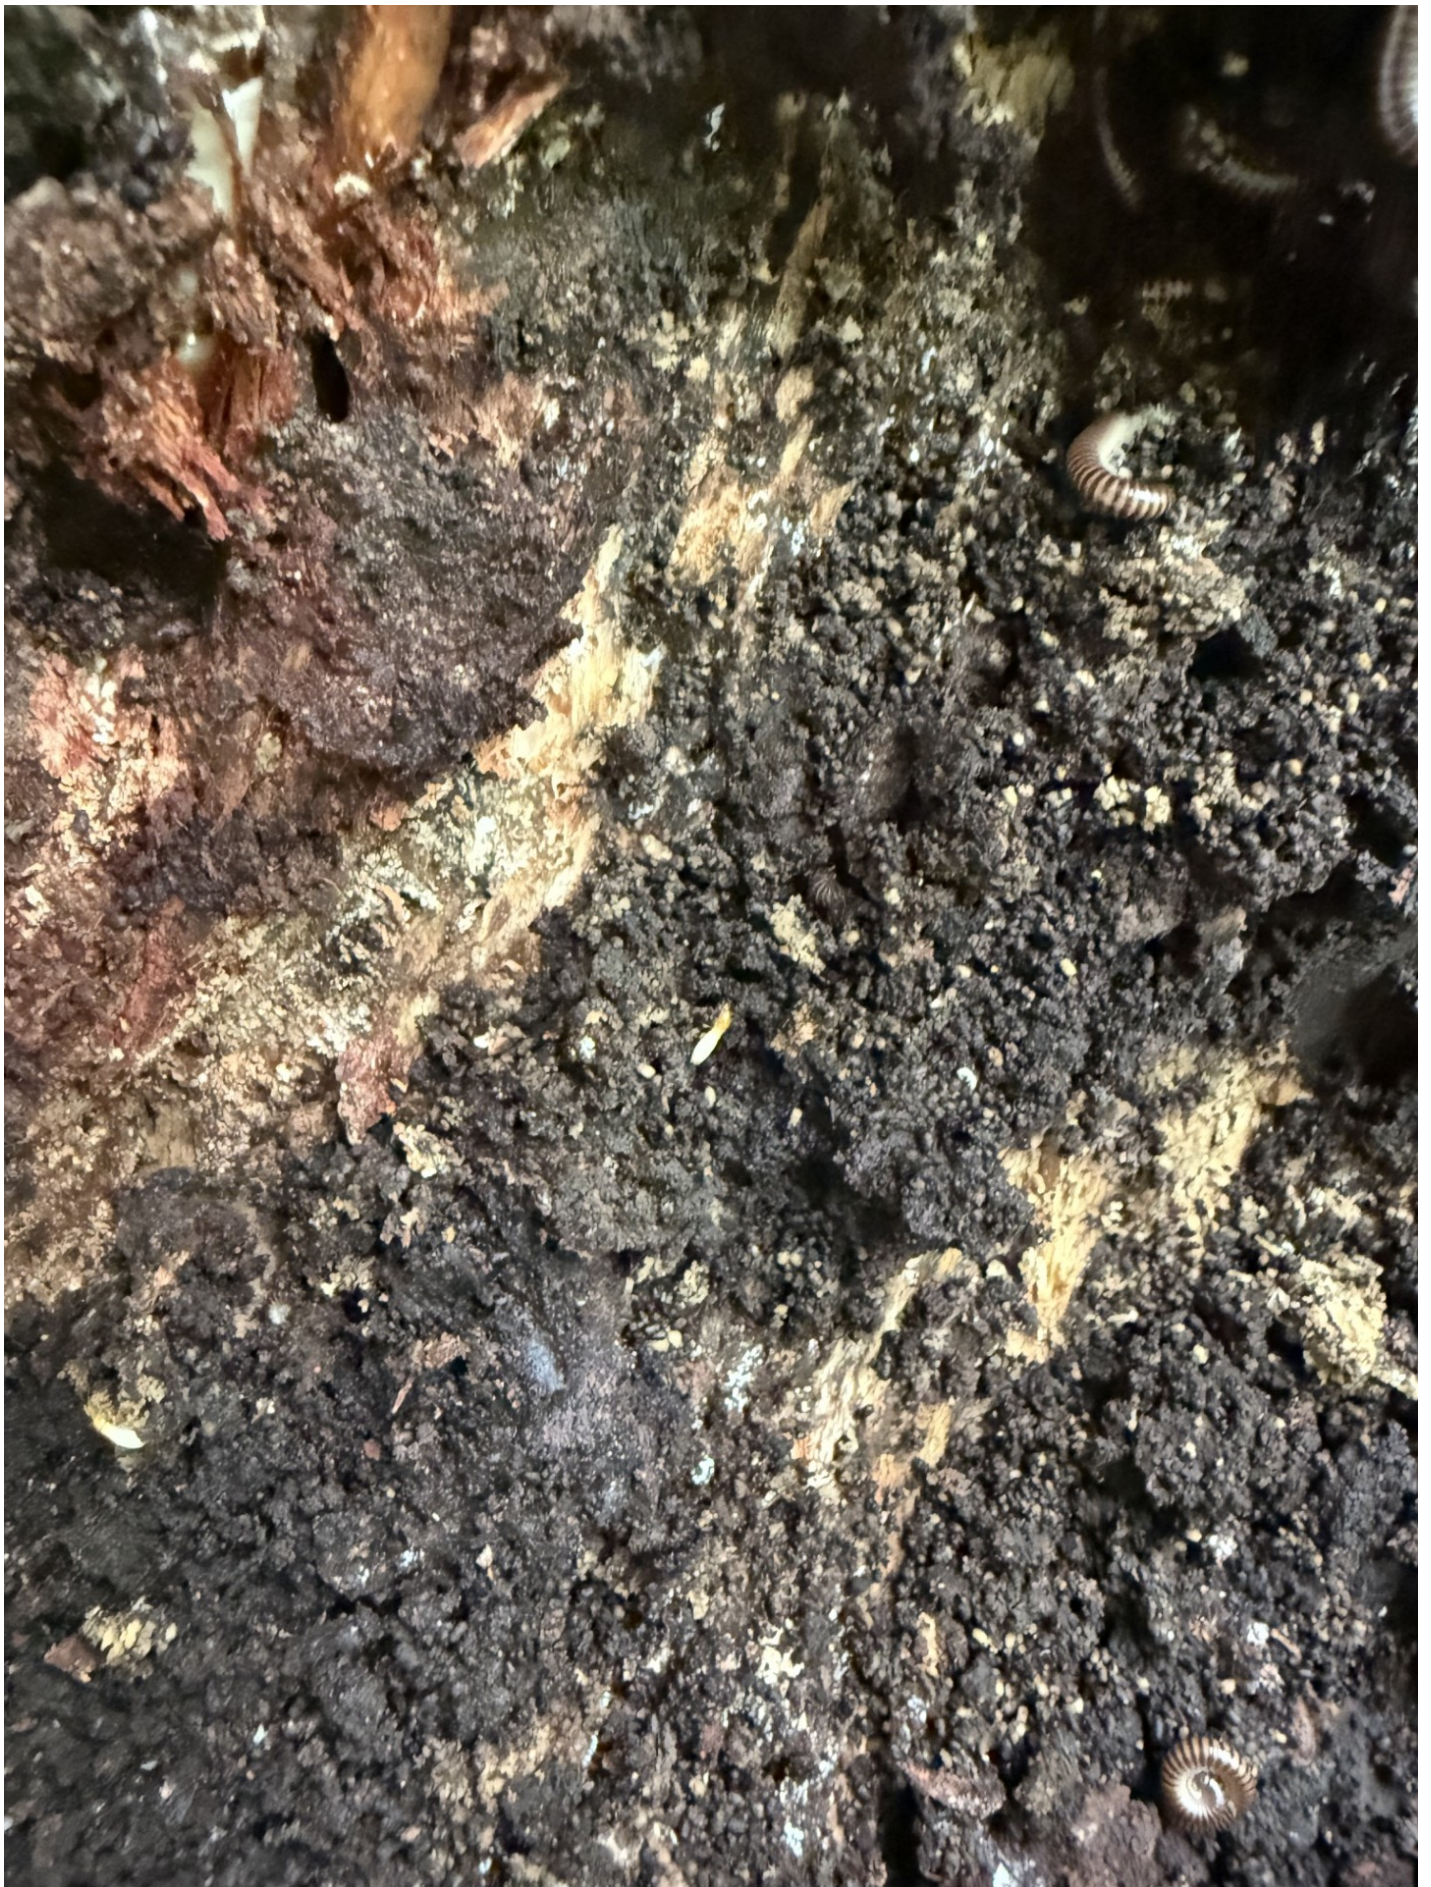
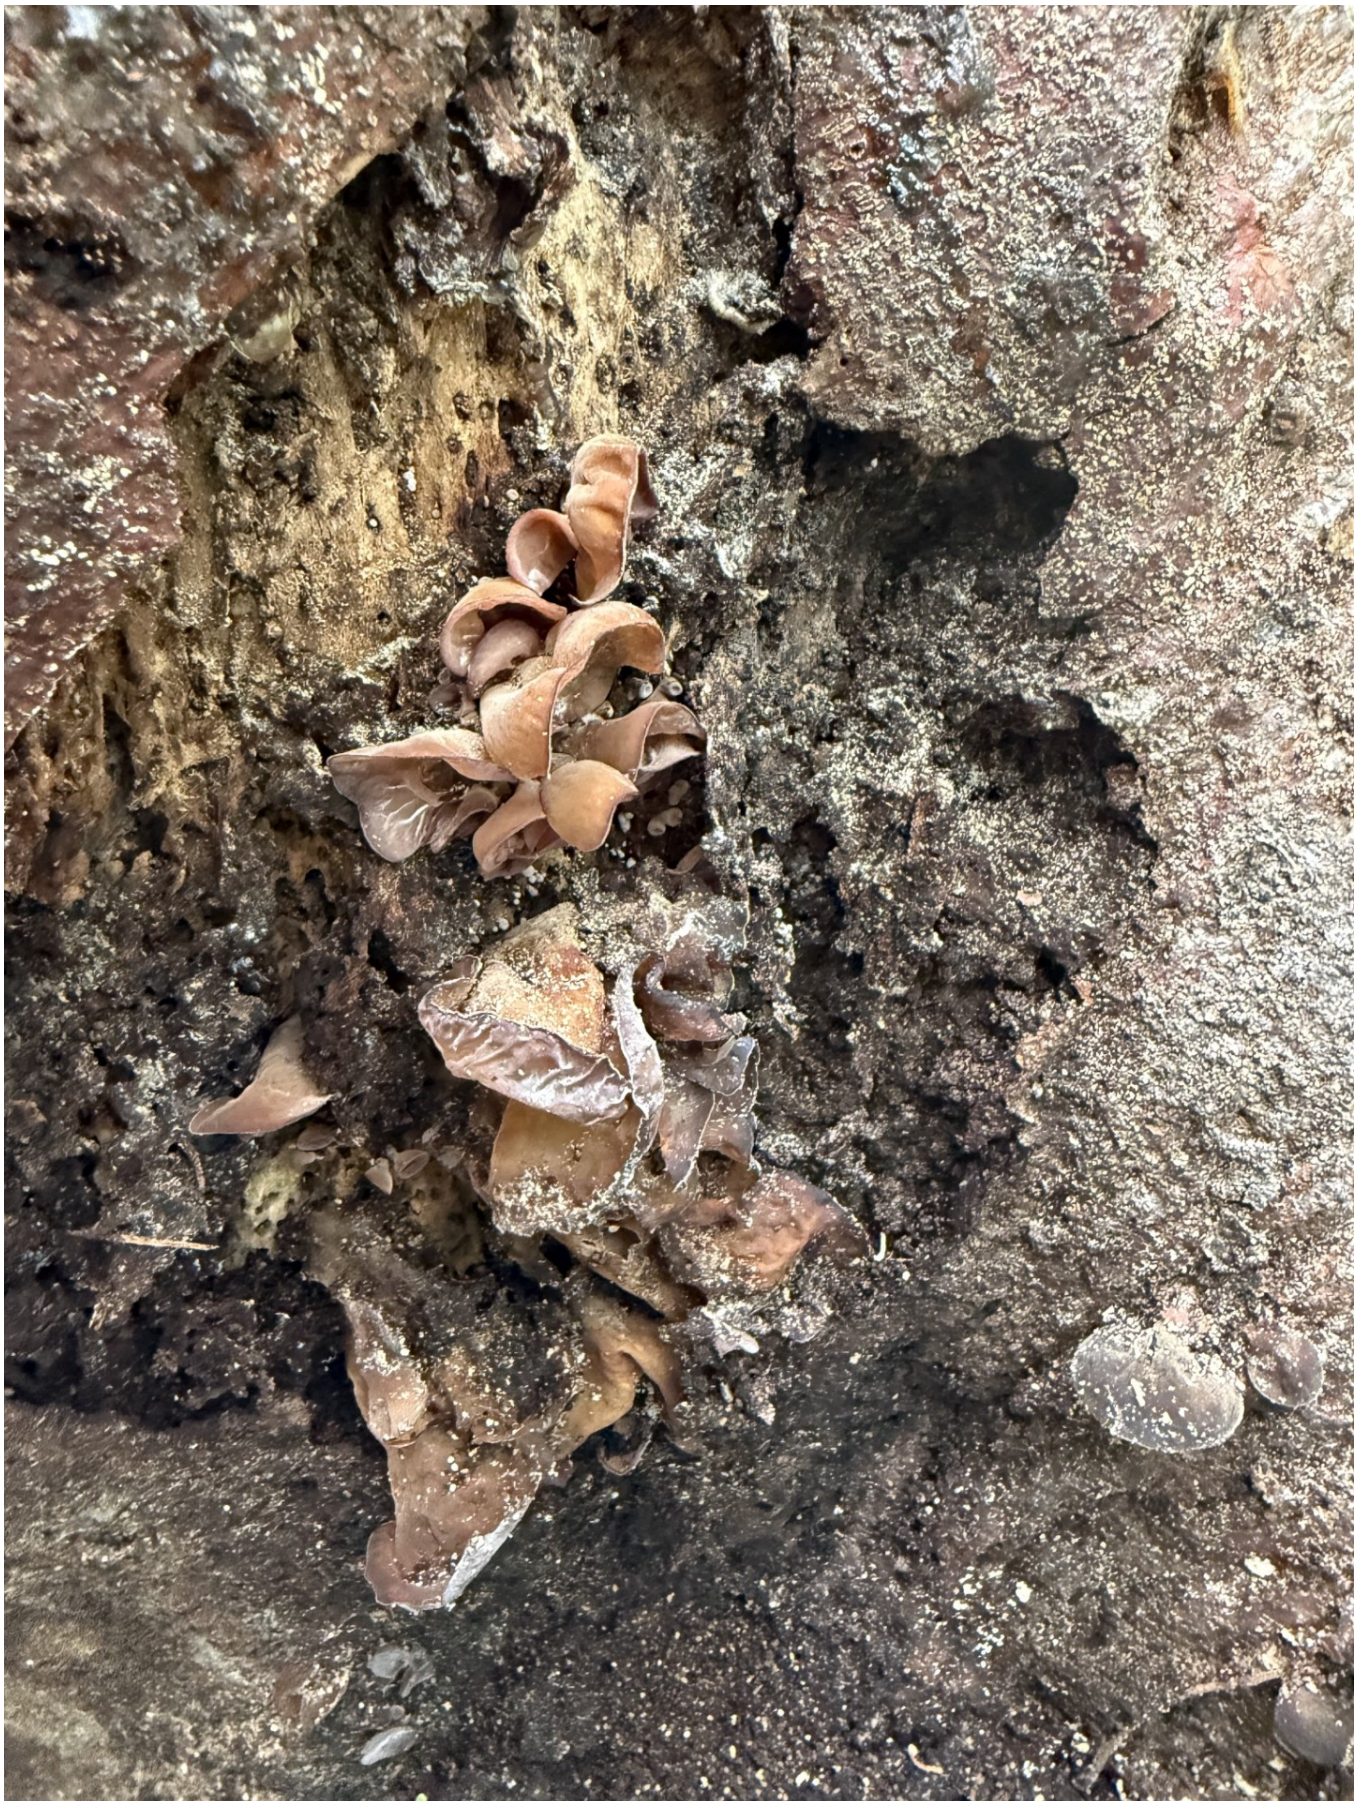
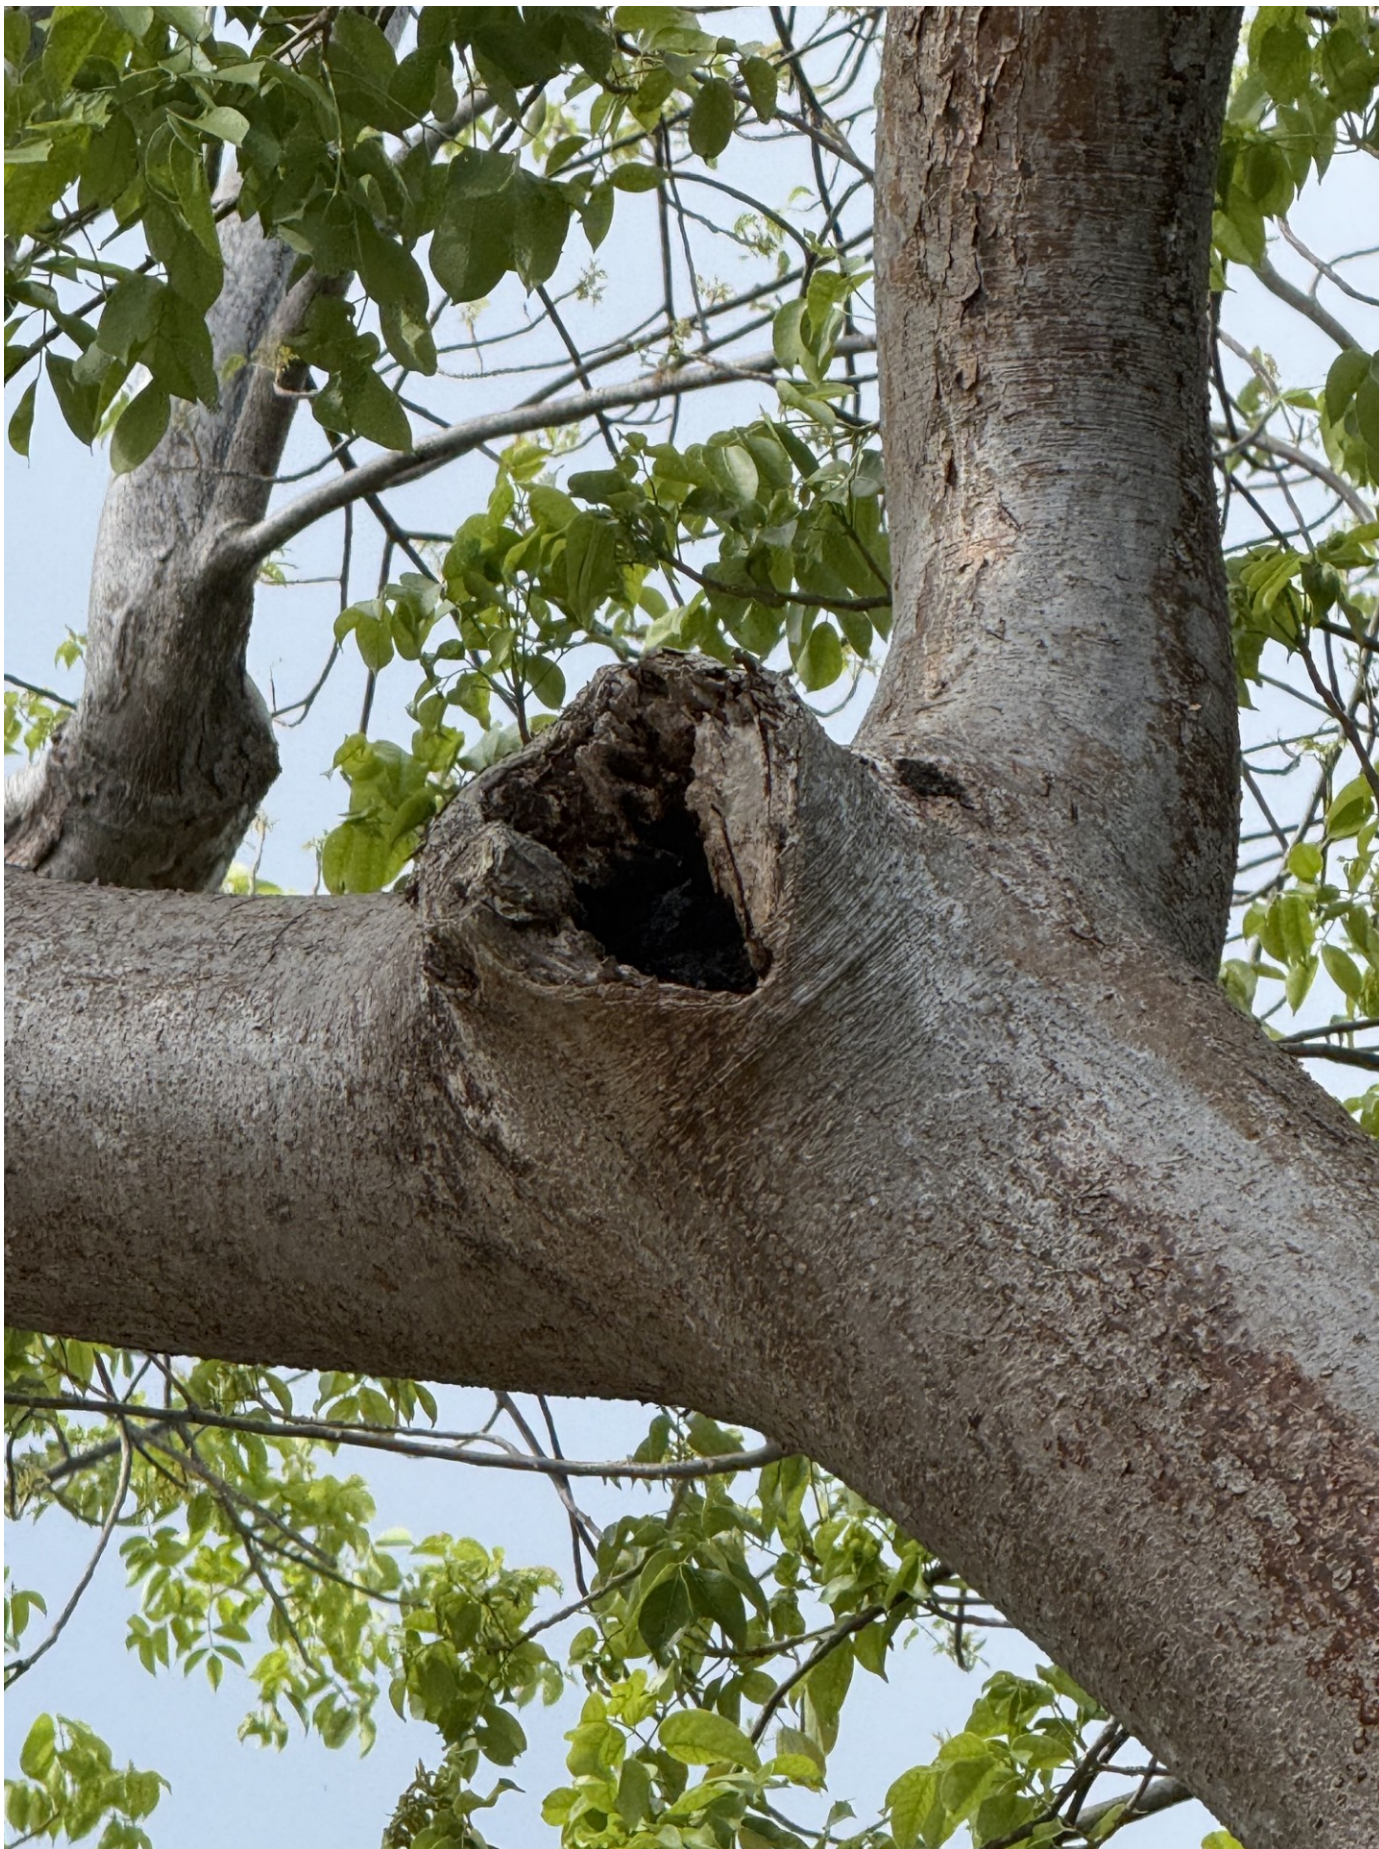
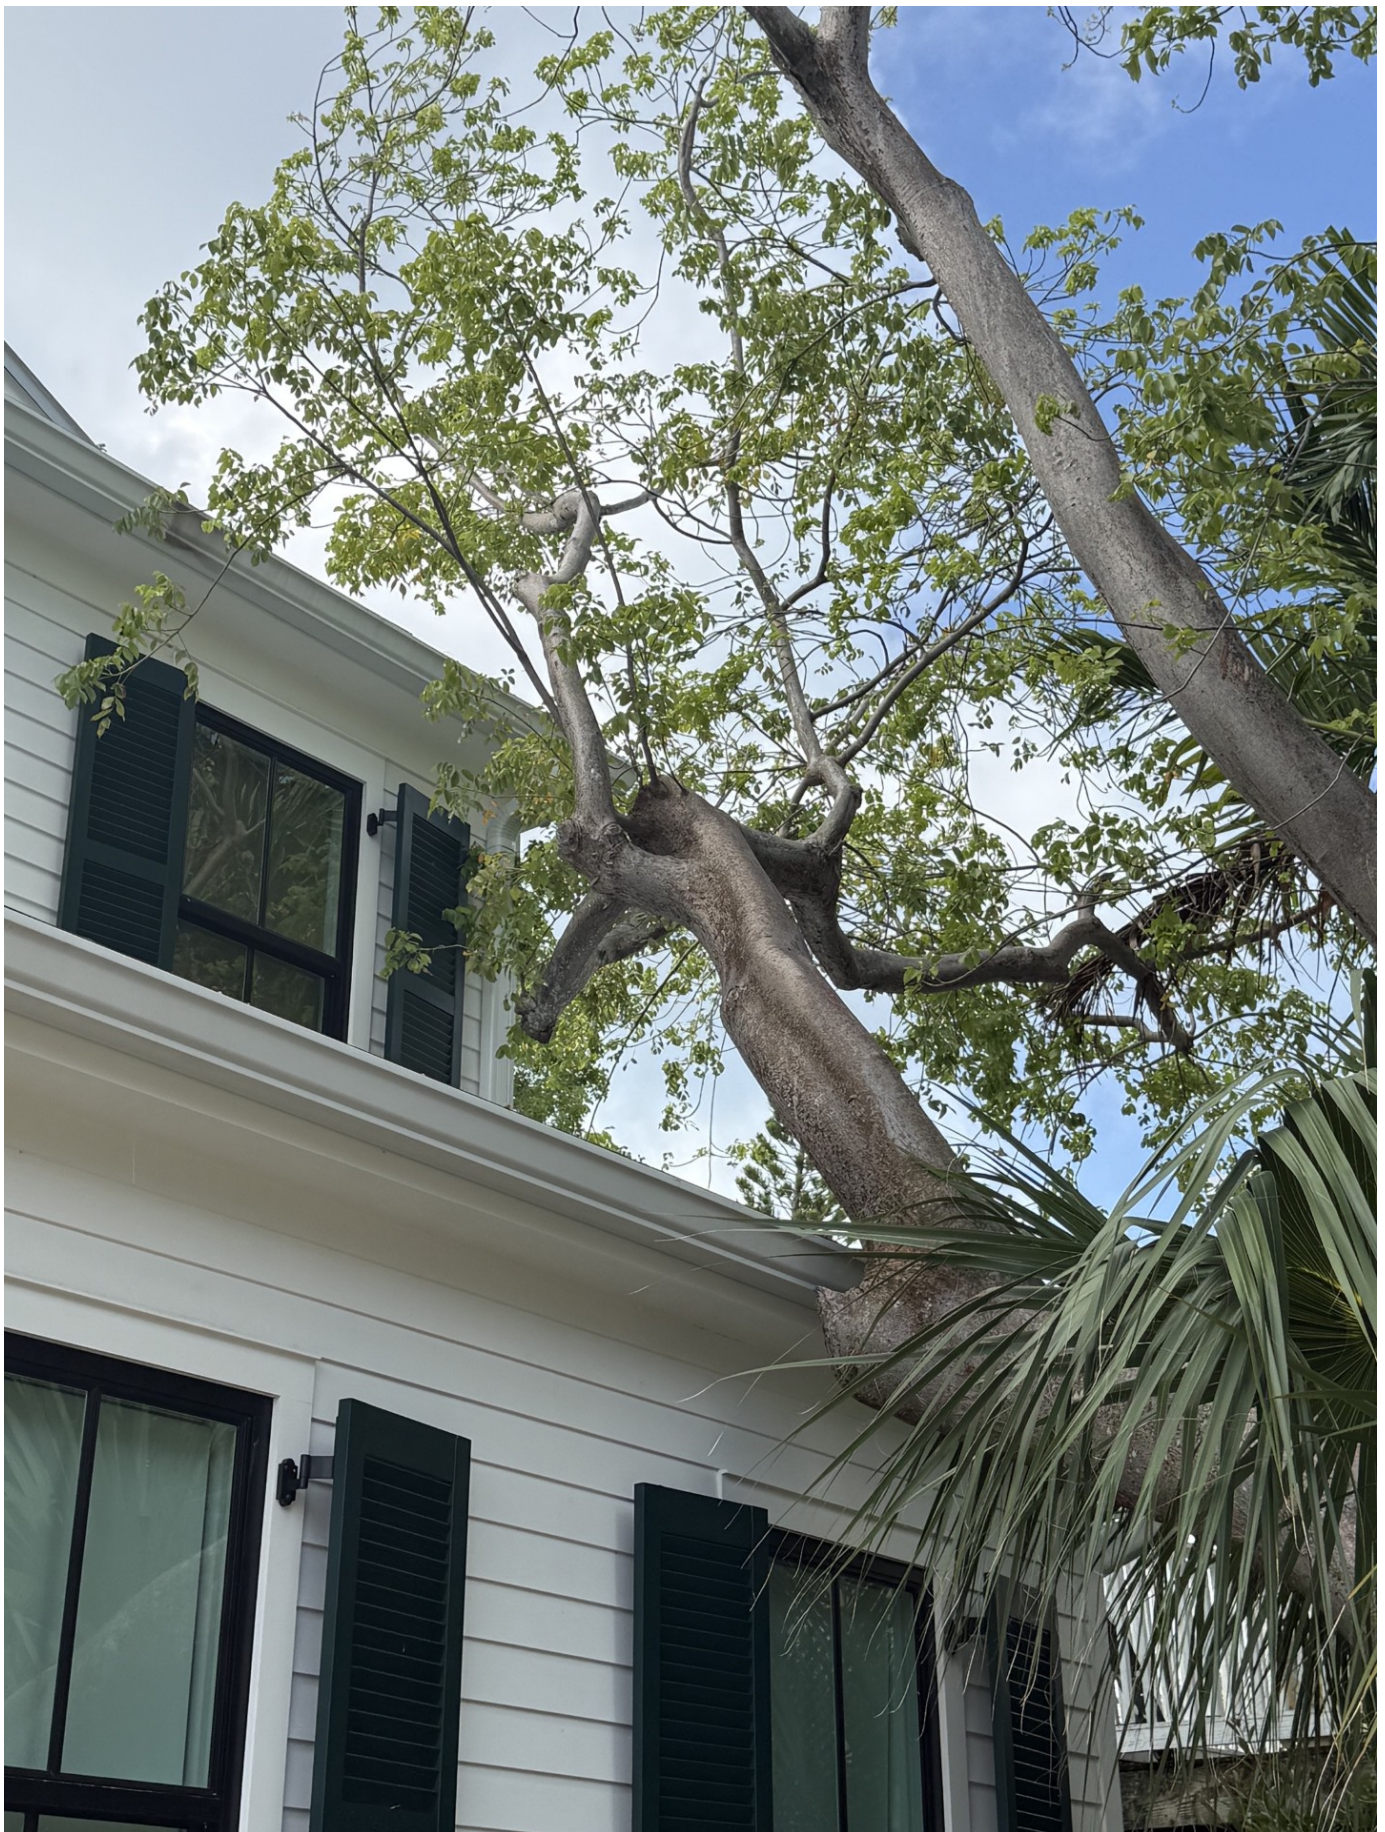
## **Gumbo Limbo**

**Condition: 20%**

The fungal fruiting bodies observed within the basal trunk cavity are consistent in appearance with a jelly fungus, likely belonging to the genus *Auricularia* (wood ear fungus). While definitive identification would require laboratory analysis, the presence of these fruiting bodies is indicative of advanced wood decay within the trunk cavity.

In addition to the fungal activity, evidence observed during the inspection is consistent with suspected and documented subterranean termite activity. The combination of active fungal colonization, extensive internal wood decay, and suspected termite infestation suggests that the structural integrity of the trunk has been significantly compromised.

It is important to note that the fungal fruiting bodies themselves are not necessarily the primary cause of decay; rather, they serve as an indicator that decomposition of the woody tissues is ongoing. The suspected termite activity may further accelerate the degradation of already compromised wood.

**Recommended Mitigation: 20 Caliper Inches**

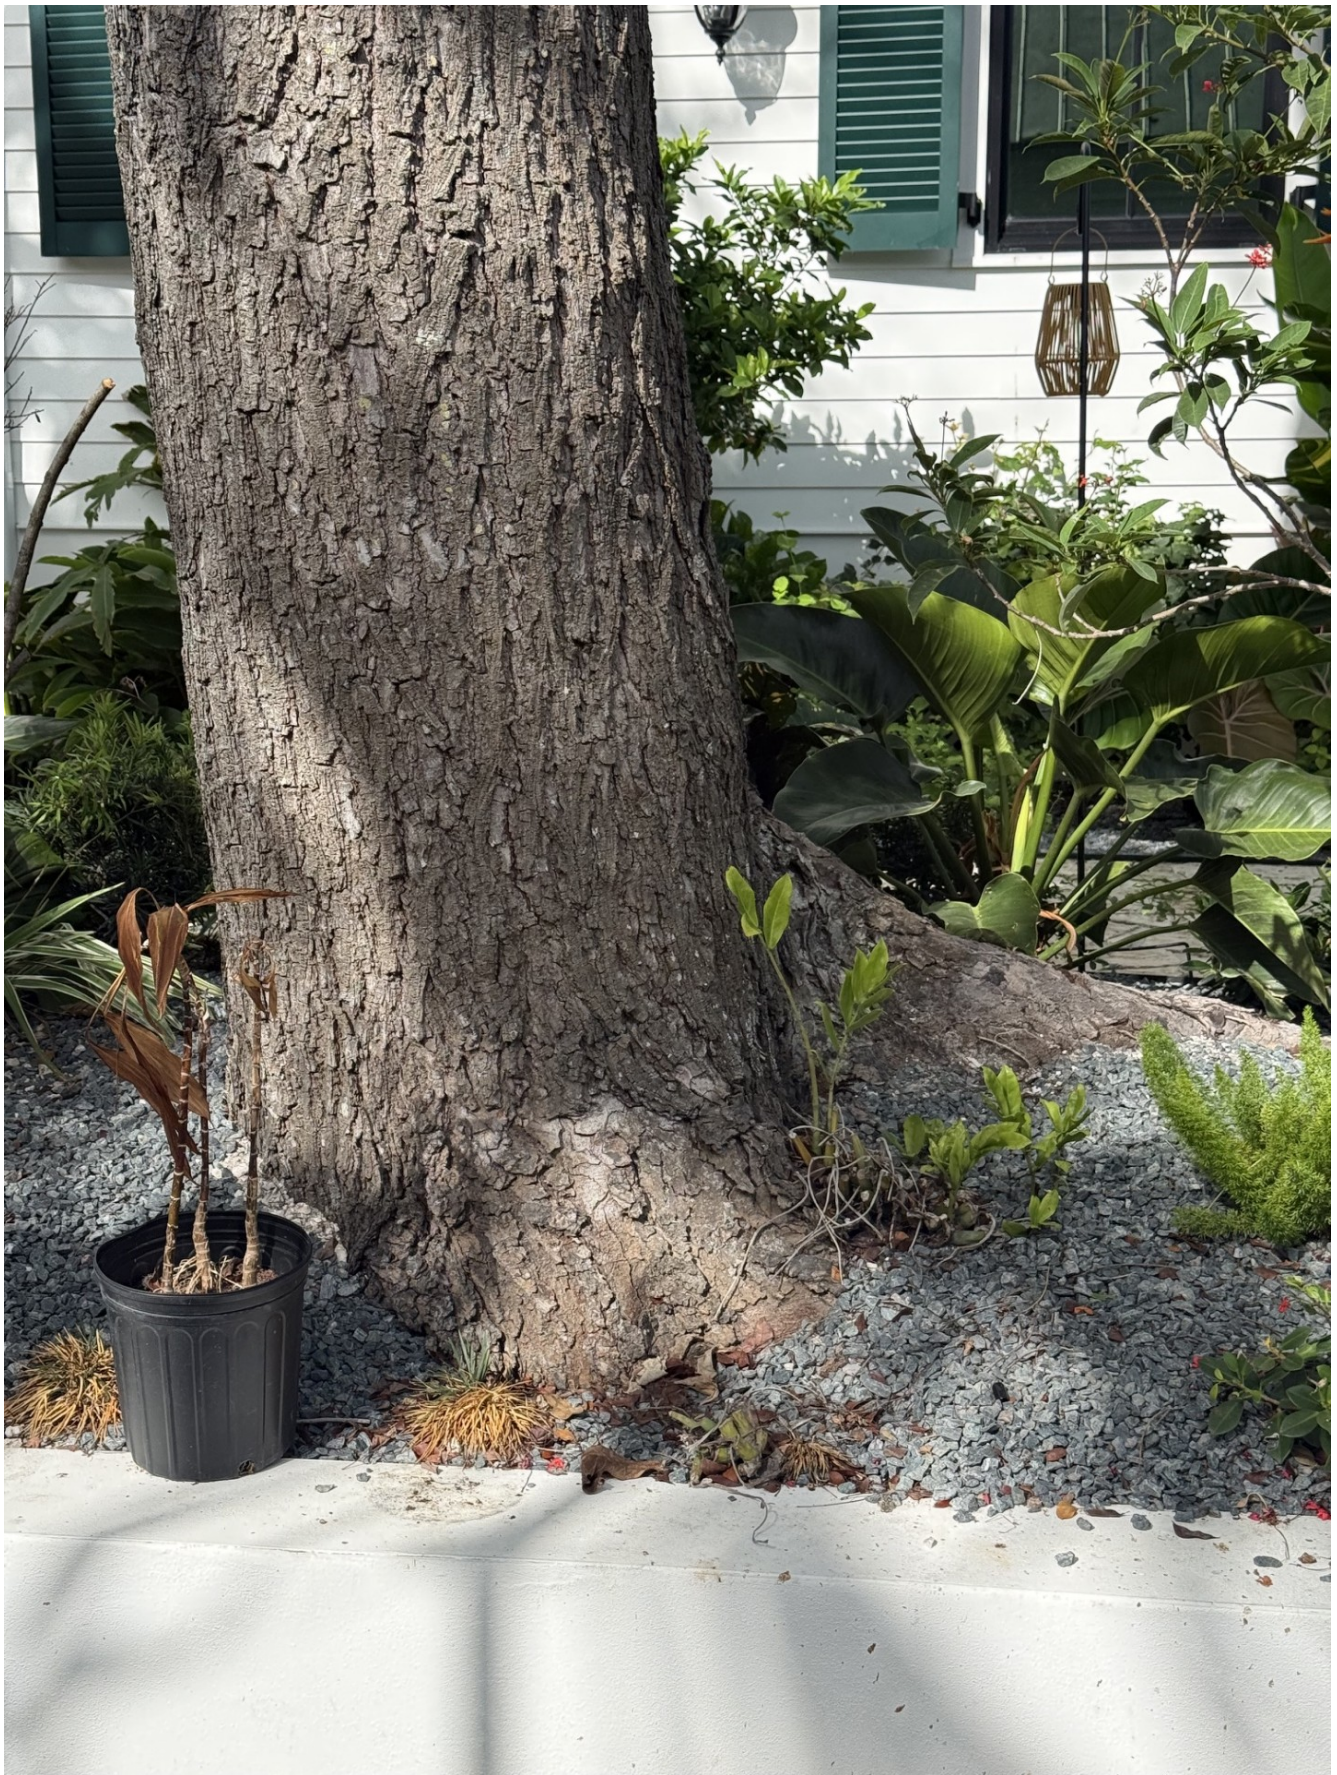
**Condition: 70%**

The subject tree is a mature Cuban mahogany measuring approximately 28 inches DBH and is located in the front yard of a single-family residence. Overall, the tree exhibits fair canopy condition with acceptable foliar density and no significant canopy-wide decline observed during the inspection.

The primary observation of concern involves one of the main scaffold leaders extending over the home's front porch. This leader exhibits extensive bacterial wetwood, which has progressed to the point of causing substantial bark sloughing. Large sections of bark have detached, exposing underlying wood that appears dry, dull, and lacking the typical appearance of healthy cambial tissue. While bacterial wetwood is a relatively common condition in Cuban mahogany, it is less common for the condition to result in bark loss of this magnitude. The extent of exposed wood warrants continued observation as it may indicate localized structural degradation or advancing decline within this leader.

A second large scaffold leader is in direct conflict with the residence. The home's front porch soffit has been constructed with a large cutout to accommodate the stem, indicating the structure was built around the existing tree. At the time of inspection, no obvious signs of active structural failure, cracking, or significant defects were observed within this leader.

No additional significant structural defects, root concerns, or canopy abnormalities were identified during this Level 2 visual assessment.

**Recommended Mitigation: 21.5 Caliper Inches**
