## Tree Removal Report

**PROPERTY:** 629 Dey St.

**APPLICATION NUMBER:** T2026-0125

**REQUEST:** The applicant is requesting removal of (2) Cuban Mahogany Trees (1) Gumbo Limbo Tree.

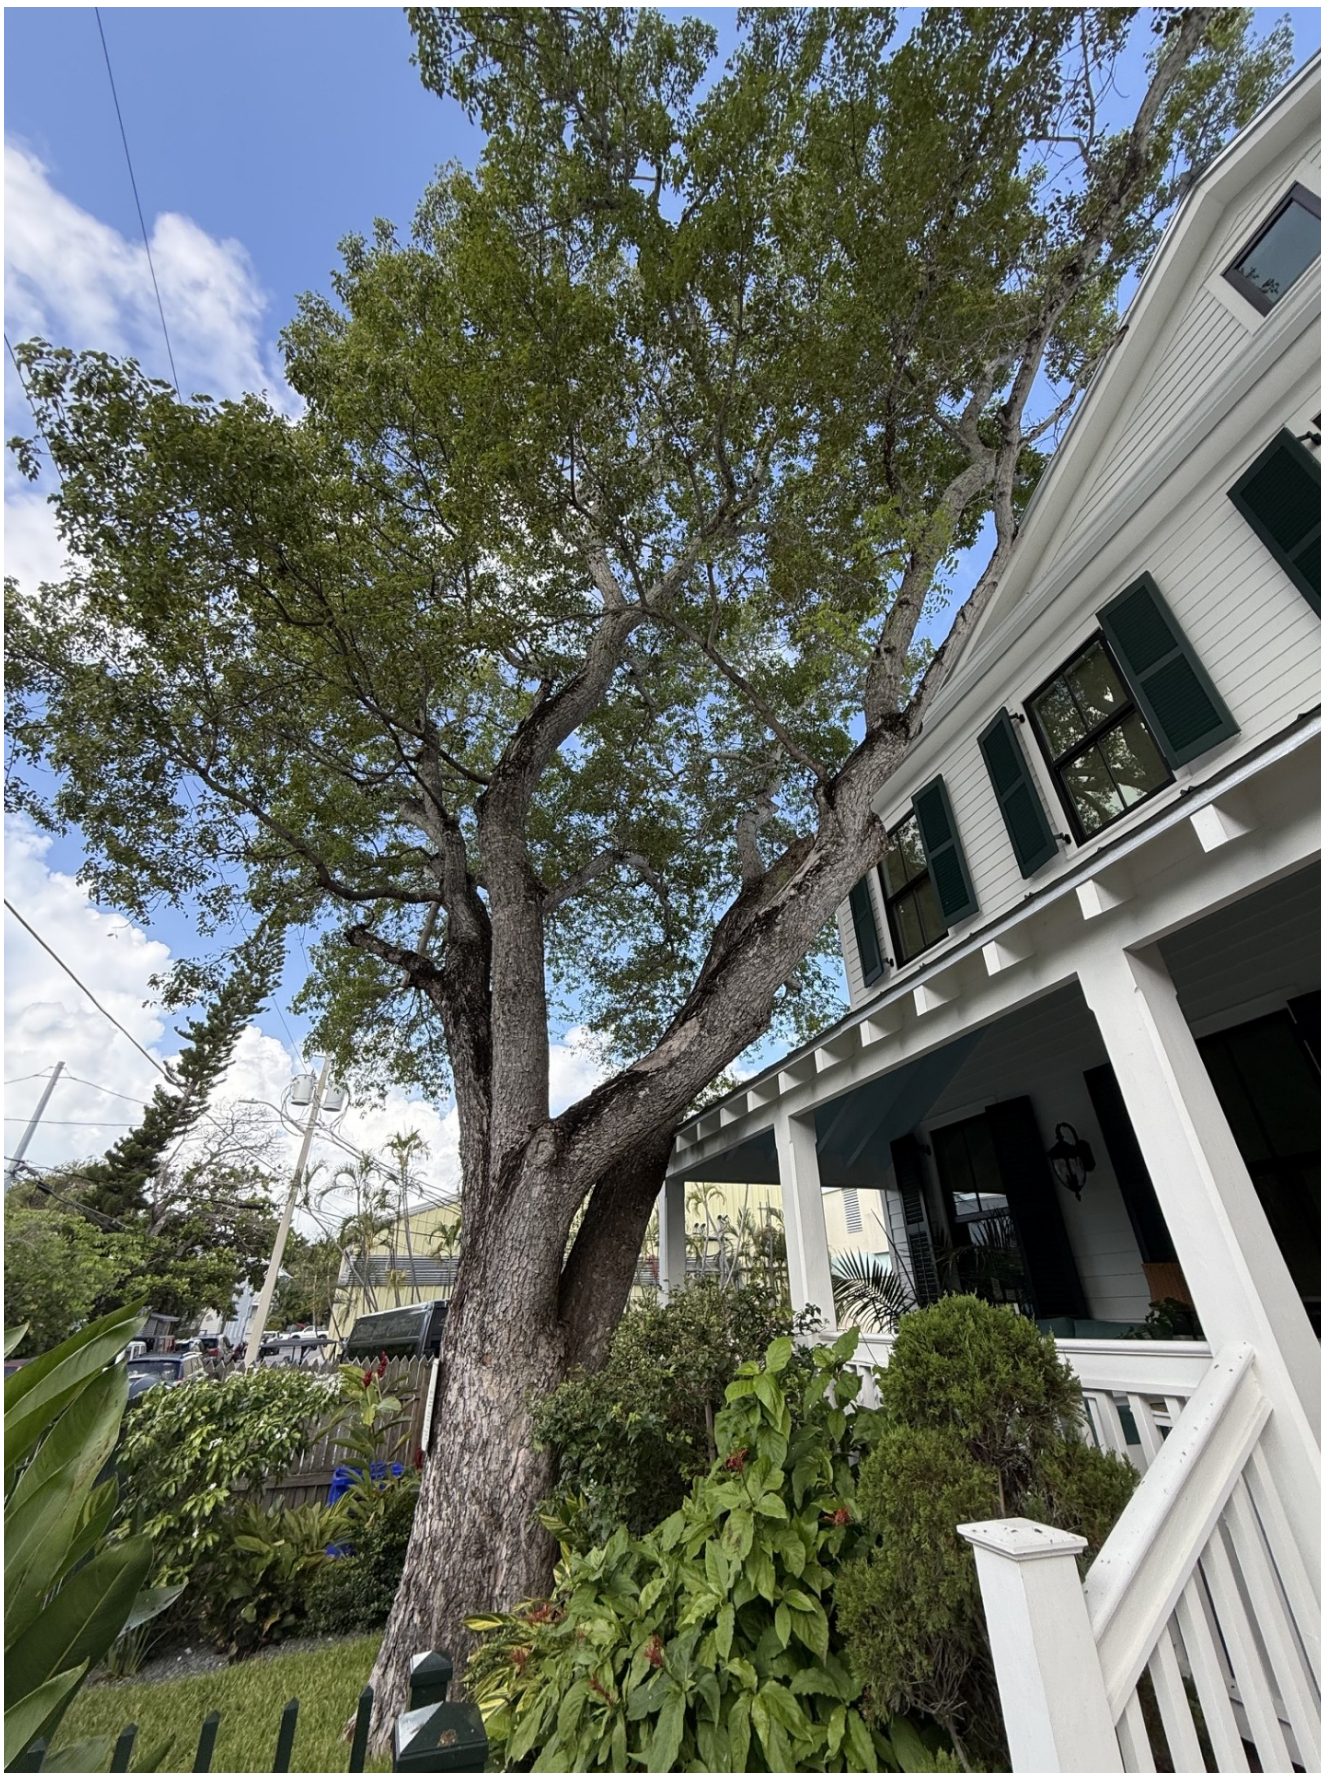
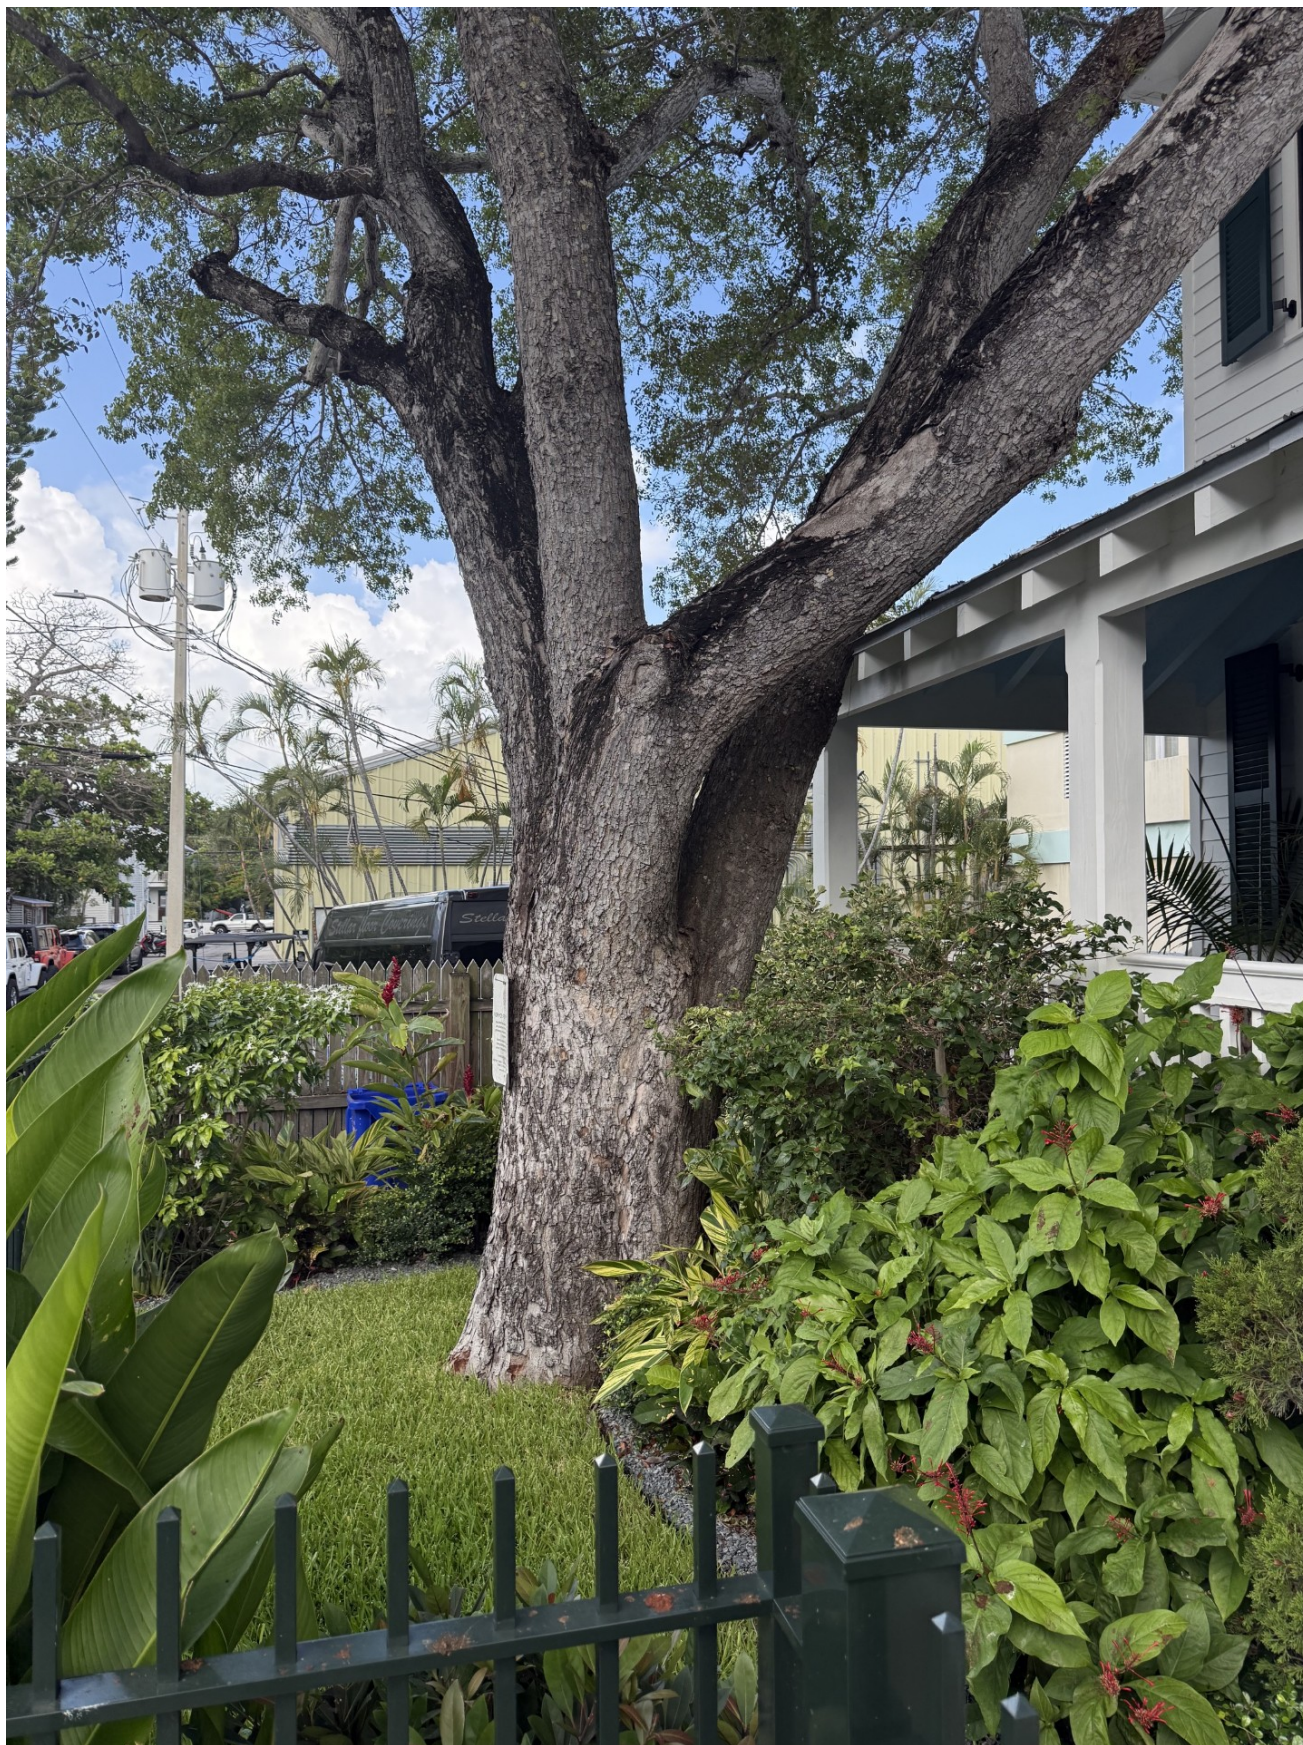
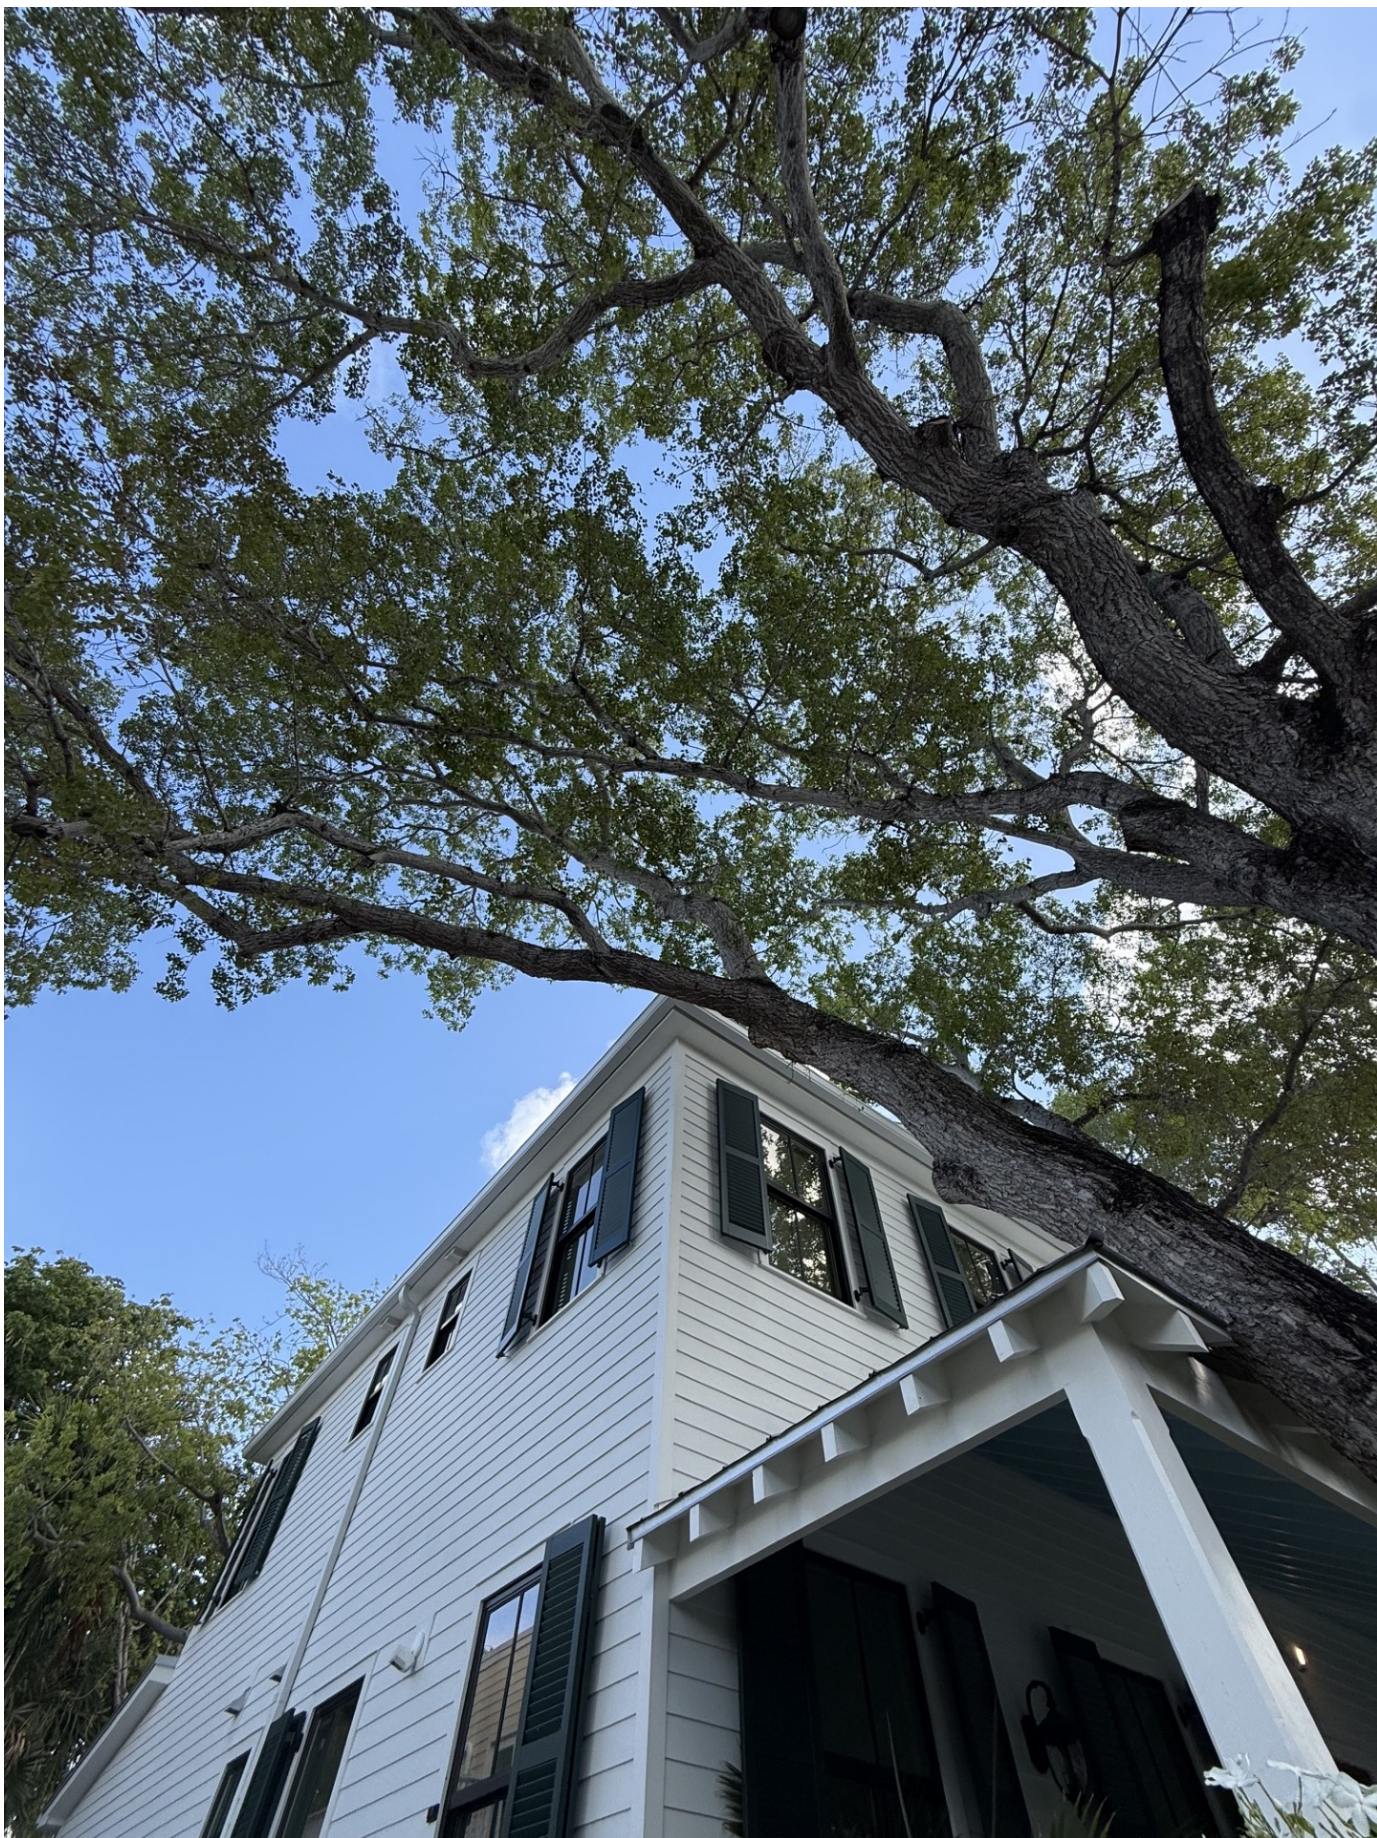
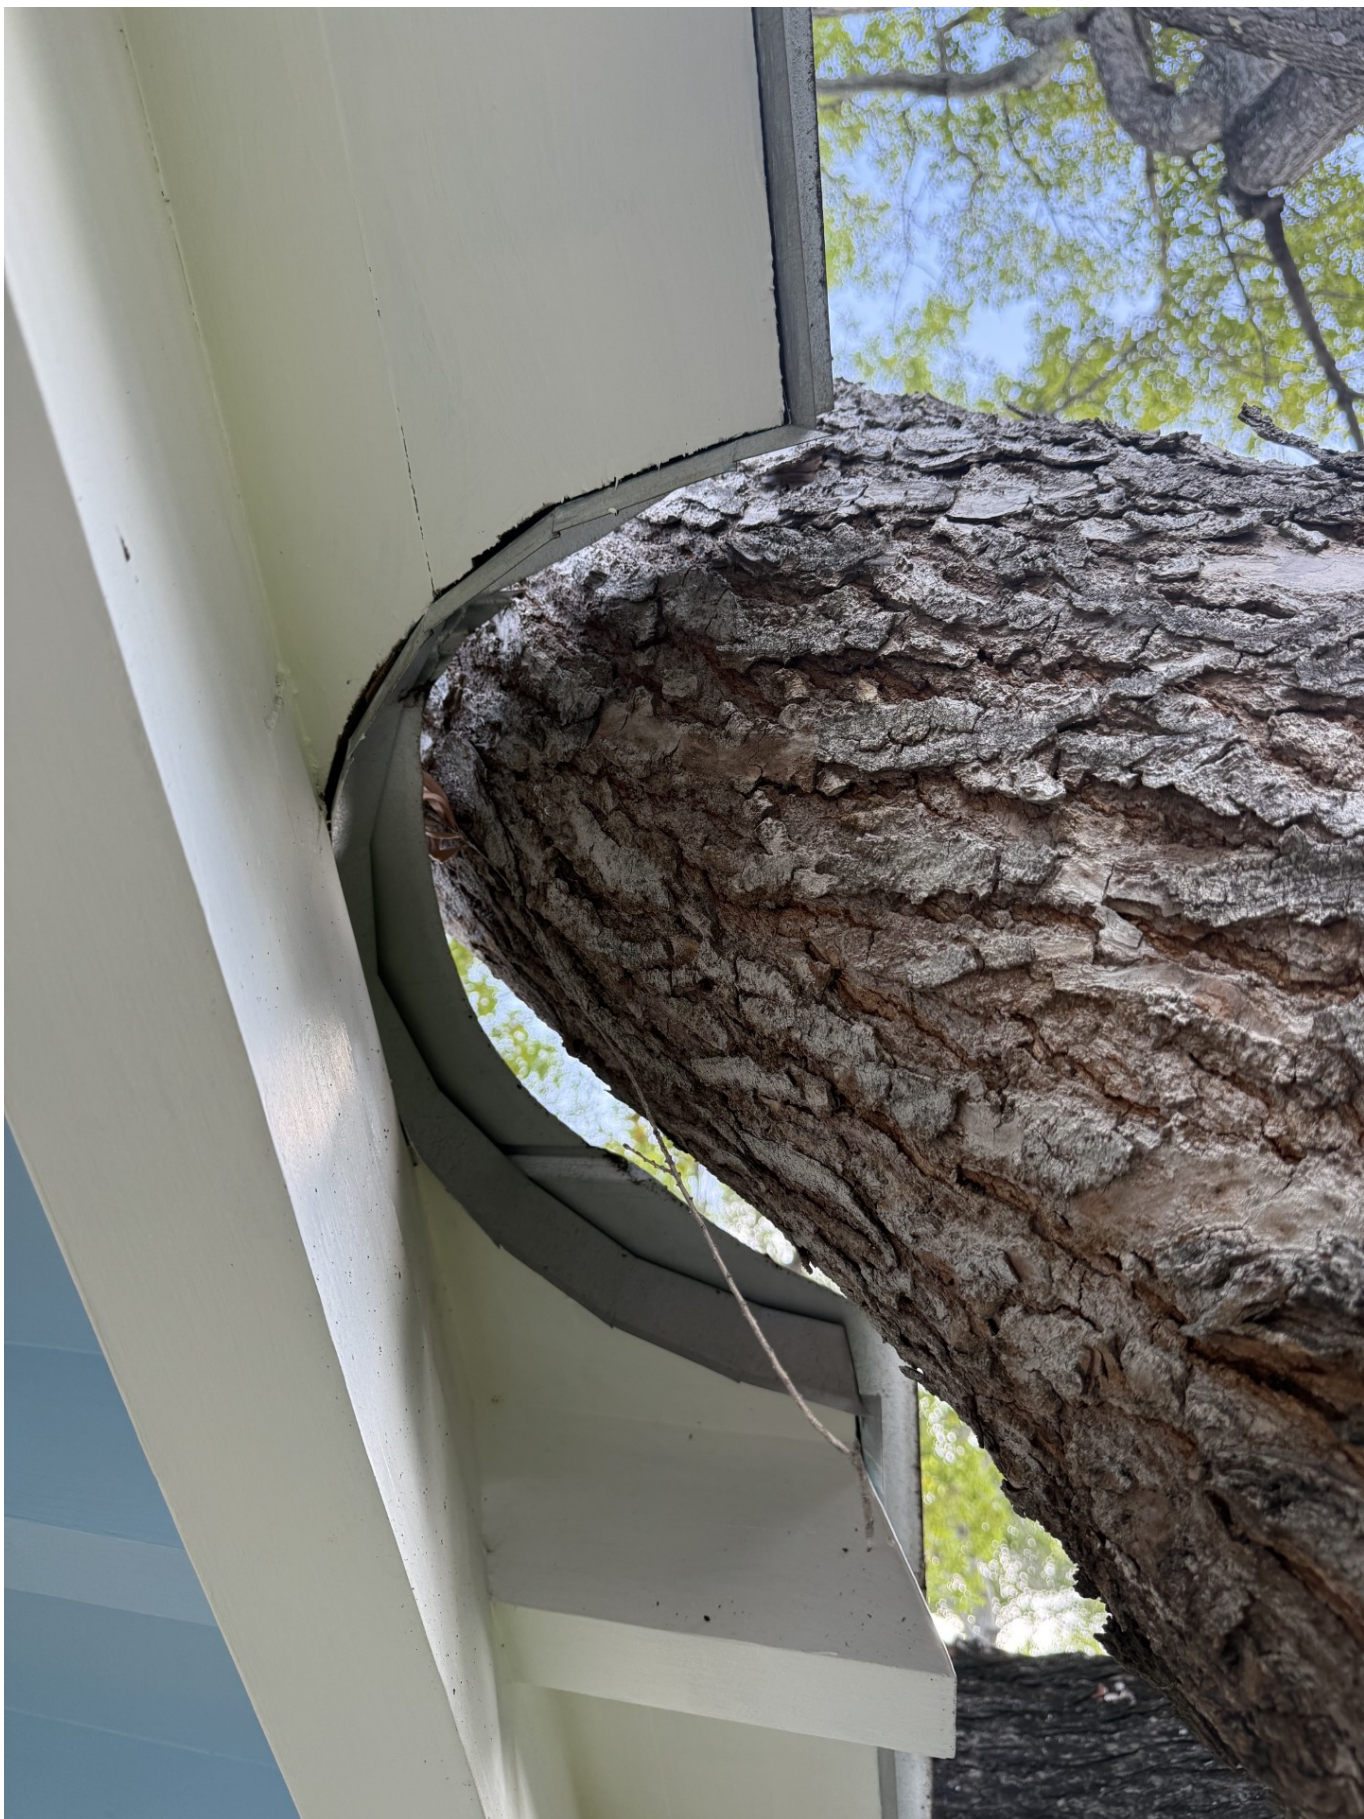
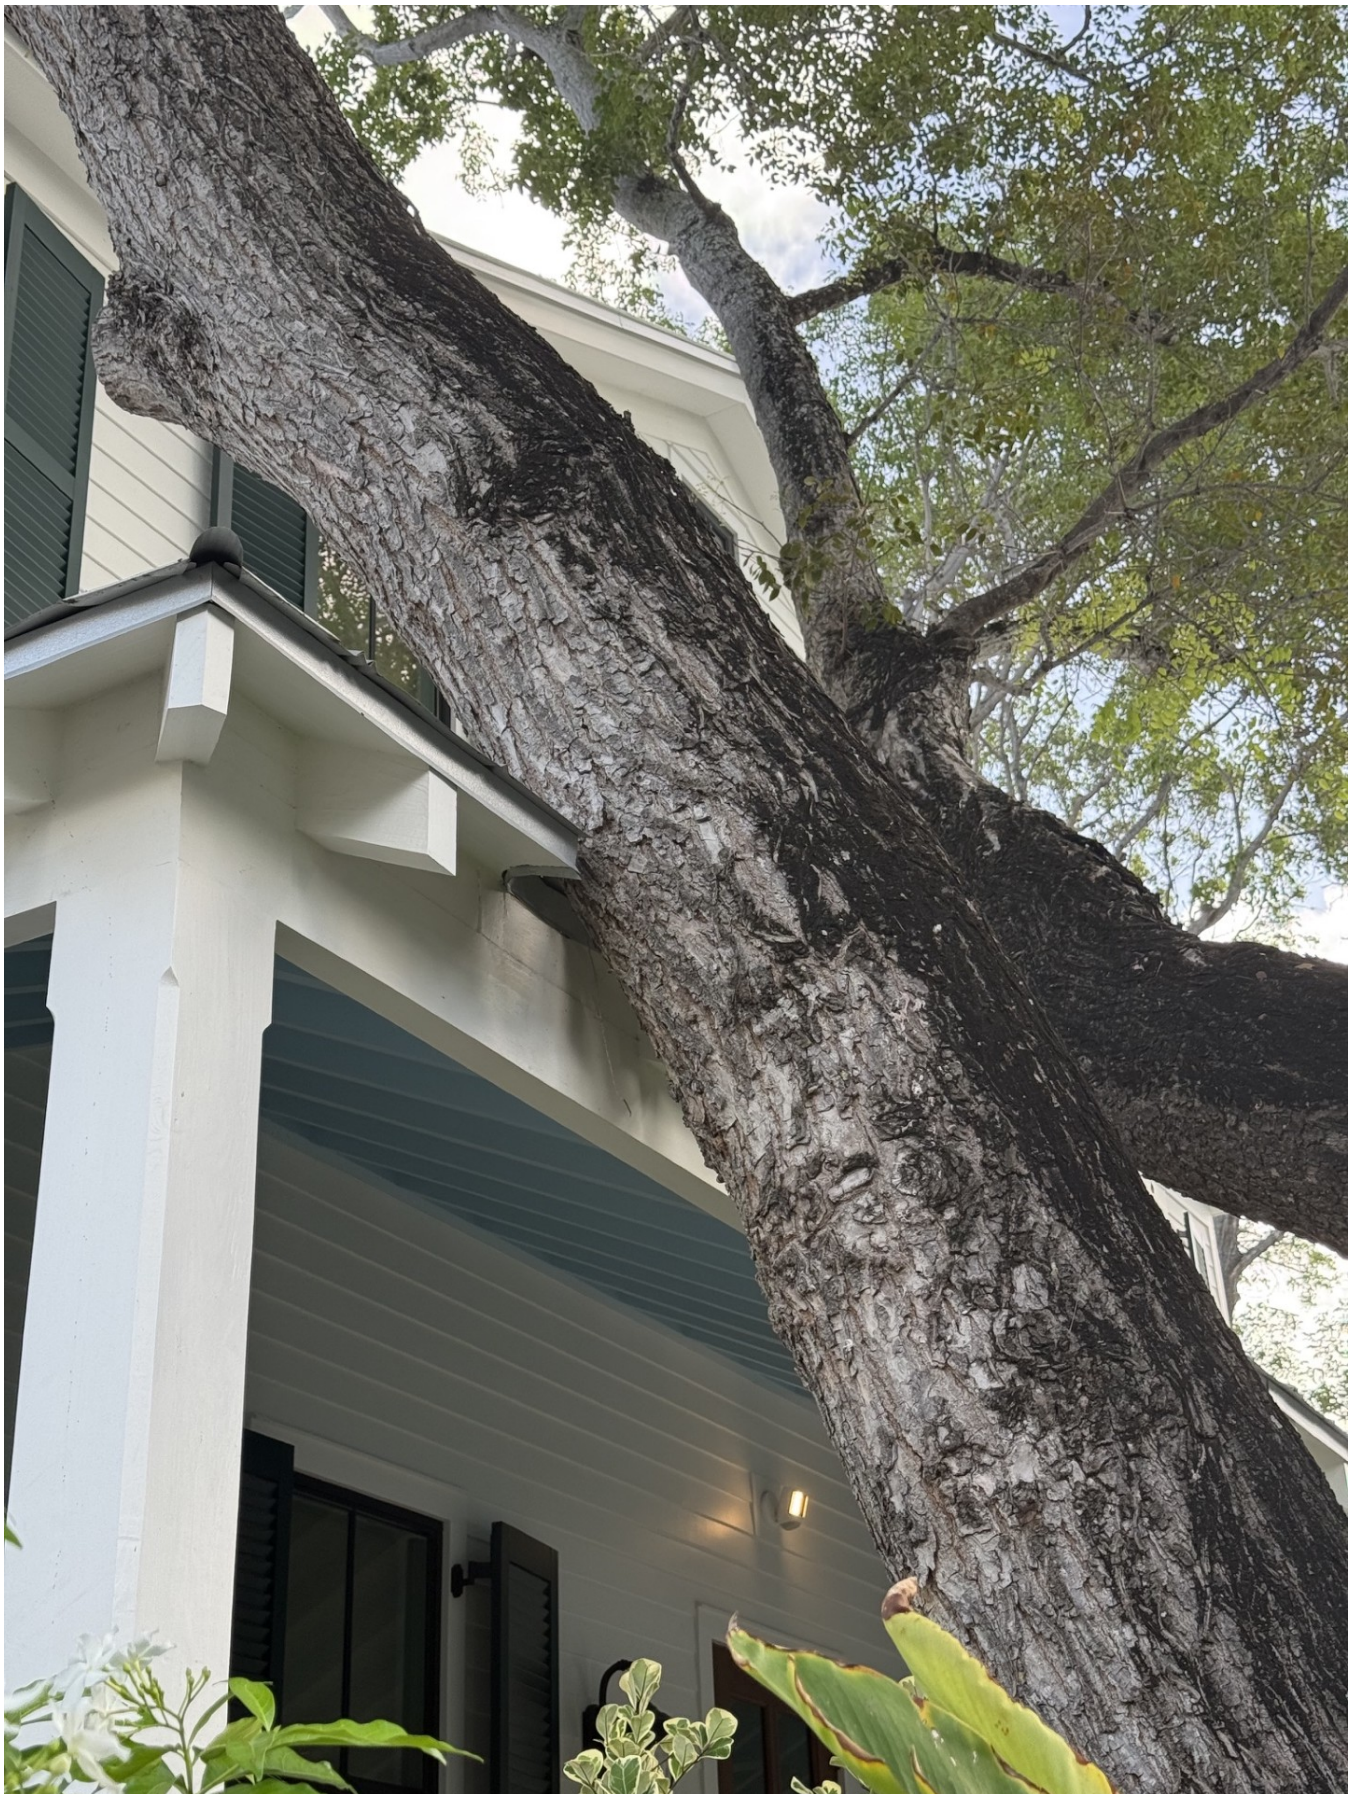
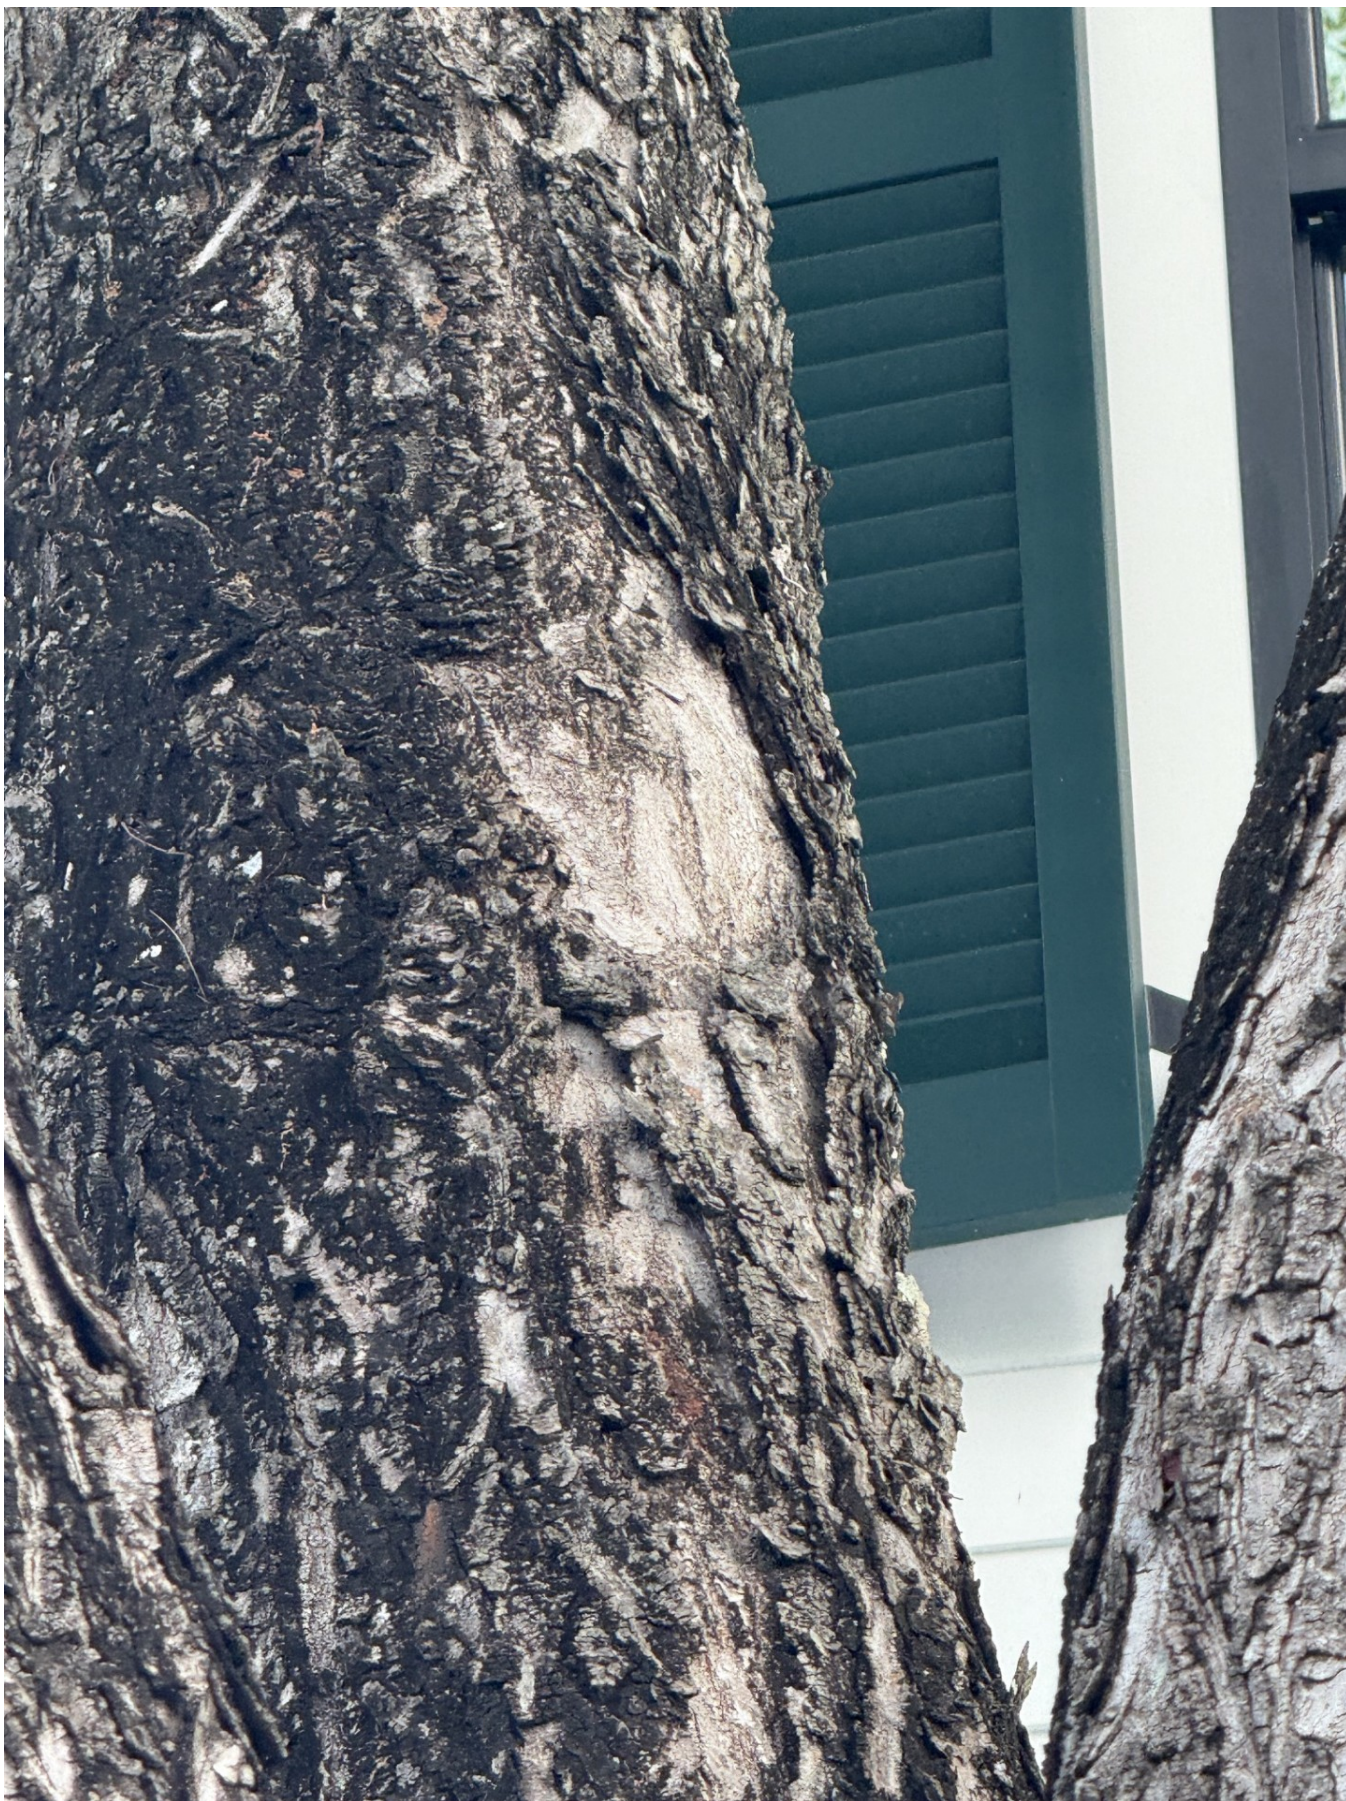
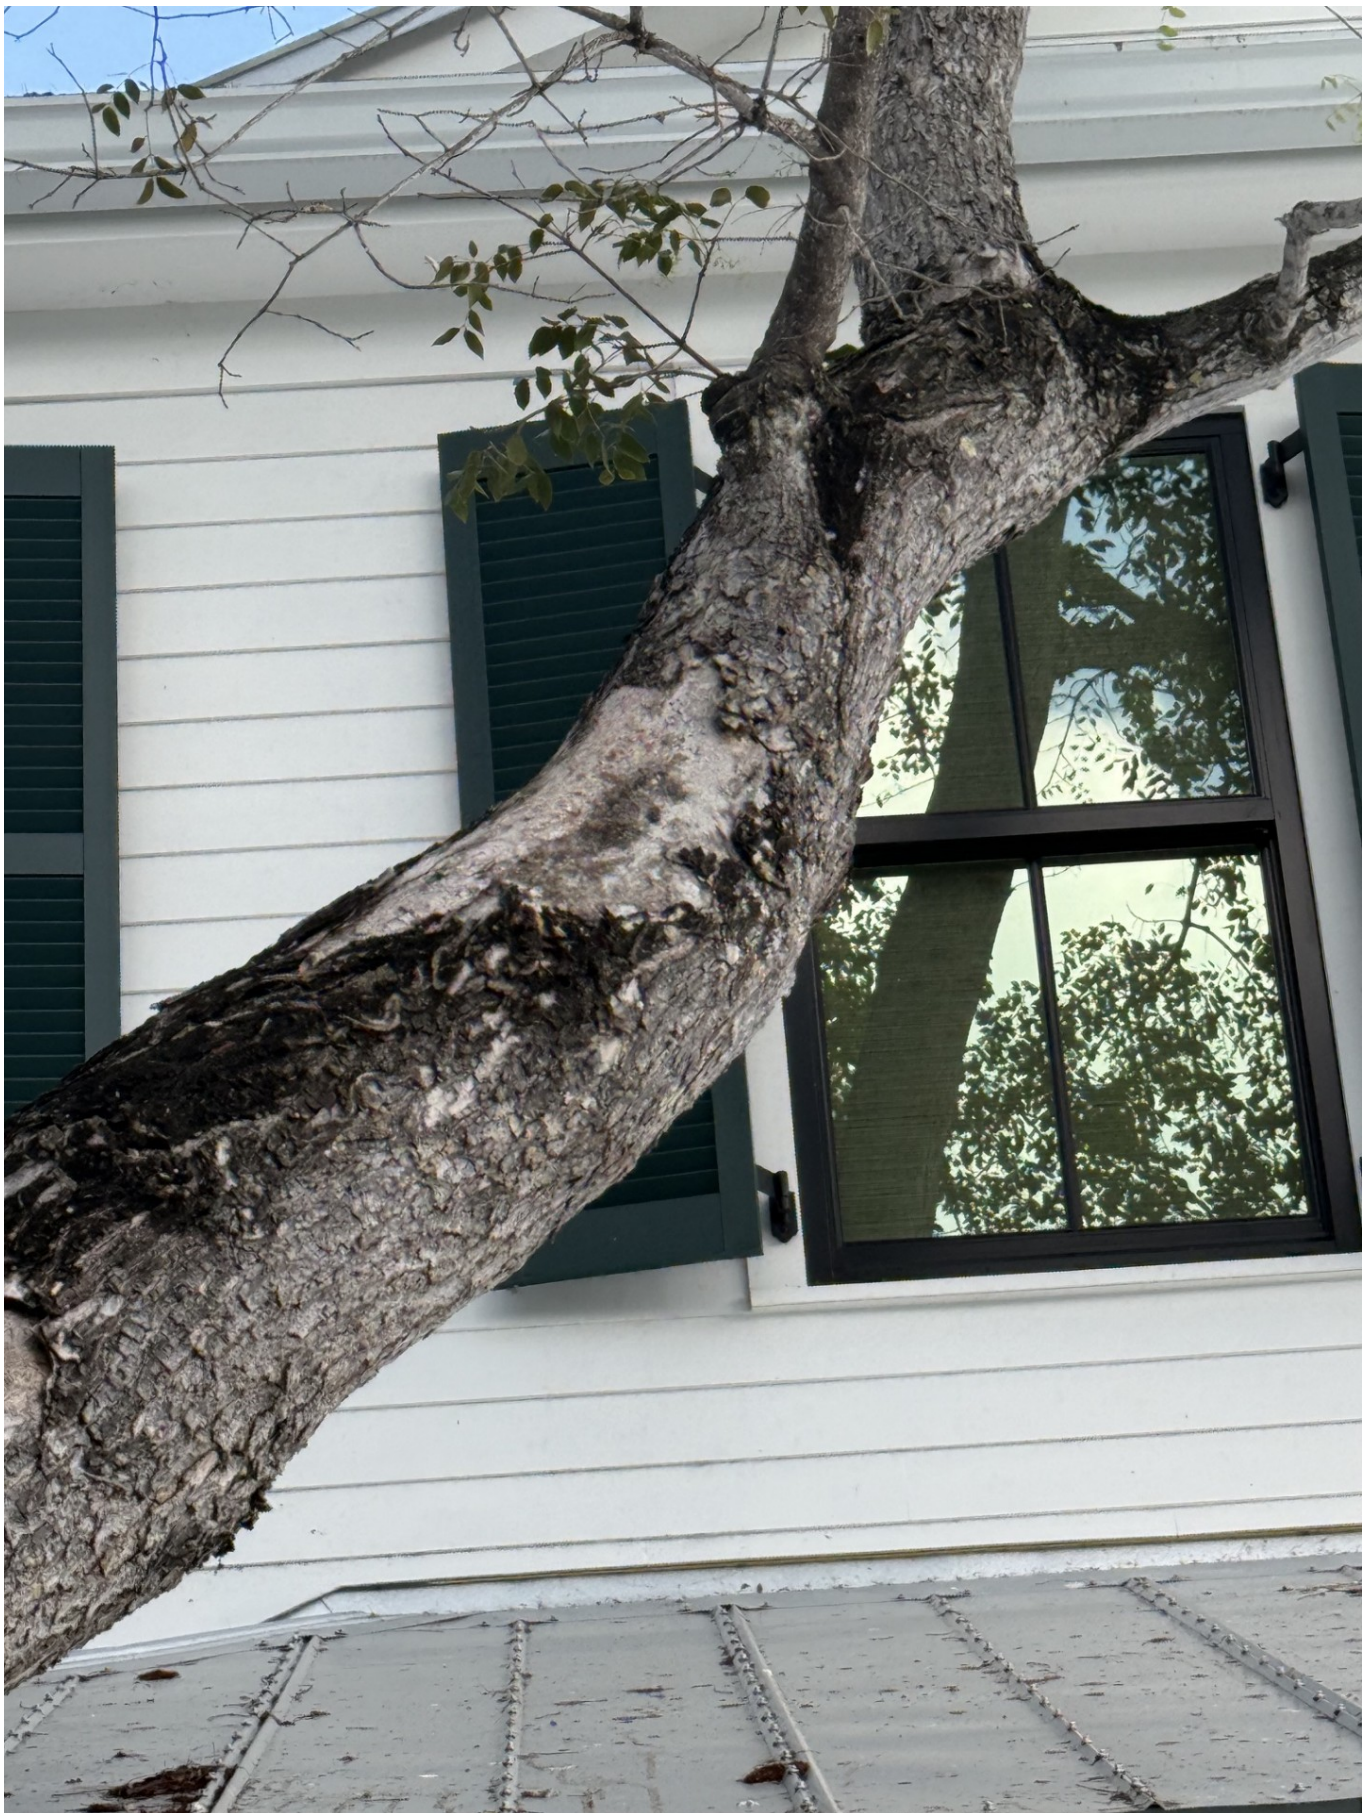
**Condition: 80%**

The root flare is visible and appears healthy, with no obvious indications of basal decay, root damage, or structural instability observed during the inspection.

One scaffold branch extends toward and partially over the roof of the adjacent two-story residence. While branch overhang of a structure is generally not considered ideal, this particular limb tapers substantially before reaching the home. The branch originates at approximately 10 inches in diameter and is located roughly 12 feet from the residence. By the point where it extends over the roof gutter, the branch has tapered to approximately 3 to 4 inches in diameter. Based on the branch taper and the reduced loading at its distal end, this condition is not considered an immediate structural concern.

No additional significant structural defects, trunk decay, root defects, or canopy abnormalities were identified during this Level 2 visual assessment.

**Recommended Mitigation: 22.5 Caliper Inches**
