## Structural Assessment Report for the existing Edward B. Knight Pier

Property Address:  
**Edward B. Knight Pier**  
**1900 White Street, Key West, FL 33040**

AUGUST 2025

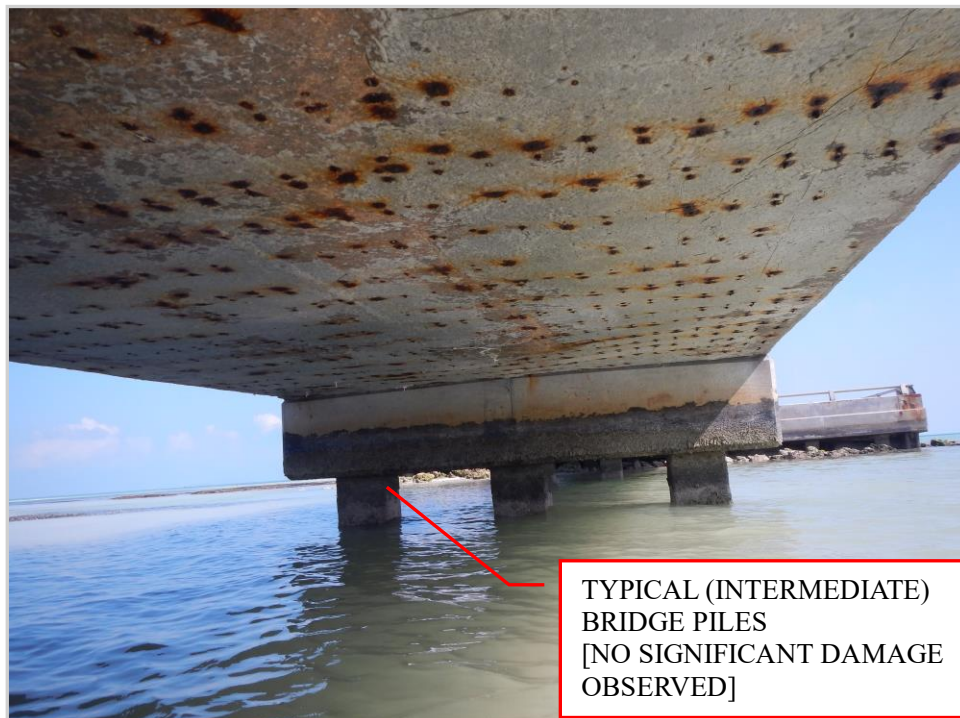
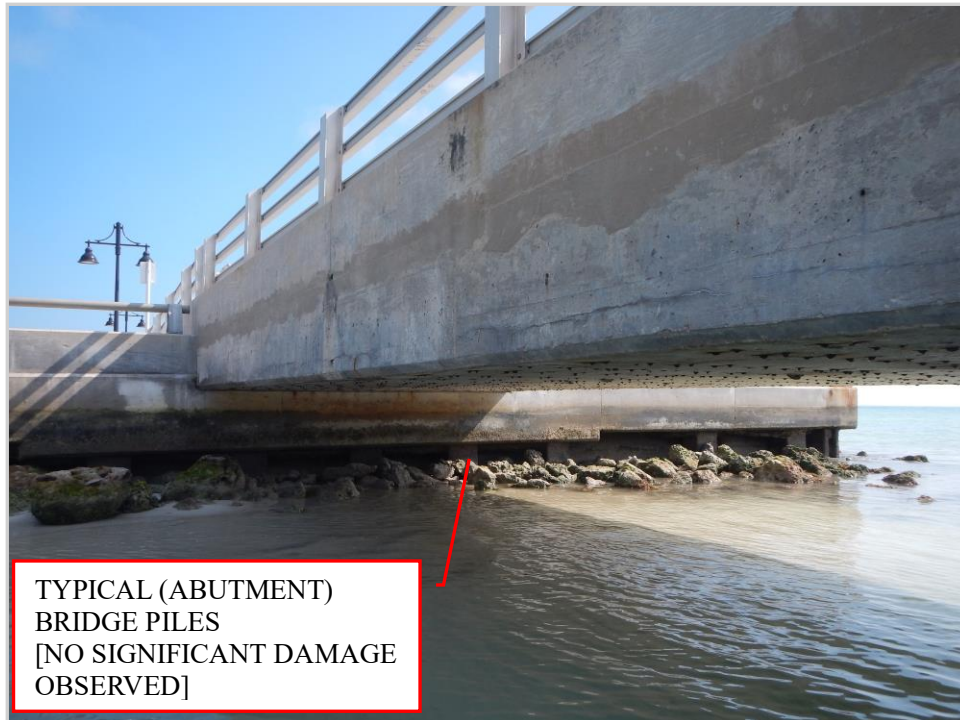
No significant pile damage was observed at intermediate bridge piers or bridge abutments. This is consistent for the approach bridges and the terminus bridge.

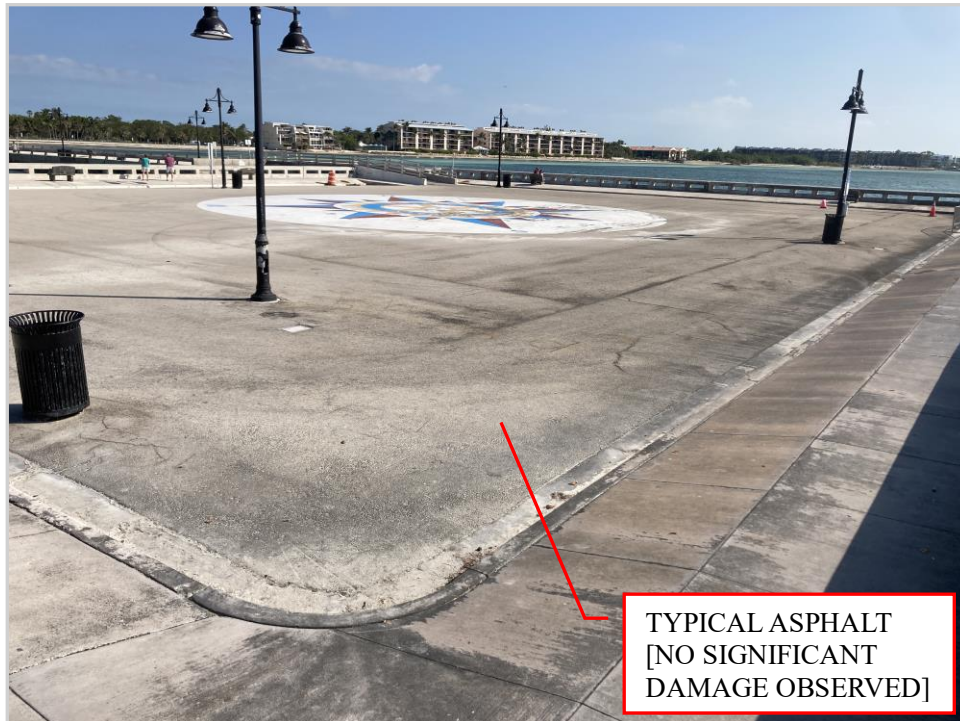
No significant asphalt damage was observed. However, it is expected that asphalt repaving will be required prior to entire pier replacement.

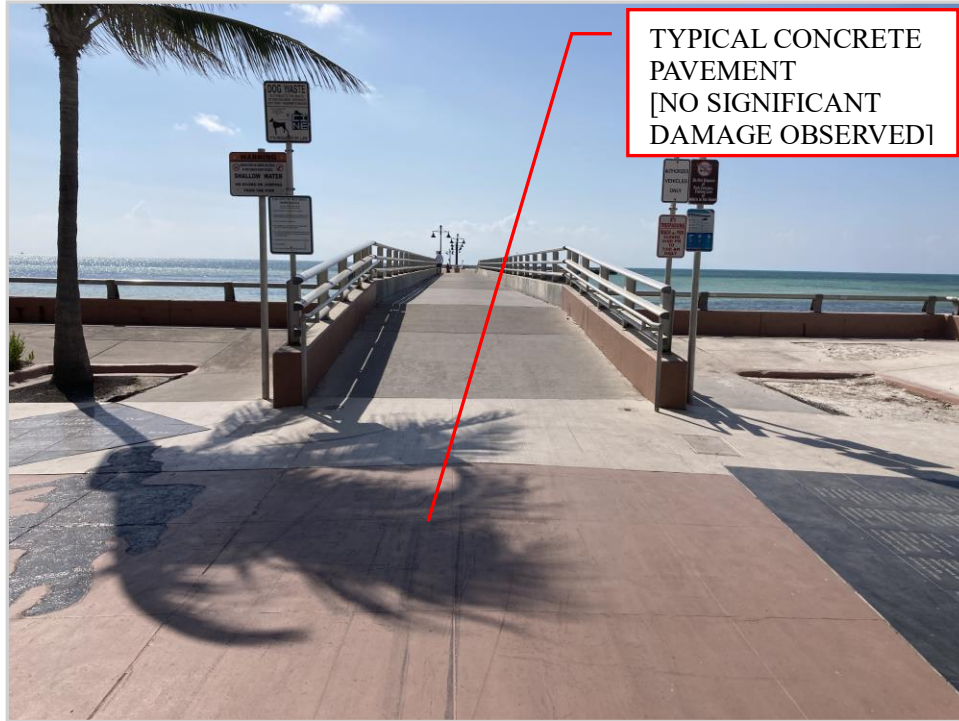
No significant concrete pavement damage was observed.

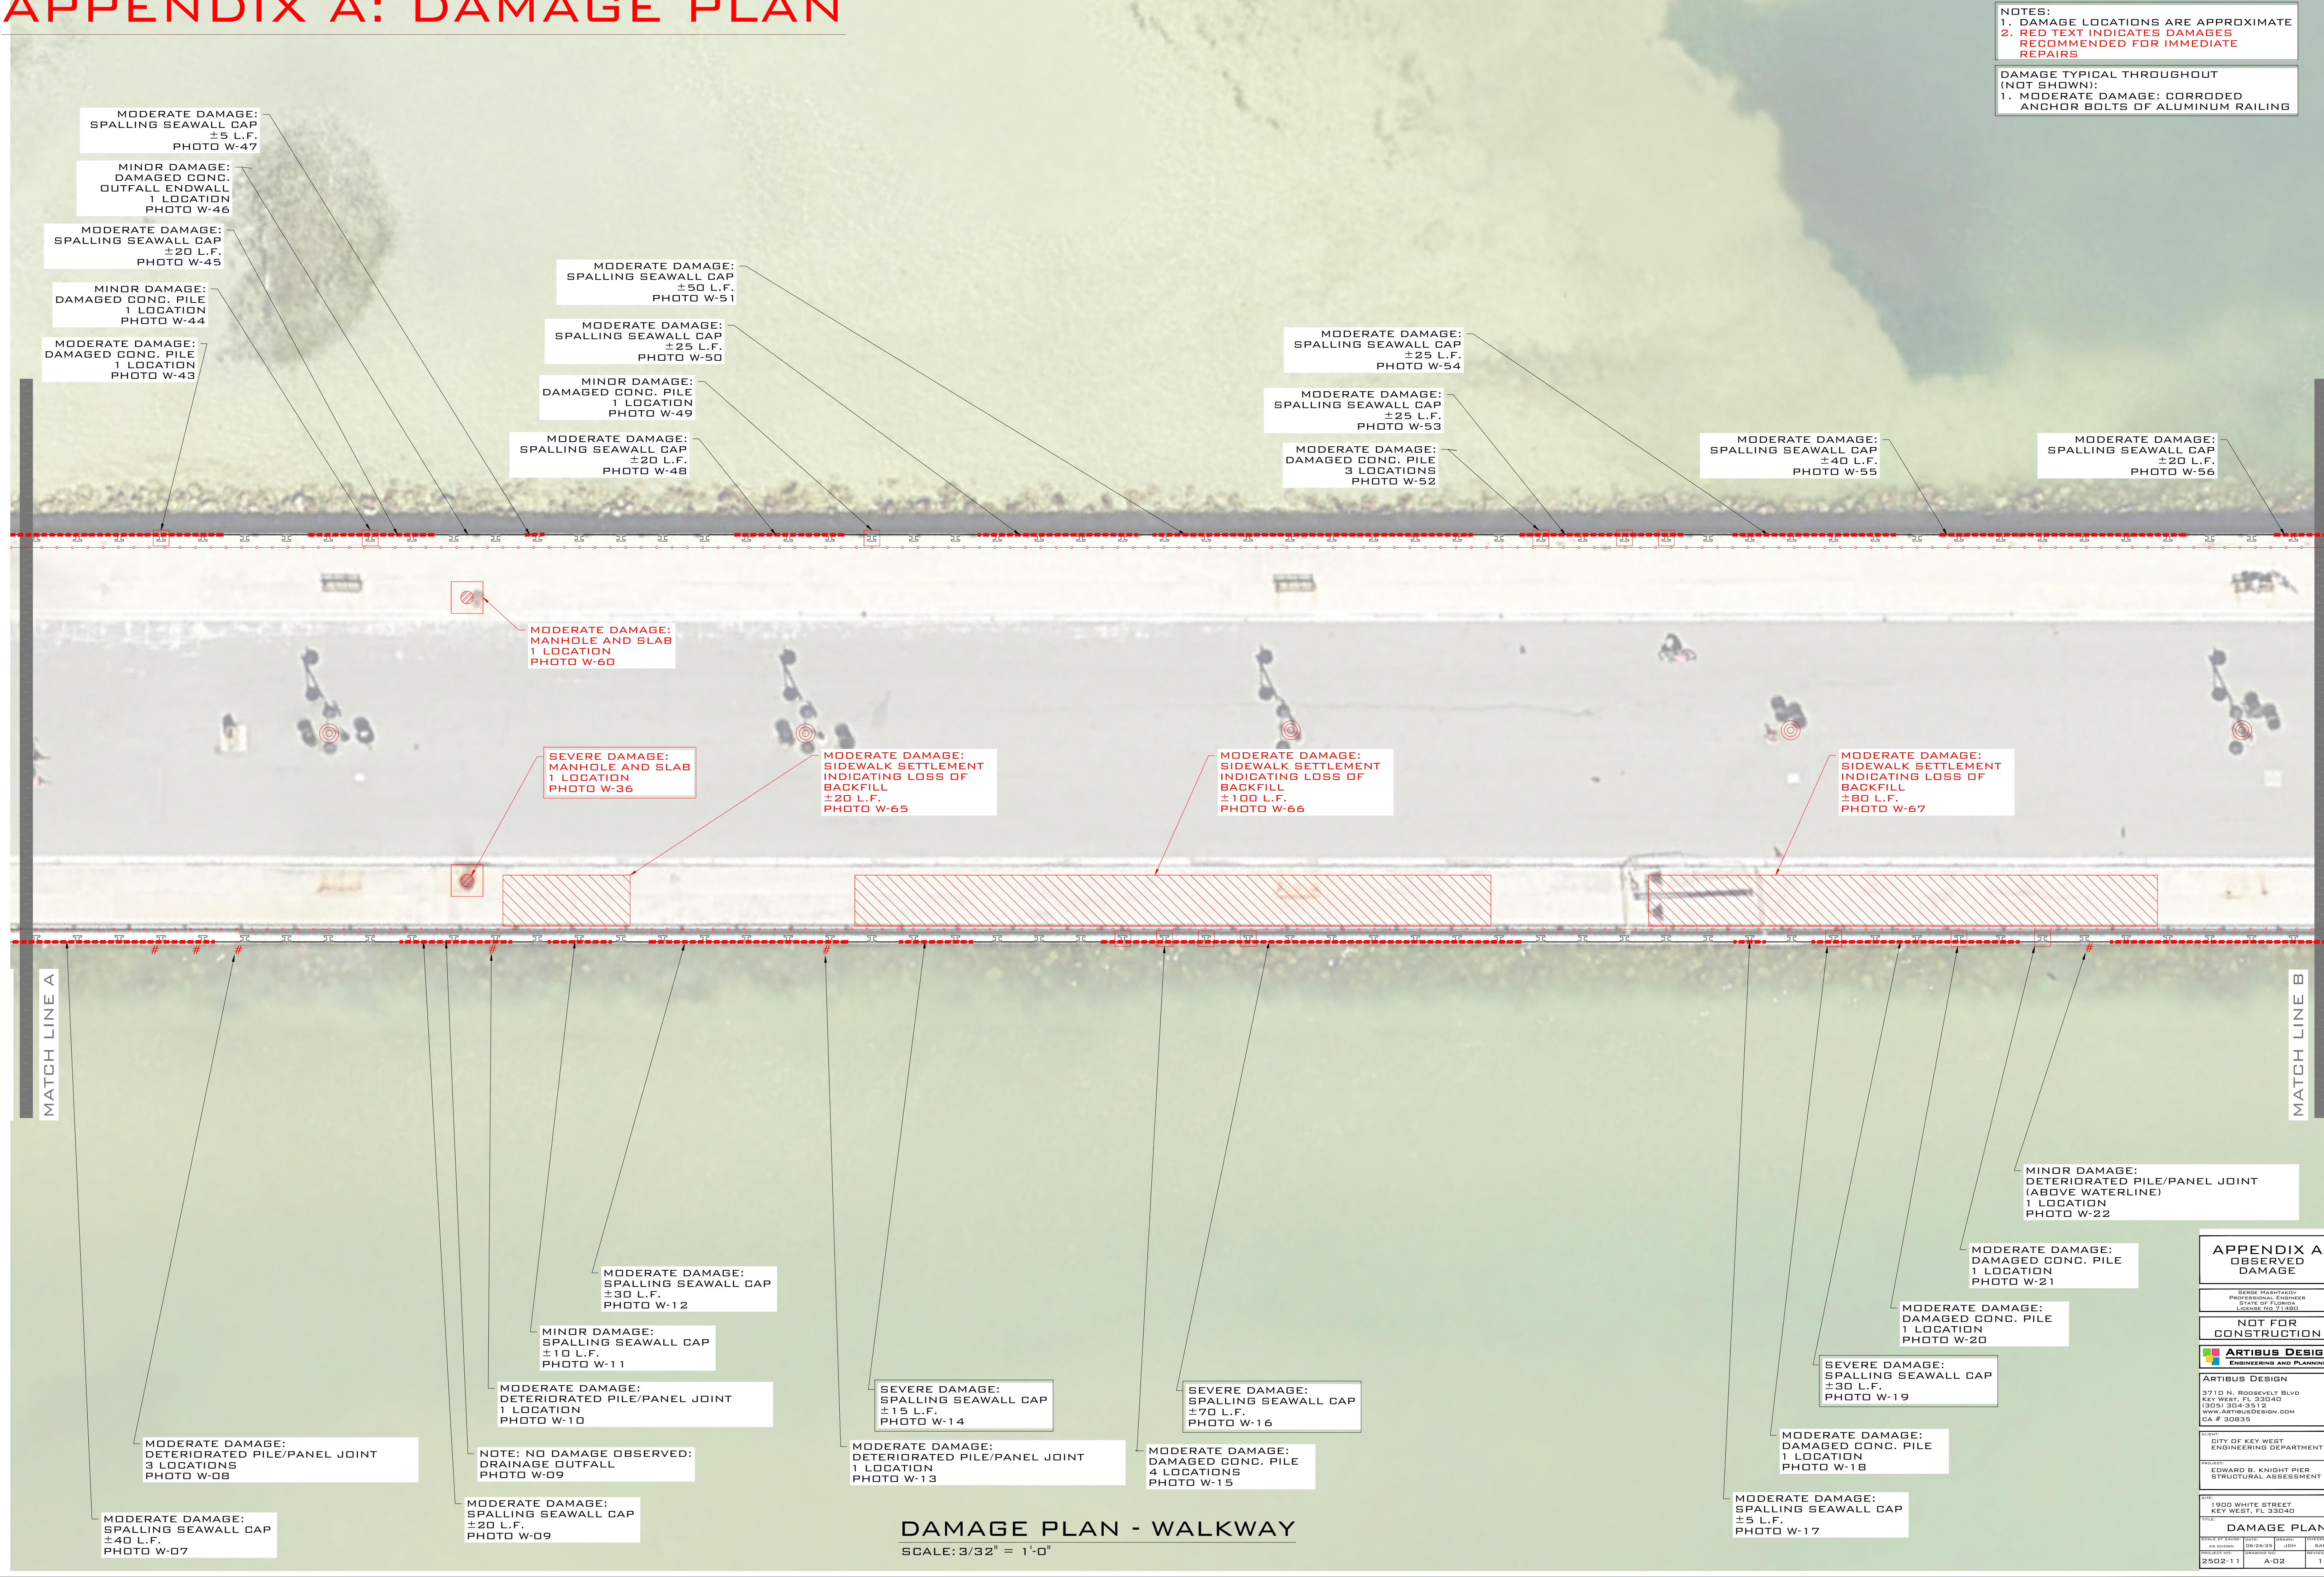
DAMAGE PLAN - PLAZA & APPROACH  
SCALE: 3/32" = 1'-0"

DAMAGE TYPICAL THROUGHOUT  
(NOT SHOWN):  
1. MODERATE DAMAGE: CORRODED  
ANCHOR BOLTS OF ALUMINUM RAILING
