**TREE COMMISSION TREE REMOVAL REPORT  
CITY of KEY WEST**

**PROPERTY: 729 Truman Ave**

**APPLICATION NUMBER: T2026-0102**

**REQUEST: The applicant is requesting removal of (1) Gumbo Limbo & (1) Poinciana tree.**

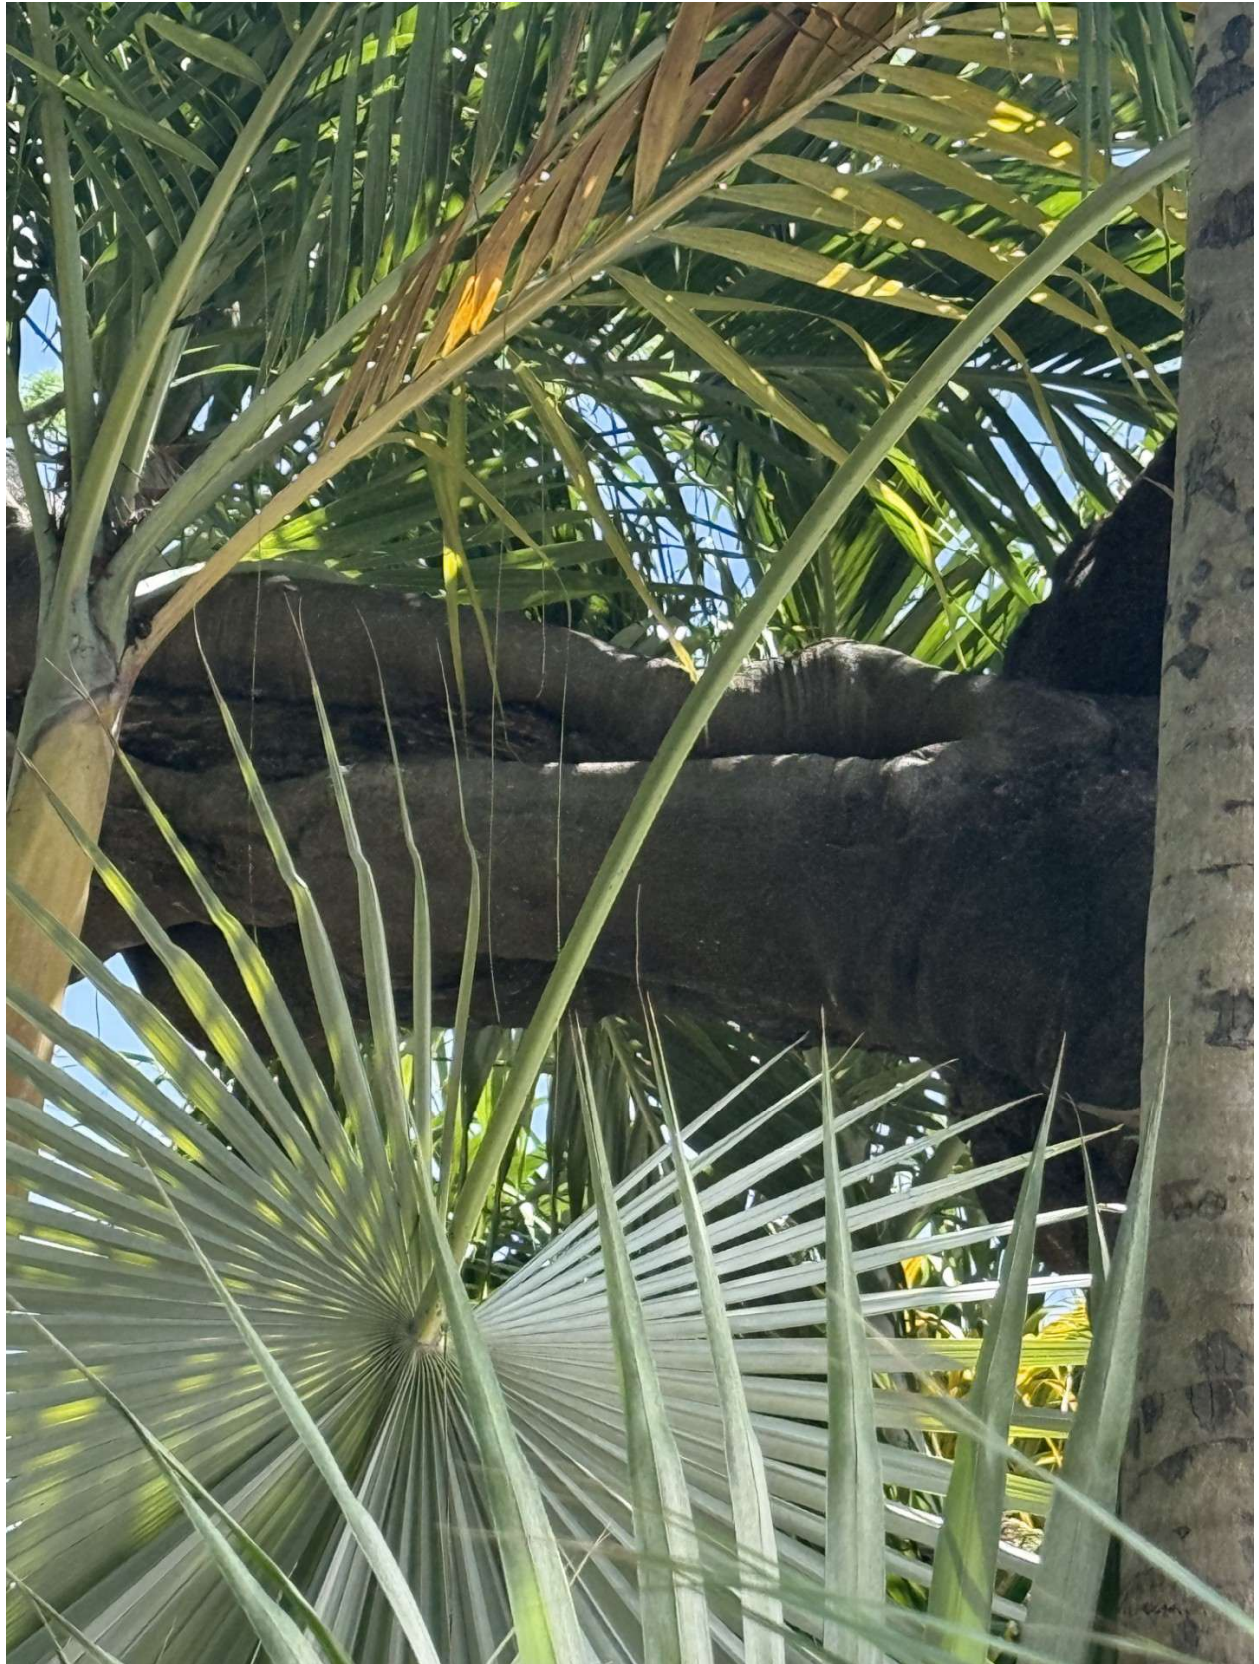
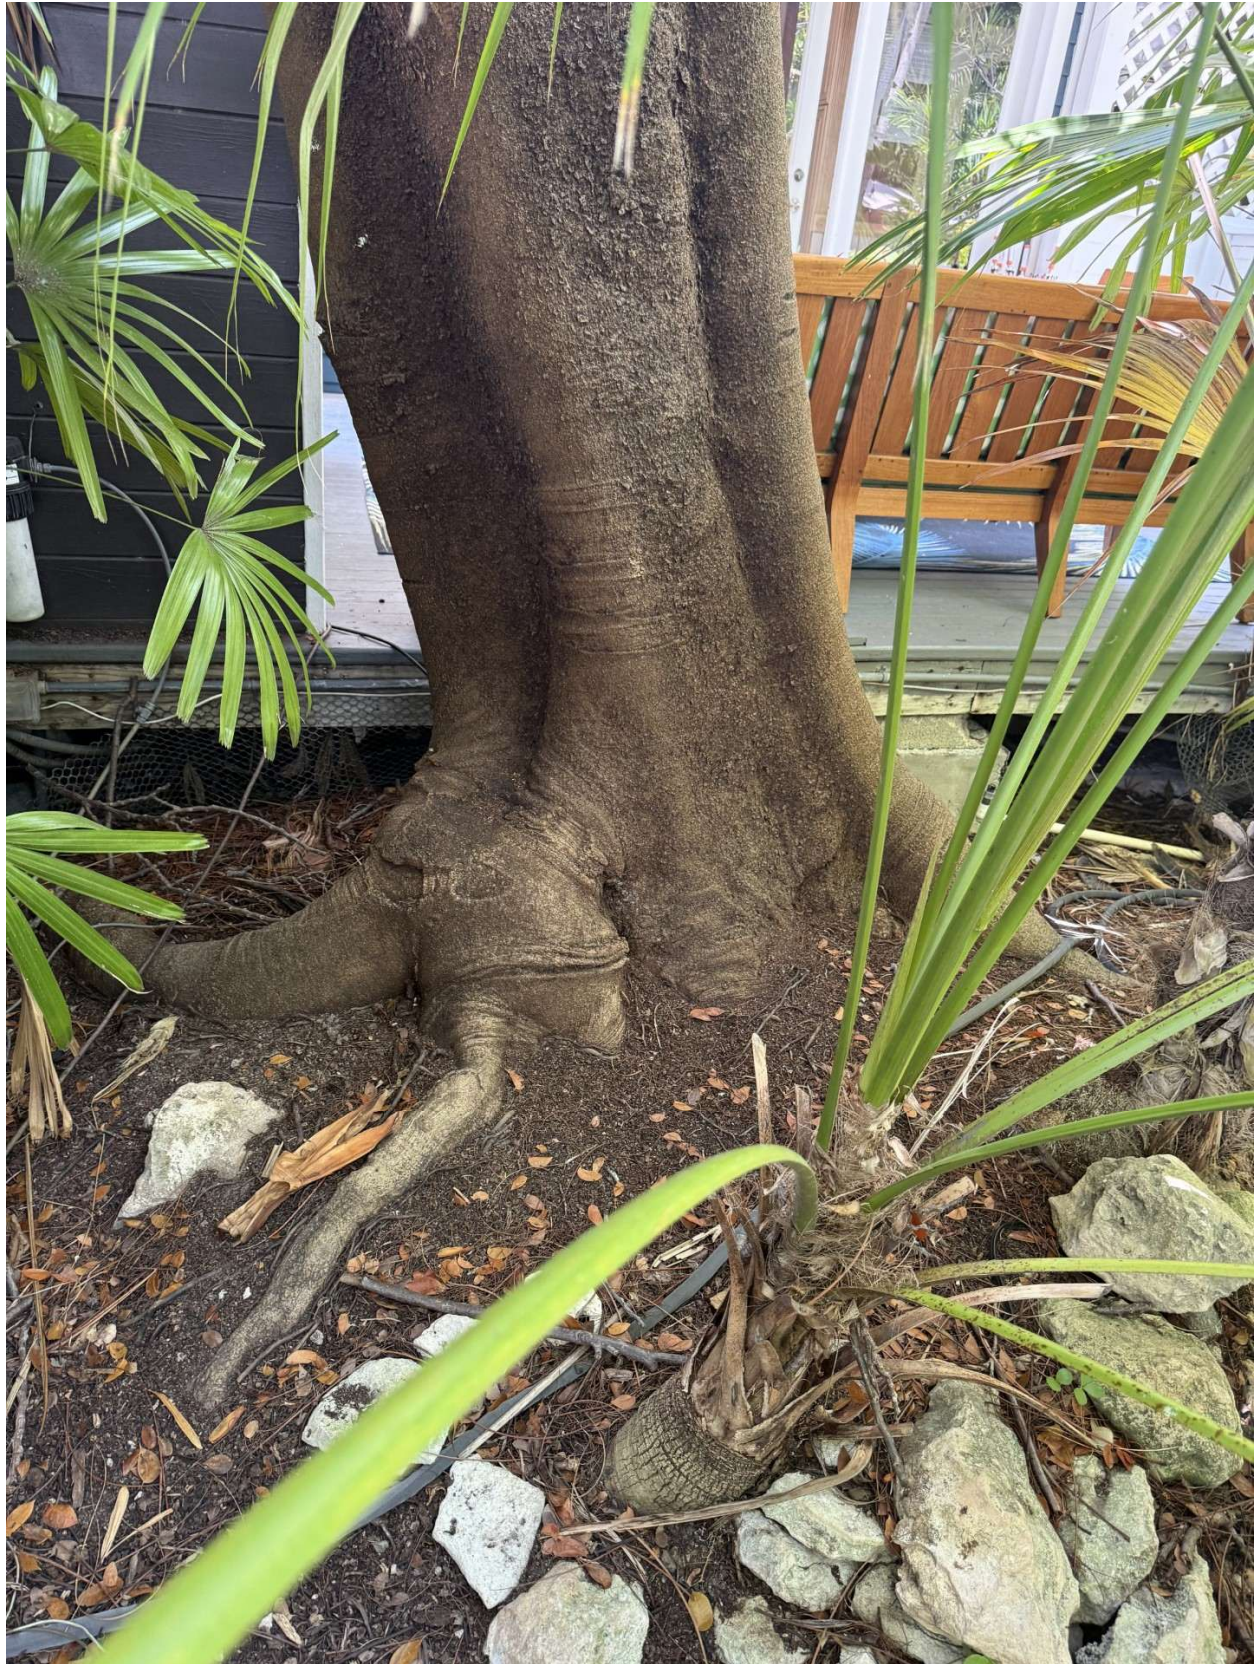
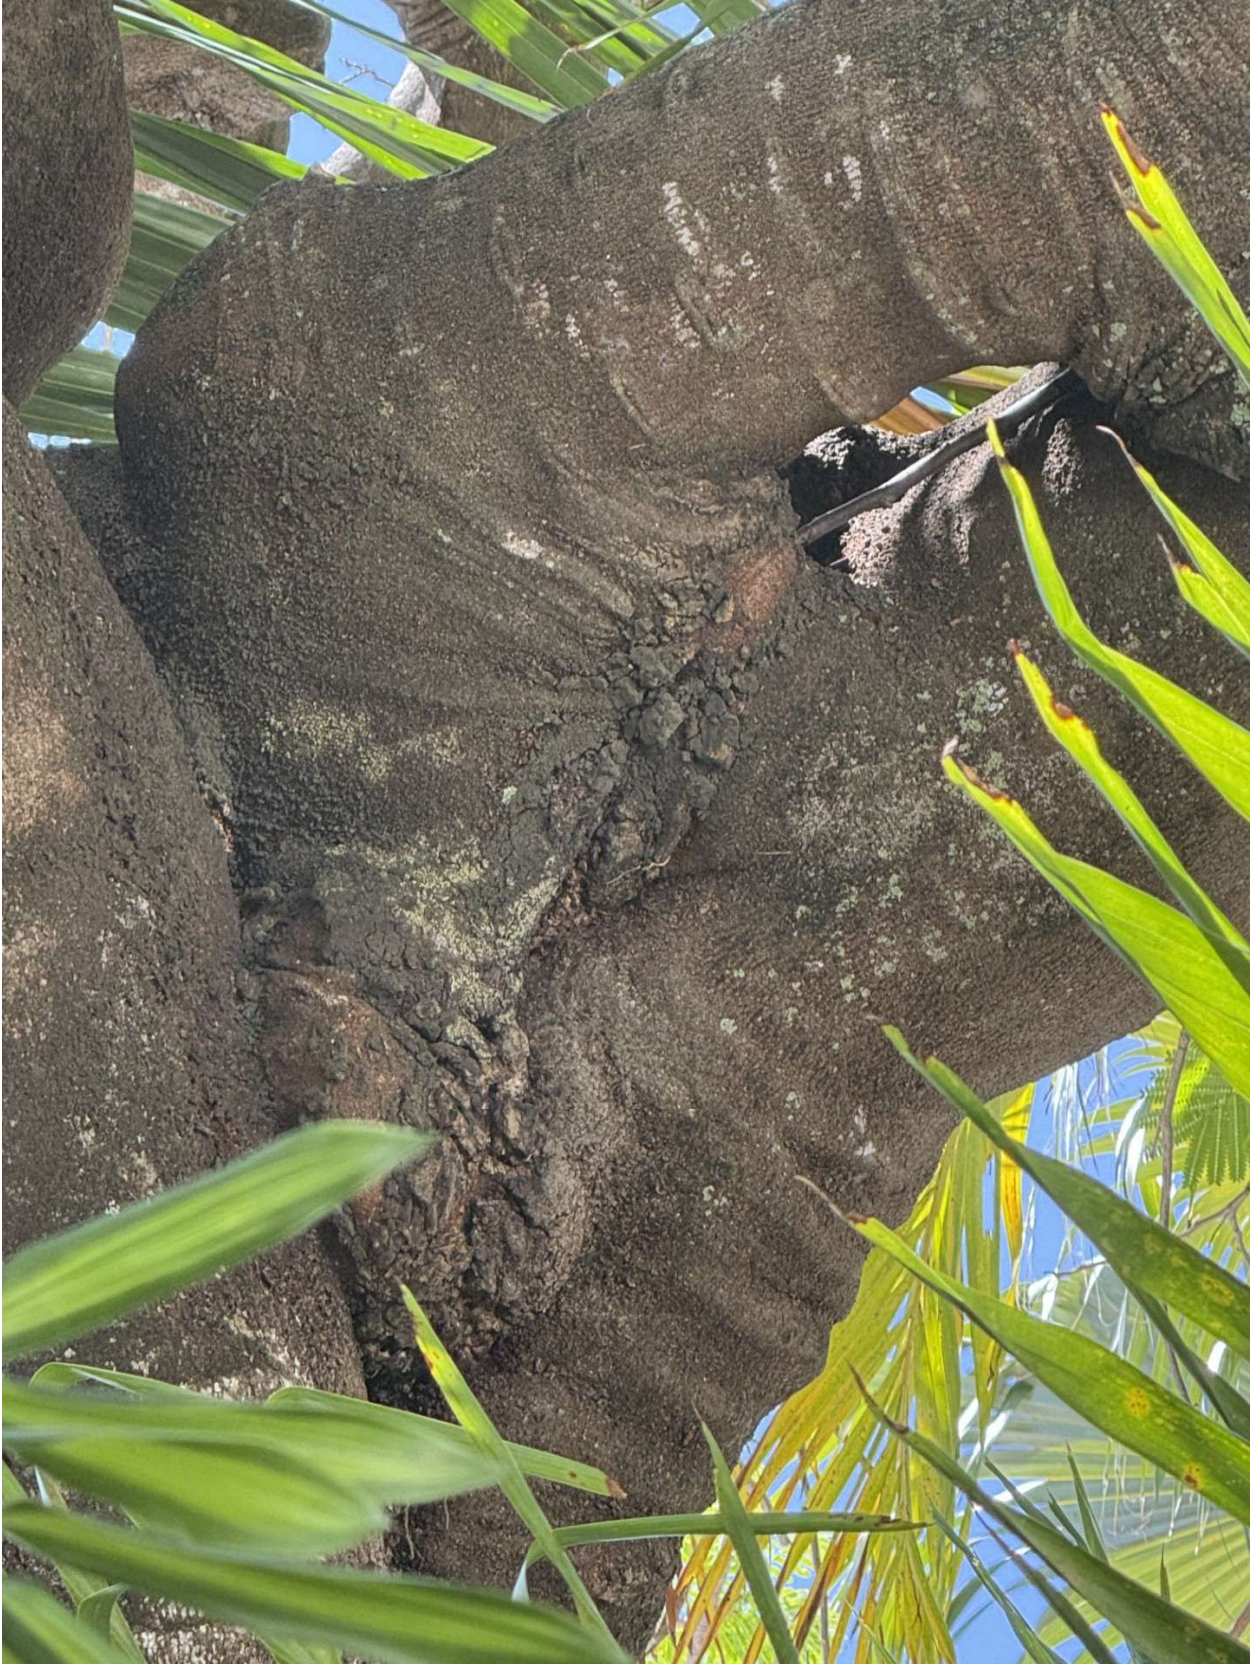
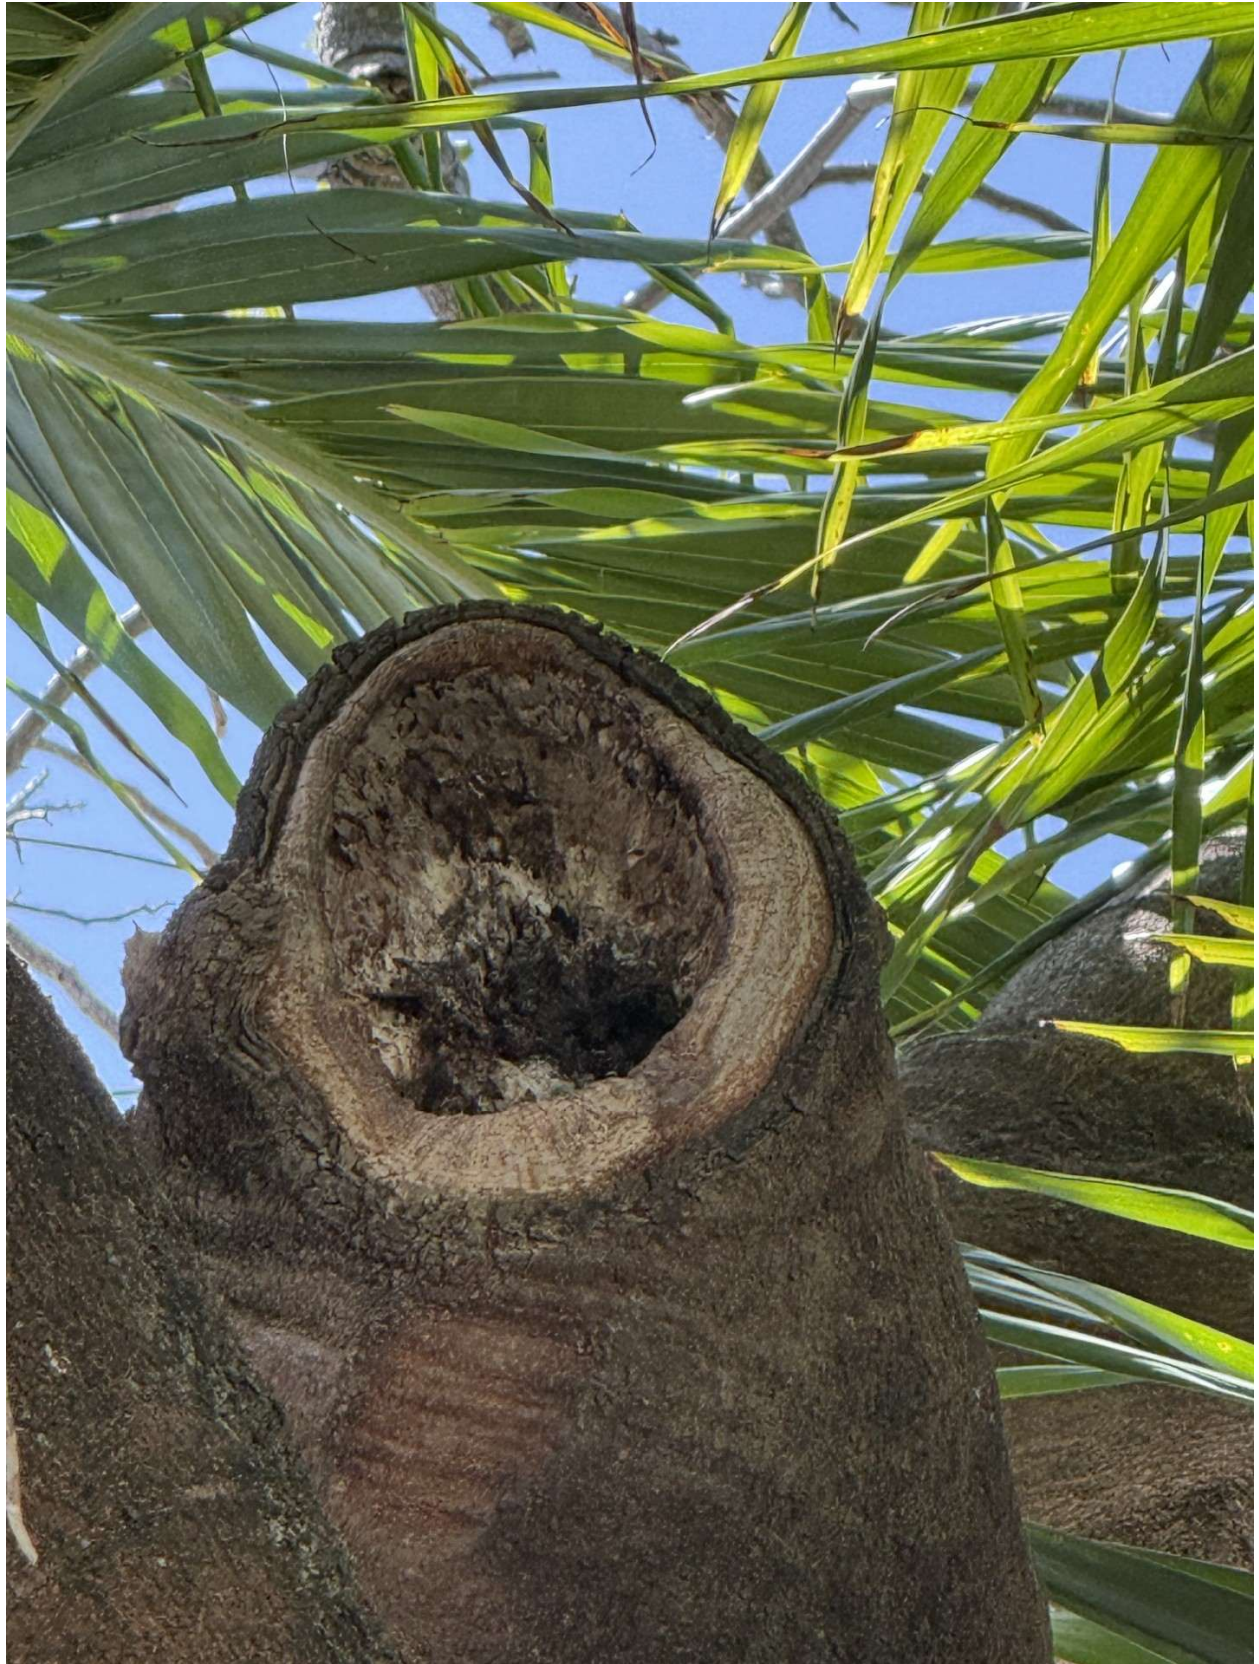
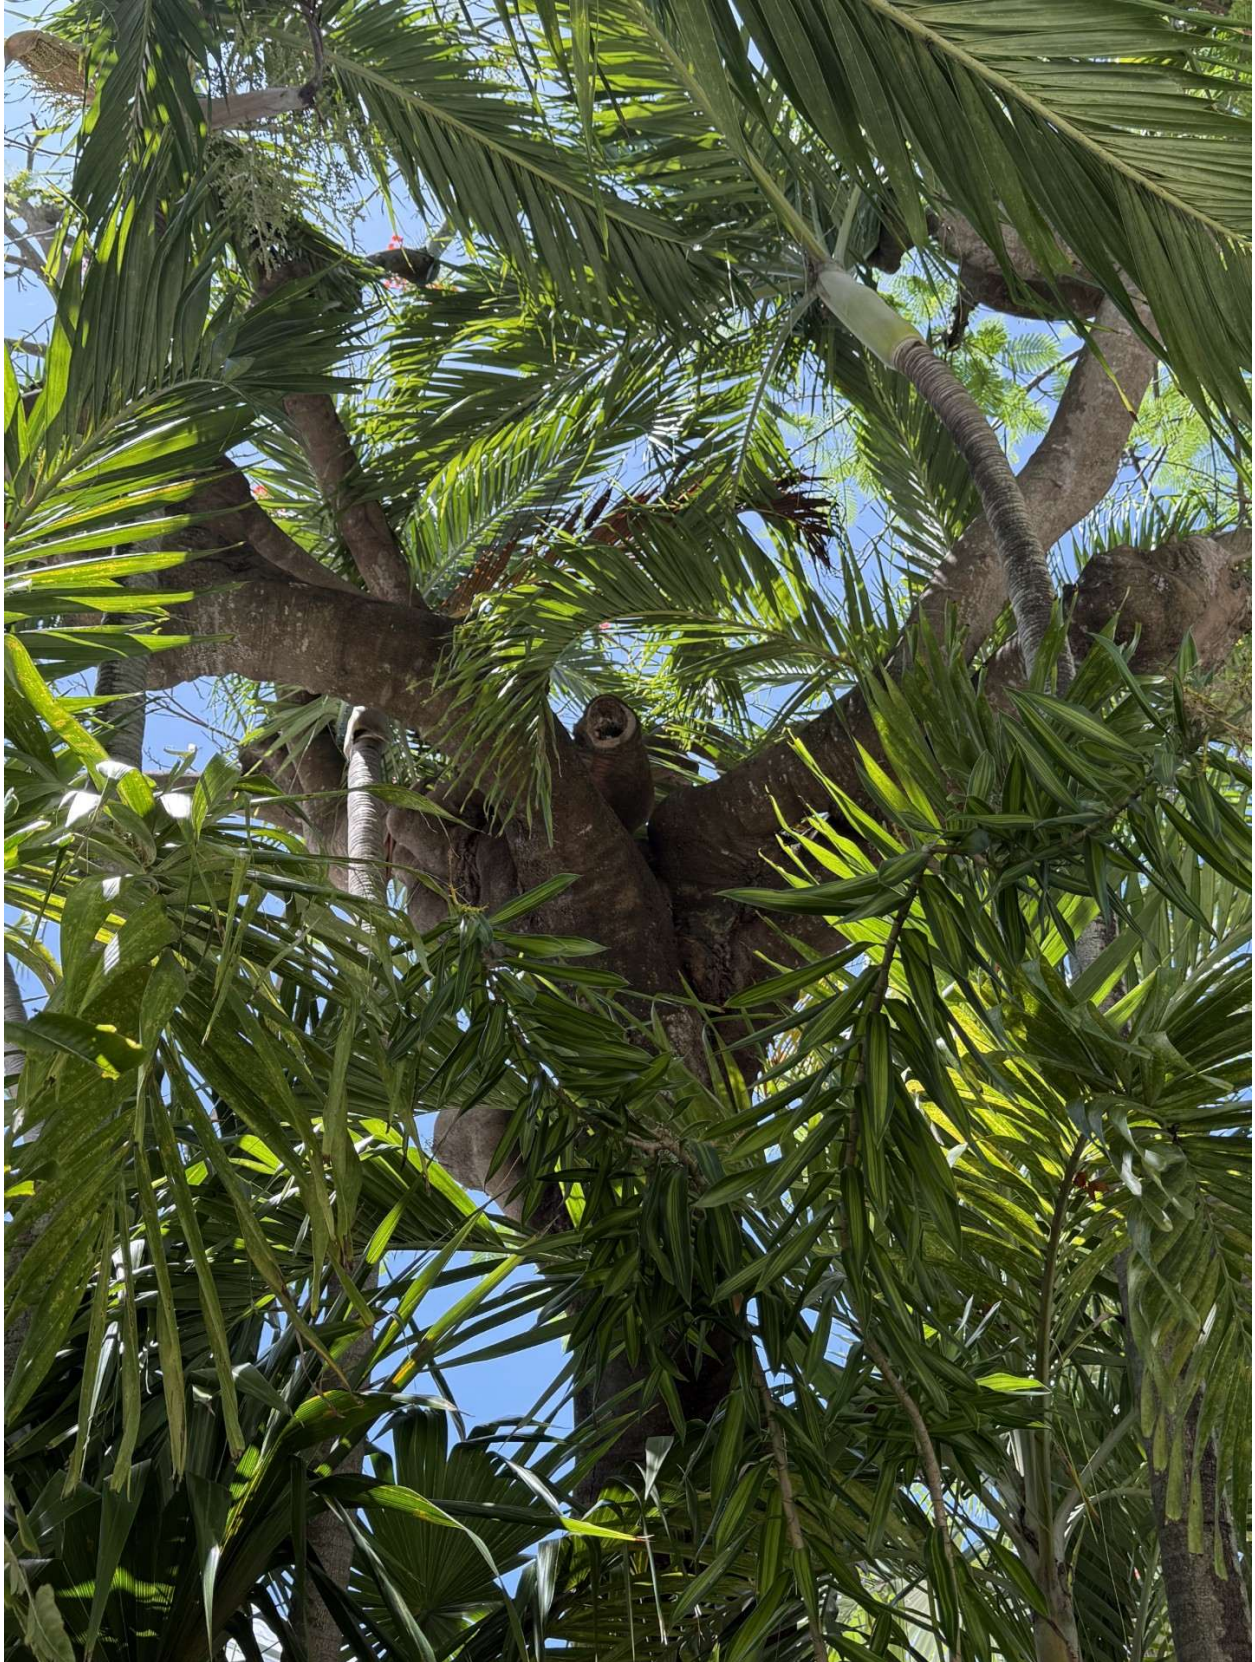
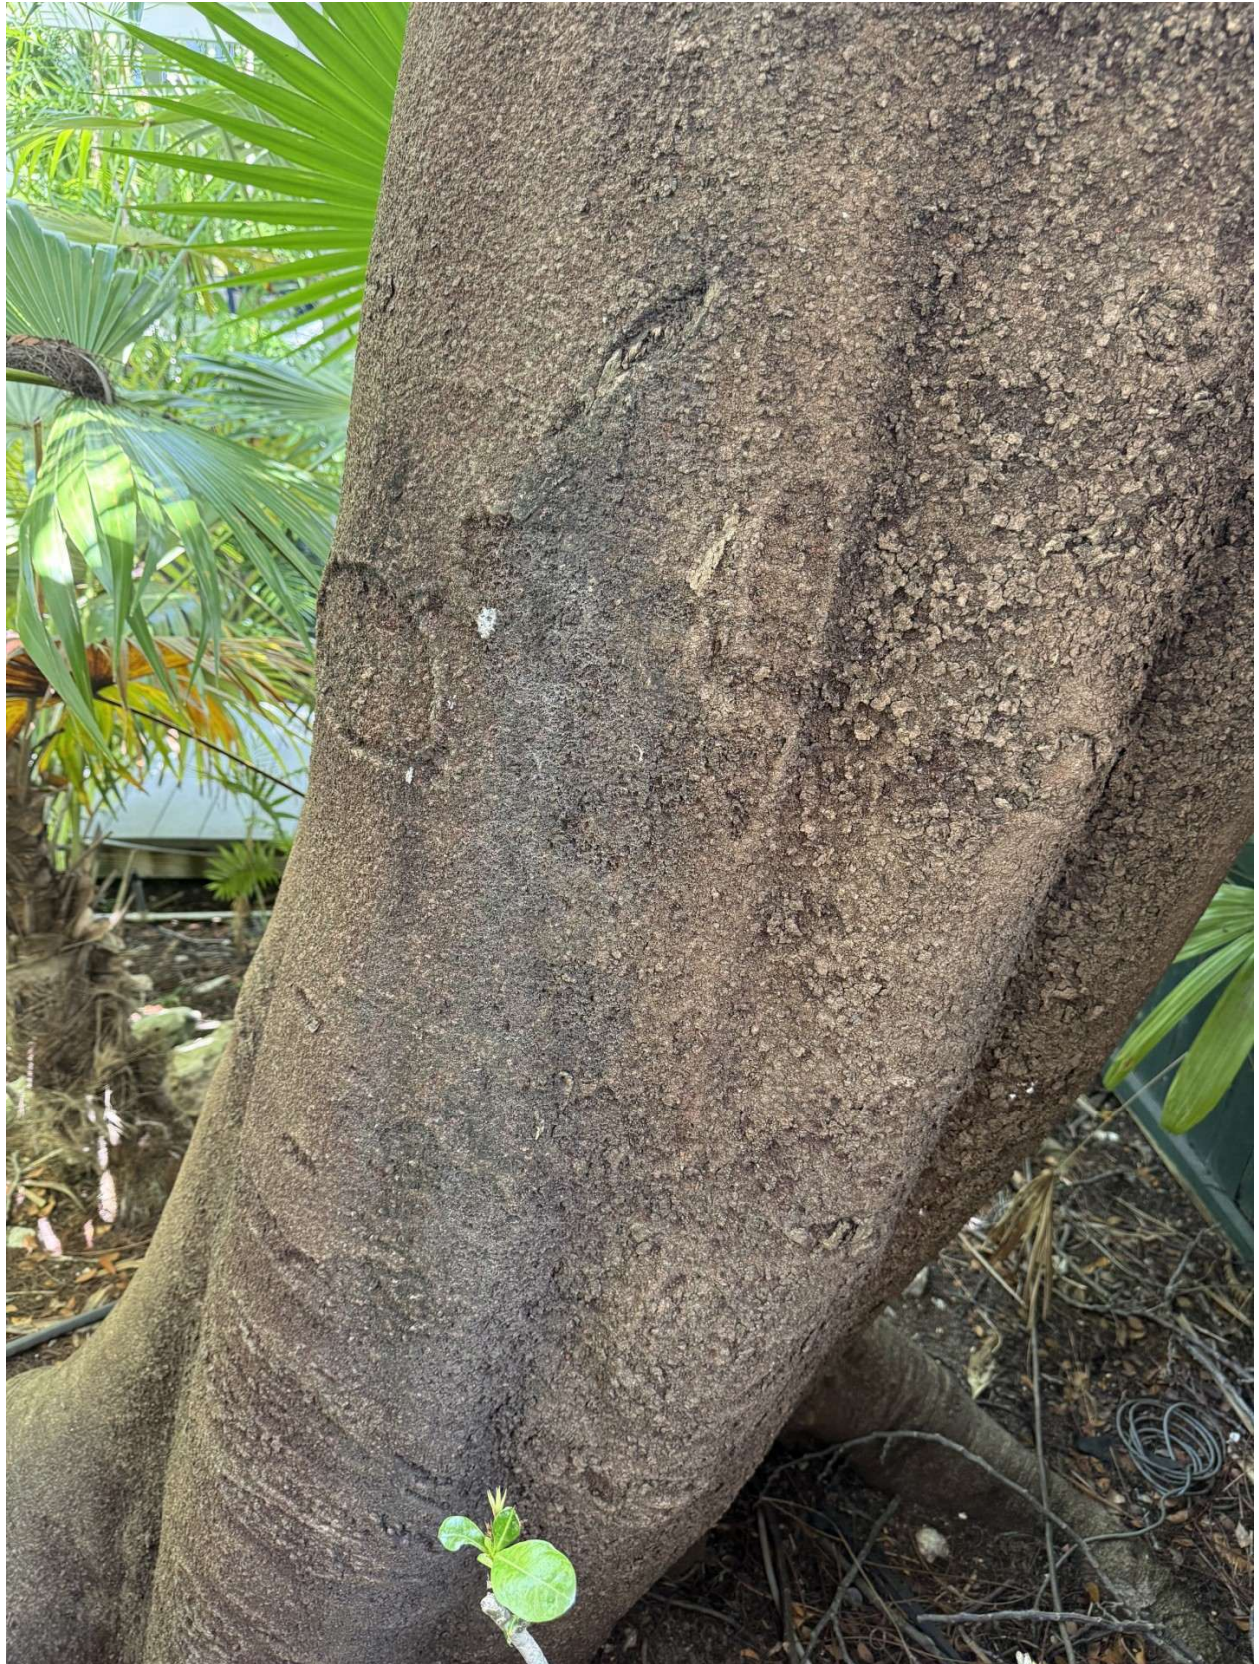
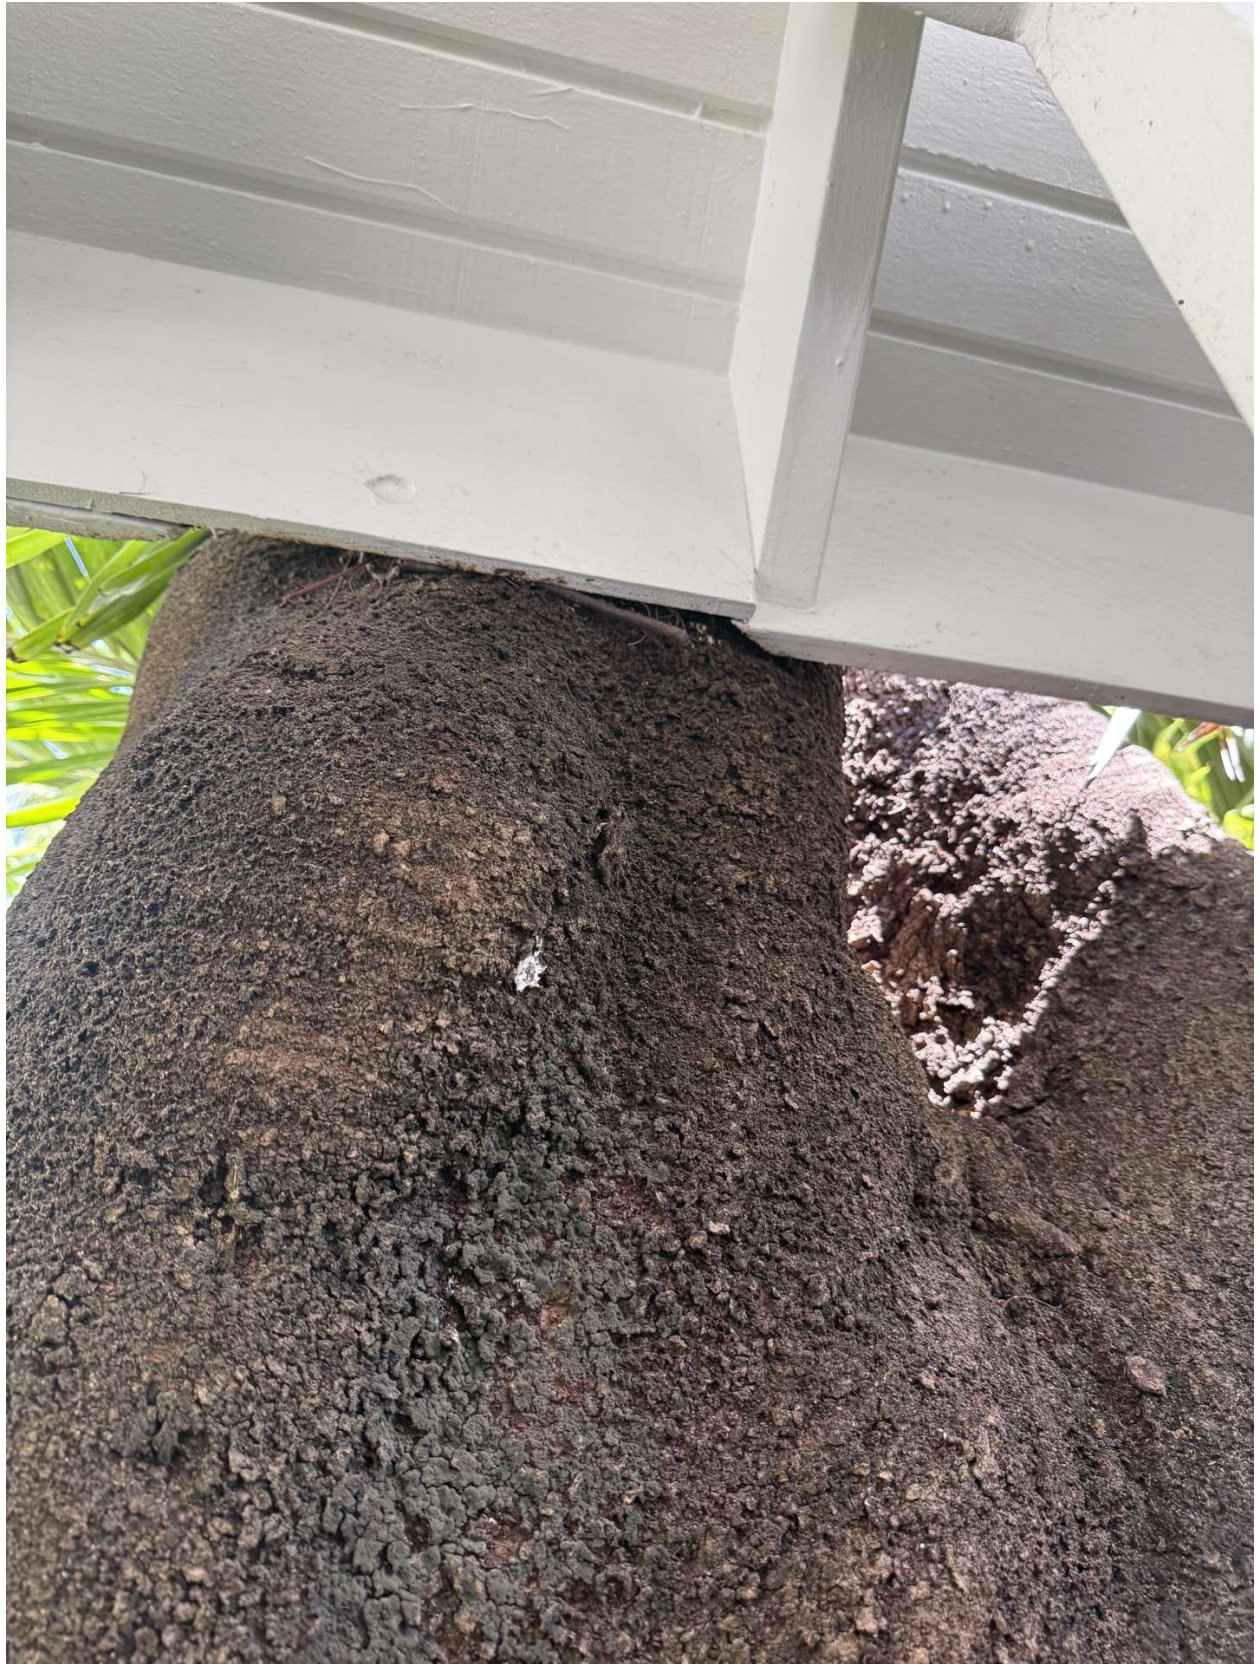
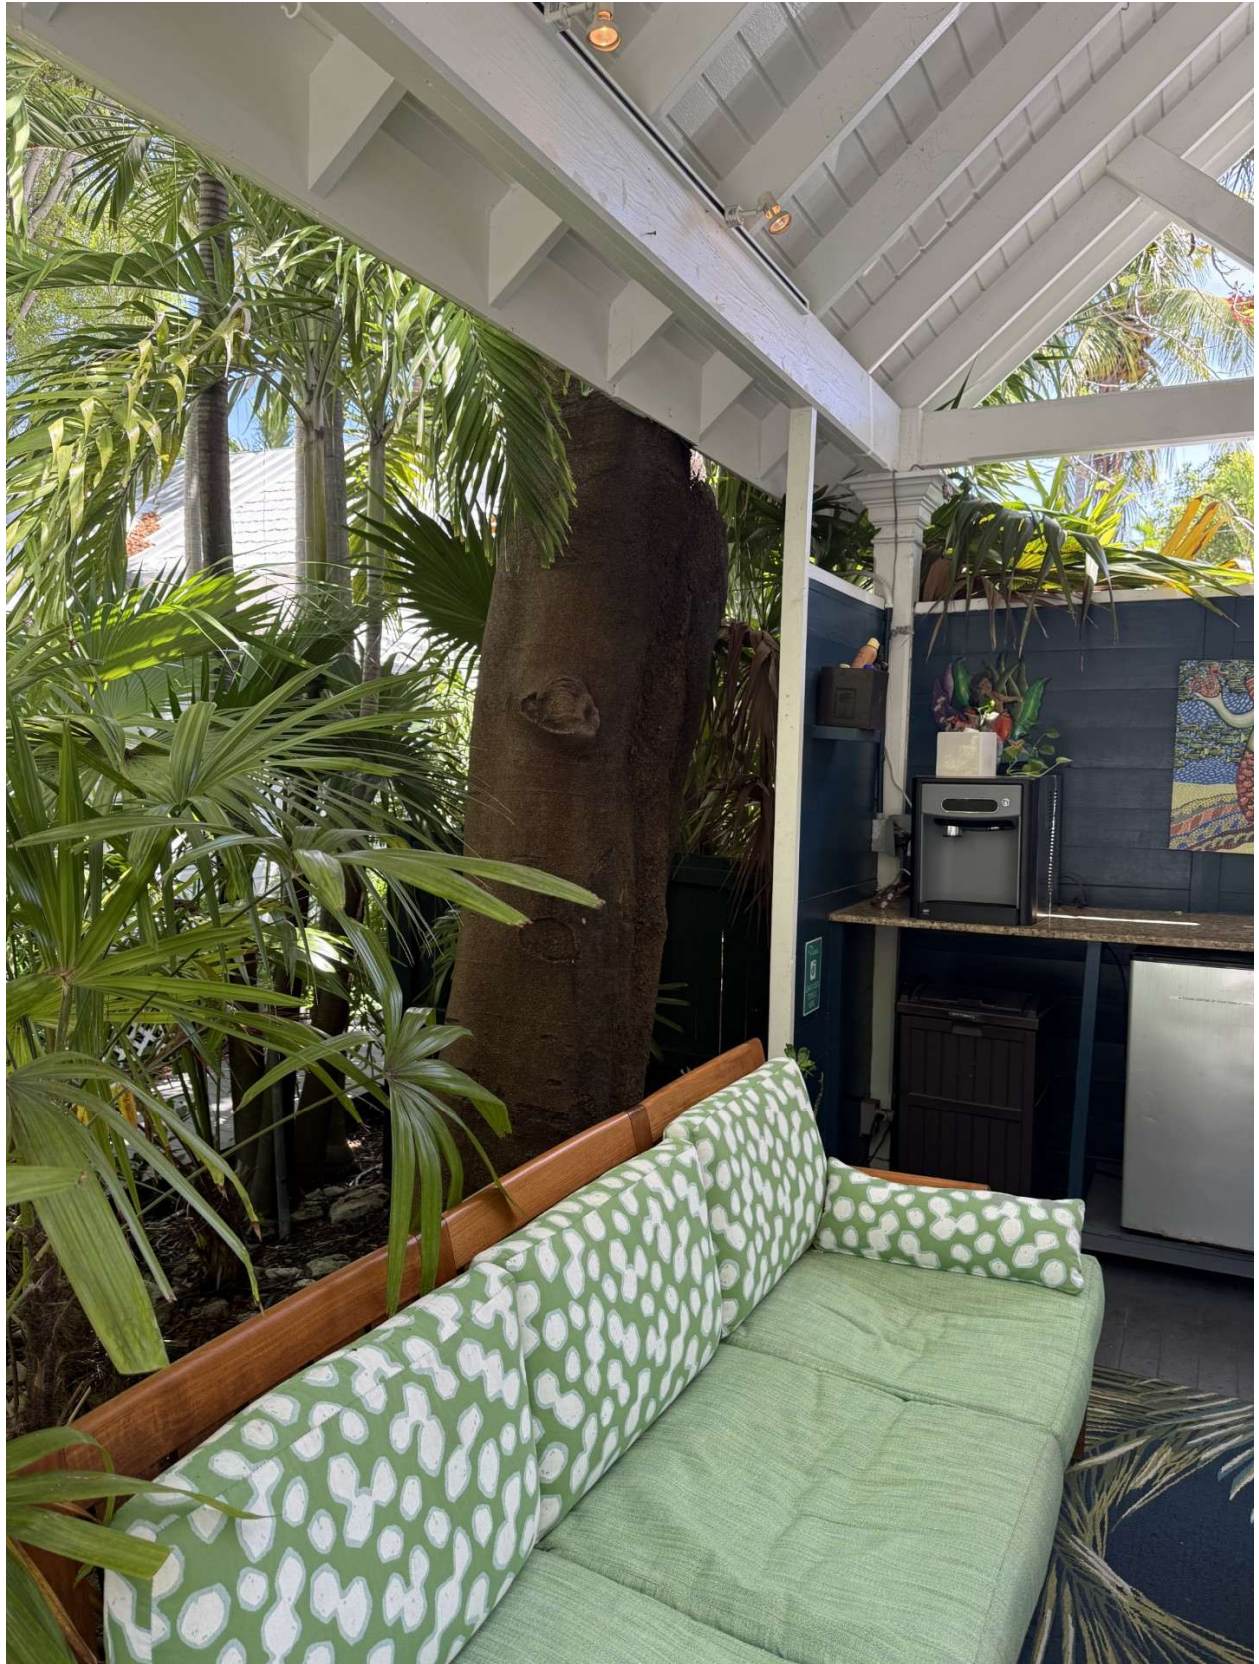
**The subject tree #1 is a 15-inch DBH Gumbo Limbo tree located on a transient lodging property, growing in close proximity to other mature canopy trees, including another mature Gumbo Limbo less than two feet away. The tree exhibits significant structural and physiological deficiencies which adversely affect both its condition and long-term viability. A pronounced split is present near the base of the trunk, creating openings that are likely facilitating internal infestation and decay. Evidence of chronic stress and internal dysfunction is further**

demonstrated by the presence of dark and white exudates emerging from the crack, indicative of bacterial activity, decay organisms, or other pathological issues within the trunk structure.

The canopy exhibits sparse foliage and poor architectural form, lacking the density and vigor expected of a healthy specimen. Numerous large branches have previously failed or been improperly pruned, leaving behind substantial exposed heartwood and open wounds that have not compartmentalized effectively. These areas now display advanced decay and are likely contributing to continued structural degradation and potential insect infestation. The overall structure of the tree is compromised, and in its current condition, the specimen is approaching the threshold at which emergency mitigation or removal could become necessary.

Based upon the observed defects, poor canopy vitality, structural instability, and evidence of ongoing decay, the condition rating of this tree is estimated at no greater than 40%. Given the extent of the defects present and the elevated likelihood of future failure, removal of the tree is worthy of serious consideration by the Tree Commission.
