**TREE COMMISSION TREE REMOVAL REPORT  
CITY of KEY WEST**

**PROPERTY: 729 Truman Ave**

**APPLICATION NUMBER: T2026-0102**

**REQUEST: The applicant is requesting removal of (1) Gumbo Limbo & (1) Poinciana tree.**

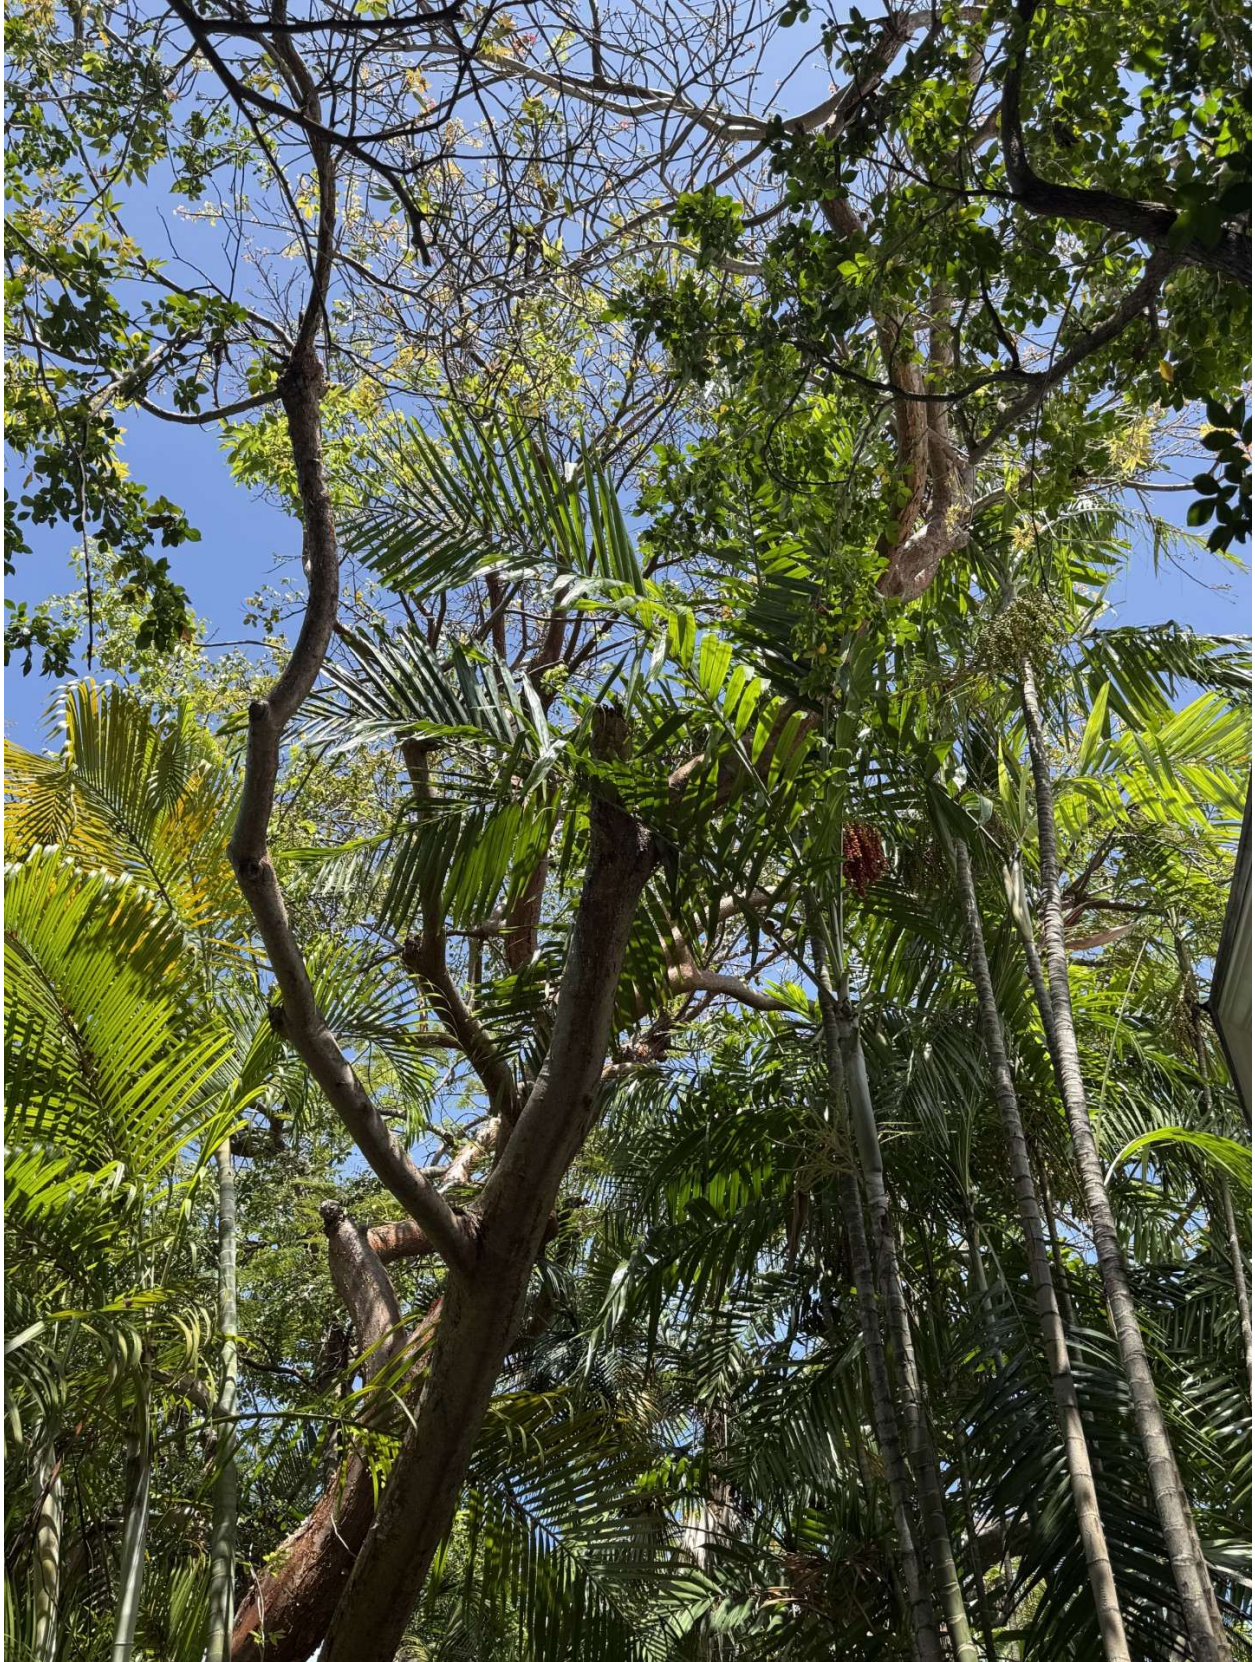
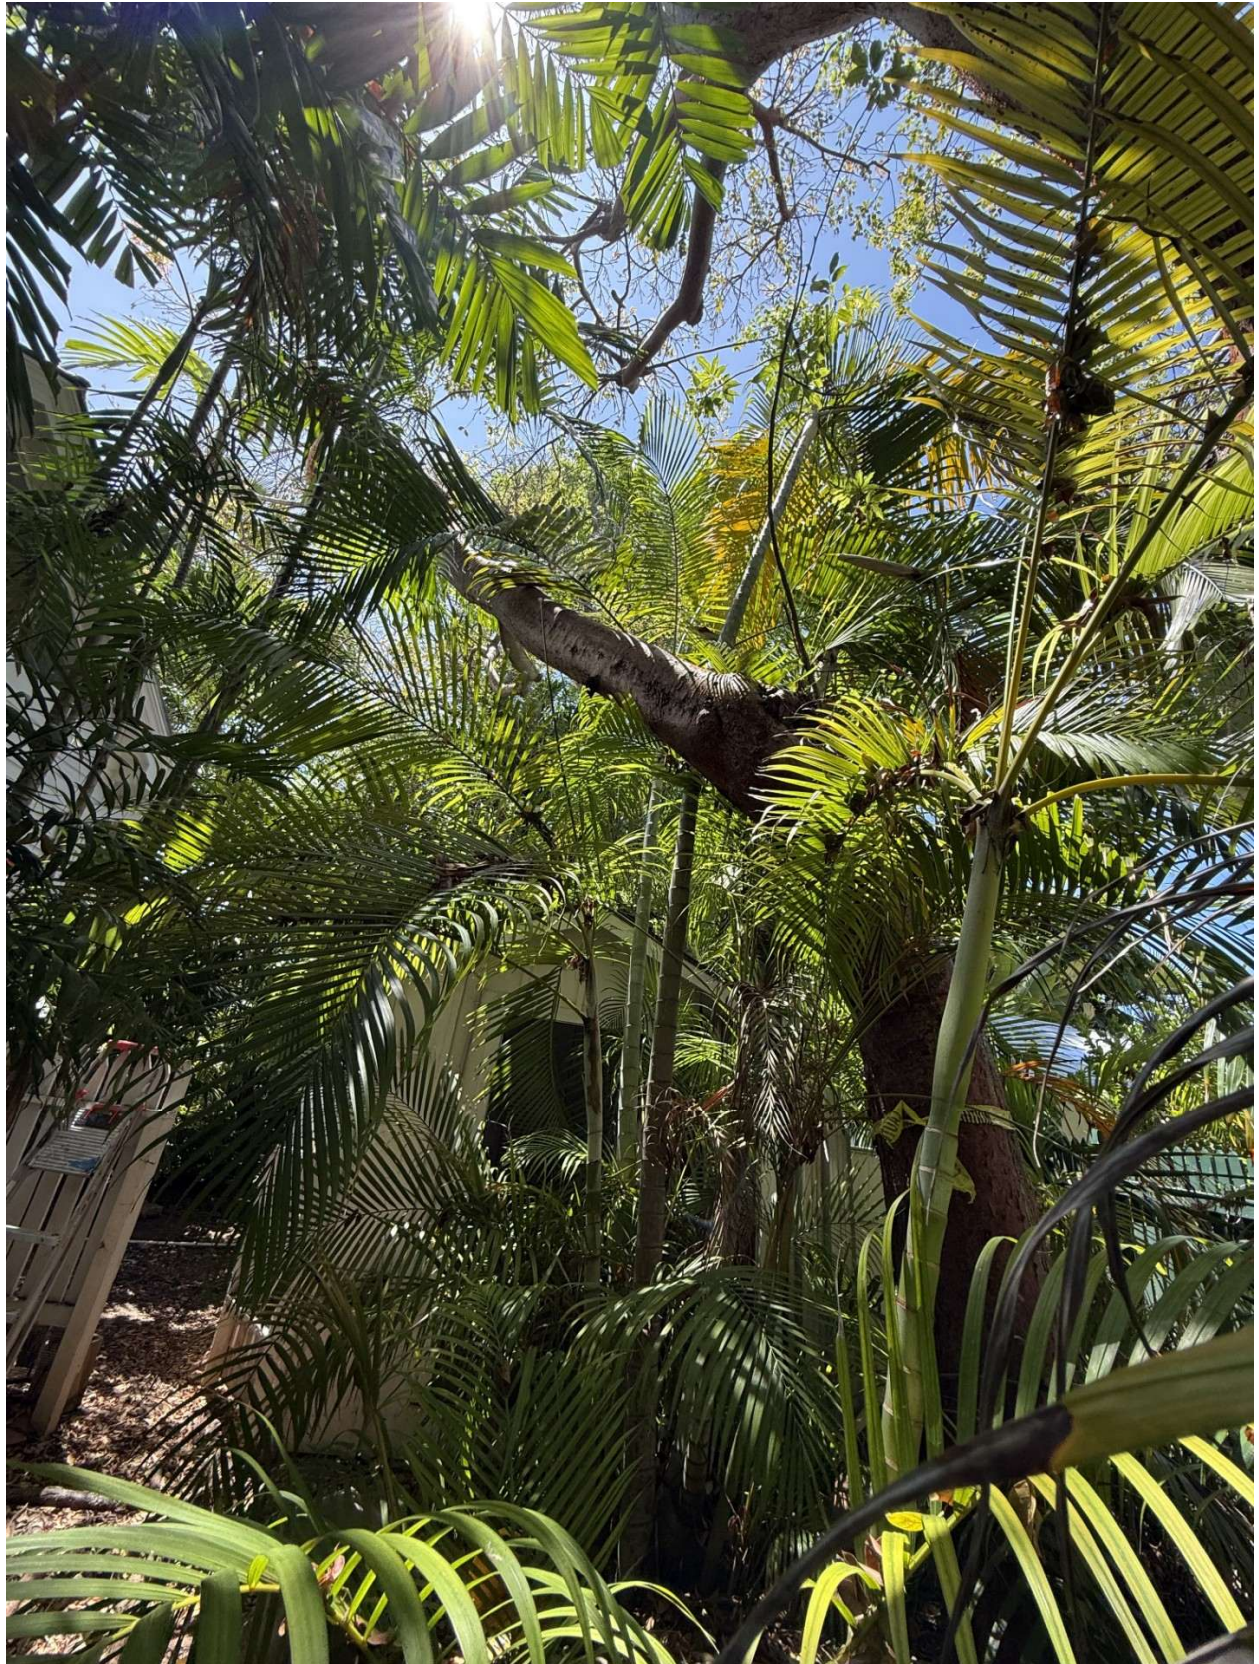
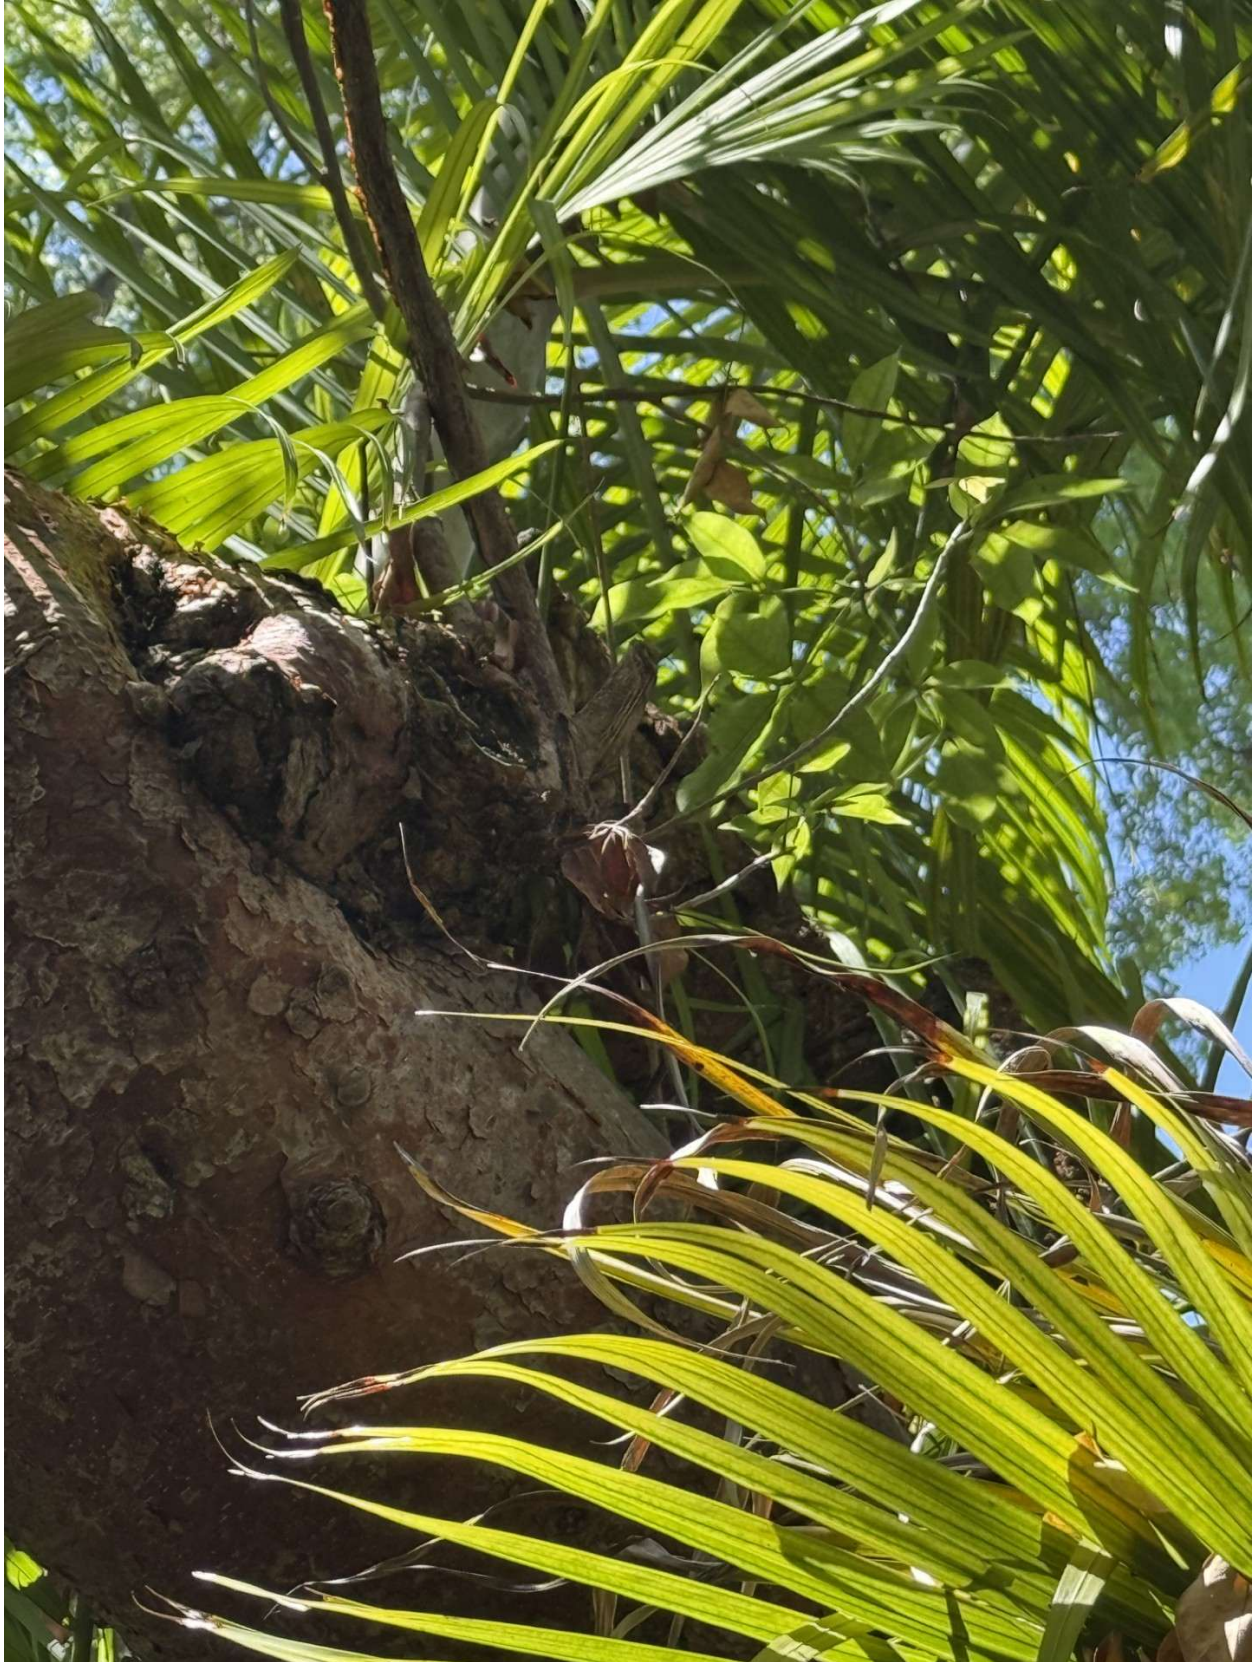
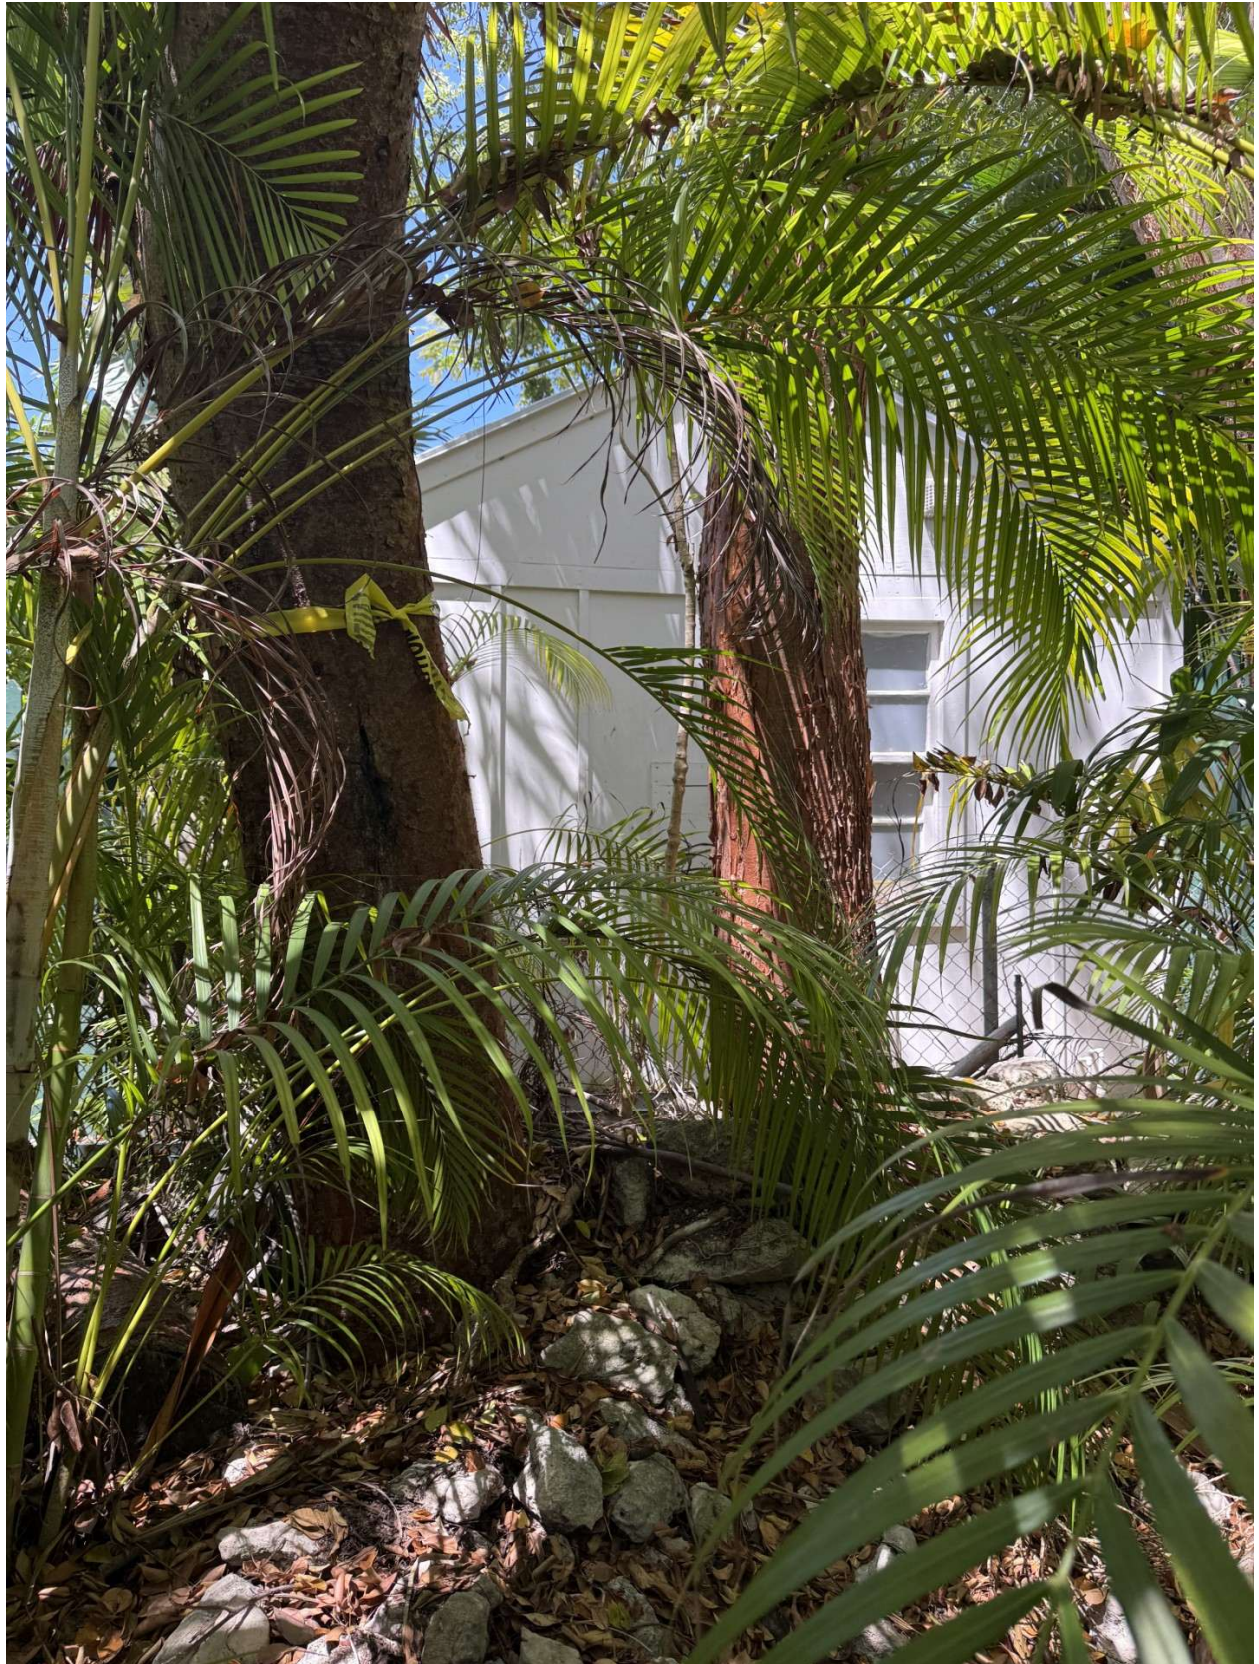
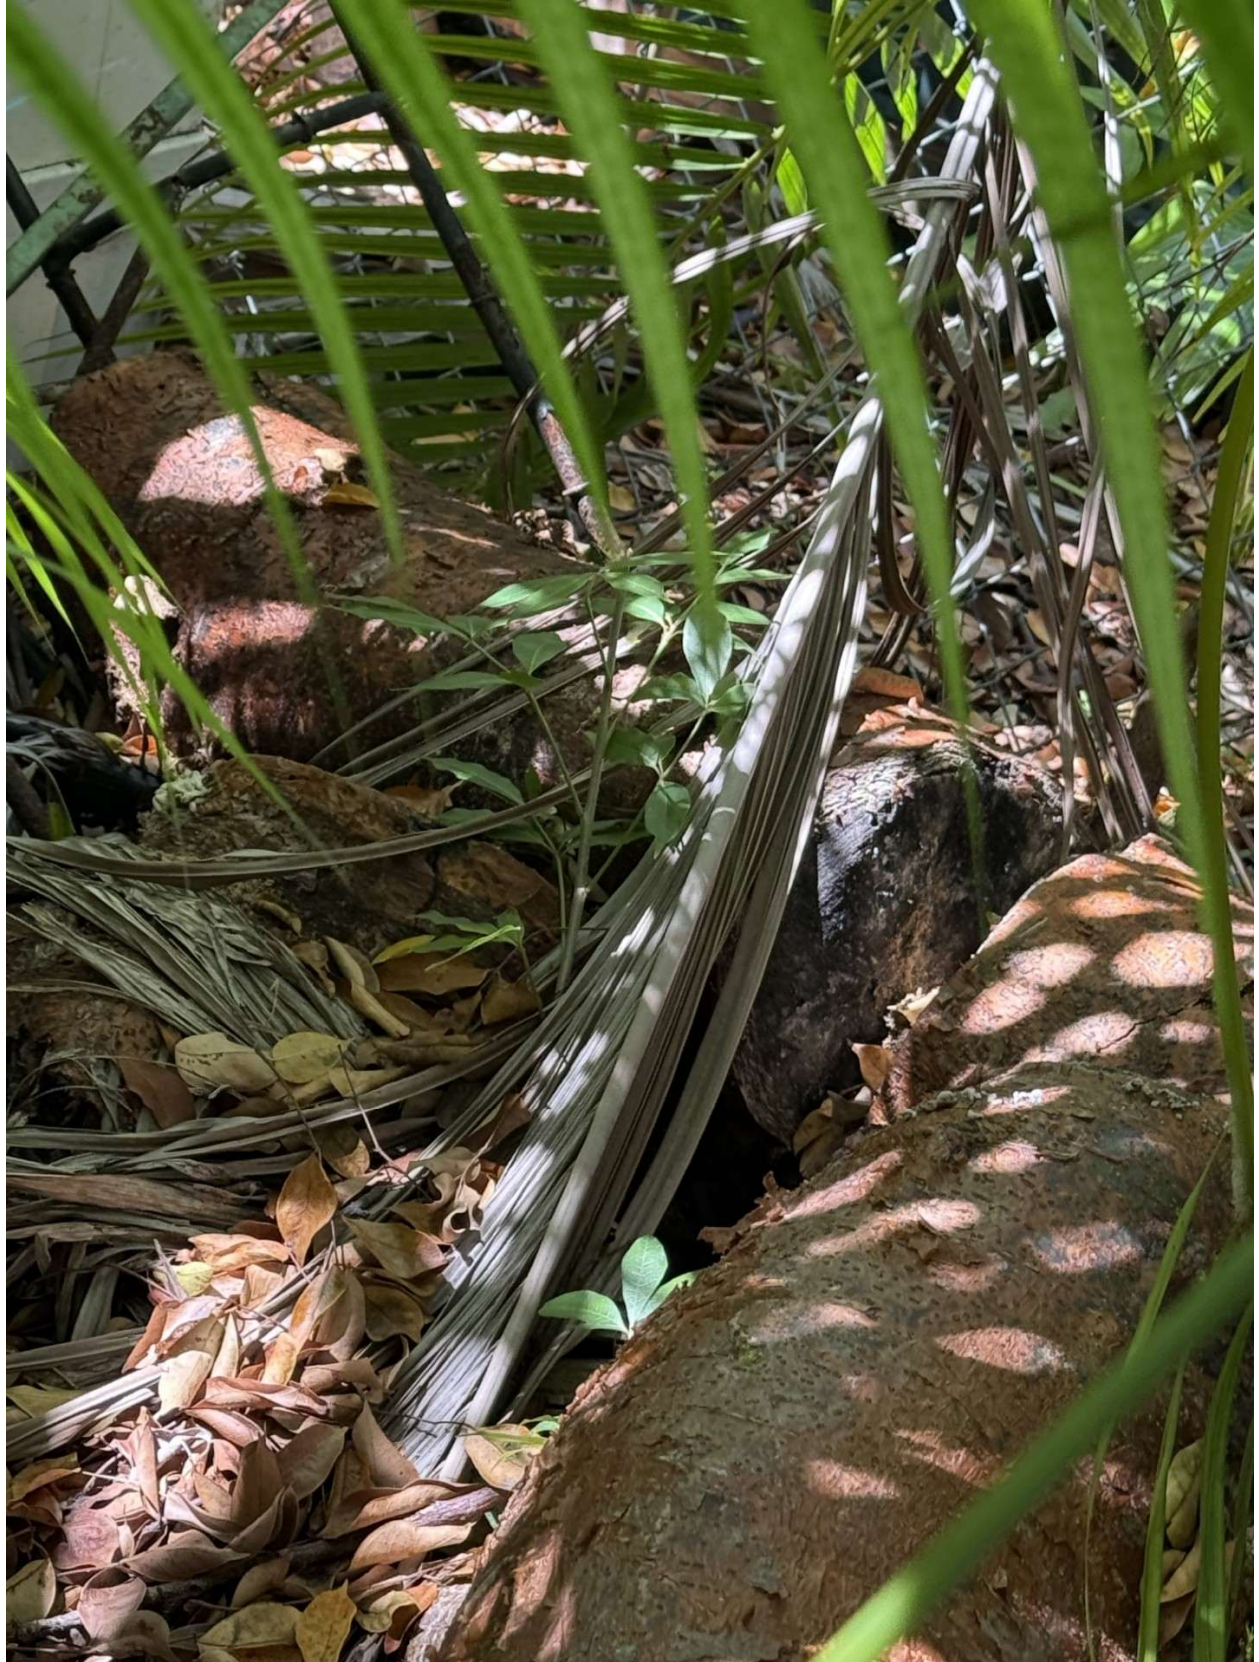
The subject tree #2 is a 28-inch DBH Royal Poinciana growing immediately adjacent to a permitted covered deck structure. The base of the trunk is in direct proximity to the deck, nearly contacting the structure, while the main stem at approximately eight feet in height is actively growing into and against the roof system. This ongoing conflict is not only causing physical damage to the roof structure, but is also resulting in abrasion and compression against the tree itself, with the structure beginning to intrude into the bark and cambial layer of the stem. The location of the tree relative to the structure is highly constrained and incompatible with the mature size and growth habit of the species.

**The tree exhibits numerous large historical pruning wounds throughout the canopy and scaffold structure. Nearly all observed pruning cuts display varying degrees of hollowing, decay, and likely infestation. In the local environment of Key West, Royal Poinciana trees commonly demonstrate poor compartmentalization of large pruning wounds, even when cuts are performed in accordance with accepted arboricultural standards and best management practices. As a result, large pruning wounds frequently become long-term points of structural weakness and decay development. The subject tree presently exhibits poor canopy architecture, compromised structure, and overall diminished vitality.**

**Based upon the structural conflicts with the permitted structure, the extensive decay associated with prior pruning wounds, and the poor overall form and canopy condition, the condition rating of this Royal Poinciana is estimated at no greater than 50%. Given the current defects and ongoing structural impacts to both the tree and adjacent improvements, removal of the tree is worthy of consideration by the Tree Commission.**

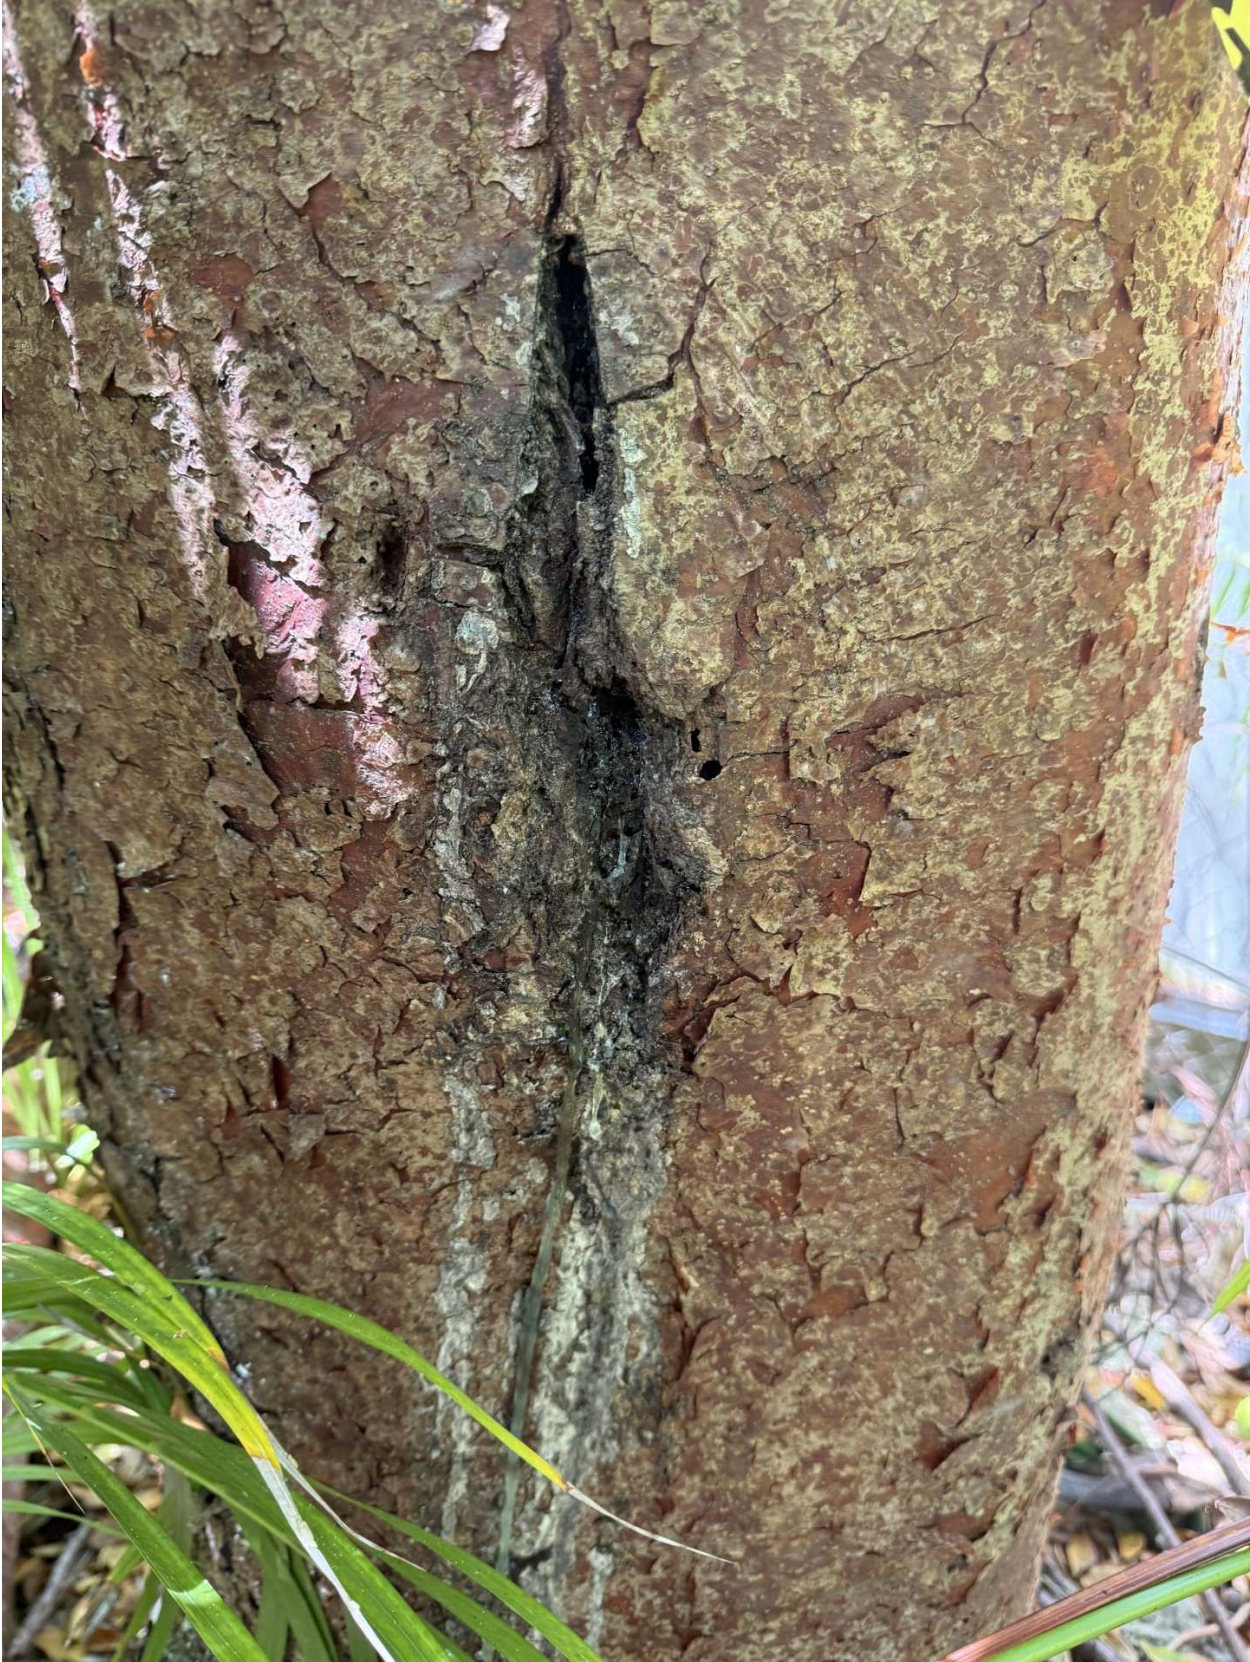
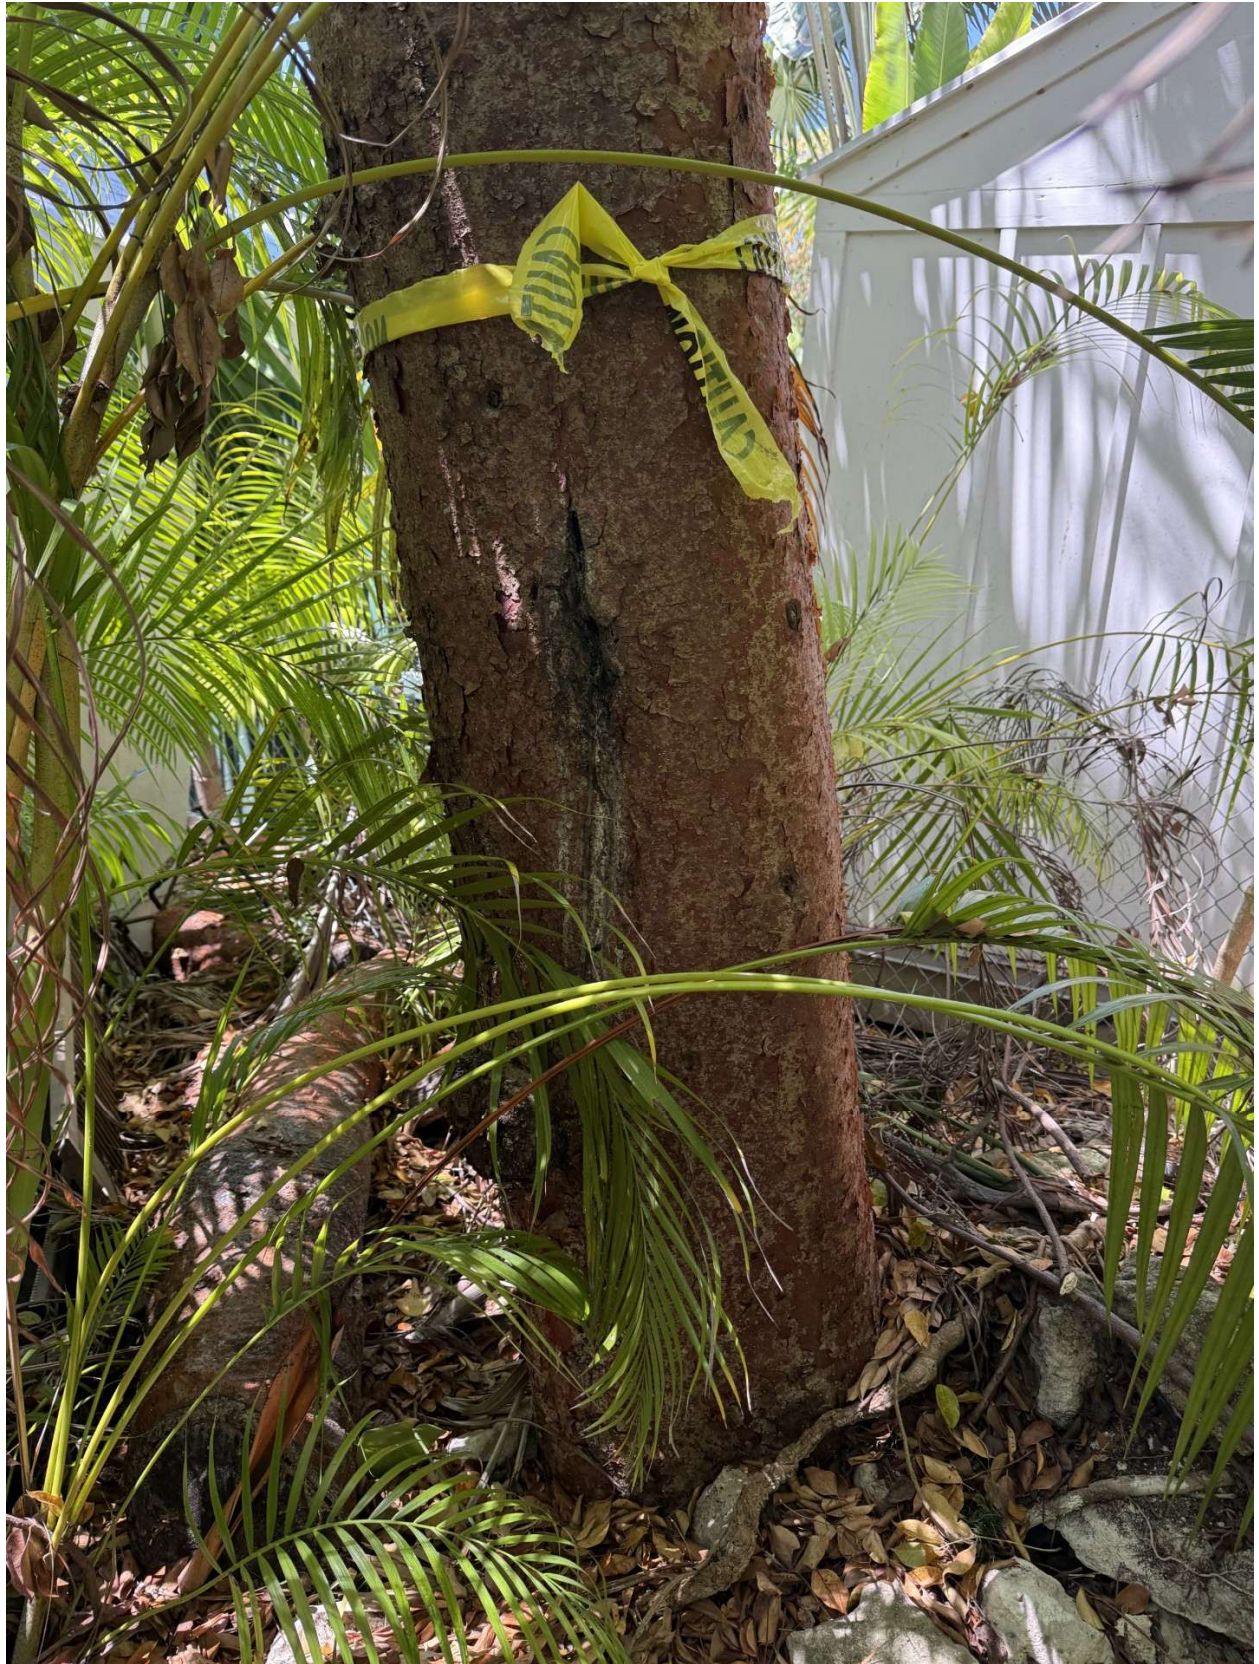
**Broken branch. I am told it fell into neighboring property and was tossed back over the property line.**
