## Cynthia's Blue Palms

City of Key West Tree Commission

July 25, 2018

Purpose: Following are my findings of plant evaluation located at Marty's Place, 1515 Bertha and Dennis Streets, Key West, Florida, concerning the removal of: 1 Black Olive tree, 2 Bridalveil trees, 1 Pigeon Plum tree, 1 Frangipani tree, 1 Spanish Stopper tree, 1 Crabwood tree, 1 Barbados Cherry tree, 1 Jamaica Caper seedling, 1 Orange Geiger tree, 1 Bay Cedar shrub, 1 Green Buttonwood tree, 1 Fiddlewood tree, 3 Bahama Tabebuia trees, 1 Simpson Stopper tree, 2 Paradise trees, 6 Gumbo Limbo trees, 1 Royal Poinciana tree, 2 Yellow Tabebuia trees, 7 Washingtonia palms, 23 Christmas palms, 9 Coconut palms, 13 Areca palms, 1 Alexander palms, and 1 Triangle palm. This tree disposition is to be used in conjunction with the submitted July 16, 2018, tree inventory.

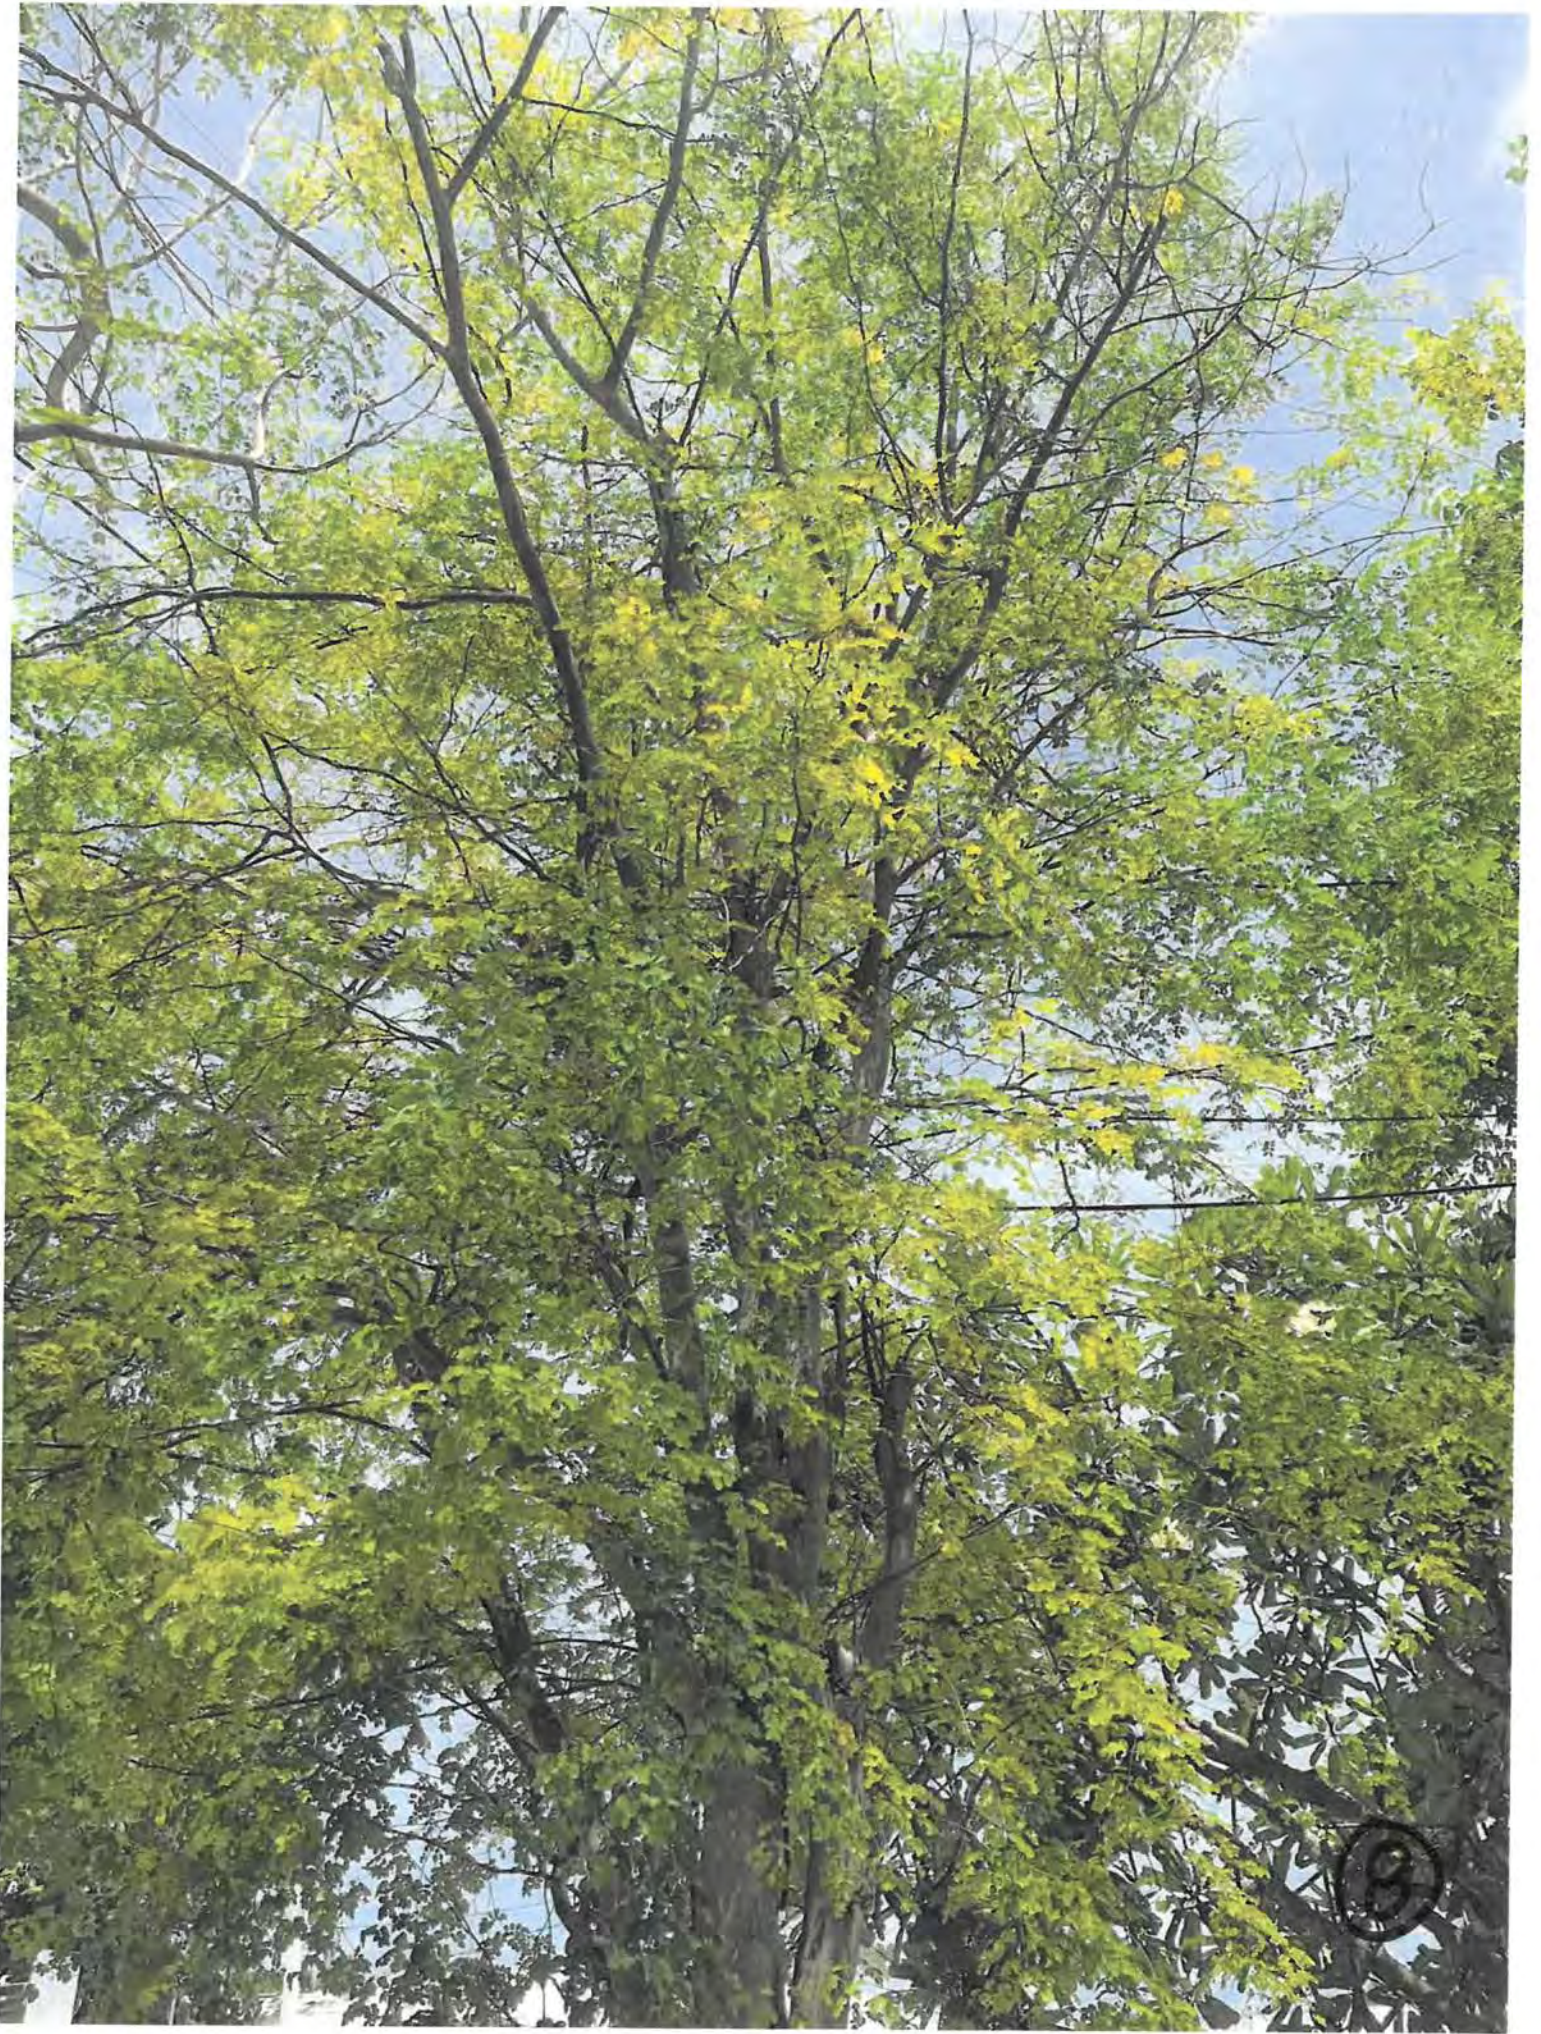
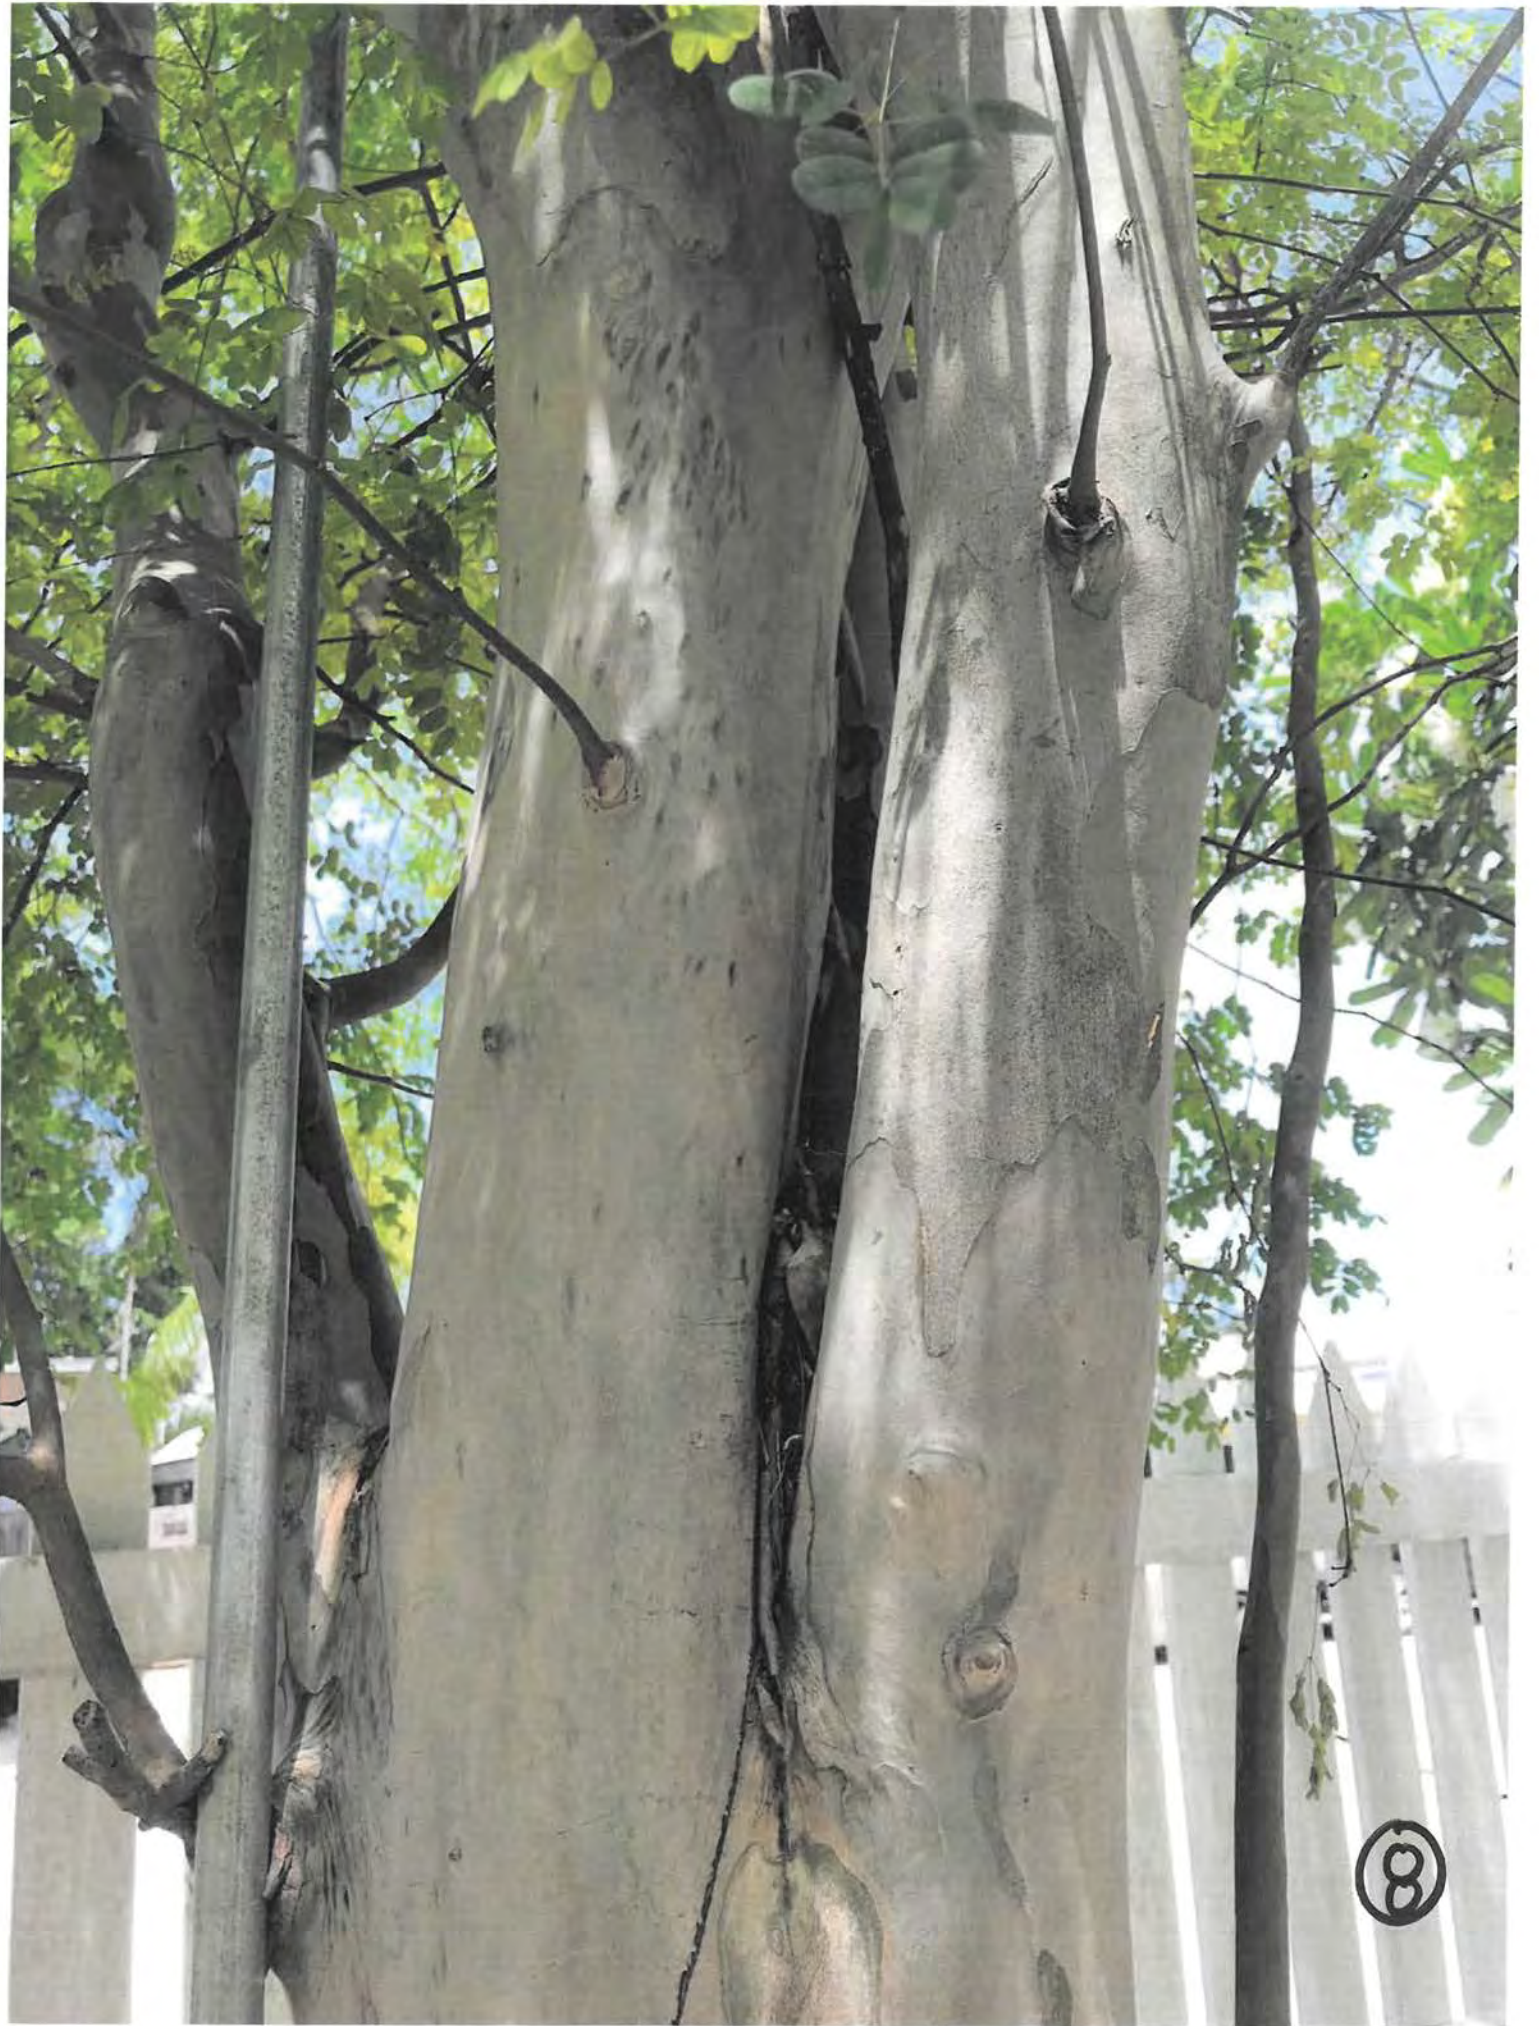
8

**Bridalveil**, tree number 8, remove, poor condition, 6.5" diameter, codominant with included bark.

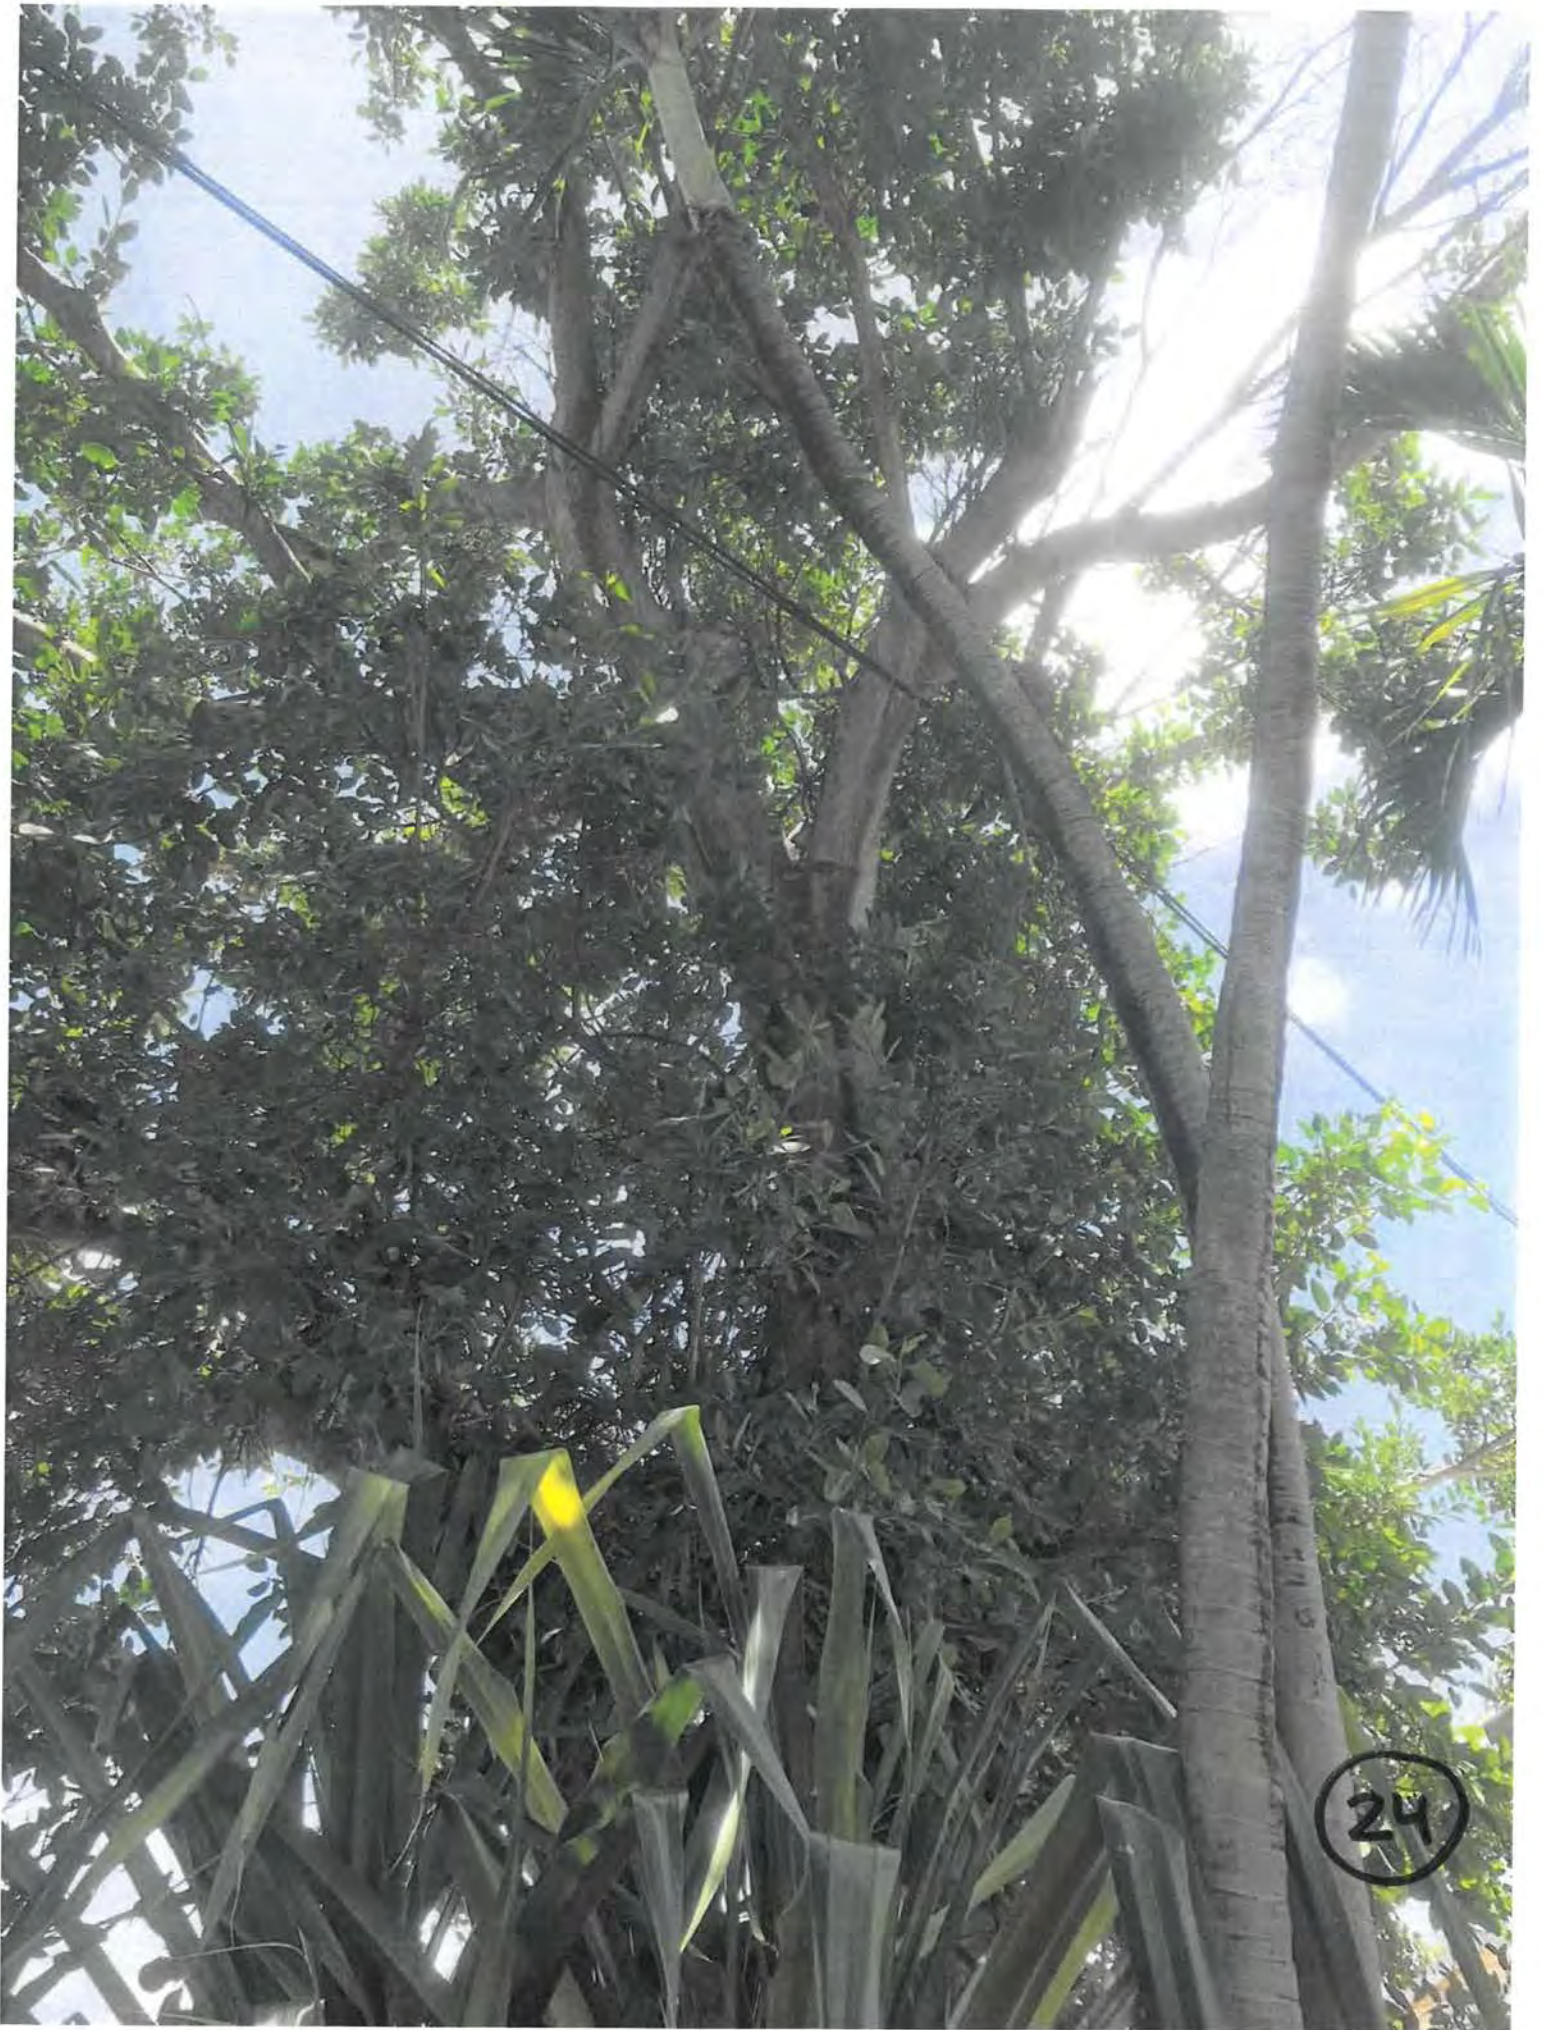
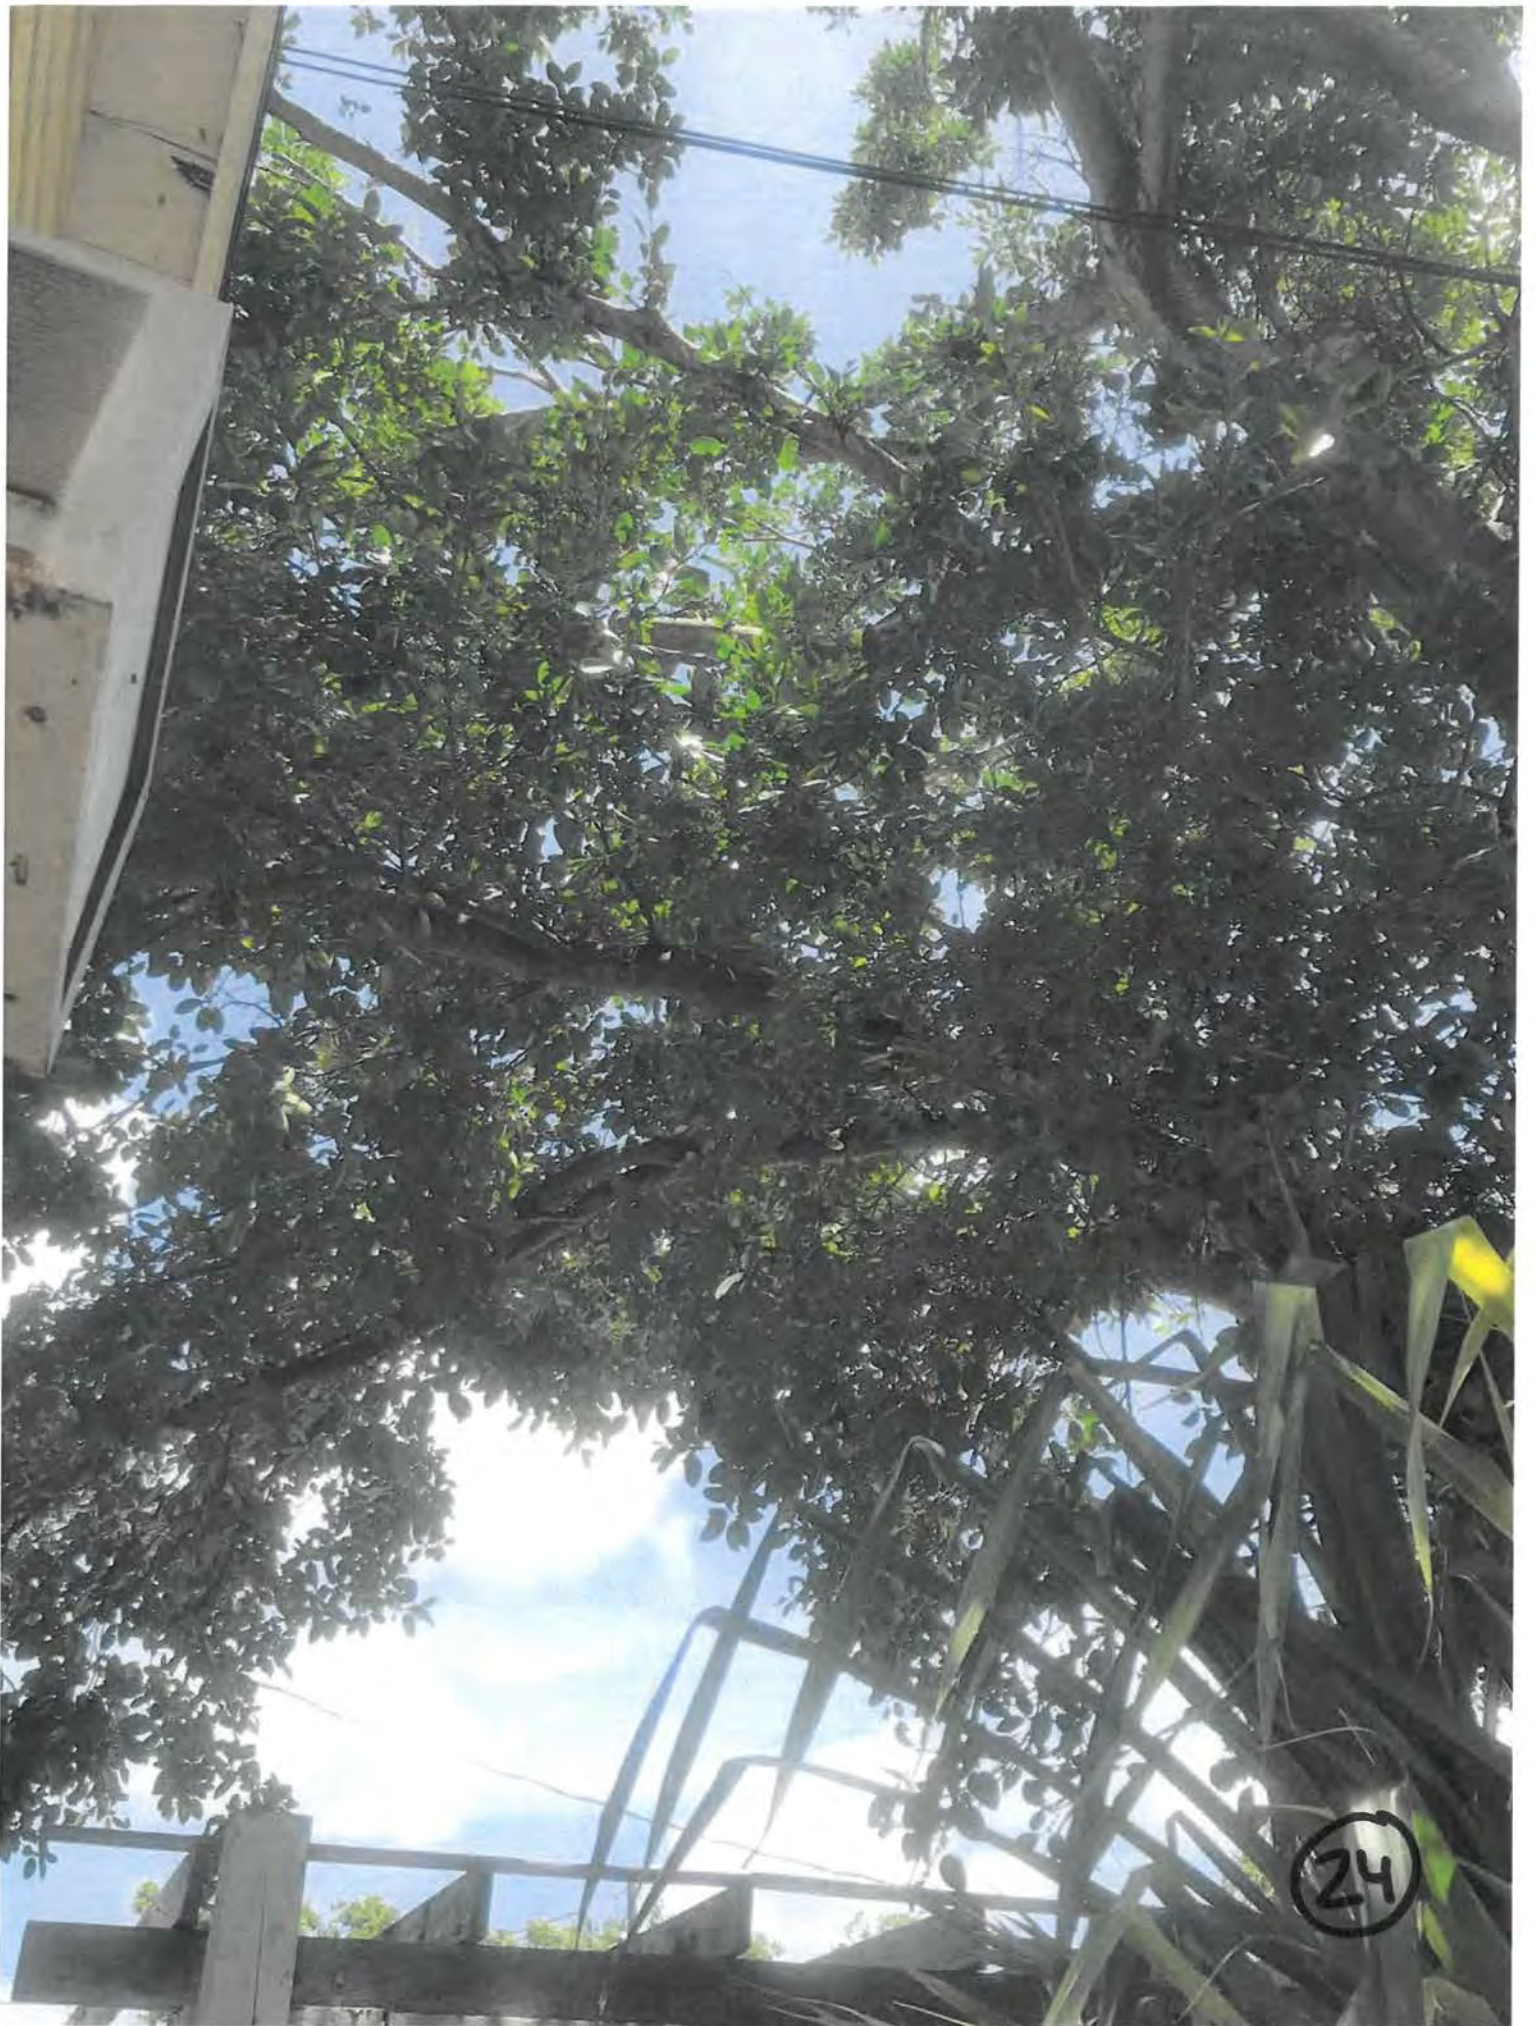
24

**Ficus aurea**, tree number 24, retain and protect with fencing.

23. Christmas Palm/*Adonidia merrillii* -Remove 10'-13' wood
24. Ficus/*Ficus aurea* -Retain/Protect 4 ½ - 5' diameter, fair, storm and utility pruning damage
