**TREE COMMISSION TREE REMOVAL REPORT  
CITY of KEY WEST**

**PROPERTY: 3720 Duck Ave.**

**APPLICATION NUMBER: T2026-0091**

**REQUEST: The applicant is requesting removal of (1) Mahogany tree.**

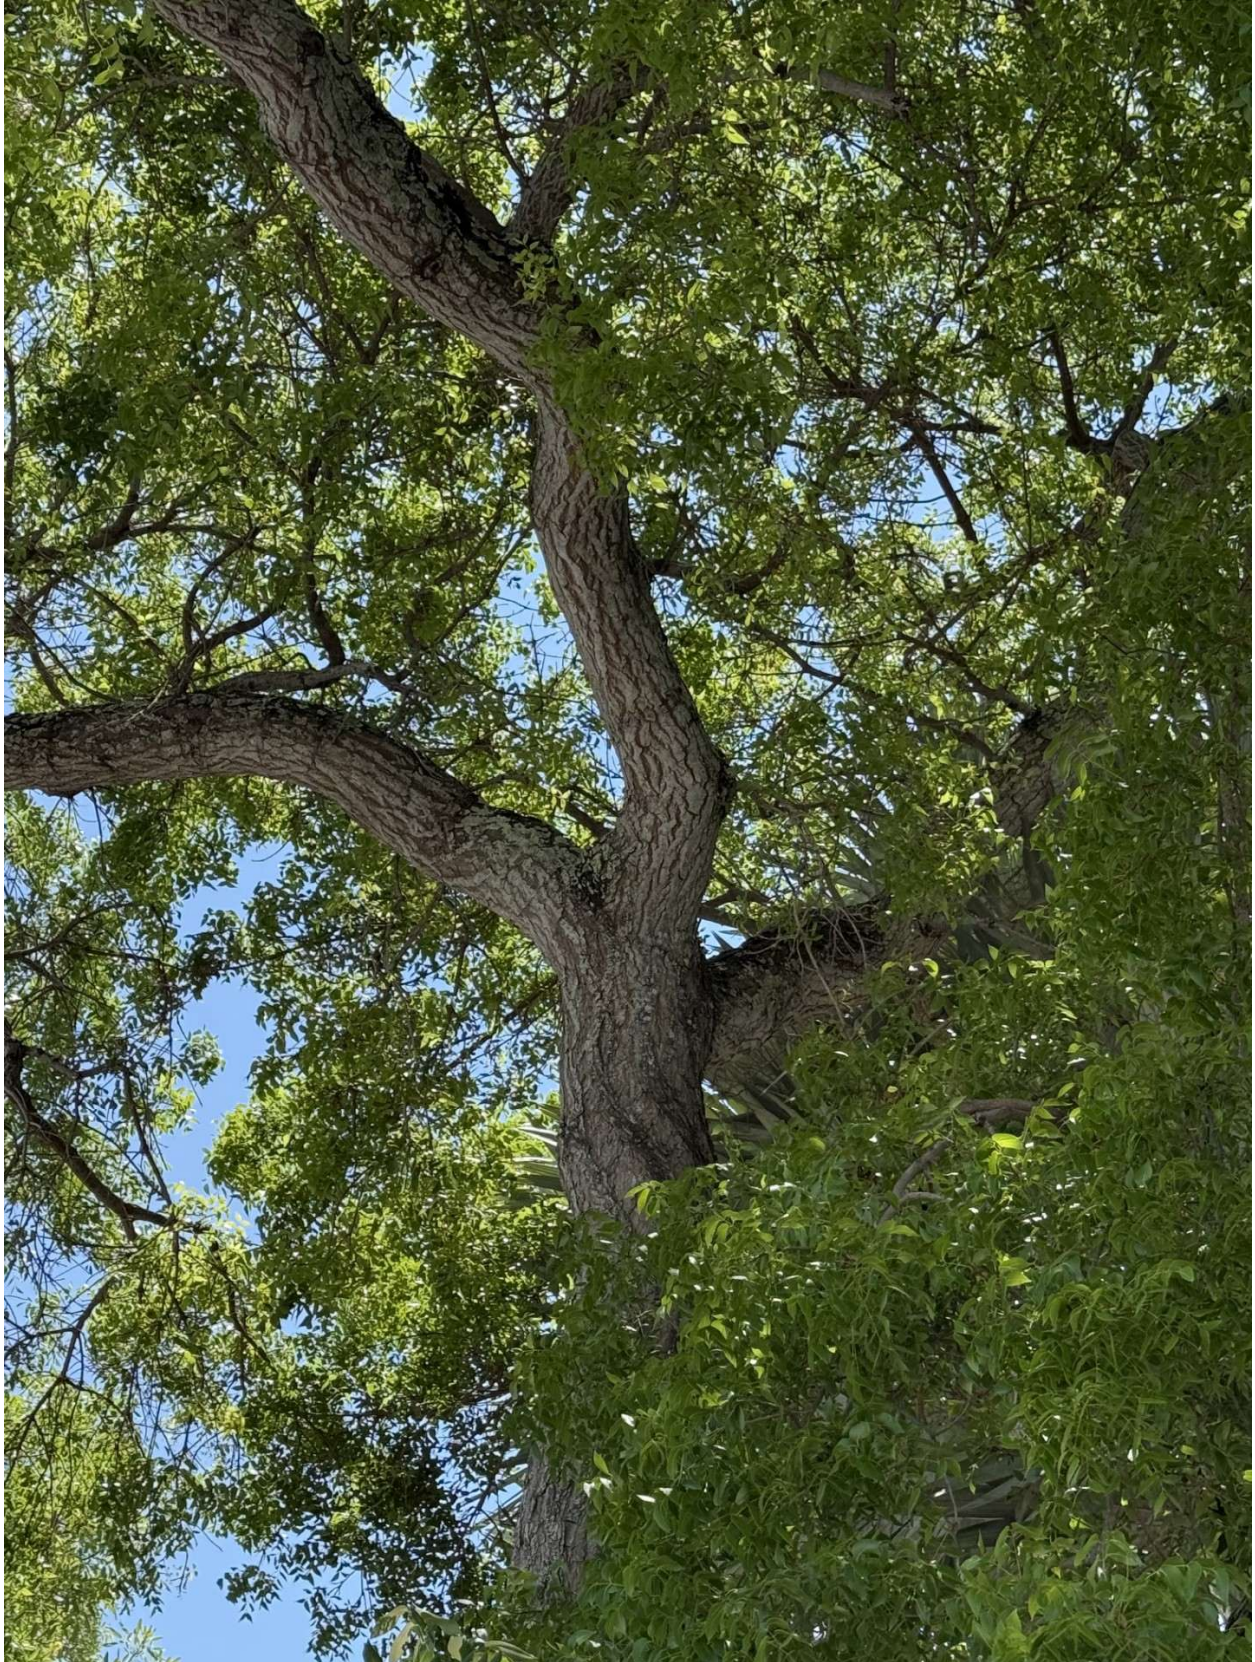
**Tree appears to have a lean. It does not appear to be from phototropic growth which means the tree likely lacks reaction wood associated with phototropic growth.**

**The overall canopy architecture is considered suboptimal. When viewed from certain angles, the tree exhibits a pronounced lean that does not appear attributable to phototropic growth, as there are no nearby competing canopy trees influencing directional light growth. The lean is therefore more consistent with displacement associated with a previous wind event. Supporting this assessment is the observation of a major exposed structural root on the side opposite the direction of lean appearing partially lifted from the soil surface, indicating possible root plate disturbance or movement.**

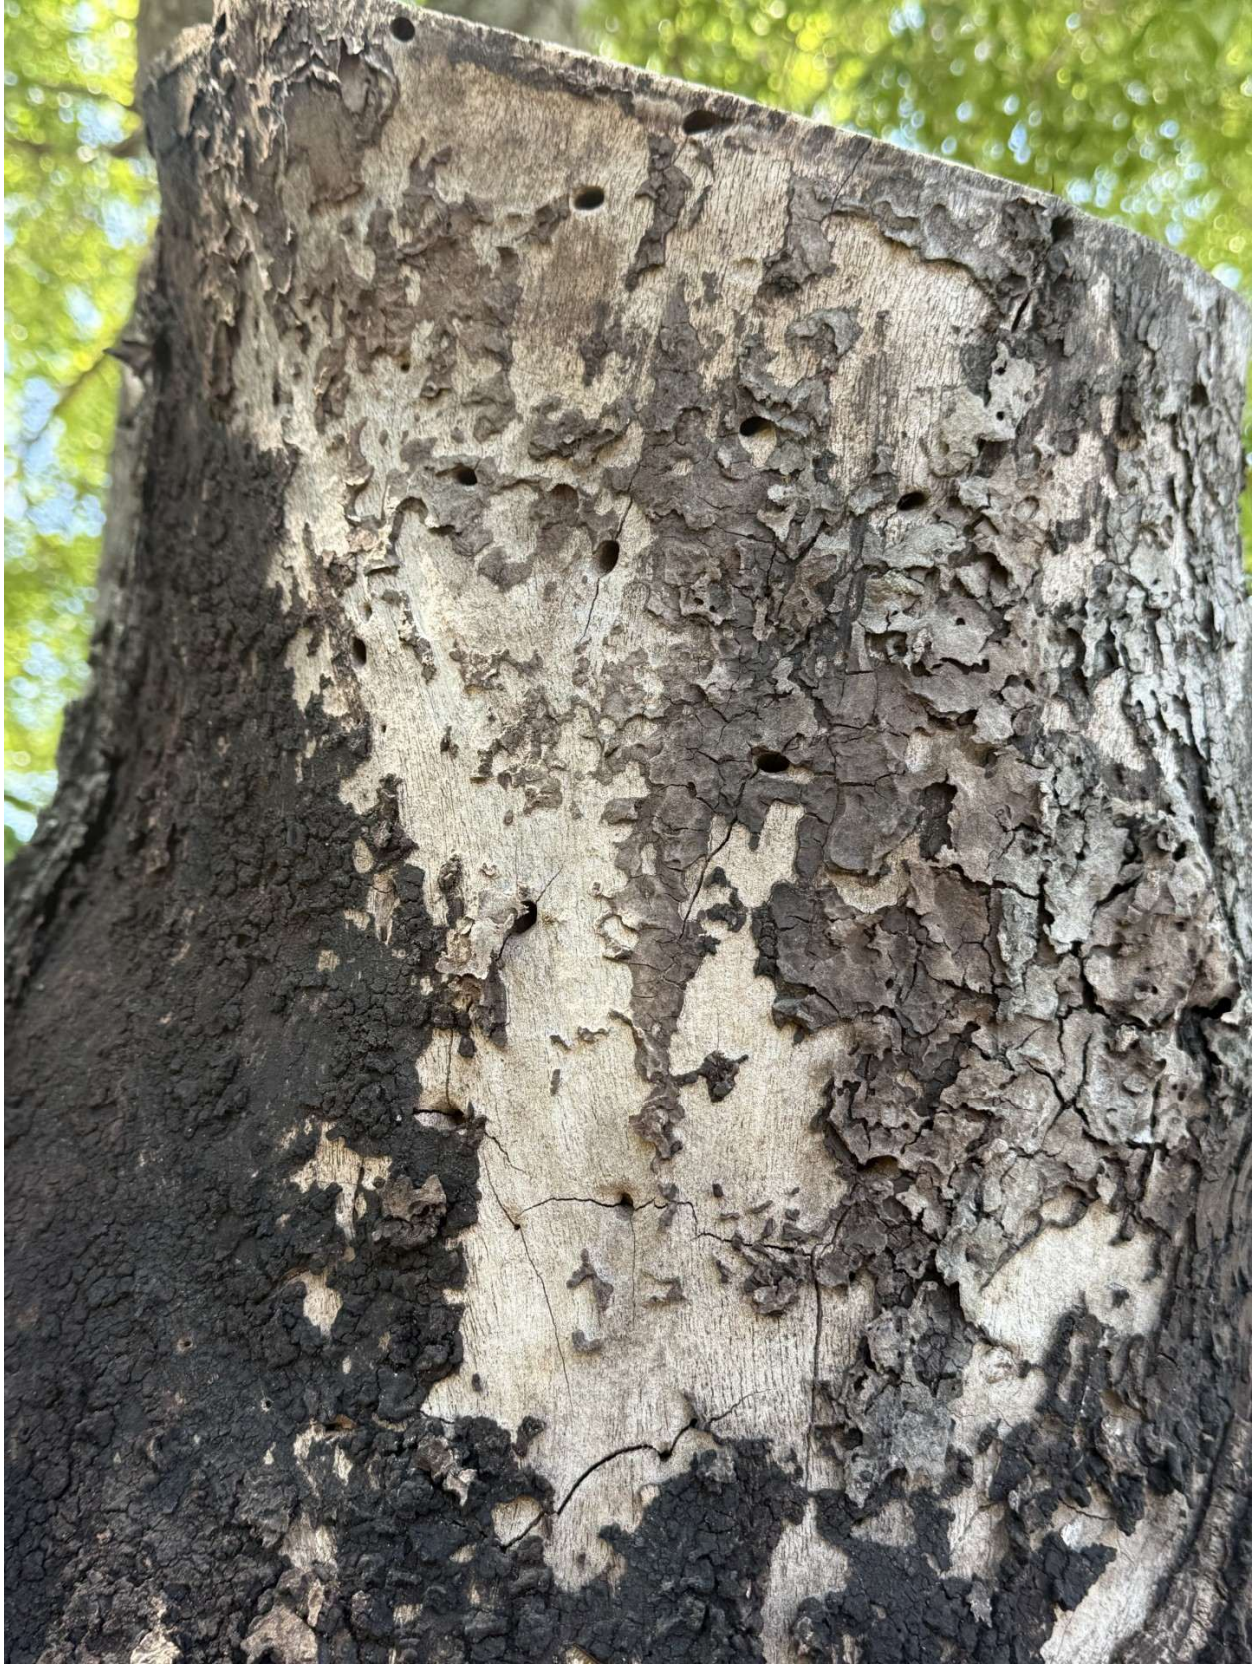
**Poor pruning and resulting exposed heartwood and decay.**

**The subject tree is a mature Cuban mahogany (*Swietenia mahagoni*) with an approximate diameter at breast height (DBH) of 26 inches, located within the front yard of a residential property. The overall condition of the tree is assessed at approximately 60%; however, several structural and physiological defects are present which warrant consideration. A previously removed large leader was improperly cut, leaving behind an approximate 1.5-foot stub. This remaining stub exhibits signs consistent with bacterial wetwood, visible insect-related holes, and apparent internal wood decay. Additionally, the tree's two primary remaining leaders originate approximately two feet above the root flare and contain included bark at their union, resulting in a structurally weak attachment point.**
