**TREE COMMISSION TREE REMOVAL REPORT  
CITY of KEY WEST**

**PROPERTY: 630 Mickens Lane**

**APPLICATION NUMBER: T2025-0229**

**REQUEST: The applicant is requesting removal of (2) Tropical Almond Trees, (1) Spanish Lime Tree, and (1) Sapodilla Tree.**

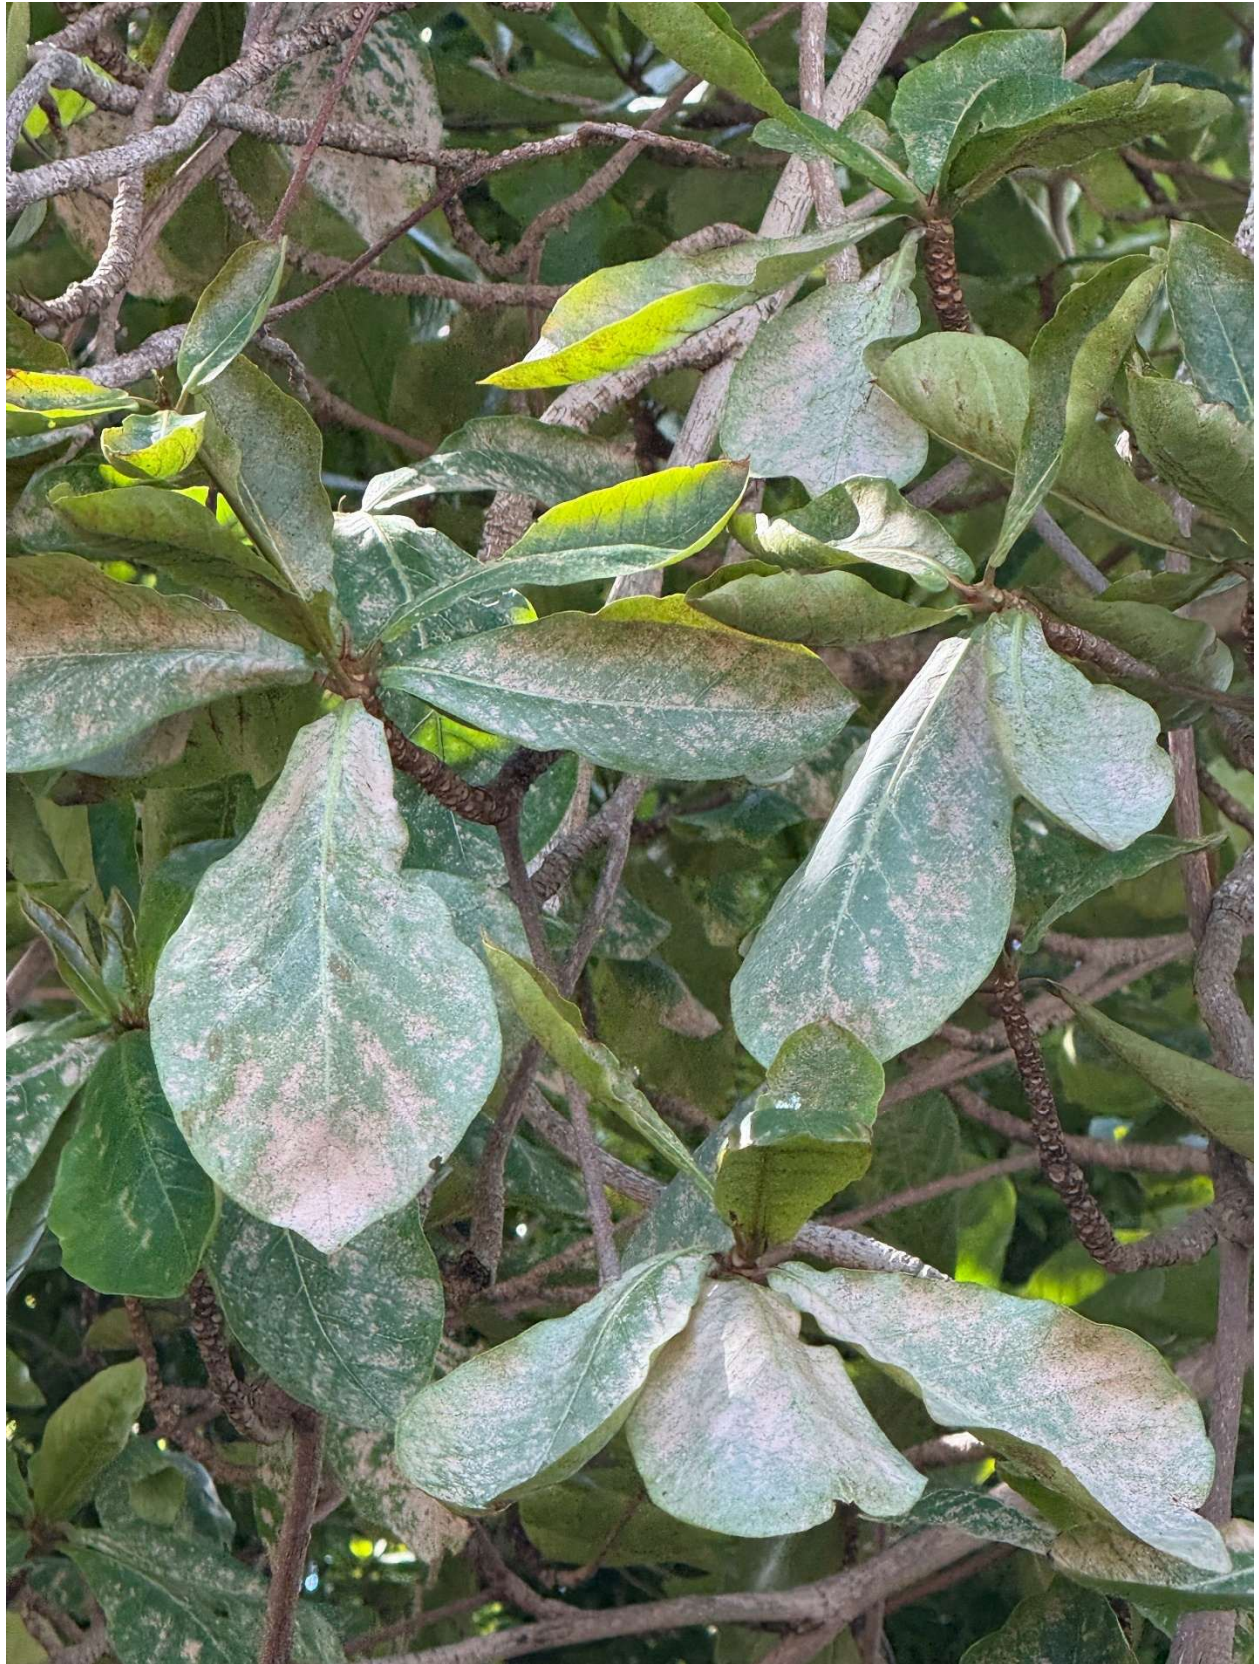
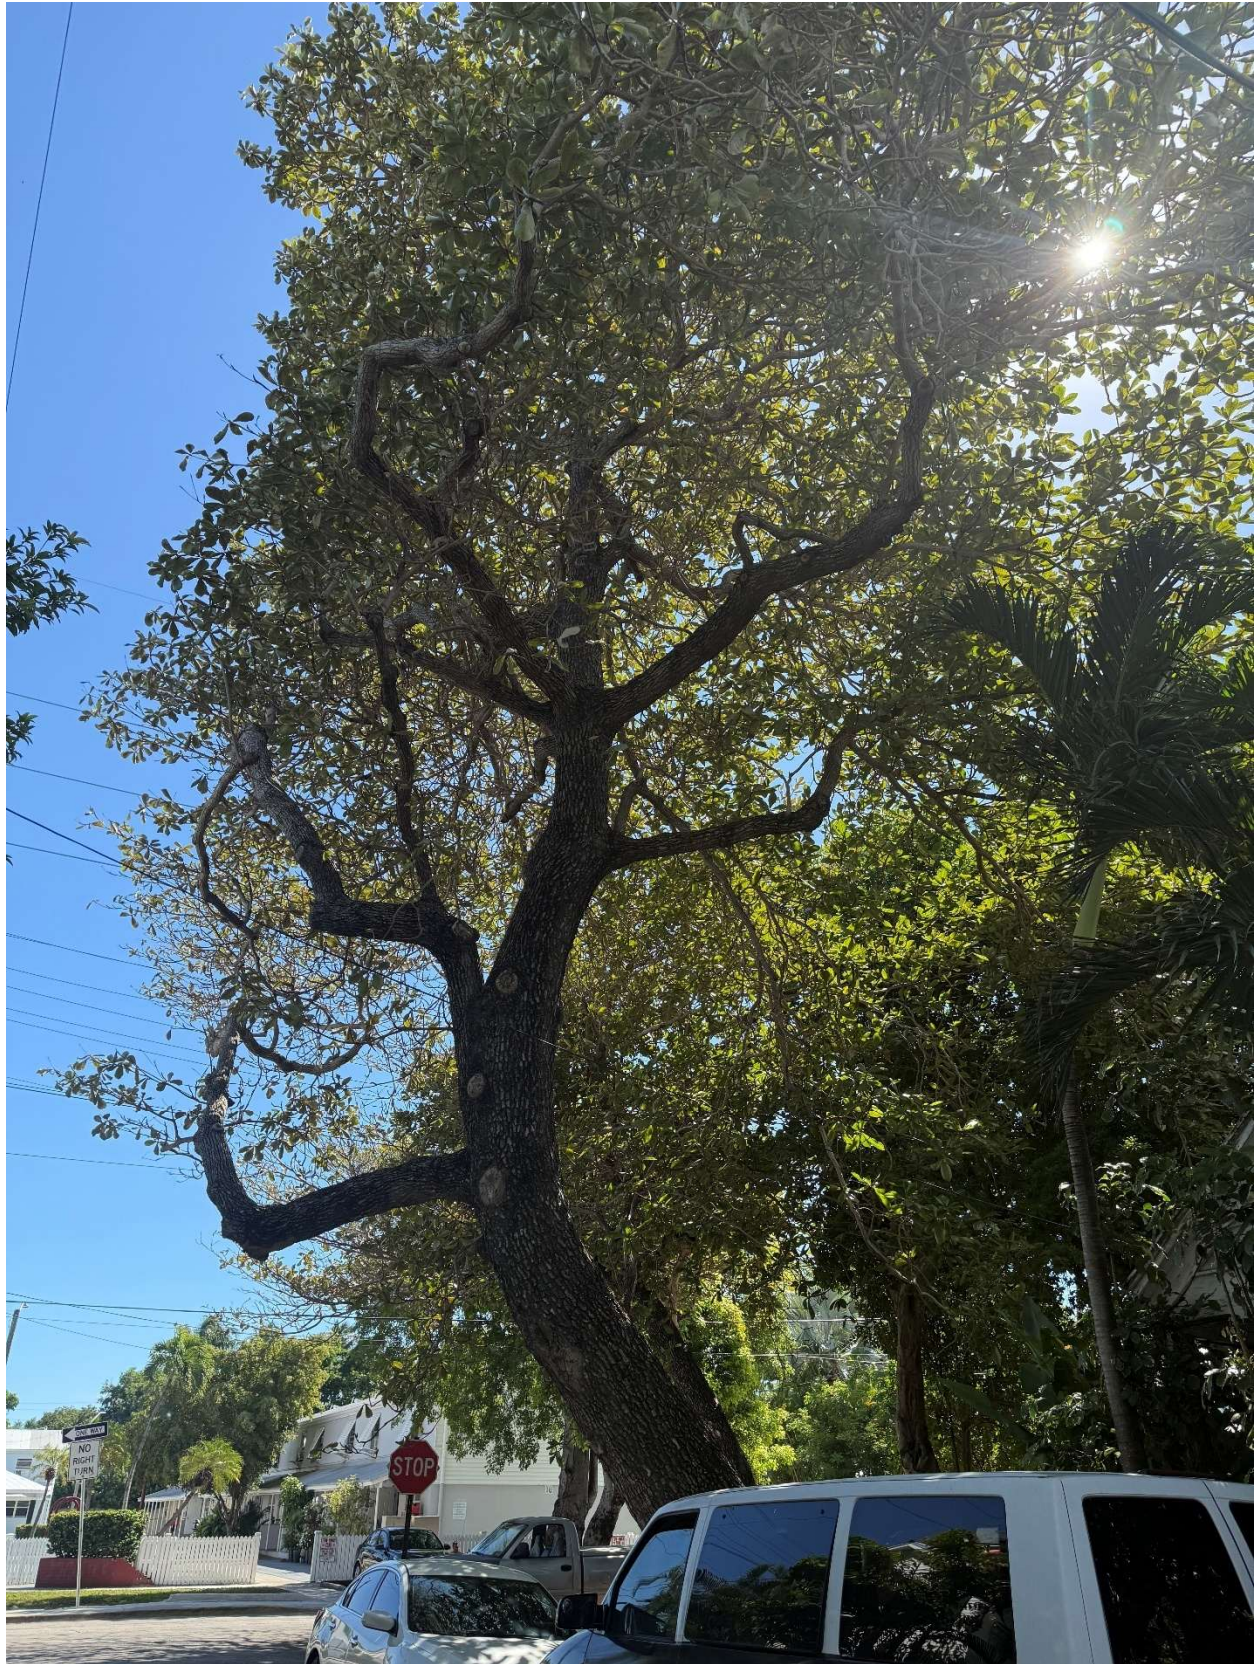
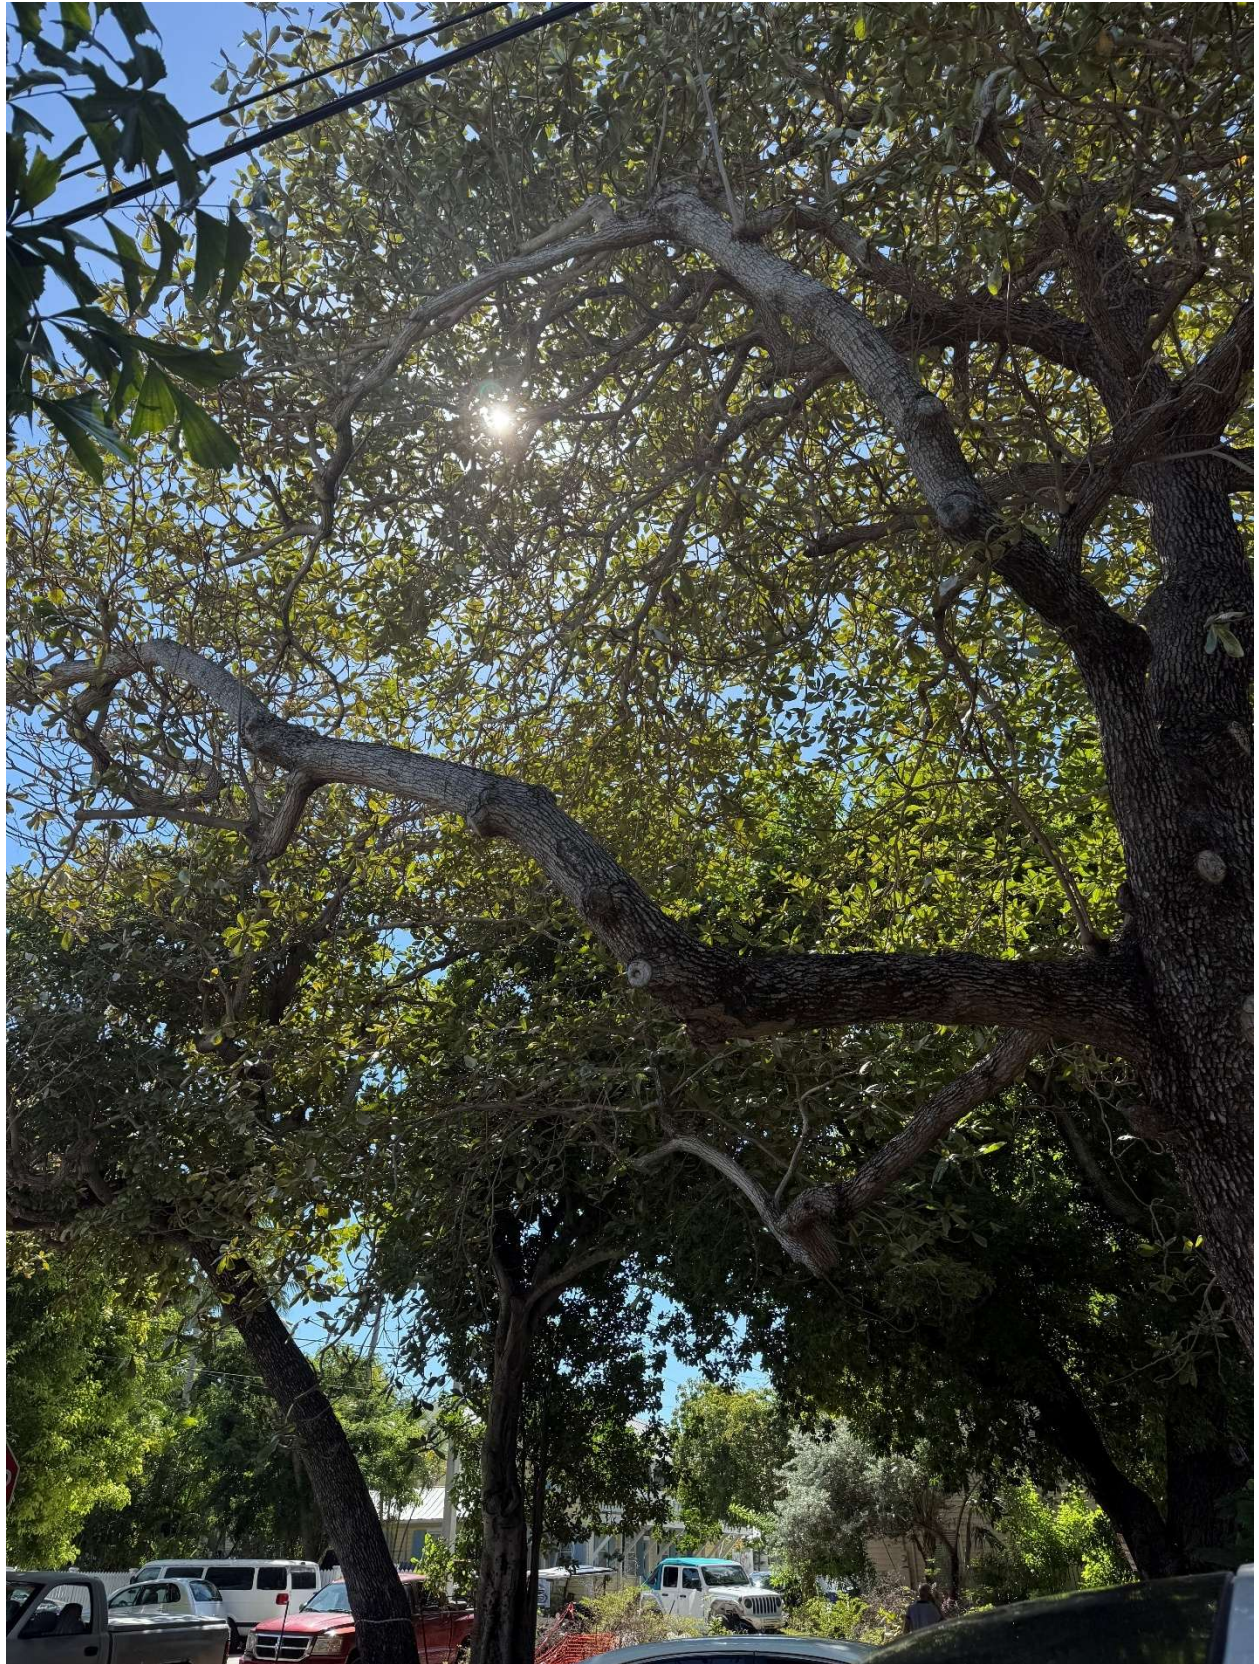
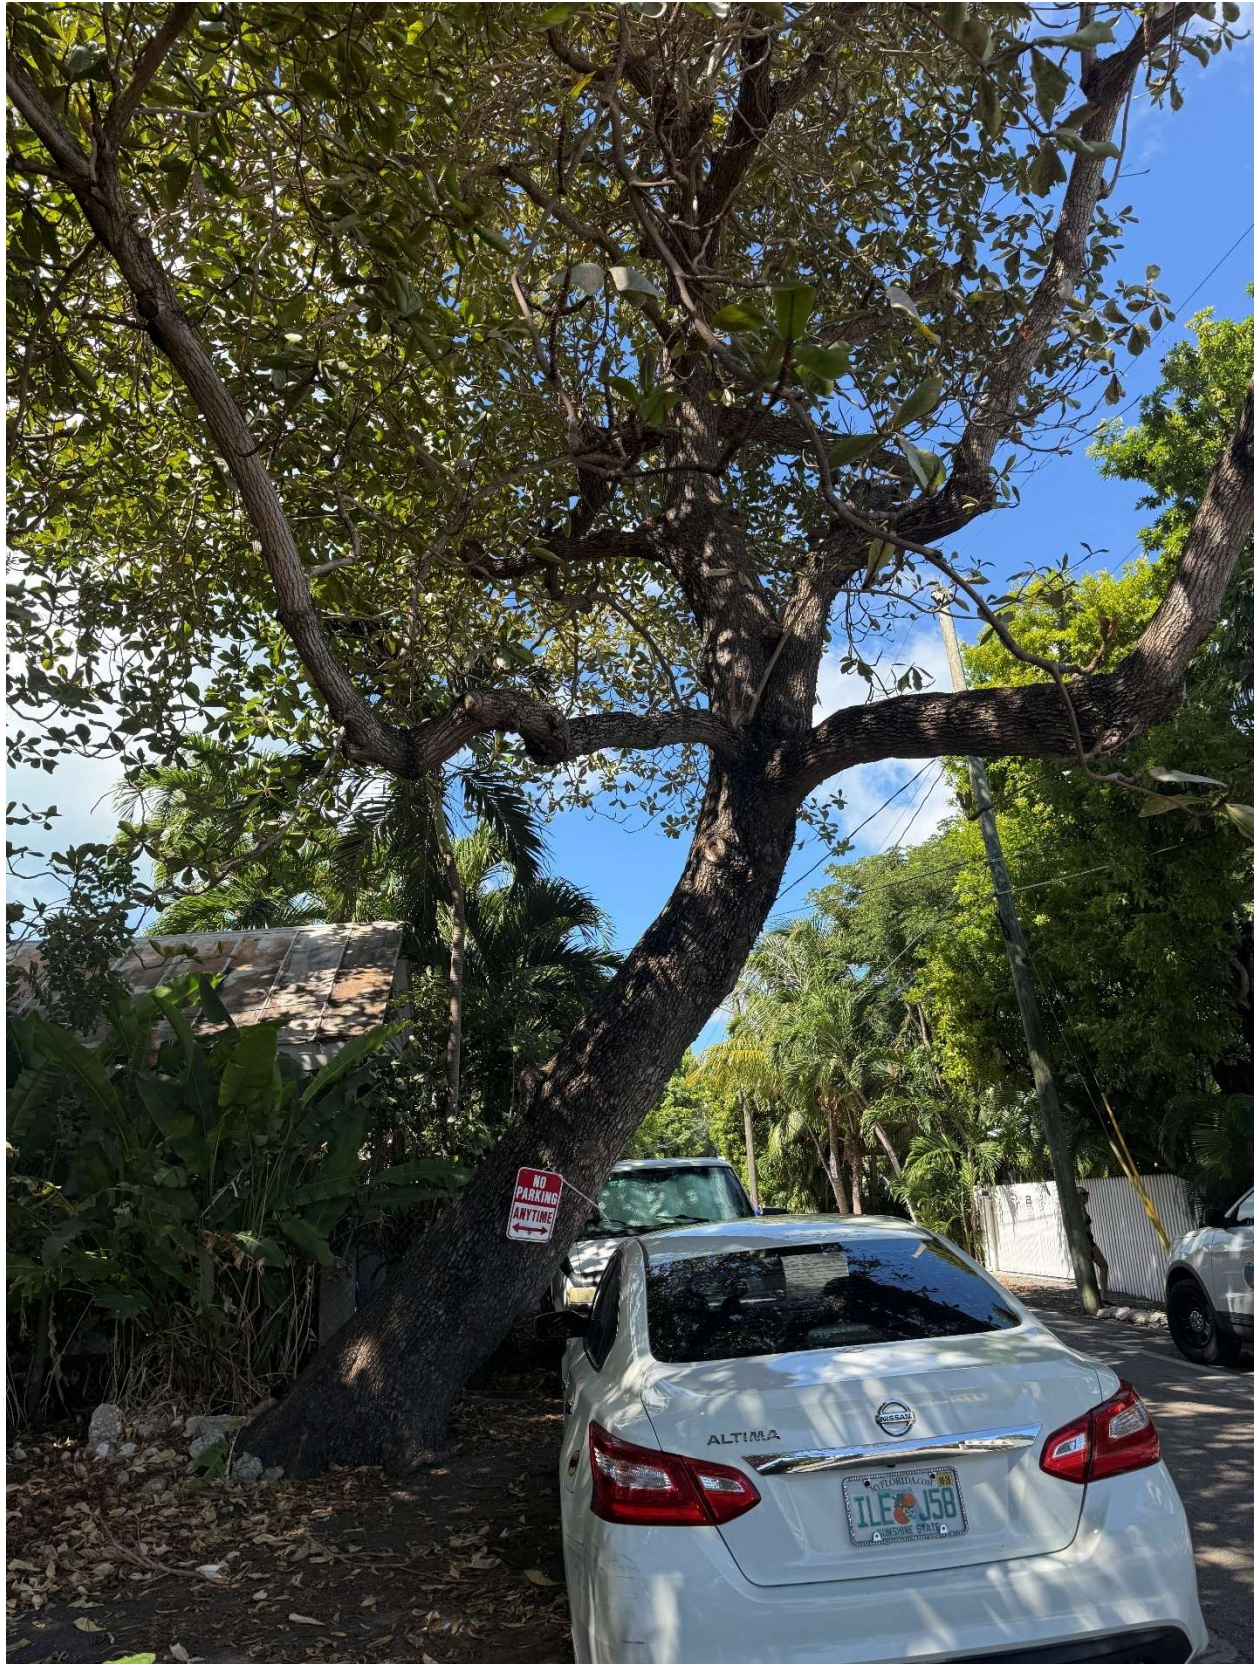
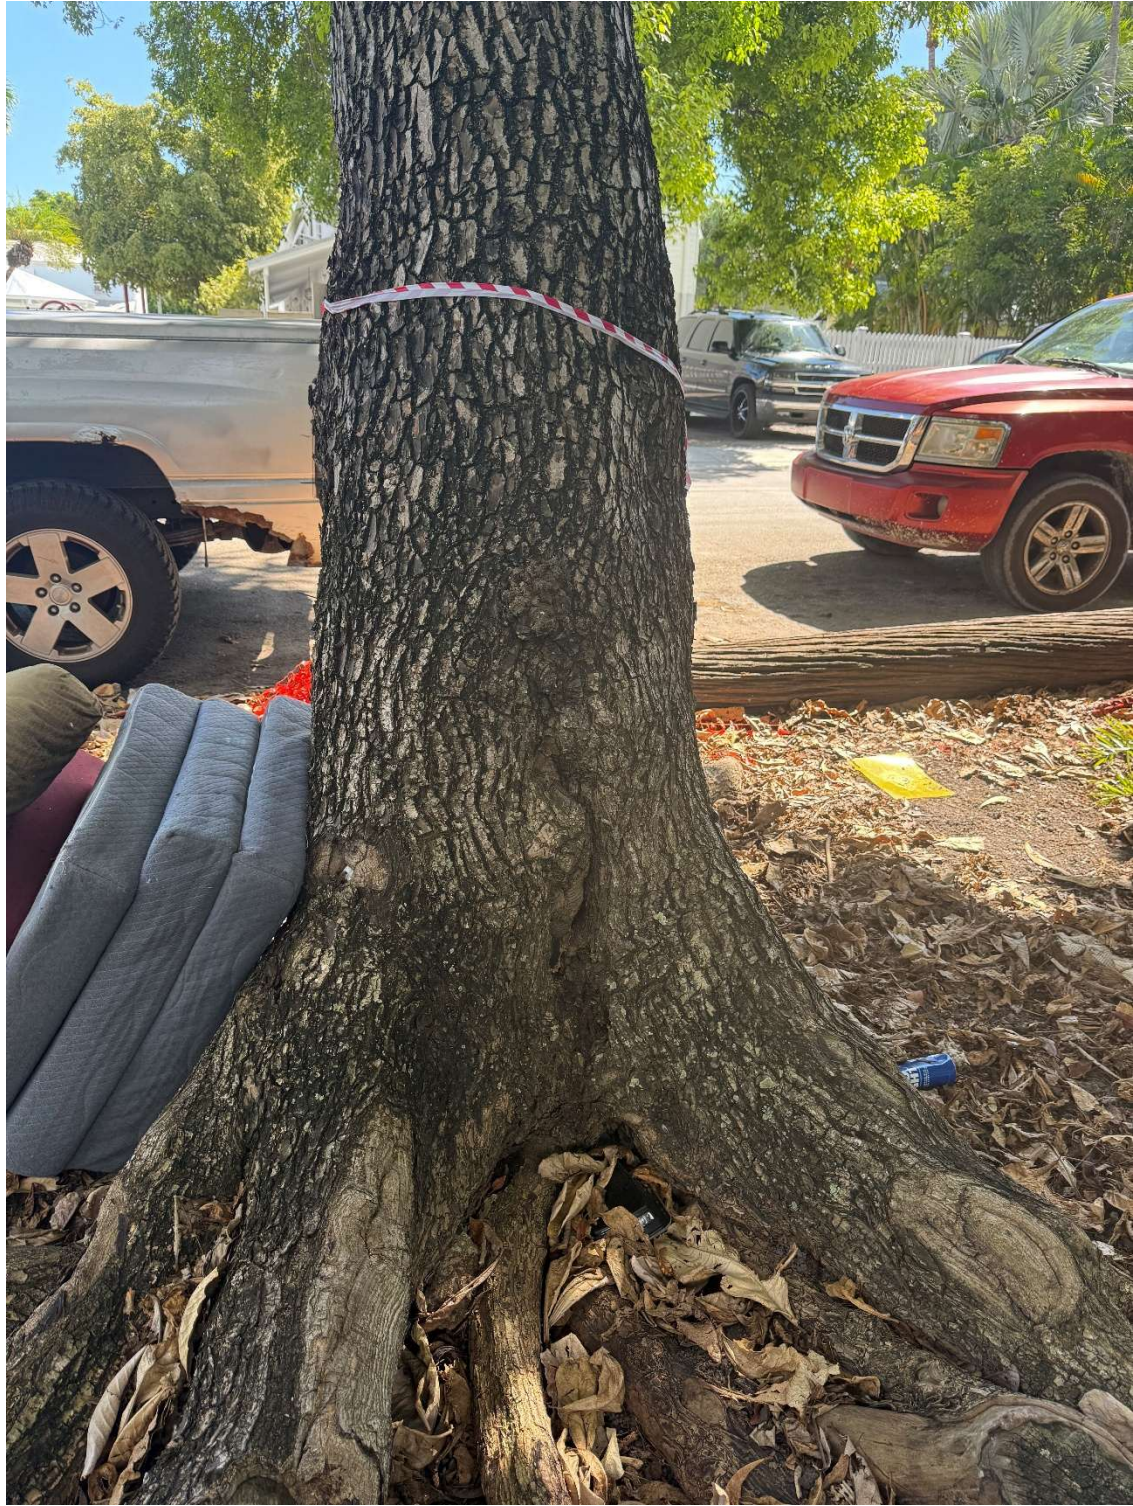
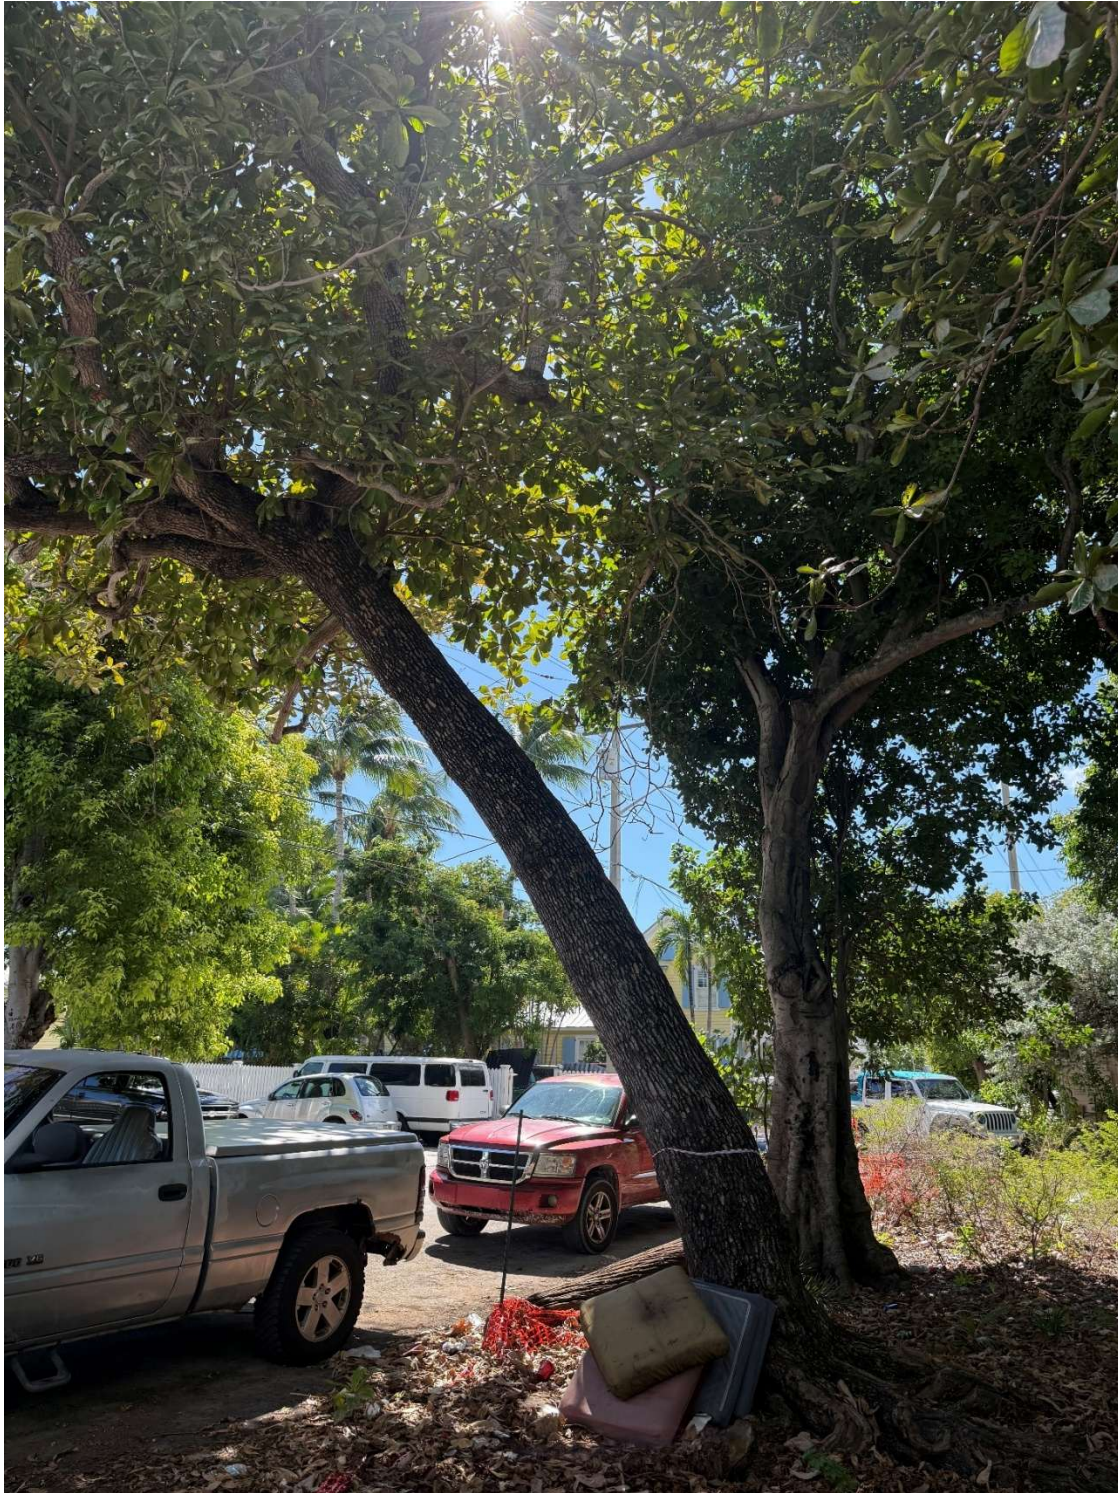
**Tropical Almond #1 is severely stressed. The color of the canopy which can be seen in the close-up picture of the leaves is an early indicator of vascular issues.**

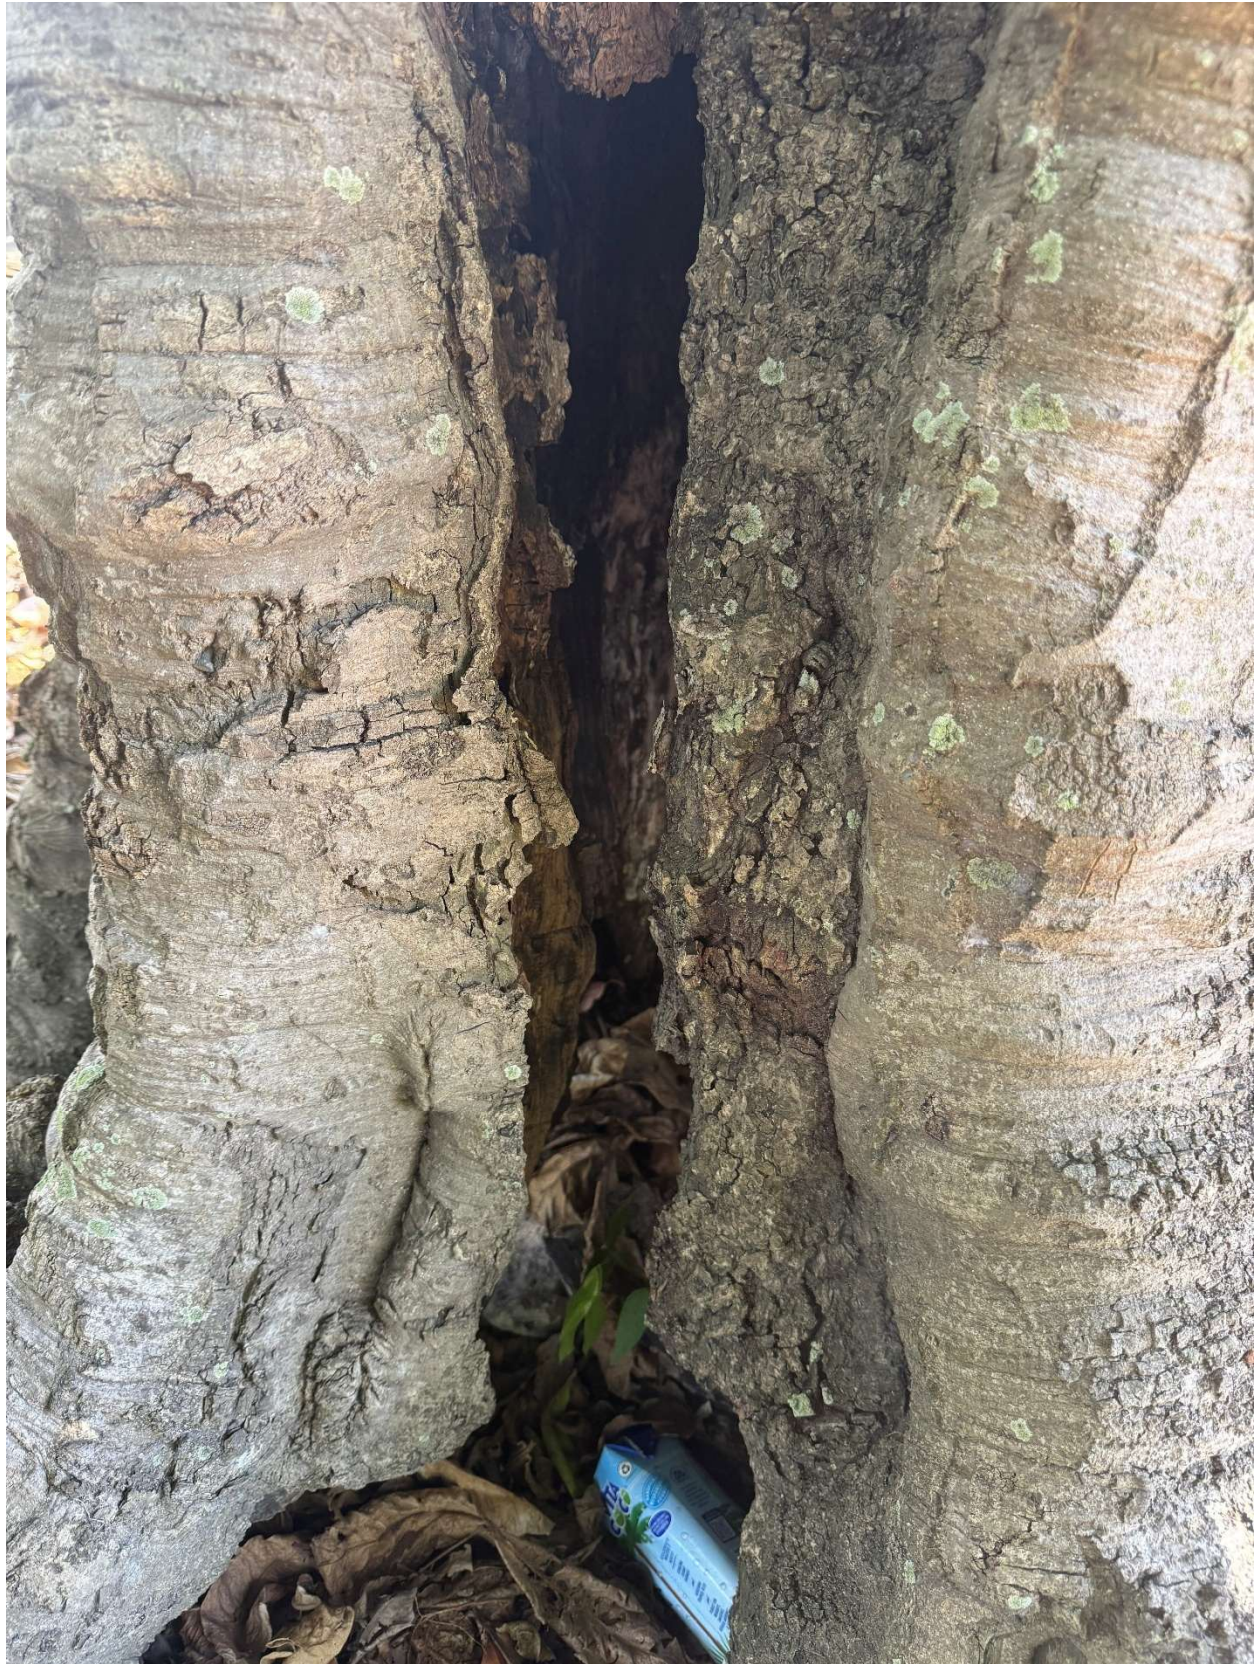
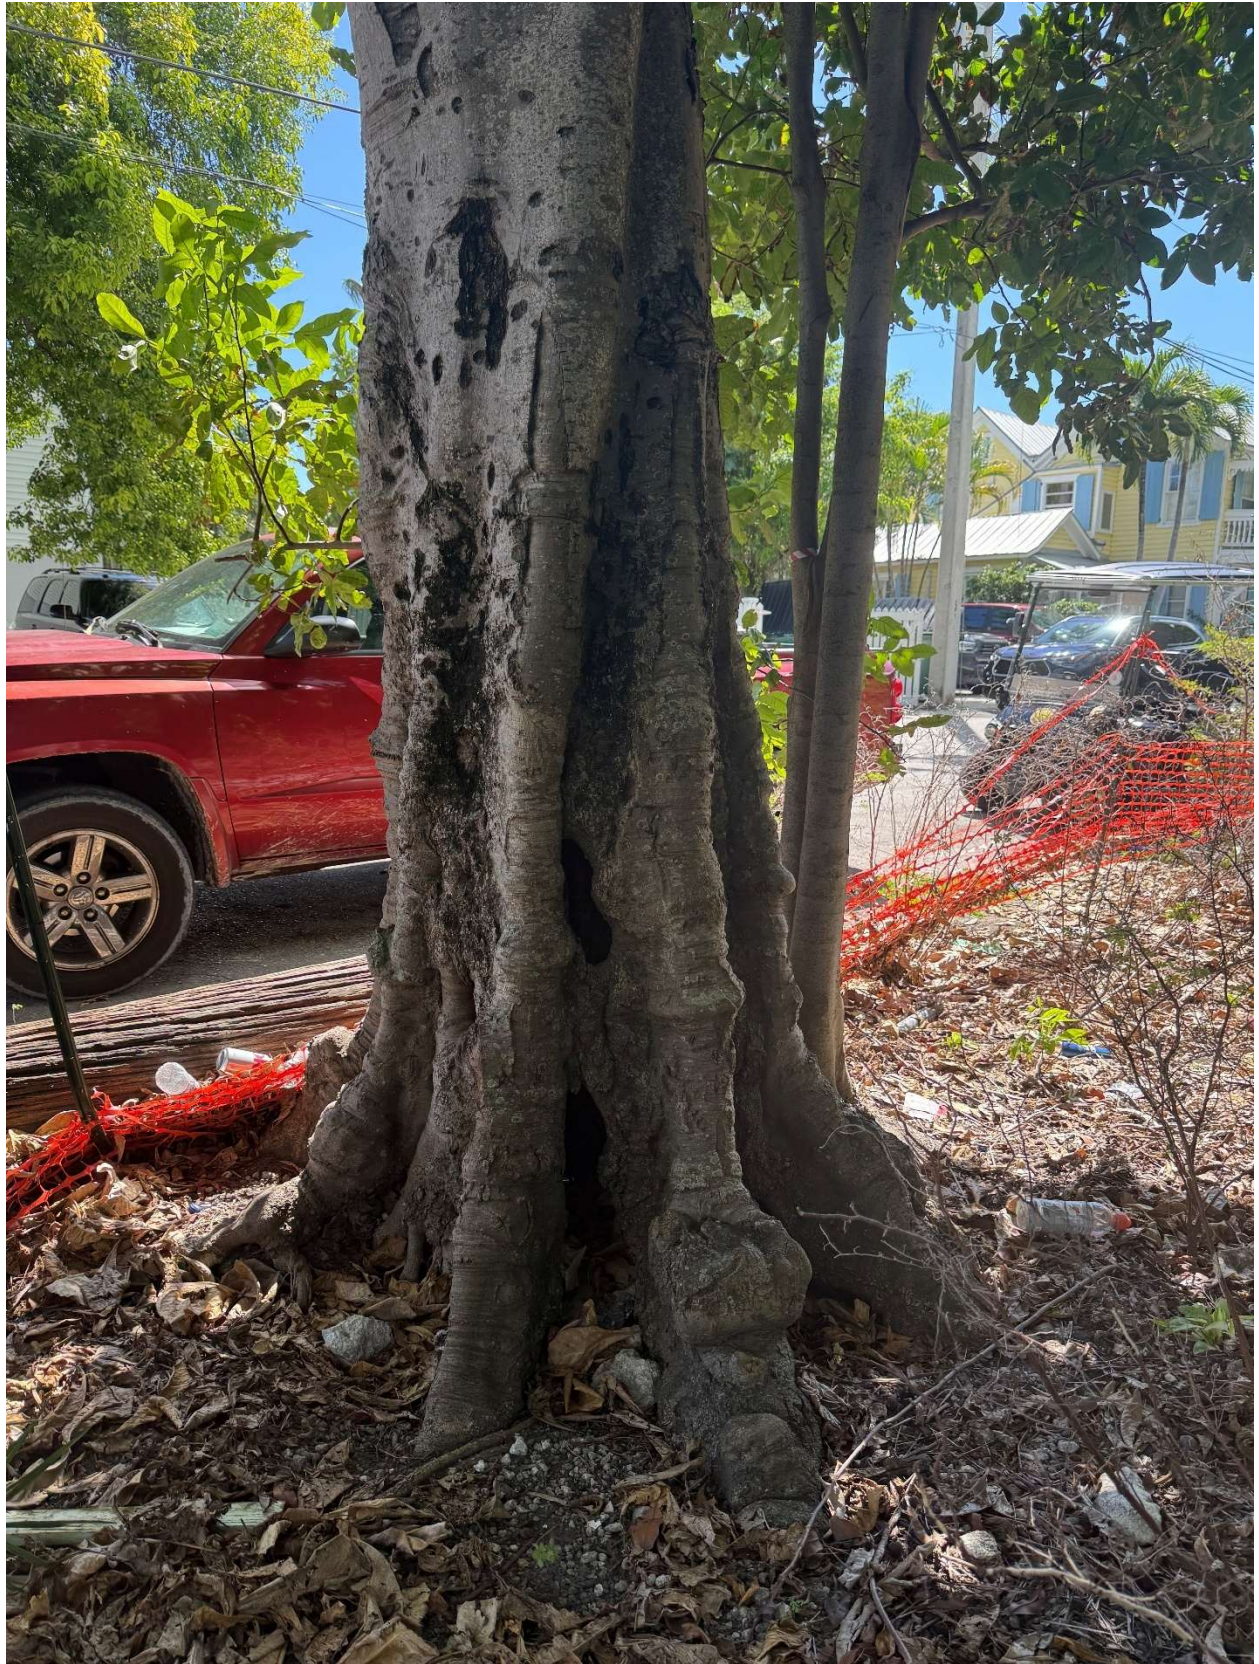
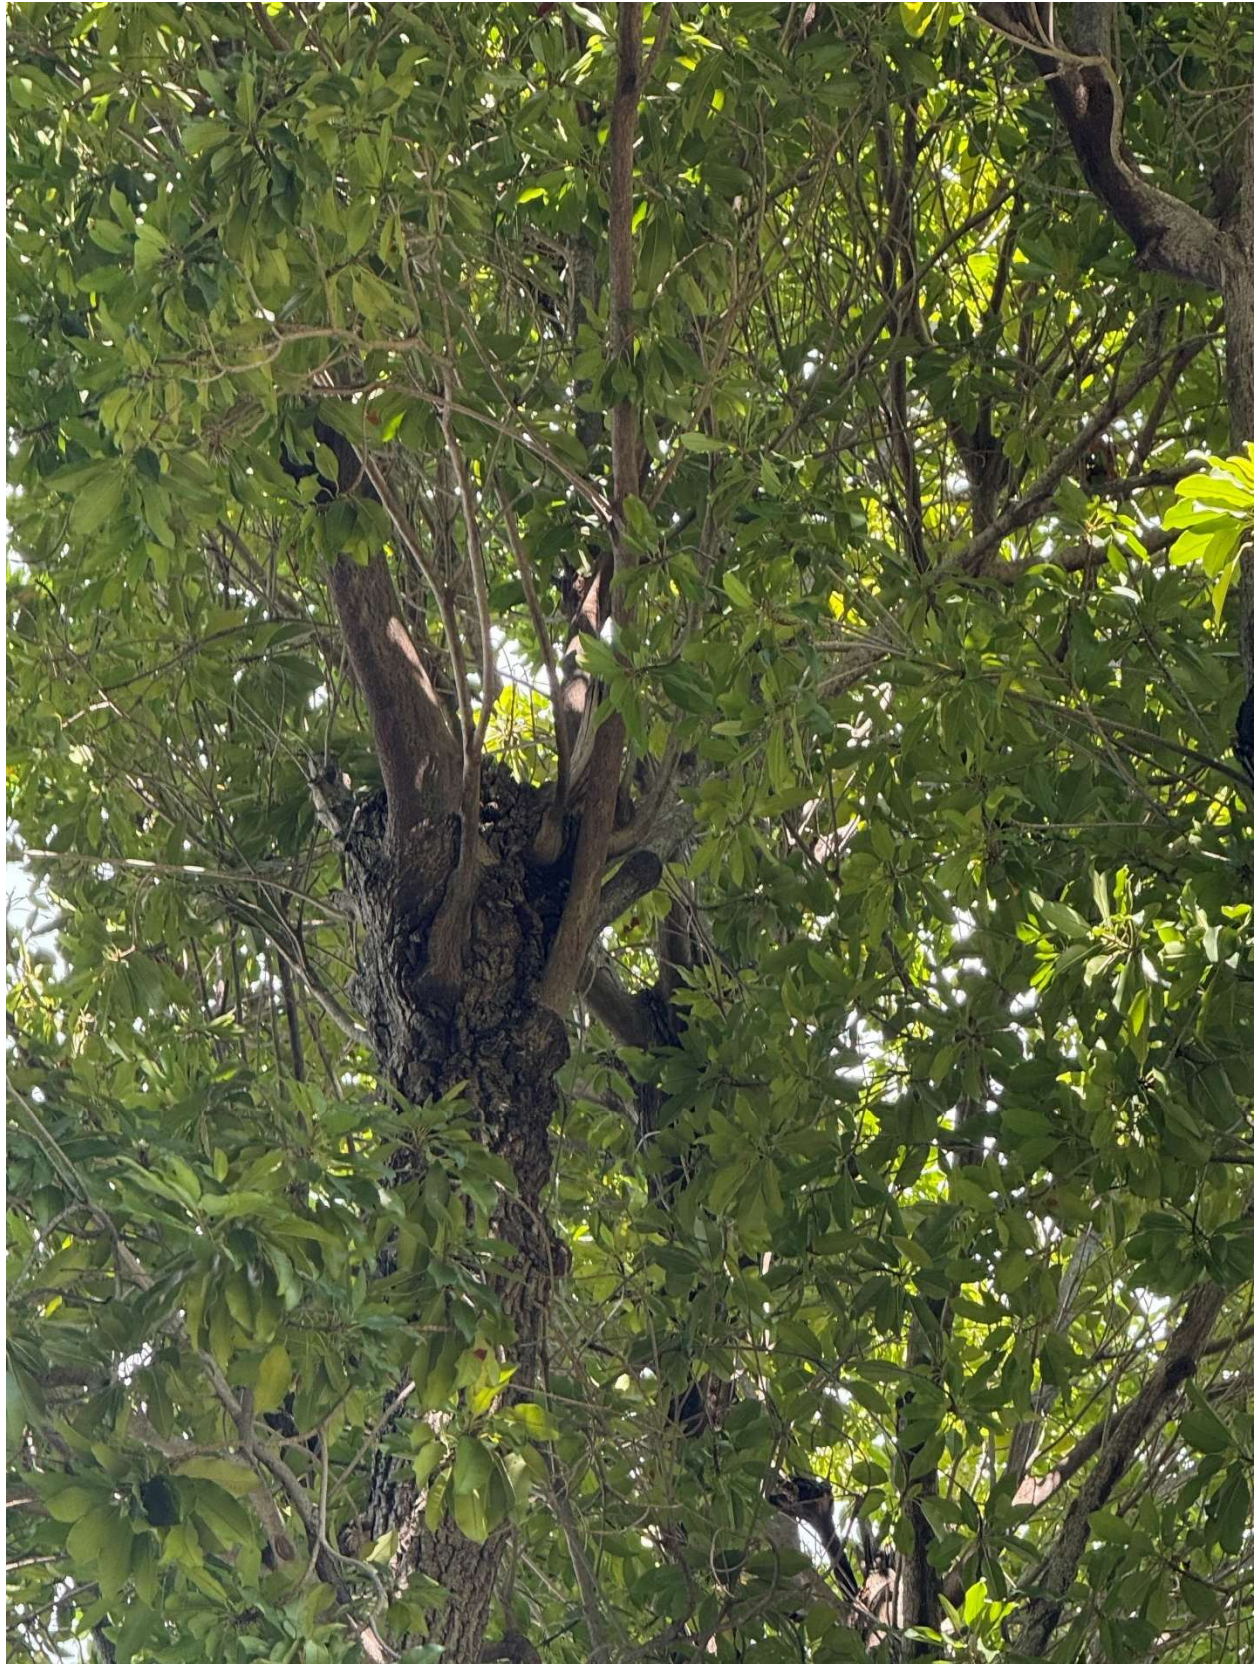
**Base of stem is 50% hollow.**
