**TREE COMMISSION TREE REMOVAL REPORT  
CITY of KEY WEST**

**PROPERTY: 630 Mickens Lane**

**APPLICATION NUMBER: T2025-0229**

**REQUEST: The applicant is requesting removal of (2) Tropical Almond Trees, (1) Spanish Lime Tree, and (1) Sapodilla Tree.**

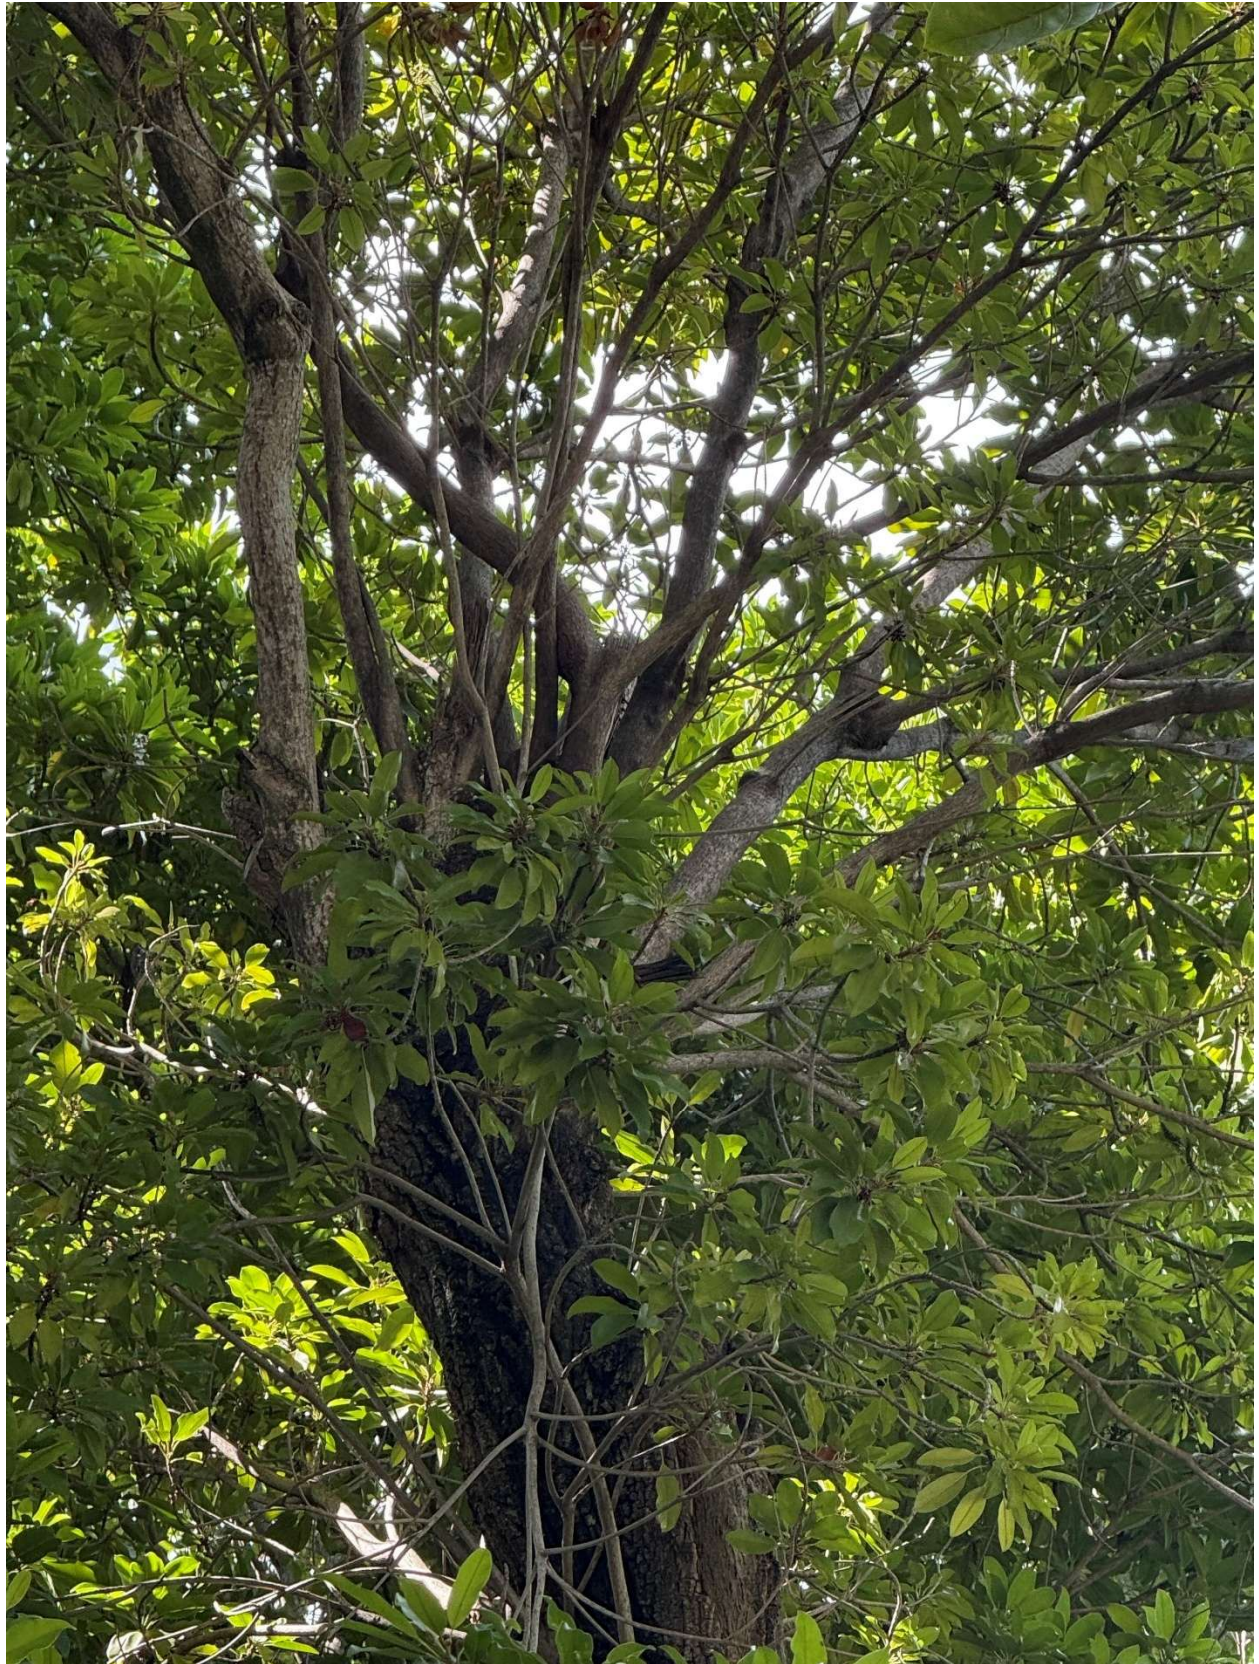
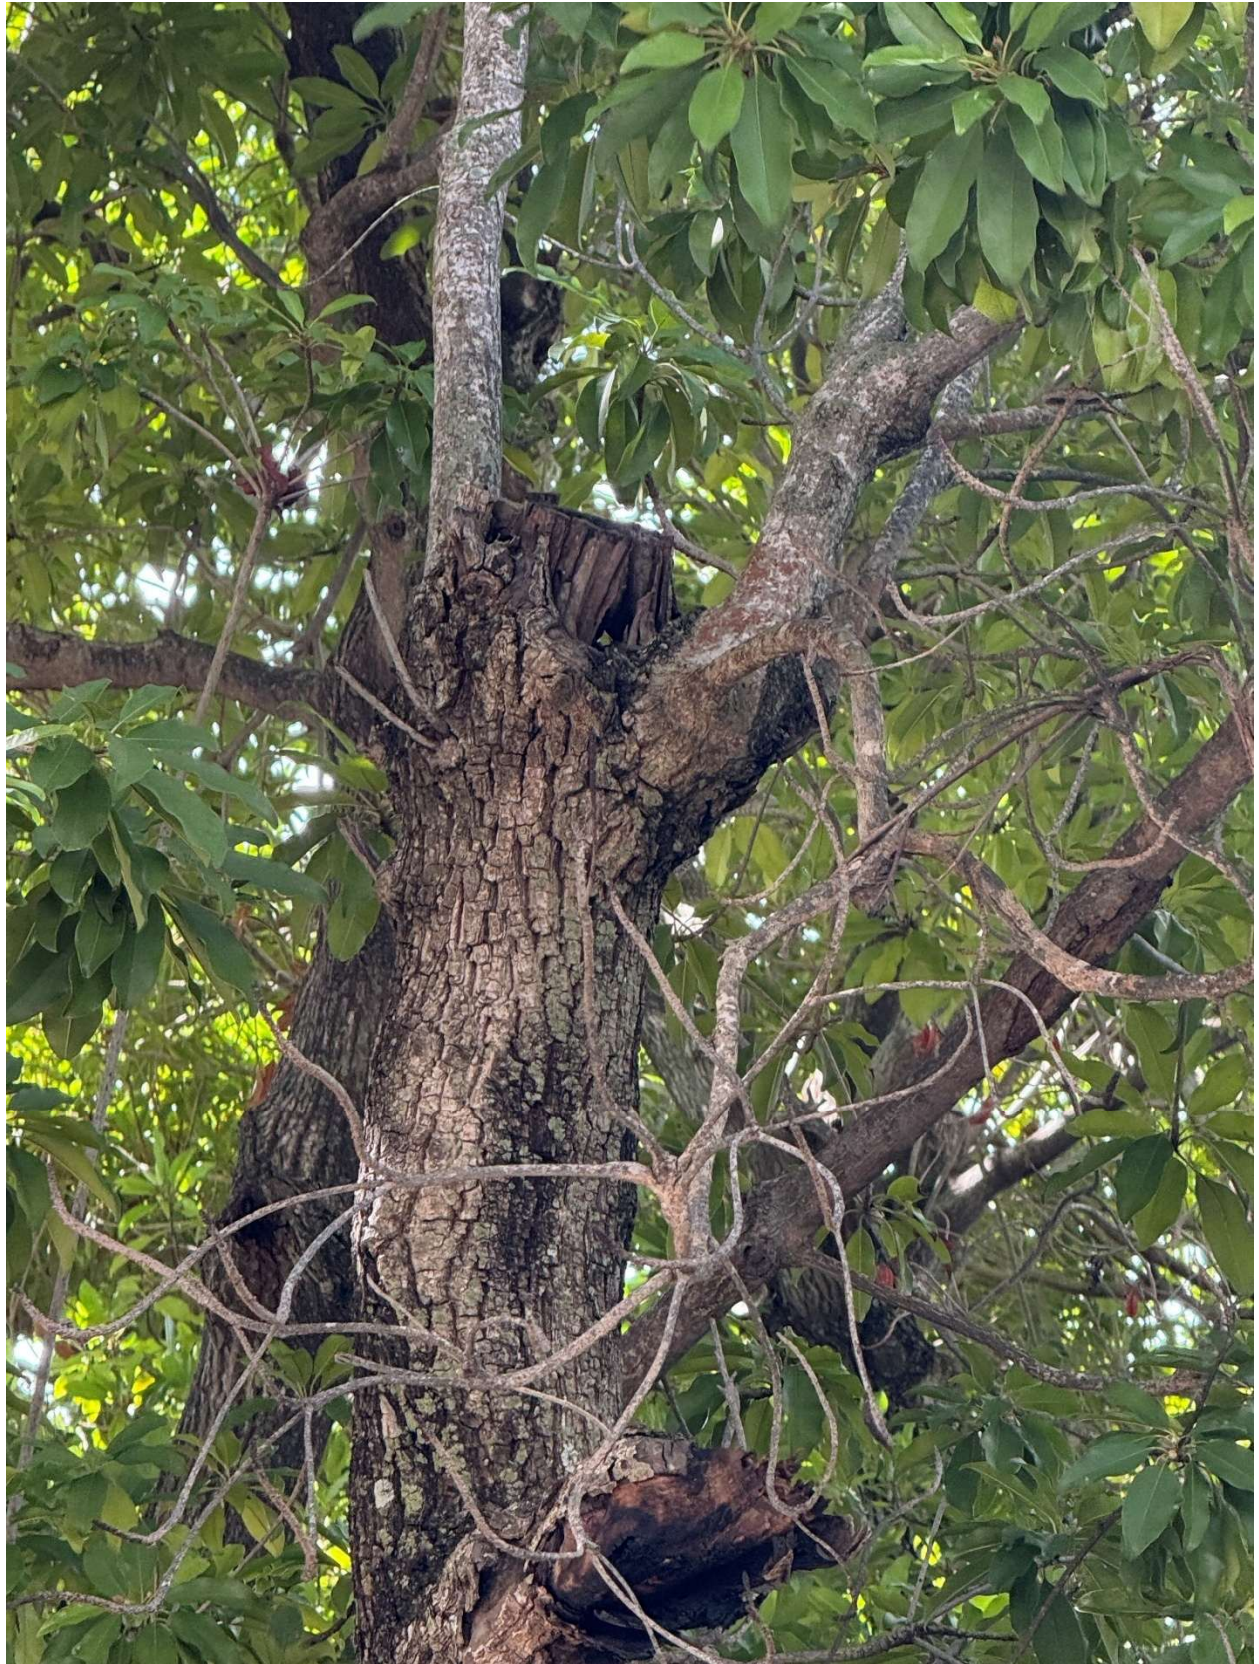
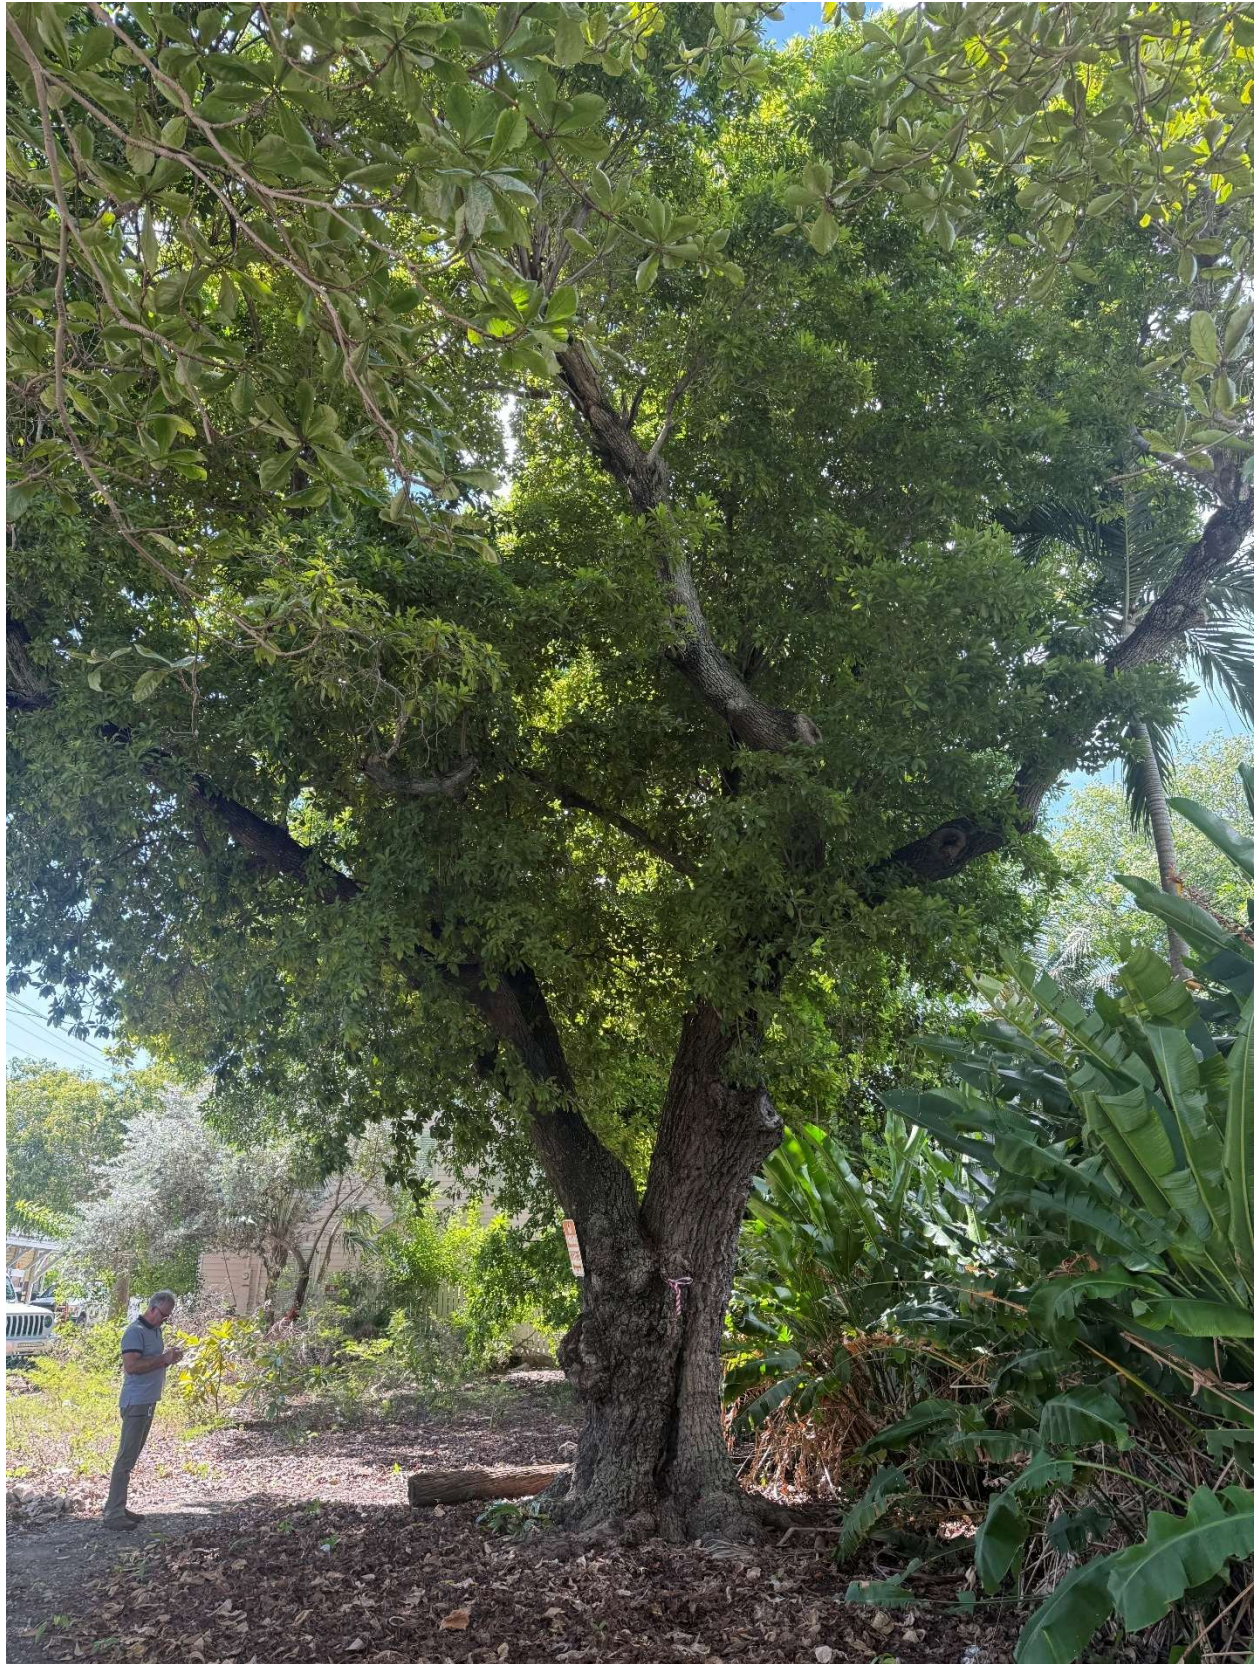
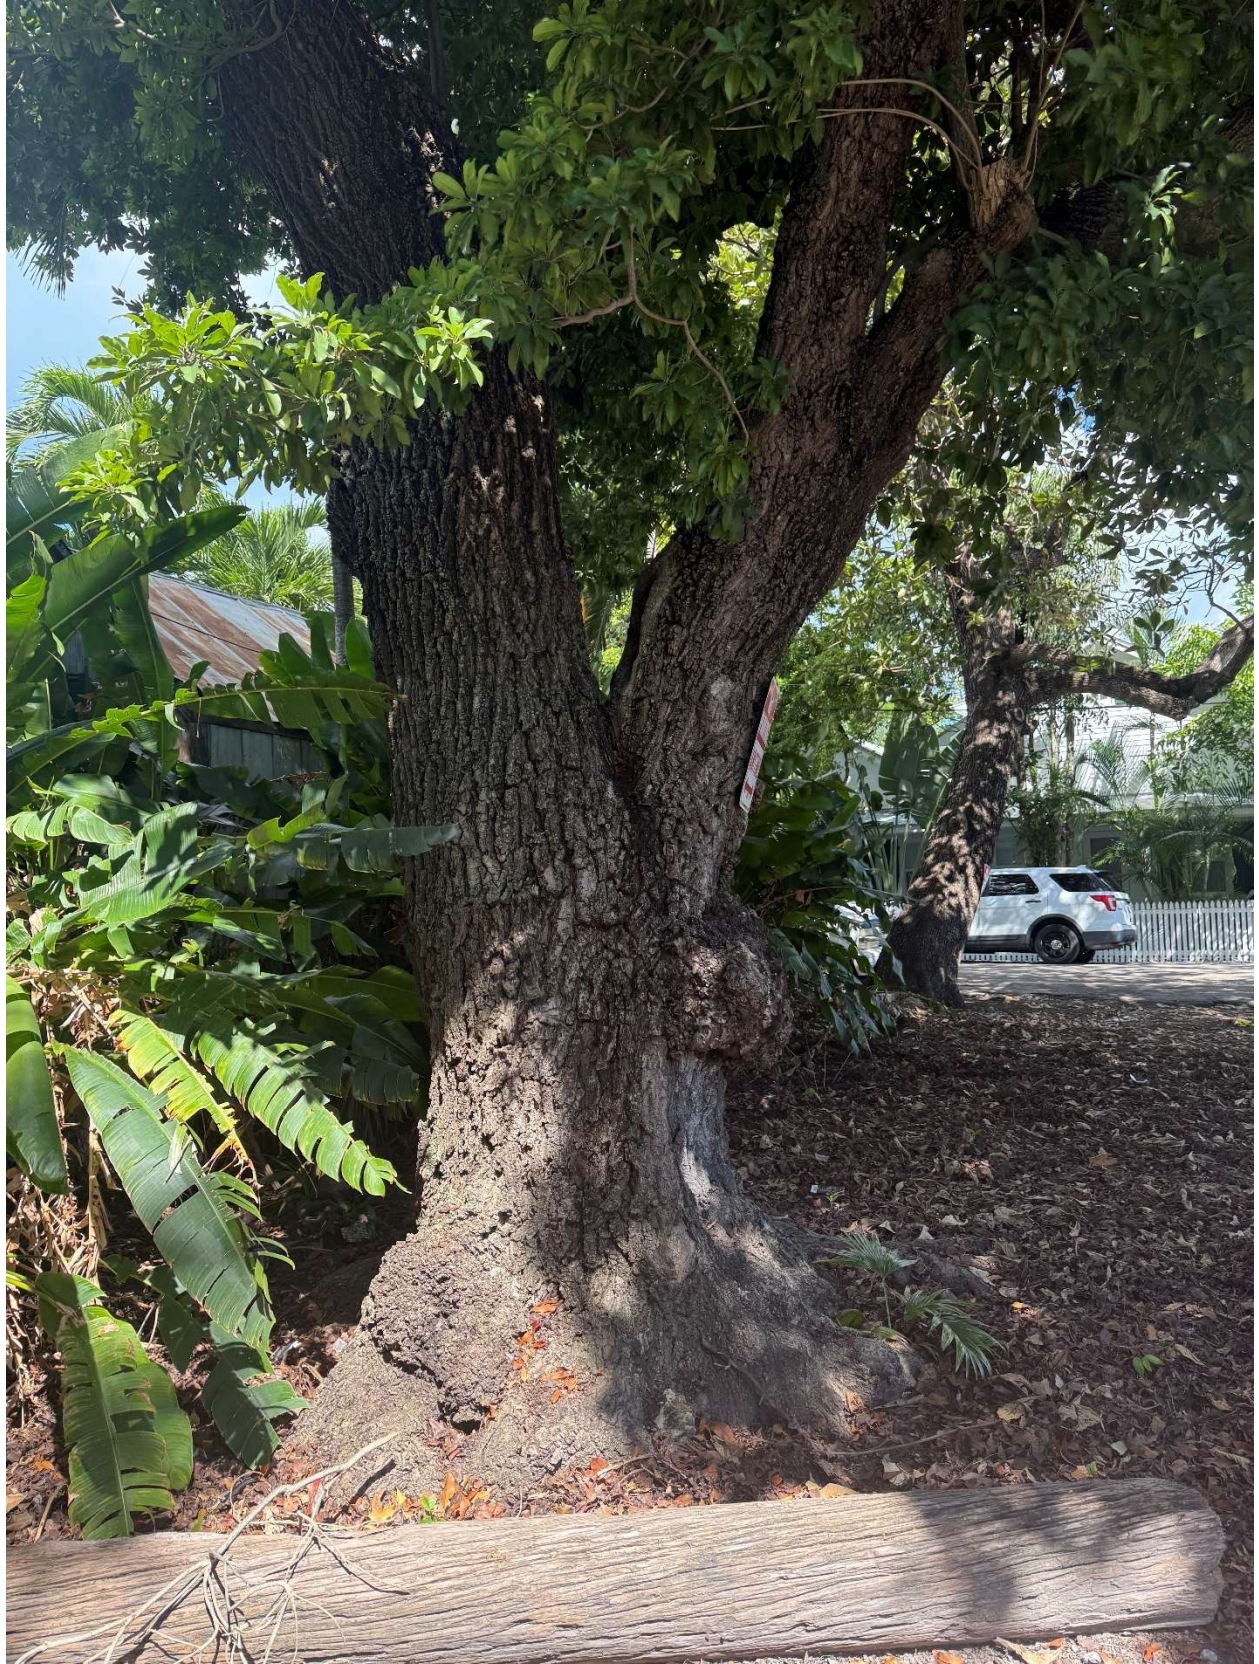
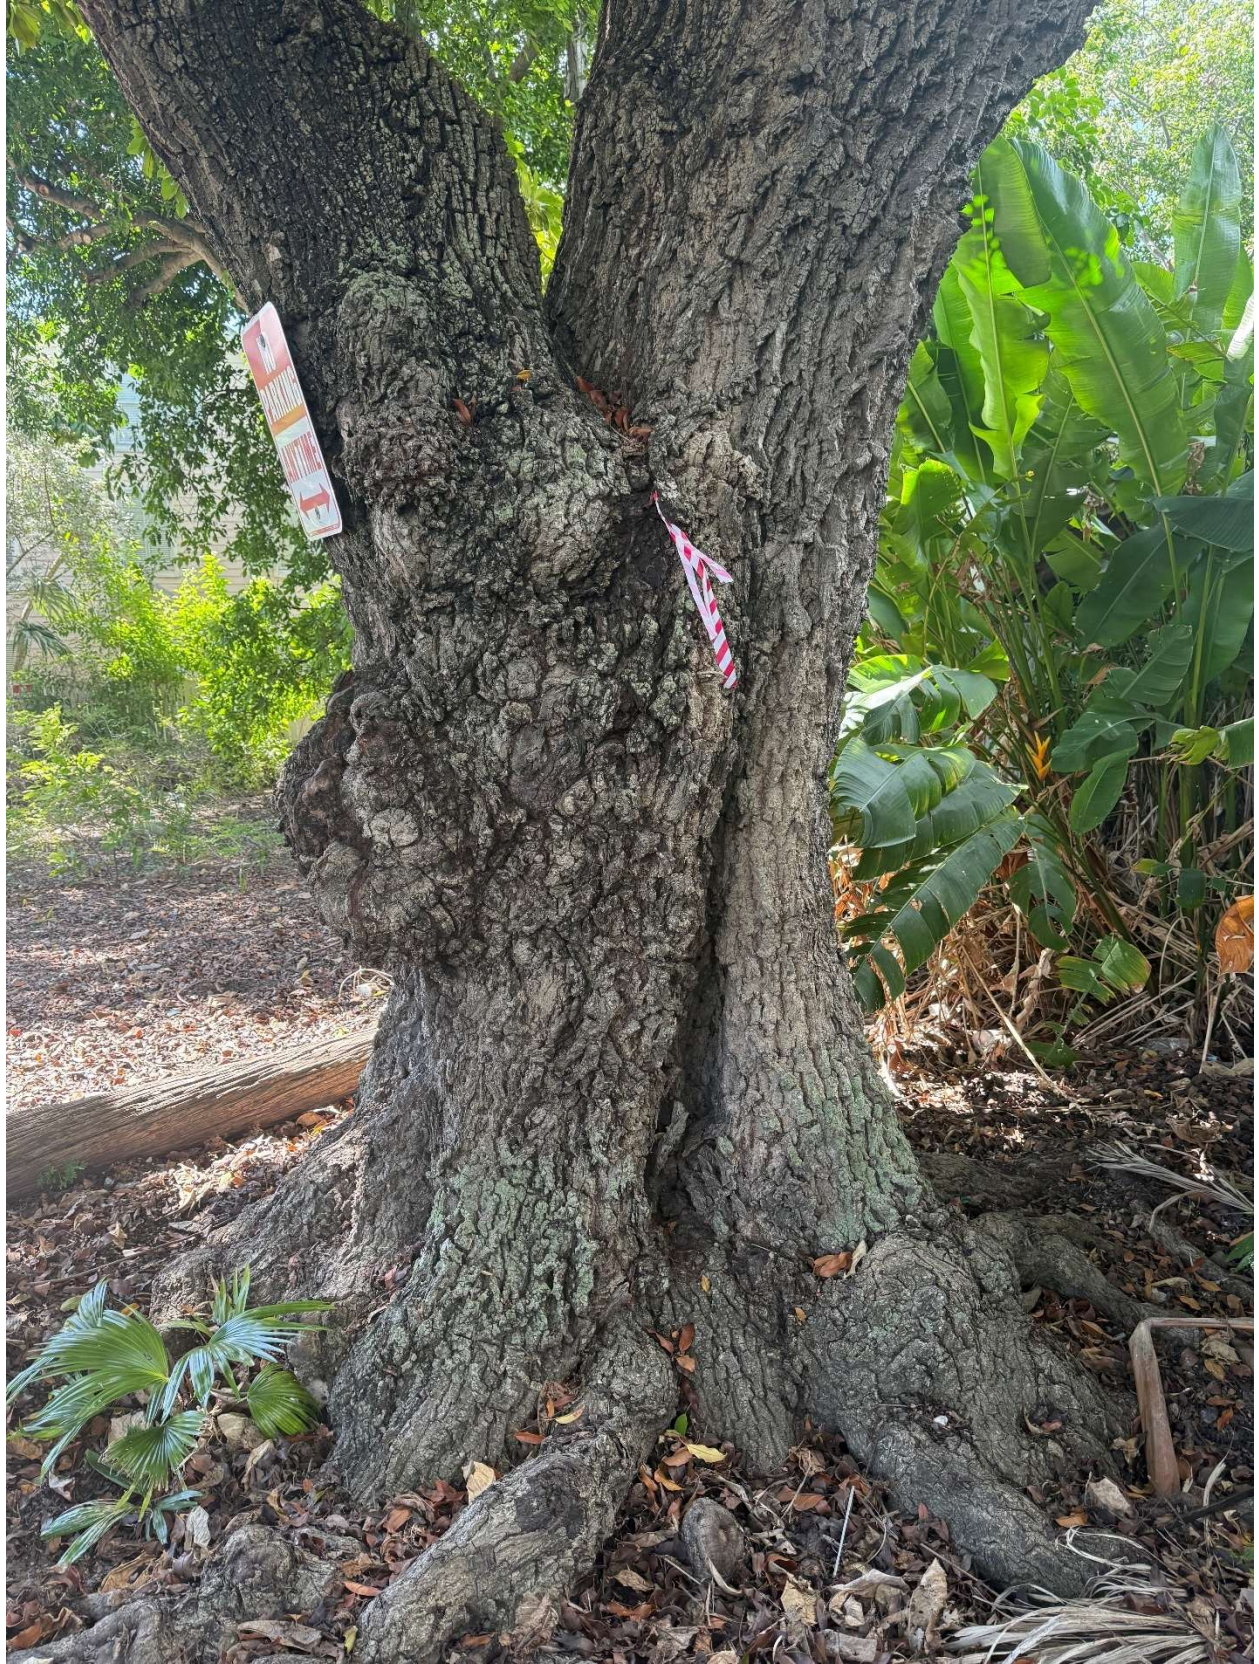
**Sapodilla Tree**

**The Sapodilla Tree was also not pruned in accordance with ANSI 300 standards. The stubs that were left behind create growth patterns and a growth form that is not conducive to a healthy canopy structure.**

**Diameter: 44"**

**Condition: 60%**

**Recommended Mitigation: 38 Caliper Inches**
