Subject: Key West Angelfish Pier Seawall Structural Assessment

CITY OF KEY WEST
PORT & MARINE SERVICES

KEY WEST GARRISON BIGHT MARINA
ANGELFISH PIER SEAWALL STRUCTURAL ASSESSMENT REPORT

Prepared By:
Tetra Tech, Inc.
759 South Federal Highway, Suite 314
Stuart, FL 34994

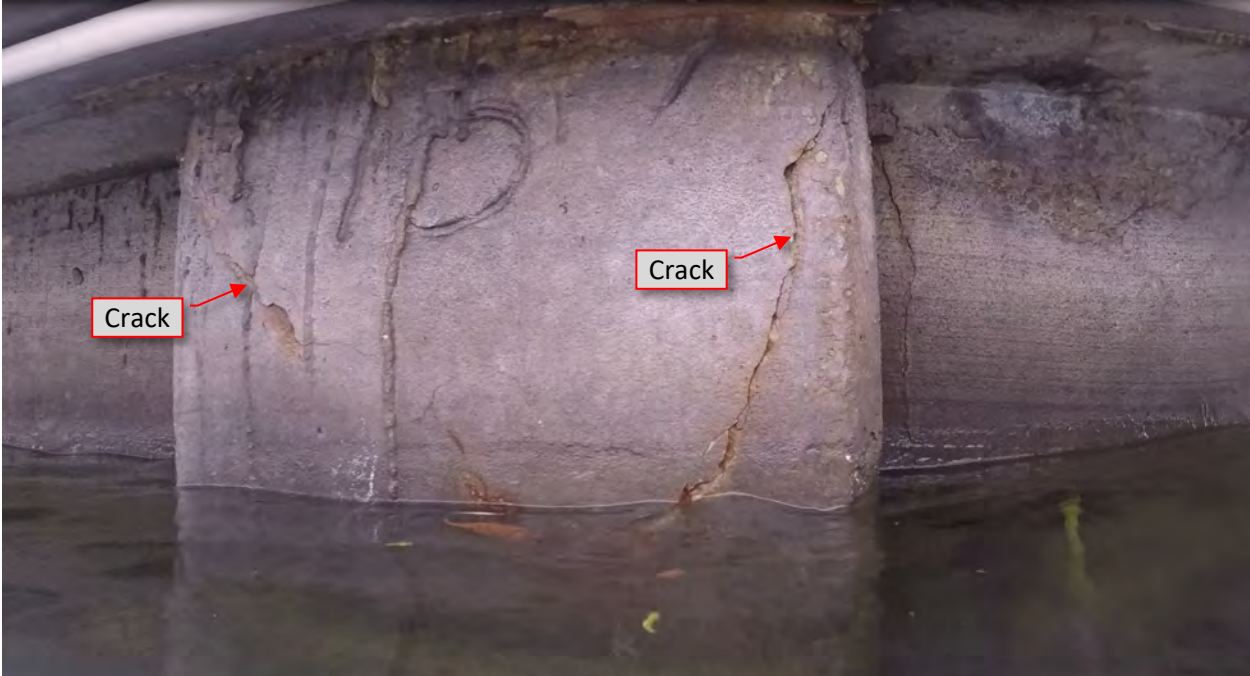
Figure 3: P2. STA 1+64. Crack/spall on pile.

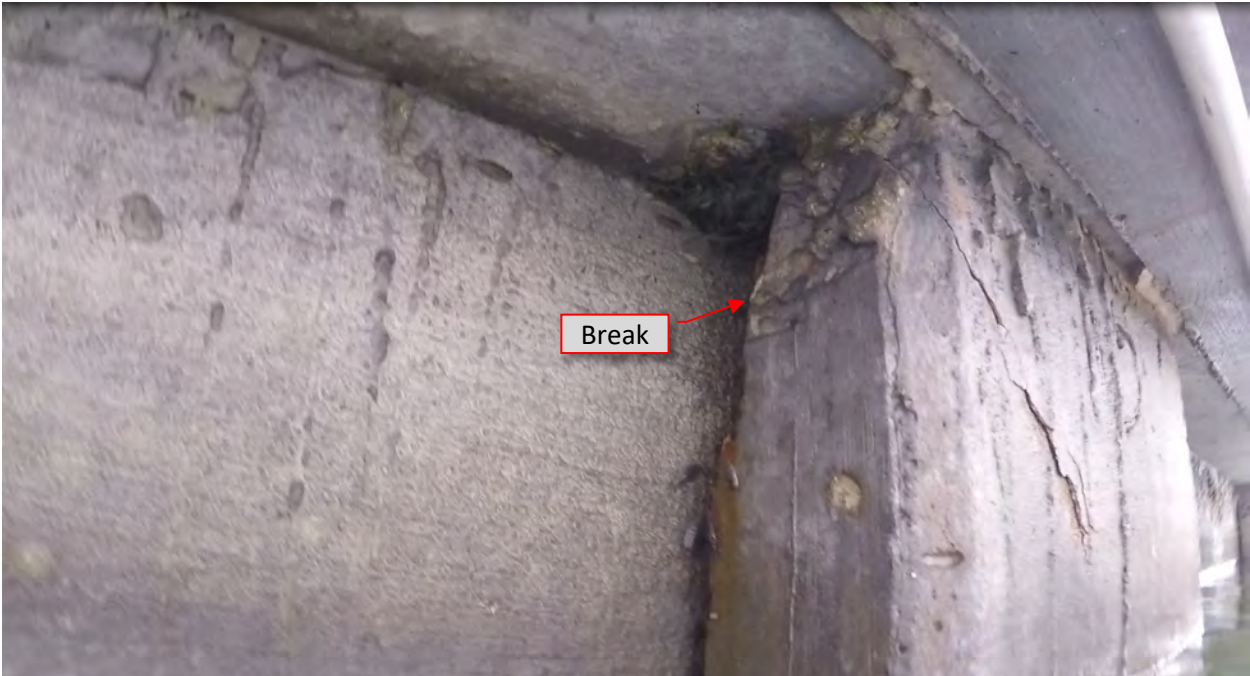
Figure 4: P2. STA 1+64. Break at top west flange and crack on south face on pile.

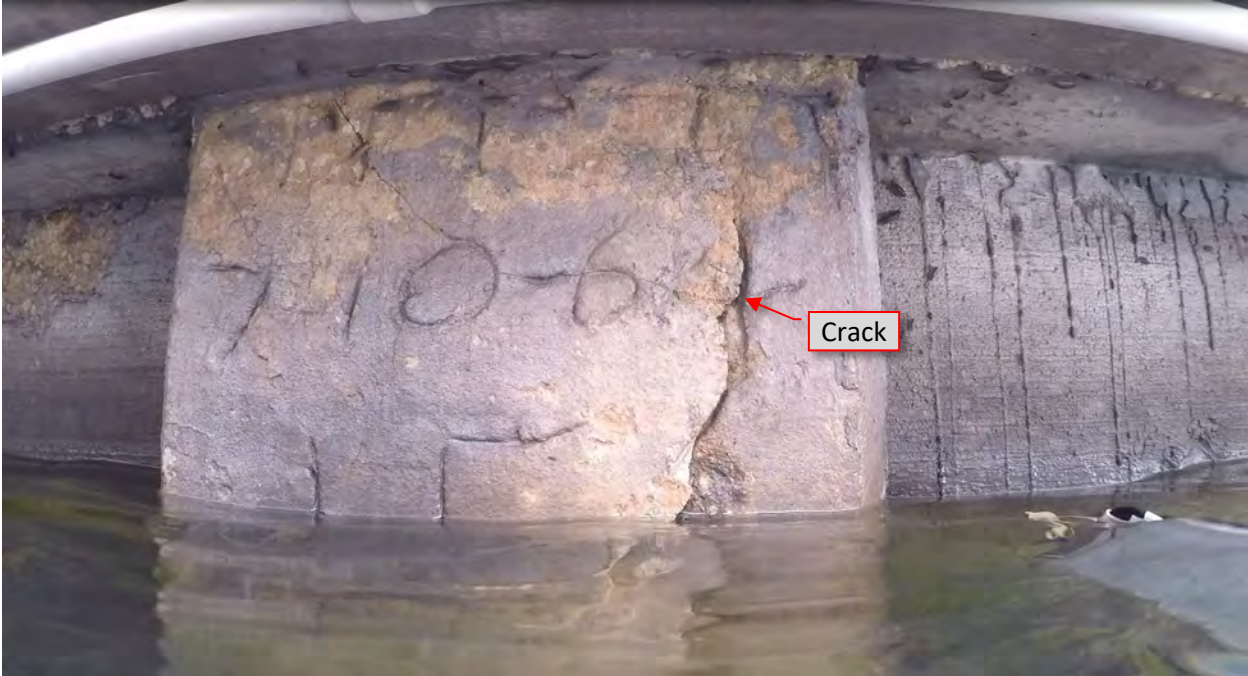
Figure 6: P3. STA 1+72. Crack/spall at pile.

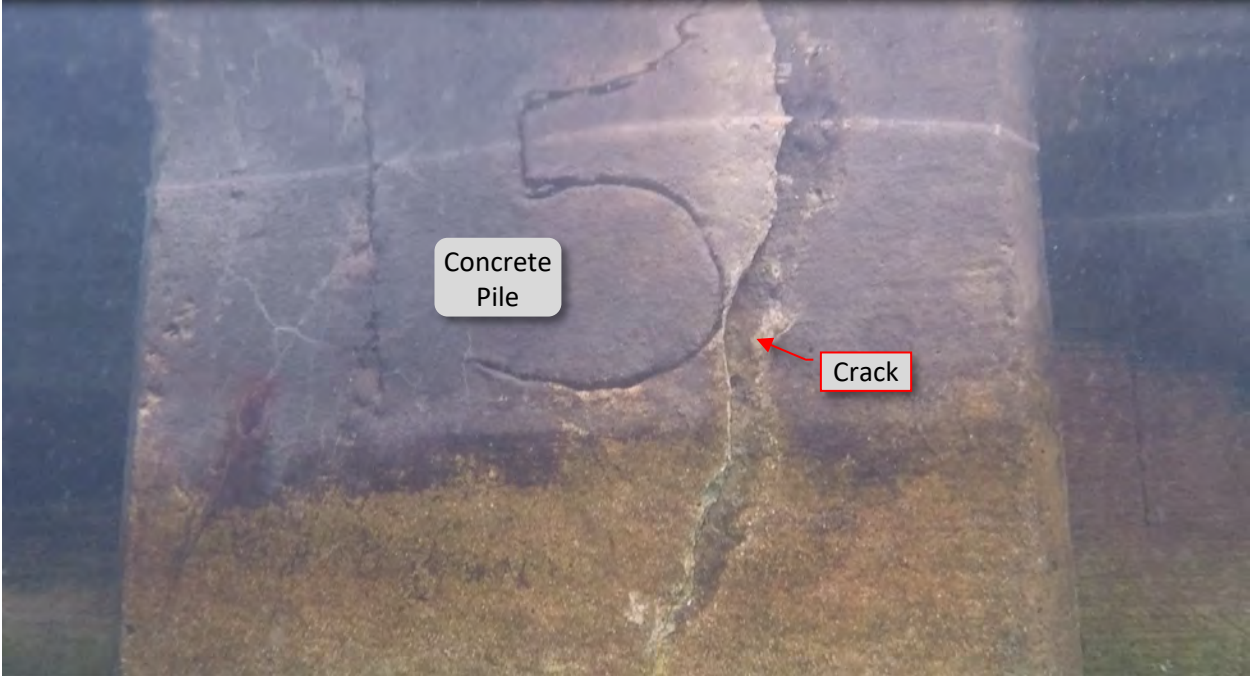
Figure 7: P3. STA 1+72. Crack/spall at pile. Underwater view.

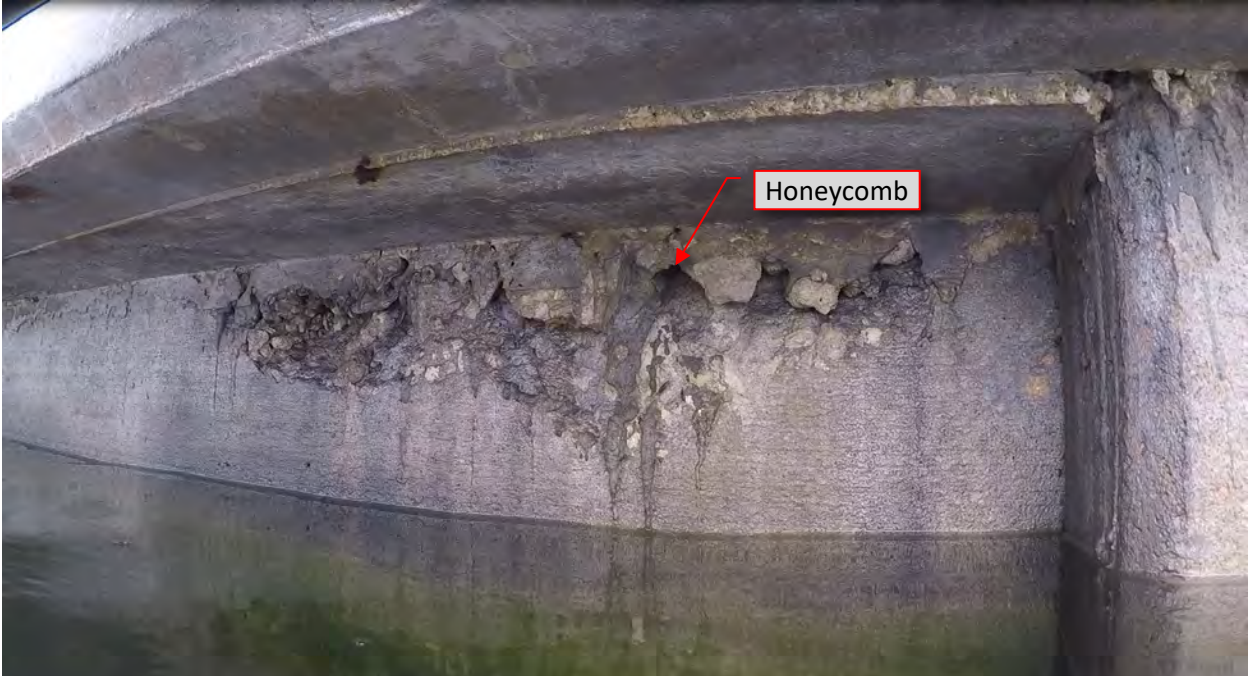
Figure 8: S2. STA 2+31 - 2+34. Concrete erosion at honeycomb area on slab.

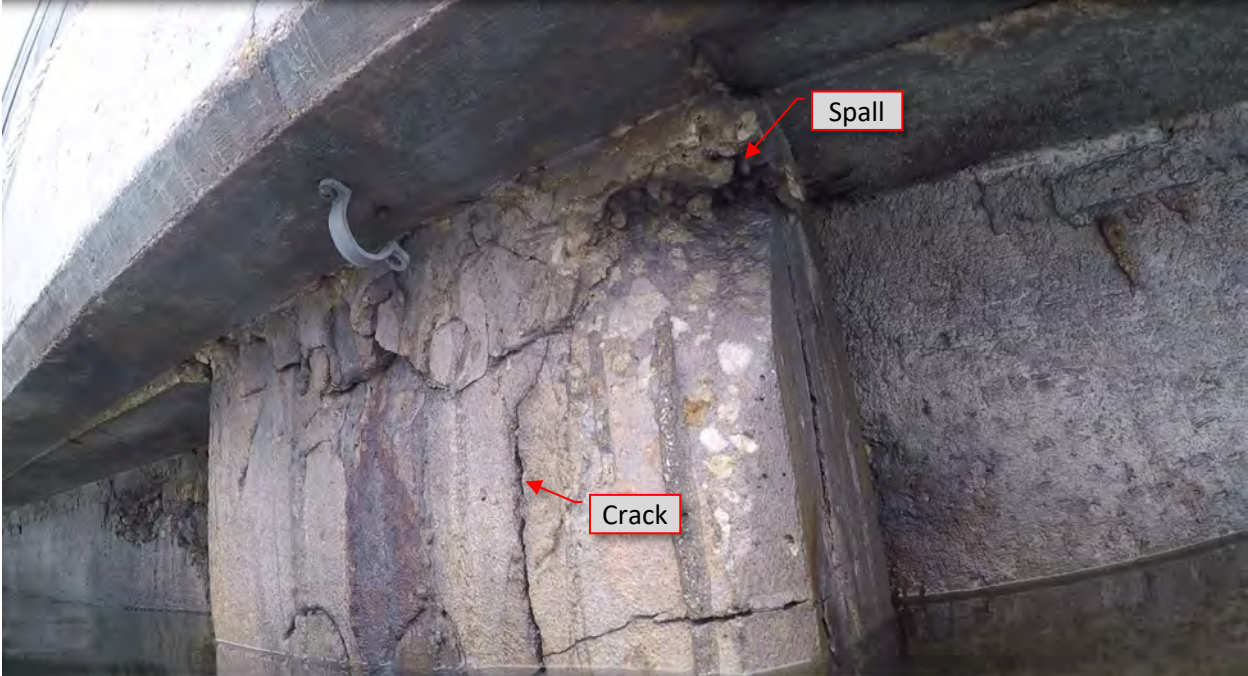
Figure 9: P4. STA 2+35. Multiple cracks and spalls at pile.

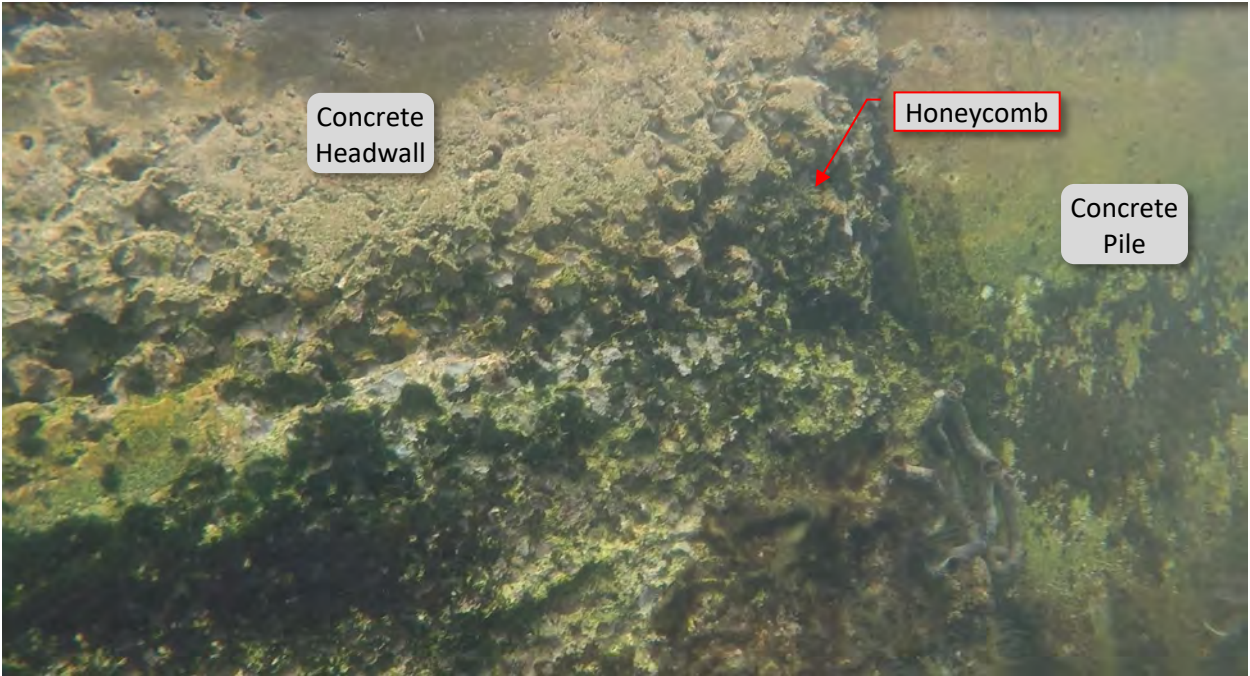
Figure 12: HW1. STA 2+49 - 2+50. Honeycomb area at culvert headwall.

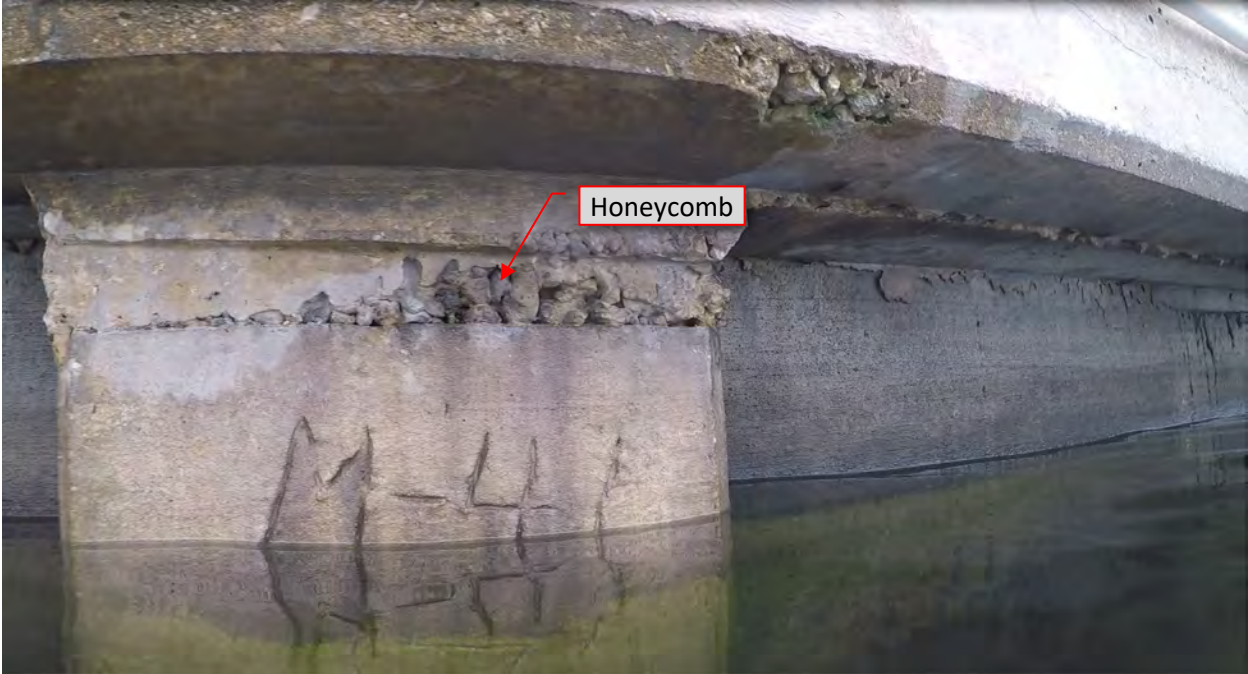
Figure 14: P5. STA 2+60. Honeycomb at pile top.

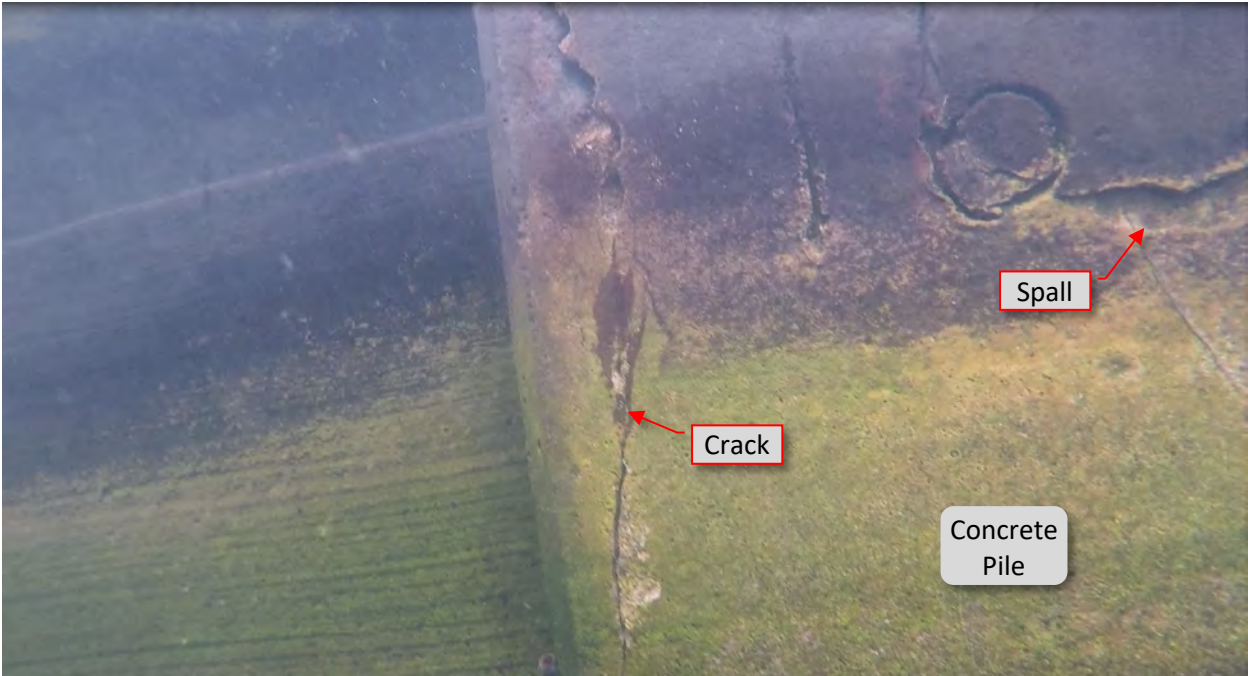
Figure 16: P6. STA 2+76. Crack/spall at west flange on pile. Underwater view.

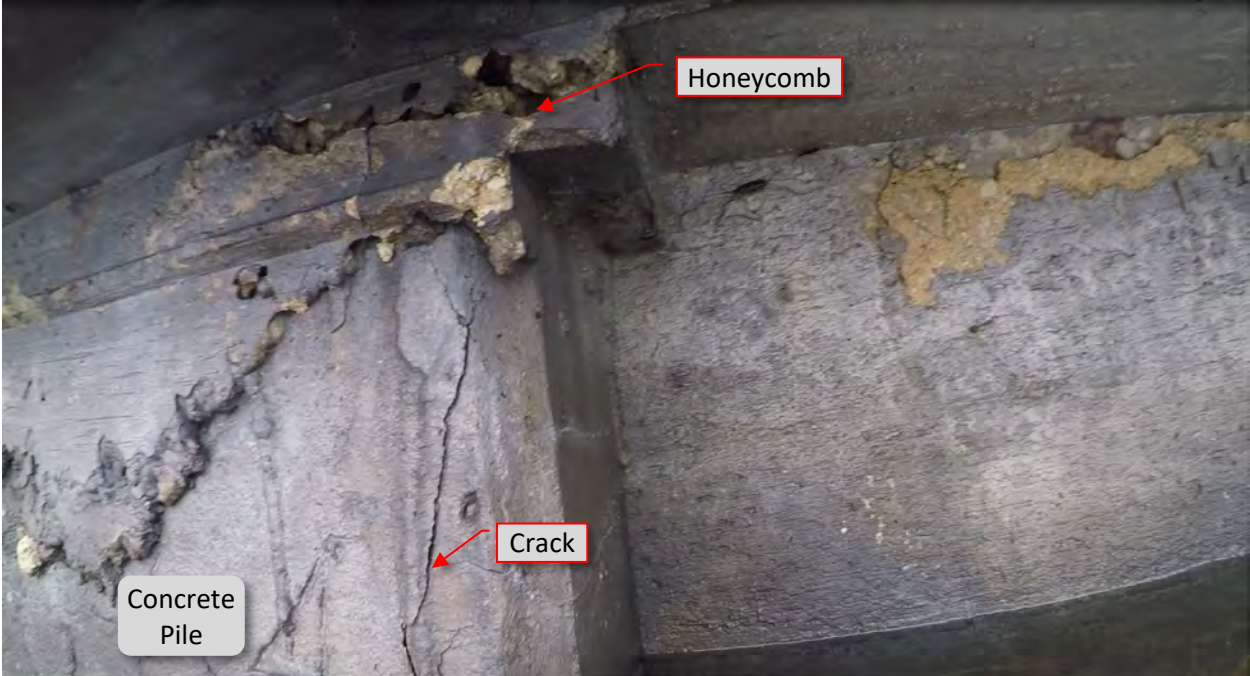
Figure 17: P6. STA 2+76. Honeycomb across the pile top. Crack/spall at east flange on pile.

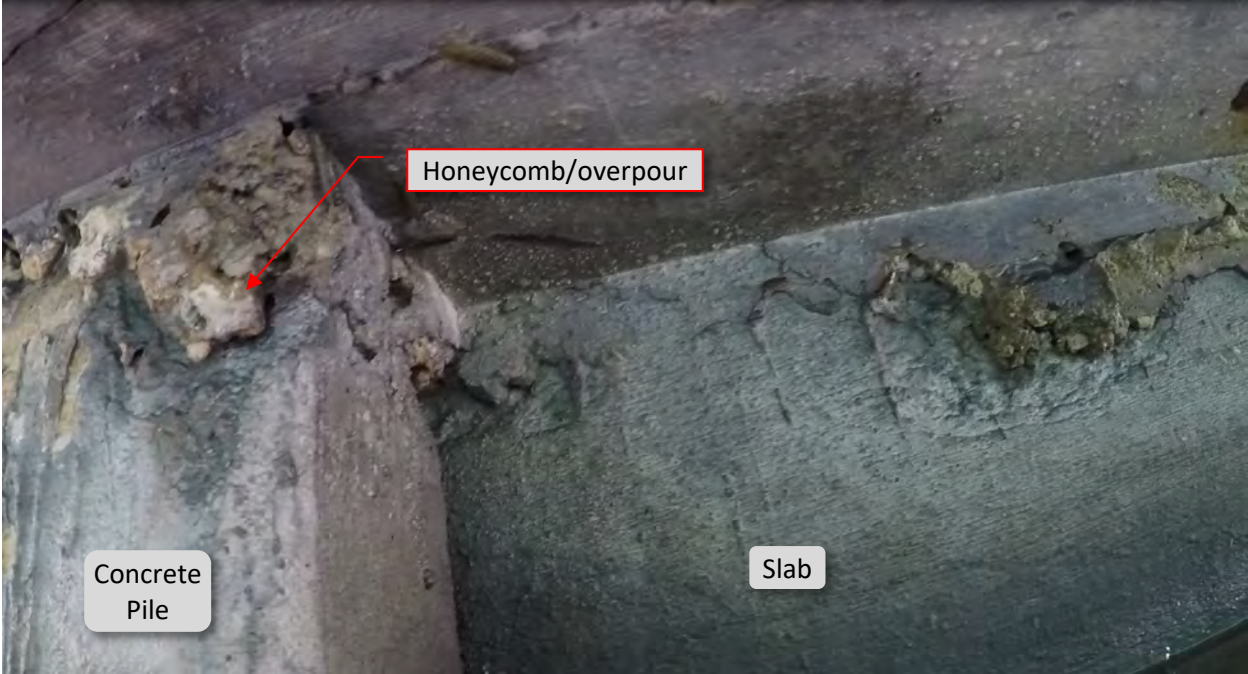
Figure 21: P8. STA 2+94. Honeycomb area and concrete overpour at east flange at pile.

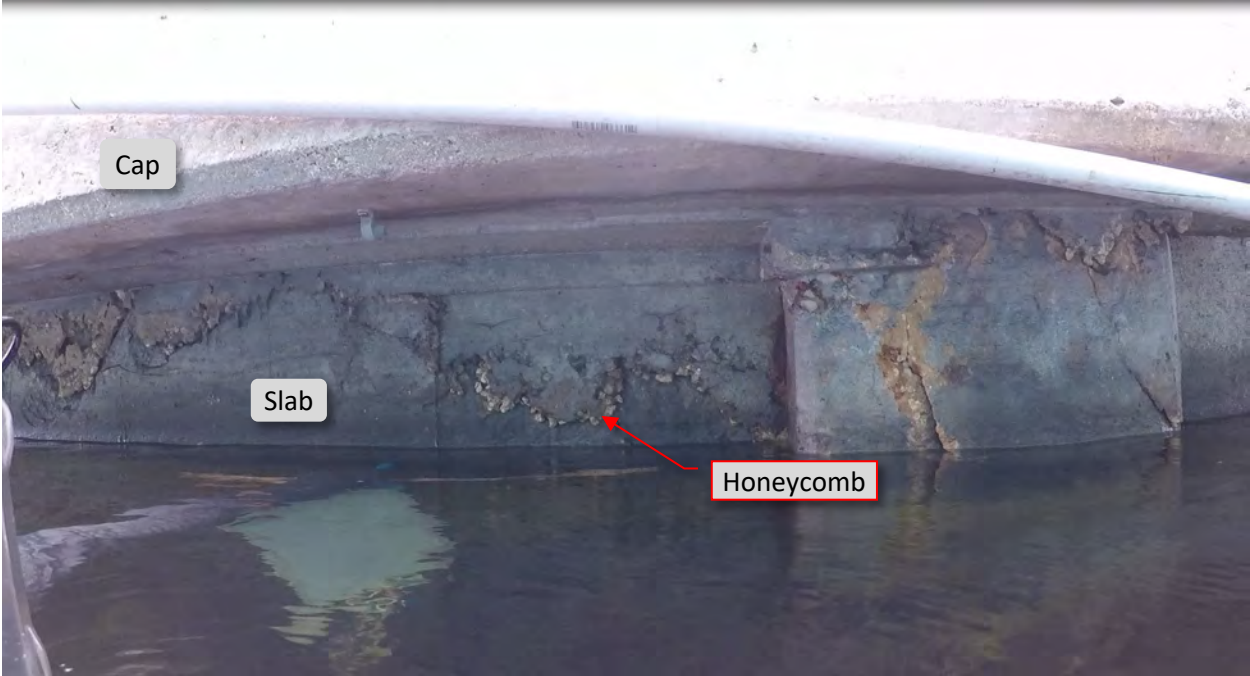
Figure 23: S5. STA 2+93 - 2+99. Honeycomb at top of slab. North direction view.

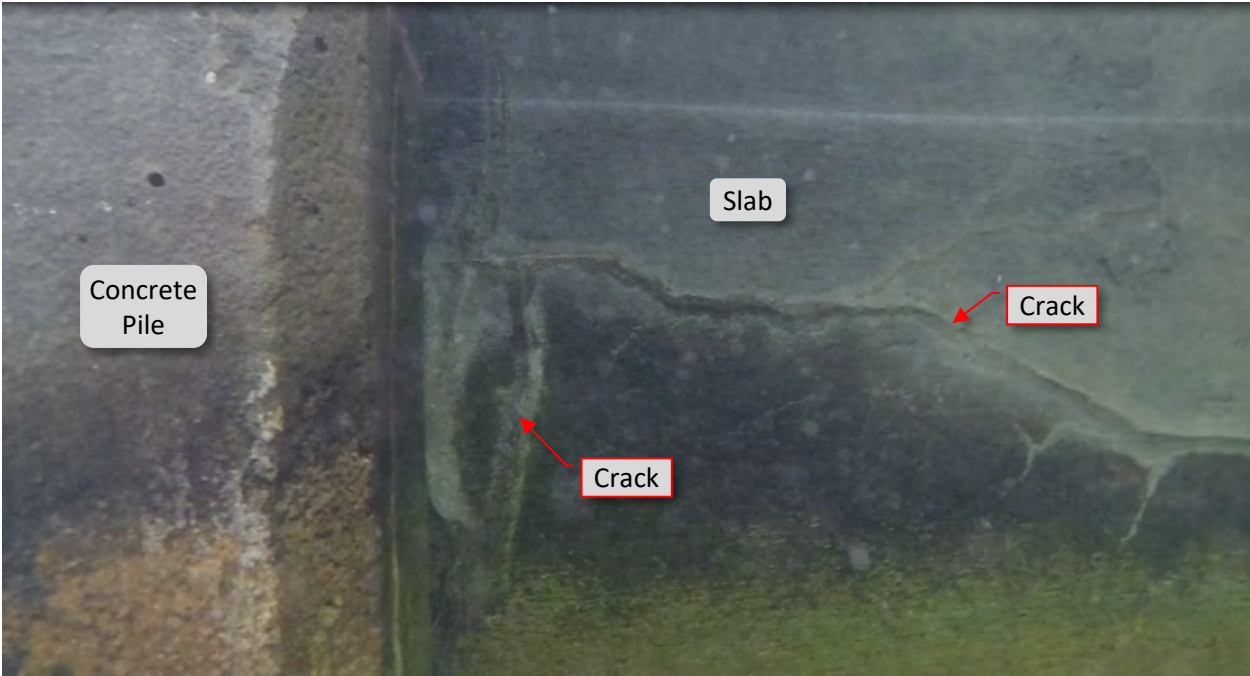
Figure 26: S6. STA 3+01 - 3+04. Two perpendicular cracks on slab at mid height from shelf to cap. Underwater view.

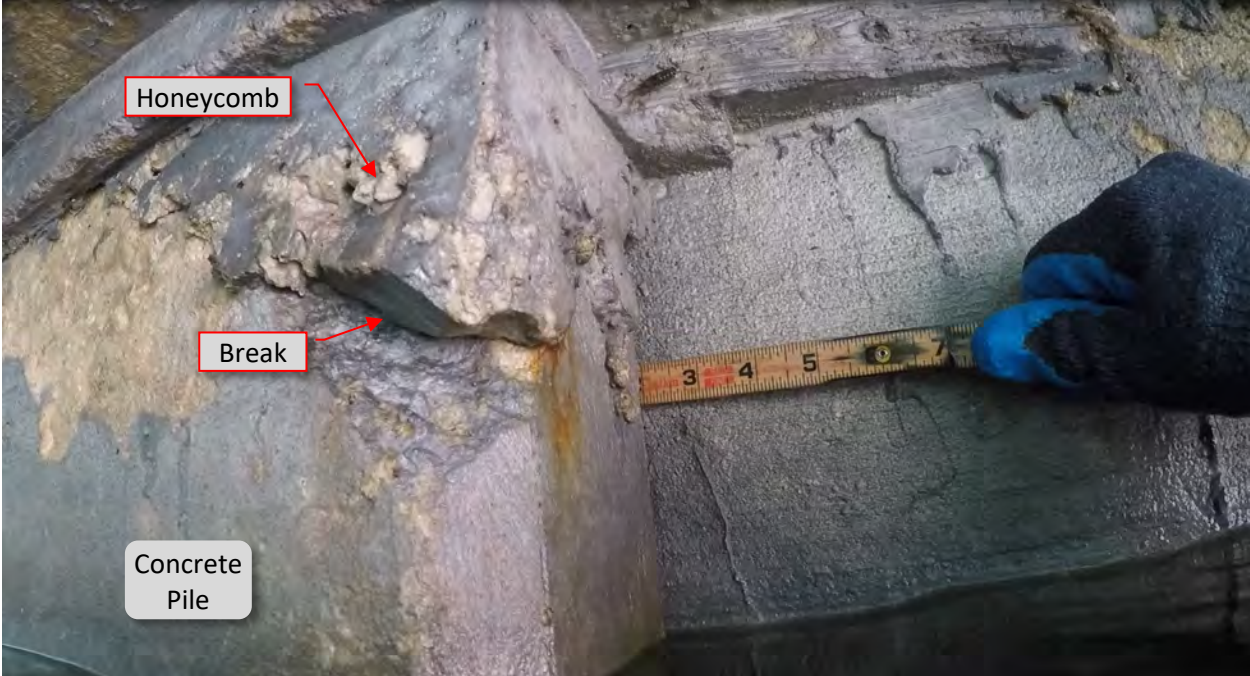
Figure 27: P10. STA 3+07. Break at top east flange corner at pile. Honeycomb area.

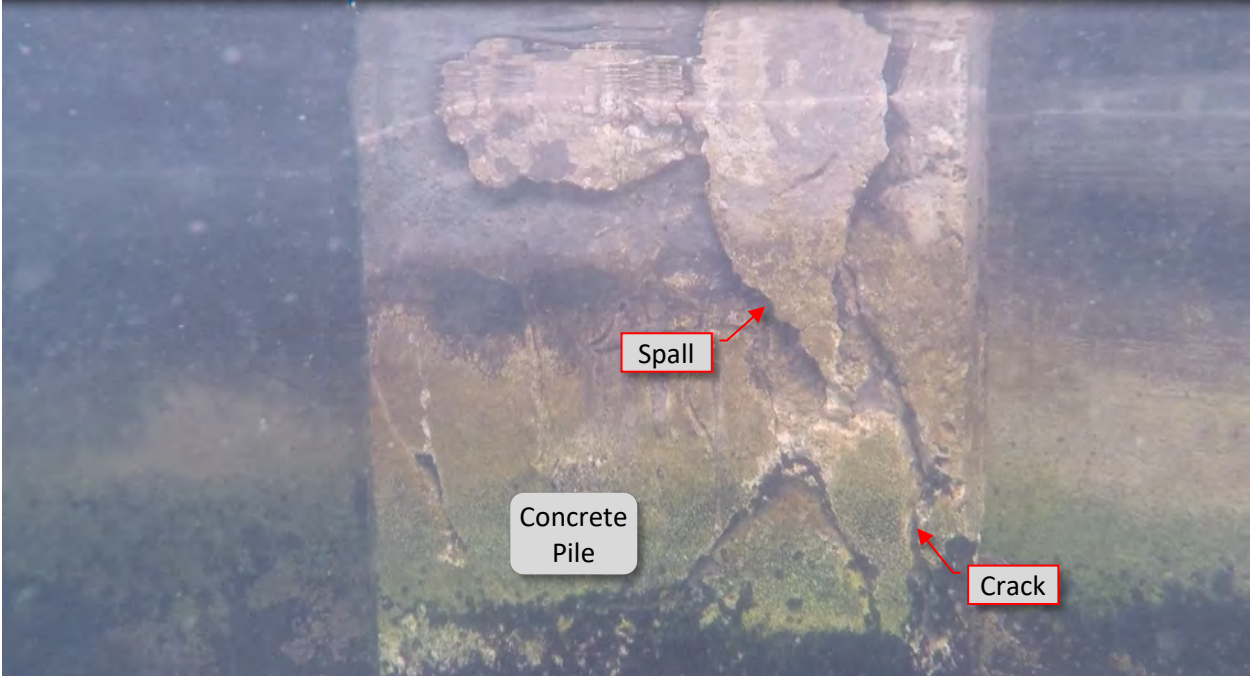
Figure 29: P11. STA 3+16. Crack/spall at east flange at pile. Underwater view.

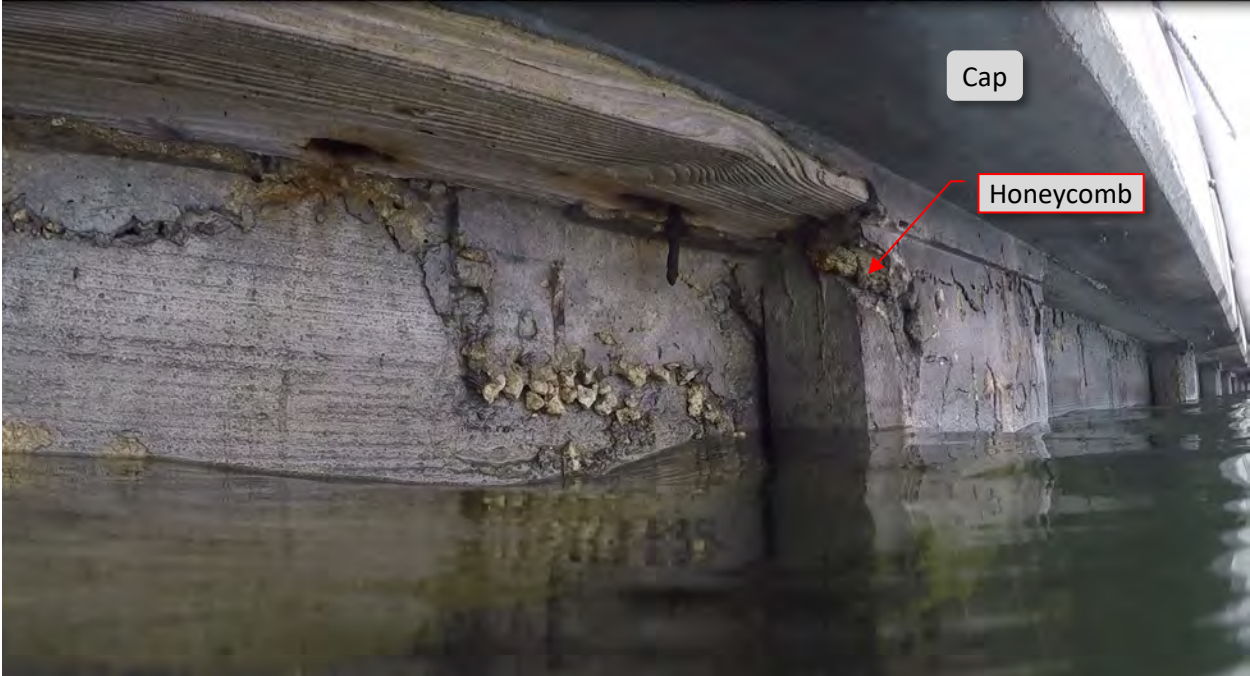
Figure 31: P12. STA 3+24. Honeycomb at pile top.

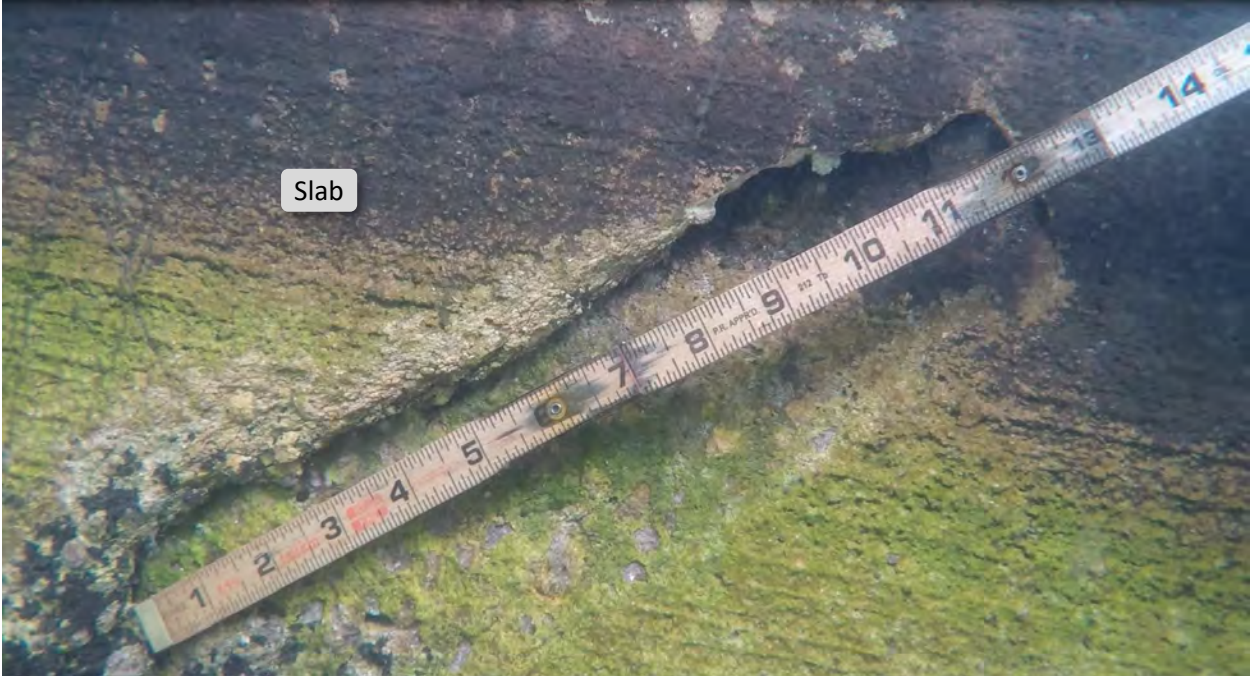
Figure 35: S8. 3+33 - 3+41. Crack at slab midspan. Underwater view.

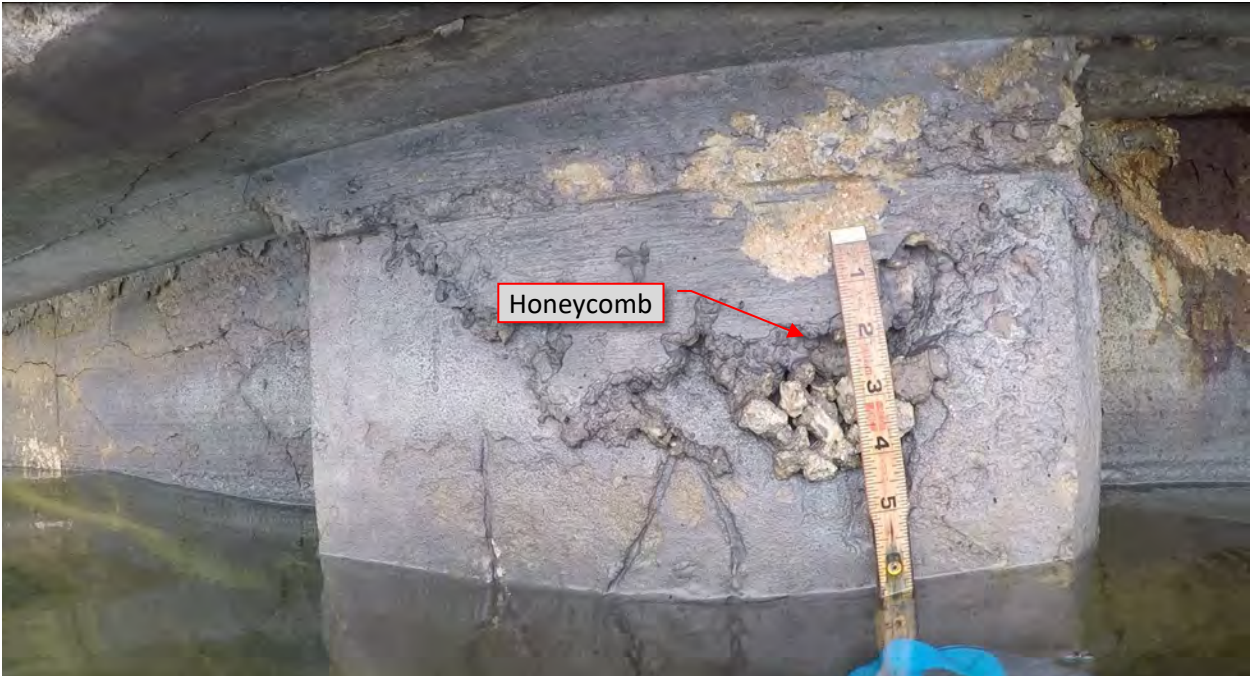
Figure 36: P14. STA 3+39. Honeycomb area at pile.

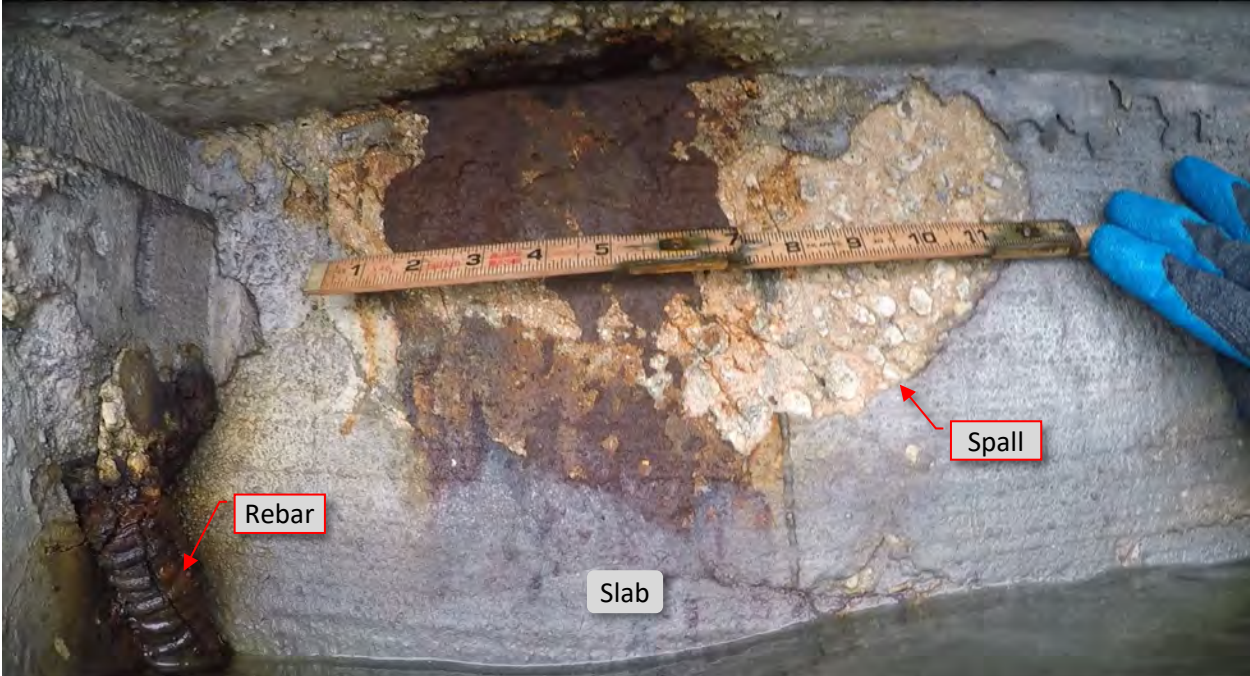
Figure 37: P14. STA 3+39. #11 Size rebar protrusion at east flange. S9. STA 3+41. Spall with rust staining at slab west corner.

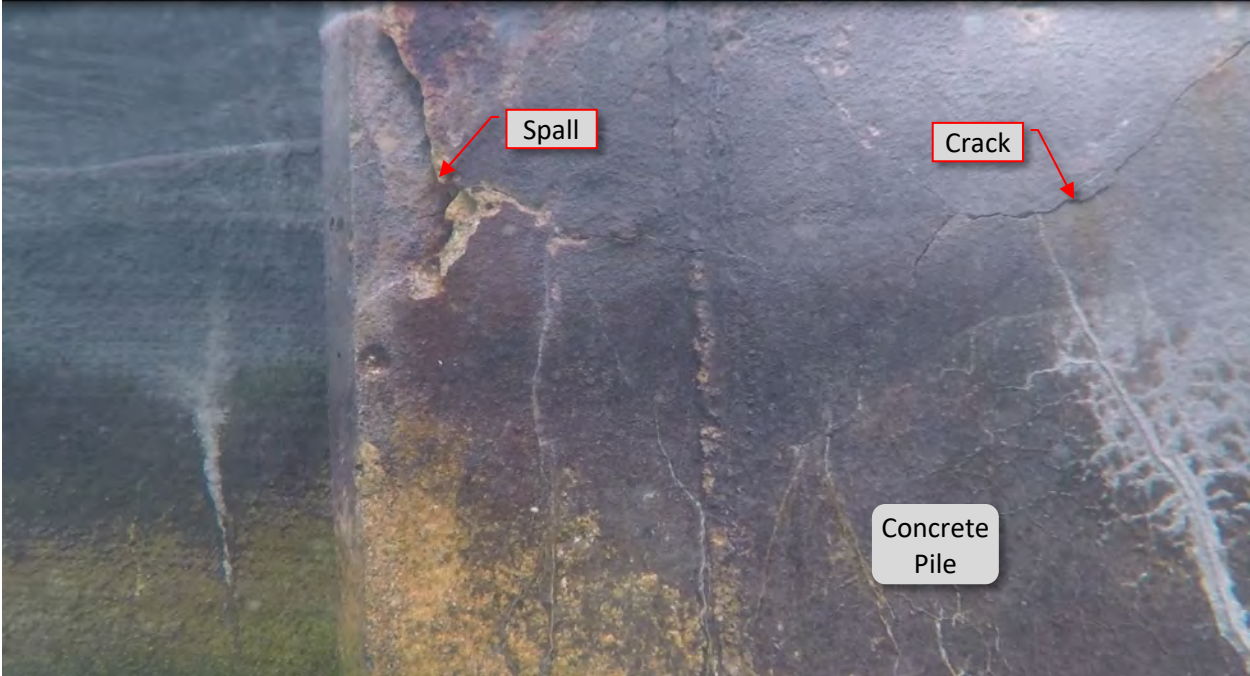
Figure 40: P15. STA 3+48. Cracks at south face and spall at west flange at pile.

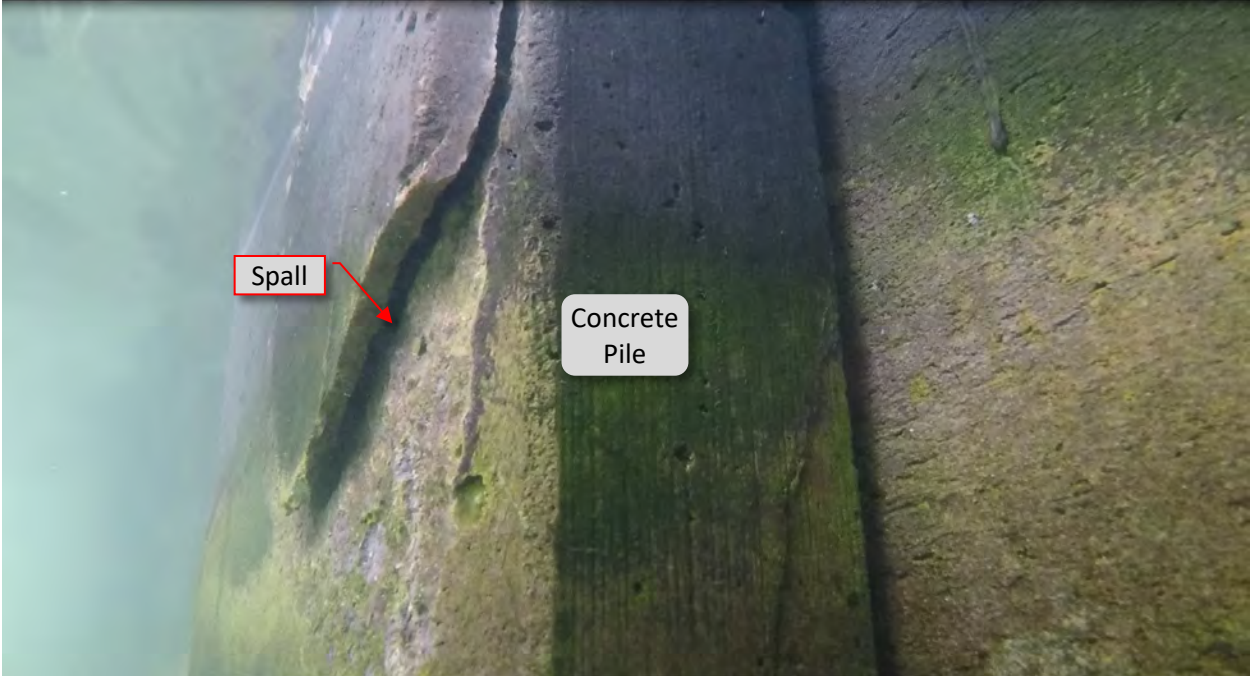
Figure 43: P16. STA 3+56. Spall/crack on south side and near east flange at pile.

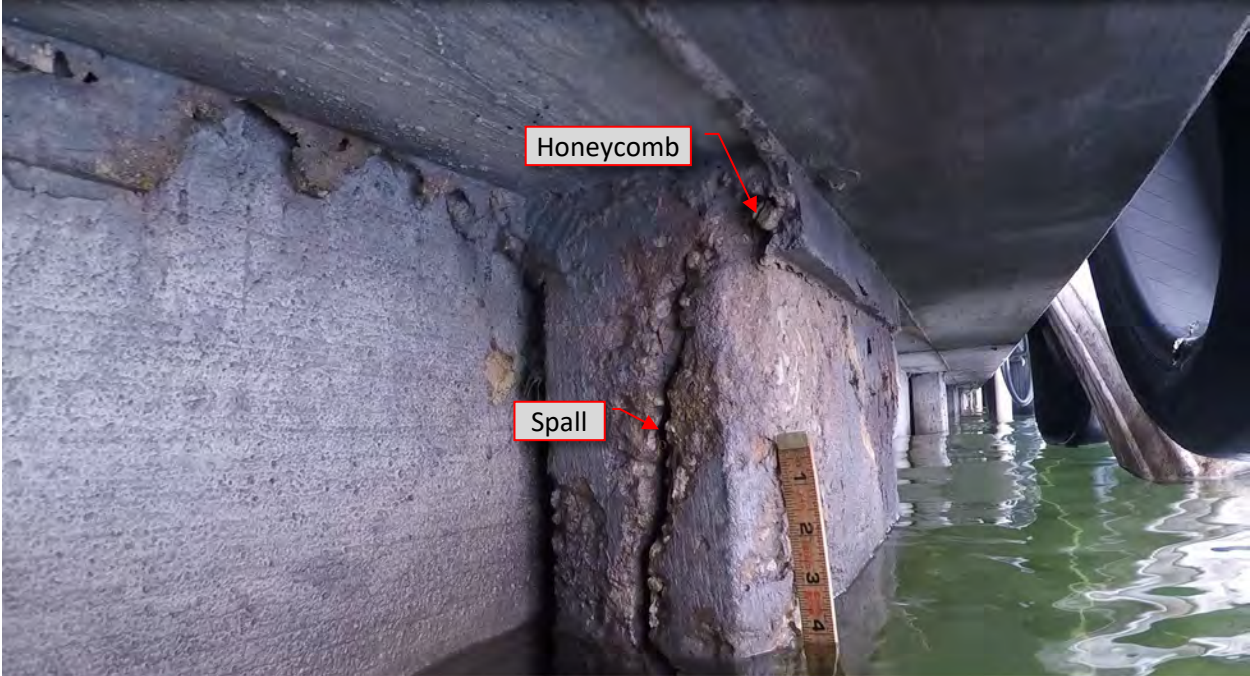
Figure 47: P18. STA 3+71. Spall/crack at west top of flange at pile. Honeycomb area.

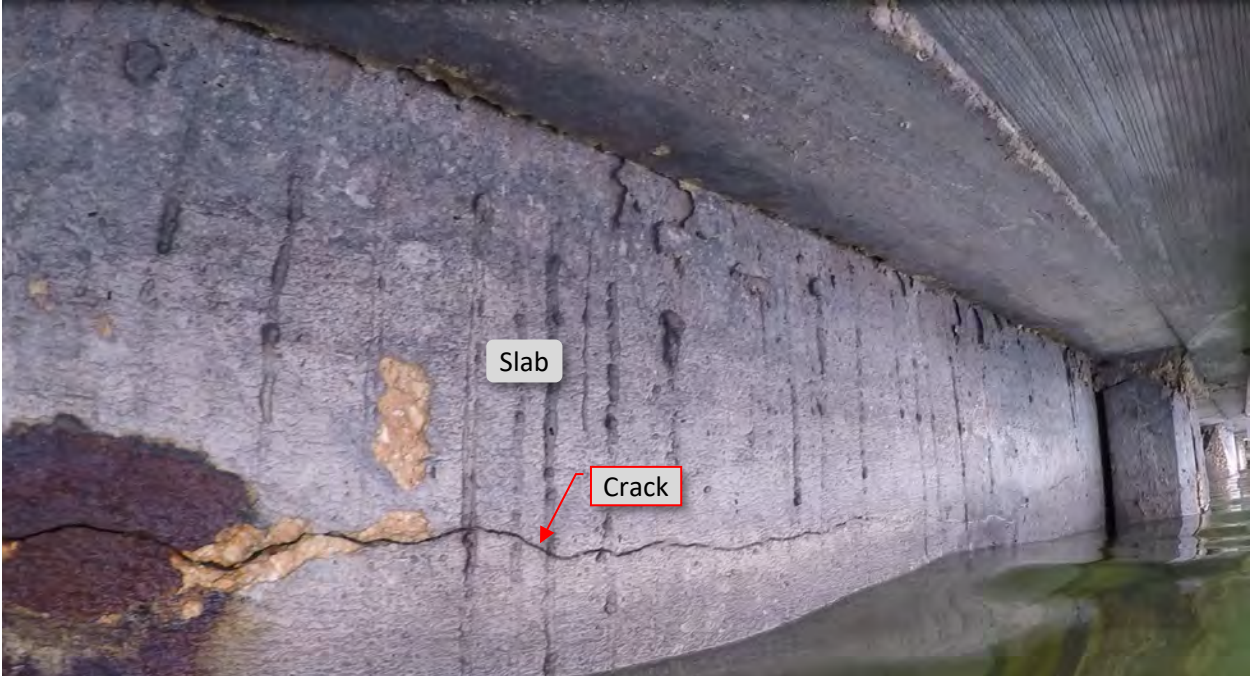
Figure 51: S12. STA 3+87 - 3+95. Crack at top of slab.

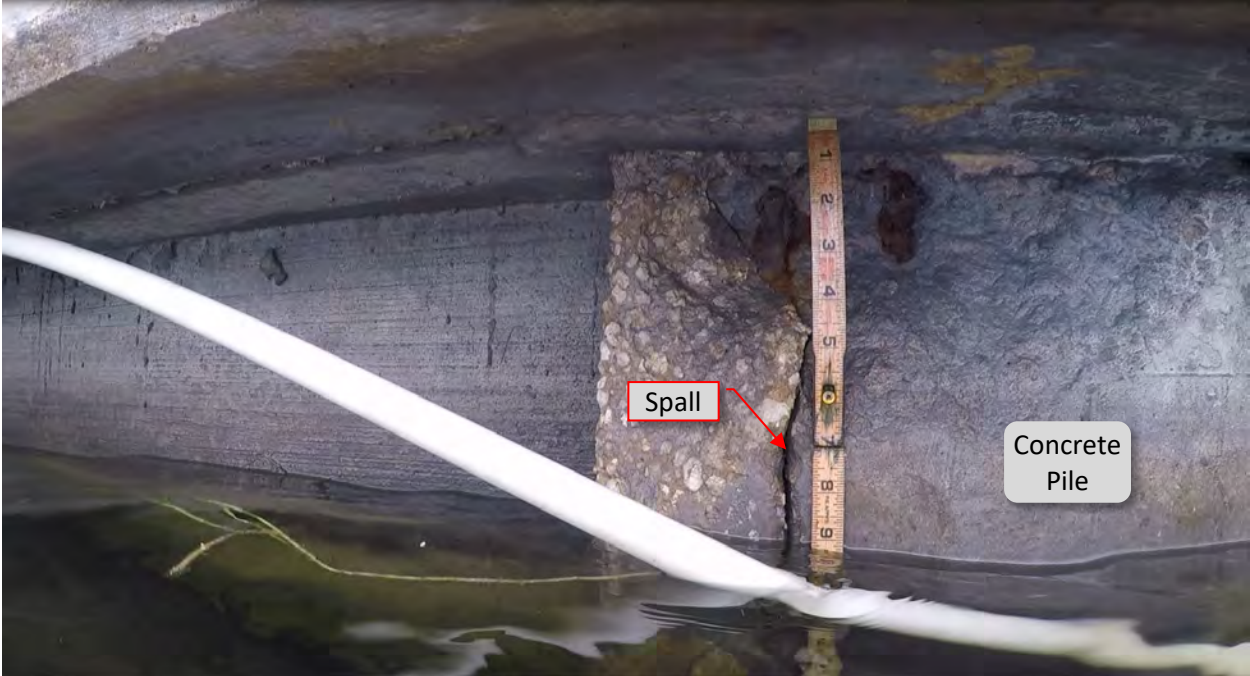
Figure 55: P20. STA 4+04. Spall/crack at west flange at pile.

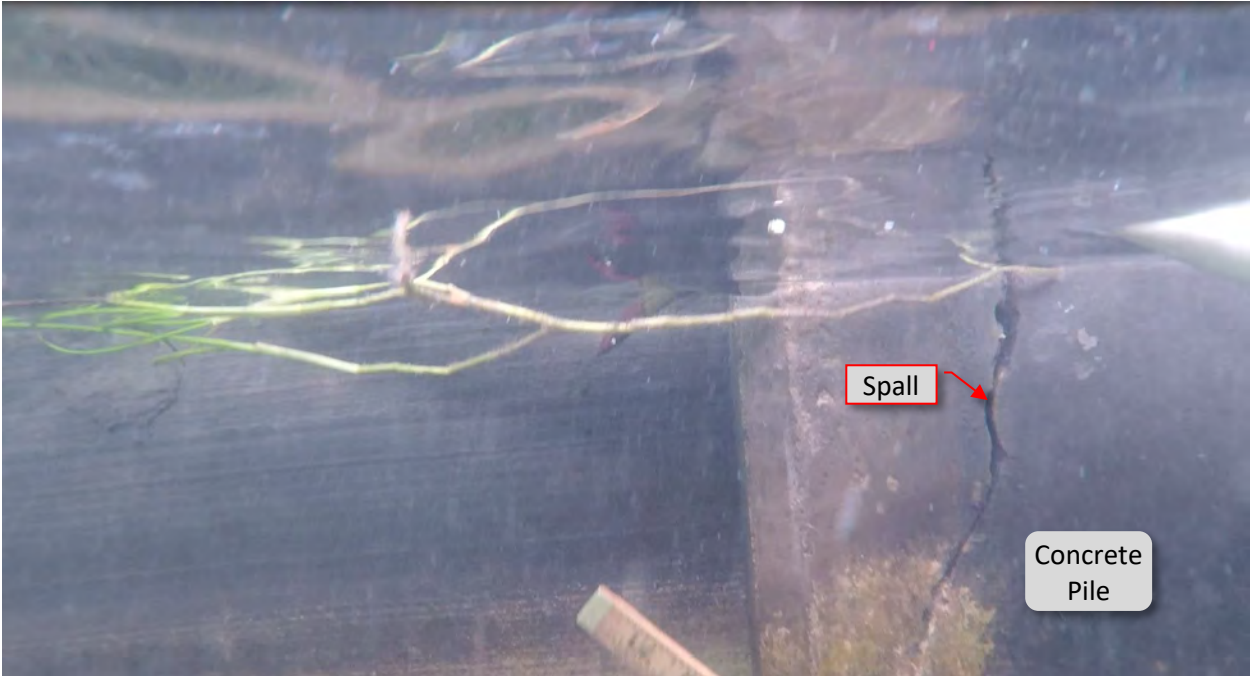
Figure 56: P20. STA 4+04. Spall/crack at west flange at pile. Underwater view.

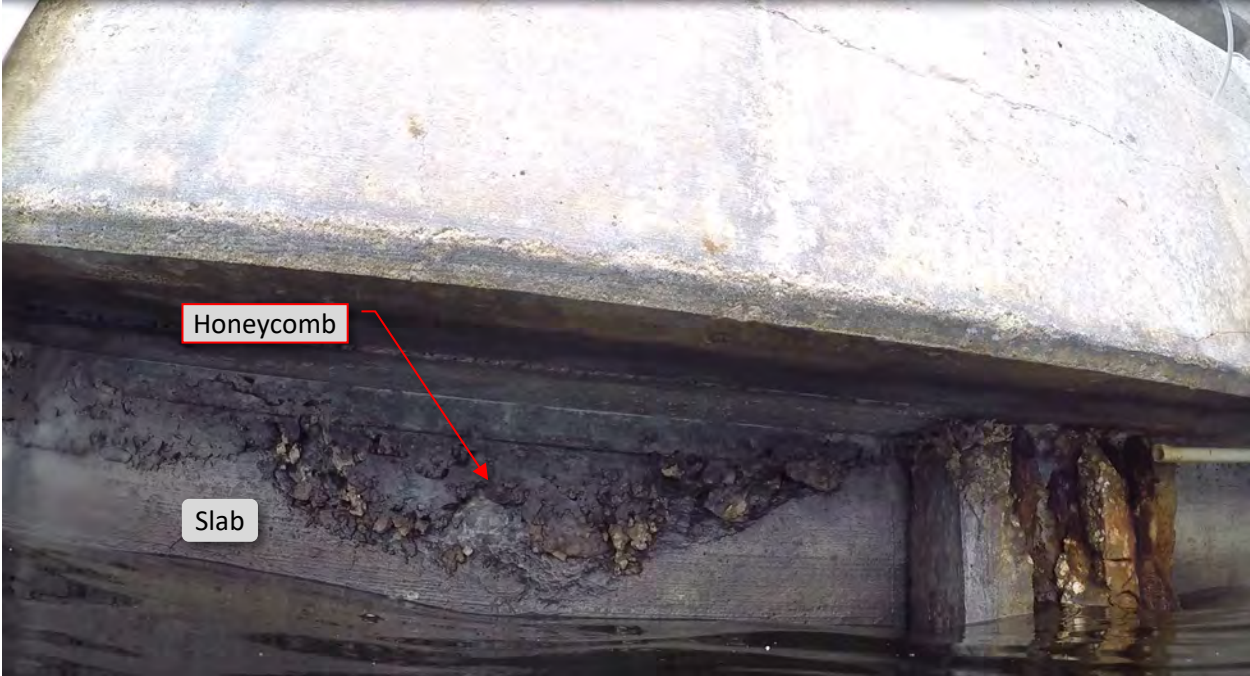
Figure 57: S14. STA 4+08 - 4+11. Honeycomb at top of slab.

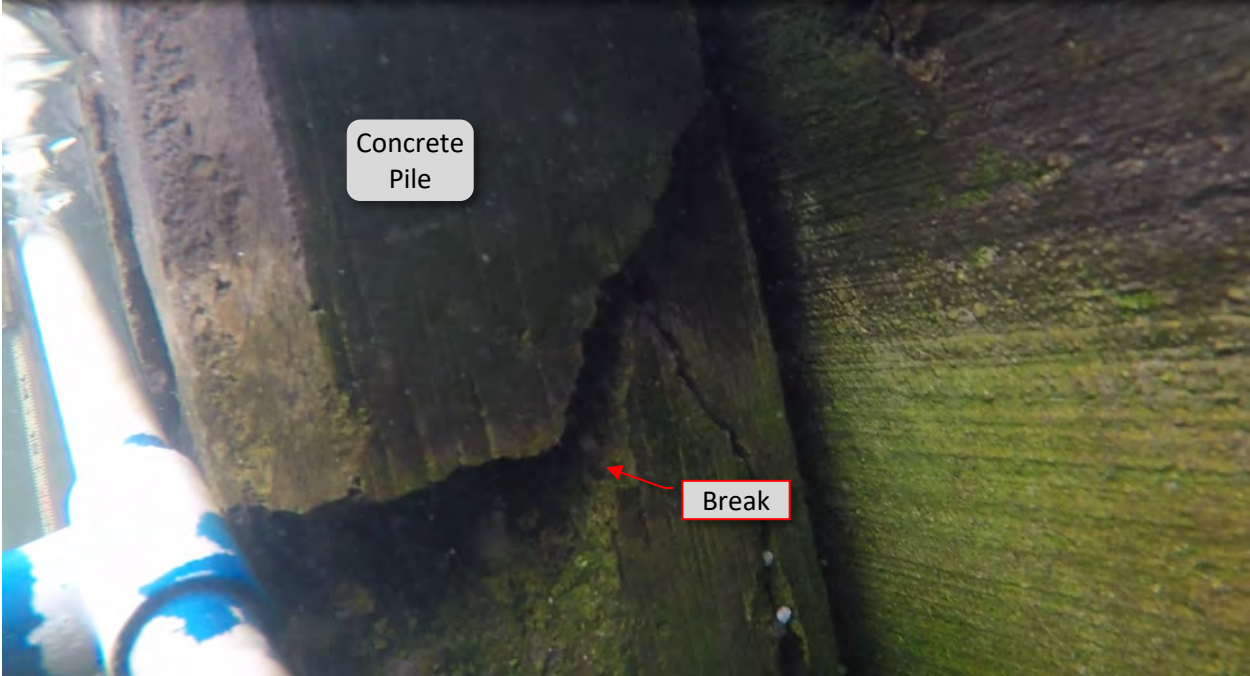
Figure 62: P23. STA 4+28. Break/spall at east flange at pile. Loss of concrete.
