Subject: Key West Angelfish Pier Seawall Structural Assessment

CITY OF KEY WEST
PORT & MARINE SERVICES

KEY WEST GARRISON BIGHT MARINA
ANGELFISH PIER SEAWALL STRUCTURAL ASSESSMENT REPORT

Prepared By:
Tetra Tech, Inc.
759 South Federal Highway, Suite 314
Stuart, FL 34994

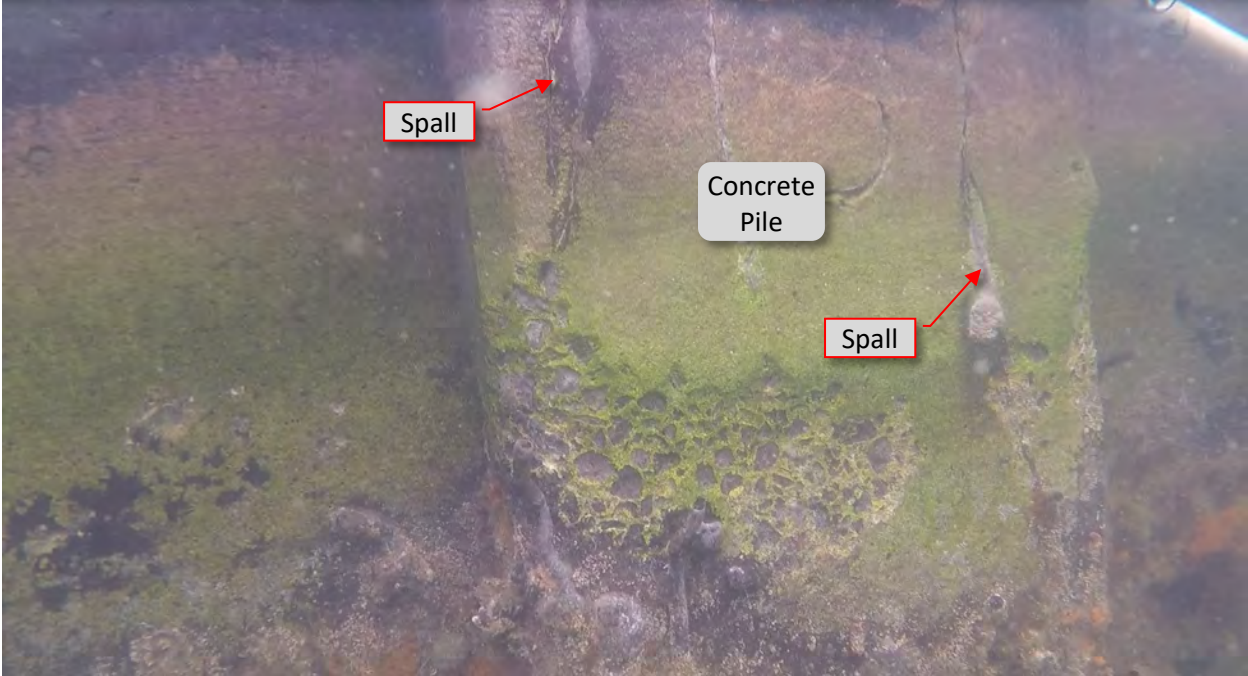
Figure 63: P23. STA 4+28. Spalls at both flanges at pile.

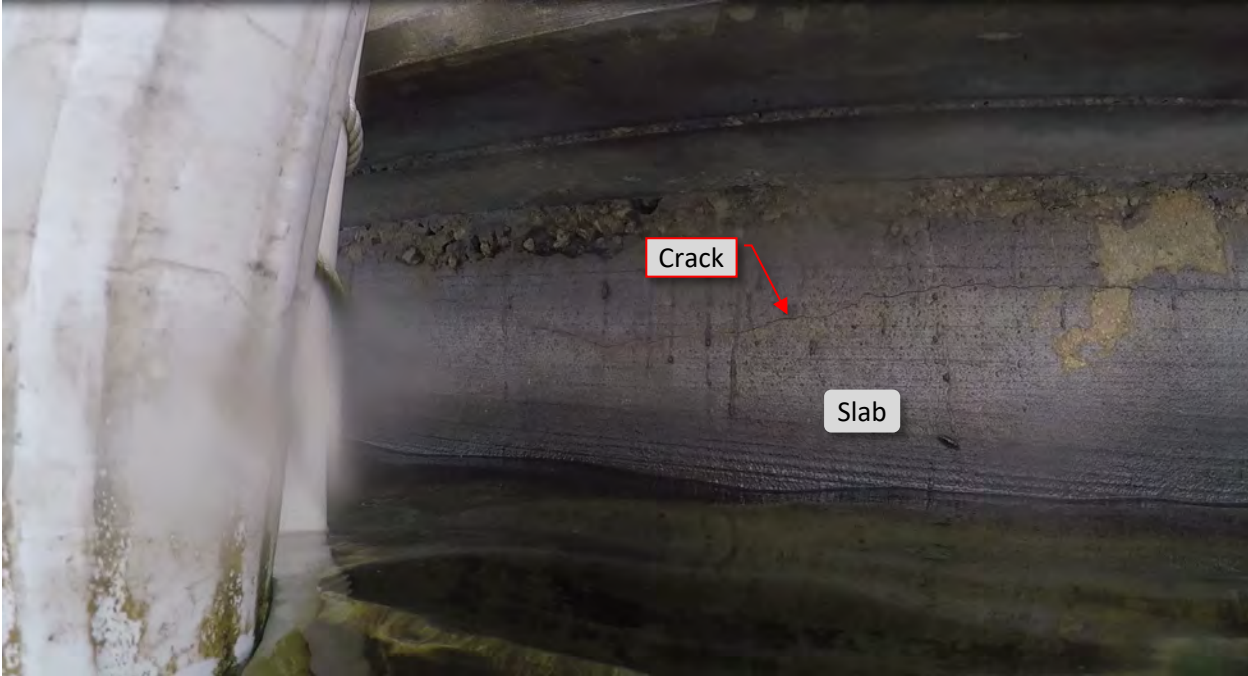
Figure 64: S15. STA 4+30 - 4+35. Crack at top of slab. Honeycomb area.

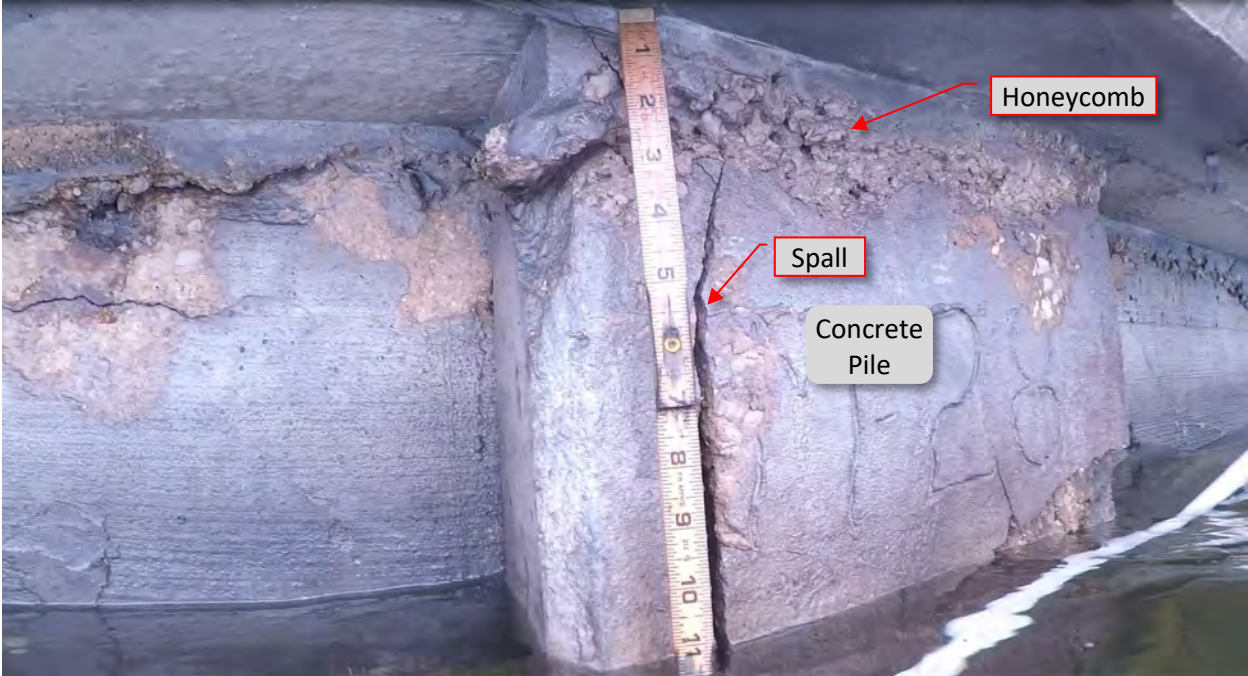
Figure 65: P24. STA 4+36. Break/spall at both flanges at pile. Honeycomb area.

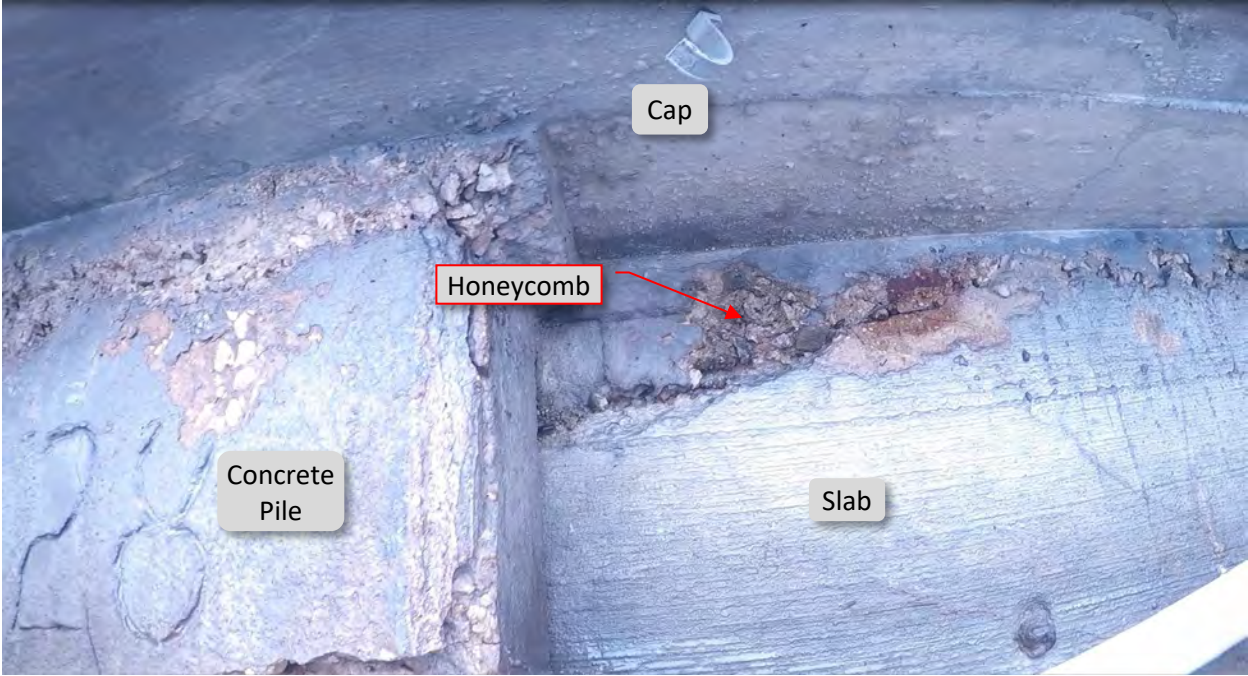
Figure 67: S16. STA 4+37 - 4+38. Honeycomb area at west top corner of slab.

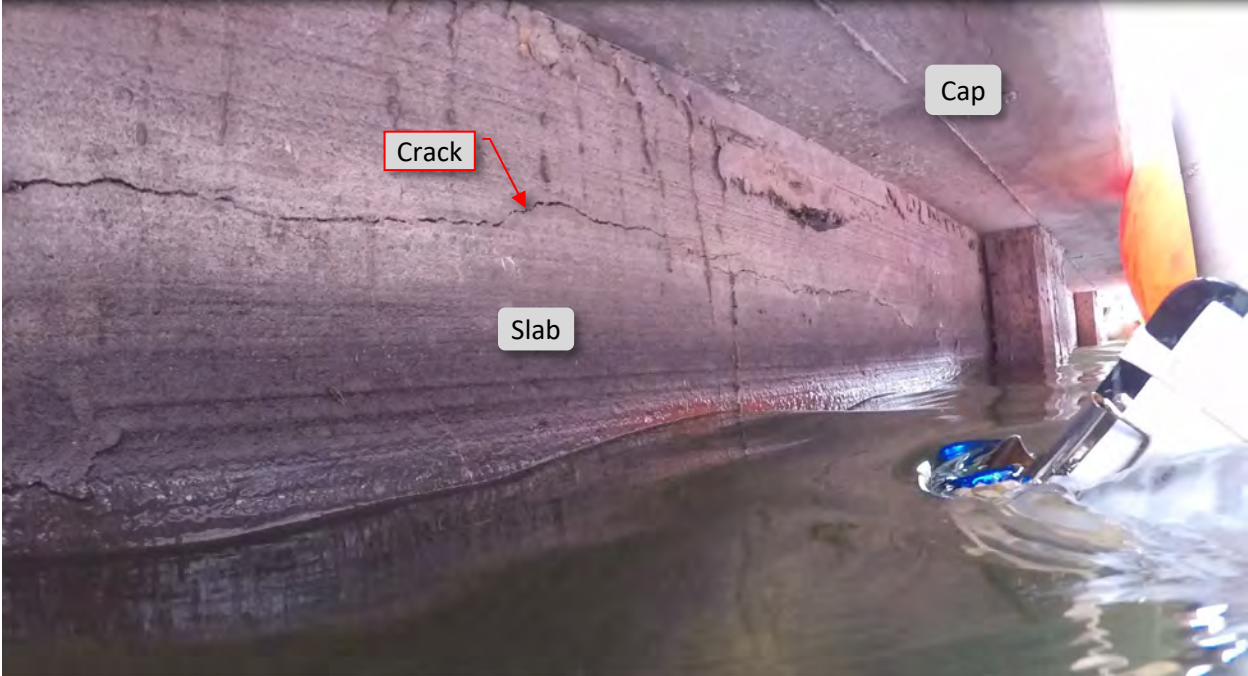
Figure 73: S18. STA 4+54 - 4+59. Crack at top of slab.

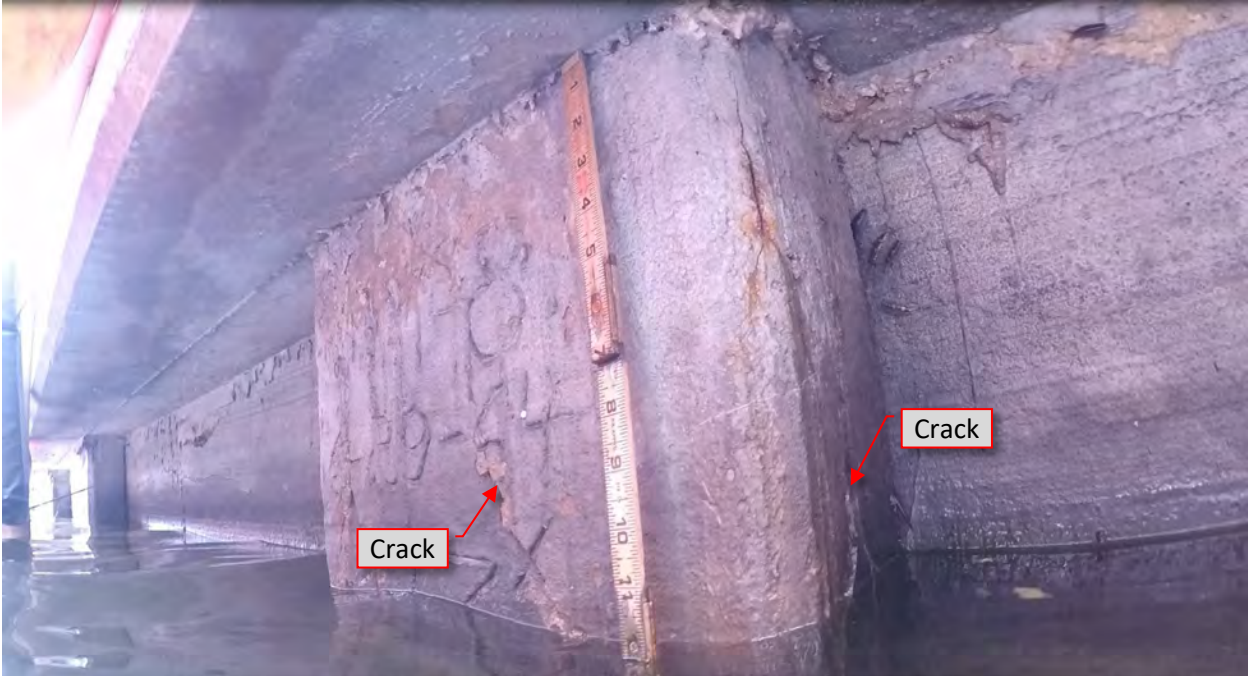
Figure 74: P27. STA 4+60. Crack/spall at top of east flange.

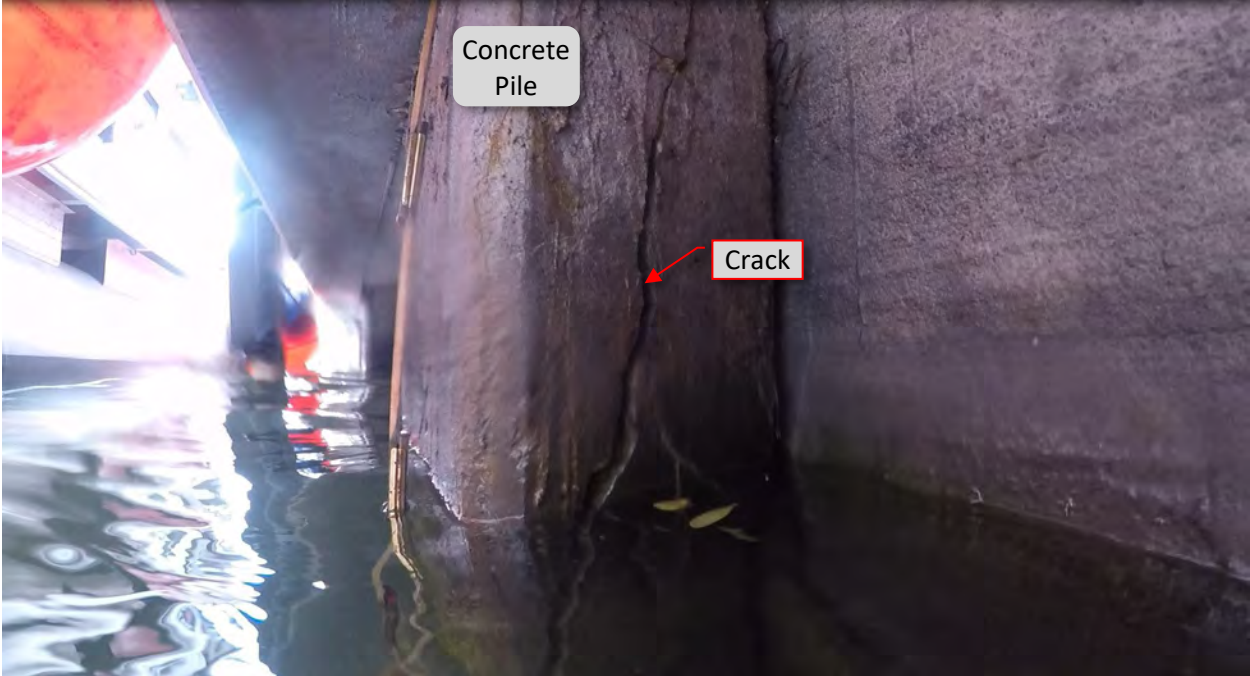
Figure 75: P27. STA 4+60. Crack/spall at top of east flange. View of east face at pile.

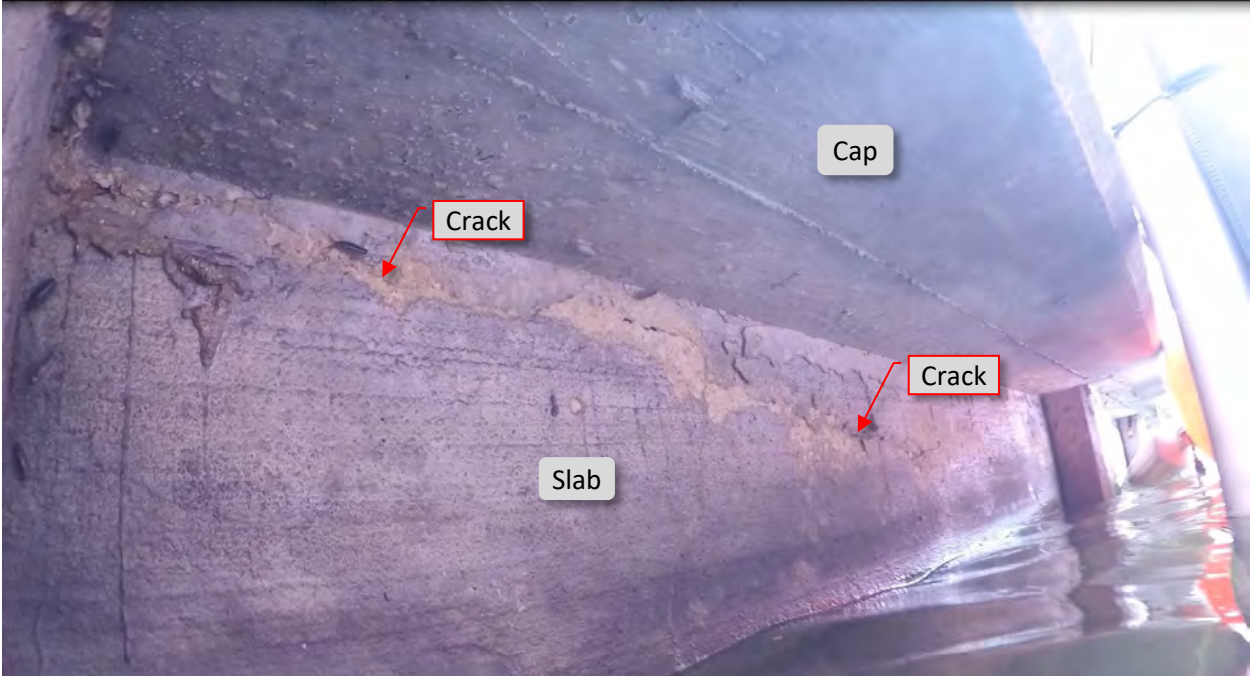
Figure 76: S19. STA 4+61 - 4+67. Crack at top of slab.

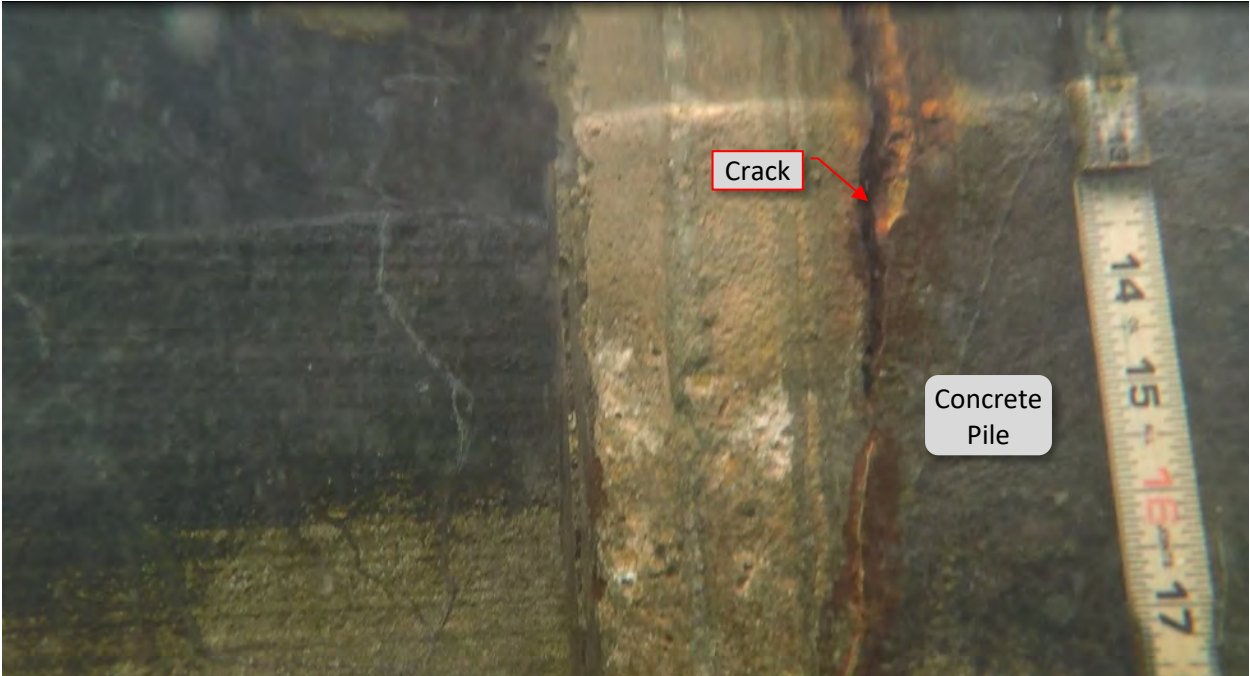
Figure 84: P29. STA 4+92. Cracked and spalled west flange and rust staining at pile

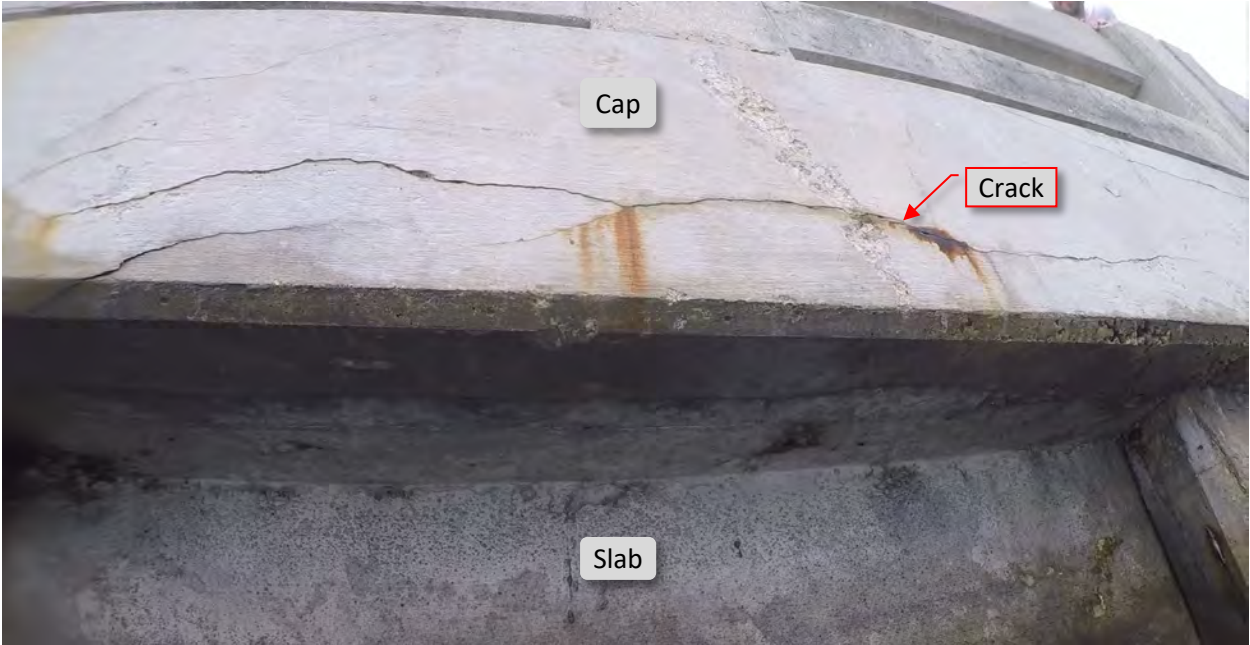
Figure 86: C2. STA 4+92 - 4+95. Crack at cap vertical face.

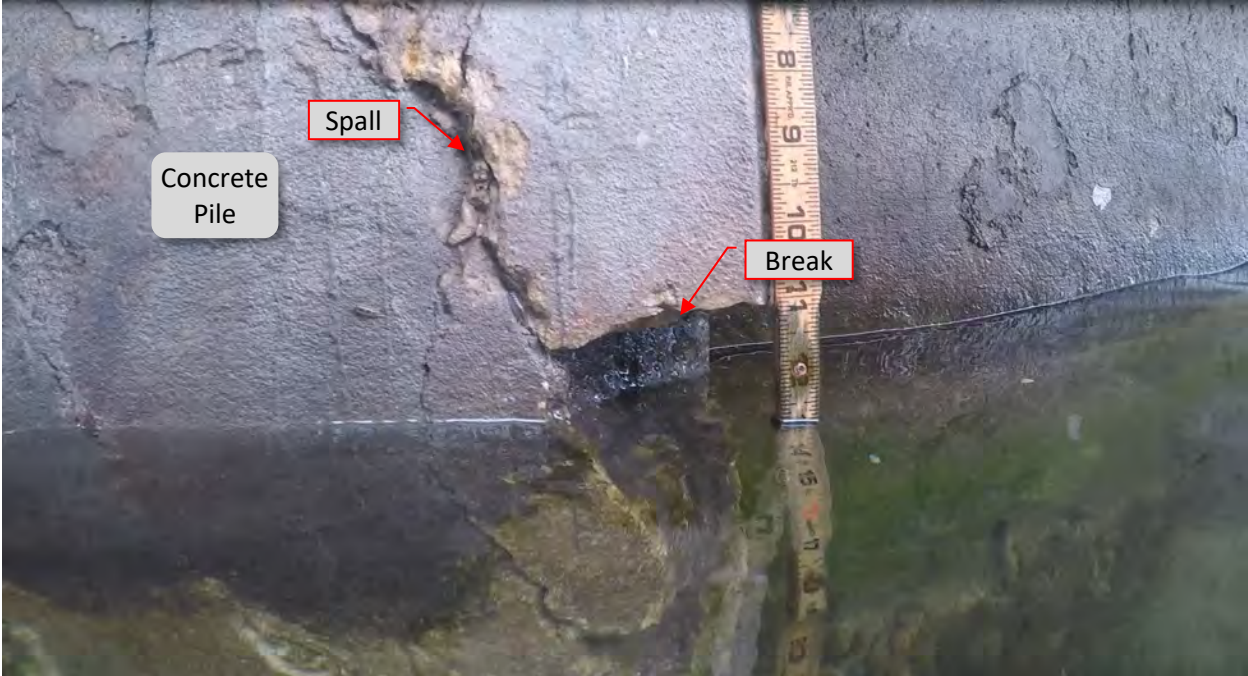
Figure 91: P31. STA 5+08. Cracks/spalls at east flange and loss of concrete.

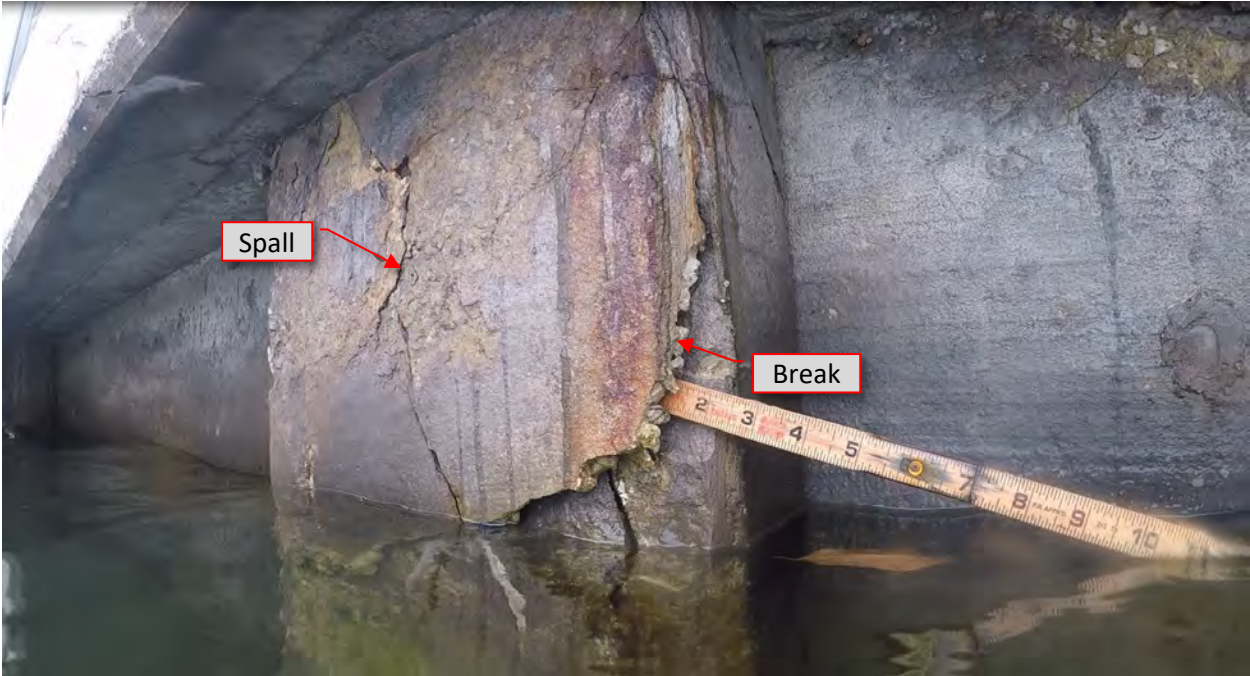
Figure 94: P32. STA 5+16. Cracks/spalls at both flanges and south face, loss of concrete, and rust staining.

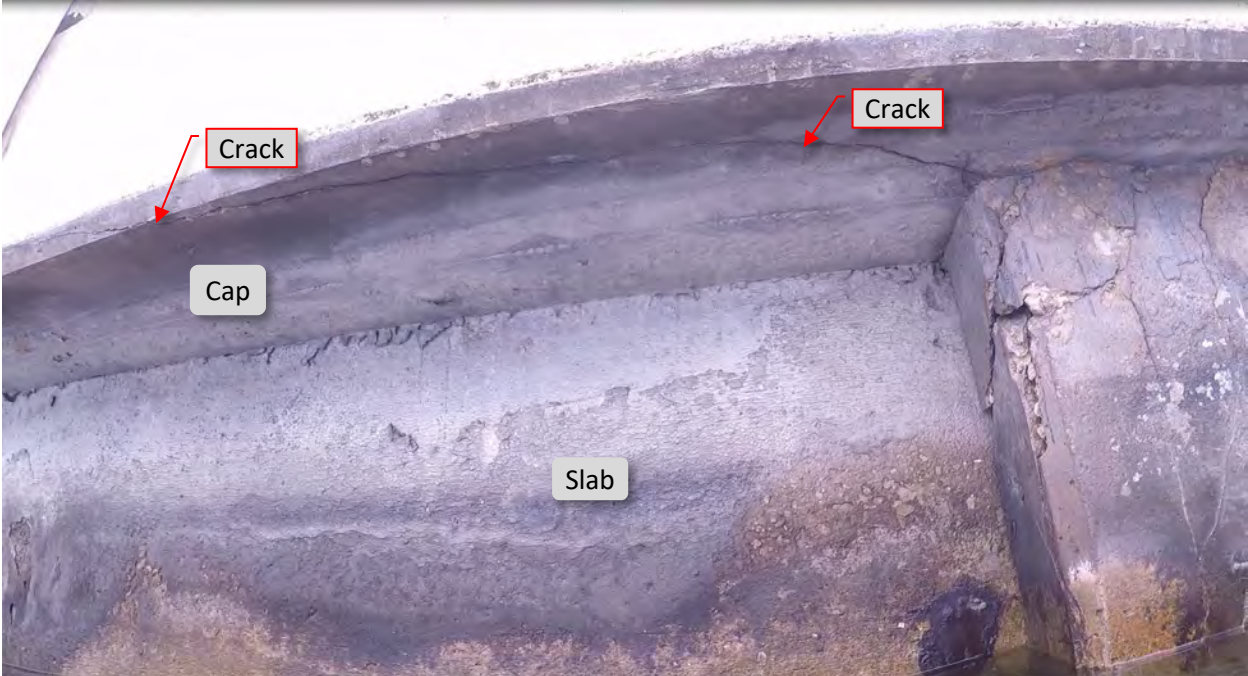
Figure 97: C6. STA 5+25 - 5+30. Crack at cap bottom face.

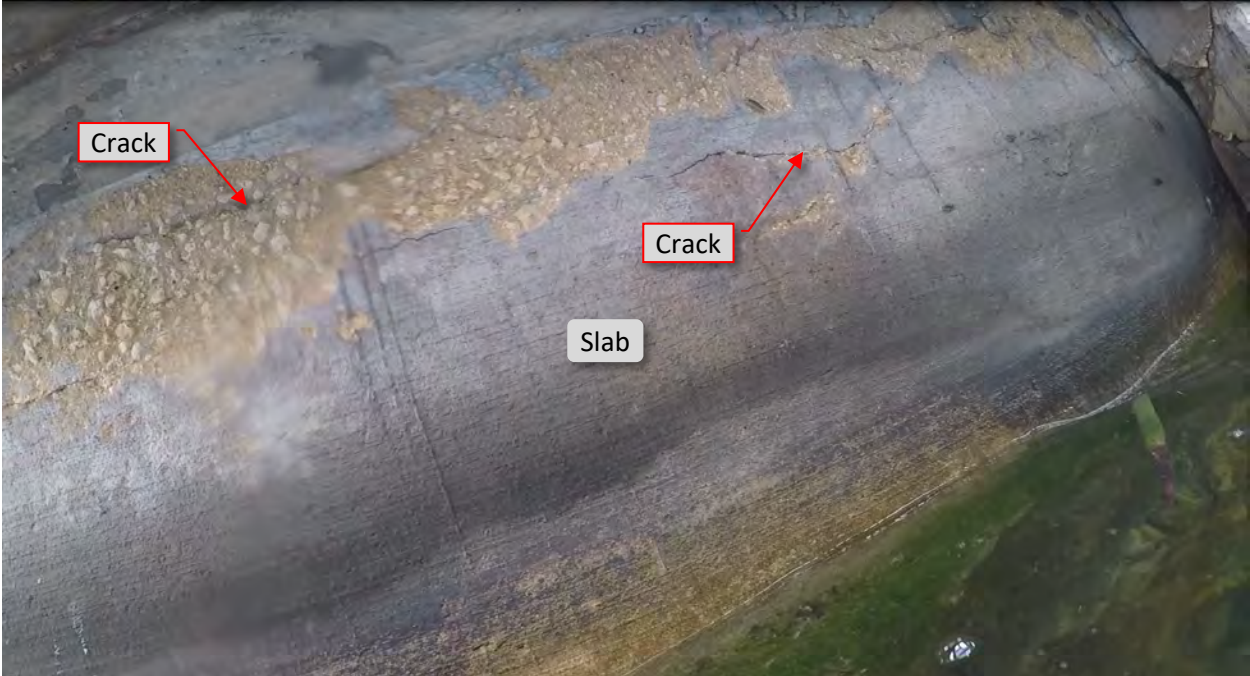
Figure 103: S22. STA 5+42 - 5+47. Crack at top of slab.

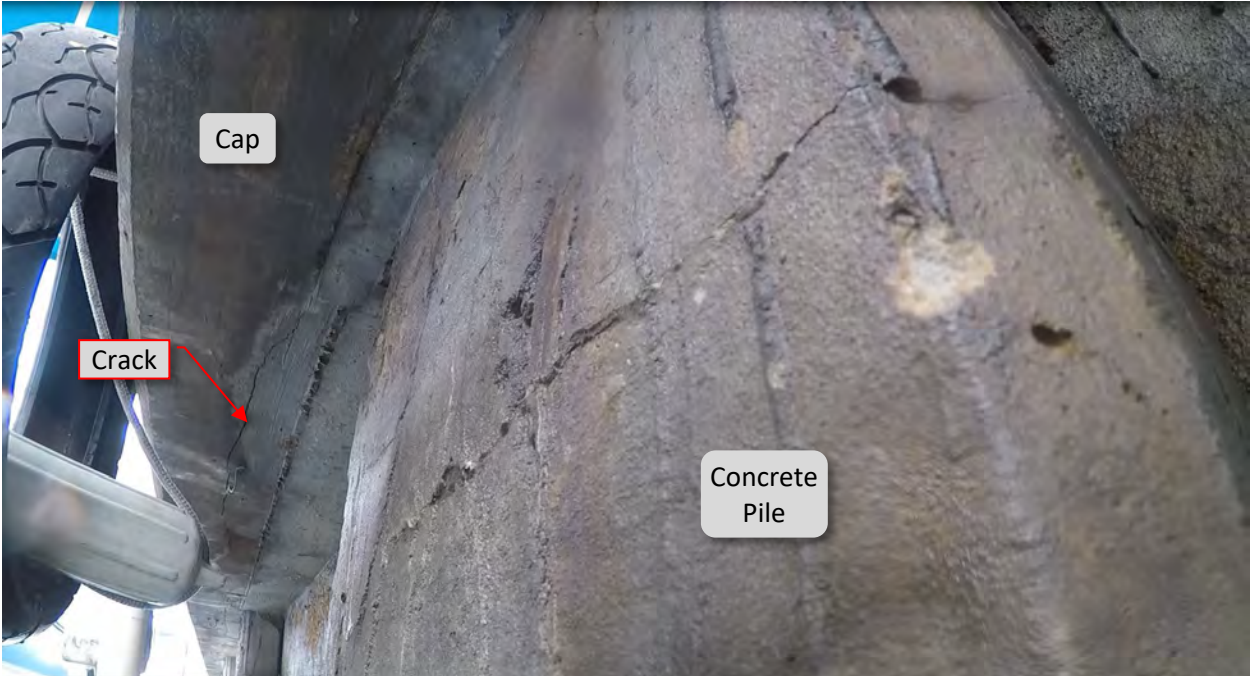
Figure 104: C7. STA 5+40 - 5+48. Crack at cap's bottom face.

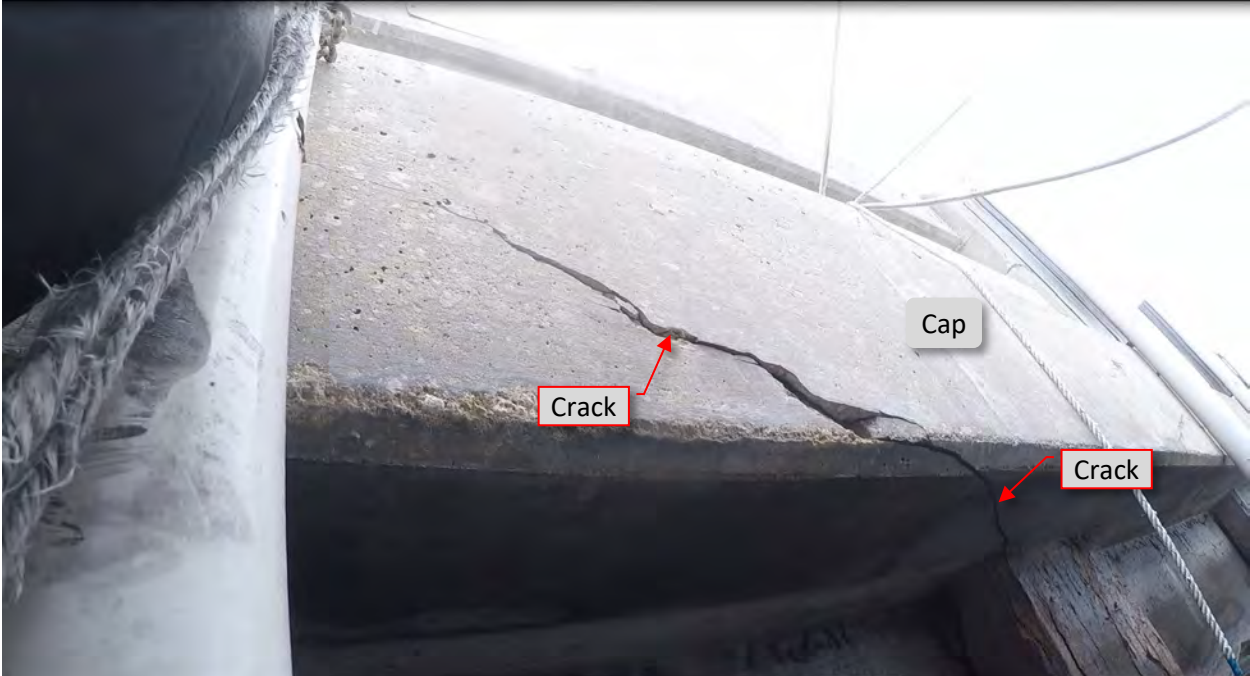
Figure 107: C8. STA 5+51 - 5+55. Crack at cap's bottom and south faces west of pile.

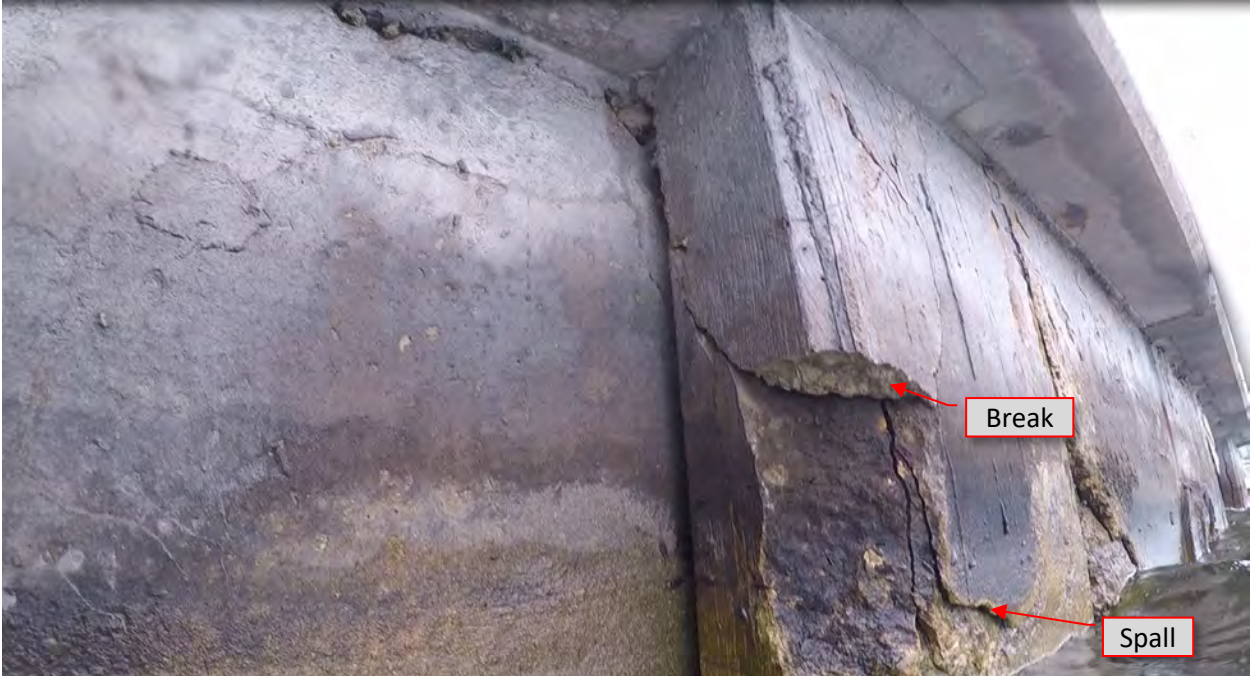
Figure 111: P38. STA 5+64. Cracks/spalls at both flanges at pile and loss of concrete. View of west flange.

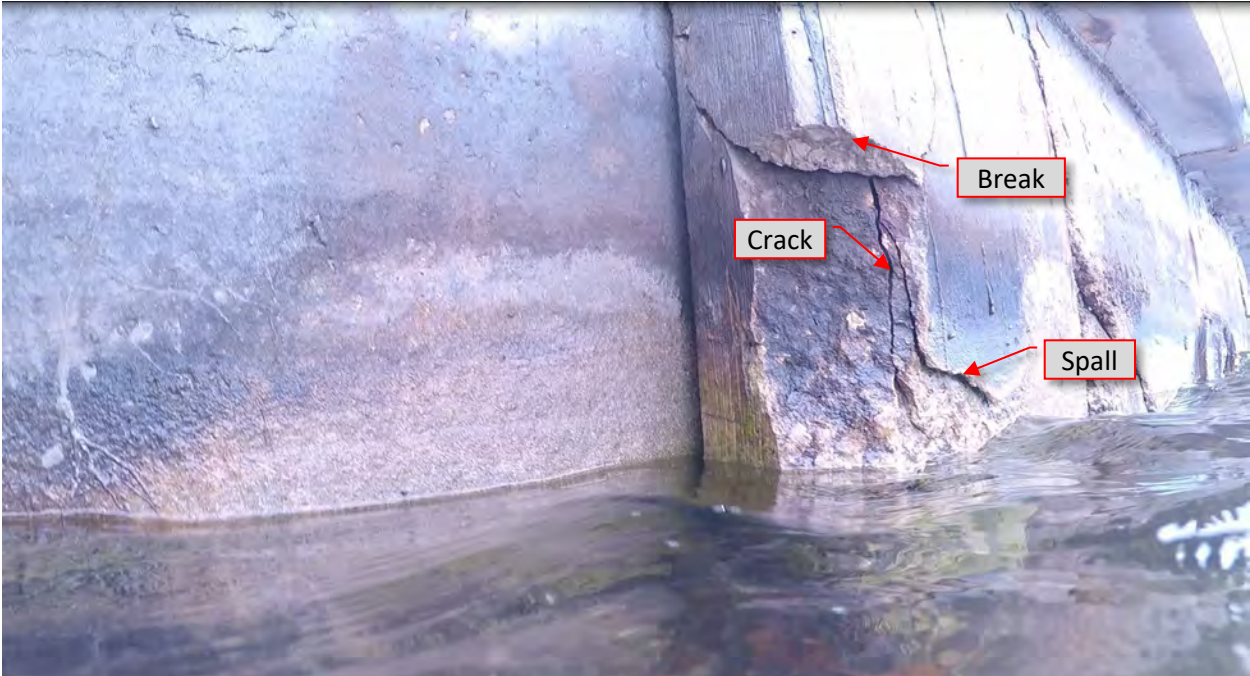
Figure 112: P38. STA 5+64. Cracks/spalls at both flanges at pile and loss of concrete. View of west flange at water level.

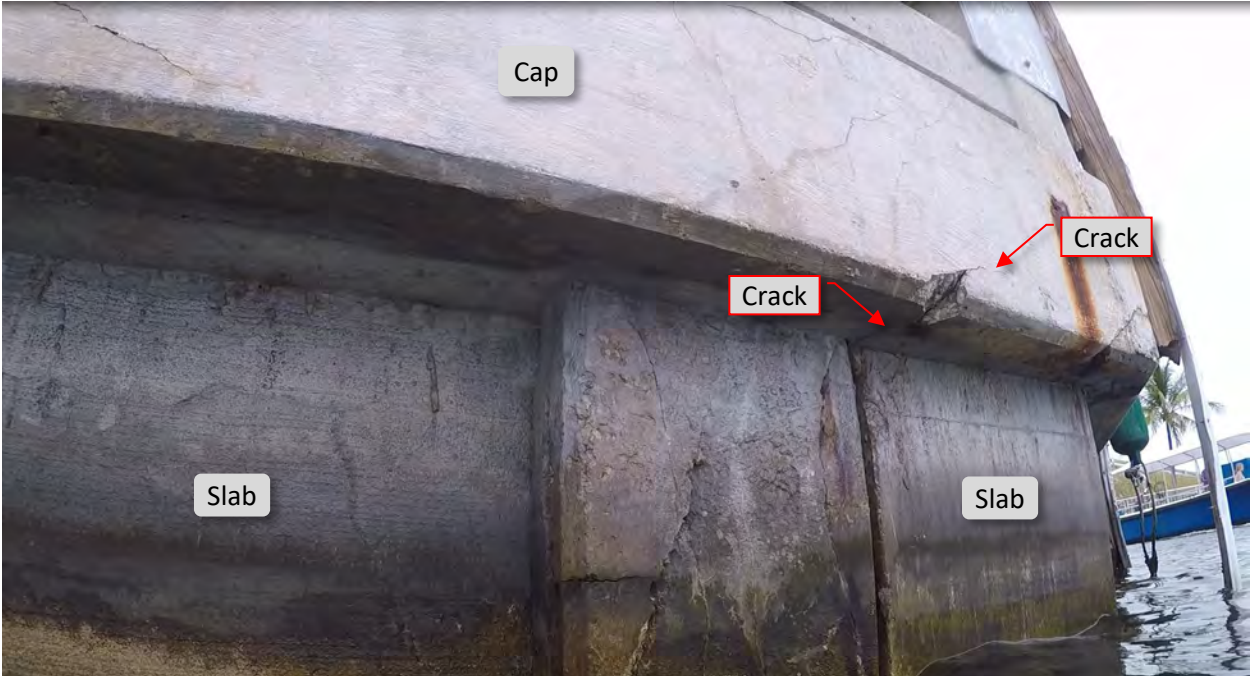
Figure 116. C9. STA 5+75 - 5+90. Crack at cap's bottom and vertical faces in the eastward direction, starts from pile.

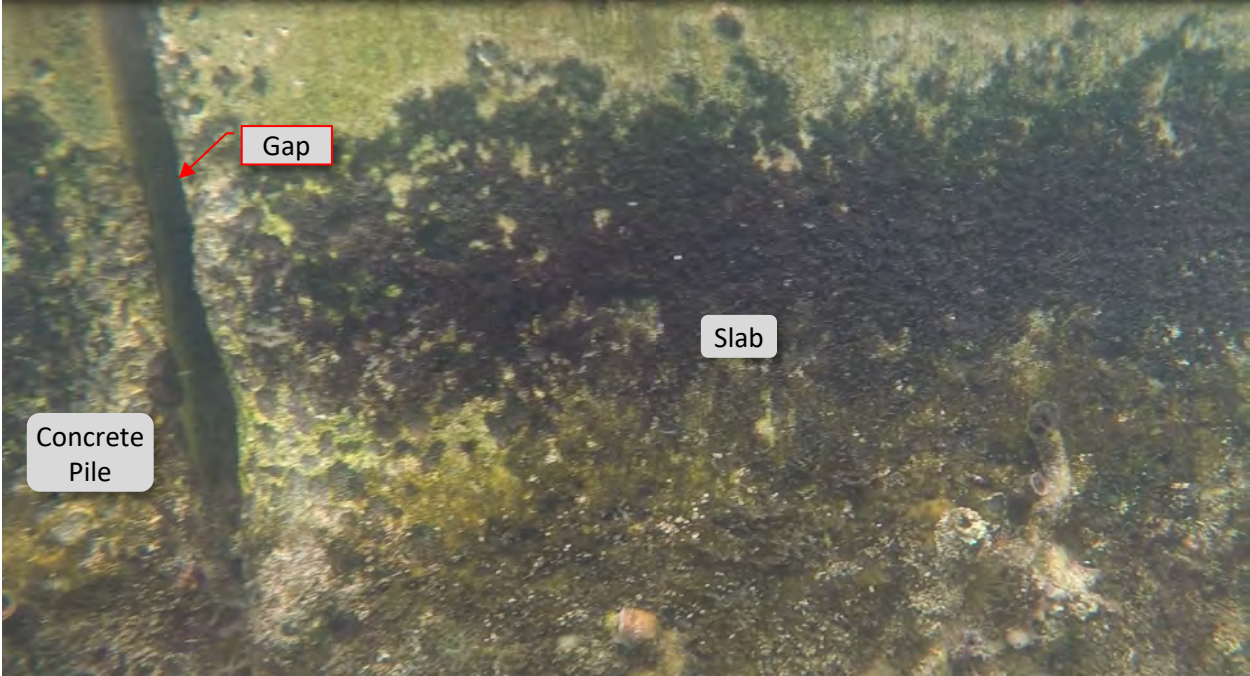
Figure 119: P40. STA 5+80. Gap at construction/expansion joint. Underwater view.

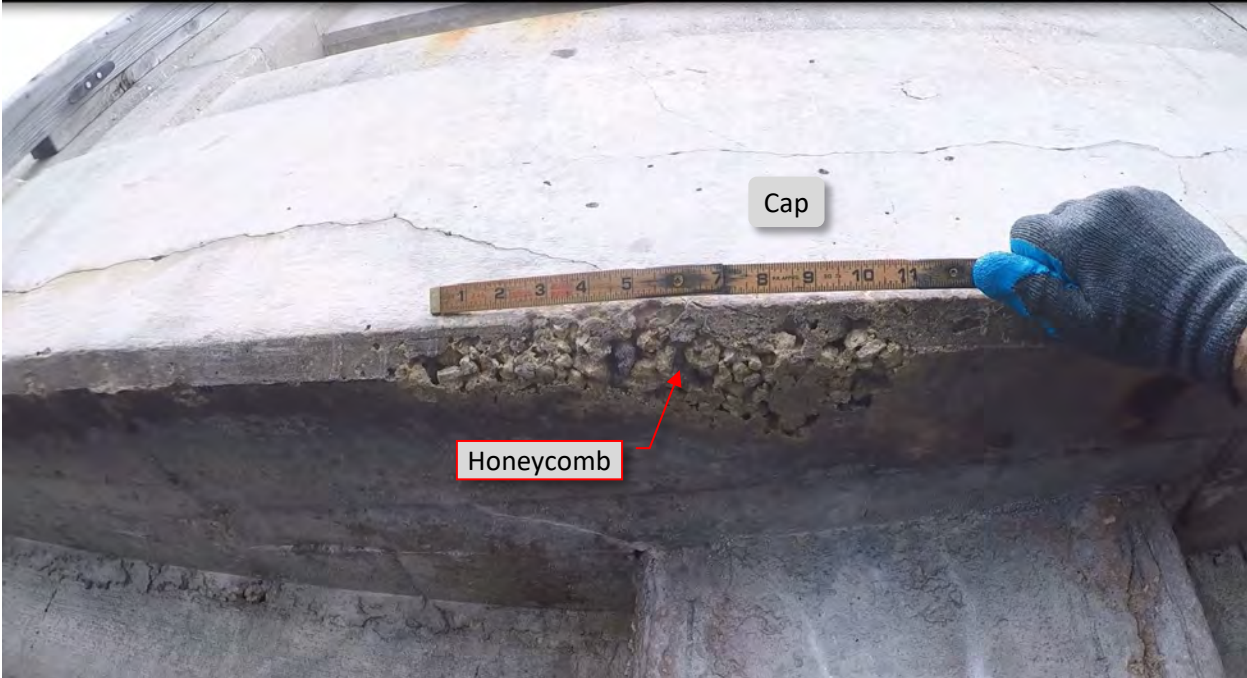
Figure 126: P43. STA 5+93 - 6+00. Honeycomb area at cap's bottom edge.

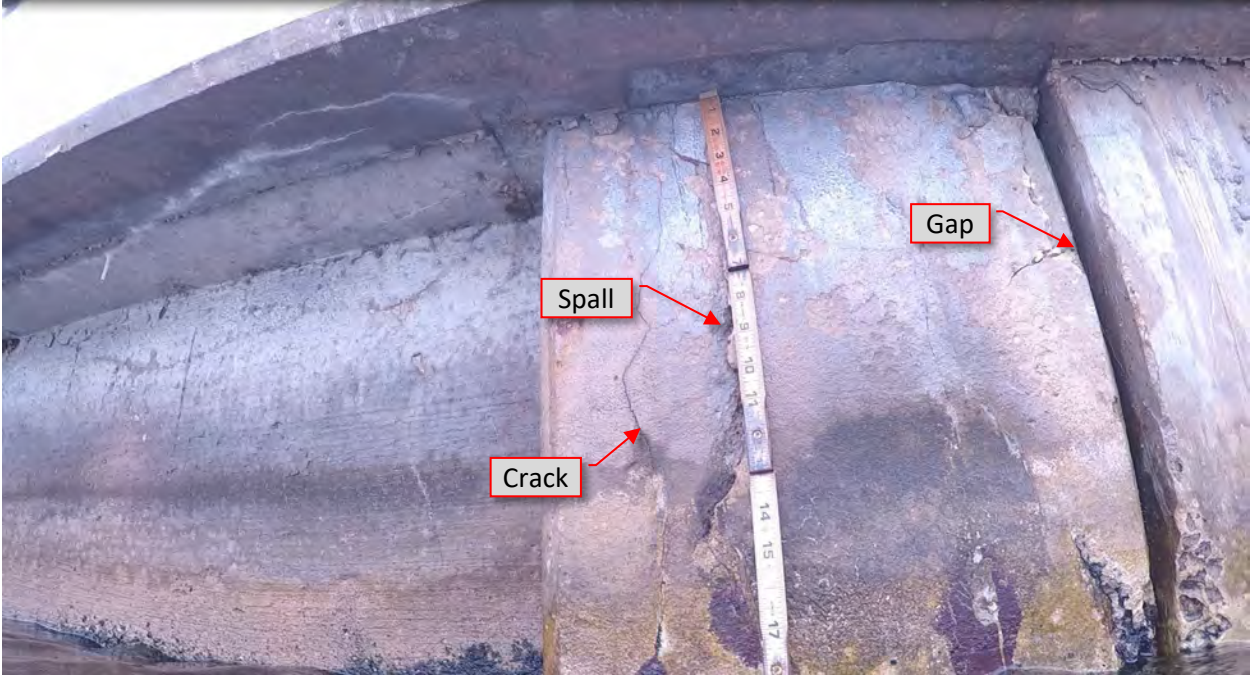
leaning out of its plane toward the water. The presence of typical cracks and spalls on the slab's and cap's exterior surfaces and varied gap widths at the slab and piling interface may directly correlate to the slab's unsupported length. Described observations are illustrated in Appendix C in Figures 127 - 129, 132, and 134. The extent of eroded backfill is unknown.

Figure 127: P44. STA 6+07. Cracks/spalls at both flanges at pile. Gap at construction/expansion joint.

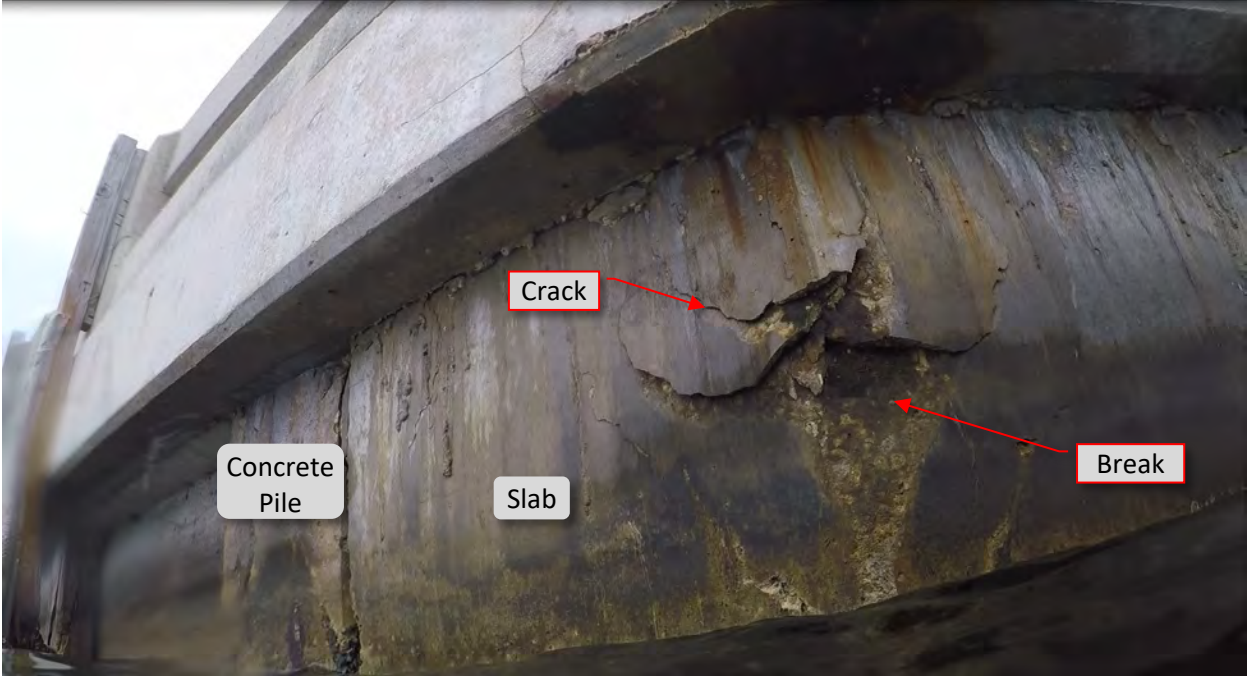
Figure 129: S24. STA 6+11. Crack at slab corner and loss of material.

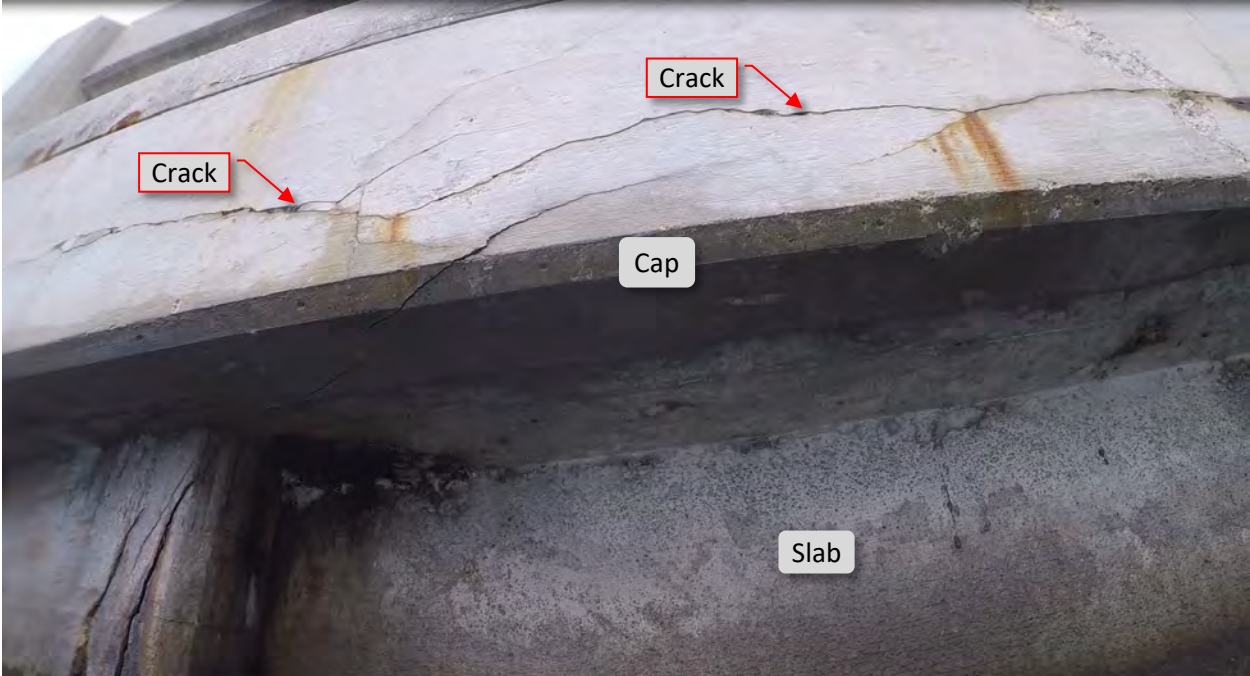
Figure 136: C12. STA 6+14 - 6+21. Crack at cap's bottom and vertical faces.

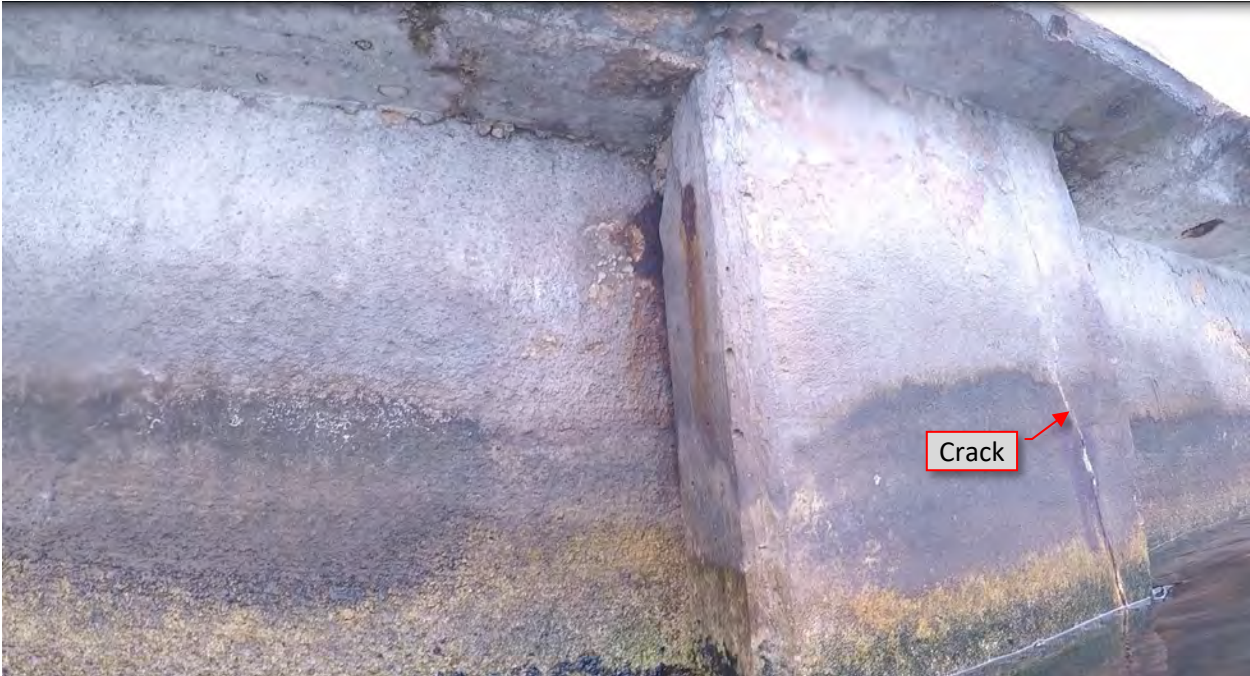
Figure 138: P47. STA 6+27. Crack at north flange at pile.

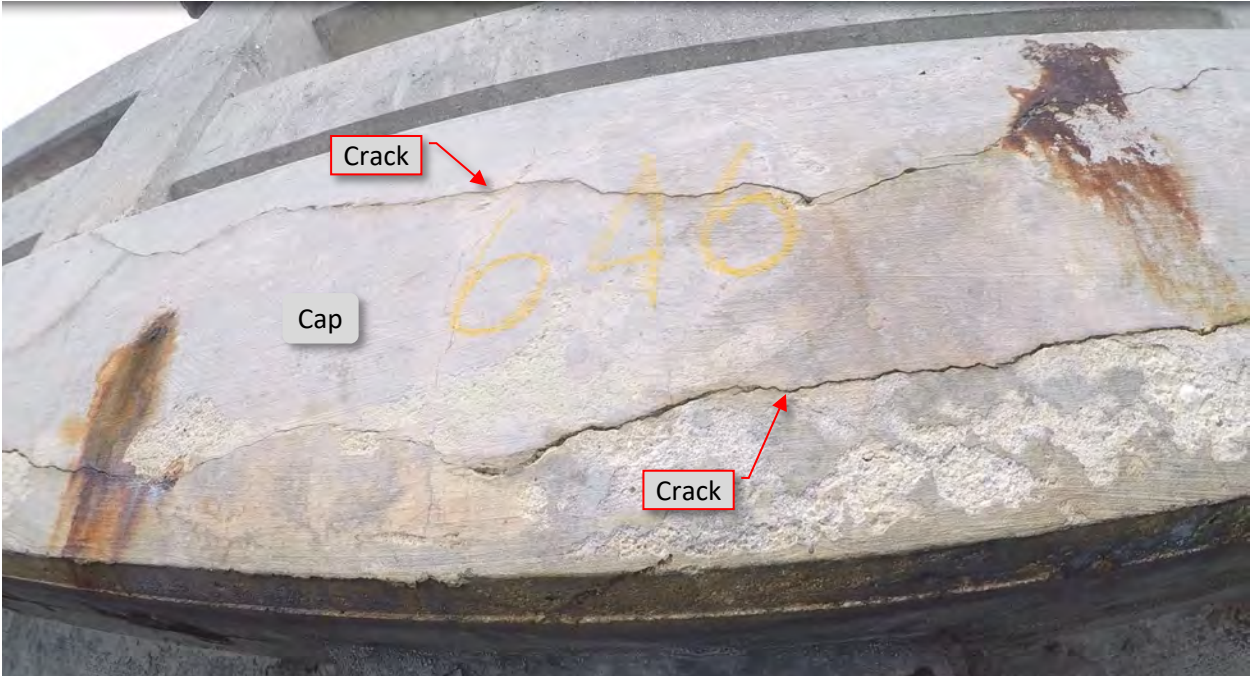
Figure 144. C15. STA 6+40 - 6+50. Crack at cap's vertical face.
