Subject: Key West Angelfish Pier Seawall Structural Assessment

CITY OF KEY WEST
PORT & MARINE SERVICES

KEY WEST GARRISON BIGHT MARINA
ANGELFISH PIER SEAWALL STRUCTURAL ASSESSMENT REPORT

Prepared By:
Tetra Tech, Inc.
759 South Federal Highway, Suite 314
Stuart, FL 34994

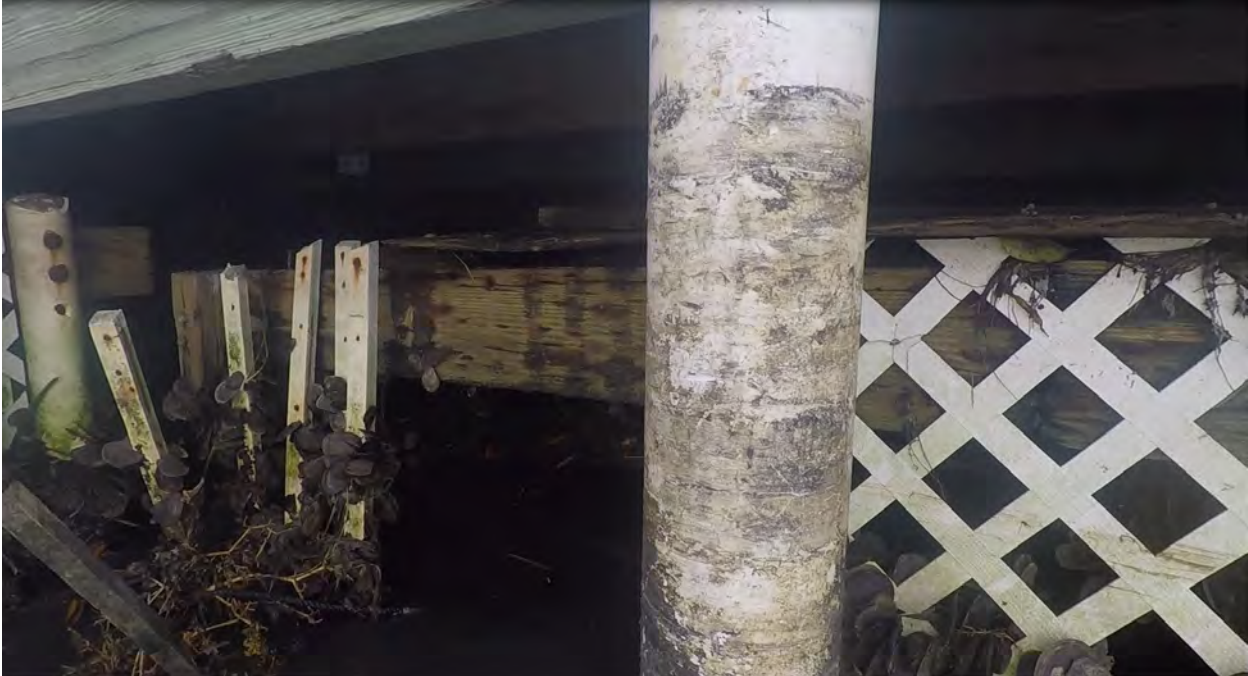
Figure 1: STA 0+00. Northwest direction view. Obstructions and debris in front of seawall.

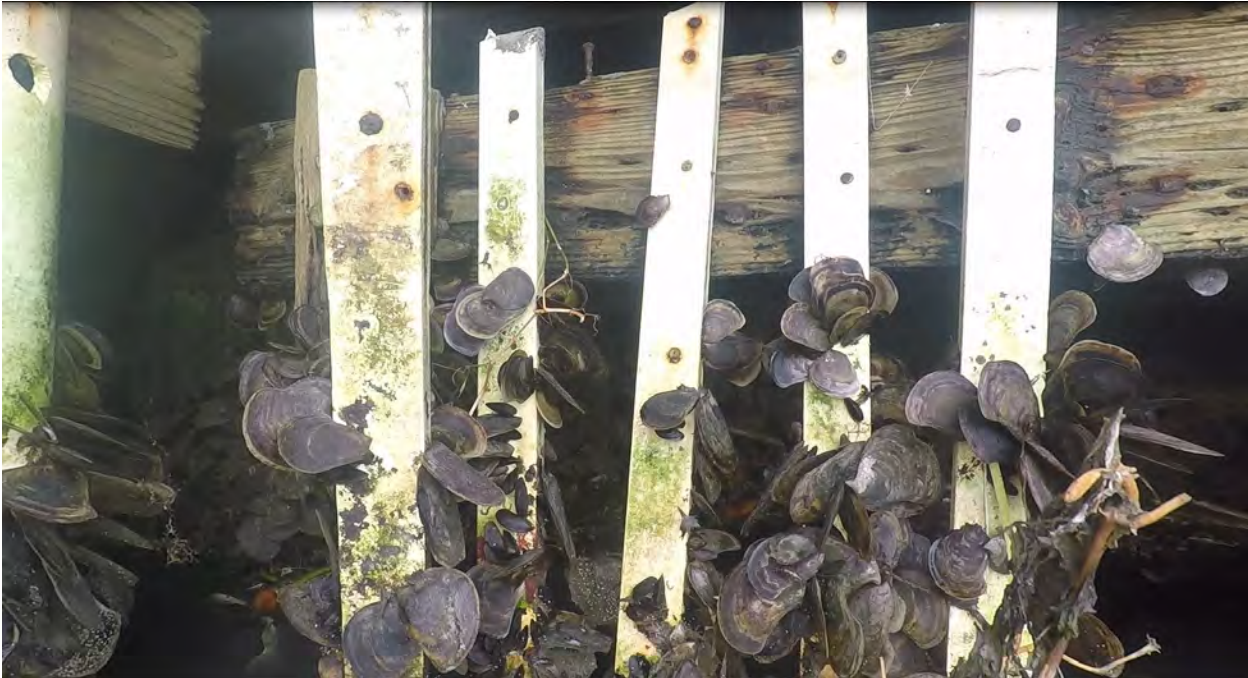
Figure 2: STA 0+00. North direction view. Obstructions and debris in front of seawall.

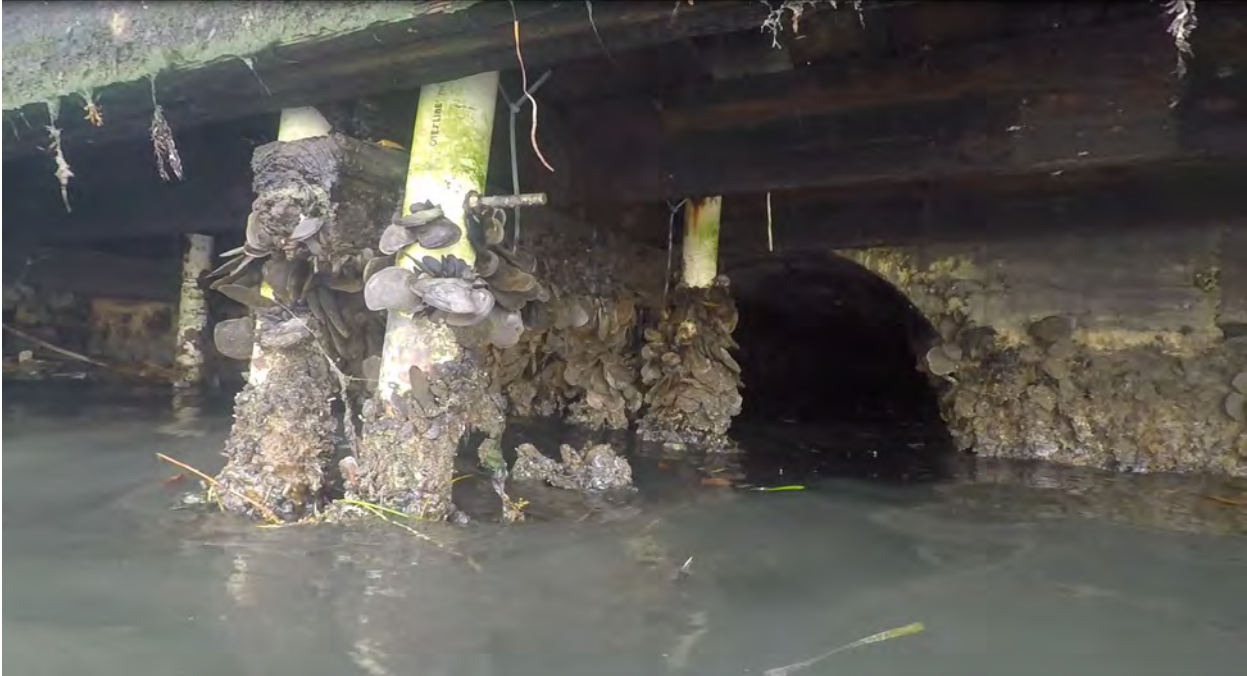
Figure 3: STA 0+10. Northwest direction view. Obstructions and debris in front of seawall and at culvert at STA 0+09.

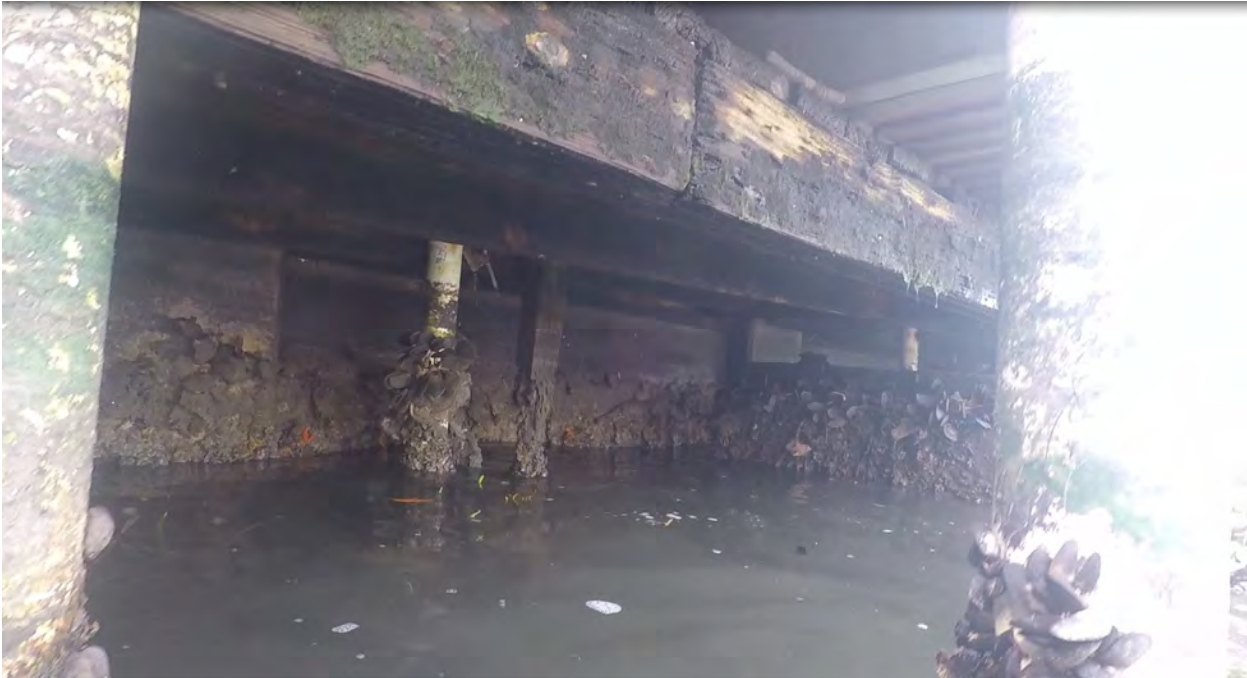
Figure 4: STA 0+10. Northeast direction view. Partial view of seawall, debris, and obstructions.

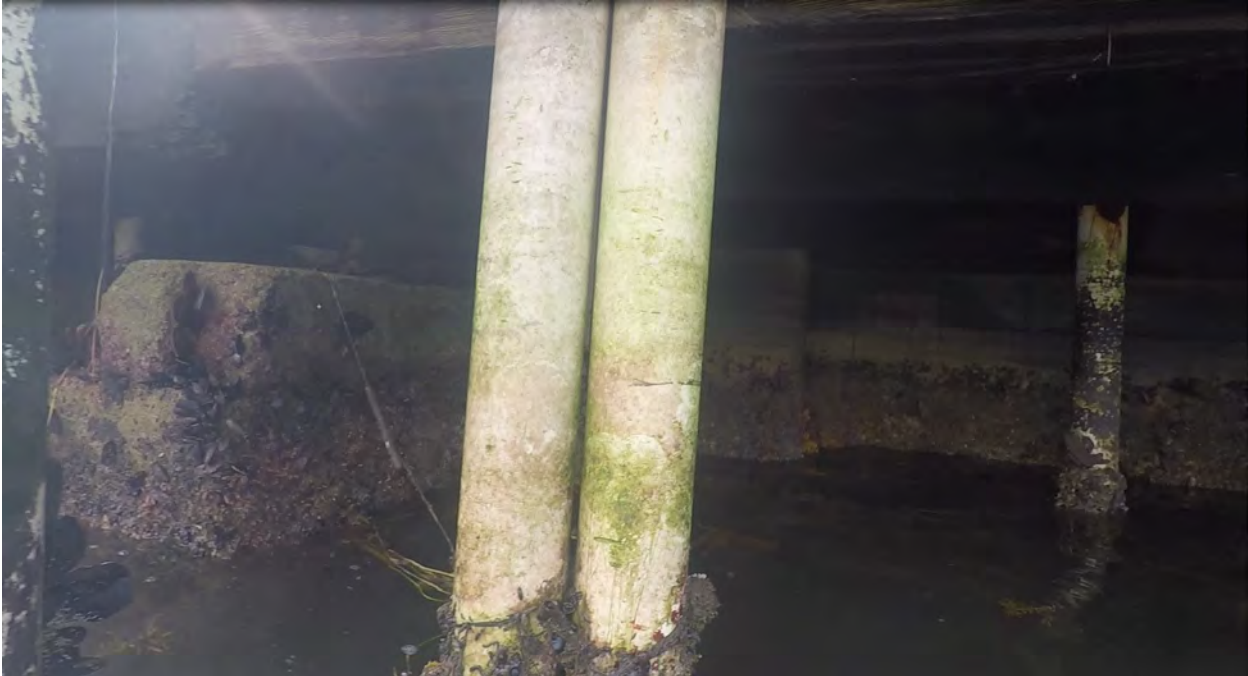
Figure 5: STA 0+20. Northwest direction view. Obstructions and debris in front of seawall, and partial view of seawall.

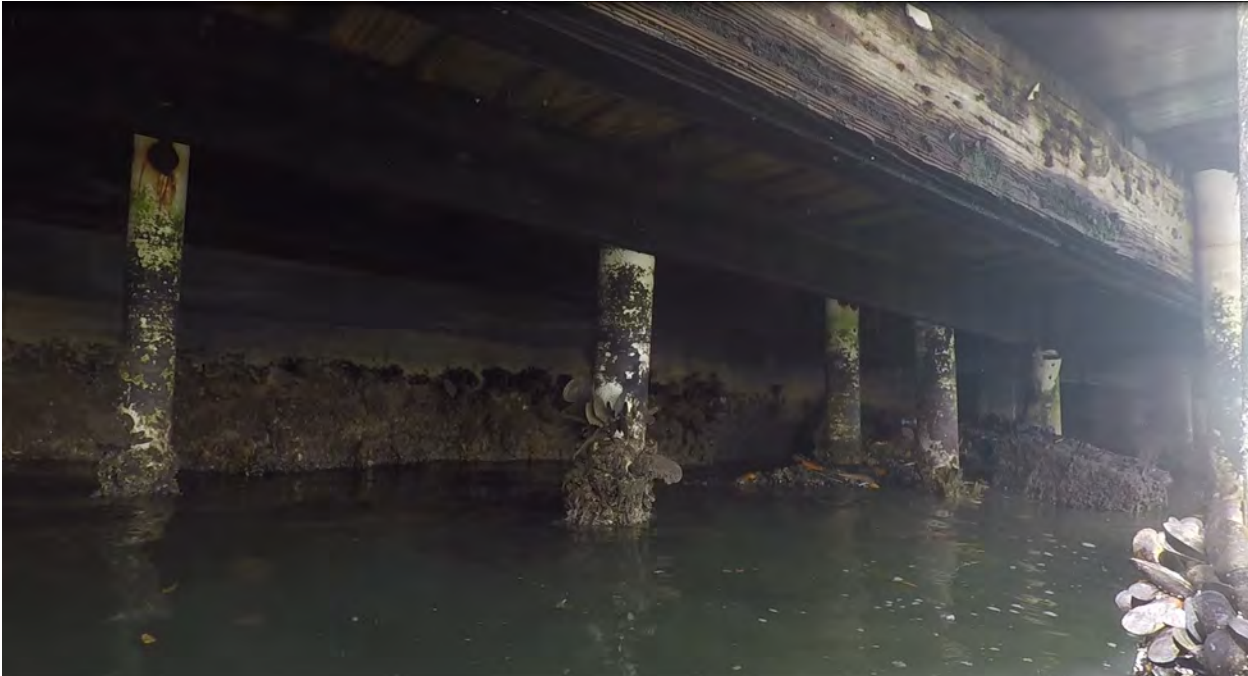
Figure 6: STA 0+20. Northeast direction view. Obstructions and debris in front of seawall, and partial view of seawall.

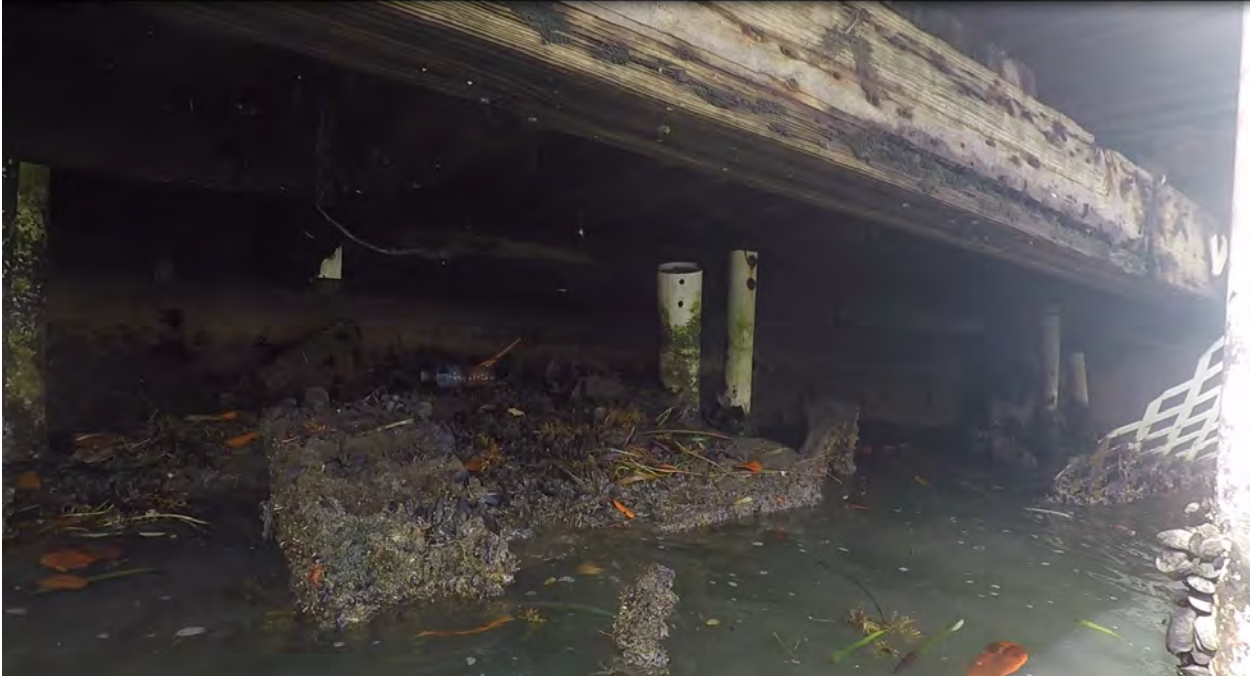
Figure 7: STA 0+30. Northeast direction view. Obstructions and debris in front of seawall, and partial view of seawall.

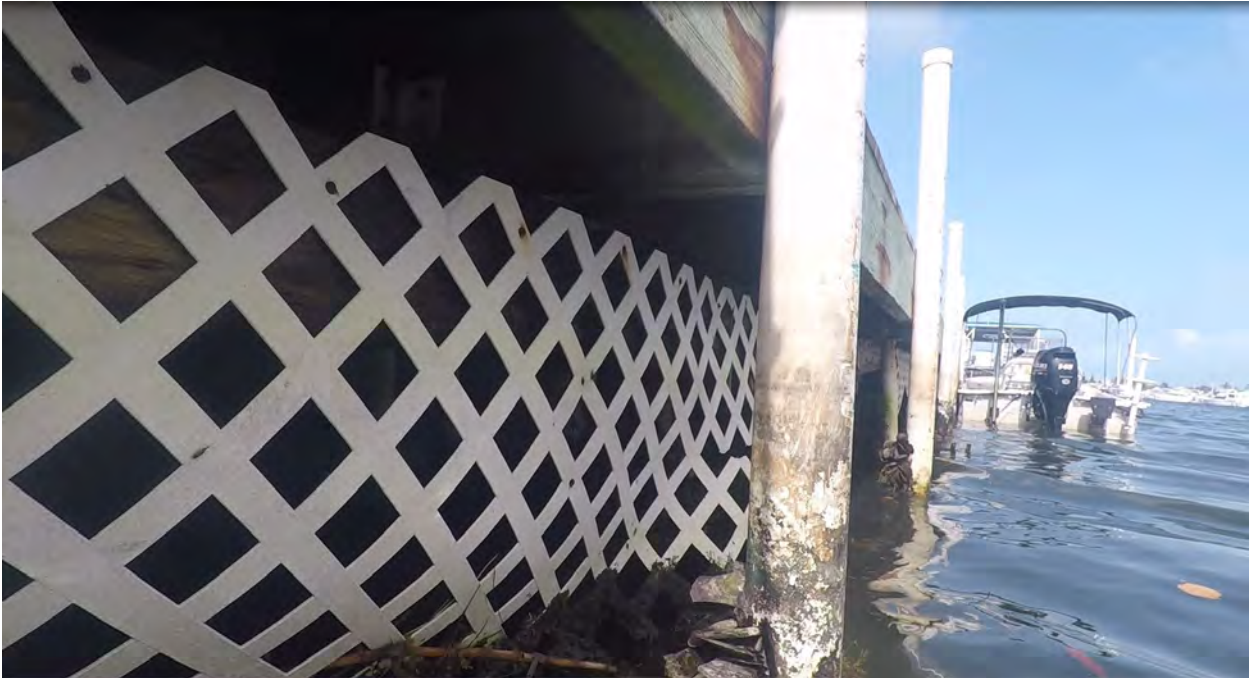
Figure 8: STA 0+40. Northeast direction view. Obstructions in front of seawall.

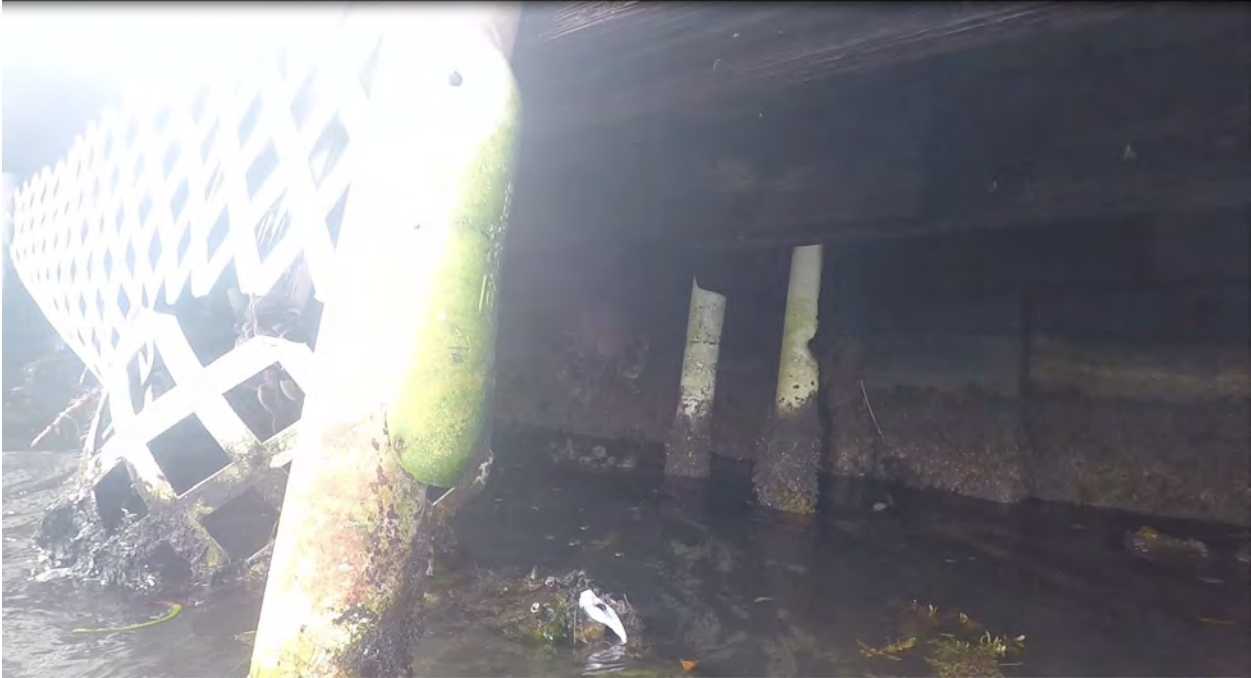
Figure 9: STA 0+40. Northwest direction view. Obstructions and debris in front of seawall, and partial view of seawall.

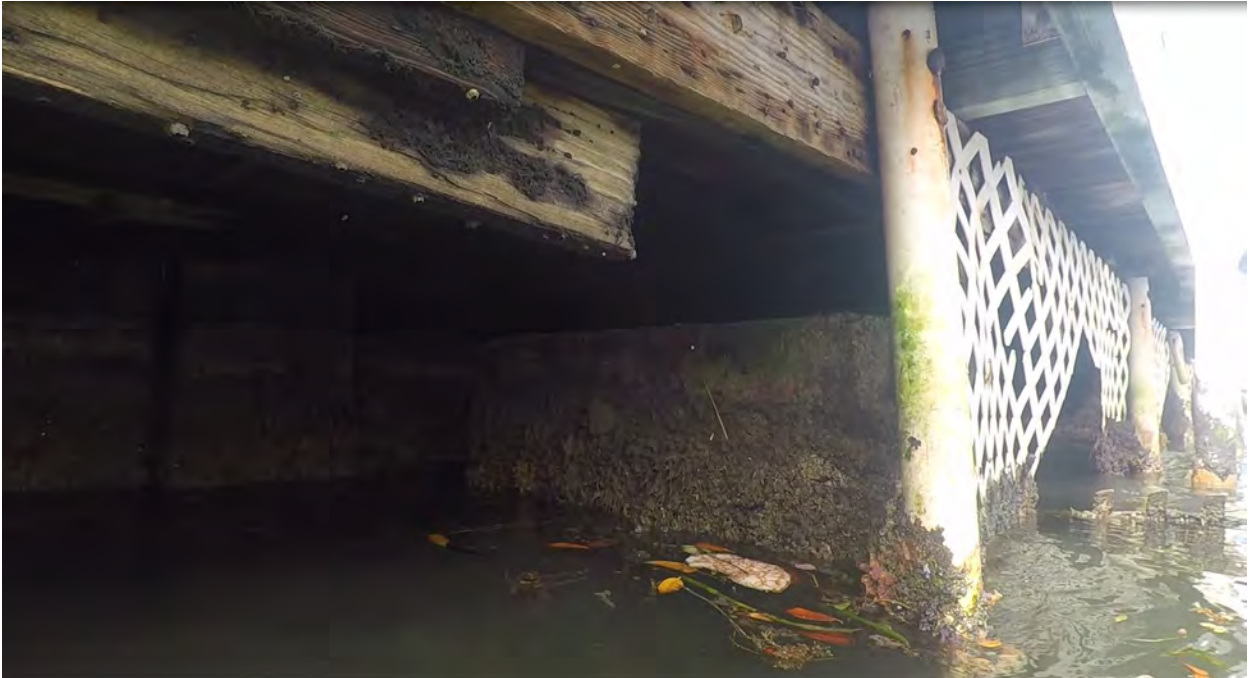
Figure 10: STA 0+50. Northeast direction view. Obstructions and debris in front of seawall, and partial view of seawall.

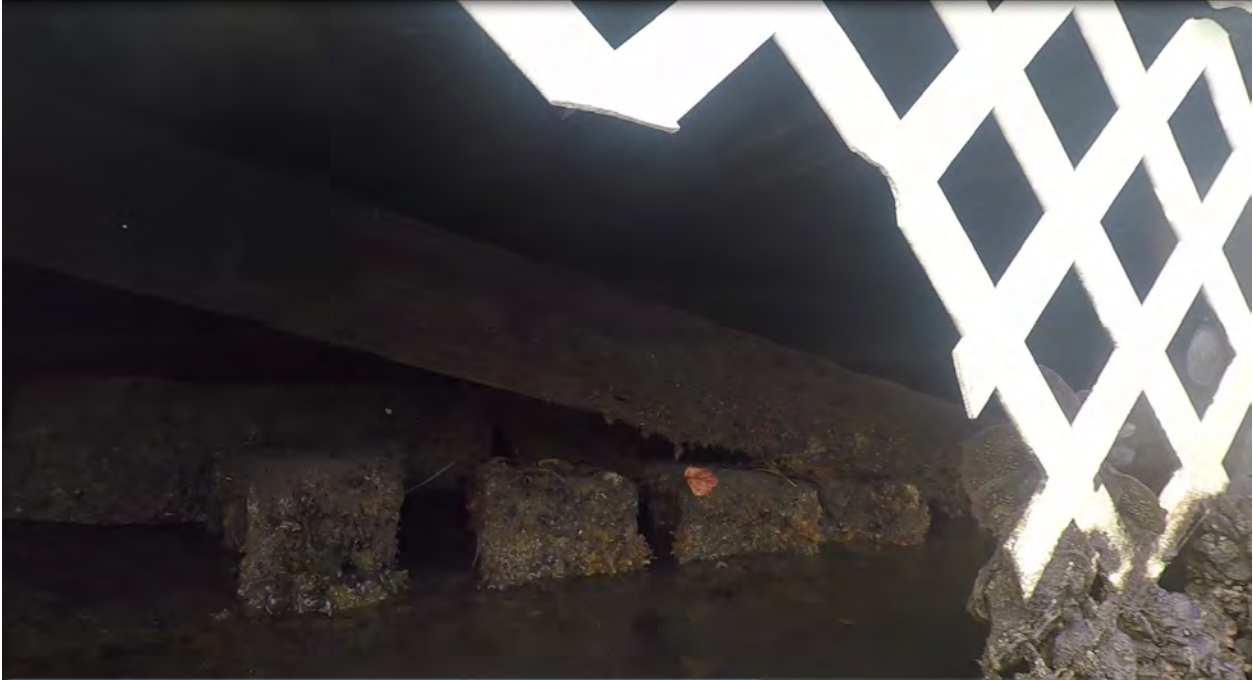
Figure 11: STA 0+60. Northeast direction view. Obstructions and debris in front of seawall, and partial view of seawall.

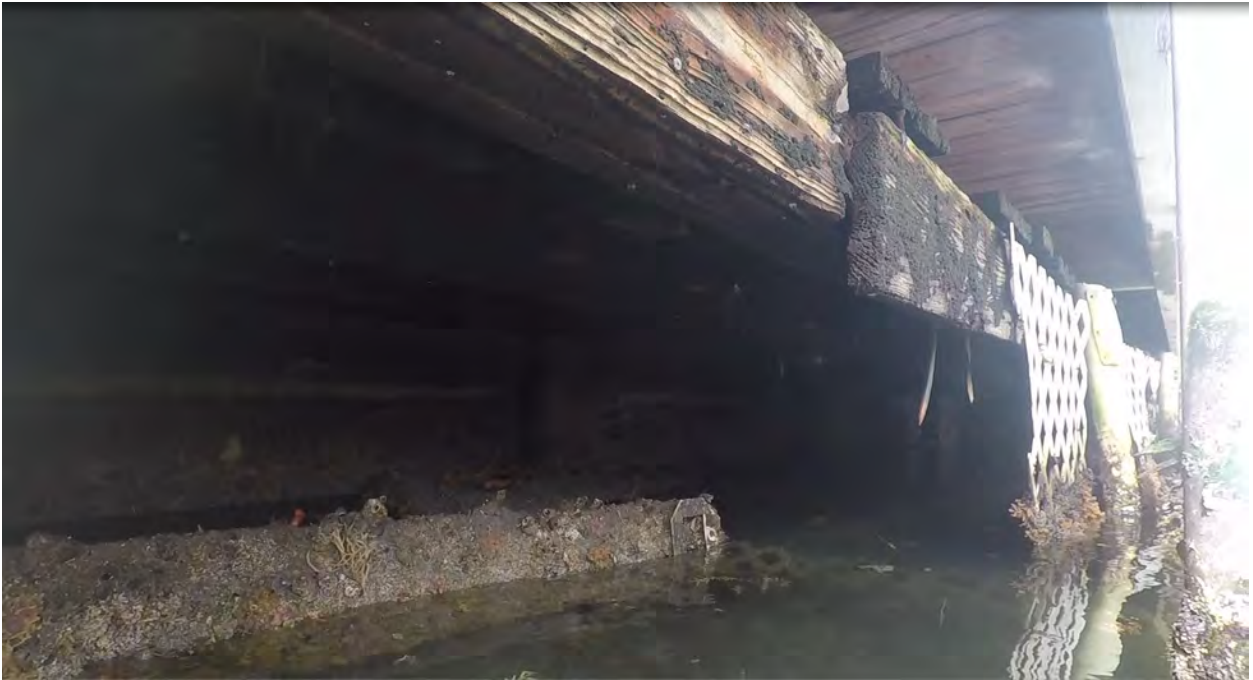
Figure 12: STA 0+70. Northeast direction view. Obstructions and debris in front of seawall, and partial view of seawall.

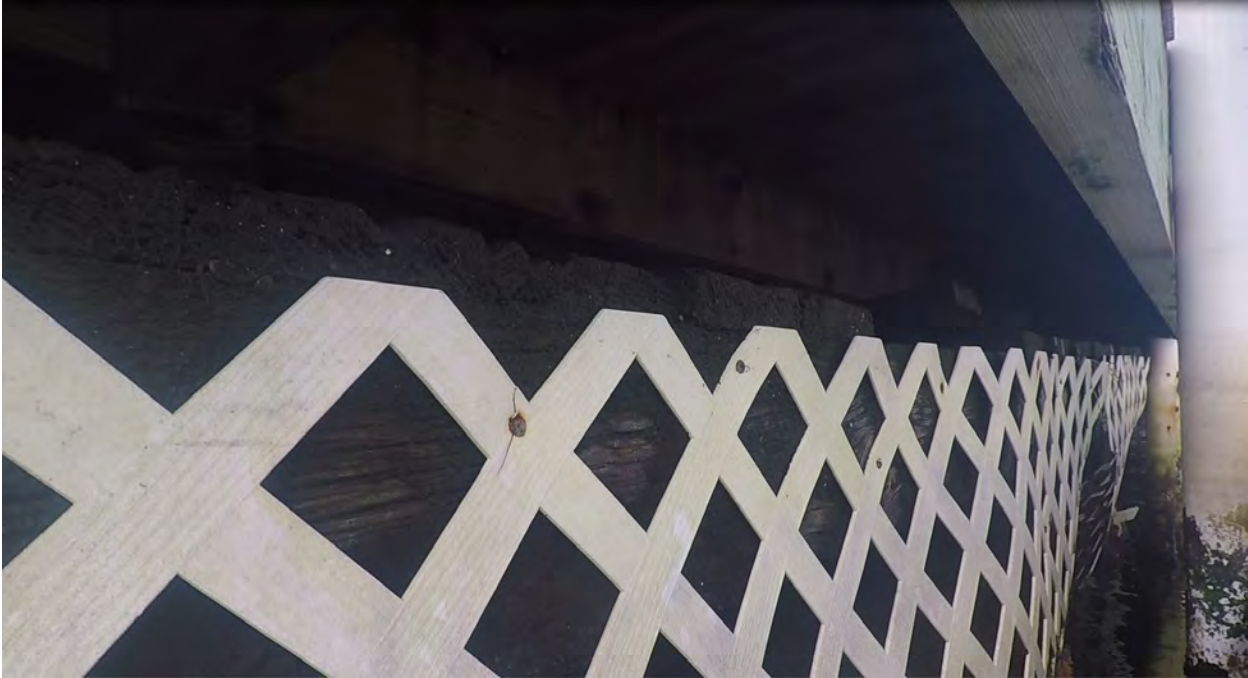
Figure 13: STA 0+80. Northeast direction view. Obstructions and debris in front of seawall.

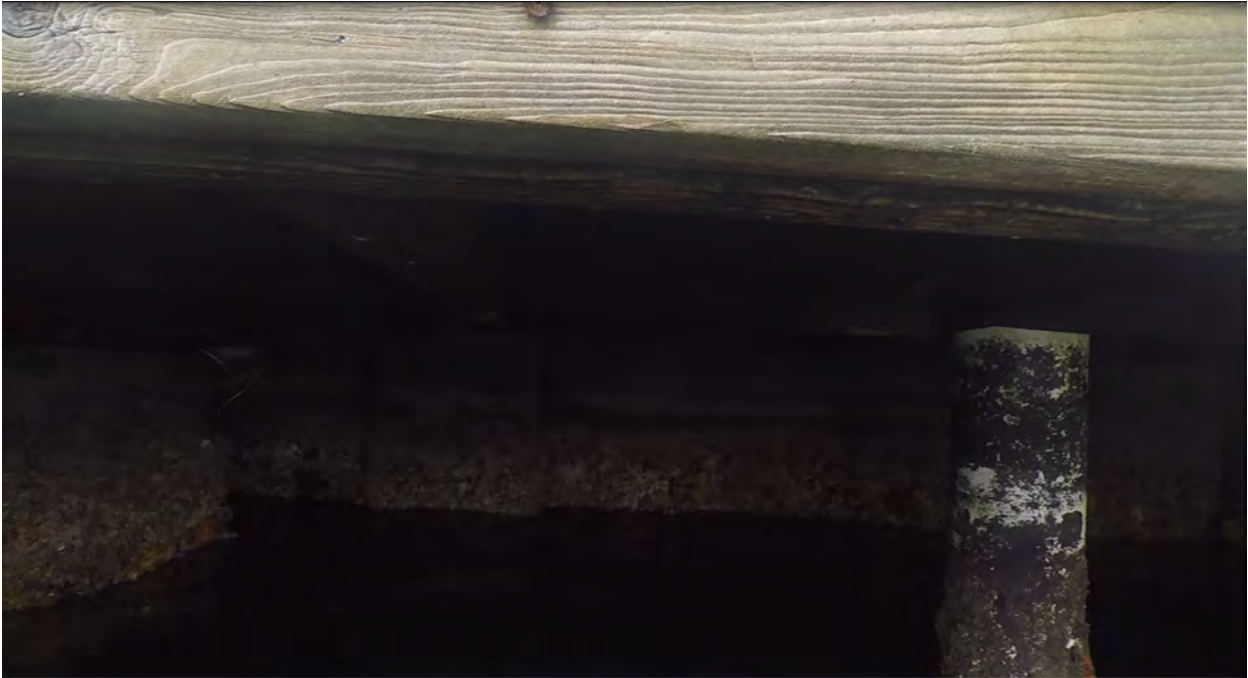
Figure 14: STA 0+90. North direction view. Seawall partial view with present debris, and partial view of seawall.

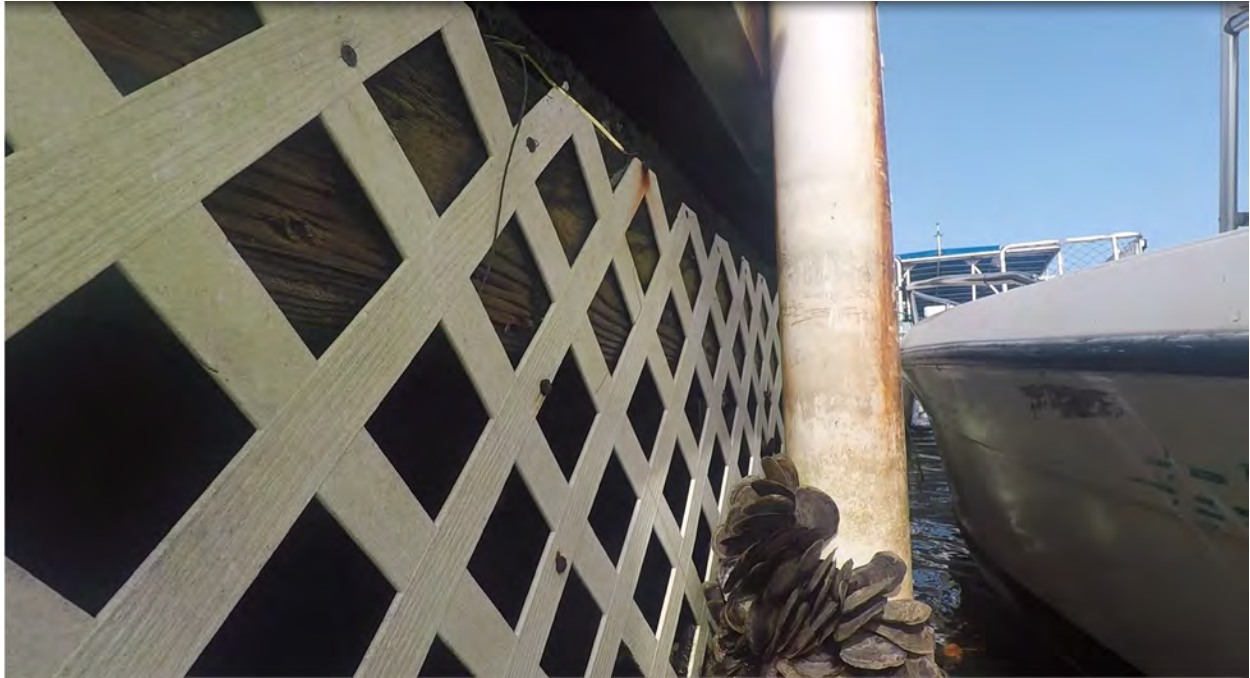
Figure 15: STA 1+00. Northeast direction view. Obstructions and debris in front of seawall.

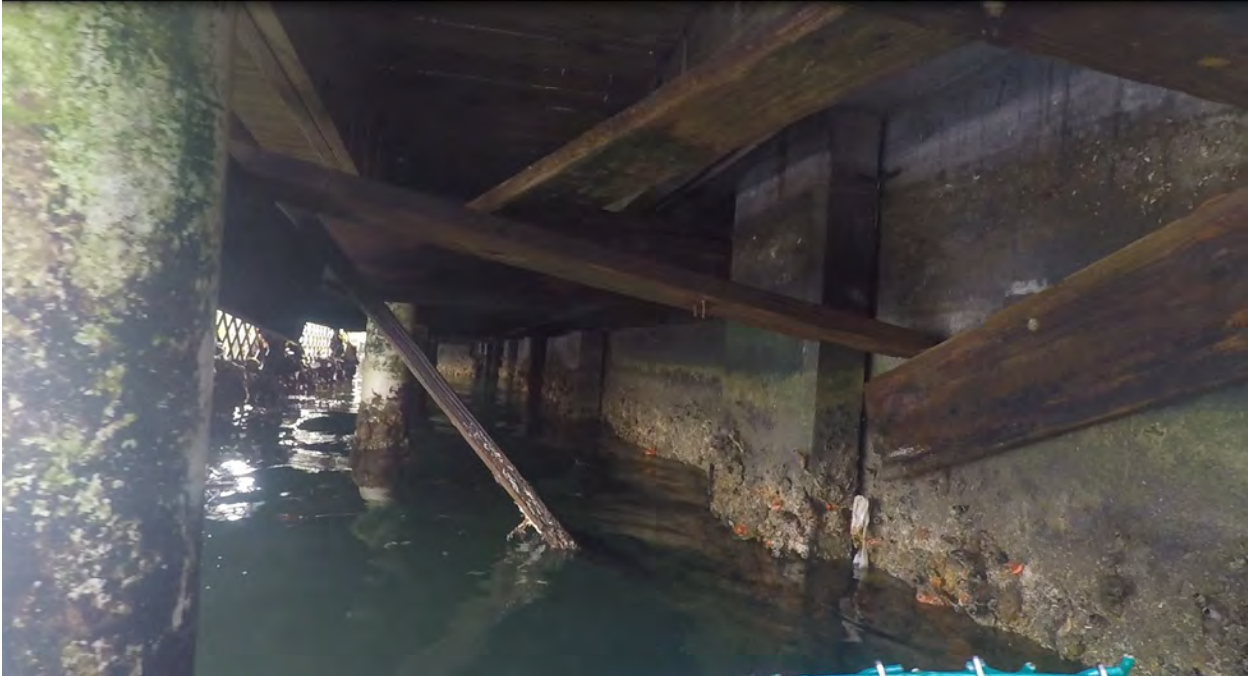
Figure 17: STA 1+20. West direction view. Seawall partial view with present overhead and in the water hazard.
